# Ven House Milborne Port Somerset

## Archaeological Watching Brief Report

April 2013

**Client: Slade Parry Ltd on behalf of  
Jasper Conran**

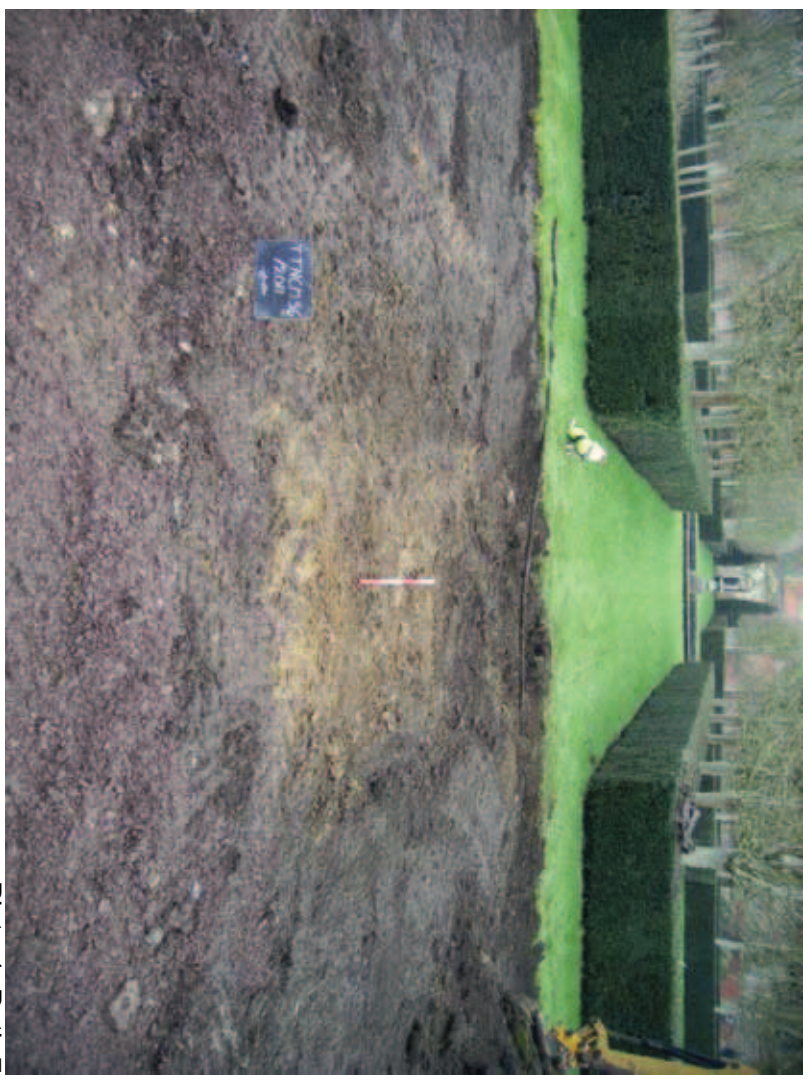
Plate 1: Path 7

- 3.1.7 Above the fill of the trenches and running the full width of the feature was a layer of medium to large sized limestone fragments up to 0.33m in depth (8). These stones appear to have been carefully placed forming a compact and stable layer rather than just tipped. The upper surface of this layer had been formed to leave a 2.2m wide by 0.18m deep depression following the axis of the feature.

- 3.1.8 Filling this depression was a layer of coarse gravel within a dark yellow sandy clay matrix (7). This layer had been compacted and its upper surface formed with a pronounced camber.

- 4.1.9 During the later phase these hedges, and possibly evidence of the original paths construction, have been removed and a compacted layer of limestone (8) laid across the full width of the path. The 2.2m wide layer of gravel, 7, probably formed the path surface itself. The presence of the limestone either side of the gravel path might indicate that there were originally low drystone walls (similar to that forming the eastern wall of the garden) flanking the path, but which have since been reduced in height below ground level. No dating evidence was found in any of the deposits within feature 10 making it difficult to fix these phases within the life of the garden. Conversations with the gardeners suggest that the gravel path was still visible in the latter part of the 20th century.
