Site/Project Name: **Westminster, 4 St James Square**

Site/Project Type: Building Survey & Watching Brief

WESTMINSTER
4 ST JAMES SQUARE
SJR 97
Box 1 file 1
INTRODUCTION

- 1.1 This note has been produced by the Oxford Archaeological Unit at the request of John Warren, architect for the Naval and Military Club, following a site meeting with representatives of Westminster City Council and English Heritage on 17 September 1997. The Listed Building Consent for works (970208 dated 26 August 1997) includes Condition 15 requiring approval from the City in consultation with English Heritage for full particulars of matters including:

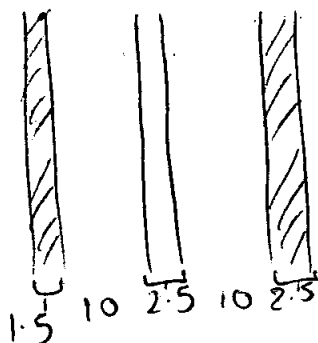
1. Partition wall = 2 brick thick wall. no cavity

27cm thick.

/// plaster - brown described before

Bricks - dark red / burg with yellow swirls. 22x10x7cm

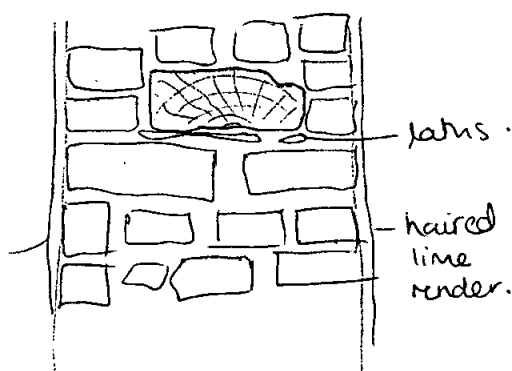
Temp hatch? or just using anything to strengthen wall build.

wall = 49cm wide.

wall built up as I. more care with wall faces than core - but all mortared in.

majority of bricks = red orange in colour. of varying shades. Creased sides. Unsharp arrises. v. few inclusions flecks of aggregate.

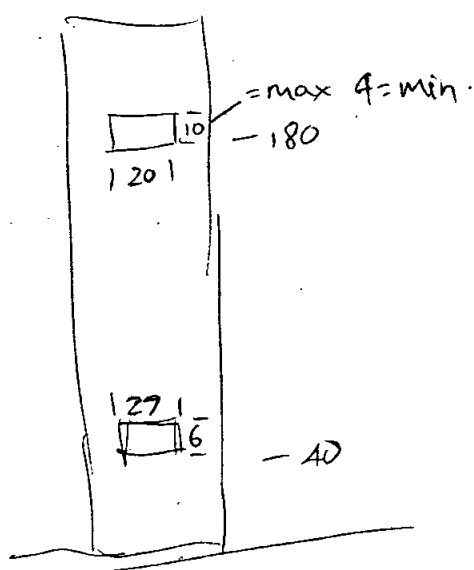
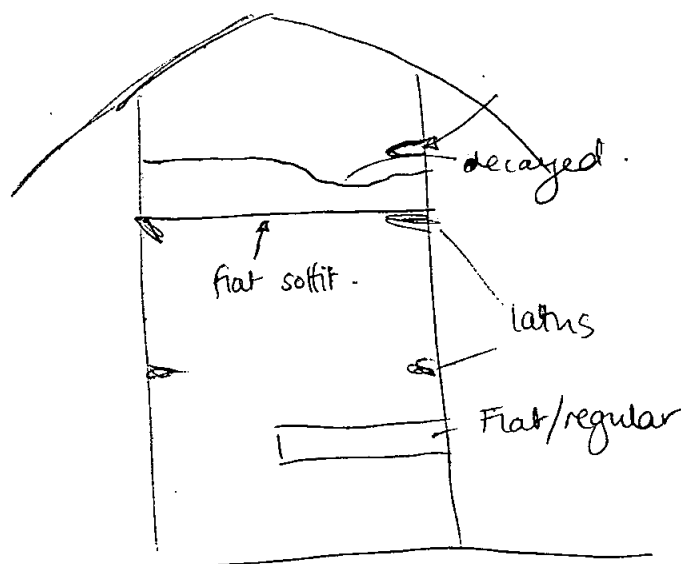
2 wooden beams were exposed - 1 at lower level c 40 cm from ground level, the other high level c 180 cm from floor. Lower does not run right across opening. It sticks out of right wall 47 cm. Upper runs right across opening. The timbers were not there as fixers as they are not flush with either wall face. They are built into centre of the wall. Not lintels either as sole piece of wood not carrying weight of wall above - bricks either side.

lower beam/plank = burnt. Possible reuse of material from burnt version of house.

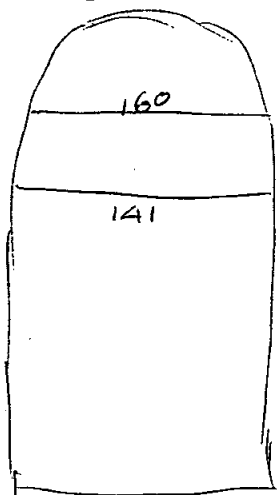
④ Level 1 New Door opening. C.

Area of brickwork exposed at upper level in blocked doorway.

109

3 courses of bricks exposed.

2 types of brick observed.

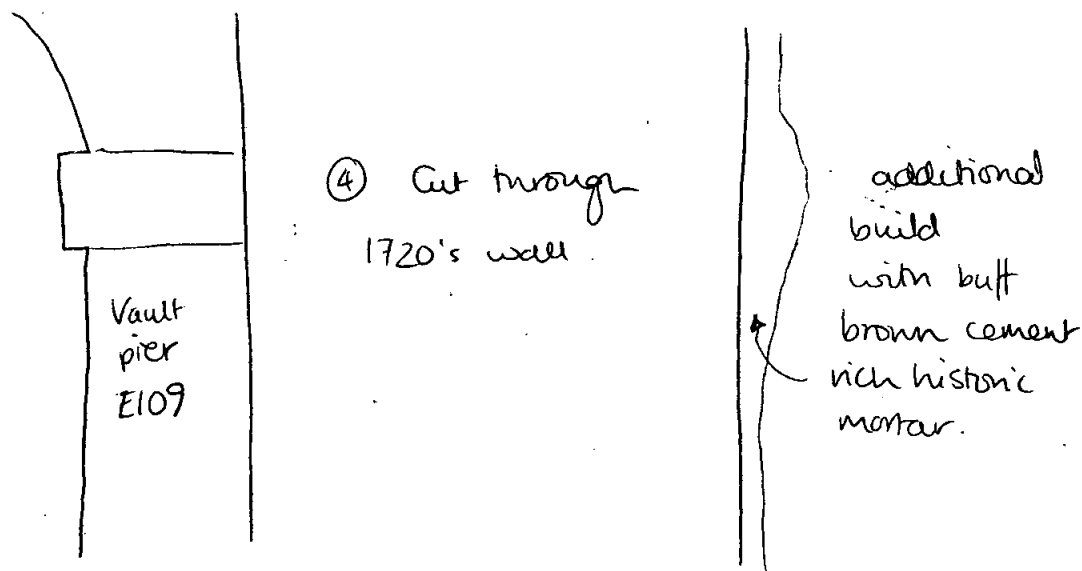
Cut through wall: majority red orange brick with few (up to 3%) inclusions. Crinkly faces, amises - not sharp. 220x60x100
 Latms included in wall build. A few B/Y's + dark red/burg stocks mortar as 2 even down to the blue/green glass like B/Y but no yellow.

Thin horizon of beige material - mortar at 149cm above floor level 3mm thick. both sides. mortar same mix either side of it. but definite break in continuity of build. mortar breaks + respects it. unclear what this signifies - ?

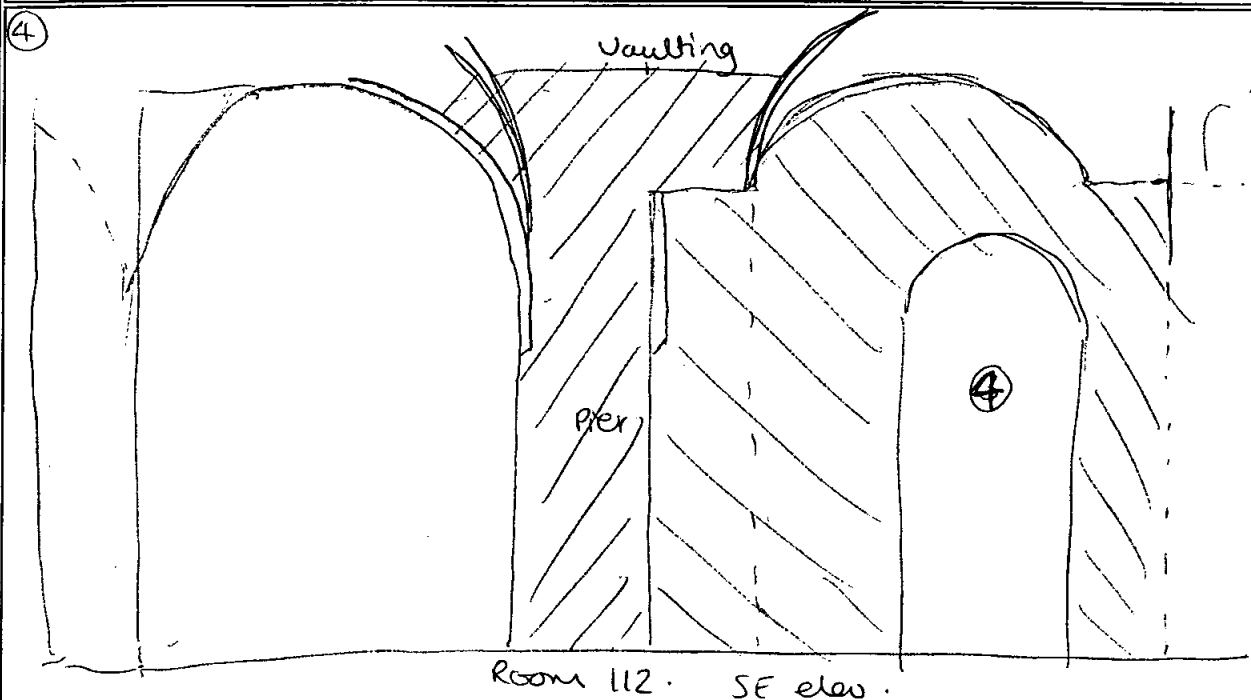
See Plan.

//// = additional later build - cut around + truncating vaulting. Purpose unclear - possibly something to do w fireplace of E109

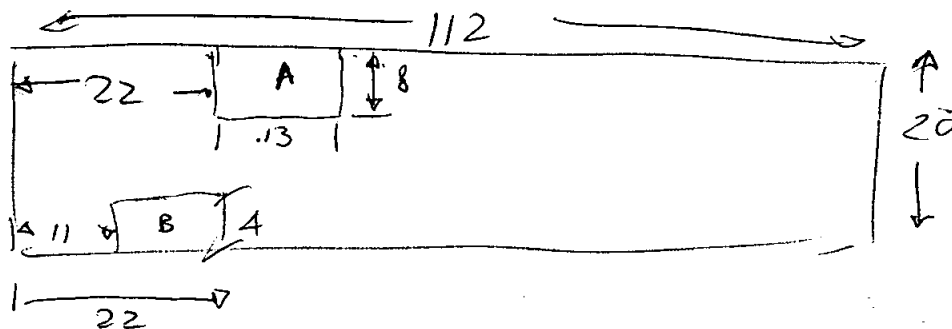
2 areas of note.

Area A Fragment of pinky yellow brick as ⑩ stuck
into to patch void + blocked around in the haired
lime plaster covering rest of wall surface.

When plaster removed + brick taken out hole 20 cm
into depth of wall is exposed.

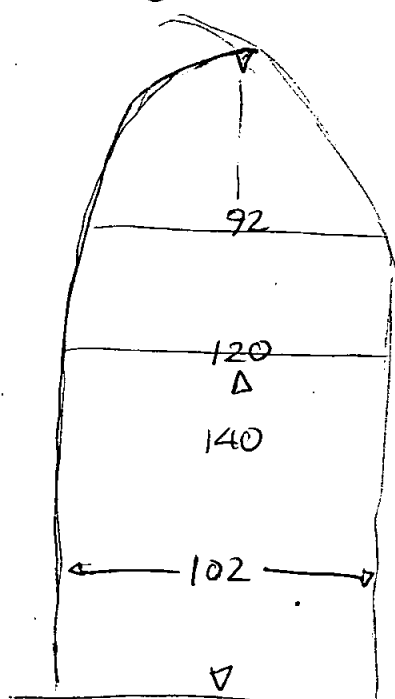
⑥ Vaulted ceiling truncates the head of this blocked doorway. See photo's + sketch.

3 courses of bricks exposed.

Very dark in doorway as one of the lights has failed. Bricks: hard to distinguish. Looks like a variety including soft orangey red $21\text{cm} \times 5\text{cm}$

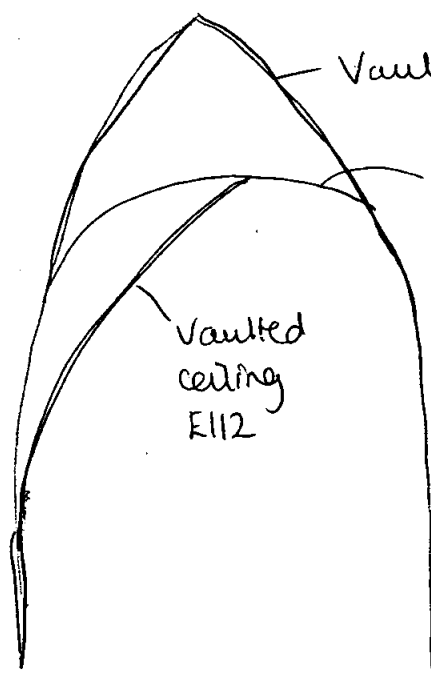
Vaulting of ceiling decorated with wooden pole detail
also seen on brown cement build + door 4a + 6
not seen on NW square headed door. All rest = round
headed.

6. Post demo. TV axis = blocking fastened in constantly to
springing level. E - just abutting door reveal. Bricks in

Vaulted ceiling passage

head of door 6.

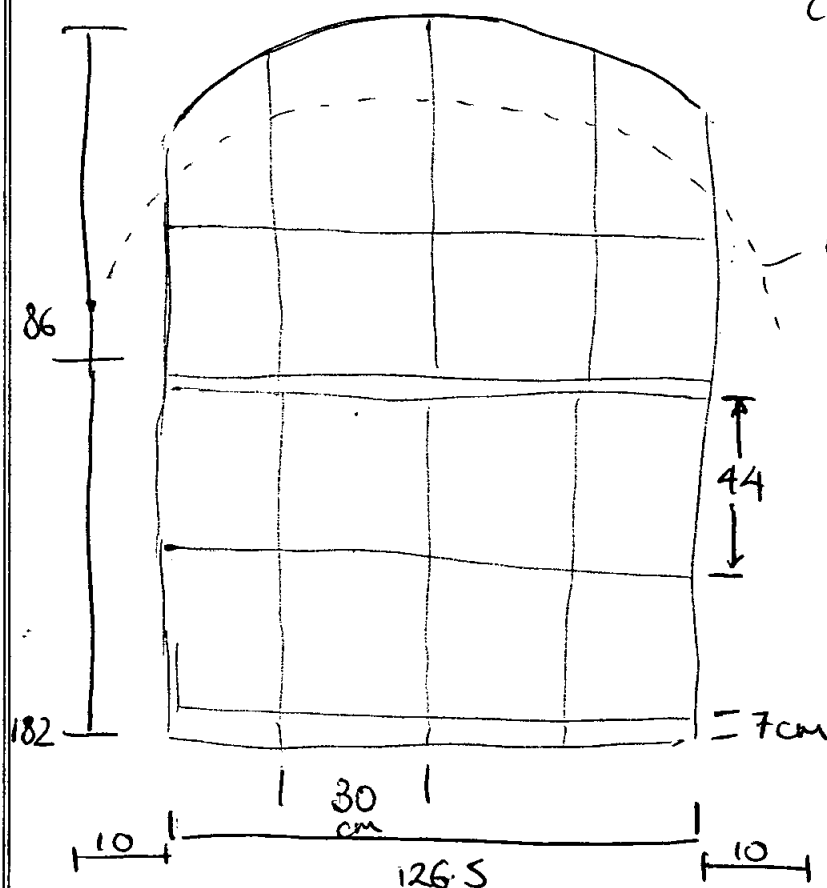
Sash window along passage fitted into an alcove 45cm back from main wall face. window opening higher than vaulted ceiling.

Thin glazing bars
c.2cm max.

arch of vaulted
ceiling.

Other sashes along
passage to be retained
same design so no
further record required.
photos taken.

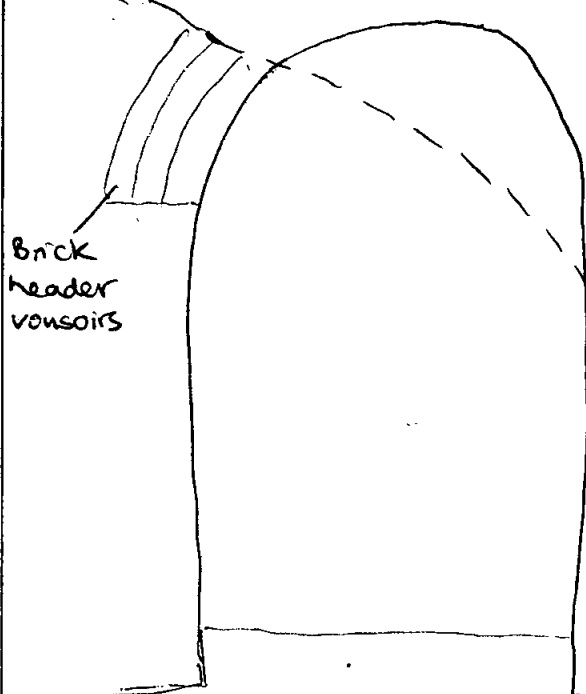
⑪ Level 1. Door re? opening.

= ~~Spinn~~ vault of ceiling.

Door blocking 48cm back from main wall face.

Crack down left side of door between blocking + door reveal.

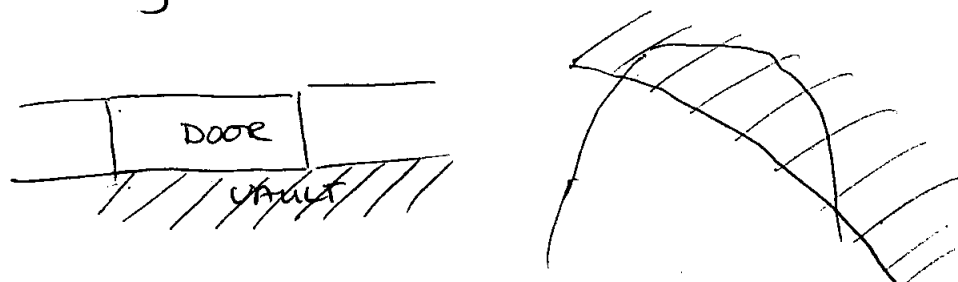
Vaulting of room seems 2ndry to door.

Vaulting truncates head.

Straight joint visible between pier on which ceiling vaulting lands and on right reveal of door. Suggests vaulting built into corner of room. This looks the case in the other corners of the room. See photos of wall & opening (12).

Semi circular vault of door is truncated by vault but is still visible in door alcove. Here on the other side of the ceiling vaulting - no white wash.

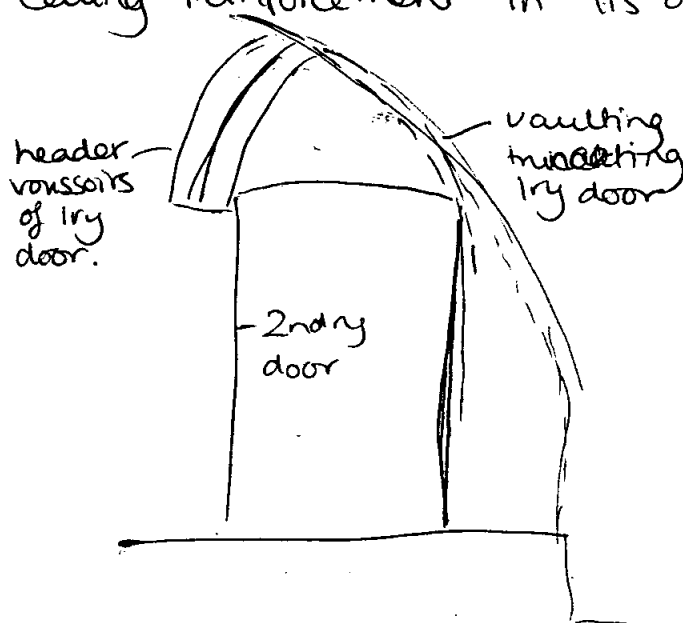
From the passage is NE side of new opening. Semicircular headed recess - back 60cm from main wall face.

frontarris = wooden pole finish. Skirting board fitted 21cm above floor level.

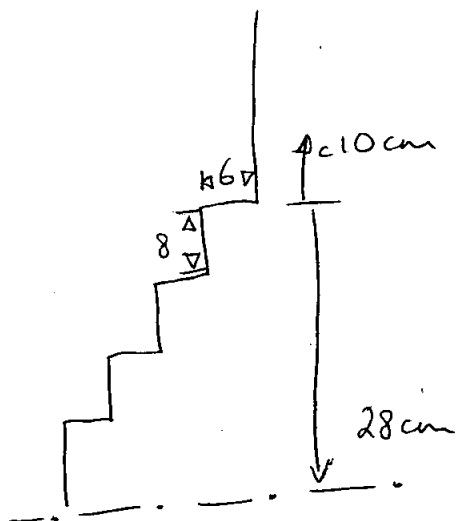
Staggered foundations exposed along E half of
corridor E115.

10 cm to previous floor level.

not continuous along wall
- see photo record.

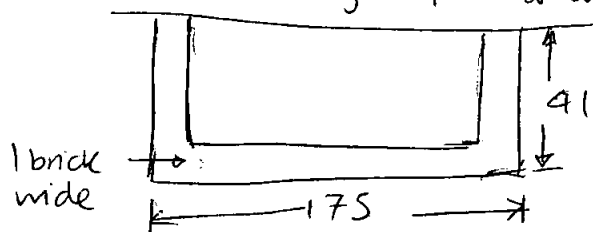
Under window immediately
to E of ⑩ brick construction
directly in front of window.

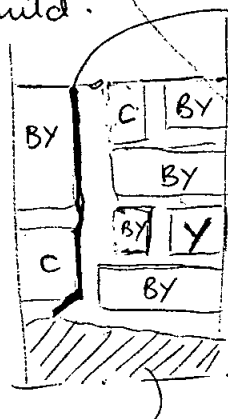
External opening - inner side areas of plaster stripped both sides of door.

To left ^{SE} strange brick formation points to this being additional build.

Crack line

3 types of brick seen

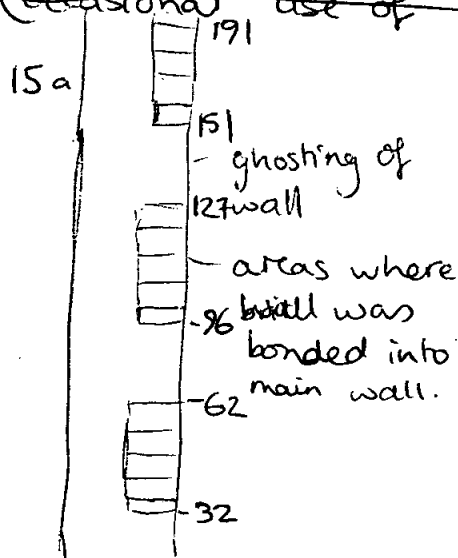
Doorway to side of 15a has been partially blocked. Type of brick unknown - some washed 5 brick spans of toothing in.

$12.5 \times 32 \text{ cm}$ = area of chopped off bricks - Bricks chopped off from partition to produce smoothish wall surface for surviving wall.

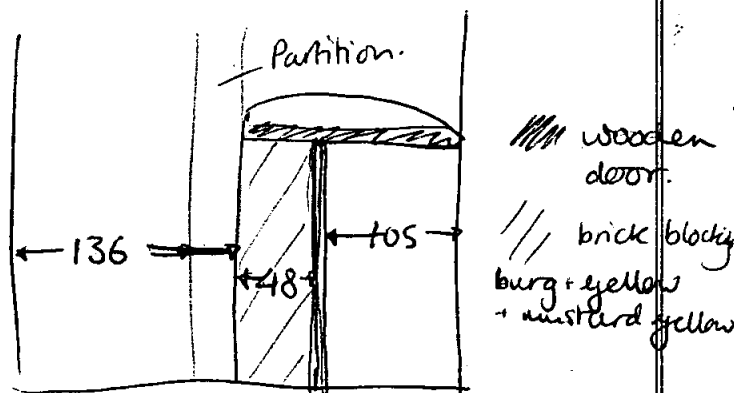
Just lighter colour no grime!

Same brick type for wall as partition. Toothing in may be way of building contemporary walls.

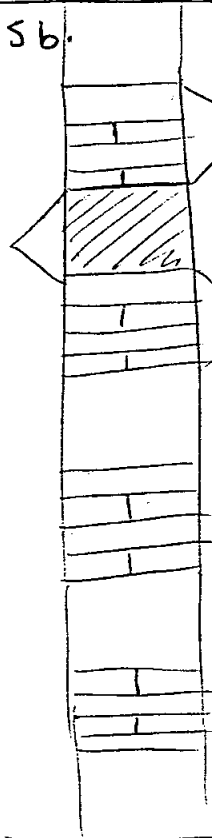
15b.

areas of
tooth in
for demolished
partition.

chopped bricks
from partition.
chunks of 4
bricks.

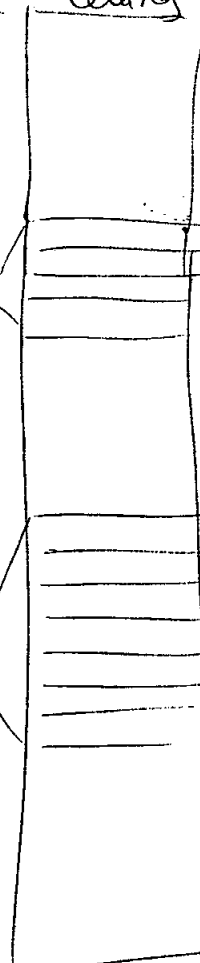
15c

15e, no tooth in
of partition except possibly
top half of wall.
However this unclear
as not all demolished
yet. - see photograph.

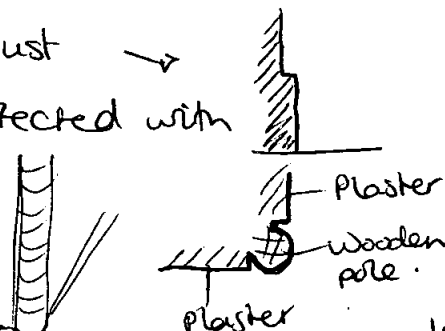
Doorway 216 \uparrow x 69 wide.

Inside walls painted maroon to 132 cm above floor then cream above.

Bricks seen in toothing in are the mustard yellow + pinky yellow type of (5) + (18)

Remains of toilet equipment fittings seen as holes in wall + ceramic tiles. At demolition - some toothing in seen at top 1/2 of wall.

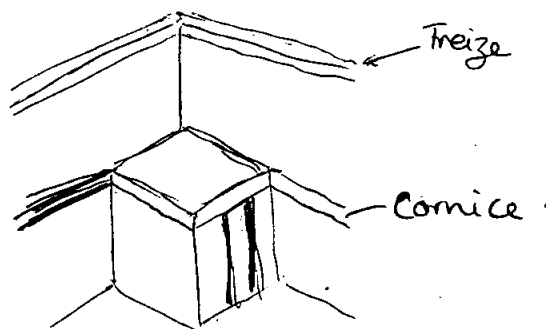
② Level 2 Removal of Draught Lobby. ①

Draught lobby partitioning off front door from room E202. Cornice around wall at mid point marks height of this partition. Same cornice around lobby as rest of room + same paneling design. Lobby not boxed to full height of room.

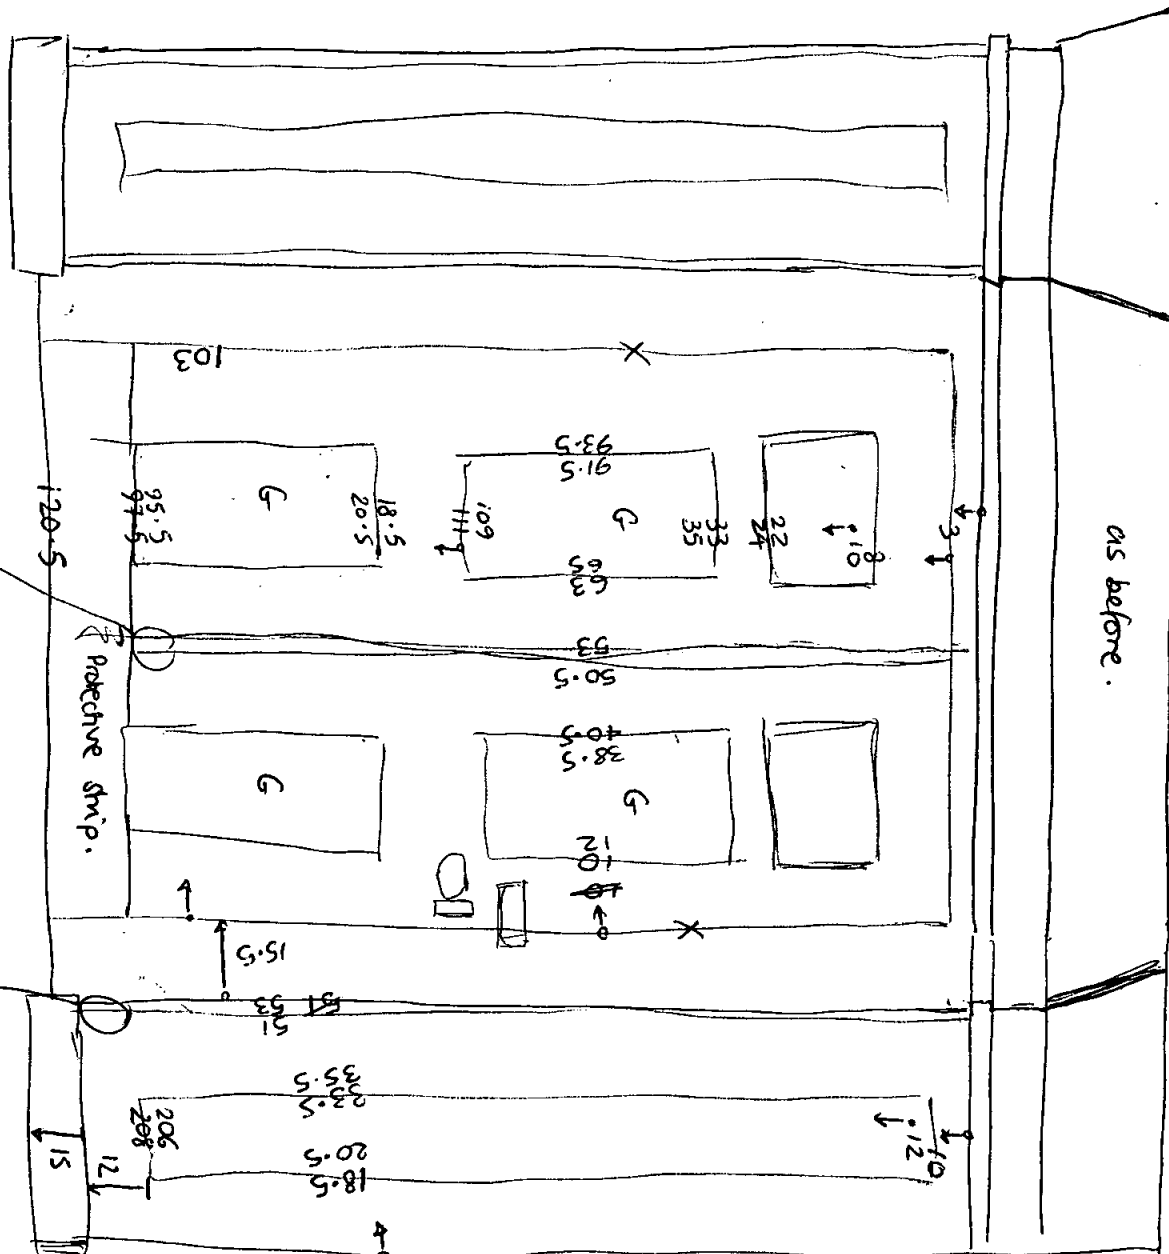
(20) NW wall.

Door portion recessed from main face 7mm. Door recessed a further 3mm

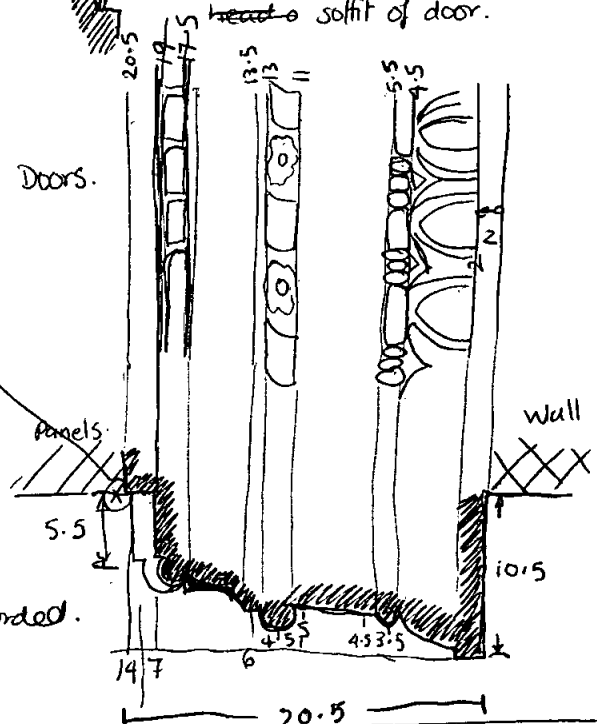
'ceiling' paneling
head of solfit of door.

NE panelled side of double door.

NW same detail - narrow panel to NW.
as in solfit panel.Prob. softwood panel. painted white.
ornate moulding - interior of 205. Plainer
moulding on exterior. - not affected so not recorded.

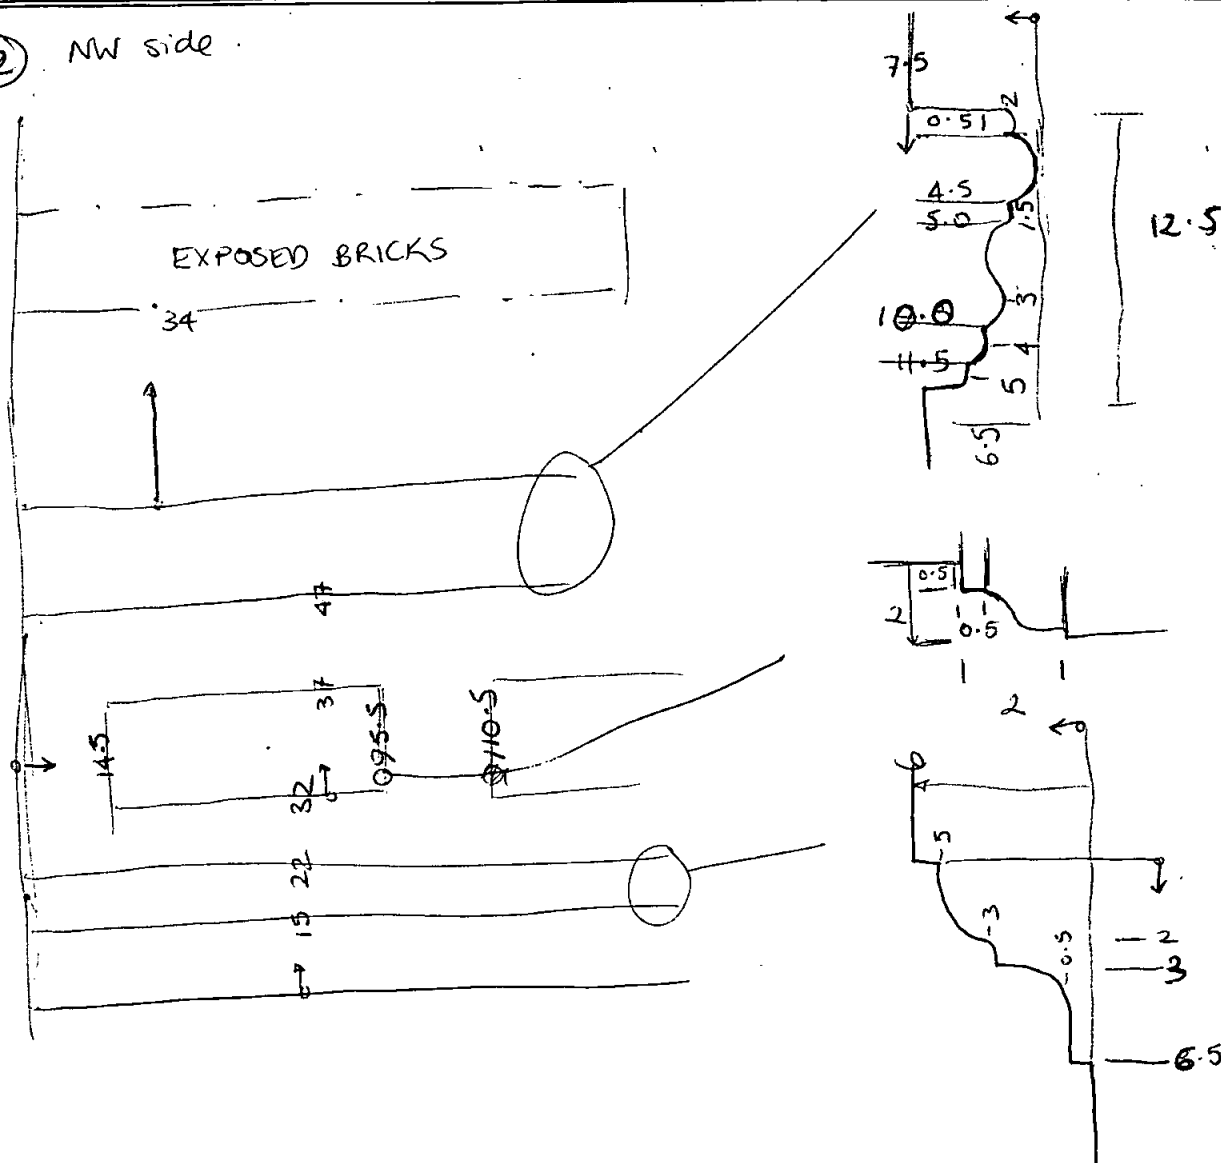
(22) NW side

Existing door to be removed, also affected some paneling.
new doorway scales 1.75m from 1:50 plans.

Paneling to be affected = same as that in situ so brief sketch only required.

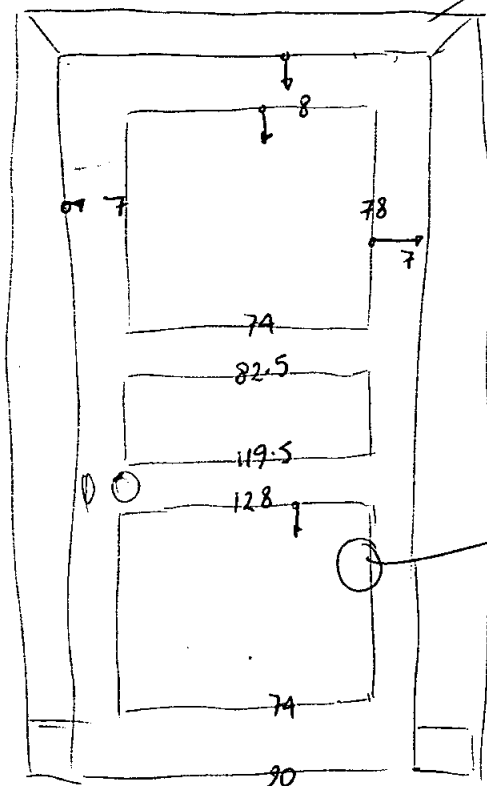
23 Door Detail

Door pretty much centred in provided panel on wall.

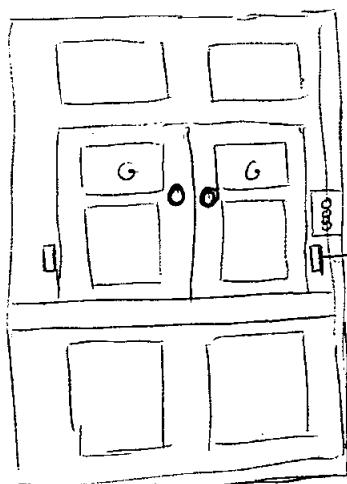
on wall by side of lift metal plate with window - probably to hold details of lift use or what floor currently on.

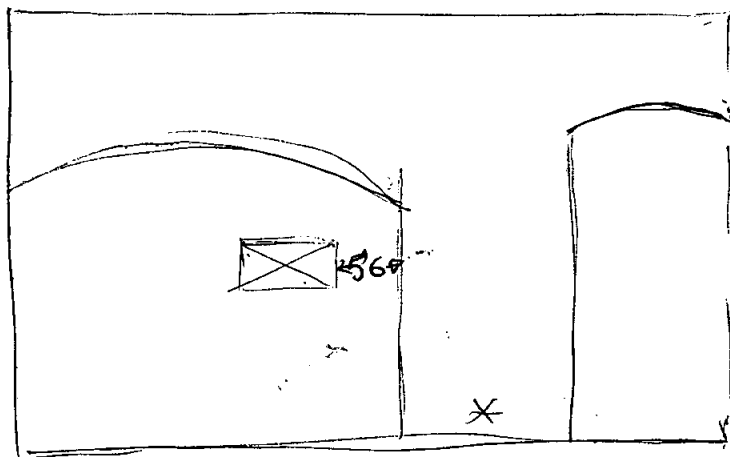
- ③1 Area of Plaster removed SW side of passage.
New opening to be knocked through during works.
53x28cm opening.

Burg + yellow brittle type bricks = majority exposed
1 other - possibly same type with just diff. colour variations.
Same size as burg/yellow i.e. 23x6.5 ~~cm~~
But colour v. different
redish orange brown mid tones.
~~Inclusions - aggr~~
Chipped another bit + yellow

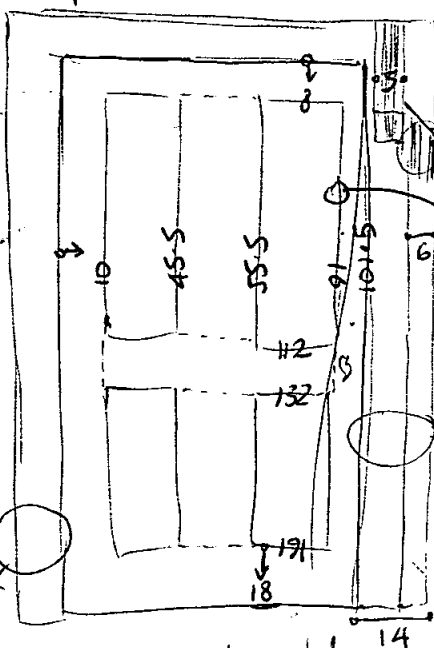
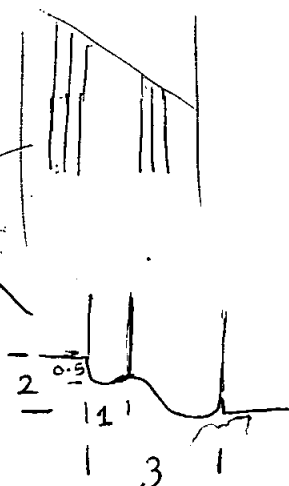
2 "Queen Anne" style corner fireplaces to be removed from what is now 1 room. Partitions shown on 'as existing' plans have been removed before arrival. But photographic record made of their imprint. Must historically have been 2 rooms with 2 corner fireplaces.

Door to be removed - details
sketched + photographed.
originally a door to room served
by W corner fireplace.
now converted to cupboard.

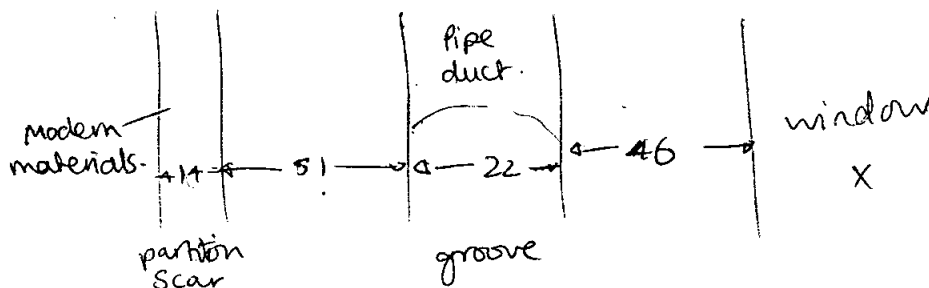
Next to partition scar on NW wall is large groove cut out of brickwork. Possibly due to "dumb waiter" remains of which are littered around room or pipes. 22cm wide, complete height of wall + continuing downwards. 11cm depth into wall. Brick + mortar exposed as described in (31) for this room.

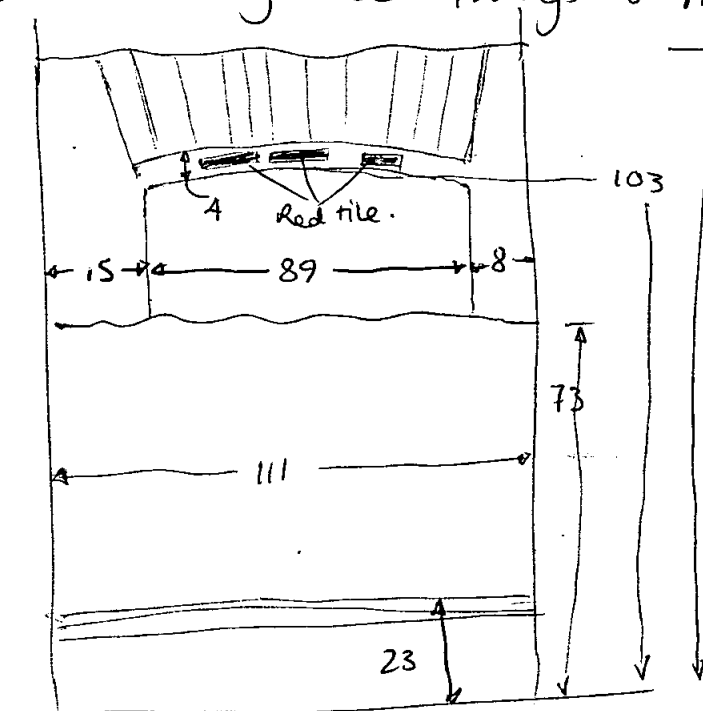
(32) Corner Fireplace. NE wall.

Unlike the remaining fireplace to W of room this one had already had fittings stripped + opening blocked.

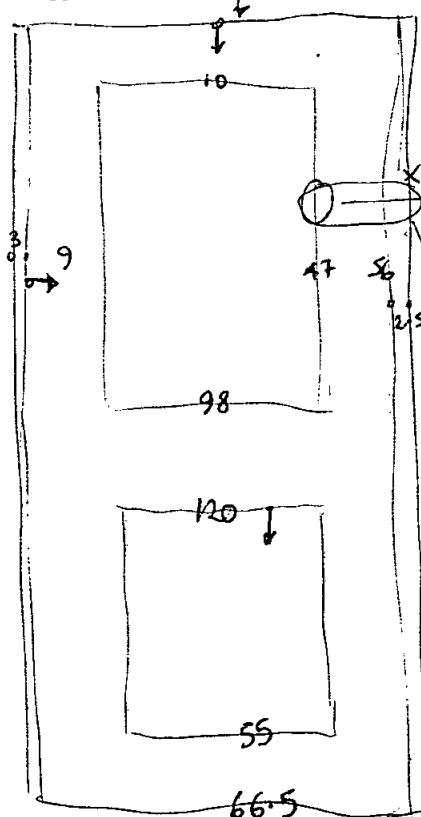
Soffit of door. 304

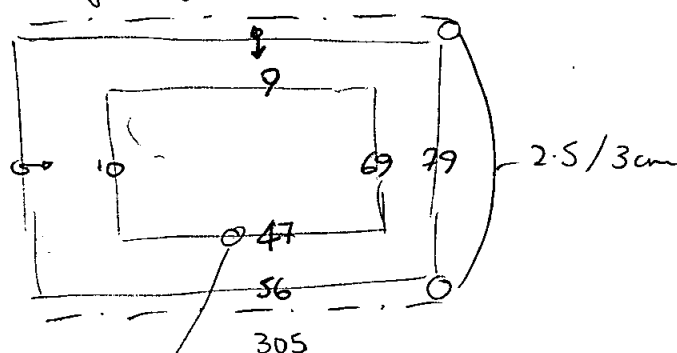
No door frames in situ.
304 side where frame would fit is hacked
back but traces of hinges left →
bottom 7 21-32 cm from floorboards
174.5-185 cm up = upper on left side
of door.

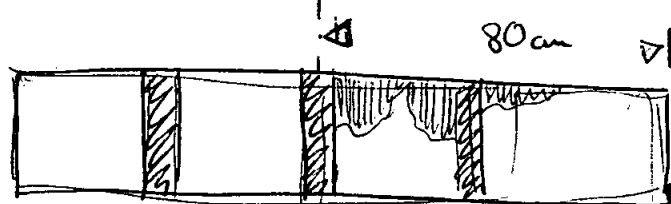
Bricks covered
in black dirt no
wall plaster.

Bricks \bar{c} frags
of wall plaster,
+ stained by plaster.

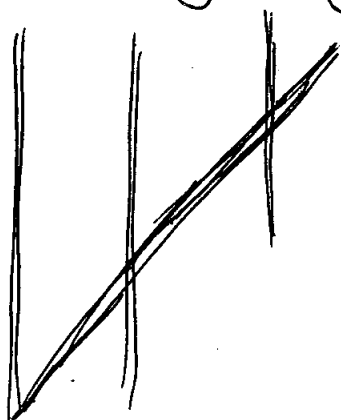
Brick noggin infil.

mortar very strong - white
high levels of sand only
inclusion.

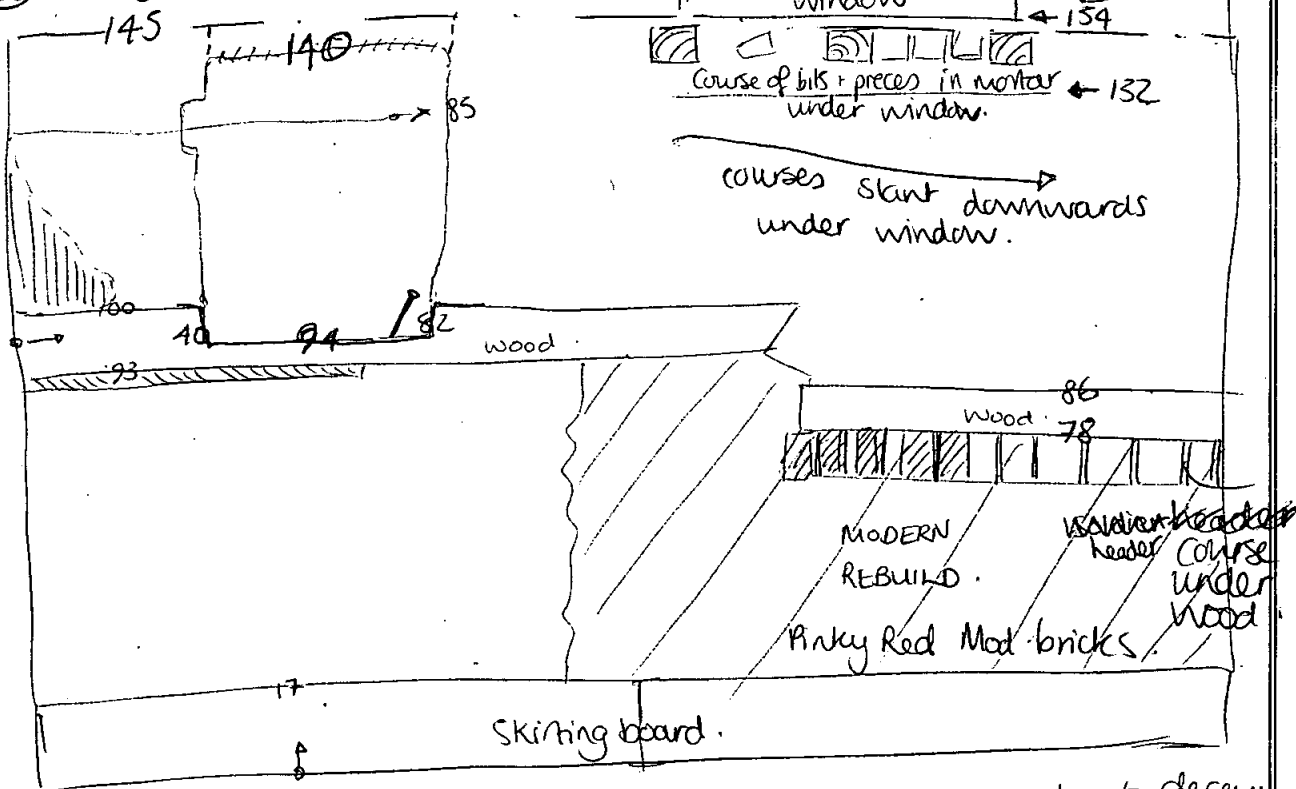
③ E318

Bricks around patched area = irregular, soft + crumbling due to decay
 Red orange + Burg Yellow + Dark Red types. No bond as such, sizes
 appear v. much random. Not many full length stretchers + where
 there are these norm Burg/Yellow type.

Mortar - badly decayed lime mortar. white in patches + sand beige -
 mottled Inclusions - fleck grits / ~~less~~ less than 0.5cm ϕ = ~~4%~~
 Grit aggregate up to 1.5cm ϕ rare - ~~4%~~ bits of red brick also.
 Lg size of inclusions - doesn't help mortar hold together.

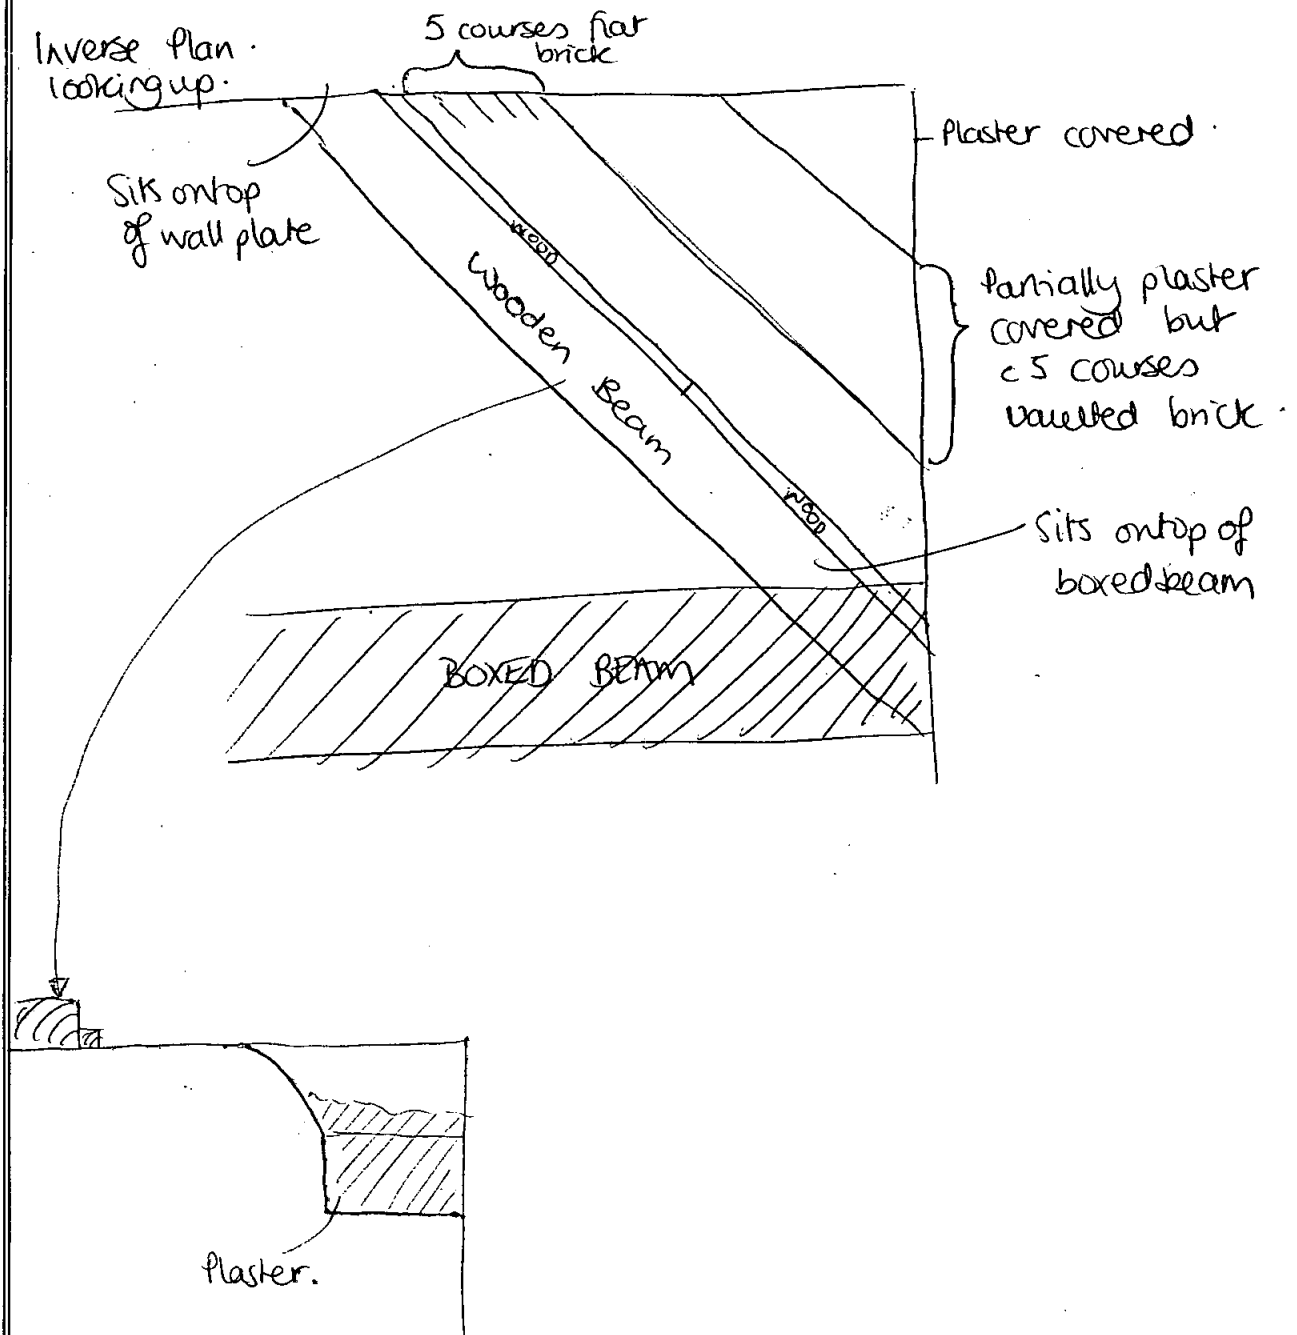
E317 38
In NW corner of room = support for upstairs corner fireplace
extent marked on 1:50 plans. Sketch here.

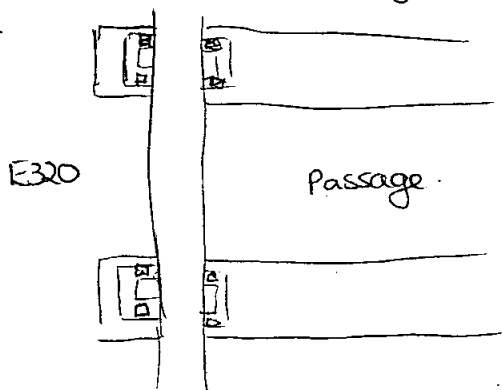
E320. Similar metal plate arrangement seen just before partition wall. Beam goes through wall c 20cm into E320

Boxed beam to NE of support also cuts through door frame.

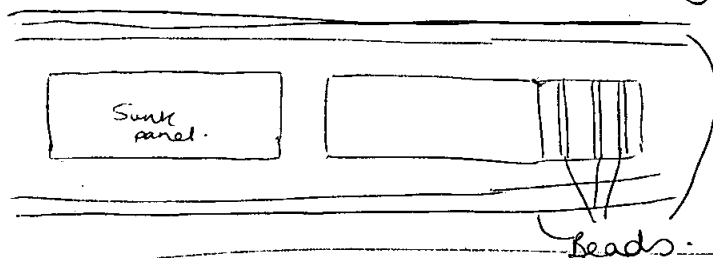
Beams housed in panelled boxing

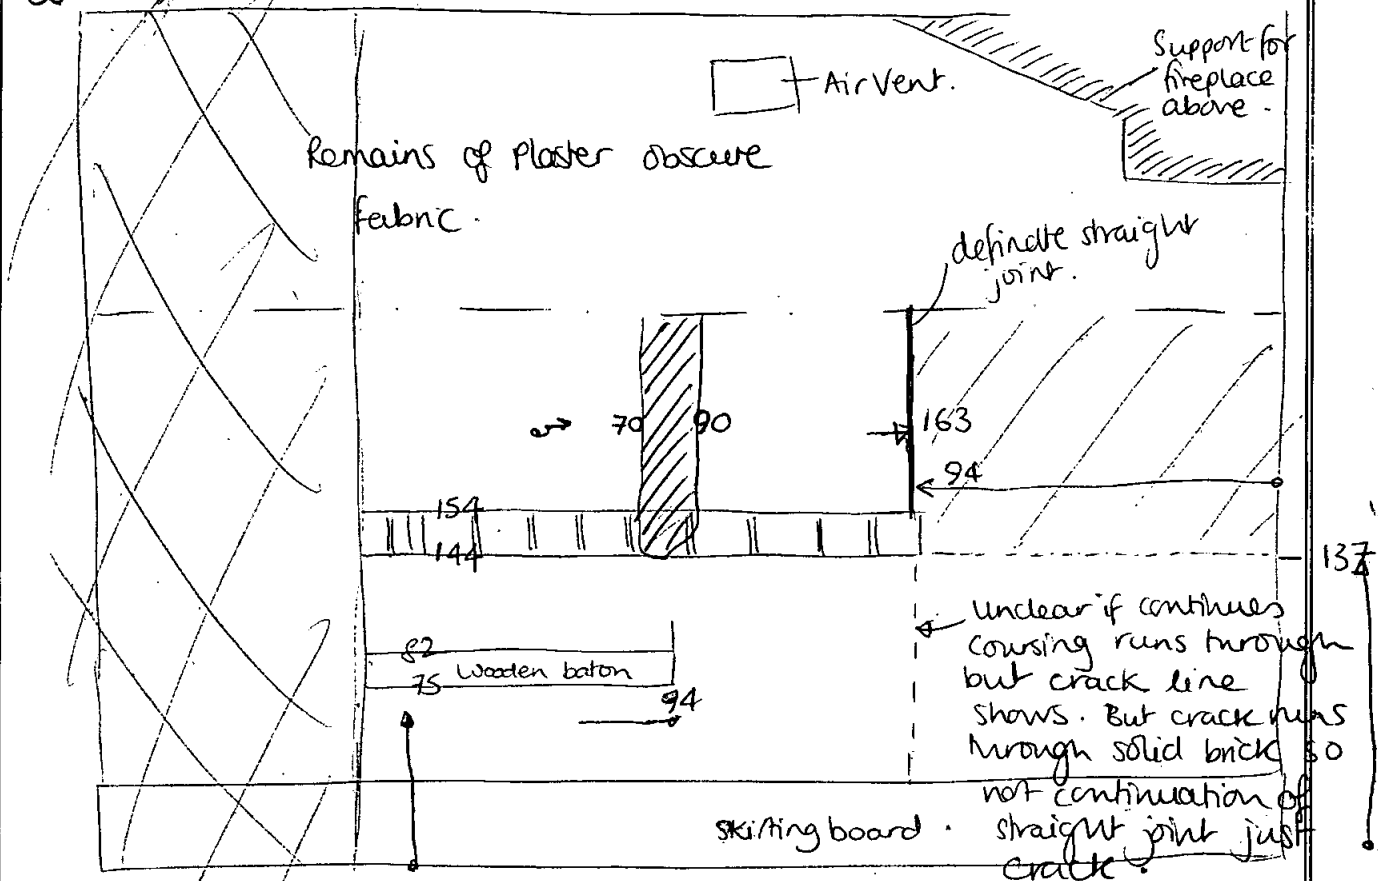
38 E317

messiest bit of wall. lots of mortar : brick ratio. Bricks ~~are~~ = majority = cut offs. i.e. ~~the~~ sealed faces seen mostly cut bits + pieces. Rest of wall also fairly messy but not like this. No bond identified, cobbled together. Red Orange + Burgundy / Yellow type bricks. -

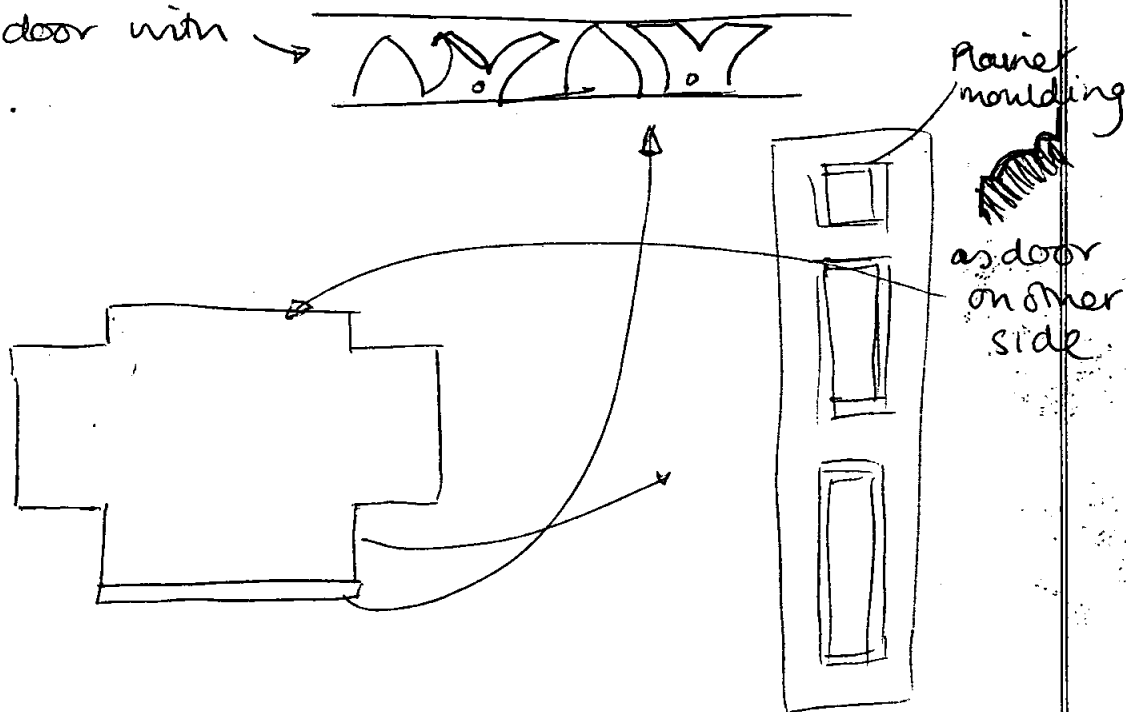
6 panel door with
decoration.

Actually not double door - see plan.

Cupboard make niche for bed chamber other side.

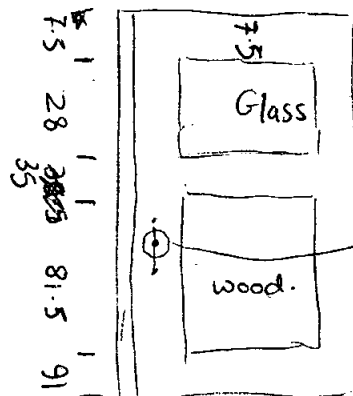
Modern metal
 handles
 holes for
 originals still
 visible.
 1 hole per door
 central

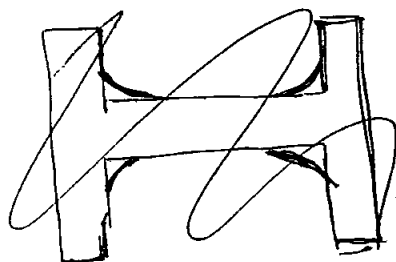
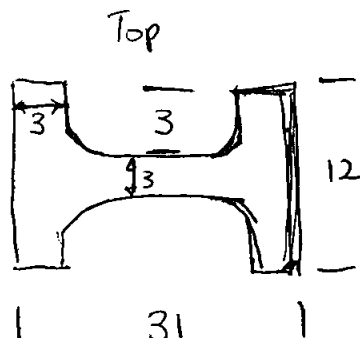
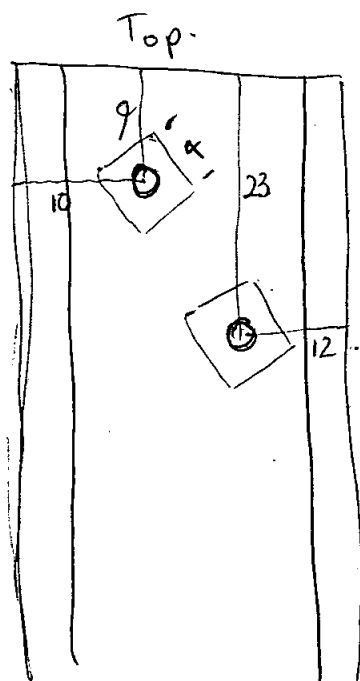
Metal girders from demolished building. (41)

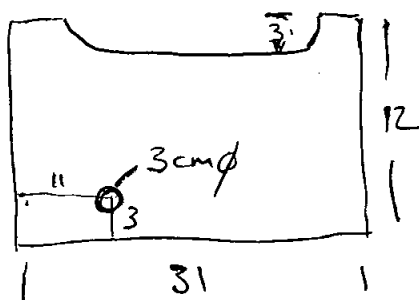
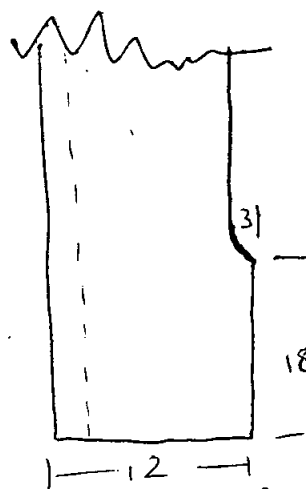
Cross Section

Side profile

metal girders from demolished wing.

Girders supported on iron column with capital. Compare with that found in E318/317 Babmaes.

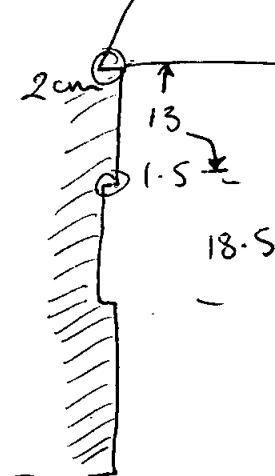
(42) Door Frame has grooves cut out
matching on both sides.

Roughly hacked out.

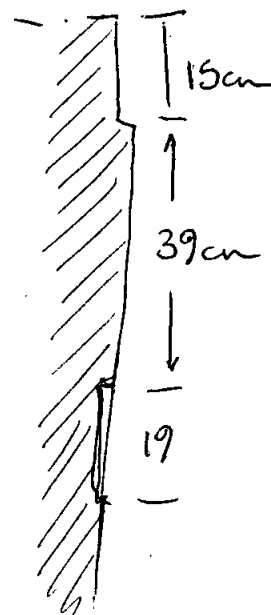
Lathes blocking this door = different
to rest of wall. not in same
framing run. Smaller nail heads.
larger laths. i.e. wider
2.5cm to 2cm

Plaster covering laths creamy white
lime plaster with inclusions of #
shell, grit / pebbles up to 1cm Ø
c30% common.

Studs 6.5 x 12. — 5.5 x 12.

33cm spacings.
