Site/Project Name: **Westminster, 4 St James Square**

Site/Project Type: Building Survey & Watching Brief

WESTMINSTER
4 ST JAMES SQUARE
SJR 97
Box 1 file 1
INTRODUCTION

- 1.1 This note has been produced by the Oxford Archaeological Unit at the request of John Warren, architect for the Naval and Military Club, following a site meeting with representatives of Westminster City Council and English Heritage on 17 September 1997. The Listed Building Consent for works (970208 dated 26 August 1997) includes Condition 15 requiring approval from the City in consultation with English Heritage for full particulars of matters including:

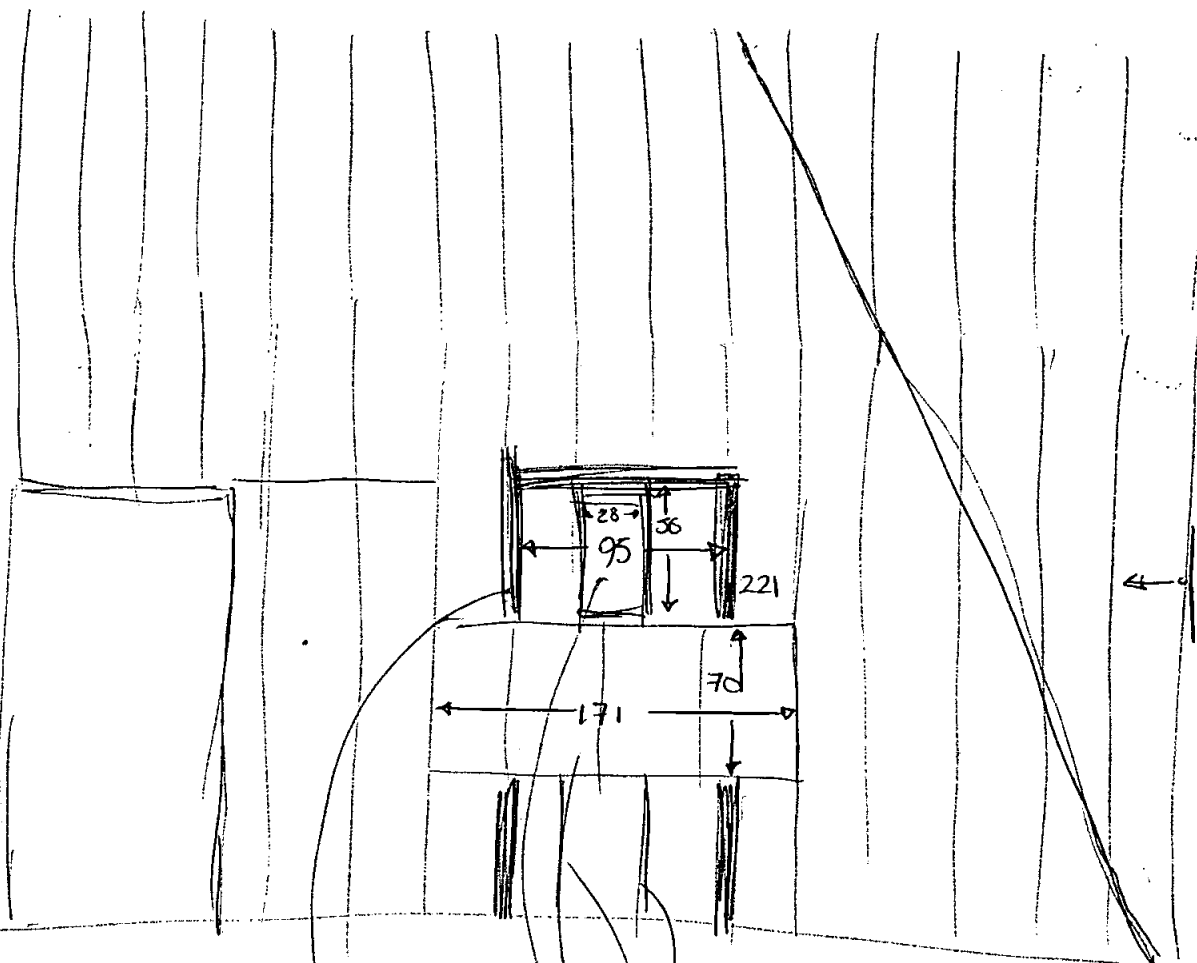
(42) SE wall stripped.

original door.
 8.5 x 12.5 \bar{c} attached
 piece 2.5 x 4 cm
 Door 96 wide
 x 2.32m height.

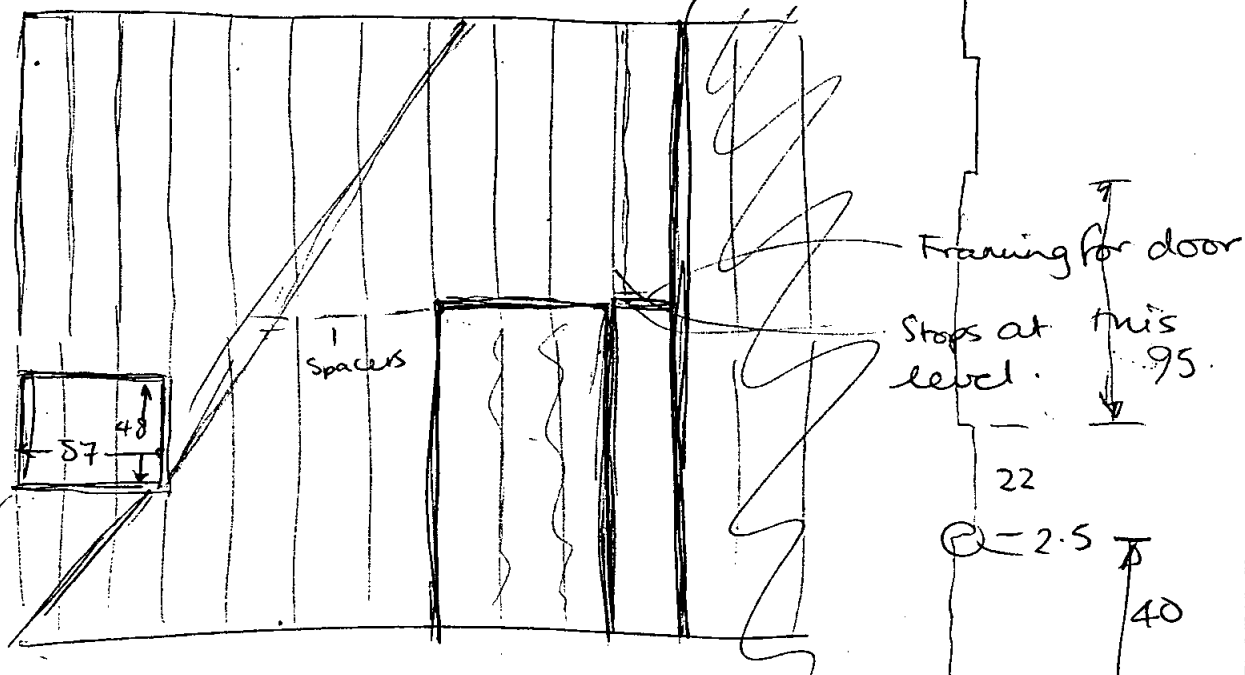
(42)

NE wall.

5x12cm → 8x12cm. = Stud measurements.
softwood

→ noticeably later softwood framing. modern - light pine. covered by grey plaster board.

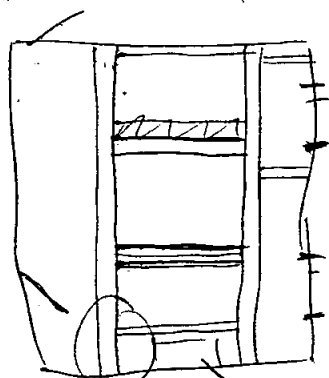
Ceiling stripped of plaster before arrival - plasterboard?
Most timber looks like replacement very light in colour
all softwood.

Some pieces do look original. They show evidence of
burning esp beam furthest from courtyard which is
positively charred at right hand end. Others just
blackened. Is this more evidence for reuse of
material from 1st house?

Brick vault for 6th floor fireplace directly above
fire place of this room. Yellow stock.

main original timbers surviving.

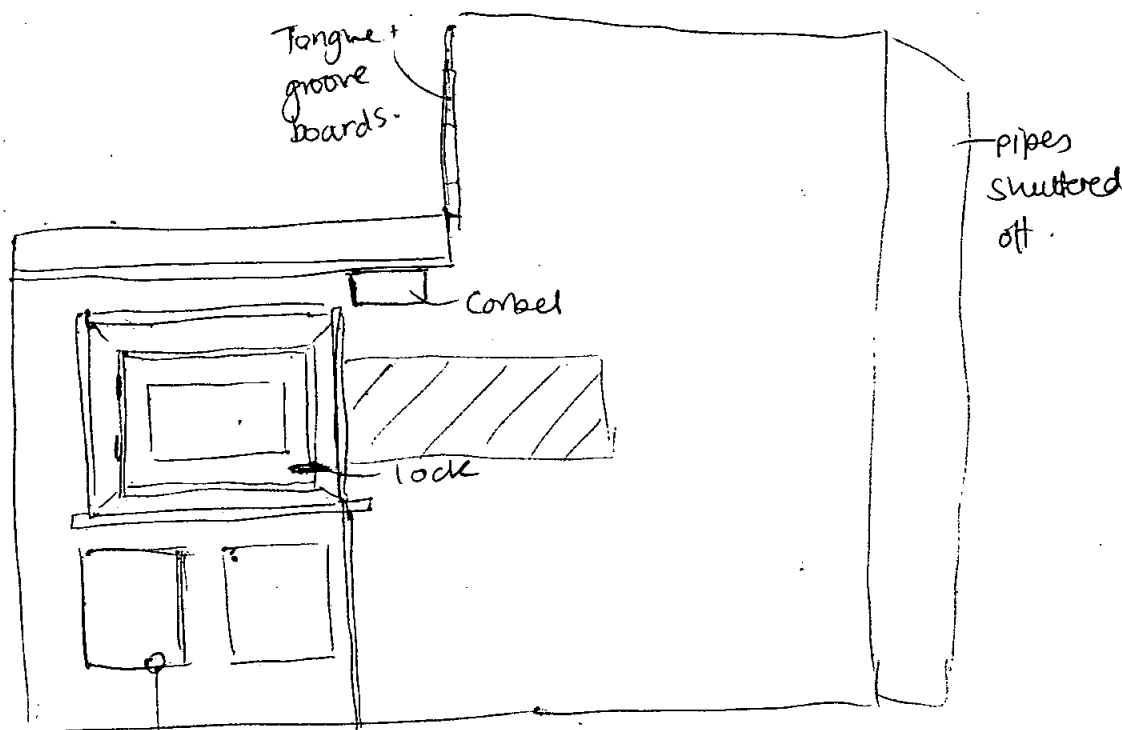
Hatch door.

Doorway / Hatch to building now demolished. wooden panelling photographed - not like panelling of doors seen before - plainer.

Bricks exposed = pinky yellow + burg/yellow as described in 51.

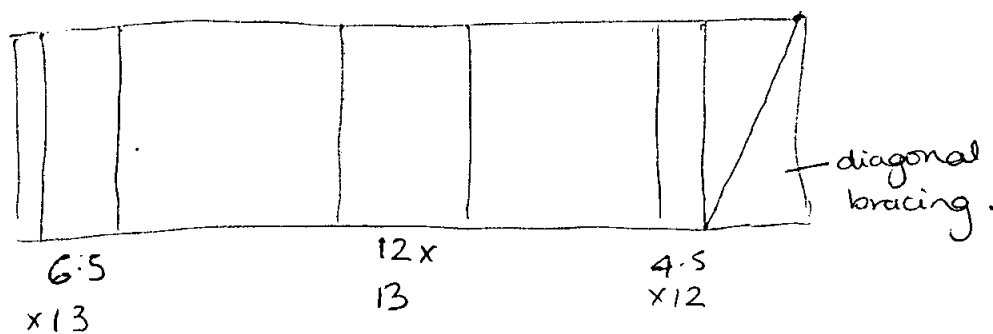
laths - 2.5 cm look split. fixed with hand made nails - irregular 1 cm heads.

4 studs revealed - all different sizes! softwood.

Wall c 18cm wide in total.

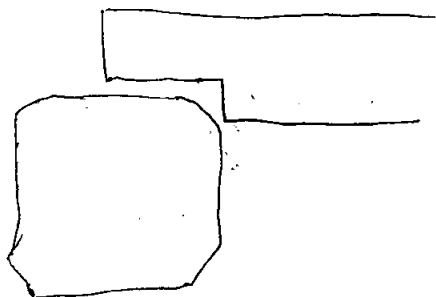
Beams run across the passage with joists for floor 7 resting on them + running lengthways

Smaller 'joists'? for ceiling are fixed in a no of ways

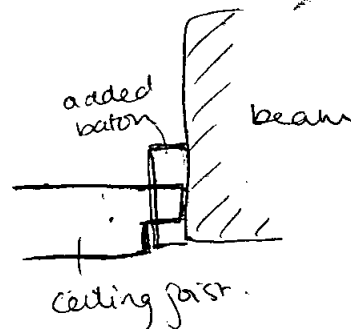
but sometimes

timbers v. variable in size - not squared off some v. waney look pretty much like branches! + 1/4 trunks!

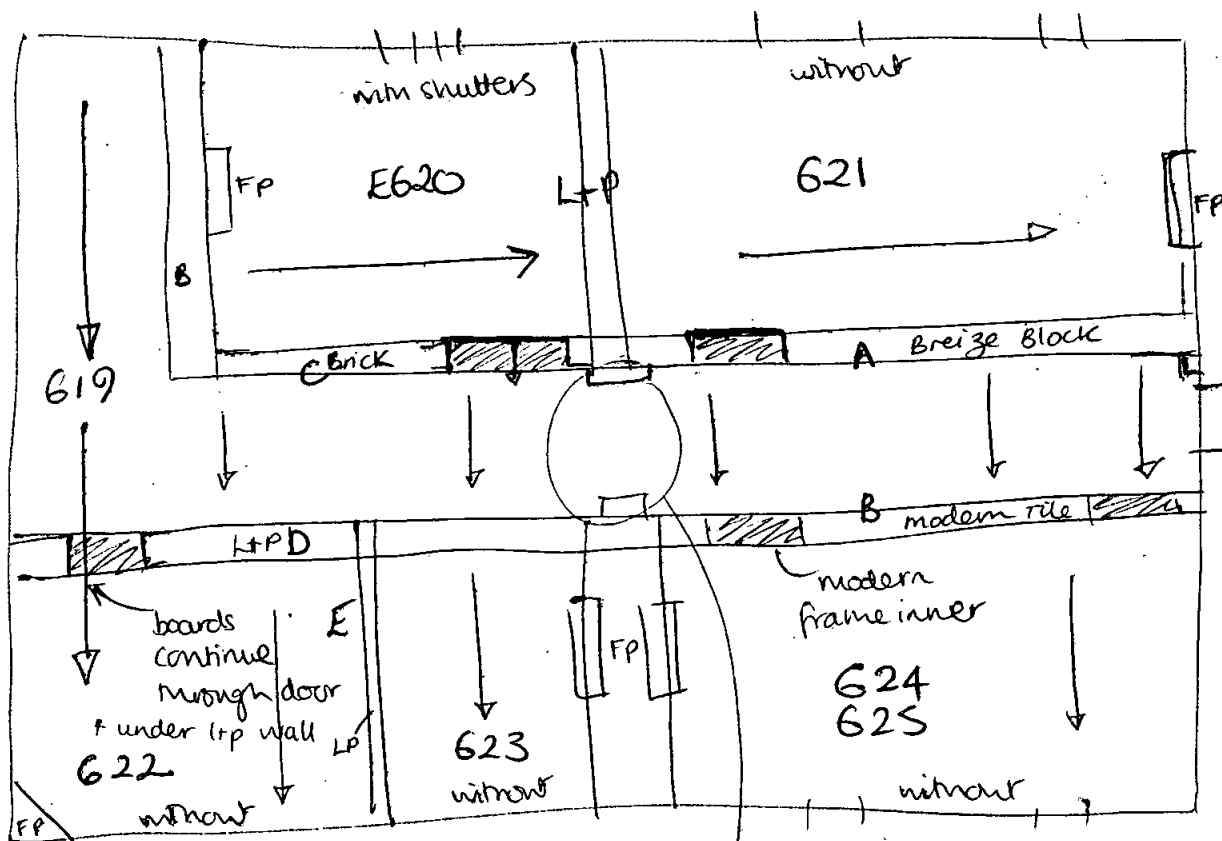
Flooring of general 65 area.

↓ = direction of floor boards

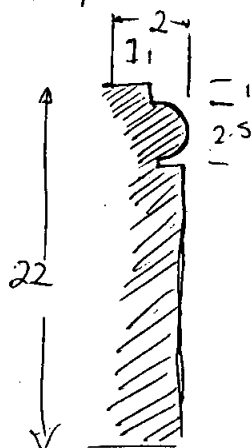
skirting.

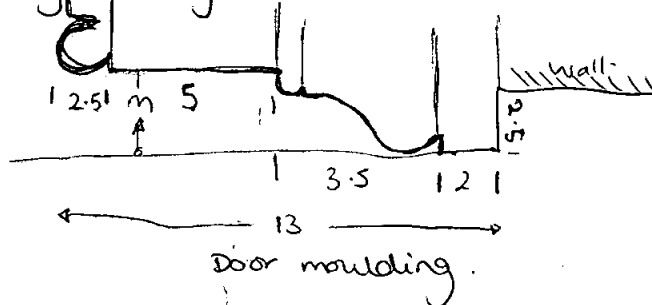
Paneling to side of reveal

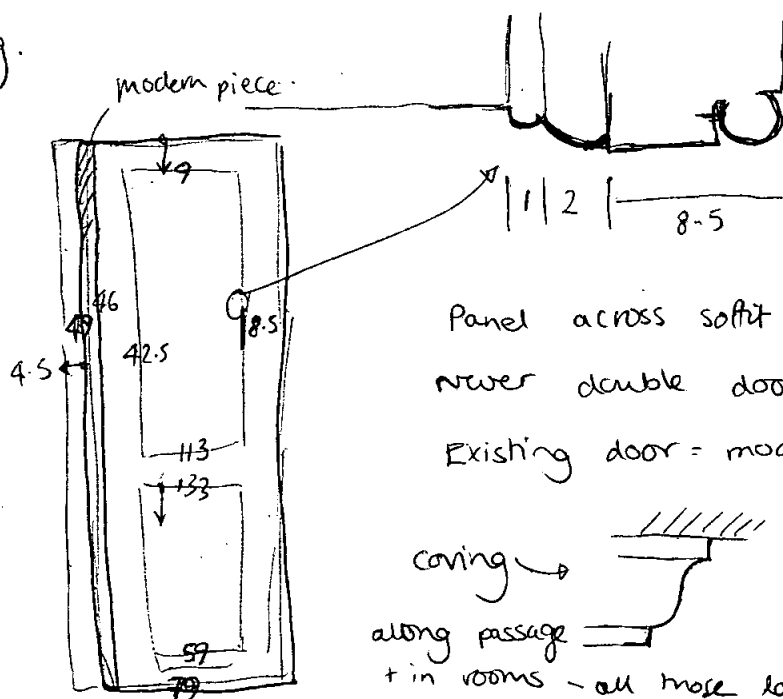
Panel across soffit of door as well
newer double door.

Existing door = modern - not pannelled.

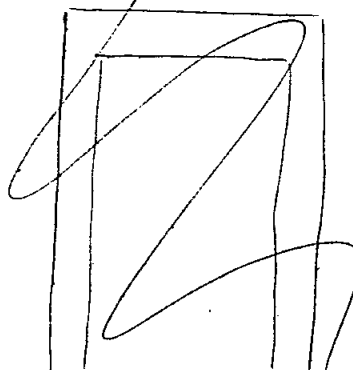
Plan

wall ÷ E620 + E621
 = lam + plaster.
 Small hole in wall
 shows this.

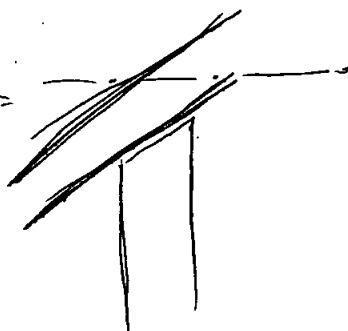
NE most stud =

Cut for diagonal bracing
 of frame to run through
 as seen in (42).

Through cavity other side plaster + lath visible.

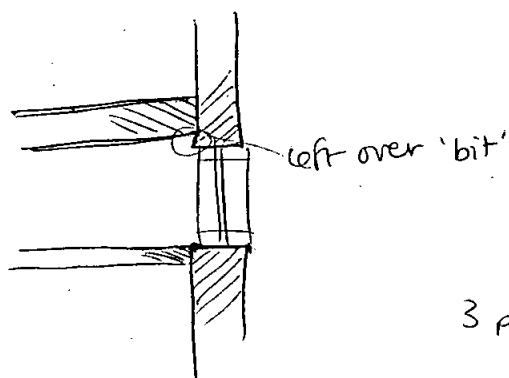
SE wall = ~~brick~~ brick block. Strange bit seen in plan - relationship of wall to end window.

Fire place NE wall - central
NW wall - 2 sash windows -
quite chunky glazing bars
+ plain ends.

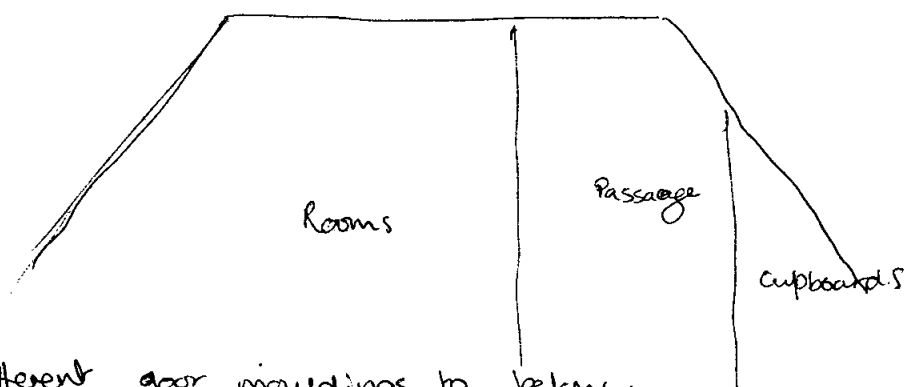
71 Passage + rooms all lined \bar{e} tongue + groove boarding.
 Some 21cm wide on right hand side of passage - laid horizontally. but most 17cm wide + used vertically.
 even ceiling done.

different door mouldings to below.

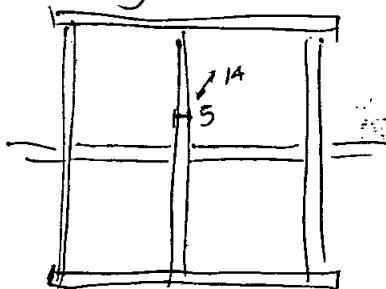
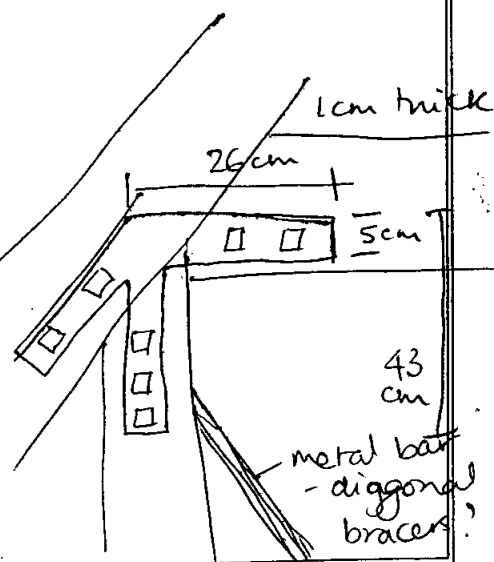
metal work holding structure together.

Framing behind tongue + groove = softwood nailed together.

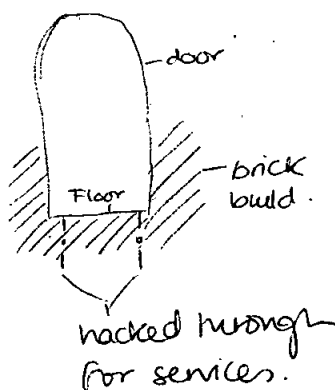
To W of door way in N112 30cm down from concrete floor wall steps out 5cm. 1 brick below this level is a deposit of black burnt ashy material - dark brown sandy silt with 10% inclusions of charcoal red brick frags - lg pieces.

Deposit seen in W section 23cm from wall 49cm down from concrete floor. 66cm down = bottom of trench deposit continues down extent not excavated. Possibly marks construction cut for post 1725 rebuild backfilled with fire debris.

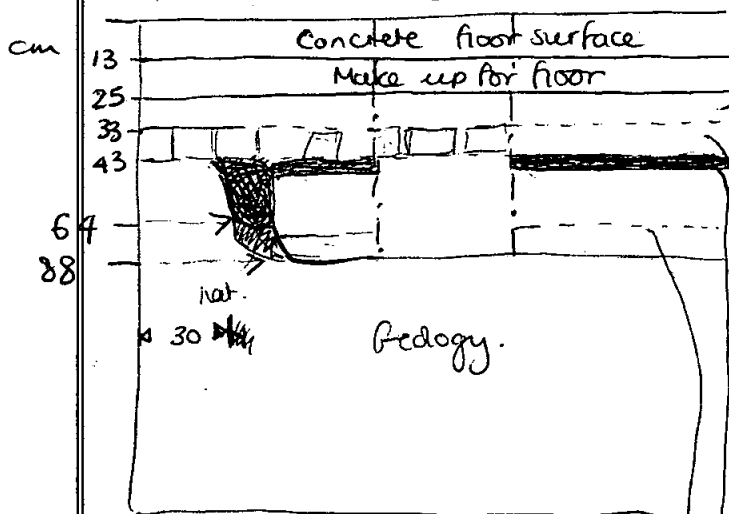
Poor ~~inner~~ lighting conditions and inaccessible trench makes detailed recording impossible.

loose sandy material with 25% pebble inclusions norm + mortar 2.5cm ϕ + 1cm ϕ

mid brown in colour but with yellow sandy material throughout + possibly inclusions of mortar - cream/white lime mortar.

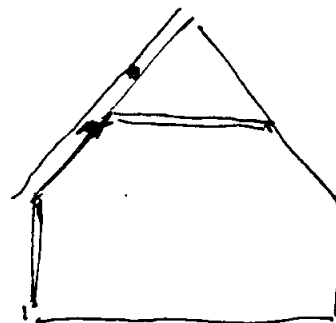
E fp block.

substantially the rest A frame →
with corner etc.

Back wing with lower pitch roof starts at 420/427 divide (part modern)
with large case beam over — ? back wall of house removed.

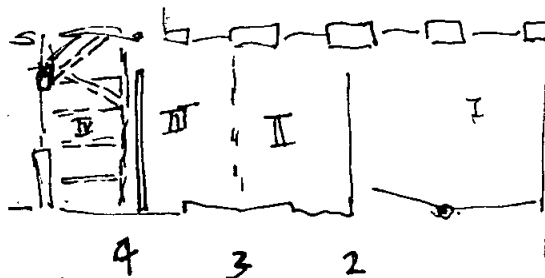
Truss 4 (made IIII) to W of partition has burnt

Bay II has frame for head/chimney + 4 joists + 1 extra to frame. all jointed to truss 4

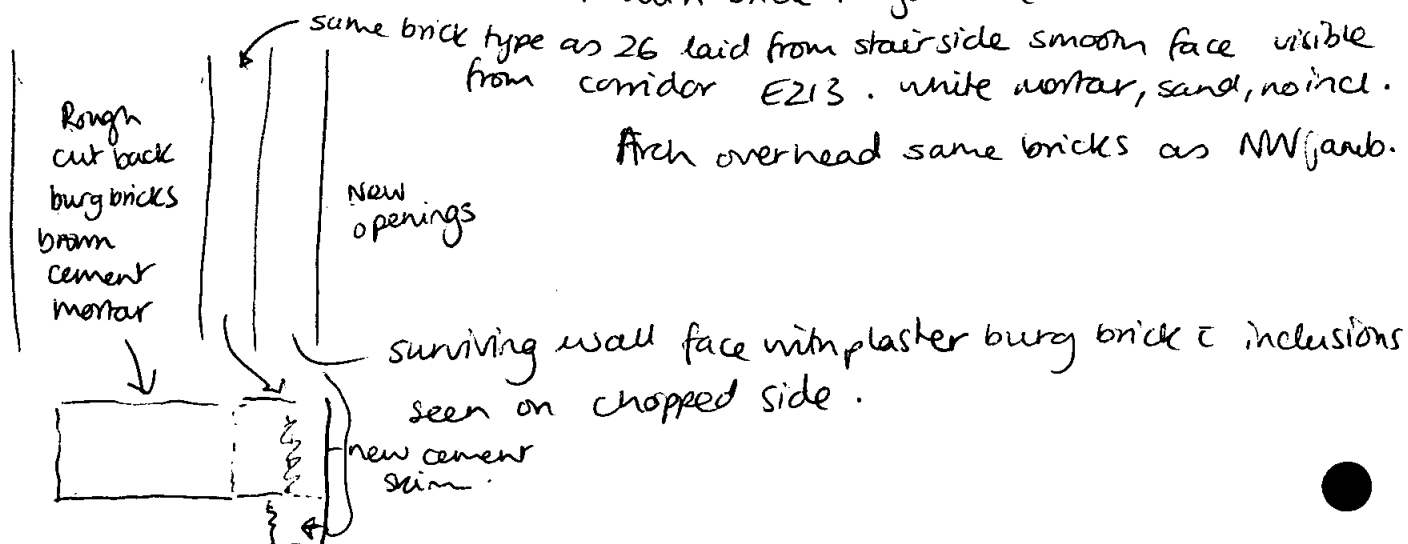
so was door then safe fitted +
made good.
blocking bricks mixture of yellow
with inclusions ie mustard type
+ brown/red/purple with inclusions.

Door to SE of 26 - woodwork removed. NW jamb = burg with inclusions
like mustard yellow brick + brown cement mortar. flush face to door
to E213 rough-cut back.
SE = Red brick white lime mortar with brick frags. = rare.

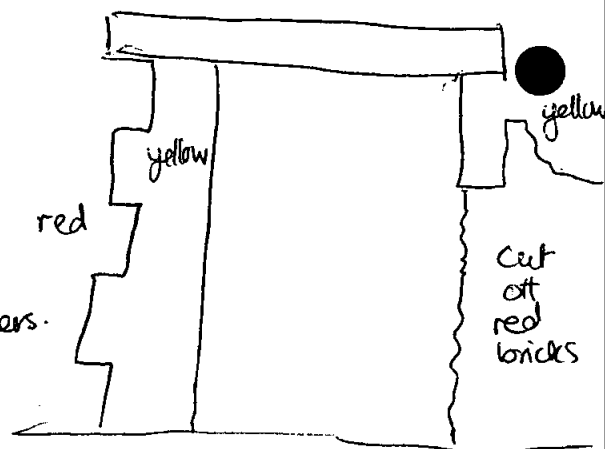
NW wall - whiter than SW incl of rounded pebbles + grit.

SW wall - beige with chalk/lime inclusions, brick bits, pebbles.

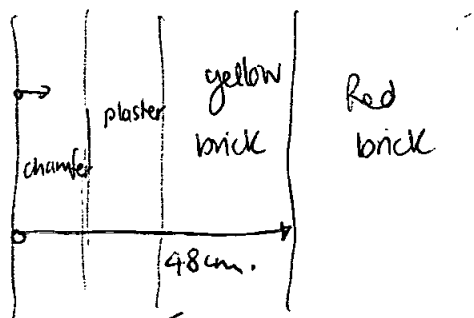
- 12 Join between red brick front
house + yellow add on.

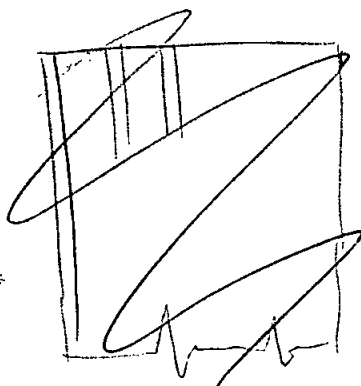
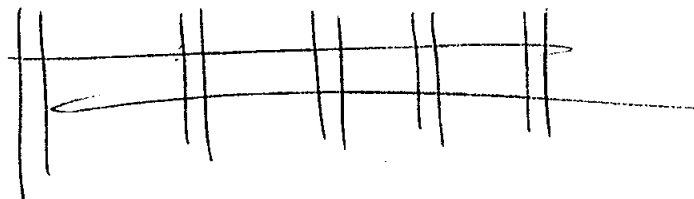
38 cm centres.

9 main timbers - 1m spacing.

Joists packed up off these.

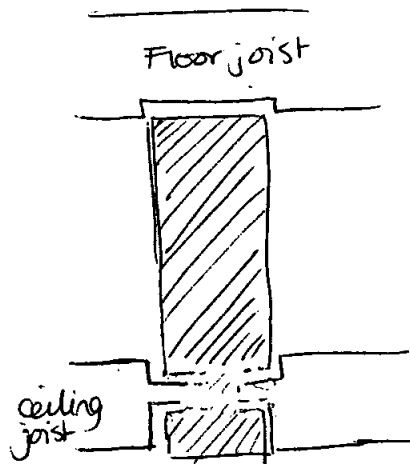
8 Joists. 39 centres.

8 25 1.14m centres.

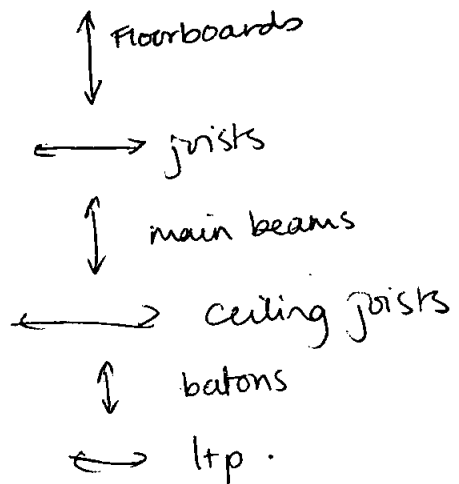
Ceiling joists -

8 7 5 3 attached to these, ltp to these.

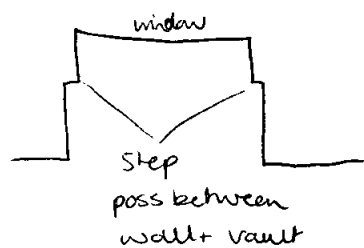
glazing bar
thick p sash

but only at window level
on W. ~~at~~ total floor to ceiling
on E.

Poss something to do with the
1790 Marchioness stuff? strip along north.

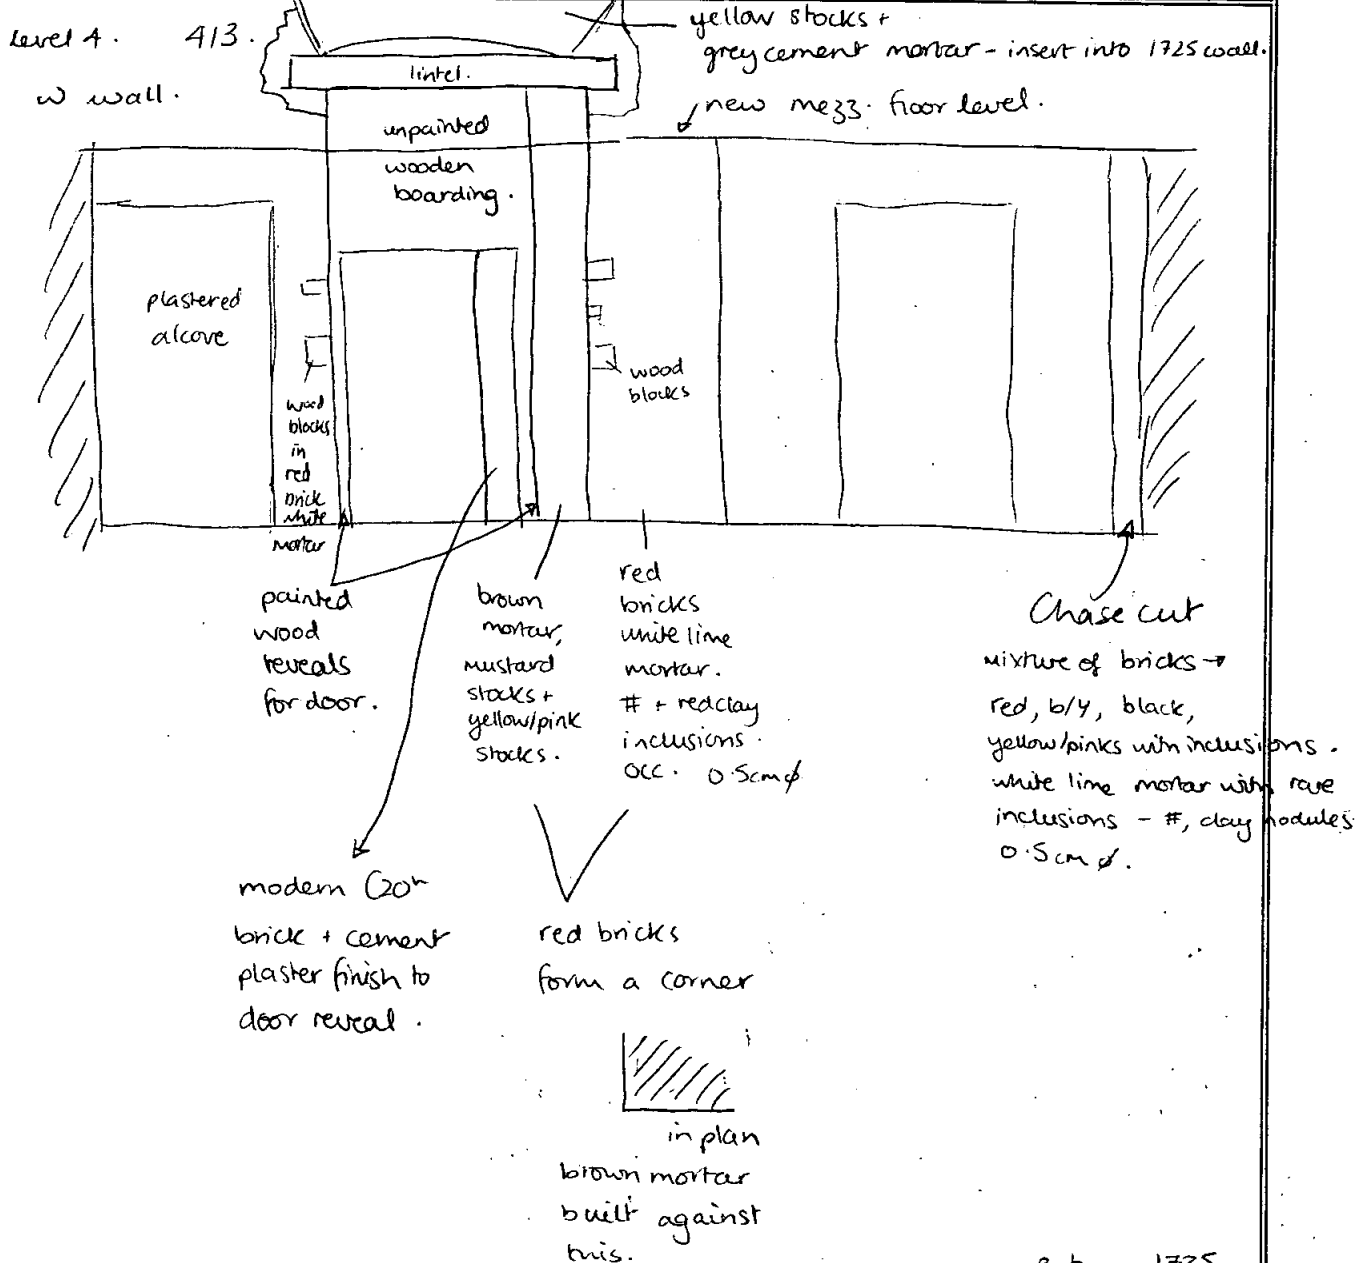
Reveals of opening with wooden blocks appear to be of the 1725 build. The lintel + its revealing arch are inserted into the wall. door too large + blocked in vrs stages.

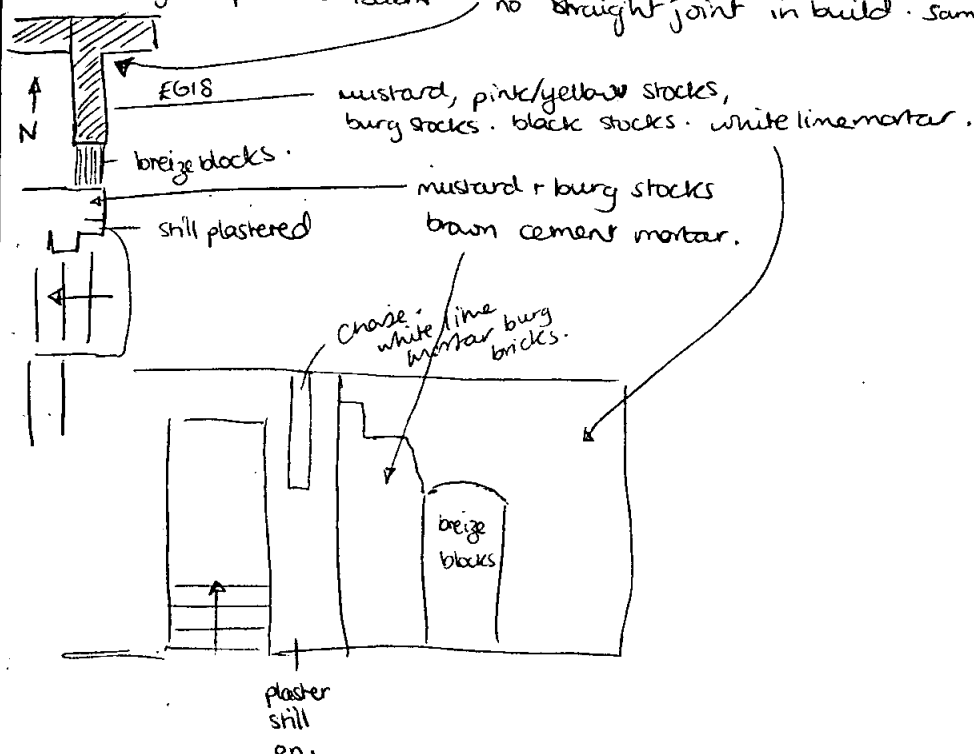
hist door head revealed in s wall of EG21. marked on plan + photos.

Corridor EG19. Plaster stripped w wall N end. ~~proves that stair turret was~~
linking to previous rooms no straight joint in build. same wall.

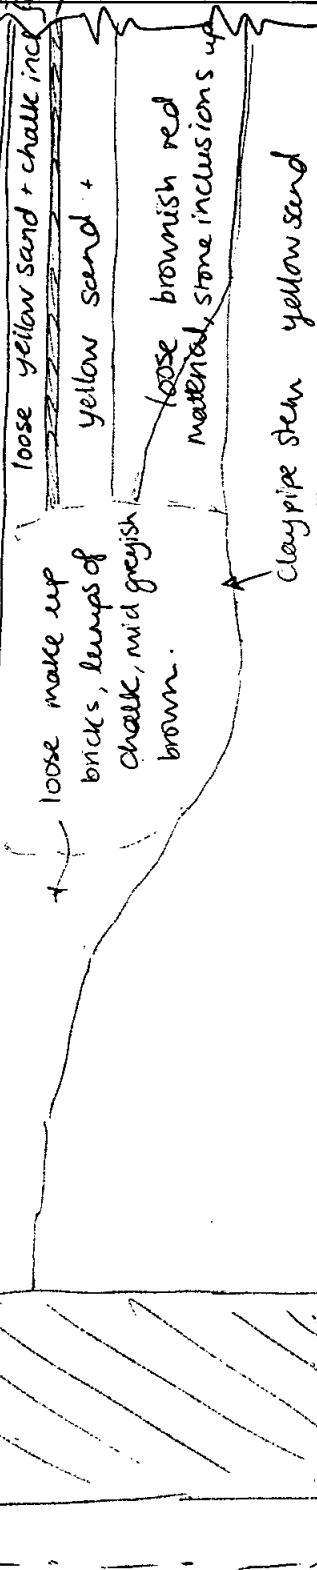
Red tile flooring under mod. cement skin

Simplified section. 67cm = total depth. Tiles 6cm down from modern floor level 4cm thick x 31cm x ? bedded in white lime mortar on yellow sand. 8cm down. Tracks on thin band of brown clay → sample level? 16cm = base. Under this = mixture of yellow sand + loose pinky brown material with brick inclusions + mortar dust. 22cm = base. Then bright reddish material. over lying more yellow sand. (natural? geology?)

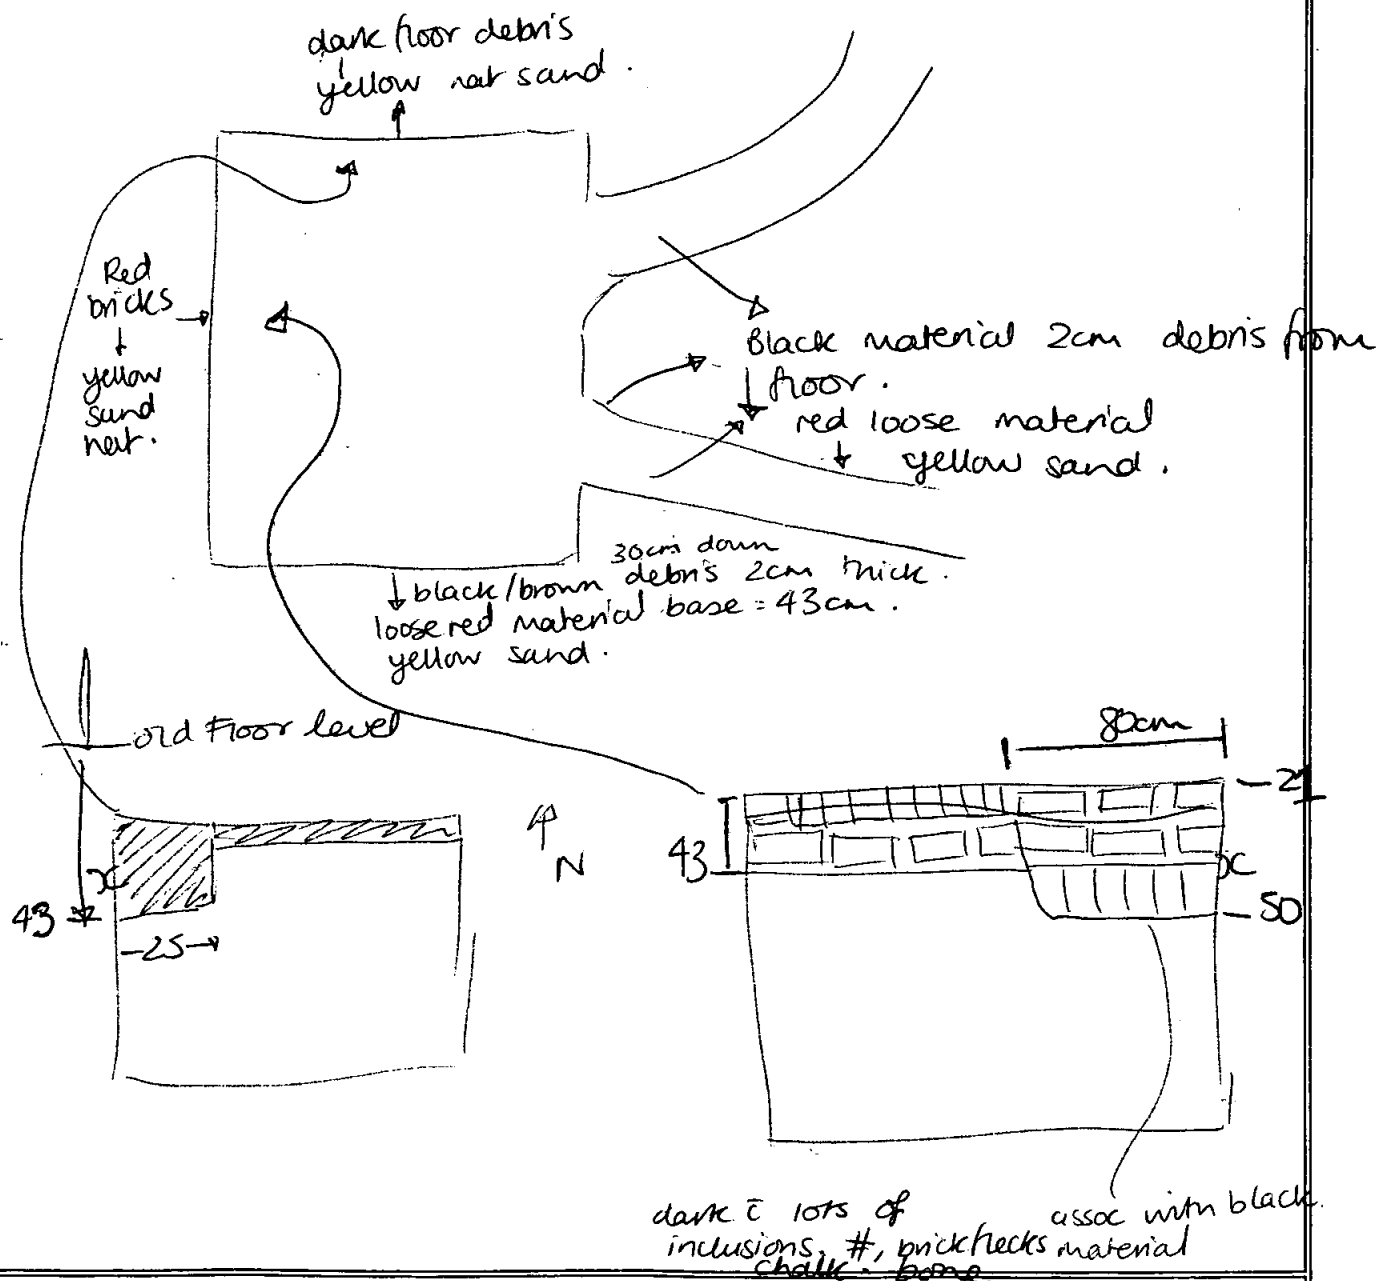
wooden floor taken up reveals lines of frogged bricks running E-W. 2 left in place at time of observation.

Thin layer - dark blackened material directly under wooden floor.

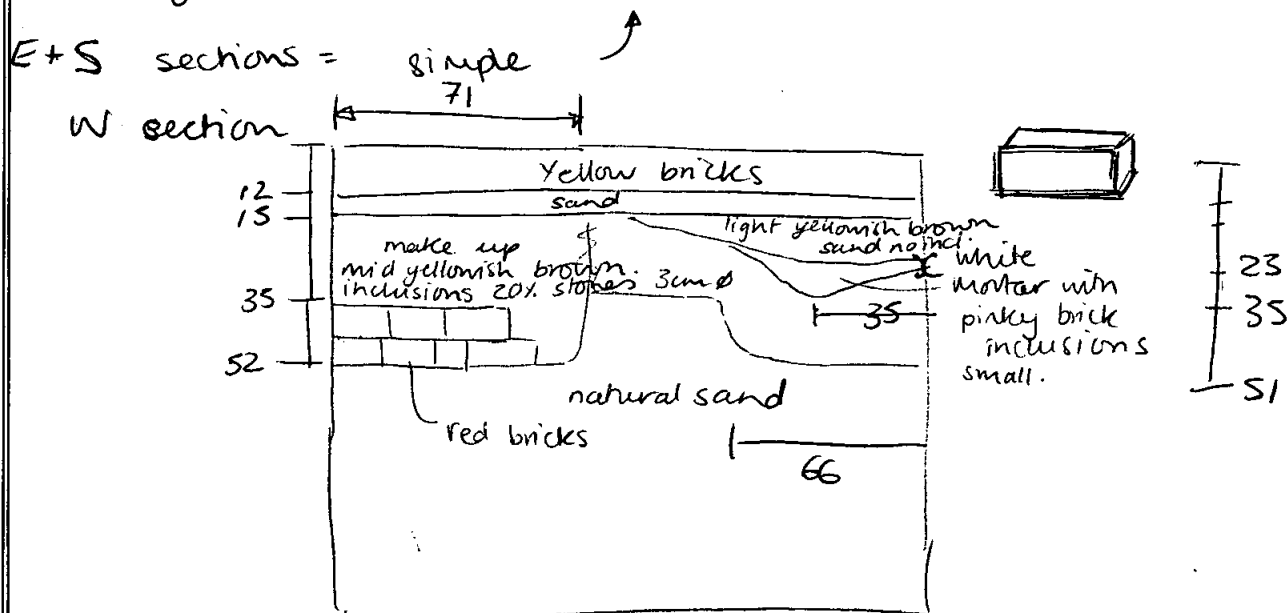
1.25m deep.

Whole floor of room laid with mustard yellow bricks laid on end in bedding of dry sand. Under this = layer of make up material, under that silty sand same yellow as bricks.

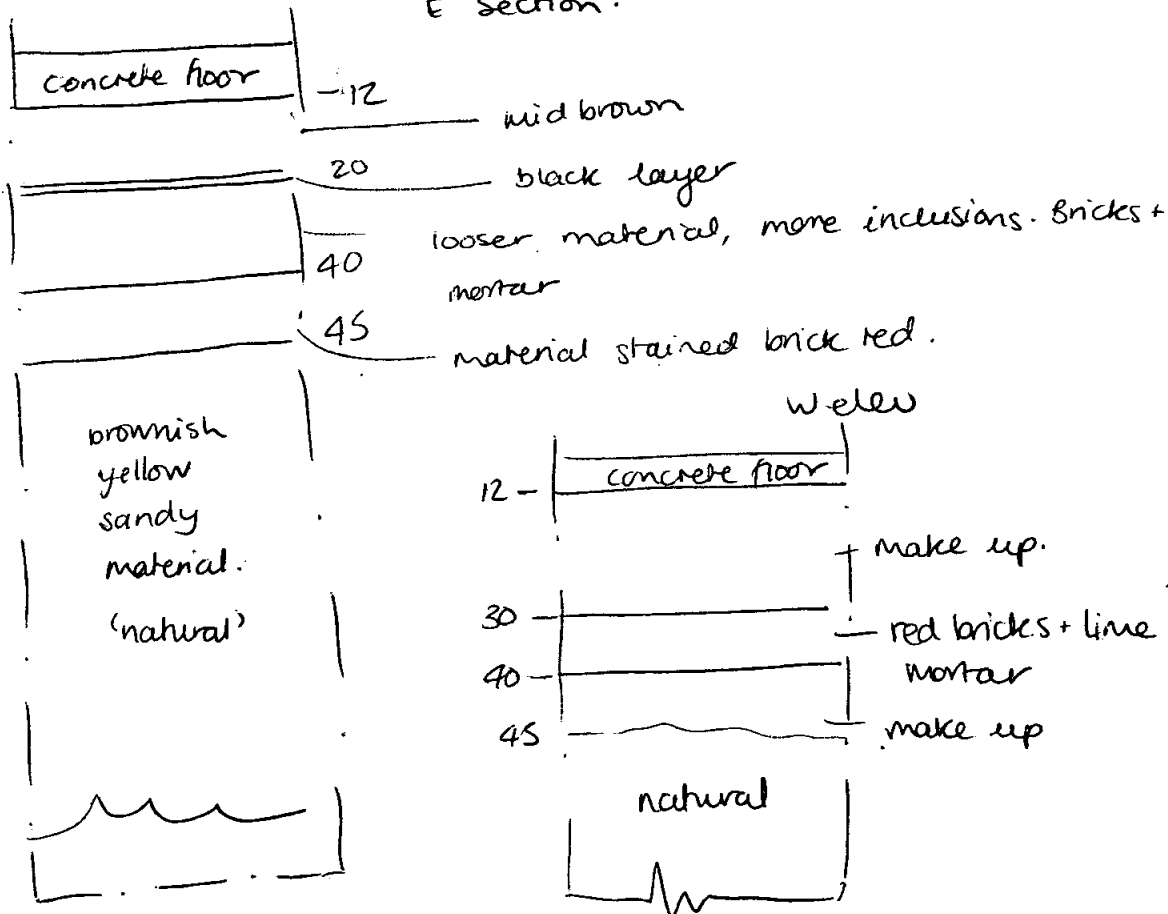
Area excavated 135cm down. 125cm to water level
E section.

Possible that brick layer seen clearly in W, S + part of N elev marks a floor surface.

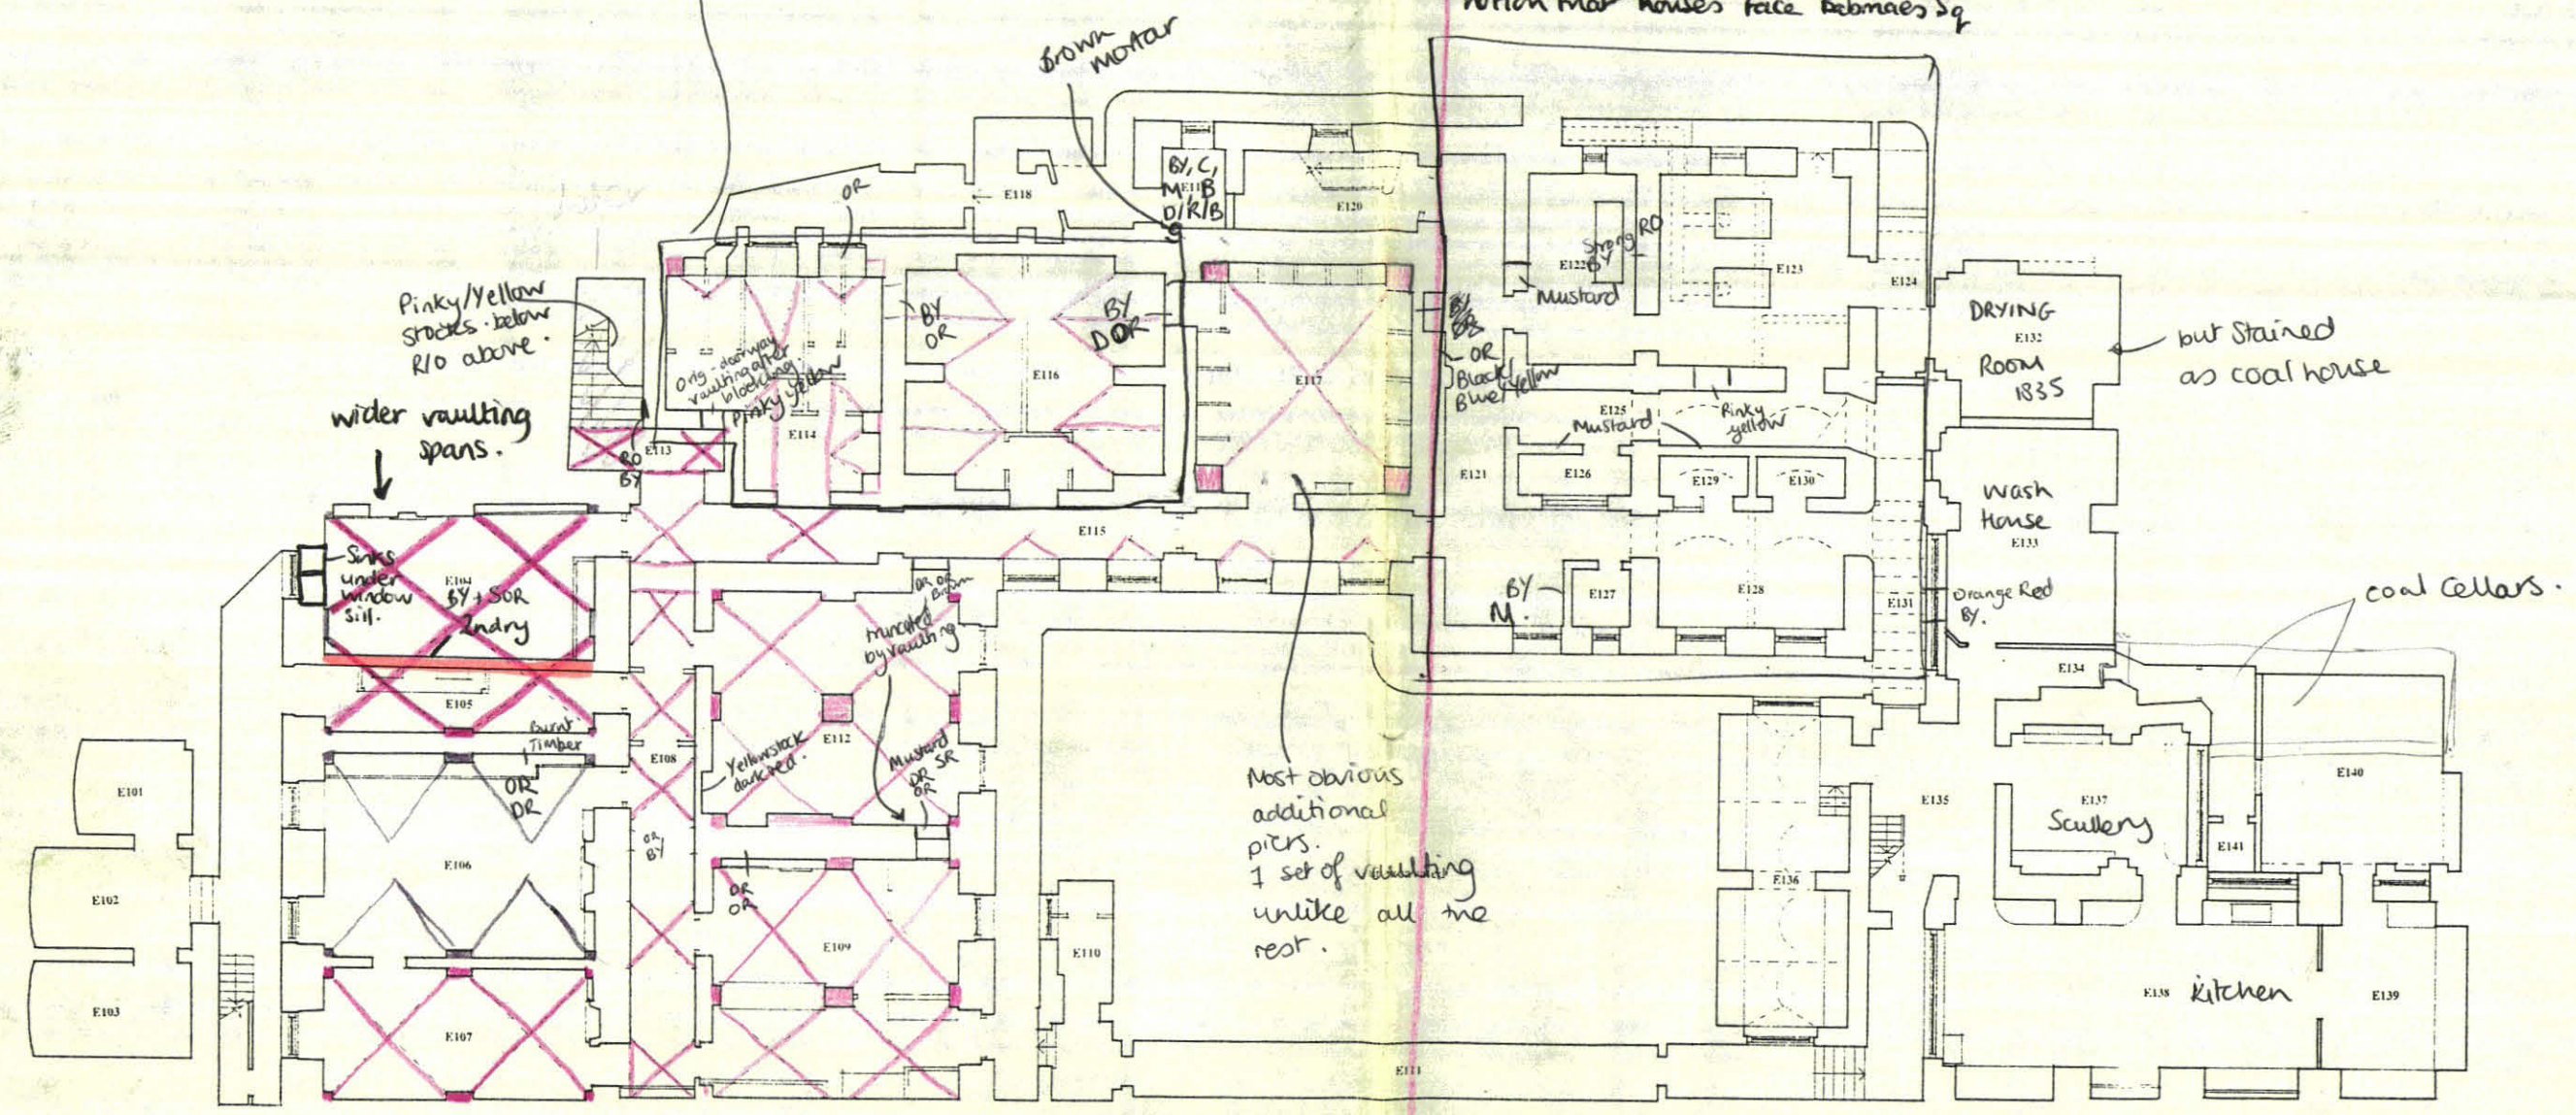
Vaulting E114 + E116 diff span to that facing St James Sq. short spans.

Edg alignment of walls reinforces notion that houses face St James Sq

Phase I - Vaulted ceilings - landing on piers built out from walls. Truncating window + door openings. But apparently of same maj red/orange bricks with greyish white # lime mortar.

E117's vaulting = 2ndary.
