Site/Project Name: **Westminster, 4 St James Square**

Site/Project Type: Building Survey & Watching Brief

WESTMINSTER
4 ST JAMES SQUARE
SJR 97
Box 1 file 1
INTRODUCTION

- 1.1 This note has been produced by the Oxford Archaeological Unit at the request of John Warren, architect for the Naval and Military Club, following a site meeting with representatives of Westminster City Council and English Heritage on 17 September 1997. The Listed Building Consent for works (970208 dated 26 August 1997) includes Condition 15 requiring approval from the City in consultation with English Heritage for full particulars of matters including:

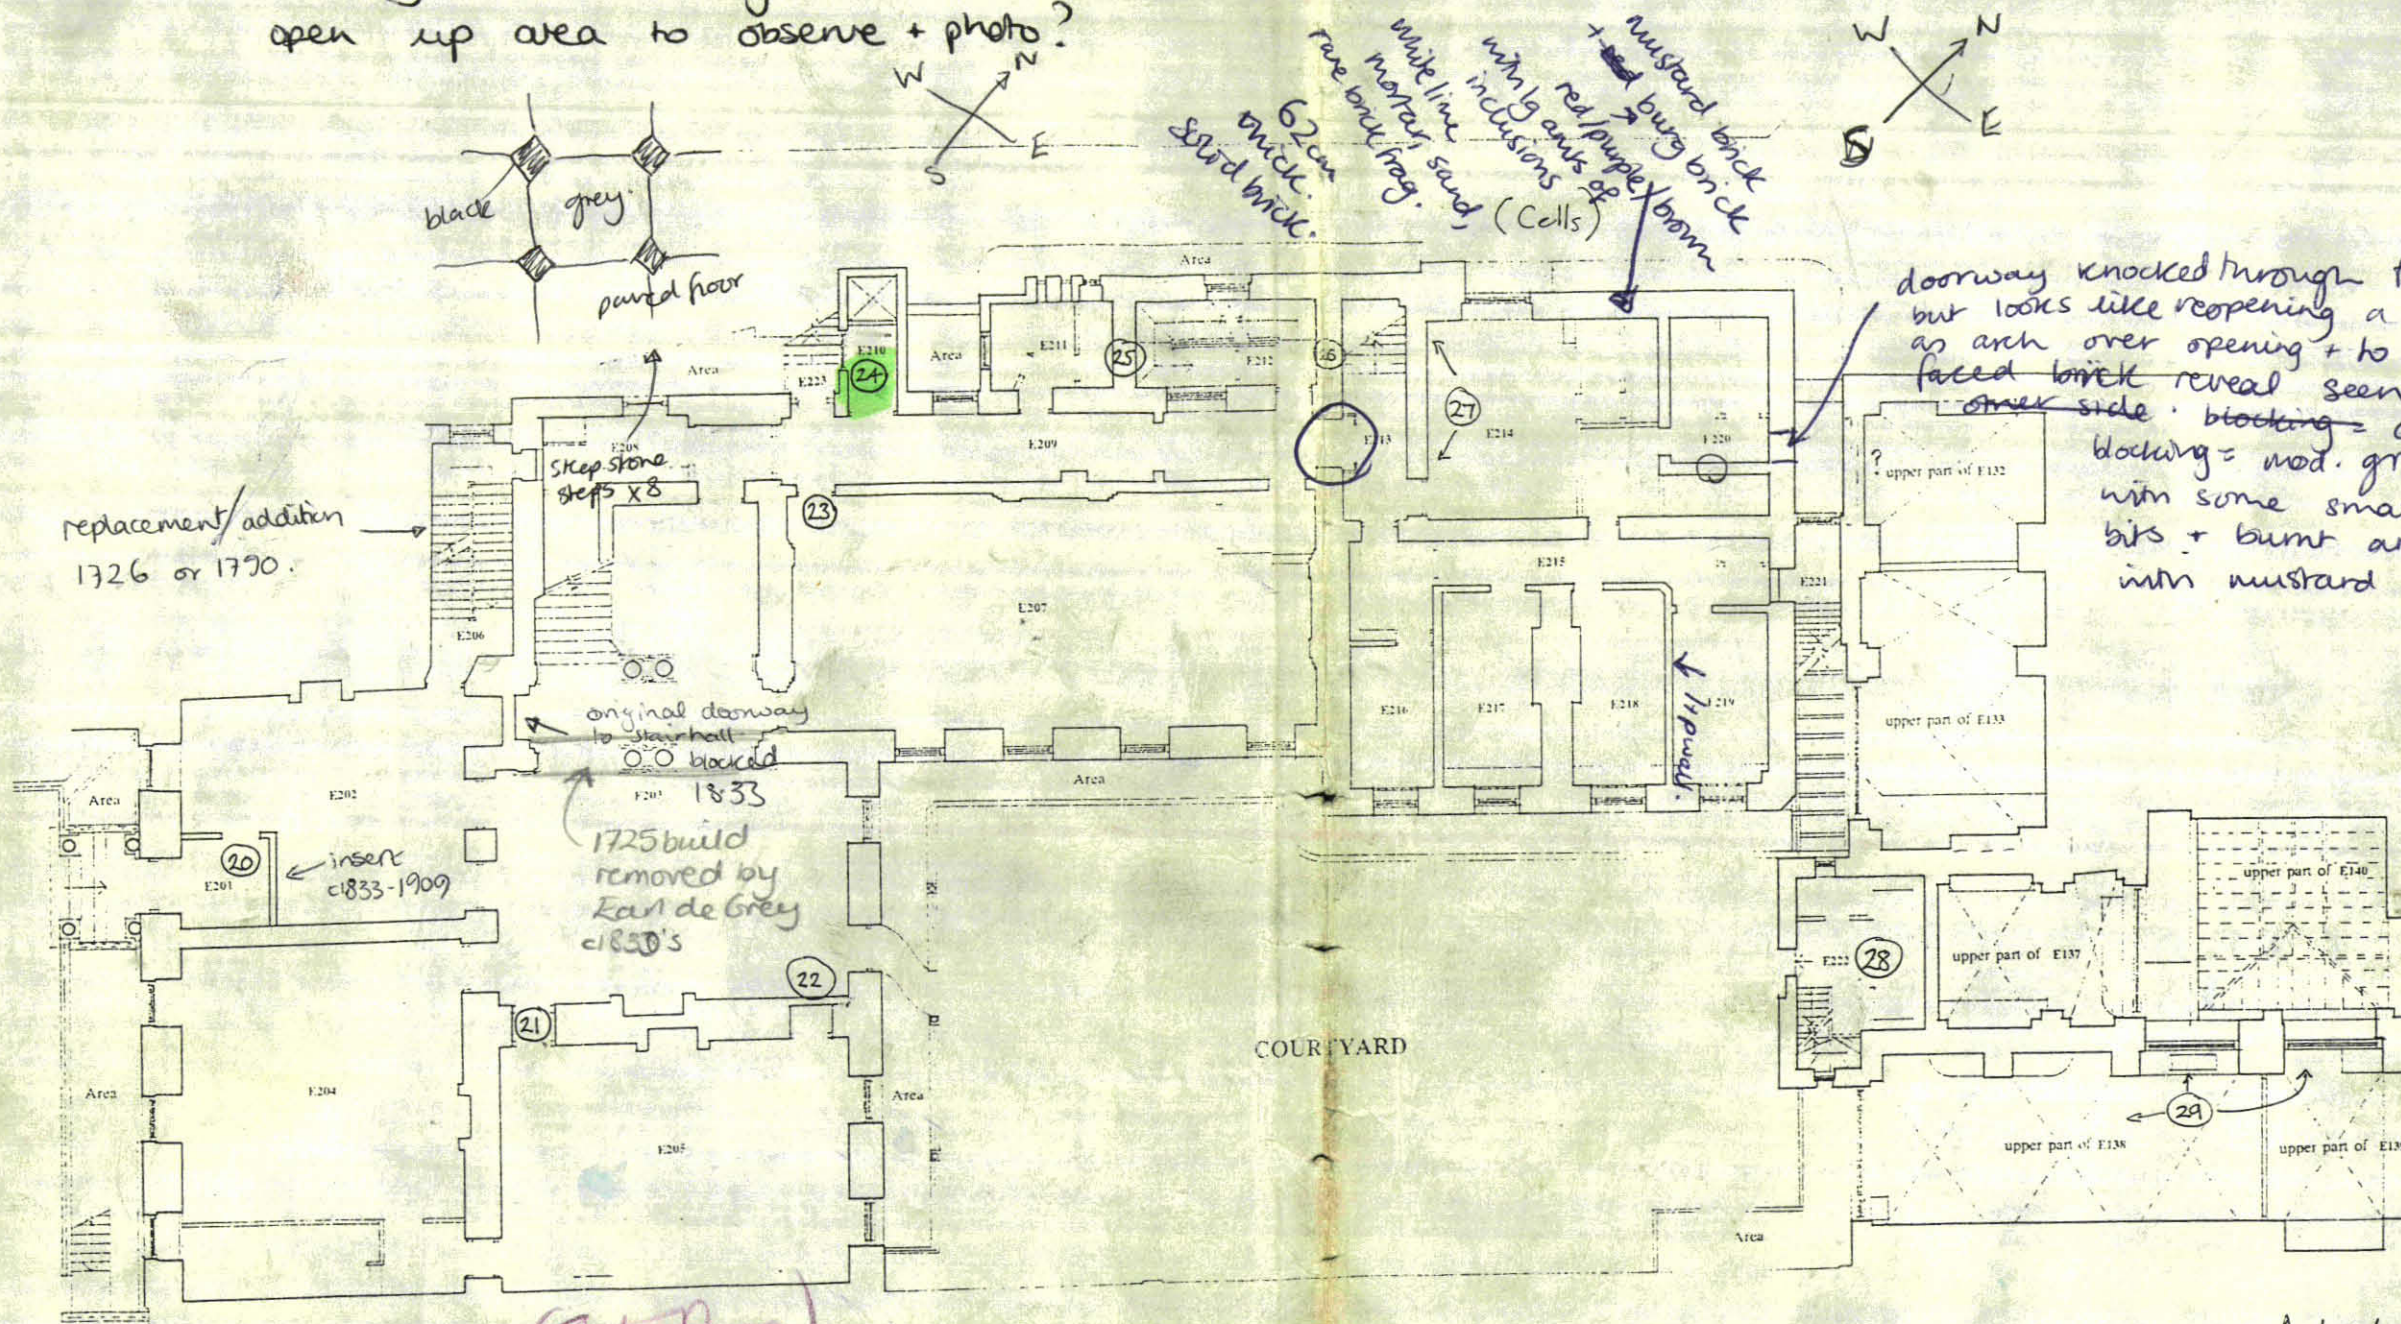
doorway knocked through for development but looks like reopening a blocked doorway as arch over opening + to NW glimpses of faced brick reveal seen - no extent visible other side. blocking = other side reveal chancery blocking = mod. grey cement + burg bricks with some small inclusions - yellow bits + burnt areas. door itself = burg with mustard incl.

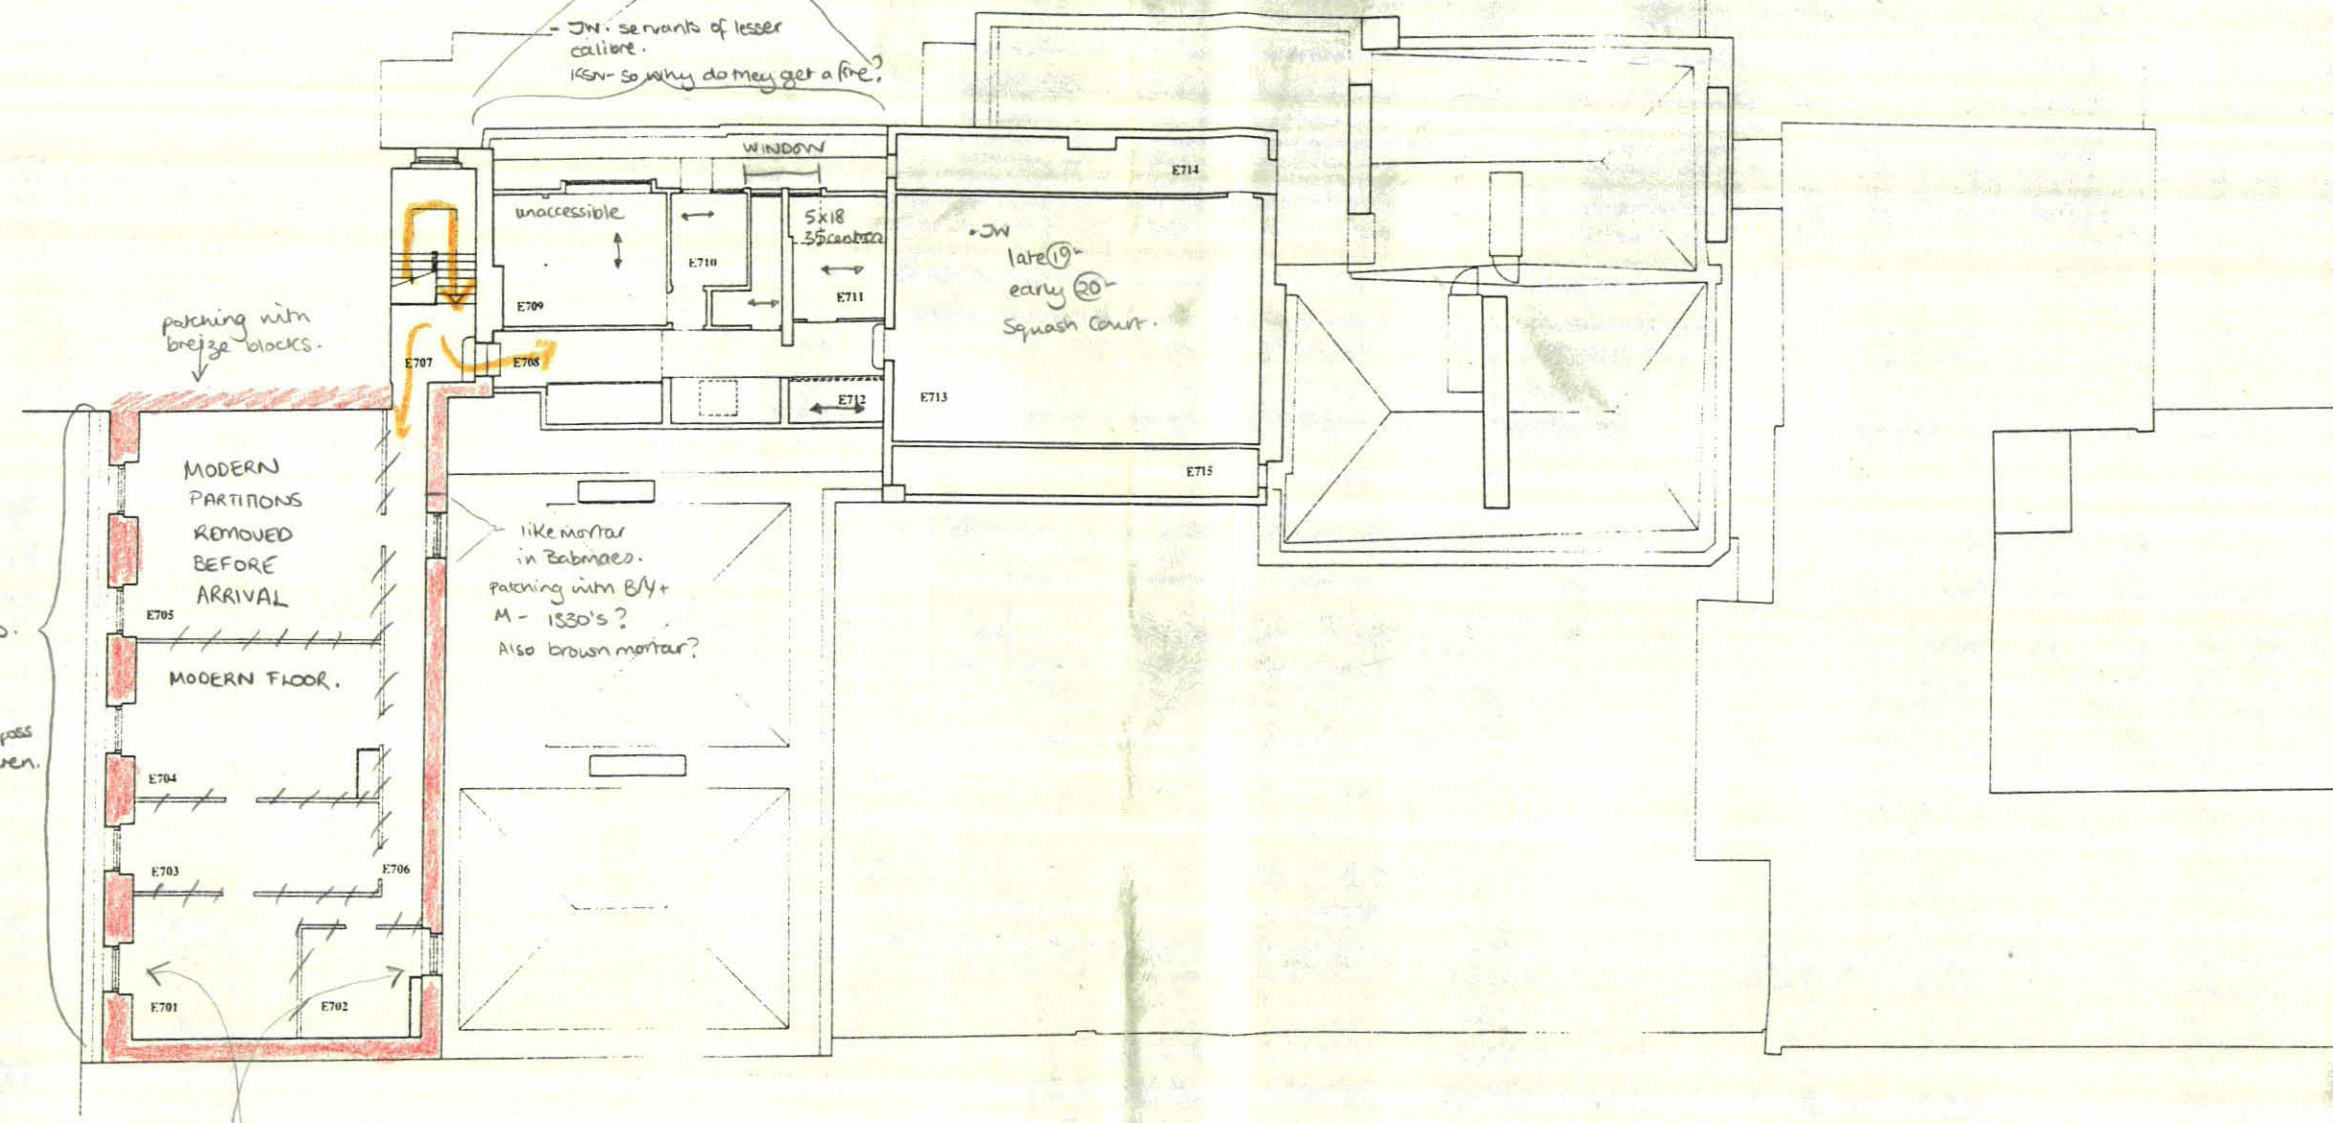
- TrG pannelled rooms
- S of passage 21cm wide, horizontally laid.
- N of passage 17cm wide, vertical, ceiling included

JW. servants of lesser calibre.
KSN - so why do they get a fire?

JW
• No fireplaces.
presumably
servants.
Though just poss
adult children.

Front + back windows
do not match.

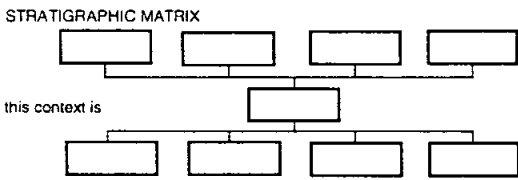
8.dimensions as found
Matrix location	Relationships uncertain			9.other comments
Description (See check lists):		STRATIGRAPHIC MATRIX		
<u>Area in 19 dominated by</u>

<u>brick + tile fragments + grey stone</u>				
<u>- looks like debris from a floor</u>				
<u>surface. Red tile - blackened</u>				
<u>surface - grey stone - paving slab - v. flat surfaces.</u>				
<u>up to 22cm x 20cm.</u>				
Interpretation/Discussion:				
Finds (tick): None <input type="checkbox"/> Pot <input type="checkbox"/> Bone <input type="checkbox"/> Flint <input type="checkbox"/> Stone <input type="checkbox"/> Burnt stone <input type="checkbox"/> Glass <input type="checkbox"/> Metal <input type="checkbox"/>				
CBM <input type="checkbox"/> Wood <input type="checkbox"/> Leather <input type="checkbox"/>				
ΔSmall Finds				Recorder
◇Samples				Date <u>19/11/97</u>
△Building Materials				Initials <u>KSN</u>

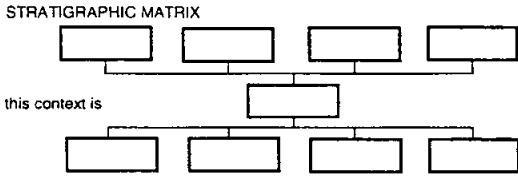
SITE <u>SJQ 97</u> Wes 97		CONTEXT RECORD		Context No. <u>122</u>
Trench <u>E106</u>		Additional Sheets:		Type <u>DEPOSIT</u>
Site sub-div	Context Type: <u>Deposit</u> Cut / Structure	Check Lists:		
Structure No.	Overlain by:	DEPOSIT:		
Plan No.	Abutted by:	1.compaction 2.colour 3.composition 4.inclusions 5.thickness 6.extent 7.comments 8.method & conditions		
Section No.	Cut by:	CUT:		
Co-Ordinates	Filled by:	1.shape in plan 2.base/sides/top profile 3.dimension and depth 4.sketch 5.truncation 6.fill nos 7.other comments		
Level	Same as:	MASONRY:		
Slide No.	Part of:	1.materials 2.size of bricks etc 3.finish of stones 4.coursing/bond 5.form 6.faces 7.bond 8.dimensions as found 9.other comments		
Neg No.	Consists of:			
Matrix location	Overlies:			
	Butts:			
	Cuts:			
	Fill of:			
	Relationships uncertain			
Description (See check lists):		STRATIGRAPHIC MATRIX		
<u>Some kind of trench cut across</u>

<u>passage - unclear if modern or</u>				
<u>not. To E wall - there is a</u>				
<u>hole in the wall under previous</u>				
<u>floor level here suggesting pipe duct but no sign of pipes.</u>				
<u>To SW extent piece of the grey paving stone seen in 20</u>				
<u>is insitu sloping down into the cut. Sides of cut</u>				
<u>are of the yellow sand 'natural' material. This event</u>				
Interpretation/Discussion:				
<u>marks the end of wall 1. It is unclear at present</u>				
<u>if the trench truncated the end of the wall or if this is</u>				
<u>its natural end. Possibly represents robbed cut return</u>				
<u>wall trench? Also truncated (24) mortar ghost of wall.</u>				
Finds (tick): None <input type="checkbox"/> Pot <input type="checkbox"/> Bone <input type="checkbox"/> Flint <input type="checkbox"/> Stone <input type="checkbox"/> Burnt stone <input type="checkbox"/> Glass <input type="checkbox"/> Metal <input type="checkbox"/>		Recorder
