Late 18th Century
Hunting Lodge Stables
and 20th Century Cold
Stores at Gedney Road
Long Sutton Lincolnshire

Historic Building Survey

OA East Report No: 1257

Report Date: May 2011

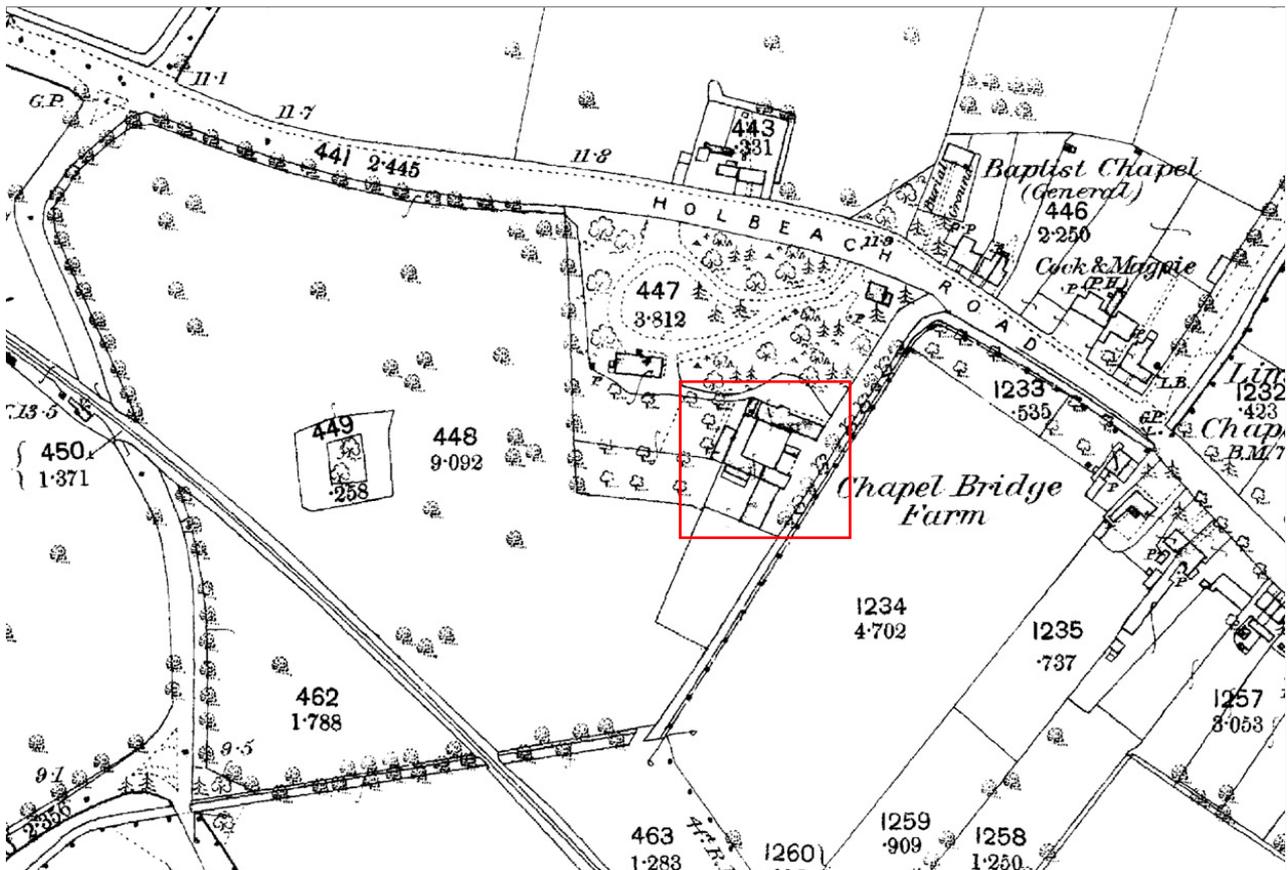
Figure 3: 1st Edition Ordnance Survey, 1888 showing location of buildings surveyed.

- 3.2.4 The 1st edition Ordnance Survey Map (1888) provides a scaled and reliable representation of the site in the late 19th century.
- 3.2.5 This map shows the site layout as very similar to that of today, although there appear to be additional buildings on the southern side on Building 2.

- 3.2.6 The setting for the buildings is also different. The current Gedney Road was called Holbeach Road and the site appears to be called Chapel Bridge Farm. Although the label of Chapel Bridge Farm is in the land to the east of the ditch and the site, according to the present owner, this land once belonged to the site before it was divided up in the 1970s.

- 3.2.7 The buildings surveyed would appear to be part of the grounds of the building now known as The Shubberies and the lodge at the entrance (which is still in existence) was there at this time – as a group these are labelled 447 on the map. There are two entrances from the main road; one directly in front of the house and another which goes via the lodge. There is a “circular” drive around the front of the main house which is still in use today and there also appears to be an access from there to the buildings surveyed.

- 3.2.8 The main buildings and driveway are enclosed by a wall and appear to have a formal layout of trees. The rest of the land associated (labelled 448, 449 and 462) is bordered by trees/shrubs but the function or use is not obvious from this map. A railway line cuts through the south western corner of the grounds.

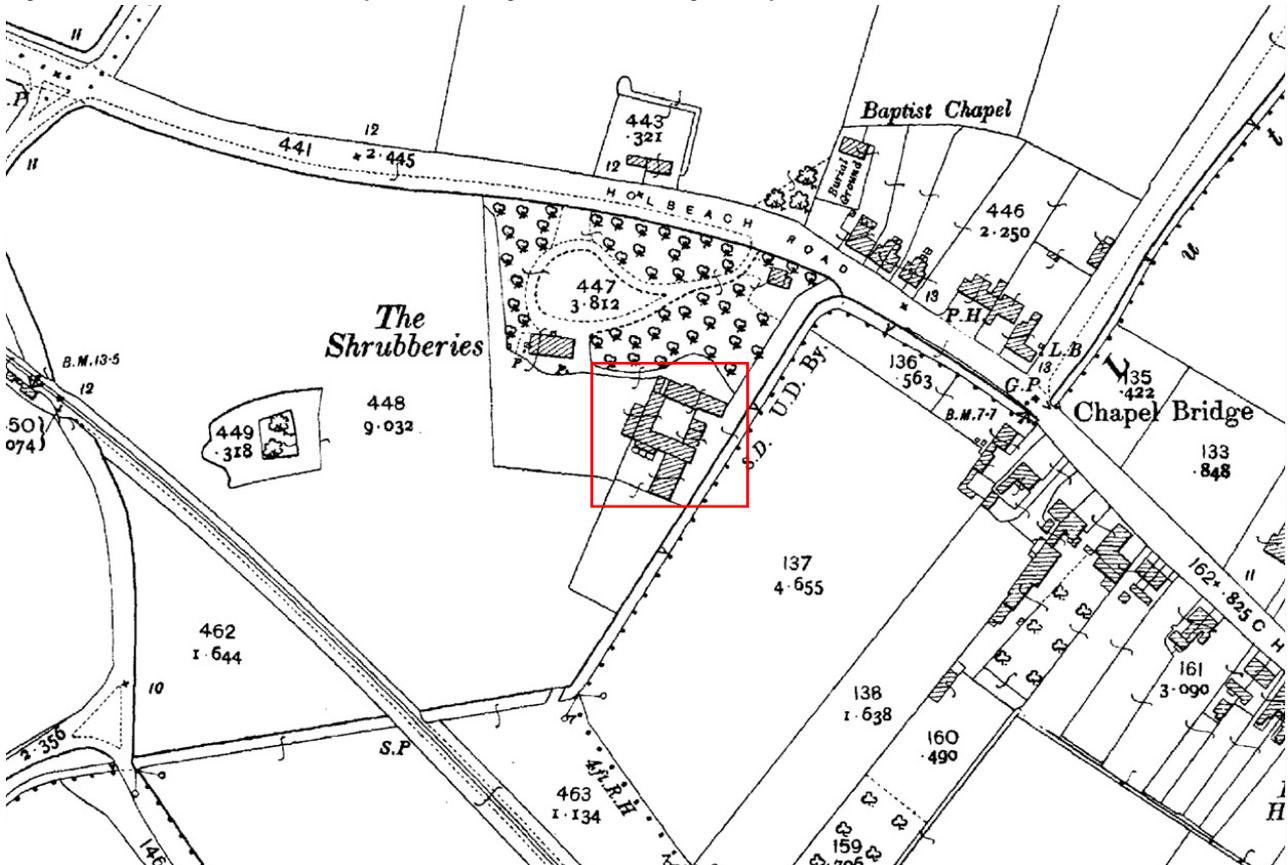
Figure 4: 1904 Ordnance Survey showing location of buildings surveyed.

- 3.2.9 By the 1904 edition of the Ordnance Survey, the site has changed very little. The buildings surveyed are depicted almost entirely as they were in the map of 15 years earlier.

- 3.2.10 The associated buildings and grounds have also changed very little – the most significant difference being the name of “The Shubberies”. The western-most building on the south side of Building 2 has more detail on this map and shows that it had divisions creating perhaps three stalls or enclosures, possibly for holding animals.

- 3.2.11 There appear to be less trees denoted in the grounds to the immediate west of the buildings surveyed and in the rest of the associated land; this may be a change in mapping style or represent a change in the use of the land.

- 3.2.12 The parish boundary to the immediate east of the site is now labelled “U D By” and a boundary wall to the immediate west of the surveyed buildings has been removed.

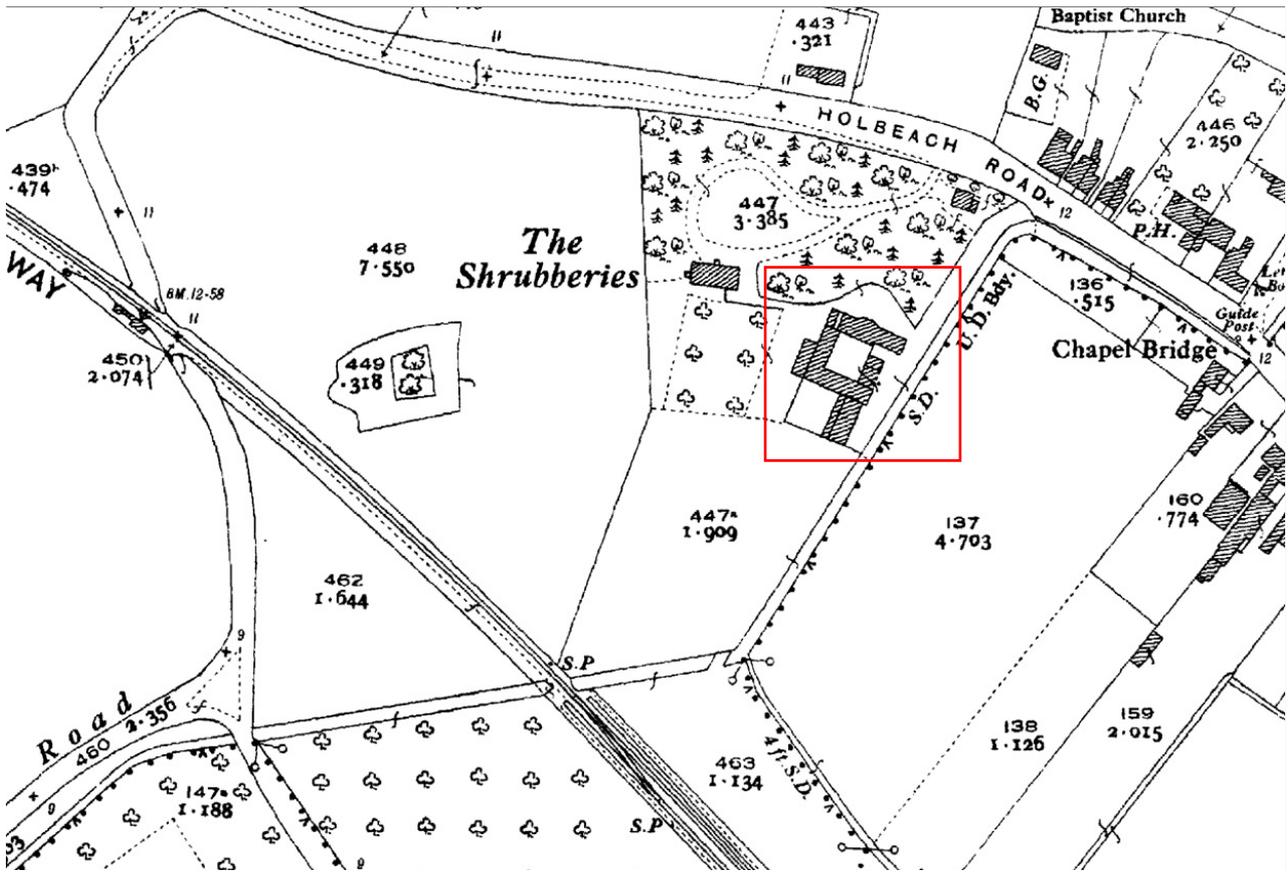
Figure 5: 1931 Ordnance Survey showing location of buildings surveyed.

- 3.2.13 The next available map which shows the site and buildings in detail is the 1931 Ordnance Survey Map (Figure 5). The only obvious alterations to the buildings surveyed is the removal of the western-most building on the south side of Building 2, which was depicted in the earlier maps.
- 3.2.14 The divided/segregated area of land previously depicted on earlier maps has been removed by 1931 and there is, by this point, just the one entrance to the site from Holbeach Road via the lodge.

- 3.2.15 There are less trees and shrubbery depicted on this map – however, this is likely to be due to the cartographers style of the time rather than wholesale removal of the trees and shrubs.

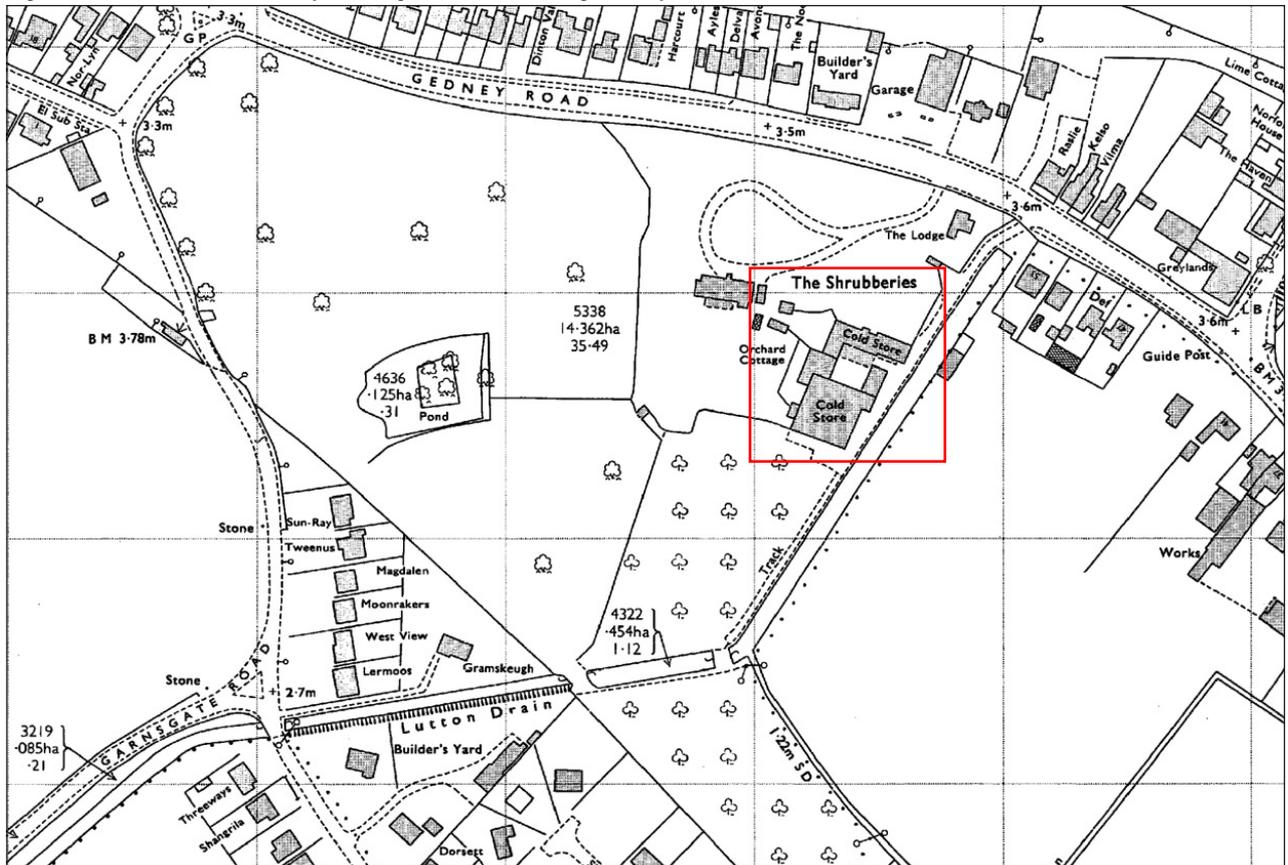
Figure 6: 1972 Ordnance Survey showing location of buildings surveyed.

- 3.2.16 The 1972 Ordnance survey map (Figure 6) shows a number of alterations to both the buildings surveyed and to the site as a whole. Although the site is still labelled as “The Shrubberies”, the buildings surveyed are now labelled individually. Buildings 2, 5 and 6 are labelled “Cold Stores” and Building 4 is “Orchard Cottage”. The Lodge is also labelled by this point and a small area within the grounds, always shown on the earlier maps is now labelled “pond”.

- 3.2.17 By the 1970s, it appears that there was a large extension to the south side of Building 2 and boundary walls around the south and west of the buildings have been altered. Although now removed, this addition on the south side of Building 2 is still present on the 1989 edition Ordnance Survey map (not illustrated). There is now an open shelter/cover on the south side of Building 5 and additional construction on the western side where Buildings 2 and 4 meet.

- 3.2.18 Holbeach Road is by this time known as Gedney Road and the railway line, which previously ran through the south-western part of the site, has gone and houses have appeared on the southern side. On the land to the immediate east, new houses have been built fronting the main road and there appears to have been an extension added to the south side of The Lodge and to the south and east side of “The Shrubberies” main house as well as two smaller buildings between there and the Cold Store buildings.

- 3.2.19 The eastern boundary is by this point denoted as a track, providing access right along its length and access is now gained from Gedney Road alongside the track via a roadway.

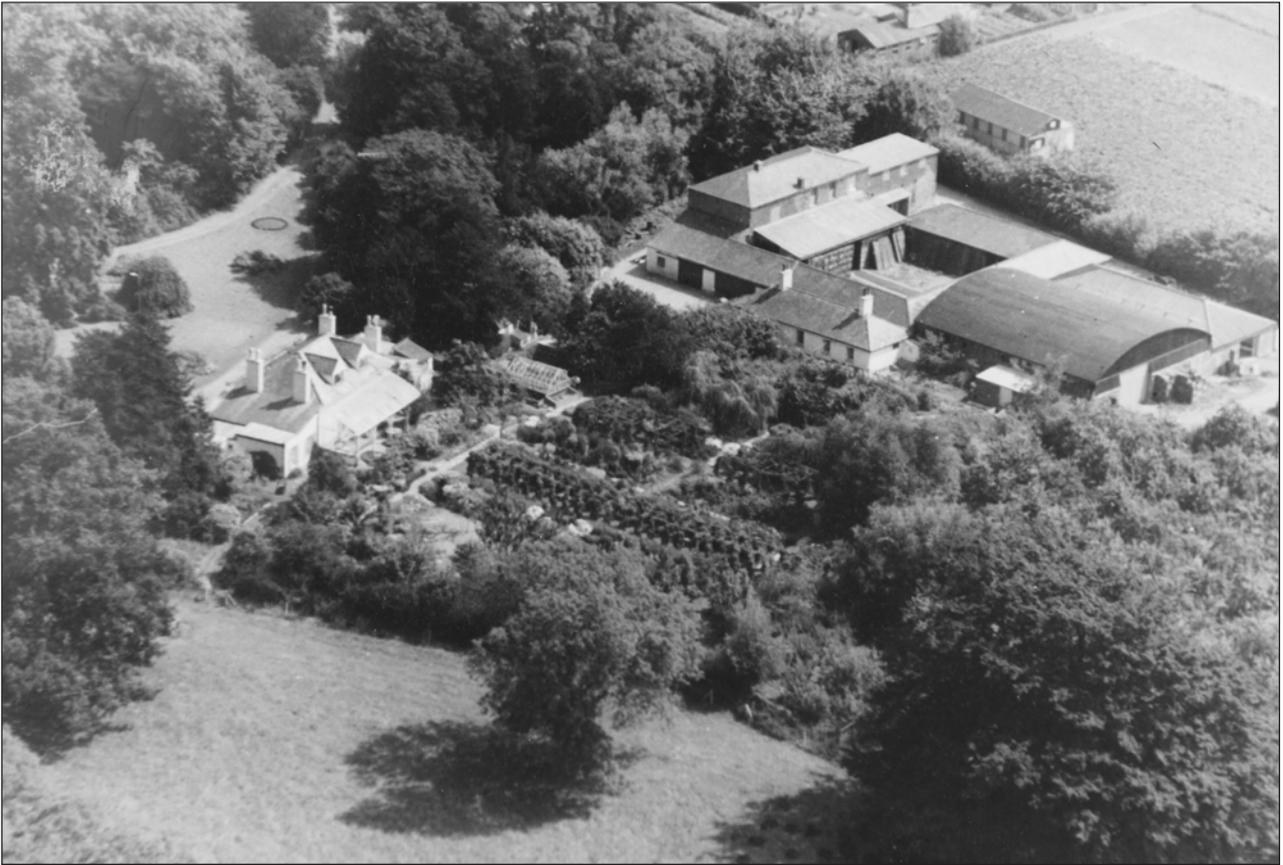
Figure 7: Aerial photograph (undated).

- 3.2.22 An undated aerial photograph supplied by the client (Figure 7), provides the only photographic evidence of the site. This image shows the buildings surveyed (on the right) with the large addition on the south side of Building 2 as present by the 1972 map, but not on the 1931 edition.

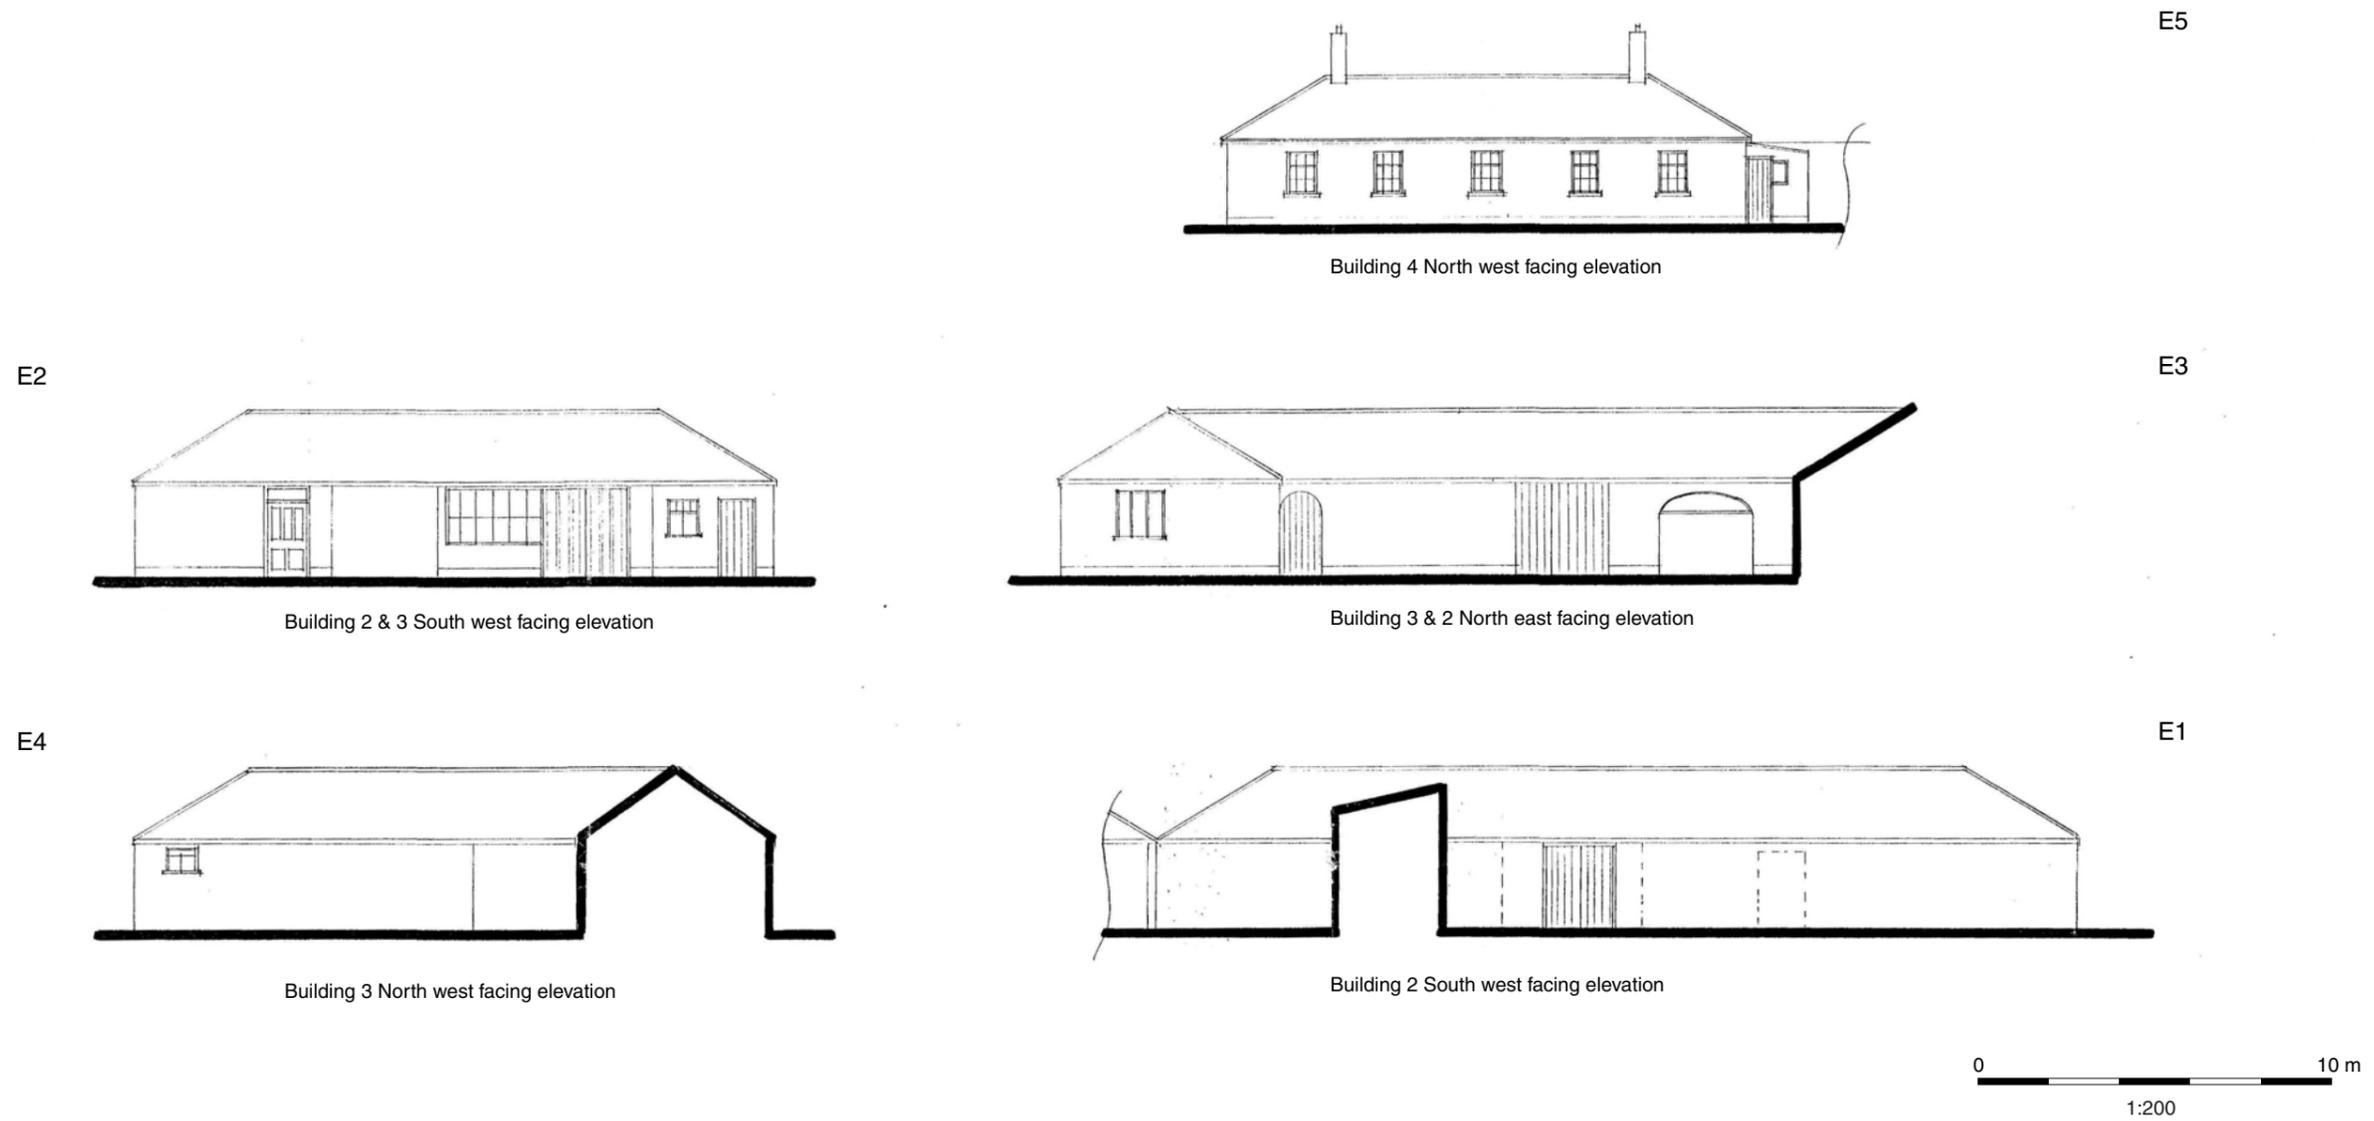
Figure 8: Elevations of Buildings 2-4. Scale 1 to 200.

- 4.2.4 The north-east facing elevation faces into the central courtyard area (Plate 5 and Figure 8, elevation 2). This elevation reveals a number of alterations have taken place. There are a set of double doors (opposite to those noted on the south-west facing elevation) that are the corresponding width to the original opening, however, detail in the brickwork above suggests there was originally an arched entranceway above. Further along on the right of this opening, another wide archway has been bricked up. This section of the wall appears slightly later in date, perhaps contemporary with the re-roofing of the entire building.

- 4.3.4 The north west-facing elevation (plate 9 and Figure 8, elevation 3) has had all render removed and has a single small window on the left side which would appear to be a later addition from the broken brickwork surround.

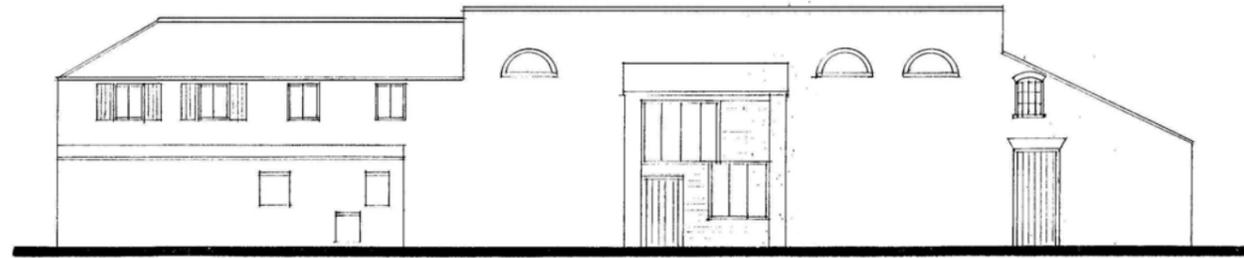
E8

- 4.6.4 The north east-facing elevation (plate 30 and Figure 9, elevation 8) was obscured by the extension at ground floor level which would conceal any original doors or windows. The extension was constructed using 20th century brick with two single glass pane, wooden framed windows and a ventilation void at ground level. At first floor level, Building 6 has four windows/openings all with green painted frames and stone sills; the two on the left have closed wooden shutters and the two on the right have the shutters missing with only iron bars behind. The brickwork respects the openings, suggesting they are all original, but on this elevation appears later in date to that on the opposite south west-facing side.

Buildings 6 & 5 North east facing elevation

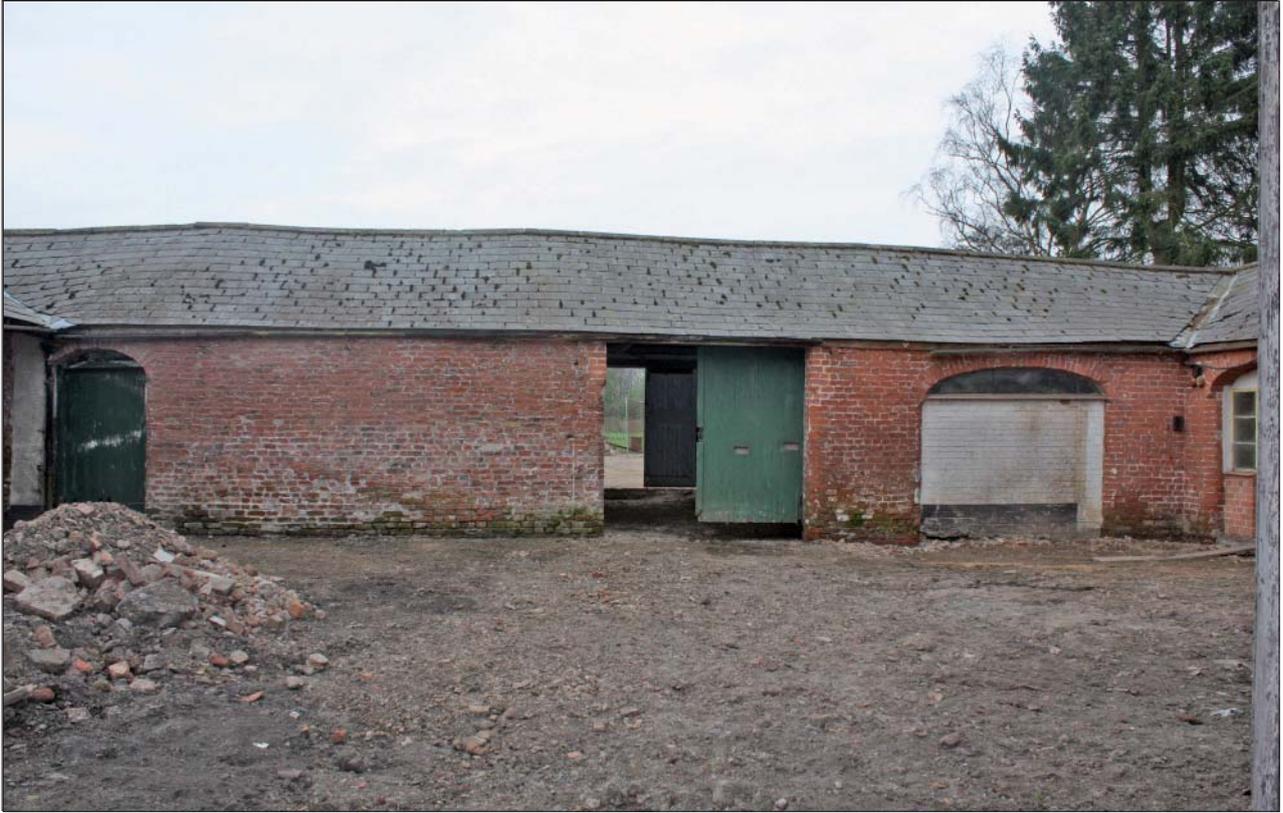
Plate 5: Building 2 from northeast

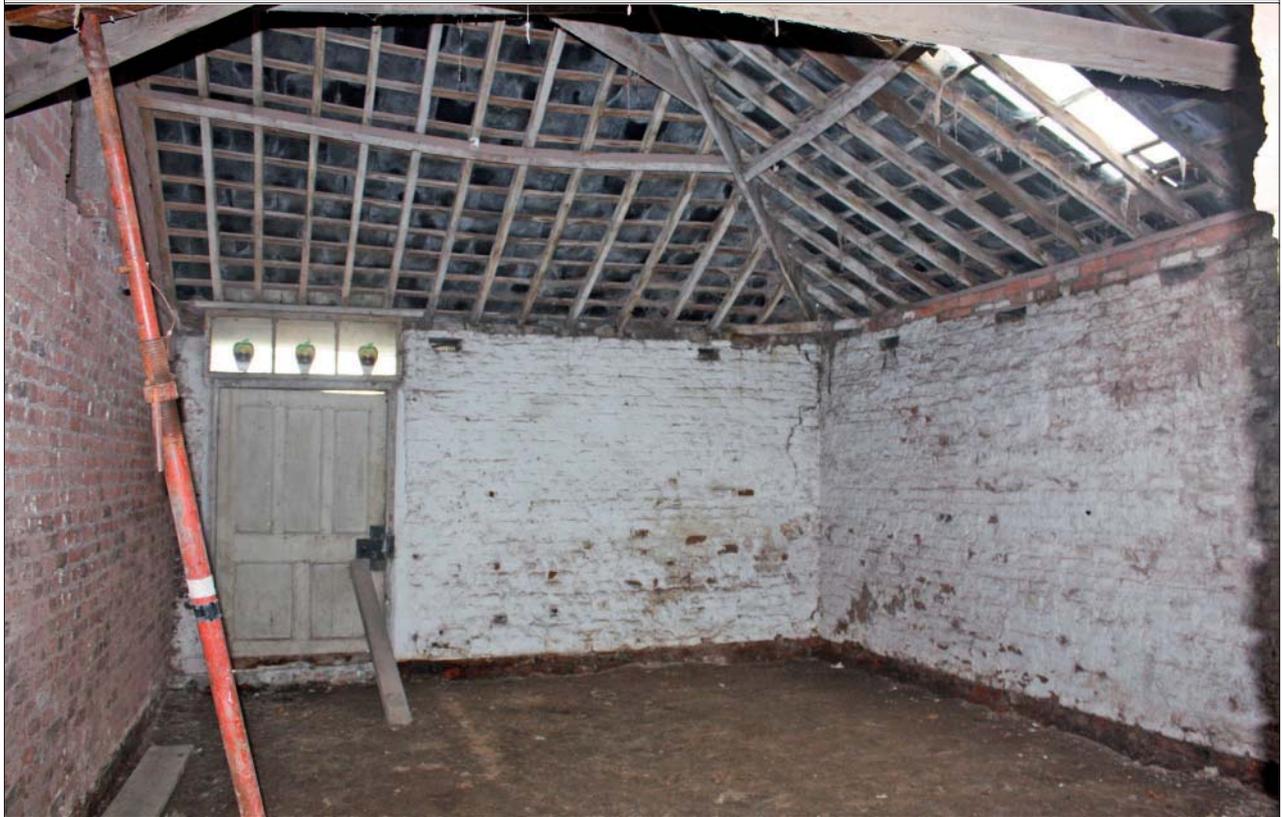
- 4.2.8 The roof structure is mainly of traditional and simple timber construction with purlins supporting the rafters – typical of 19th century date. There was evidence throughout of some repair and replaced rafters. There was no membrane or material between the timbers and slates and no evidence of a previous ceiling having been removed. From inside, it is clear that the present roof is not original. The brick used around the upper parts of the walls are later, probably 19th century in date, and have raised the upper wall level to take a new roof. Also, from this part of the building, there is evidence that the doorway at the far eastern end is a later insertion (plate 7).

Plate 7: Building 2, interior

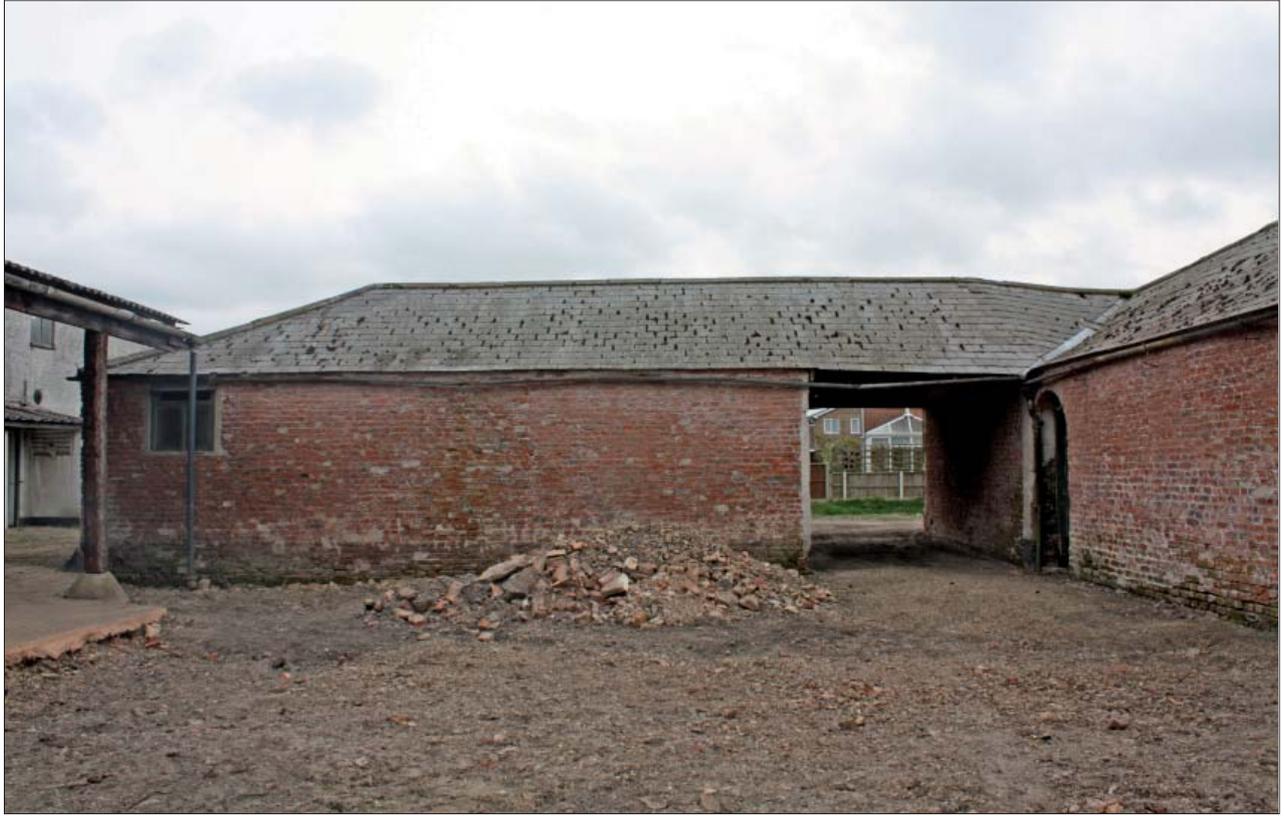
Plate 9: Building 3 from northwest

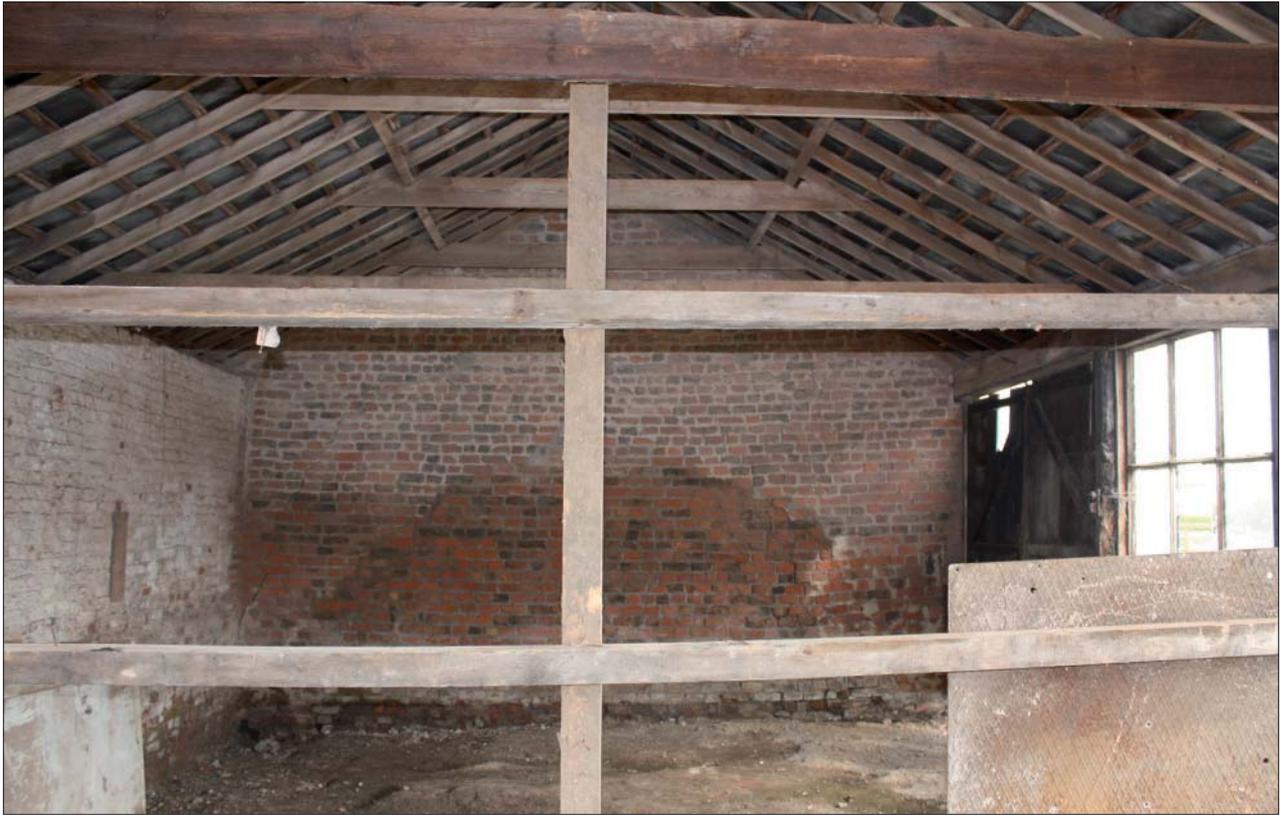
- 4.3.7 The larger area, accessed though the double doors was open at the south western end (Plate 11). The roof at this end was open and pitched and appears to have been replaced within the last century with machine cut purlins and rafters. The floor had been

Plate 11: Building 3 interior

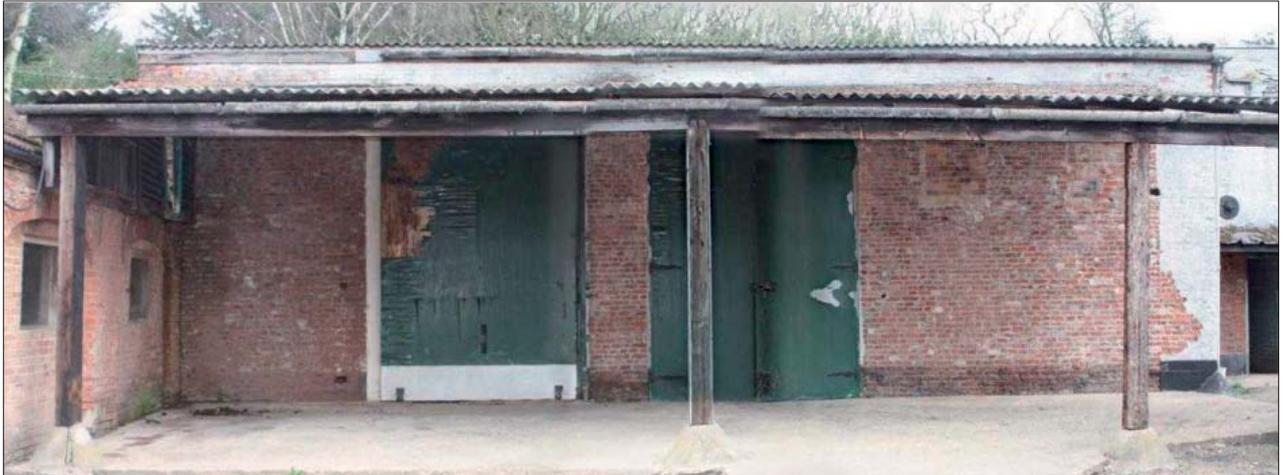
- 4.5.1 Building 5 is rectangular in plan and measures 14.2m by 7.4m. It flanks the north east side of the courtyard and is accessed via doors on the courtyard side (plate 20). This building had a single-pitched roof sloping in towards the courtyard area and was covered with a corrugated asbestos sheeting. It is constructed from late 18th century, orange coloured hand-made bricks with diagonal pressure marks and a dark, creamy, gritty mortar. The mortar had an inscribed effect known as “flush scribed joint” (Parissien, 1999), often seen in 18th century buildings where the flush pointing is then inscribed with a rule and trowel end shortly before the mortar sets, producing a neat lined-out appearance in an otherwise relatively irregular work. This additional detail is often applied on buildings of importance and is a decorative detail which would not be required on standard vernacular agricultural or lower status buildings.

Plate 20: Building 5 from southwest (images "stitched" using Autostitch)

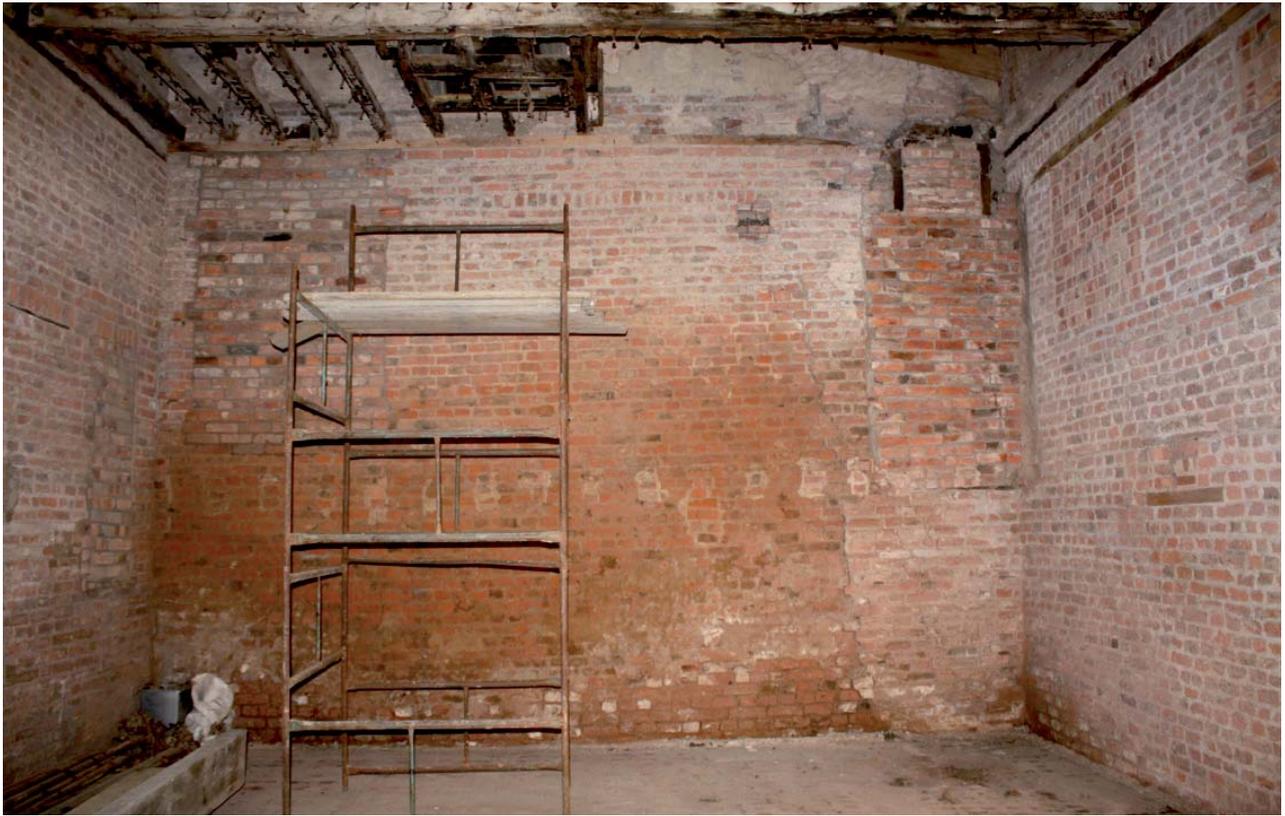
- 4.5.6 Internally, there is evidence that this building has been altered and repaired since its construction with several phases of brick visible (plate 25). Internal detail of the gable end of the south eastern end of Building 5 reveals a number of alterations and repairs which appear to have all been carried out in the 19th and 20th centuries. Although there are no surviving fixtures or fittings which indicate either an original function or later use, this internal elevation has a row of bricked-up voids which may have once held fittings such as a hay stall for horses.

Plate 25: Detail of interior wall, Building 5

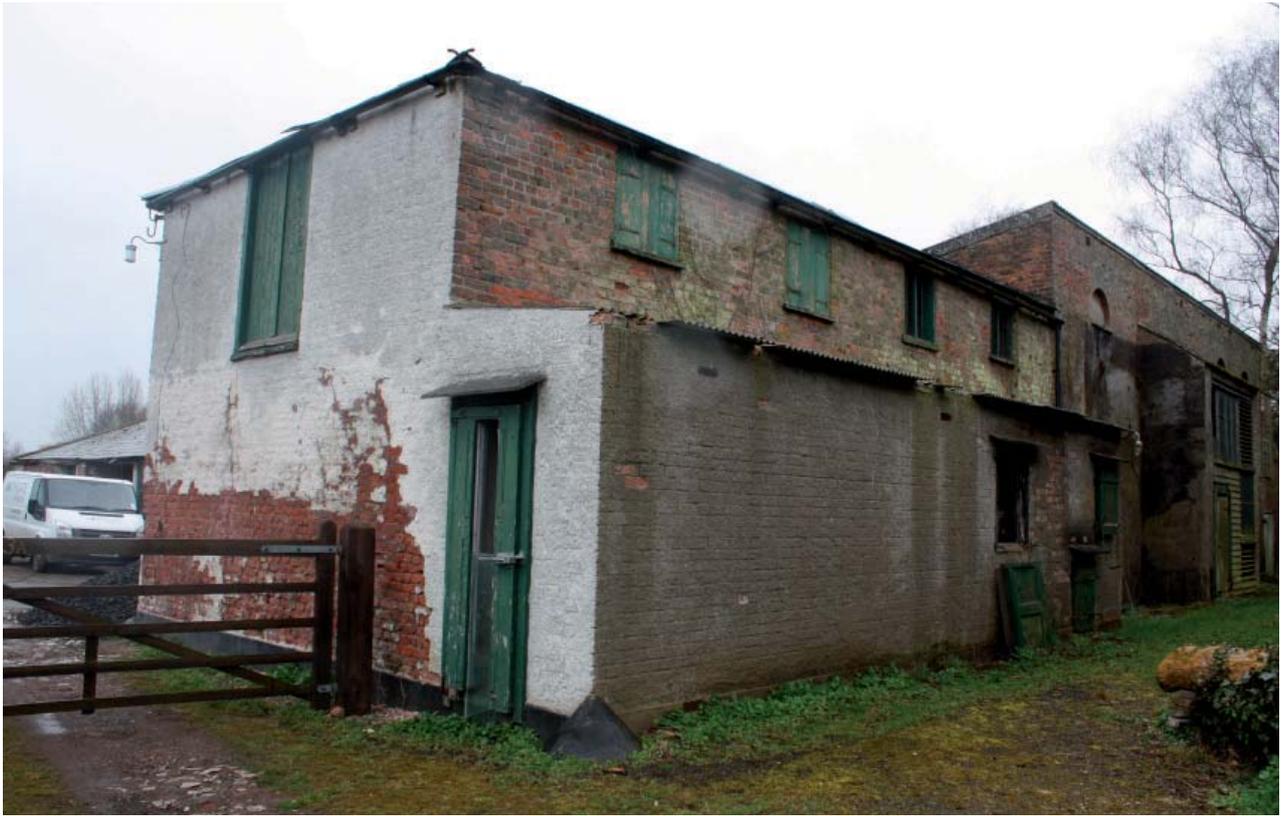
Plate 30: Building 6 from east

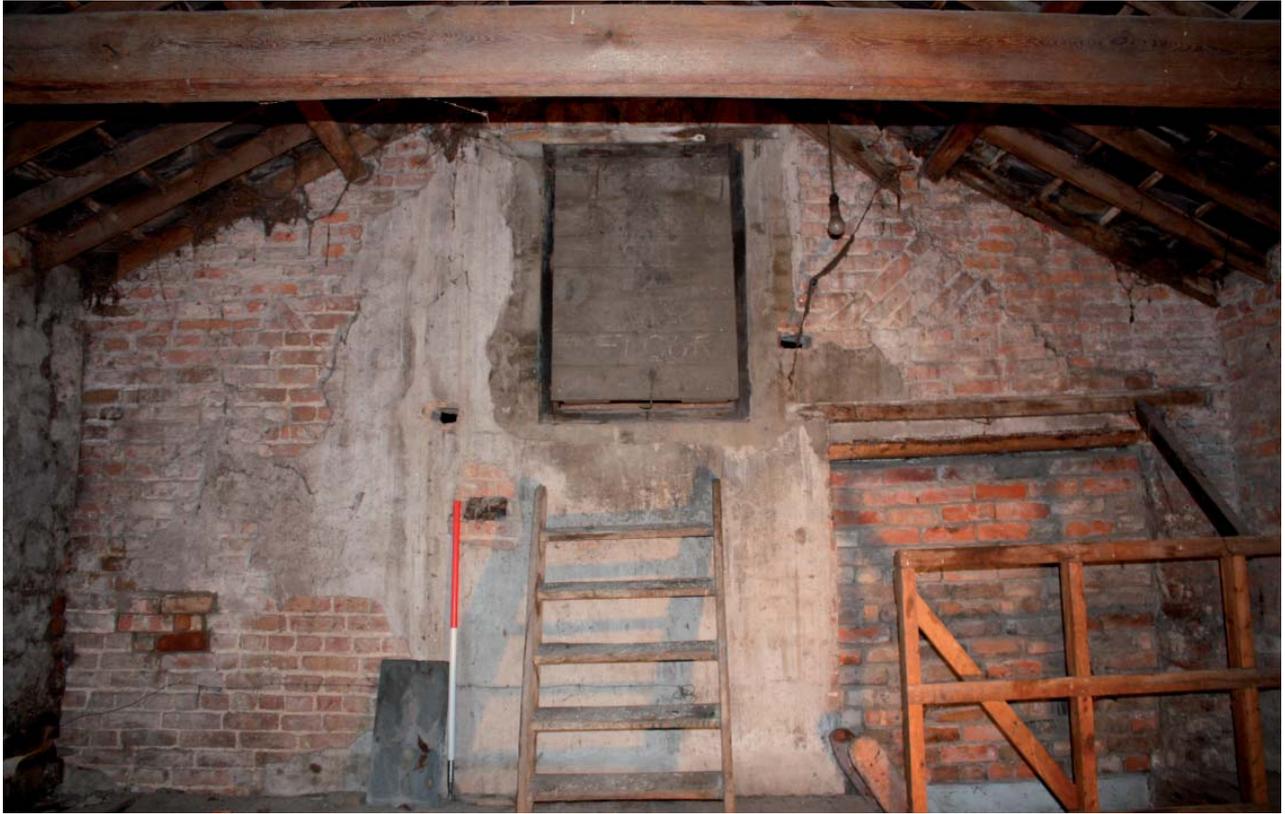
- 4.6.9 On the first floor, the inside of the original gable end of this building can be viewed and exposed brickwork suggest this is an earlier phase than Building 5 adjoining (plate 33). The exposed internal gable end shows tumbling-in brickwork which in most cases would suggest an 18th century date, and there has been no other evidence of this in the other buildings surveyed, perhaps implying an earlier building. Although tumbling brickwork is found in a number of 17th century buildings, particularly in Cambridgeshire, it is a construction style witnessed more in Lincolnshire into the 18th century; perhaps a suggestion of styles and influences spreading northwards from London around this time. This elevation shows that the roof level has been raised to the current, more gradual pitch which explains the different, later brick recorded at first floor level on the north east-facing elevation (plate 30). An access hatch has also been added to provide access to the storage area recorded in the "roof space" of Building 5.

Plate 33: Interior detail, Building 6, first floor
