28-29 Belmont Wantage Oxfordshire

Archaeological Watching Brief Report

April 2013

Client: Hanbury Development Ltd

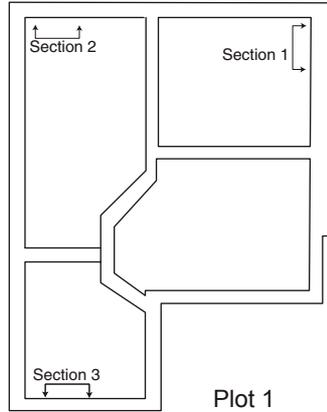
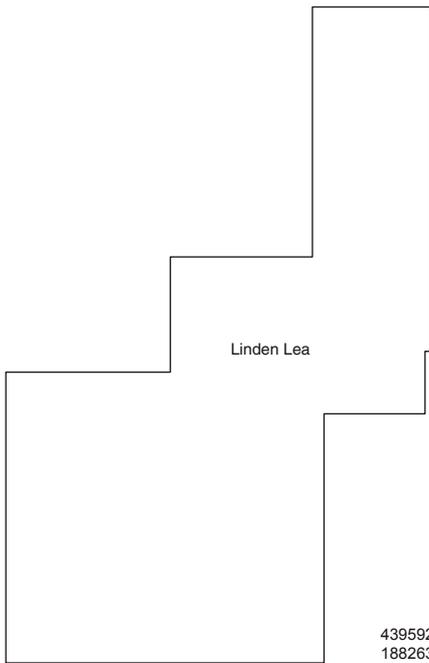
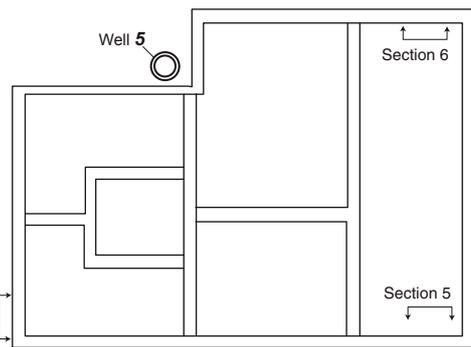
Figure 2: Site plan

- 2.2.4 A site plan showing the location of any excavations and any recorded sections was maintained at a scale of 1:100 (Fig. 2). Sample sections of trenches were drawn at a scale of 1:20.

- 3.1.9 As elsewhere on the site this was overlaid by the topsoil, (1), 0.25m in depth.
- 3.1.10 In the centre of the northern edge of plot 2, the top of a brick lined well (5) was exposed during the topsoil strip (Fig. 2). This feature was circular in plan and was constructed using a plain machine made red brick, 0.225m x 0.110m x 0.07m in size (Plate 2). These had been laid without using mortar tangentially around the circumference of the well. The cut (6) for the well shaft was exposed during later machining was seen to be approximately 1.2m in diameter and was probed to a depth of 3.4m below the garden level. The remains of a lead suction pipe could be seen rising up the side of the well before turning through 90 degrees and running out eastwards through the top courses of the brickwork. The style of construction and brick size would suggest a mid to late 19th century construction.

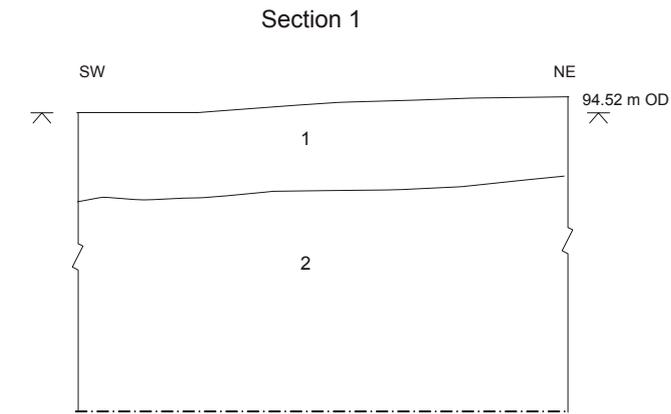
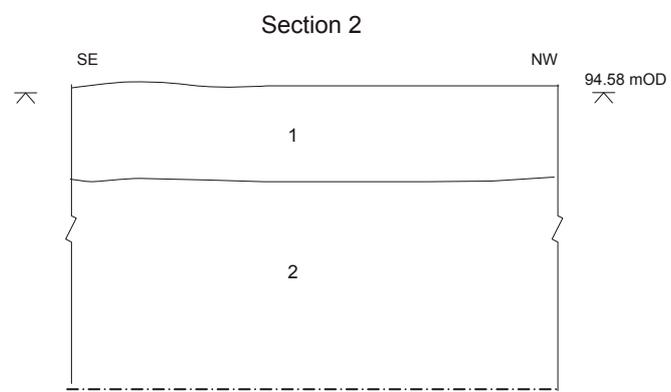
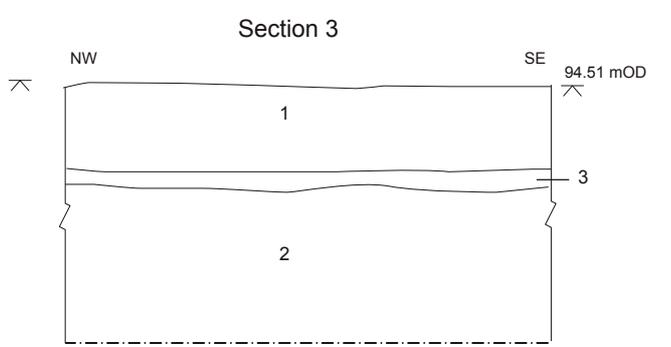
Figure 3: Sections 1-3

garden level (Fig. 3, Sections 1 and 2). This layer was very clean and appeared to be undisturbed. Overlying this deposit was a layer of cultivated soil, a dark grey-brown clay loam (1) measuring between 0.25m and 0.32m in depth. No discernible layers were visible within this deposit and it appeared to be homogeneous throughout. Examples of 19th and 20th century artefacts including pottery, clay pipe, brick and tile were observed at all levels.

- 3.1.4 Excavations in the south-west corner of the plot exposed a similar stratigraphy (Fig. 3, Section 3) with the exception of a thin layer of greenish grey clayey silt (3), 0.12m in depth, observed between layers 1 and 2.

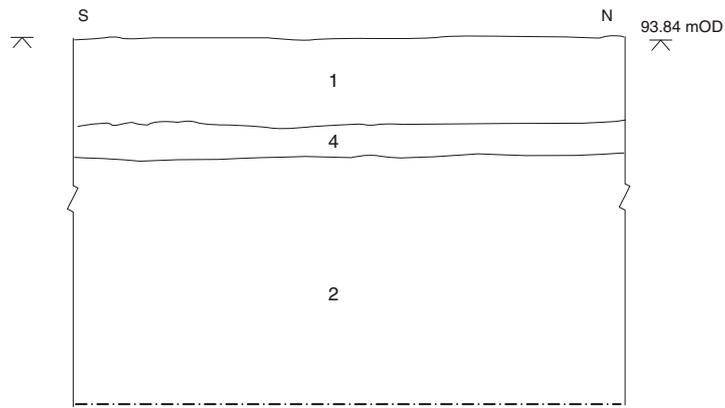
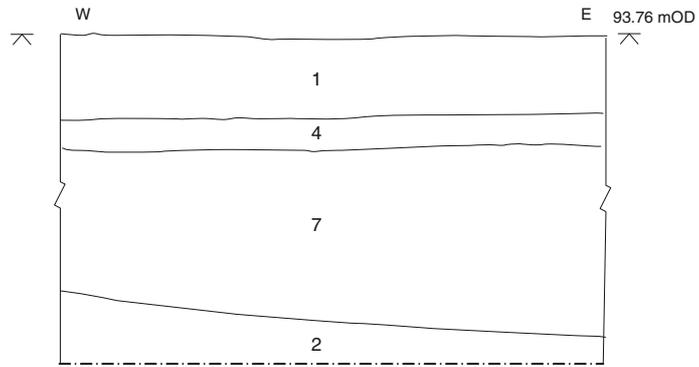
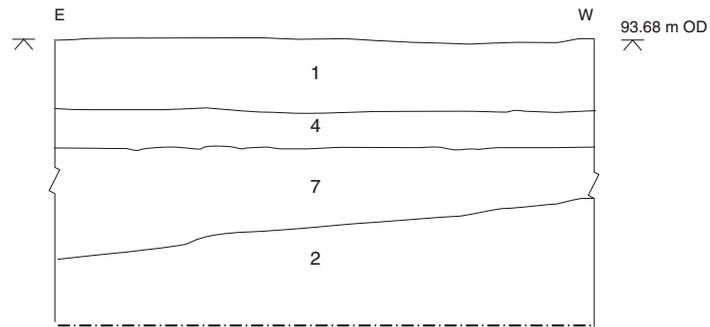
Figure 4: Sections 4-6

- 3.1.5 This was excavated along the southern edge of the development area, parallel to the public footpath.
- 3.1.6 Excavation of the foundations started in the south-west corner of the plot. Exposed within the base of the excavation was a continuation of the pale greenish grey clayey sand (2) at a depth of 0.5m below the current ground level (Fig. 3, Section 4). Overlying layer 2 was a 0.12m deep layer of gingery brown silty loam (4), a probable layer of earlier cultivated/plough soil. This was overlain by a 0.3m deep continuation of layer 1.

- 3.1.7 The natural sand (2) followed the underlying slope of the area and fell away to the south-east. At the south-east corner of the plot the natural was observed at a depth of 0.9m below the current ground level (Fig. 3, Section 5) (Plate 1). At this point the natural was overlaid with a 0.7m deep layer of a pale greenish-white sandy silt (7), a probable layer of colluvium. This was covered by a continuation of the gingery brown silty loam (4), 0.12m in depth. This in turn was overlaid by a continuation of the cultivation soil (1), 0.25m in depth.

- 3.1.8 Further up the slope of the garden at the north-east corner of the plot (Fig.3, Section 6), the natural, (2), was encountered at a depth of 0.6 m below the current ground level. The layer of colluvium (7) was thinner in here, measuring only 0.3m deep.

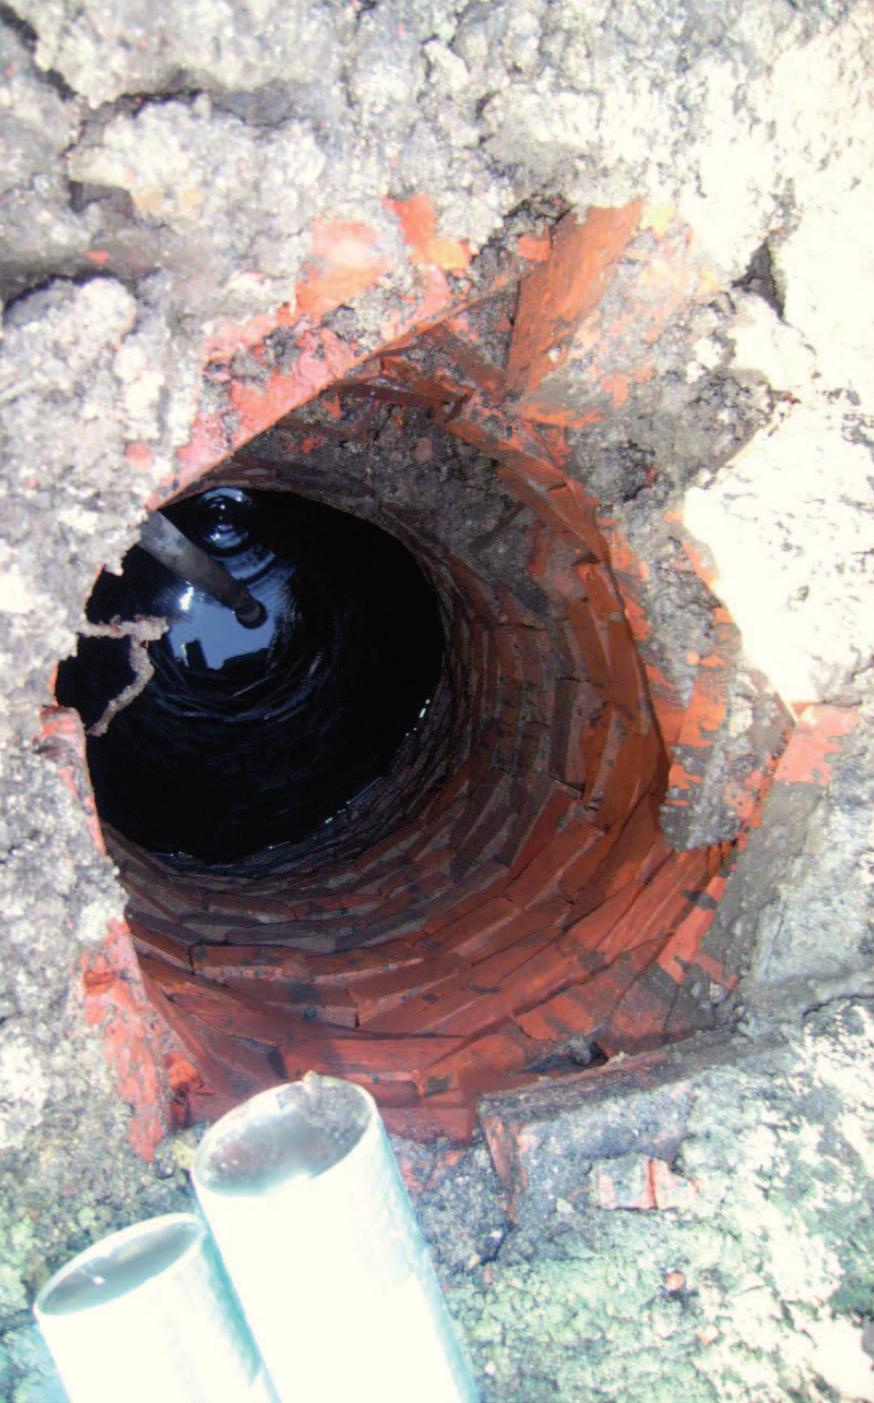
Plate 2: Well 5

- 4.1.4 The size and style of the bricks used in the lining of well 5 suggests that it was probably contemporary with the construction of the demolished houses.
