The Former Steel Designs
Construction Ltd
Lorne Road
Dover
Kent

Archaeological Evaluation Report

ARCHAEOLOGICAL EVALUATION REPORT

Oxford Archaeology (OA) carried out a field evaluation at the former Steel Designs Construction Ltd, Lorne Road Dover, Kent on behalf of BSC Group . The evaluation revealed the foundations and flagstone floor of the pit wheel housing of a 19th century mill and associated yard surfaces .

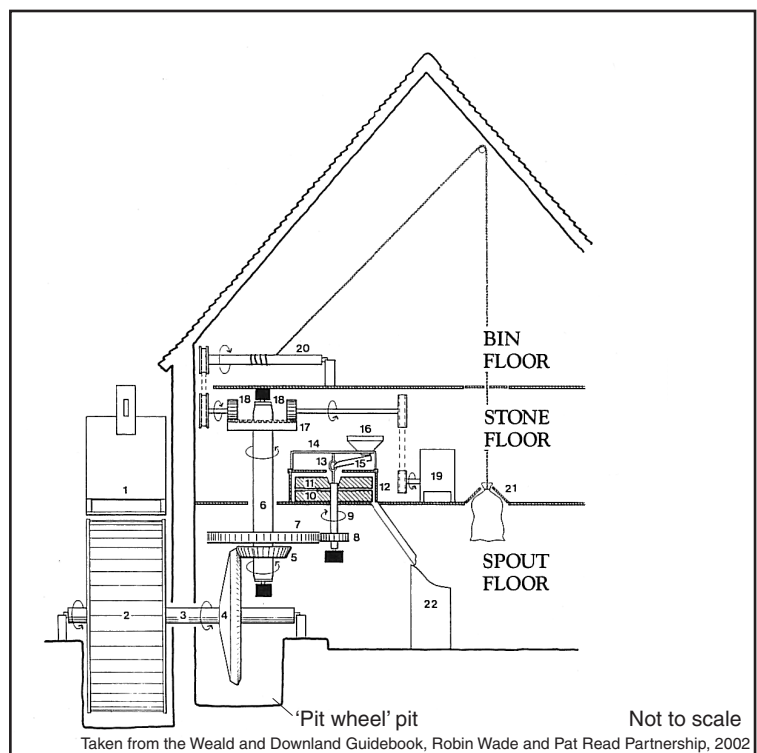
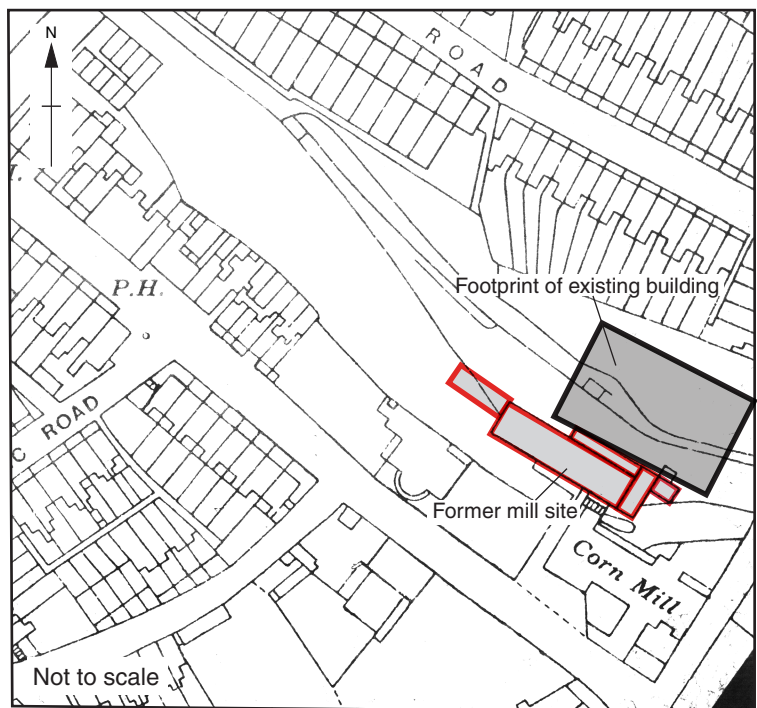
Figure 2: Trench plan and insets

Schematic diagram of Lurgashall Mill

Location of former mill

Trench 5. This was not bonded and was poorly preserved. Maps show this area to be outside the mill building suggesting that it was a yard surface (see inset Fig. 2). A similar brick yard surface (3002) was uncovered in a poorer state of preservation in Trench 3. It seems likely that the surface was also present in the area of Trench 4 but was removed by the construction of the existing building.

- 6.1.6 Comparisons with other mills such as Lurgashall mill (Wade and Read 2002) (Fig. 2) or De Montalt mill at Combe Down, Bath (OA in preparation) show a pit wheel being used for the transmission of power from the water wheel. The pit wheel was housed in a recessed room or pit. The stones in Trench 2 were not water worn and this would indicate that the evidence revealed in the evaluation trench may relate to such a structure.
