A possible medieval wall
and associated drain at
Gate House Farm,
Culworth,
Northamptonshire

**Observation, Investigation
and Recording Report**

OA East Report No: 1531

Archaeological Observation, Investigation and Recording

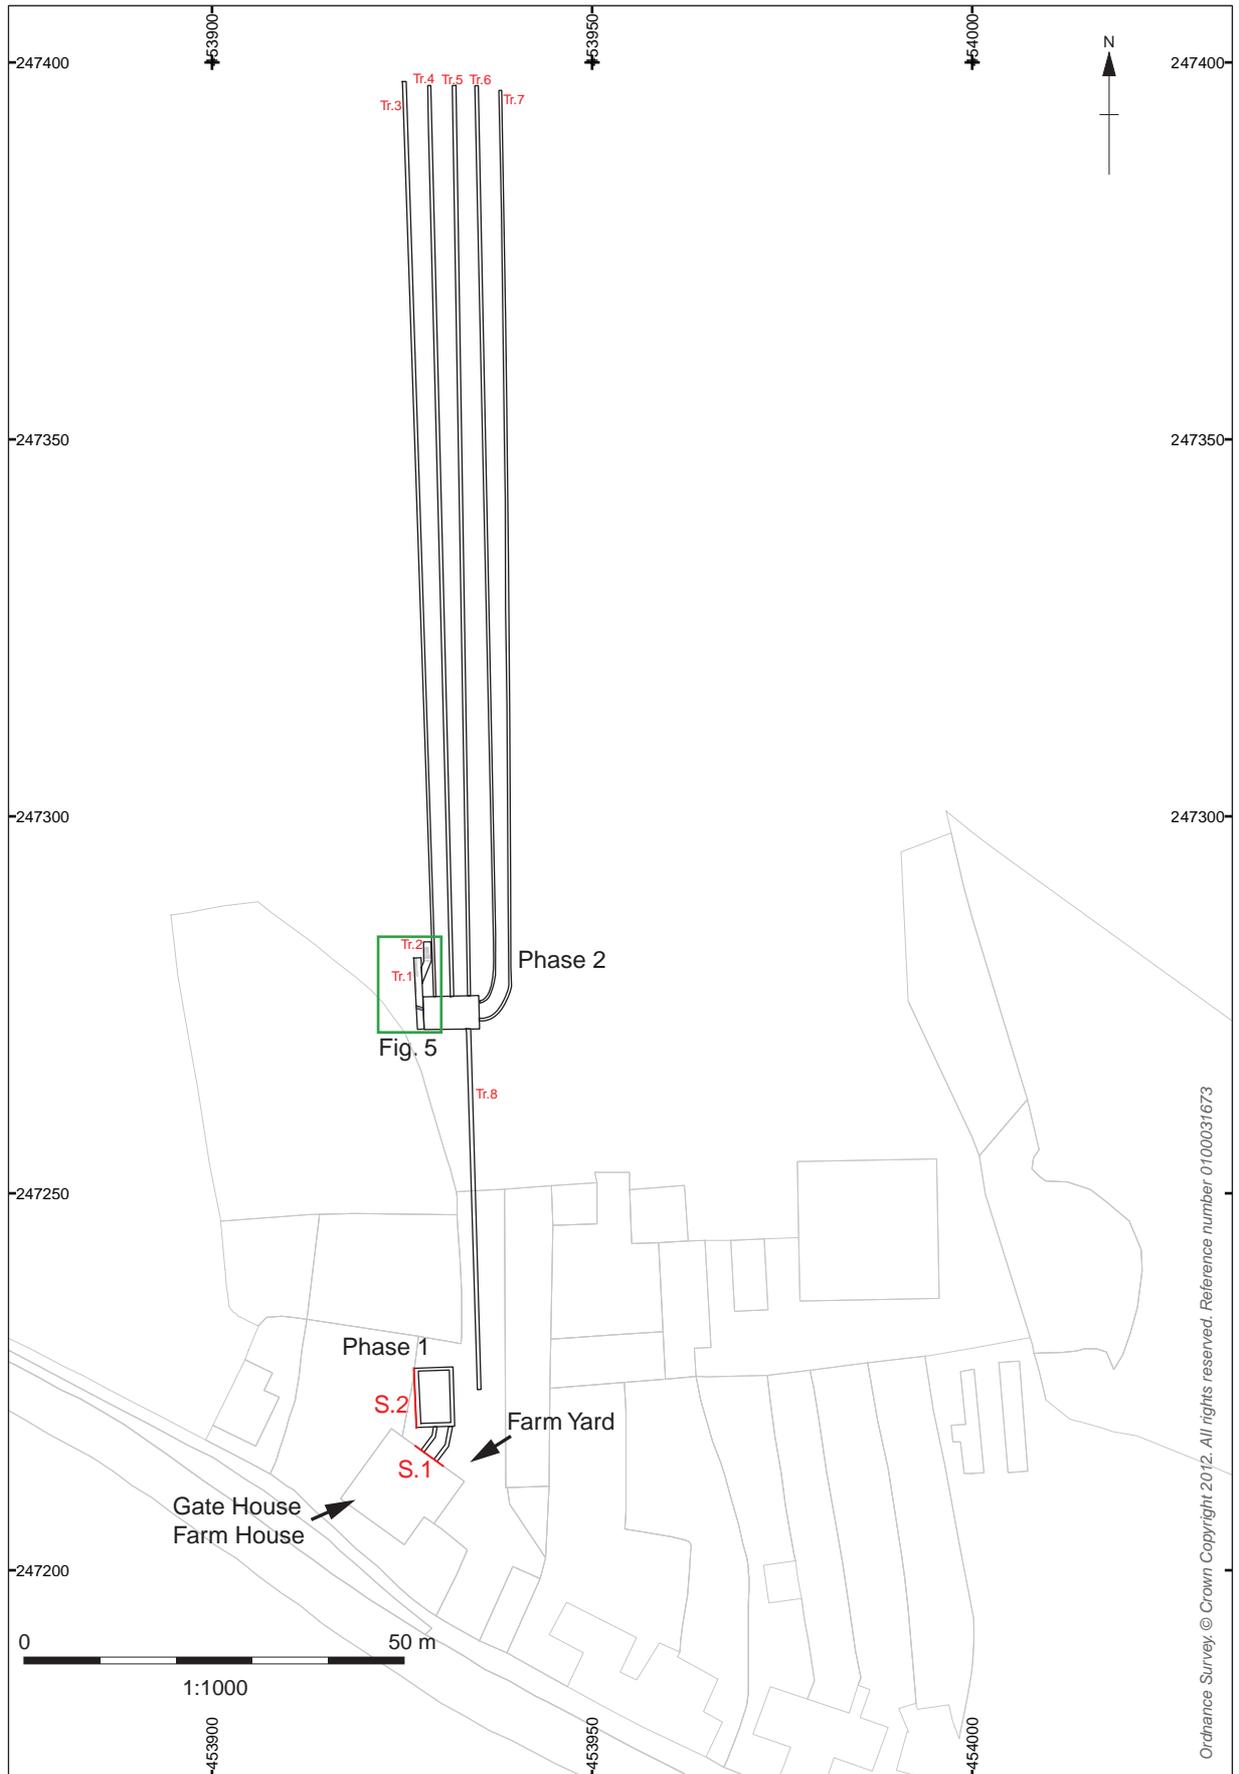
Figure 2: Plan of watching brief trenches (phases 1 and 2)

- 3.2.1 A single continuous trench running north-south was excavated to the immediate north of the farmhouse within the location of a former 20th century lean-to (Figure 2). The trench was excavated to a depth of 1.3m and a width of 0.60m. The trench formed a rectangular shape in plan, spanning an area measuring approximately 8m by 5m (Plate 1).

- 3.3.1 Seven trenches were excavated in the field to the north of the farm and one trench was excavated through the farmyard itself (Figure 2). The first trench investigated was Trench 1, which contained archaeological features after approximately 5m of excavation (Figure 5) and was consequently re-routed (Trench 2) (Plate 4). As archaeological remains were also found within Trench 2, a second diversion was attempted (Trench 3); no archaeology was found to be present in the remaining five parallel trenches and they all continued to be excavated and monitored to a length of 125m (Figure 2) (Plate 5). In addition, no archaeology was encountered in Trench 8 through the farmyard. The trenches are described below:

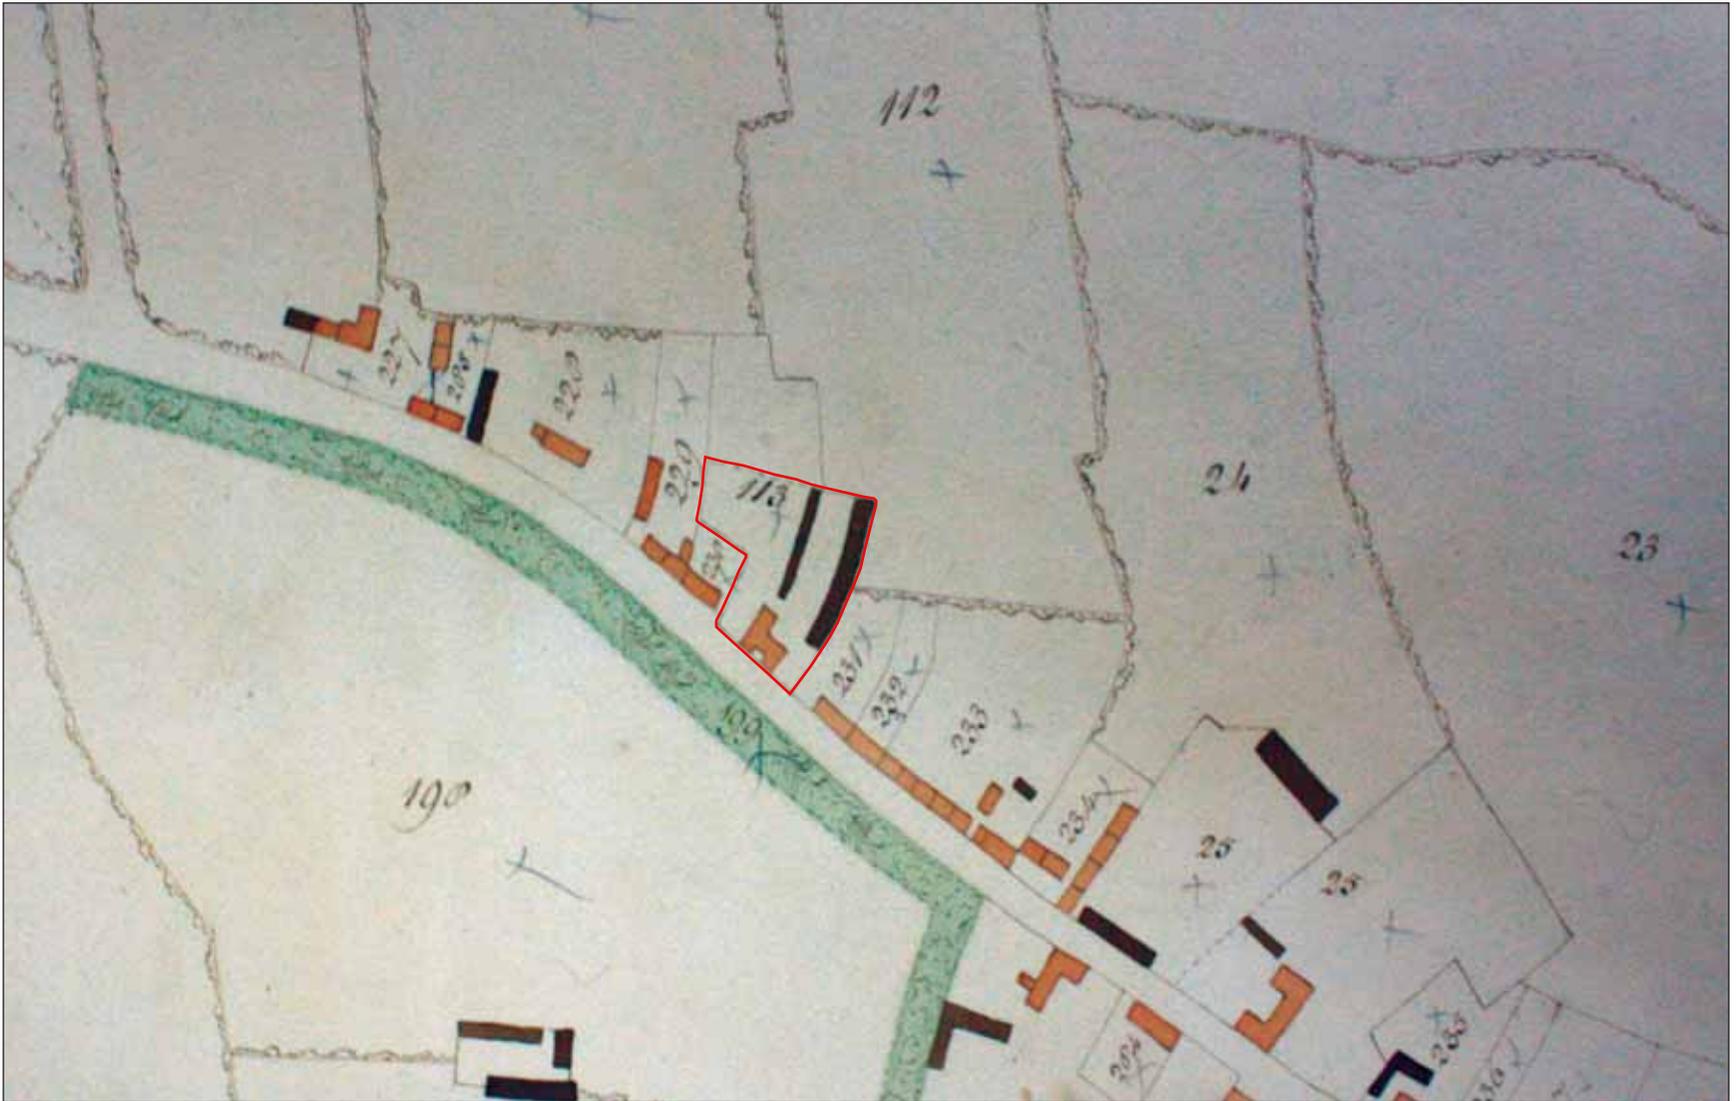
Figure 3 : Extract from Culworth Tithe Map, 1839, showing location of Gate House Farm (red)

- 1.3.9 The 1839 Tithe map was the earliest map of Culworth available at Northamptonshire Records Office (NRO) which depicts the buildings of Gate House Farm (Figure 3). The purpose of the maps was to show the owners, occupiers and size of land within a parish and buildings are not always represented. For many parishes they provide the only large scale map showing the landscape and they frequently provide the earliest evidence for the field systems in the parish. This map depicts the farmhouse (pink), fronting onto the road. Unlike the present shape in plan, in 1839 it was h-shaped. At the rear of the farmhouse are a parallel range of buildings. There is no surviving evidence of these structures within the field to the north at this time.

- 4.1.2 There is no cartographic evidence to indicate buildings surviving within this area of the site dating as far back as the 1839 Tithe Map, which was the earliest detailed map found during the background research at Northamptonshire Records Office for the 2012 investigations.

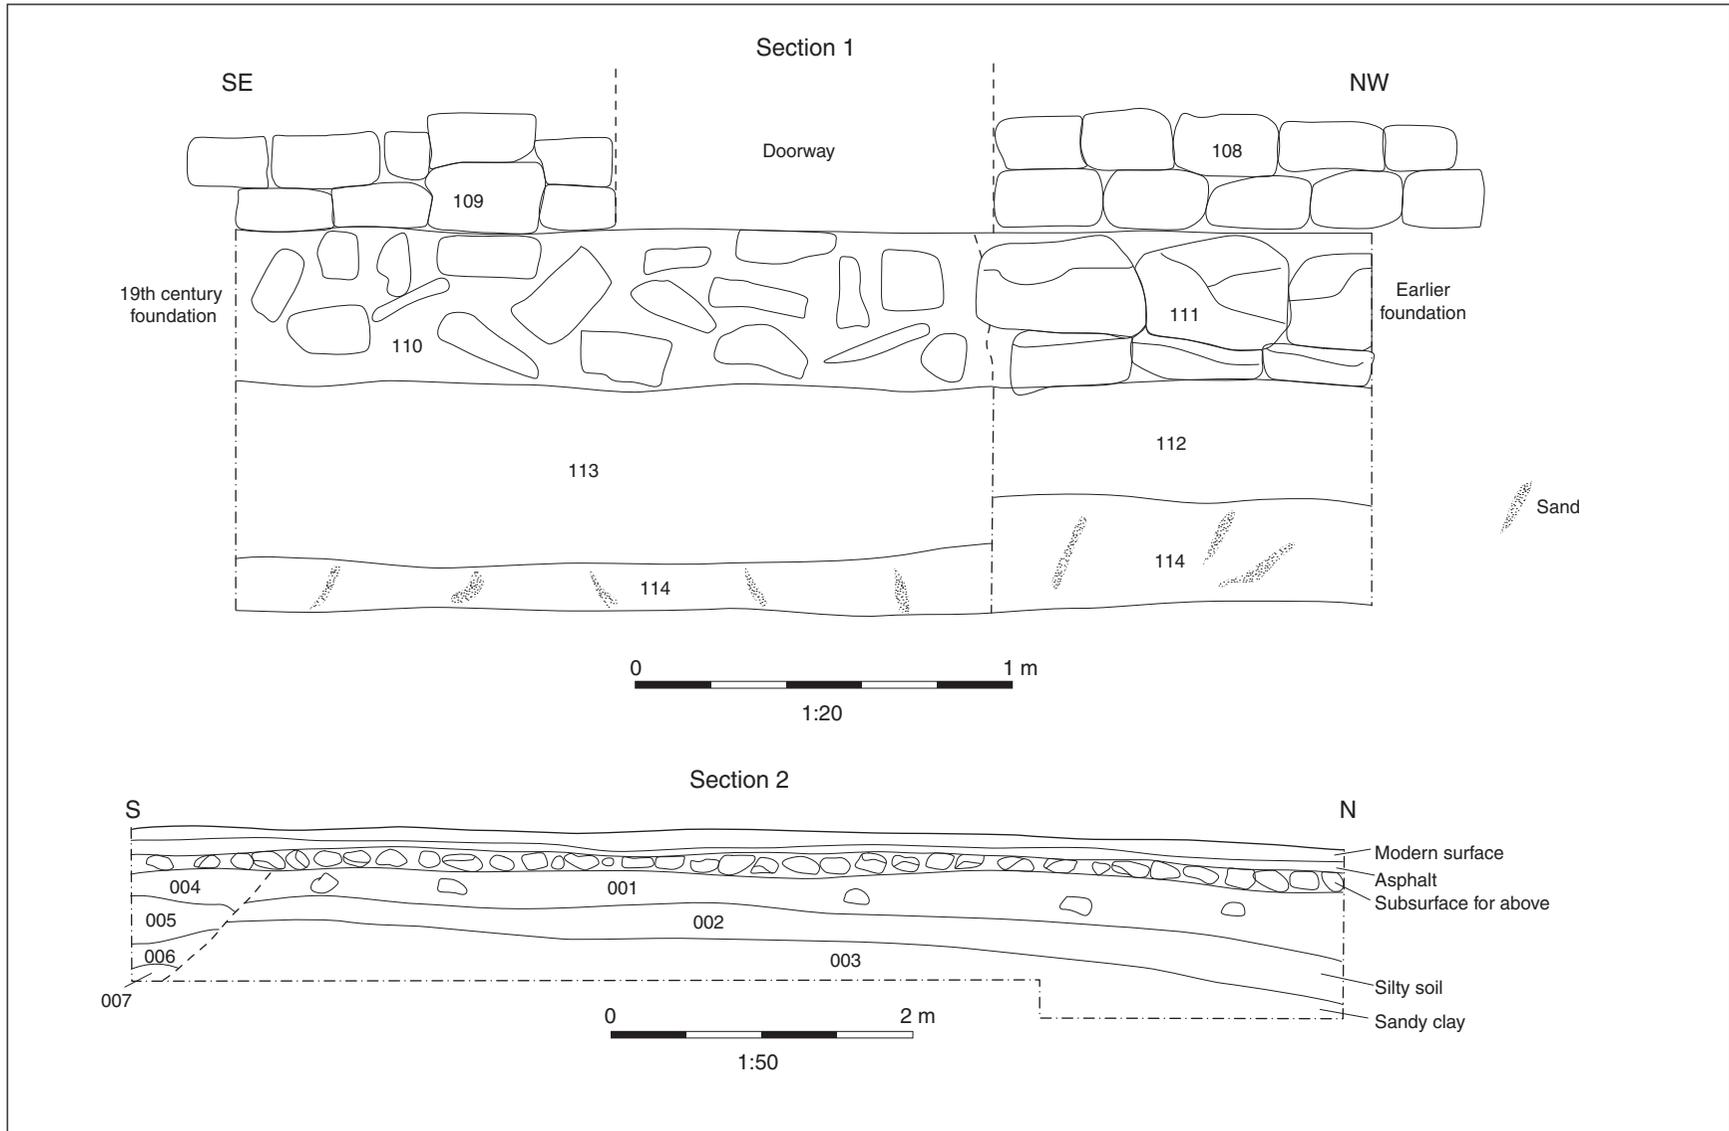
Figure 4 : Phase 1 sections

- 3.2.2 The area immediately in front of the rear property entrance revealed a sequence of 19th century and possibly earlier rubble and foundations associated with the construction of this part of the house (Figure 4, Section 1) (Plate 2). Beneath this were layers of a light orangish brown sandy clay measuring 1m in thickness (113) and a dark sandy clay layer (114), thought to be the natural geology.

- 3.2.3 The remaining trench revealed a sequence of modern car park/driveway surfaces beneath which was a mid orangish brown silty, sandy clay (001) sealing a dark grey silty clay (002), which may represent an earlier surface layer (Figure 4, Section 2) (Plate 3). This deposit was recorded over the natural geology of sandy clay (003). Within the south-west corner, the trench picked up the edge of a cut (**007**) thought to be associated with the construction of the former 20th century lean-to which had previously been located in this position (see Fletcher 2012).

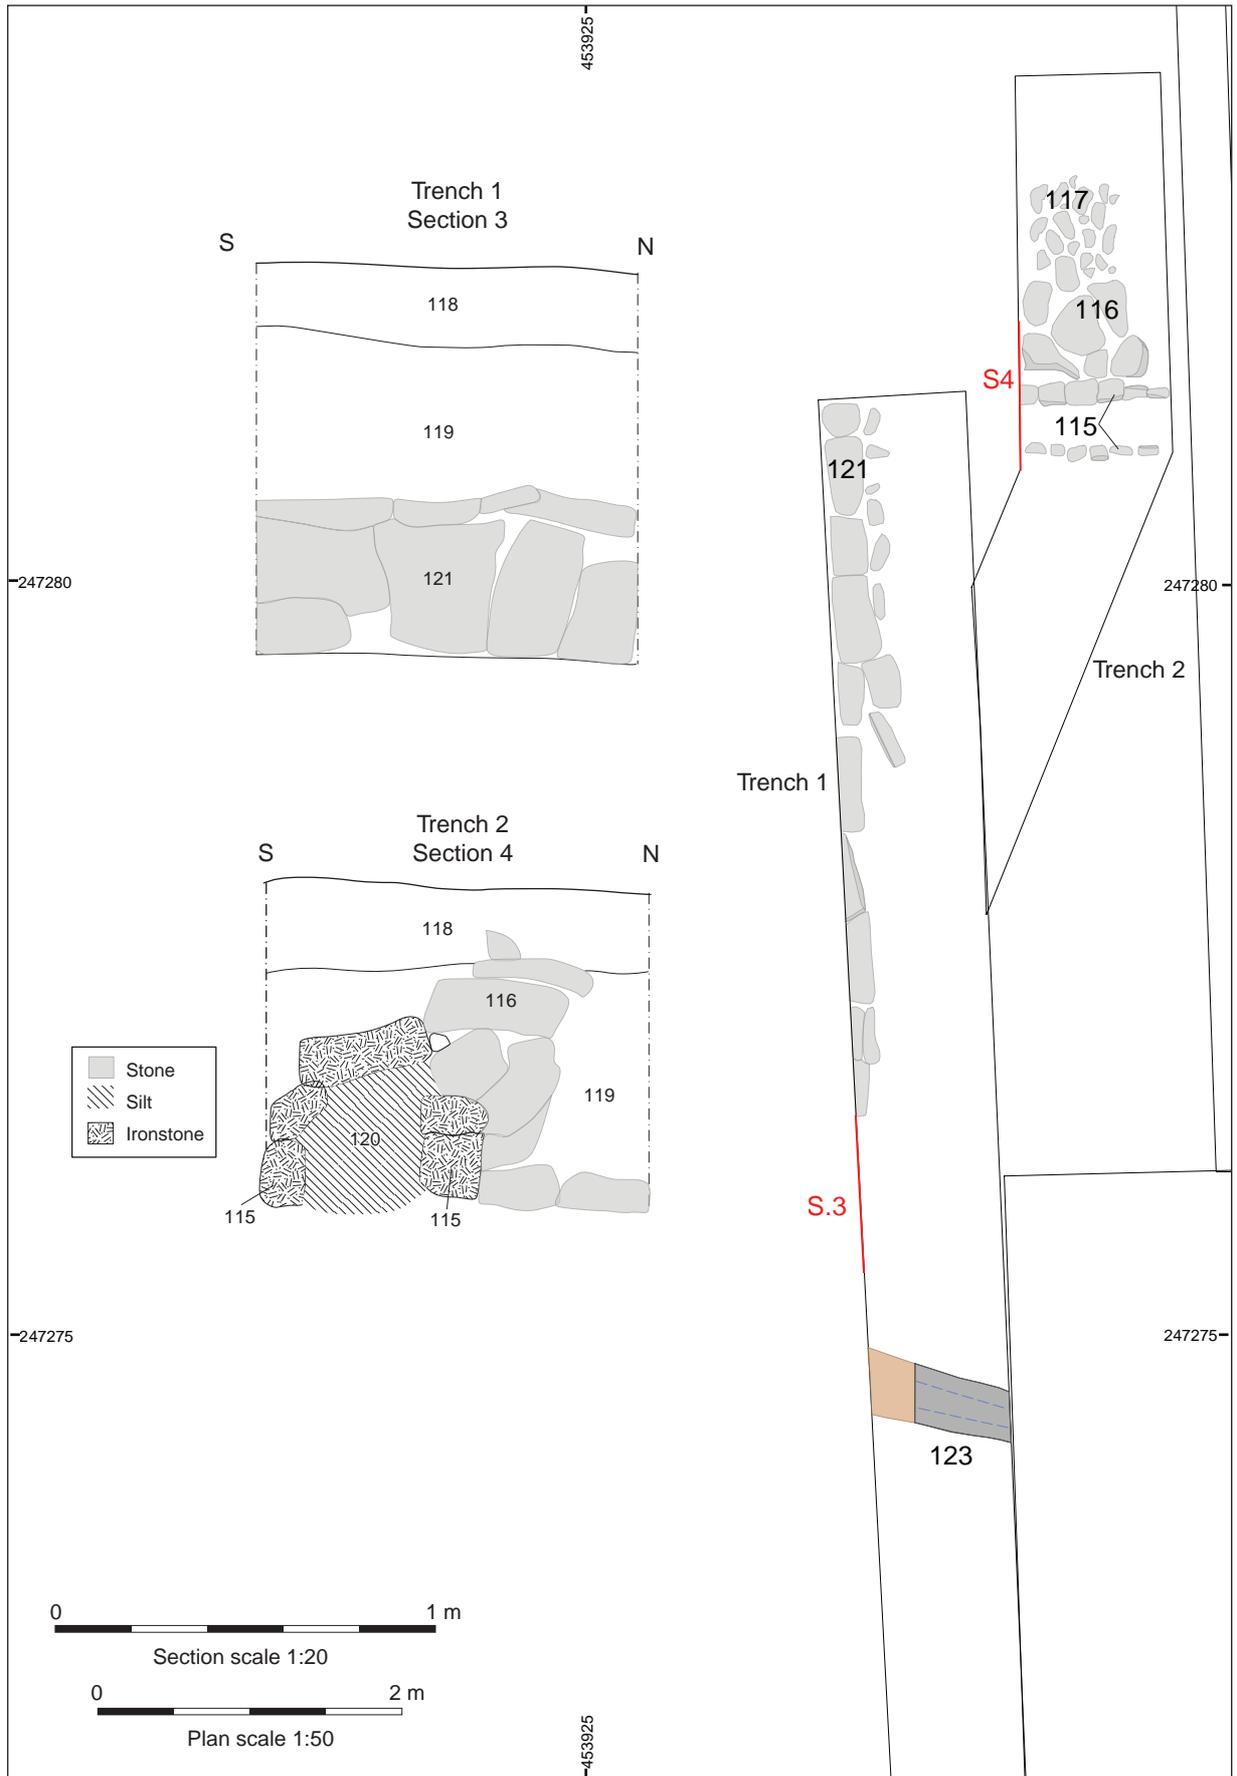
Figure 5: Phase 2 trench plan and sections

The drain was constructed from carefully sorted fragments of ironstone blocks of various sizes. Flat pieces of stone had been used to top the drain and the vertical sides were pushed into a purpose-made cut and supported by smaller stones (Figure 5, Section 3) (Plate 6).

The deposit used to backfill the drain cut (119) was a reddish brown silty clay with occasional medium-large stone inclusions measuring 0.40m in thickness. Two sherds of medieval pottery were recovered from this deposit; one fragment of shelly ware and one base sherd of a quartz tempered cooking vessel. Both are considered to be 12th-14th century in date (Carole Fletcher *pers. comm.*). Above this was a 0.20m thick deposit of topsoil (118) (Figure 5, Section 1).

- 3.3.3 This trench measured approximately 4.5m in length, 0.90m wide and was orientated north-south, forking off from Trench 1 (Figure 5). This trench contained the possible continuation of the drain recorded in Trench 1 (**115**) which may have turned at a right angle to run east-west or may have been a separate drain be connected to that recorded in Trench 1. Parallel to this were the remnants of the foundations of a limestone wall (**117**).

As in Trench 1, the deposit used to backfill the drain cut (119) was a reddish brown silty clay with occasional medium-large stone inclusions. Above this was a 0.20m thick deposit of topsoil (118) (Figure 5, Section 4).

- Running parallel to the drain were the foundations of a limestone wall (**117**) which had partially survived in loose fragments against the drain (**116**) (see plan and Section 4 on Figure 5). The wall (**117**) measured approximately 0.60m wide and the section of possible upstanding wall between **117** and the drain measured 0.50m wide. The stone blocks used in **116/117** were irregular shaped fragments of flat limestone of varying dimensions. There was no obvious mortar used in the construction.
- The orientation of the drain recorded in Trench 1 appears to be in line with a line/boundary of shrubs noted within the same field to the north (Plate 8) and a slightly raised area at the northern end of both trenches, which was covered with nettles and may represent further surviving archaeology associated or contemporary with that recorded in Trenches 1 and 2.

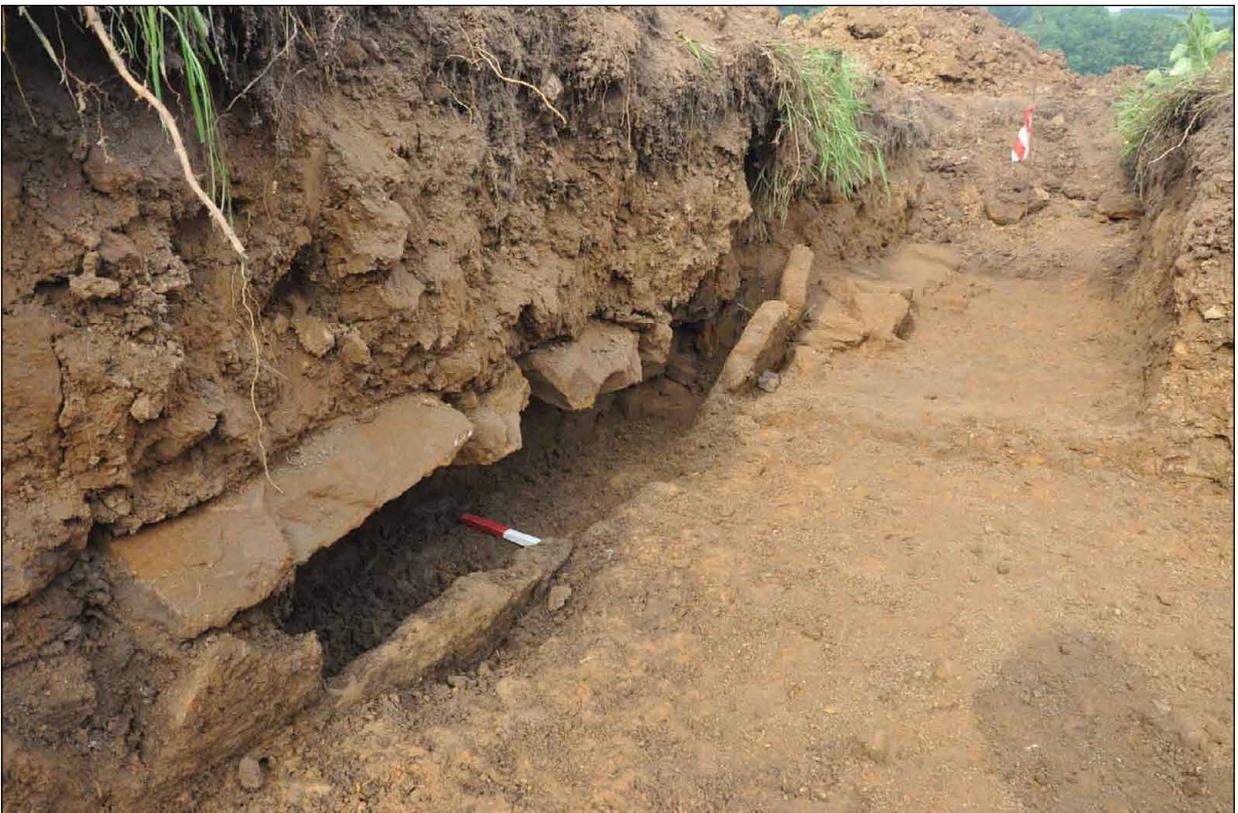
Plate 6: Culvert/drain, Trench 1, phase 2

- Culvert/drain **121** was identified orientated approximately north-south and located running along the western edge of Trench 1. It was not fully revealed in plan but continued beneath the trench edge to the west. The exposed section of the drain measured 3.2m long and it was at least 0.50m wide (Plate 6).

During excavation, the top of the drain was removed by the machine bucket, revealing the drain to be empty with a small amount of dark grey silty-clay soil in the base (120); no finds were recovered from this deposit.

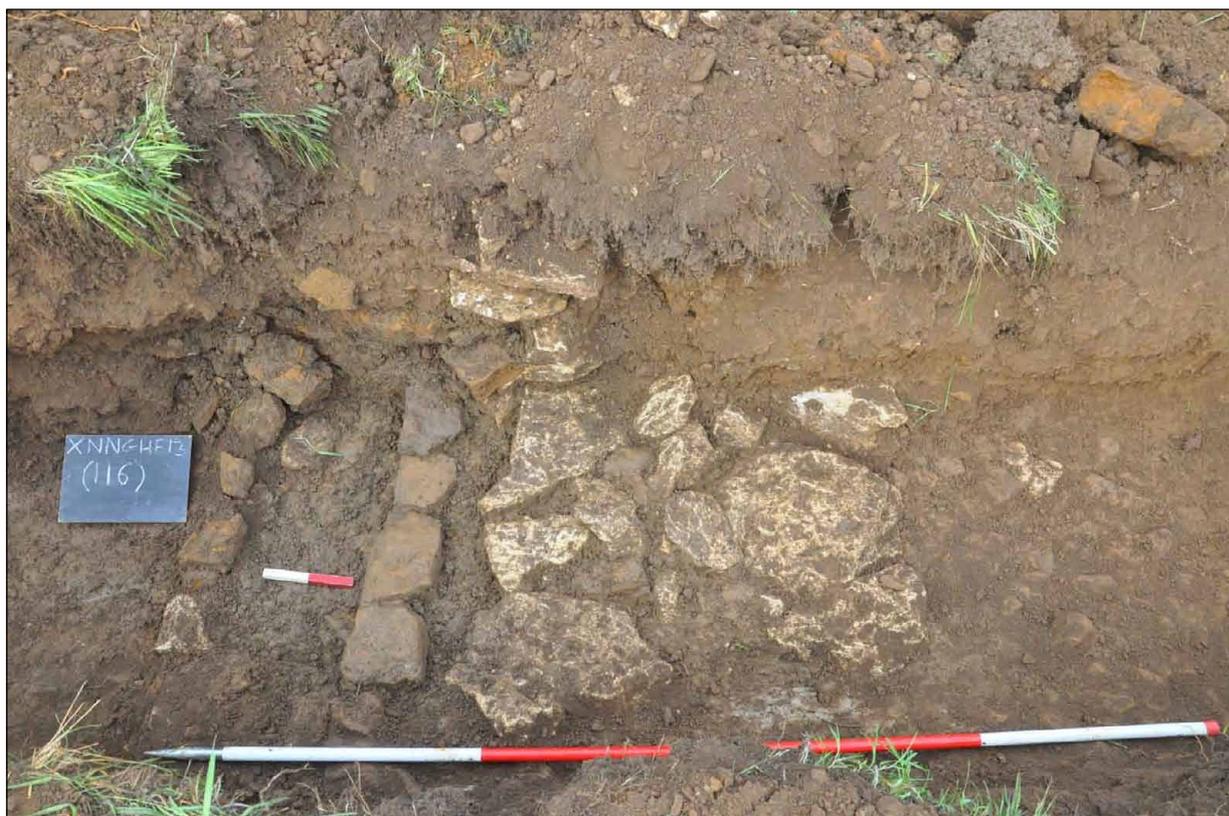
Plate 7: Culvert/drain and wall foundations, Trench 2, phase 2

- Culvert/drain **115** was linear in plan, orientated approximately east-west and measured 0.90m in length continuing beyond both edges of the trench. The full dimension of the drain were recorded from the east-facing section drain which revealed a maximum depth of 1.0m and measured 0.50m wide (Figure 5, Section 4). It had the same construction characteristics as that recorded in Trench 1, however this drain was completely silted up with the same dark grey silty-clay soil (120). Again, no finds were recovered from the fill of the drain.

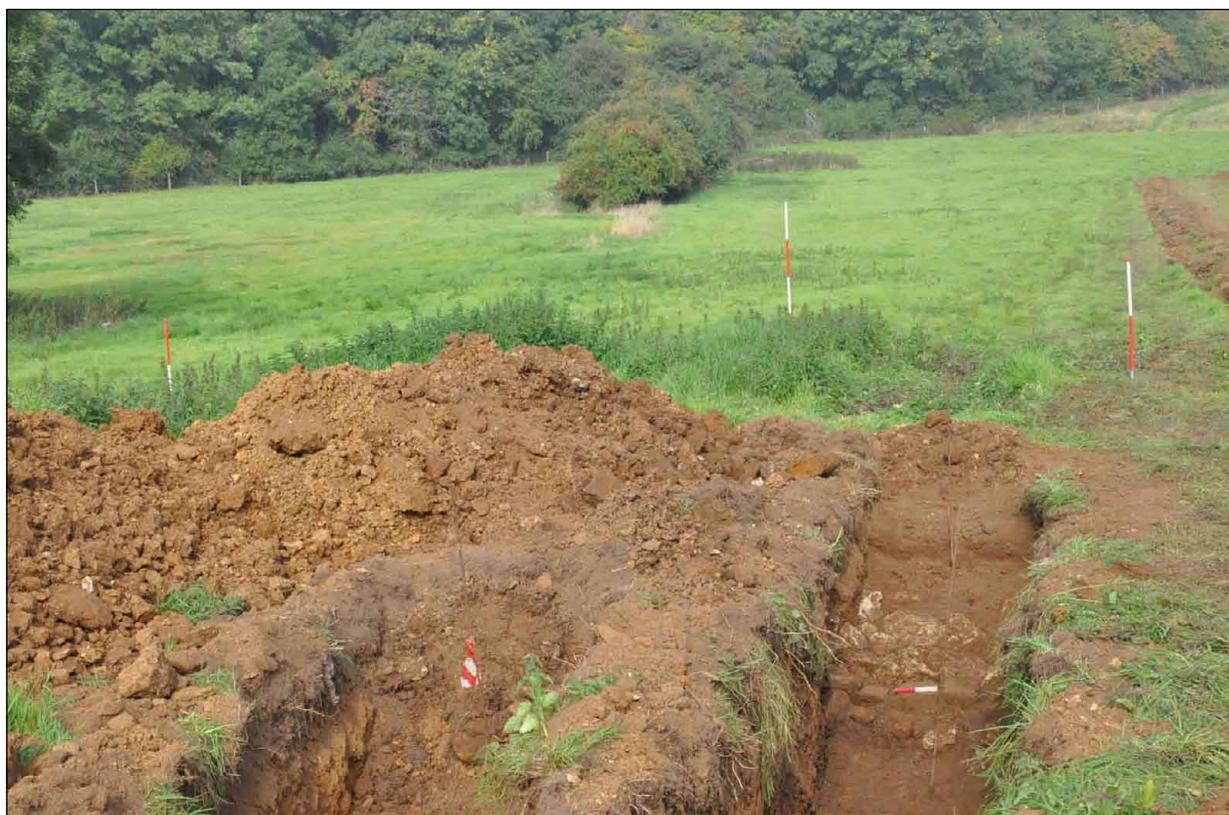
Plate 8: Culvert/drain and wall in Trench 2, phase 2, with possible earthworks within area of nettles to the north

- 4.1.1 The discovery of the undated ditch, drain and wall confirm the presence of surviving archaeological remains within the field to the immediate north of Gate House Farm. The recovery of two sherds of medieval pottery dating to the 12th-14th century provide a possible/tentative date for these recorded remains and possibly, by association, for the adjacent earthworks which were not investigated as part of this monitoring programme.

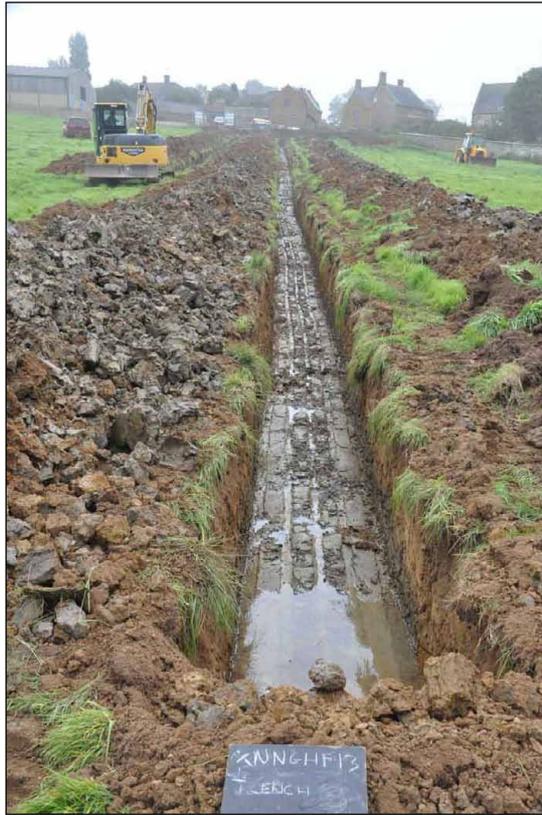
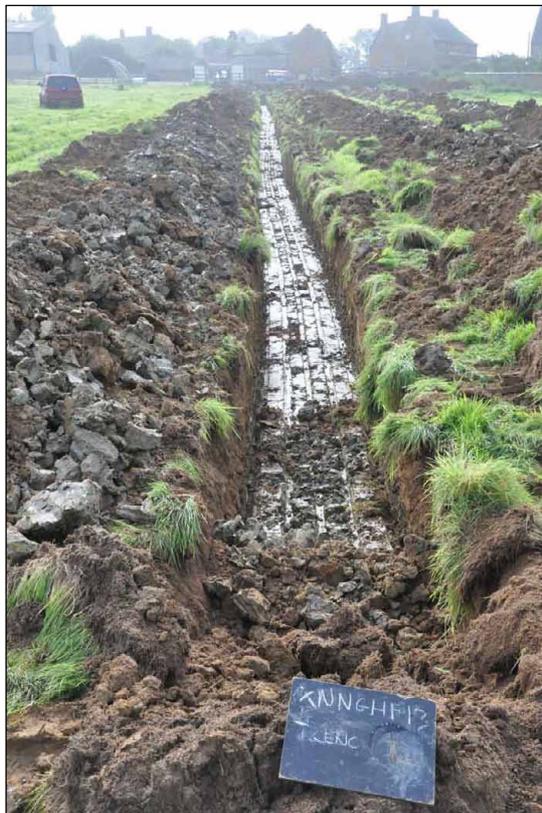
- 3.3.4 No archaeological remains were identified and no artefacts were recovered during the monitoring of these trenches (Plates 9 and 10).
