# **NANTWICH POOL, WALL LANE, NANTWICH, CHESHIRE**

## **Archaeological Watching Brief**

**Oxford Archaeology North**

February 2013

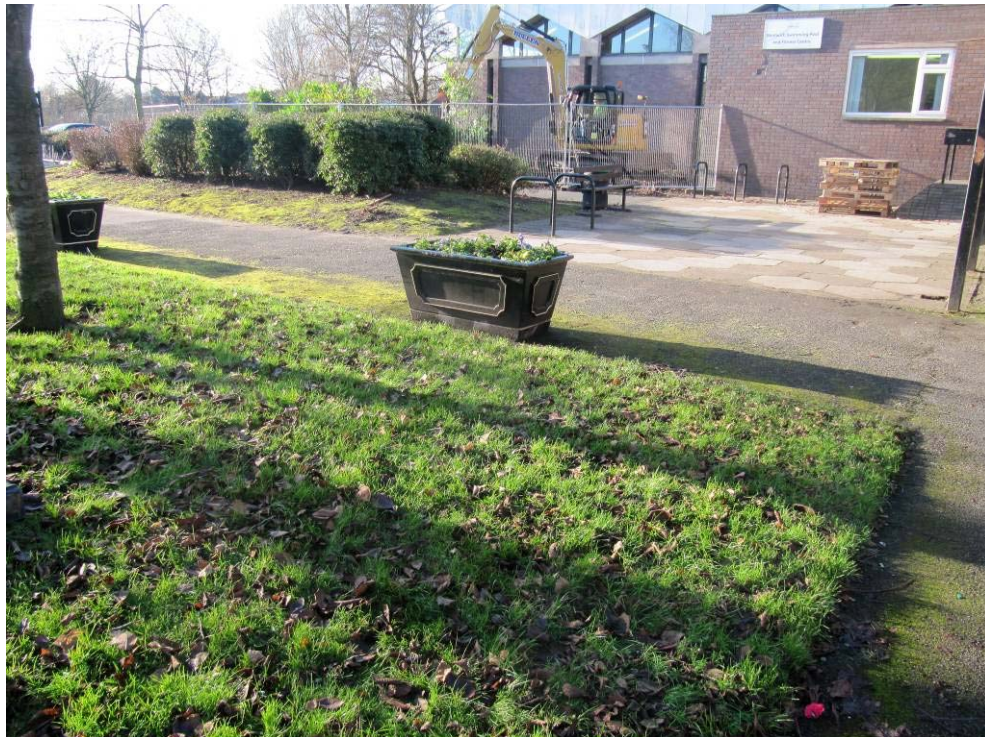
Plate 1: General view of the site facing south-west

- 1.2.1 Nantwich Pool is located approximately 400m to the north-west of the historic market town of Nantwich (NGR SJ 6497 5263; Fig 1), which lies some 30km south-east of Chester and 6km south-west of Crewe. The pool is situated between Wall Lane and Waterlode Road, and approximately 150m due north-east of the River Weaver. The area of the groundworks measured 20m x 10m on the eastern side of the indoor pool and was covered in thick dense trees and shrubs. It was bound to the north by the reception area for the pool and gym (Plate 1, Fig 2).

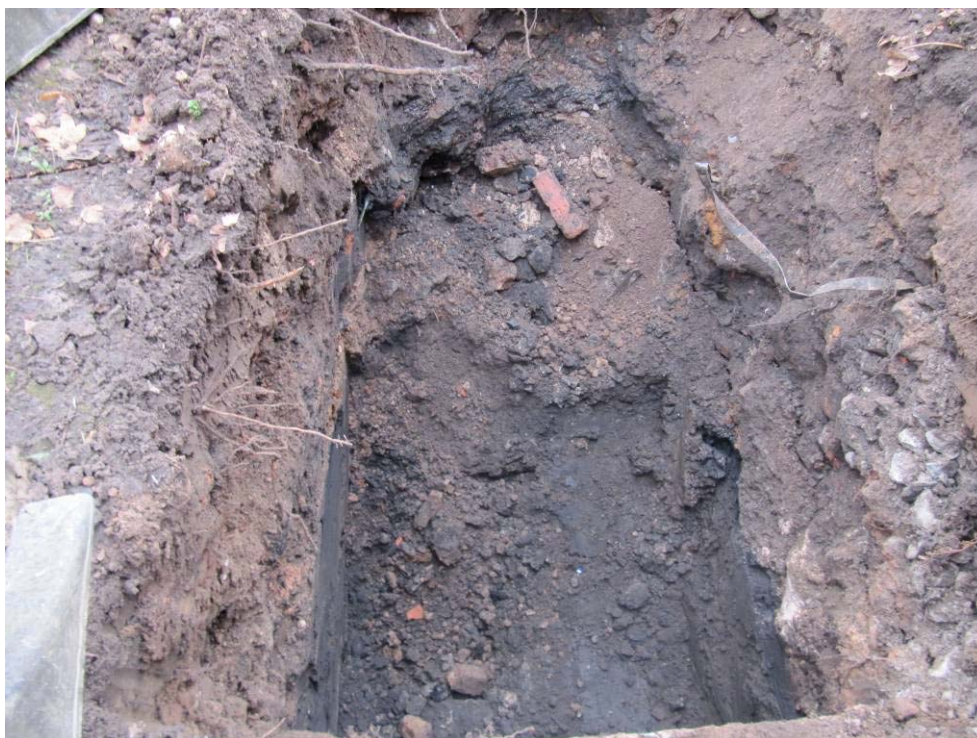
Plate 2: South-facing view of Trench 1

3.2.1 **Trench 1:** following the removal of the trees and shrubs in the vicinity of the extension, Trench 1 was excavated first, being the most southerly of the three trenches excavated (Fig 2). It measured 3m long by 1m wide and was excavated to c 2m depth.

- 3.2.2 The topsoil, a loose fine-grained dark brown sandy-silt topsoil (**101**), with small-medium rounded stone inclusions, was removed, which had a maximum depth of 0.3m (Fig 3). Beneath this, a modern deposit (**102**) was revealed to a maximum depth of 1.45m (Fig 3), which appeared to be a make-up deposit associated with the construction of the indoor pool. It was mixed greyish-orangey-brown coloured silty-sand, with 50% ceramic building material, 40% hardcore and 10% silty-sand.

- 3.2.3 Further excavation revealed a light grey compacted sand, with no inclusions, that appeared to be natural (**103**), beneath **102** (Fig 3). At the interface between the two deposits was a dark staining. The sand, **103**, was 0.2m deep and overlay a natural clay deposit (**104**) that was a mid-browny-grey colour, and very compact with no inclusions. The excavation proceeded 0.1m into clay **104** to establish its suitability for the concrete foundations (Fig 3, Plate 2).

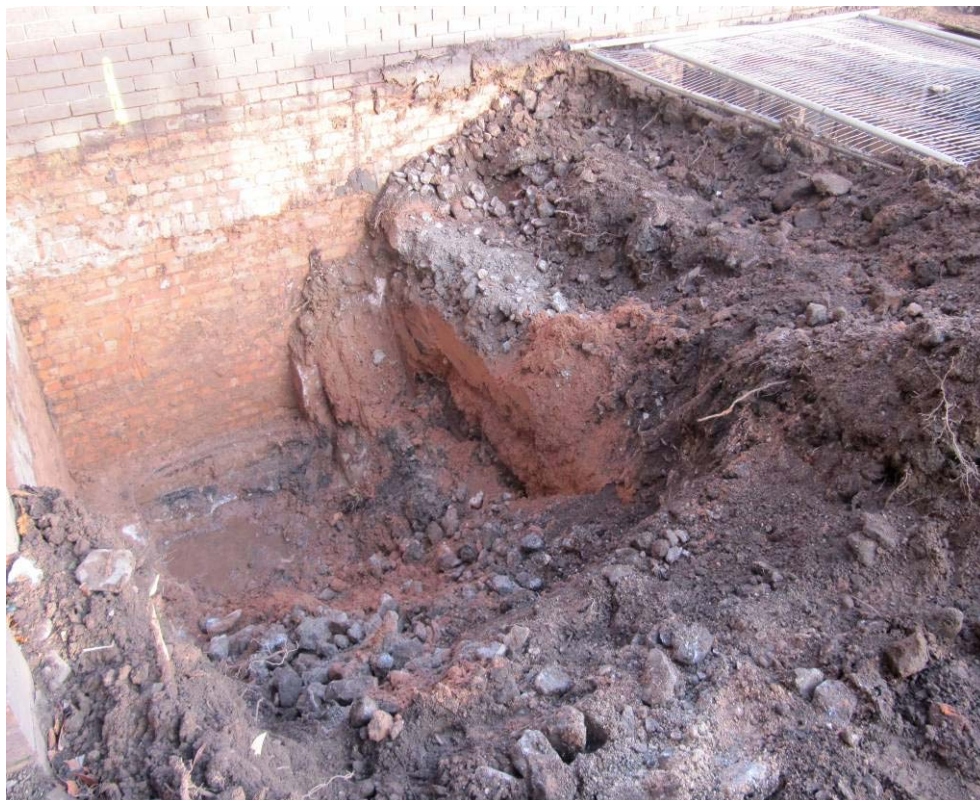
Plate 3: North-facing view of Trench 3

- 3.2.5 **Trench 3:** this trench was situated to the west of Trenches 1 and 2, and also abutted the pool building to the west (Fig 2). It measured approximately 3m in length and although it was originally intended to be 1m in width it increased to 3m due to the unstable trench sides. The deposits revealed (**301-304**) were the same as those observed in Trench 1 (**101-104**).
