# Former Gregg's Bakery, Hutton Hall, Benson Row, Penrith, Cumbria

## Building Investigation

January 2013

**Document Type:** Building Recording

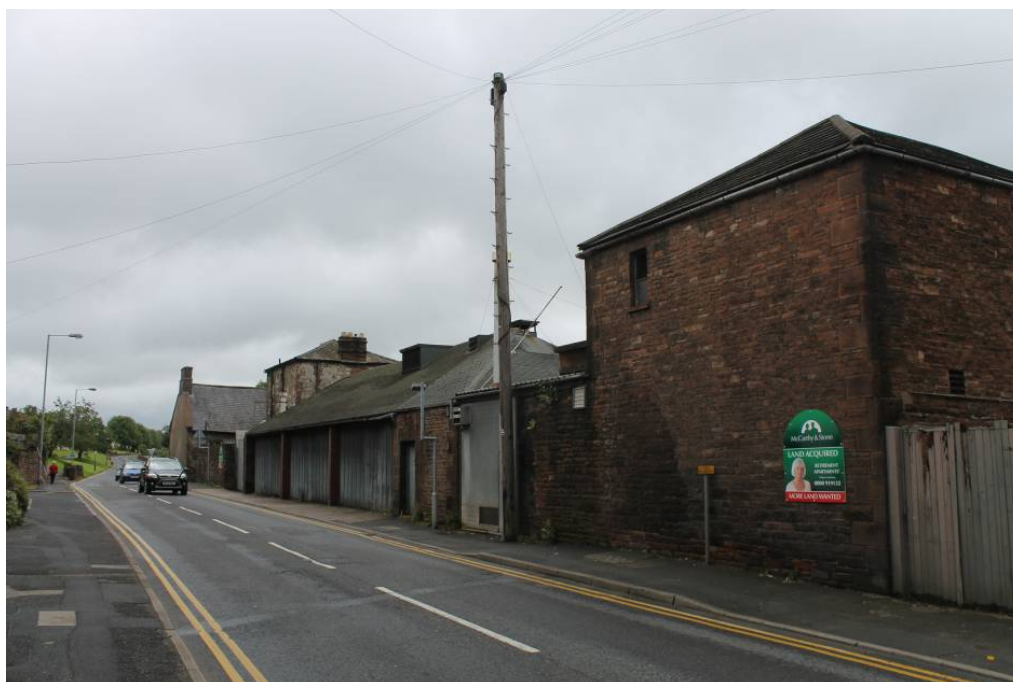
Plate 1: View of the complex from Benson Row, facing south-east, showing Building 3 in the foreground, and Building 2 further along Benson Row

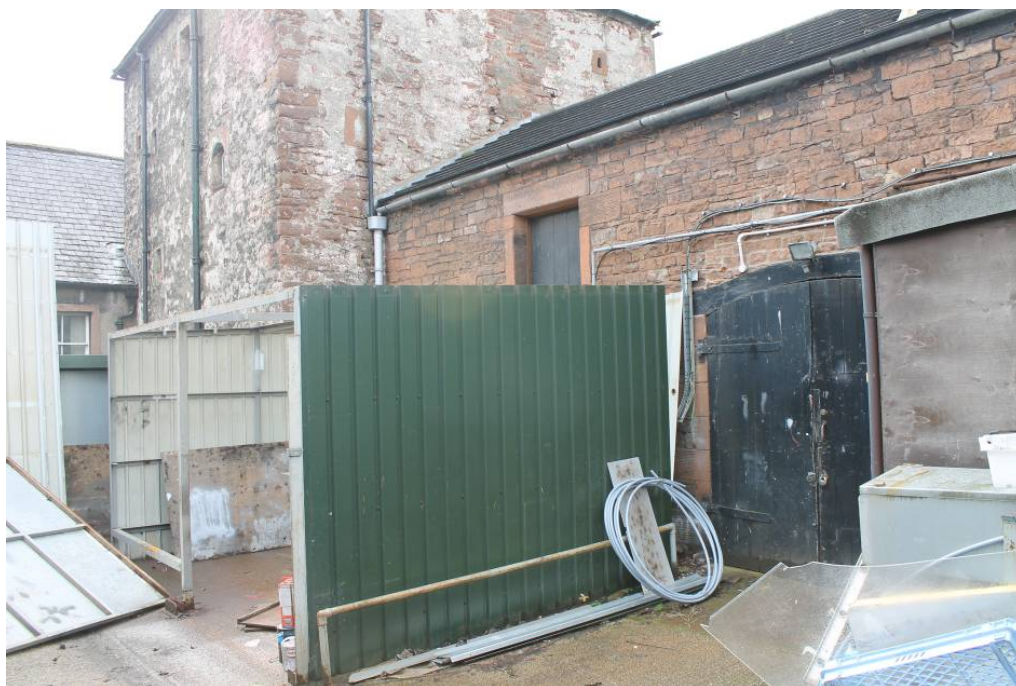
3.3.1 **Building 1:** is a one-and-a-half-storey structure of red, random-coursed, squared sandstone with mostly cement-based mortar. The building abuts the north elevation of the adjacent Pele Tower. Access is via two wide doorways situated in the north-facing elevation (Plate 2). Much of the exterior of the building is obscured by later additions, such as a metal lean-to and other modern structures.

Plate 2: North-facing side of Building 1 showing later additions

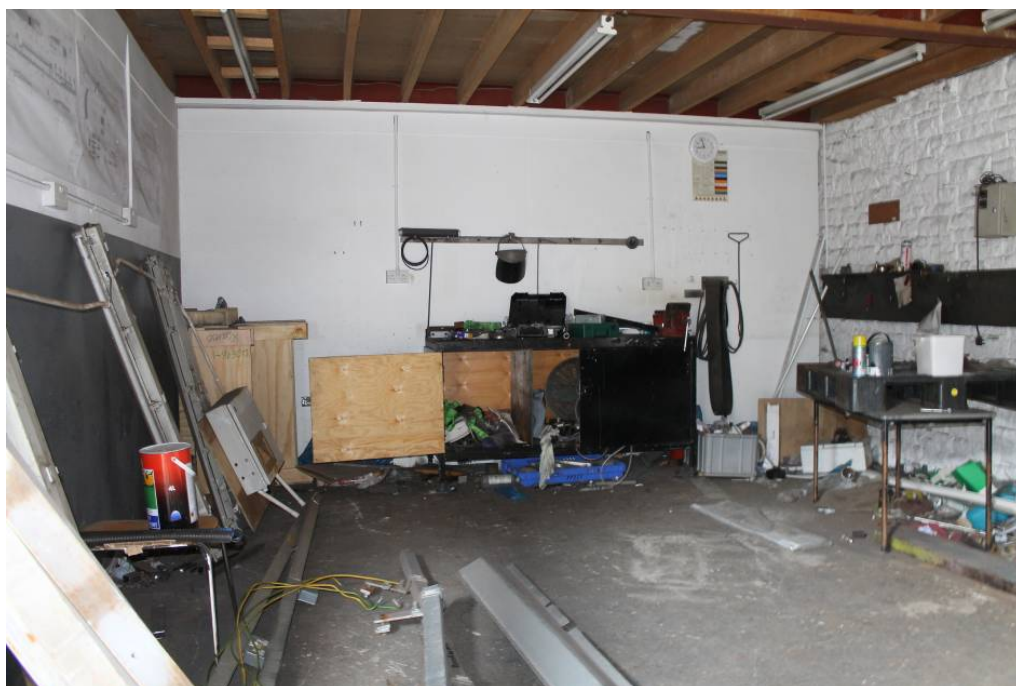
Plate 3: Internal view of the ground floor of Building 1 showing later material

- 3.3.5 Internally, the building is divided into three ground floor and two upper floor rooms by modern plasterboard partition walls (Plate 3). The upper floor has been formed by the insertion of a modern ceiling, together with a steel staircase. Access to the upper floor was limited due to the small size of the space and the lack of light. Most of the interior face of the stone walling was covered with modern boarding, obscuring all of the detail. Brief inspection of the roof revealed it to be of wholly modern construction.

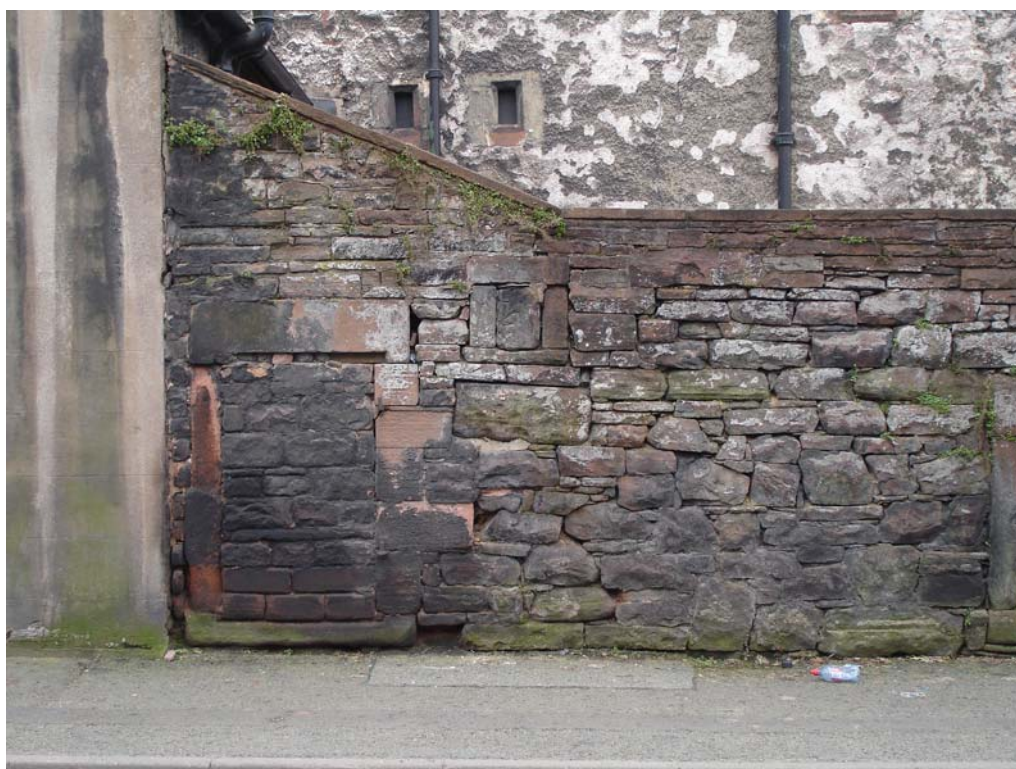
Plate 4: Two of the apertures closest to Hutton Hall in the wall forming the site boundary along Benson Row

- 3.3.6 To the north of this building, a short section of stone wall forming part of the site boundary along Benson Row is present. Just outside the development boundary, and set into this wall are three blocked apertures, each with a sandstone surround (Plates 4 and 5), the smallest of these is roughly the same size as the apertures visible in the east elevation of the Pele Tower. The largest of the apertures has been modified slightly, with the addition of tool-marked sandstone quoins, and two pintles are present indicating a door or shutter was once attached. To the right of the northern aperture (Plate 5), some evidence of

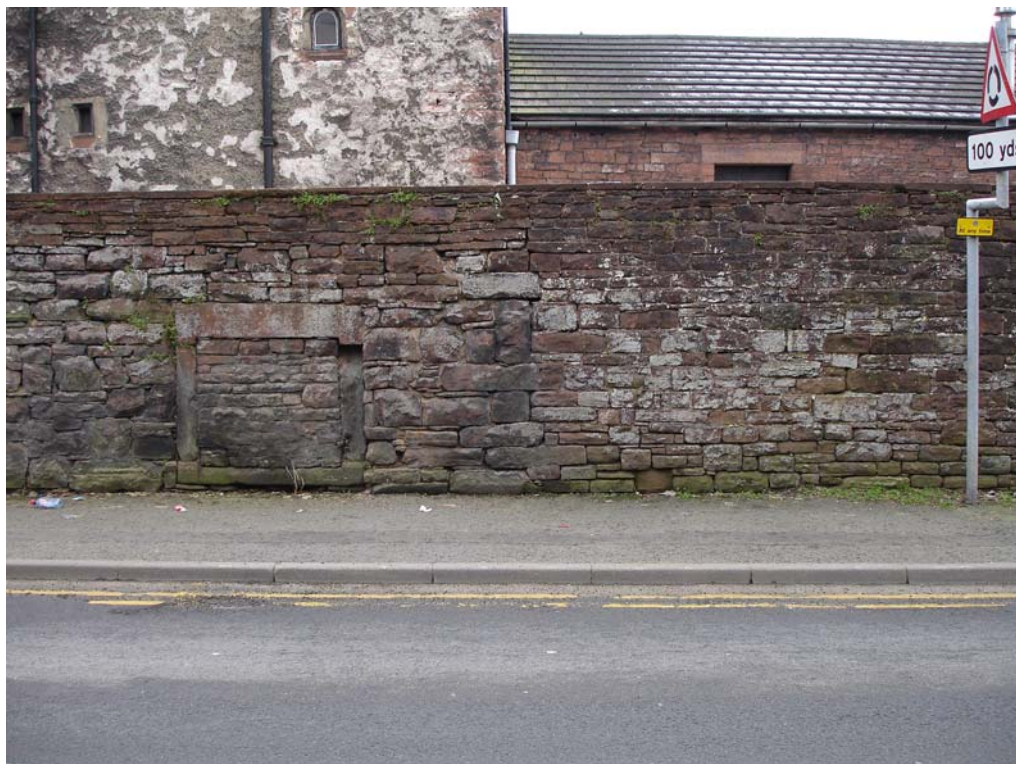
a possible vertical join is visible in the stonework. To the right of the join, the stone work differs being more squared. The uppermost part of the wall is built from thin stones, and there are flat coping stones topping off the wall.

Plate 5: Third aperture and possible vertical join in the wall forming the site boundary along Benson Row

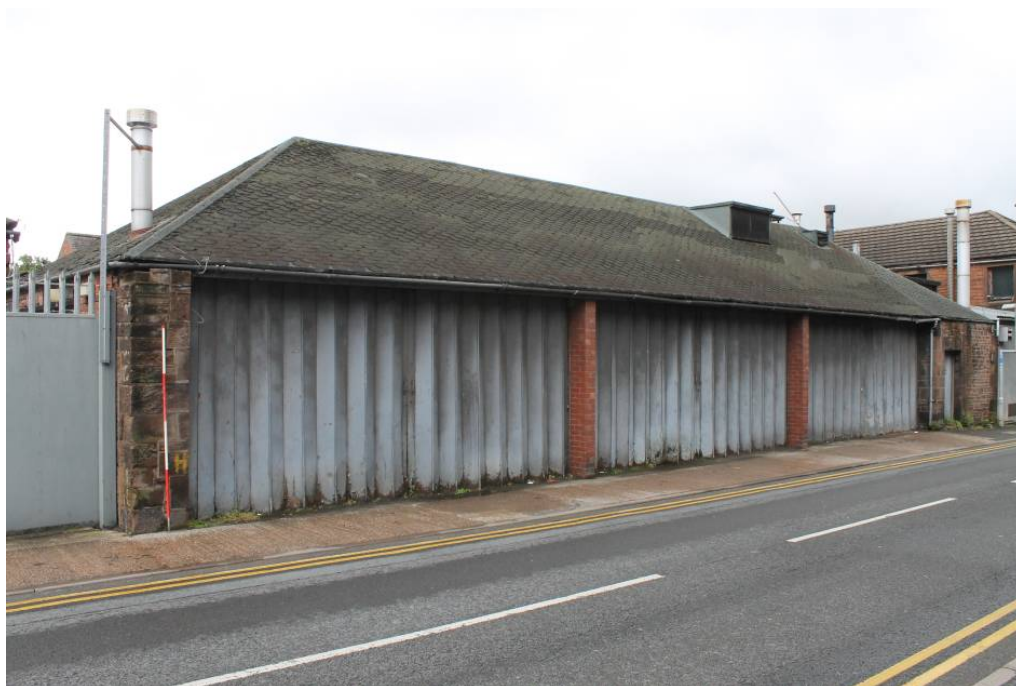
Plate 6: The north elevation of Building 2 viewed from Benson Row, with Building 3 in the background

- 3.3.7 **Building 2:** this building is a long, single-storey structure fronting on to Benson Row measuring some 19m by 7.5m (Plate 6). It is of stone and brick construction, the visible stonework being similar in style to that of Building 1. The quoins on the building exhibit pick tool marks, also of similar style to those on Building 1. The brickwork appears to be of two phases, the majority and earliest, being handmade brick laid in common bond (4-1) with mainly lime mortar. There is a soldier course at approximately 1.5m height. The remaining brick is later (of late-twentieth century manufacture) and is mainly limited to the piers supporting the roof on the north elevation facing Benson Row (Plate 6). The western end of the building is of stone construction.

- 3.3.8 Situated in-between the brick piers, are sliding steel concertina shutter doors (Plate 6). Only the right hand door is operational, the others being blocked internally with cinder block. There is a small doorway situated at the western end of the building, which has a sandstone surround exhibiting pick tool marks (Plate 7). To the right of the building, is an opening which appears to be a former entrance.

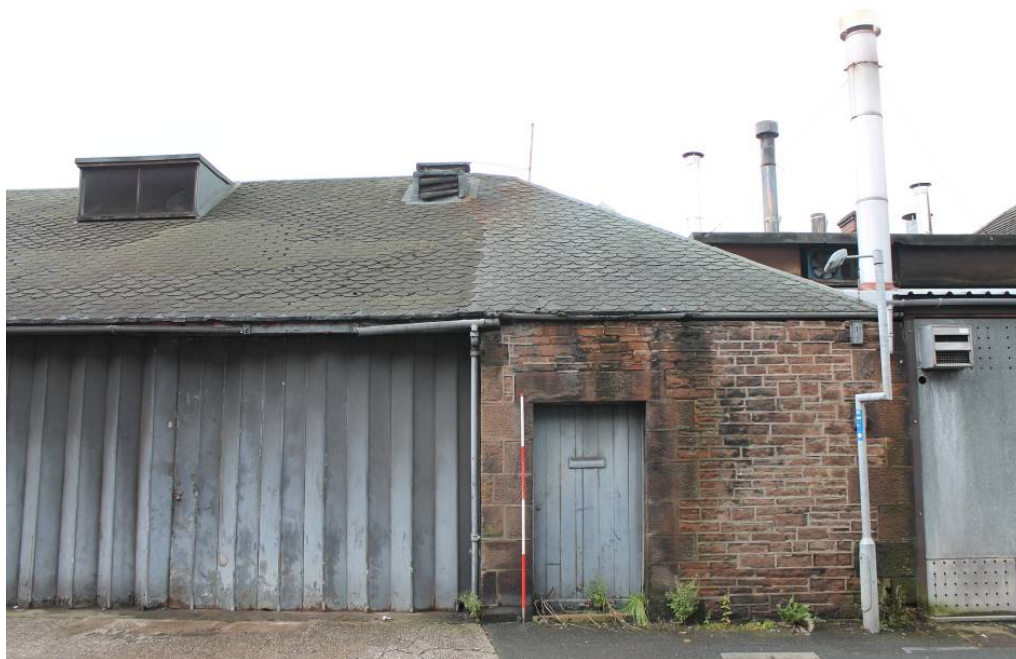
Plate 7: Doorway at the west end of the north elevation of Building 2, also showing quoins on both sides.

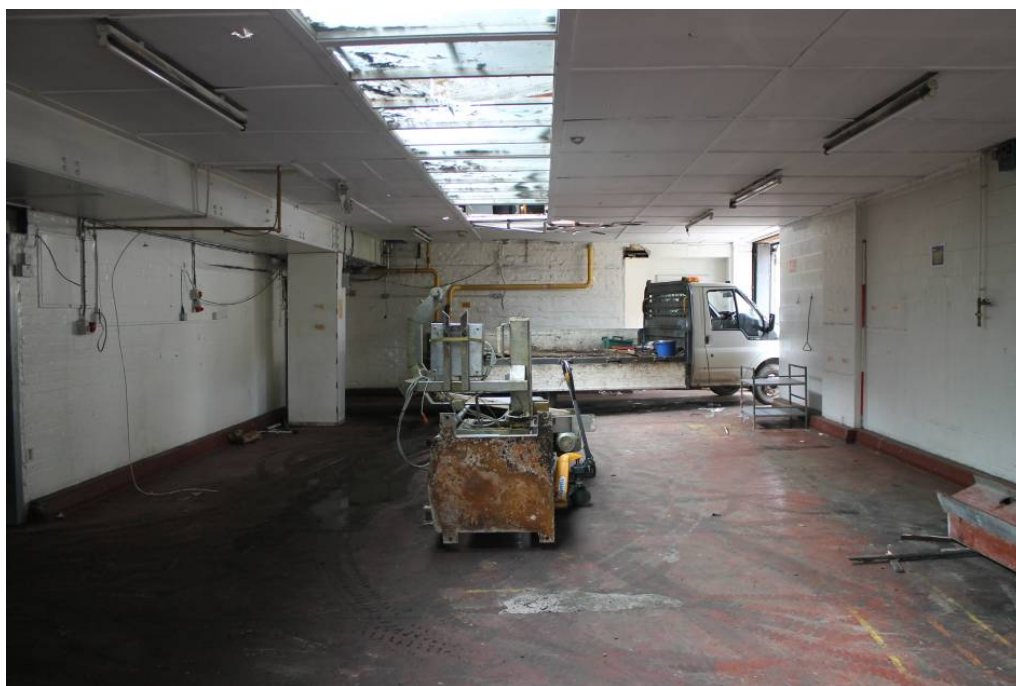
- 3.3.9 The roof is of hipped construction with felt shingles, the structure of which, from internal inspection, appears to be of twentieth century origin. All the rainwater goods are plastic.
- 3.3.10 Internally, this building has a similar appearance to Building 1 (Plate 8). A false ceiling has been inserted above which the roof structure is visible. This is supported on braced, king post trusses with boarded roof slopes and a long skylight on the south slope. Some riveted I-beams are visible. The floor is concrete and all of the walls are either covered or painted. There are some doorways present in the west and south walls, which are of modern origin.

Plate 8: Internal view of Building 2

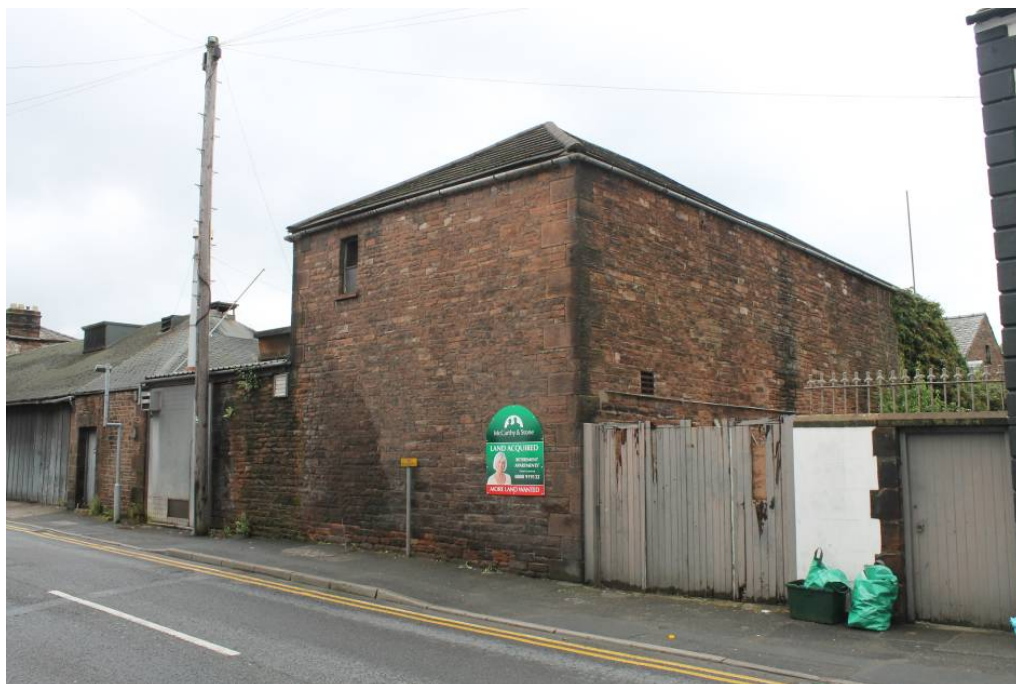
3.3.11 **Building 3:** this two-storey structure is wholly of stone construction (Plate 9). The stonework is similar to that already described and is of random, coursed, squared sandstone. The building forms the north-west boundary of the site. It has a modern hipped roof covering, with plastic rainwater goods. The north and west elevation are plain with a single window aperture with sandstone sill present on the upper floor of the north gable. The building is connected to Building 2 via a single-storey extension.

Plate 9: General view of Building 3 from Benson Row with Building 2 in the background

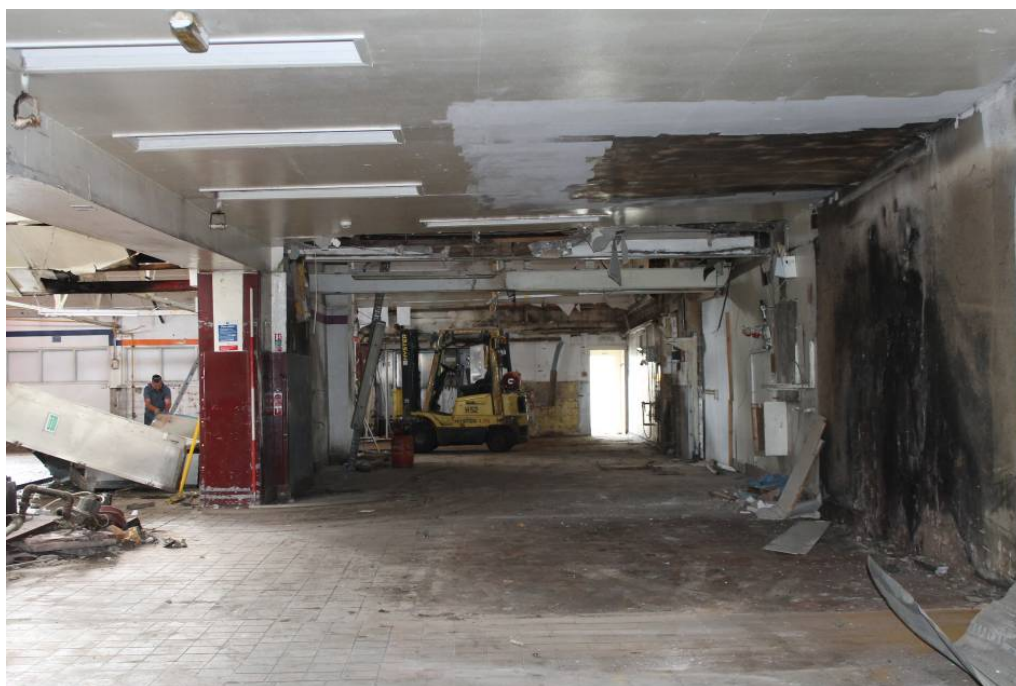
Plate 10: Ground floor of Building 3

3.3.12 The south and east walls of this building are almost entirely obscured by later structures forming the remainder of the bakery complex. Internal inspection revealed that much of the east and south walling had been removed and the building has been knocked through to provide larger internal spaces (Plate 10).

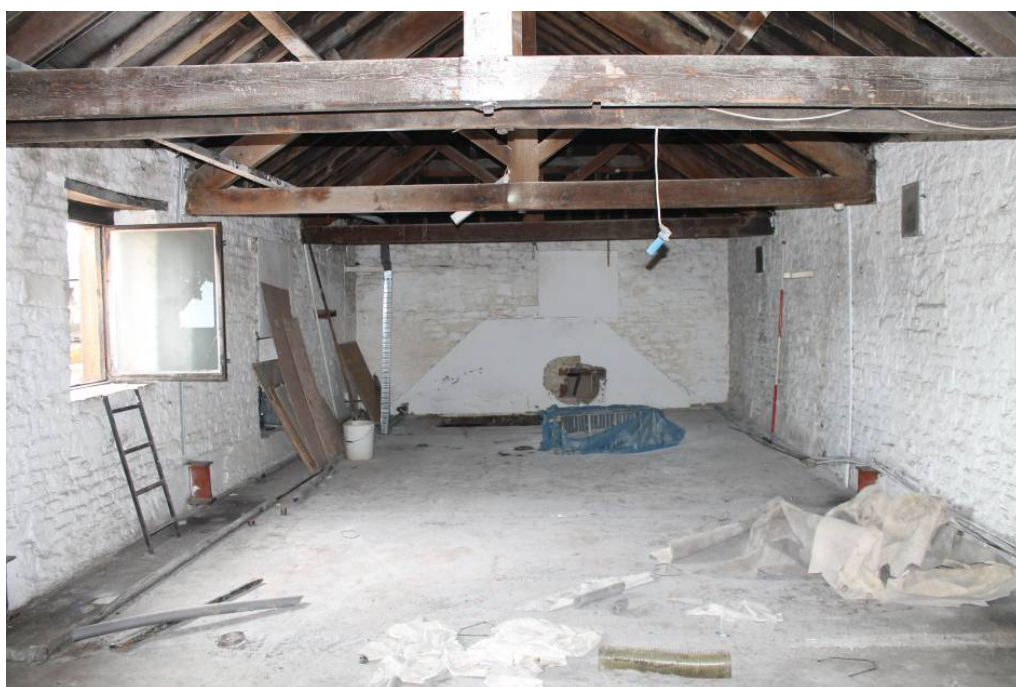
Plate 11: The upper floor of Building 3

3.3.13 Much of the ground floor has been cleared and is mainly modern in appearance, with little earlier fabric remaining. There is a doorway in the south elevation. The upper floor is plain in appearance but appears to have

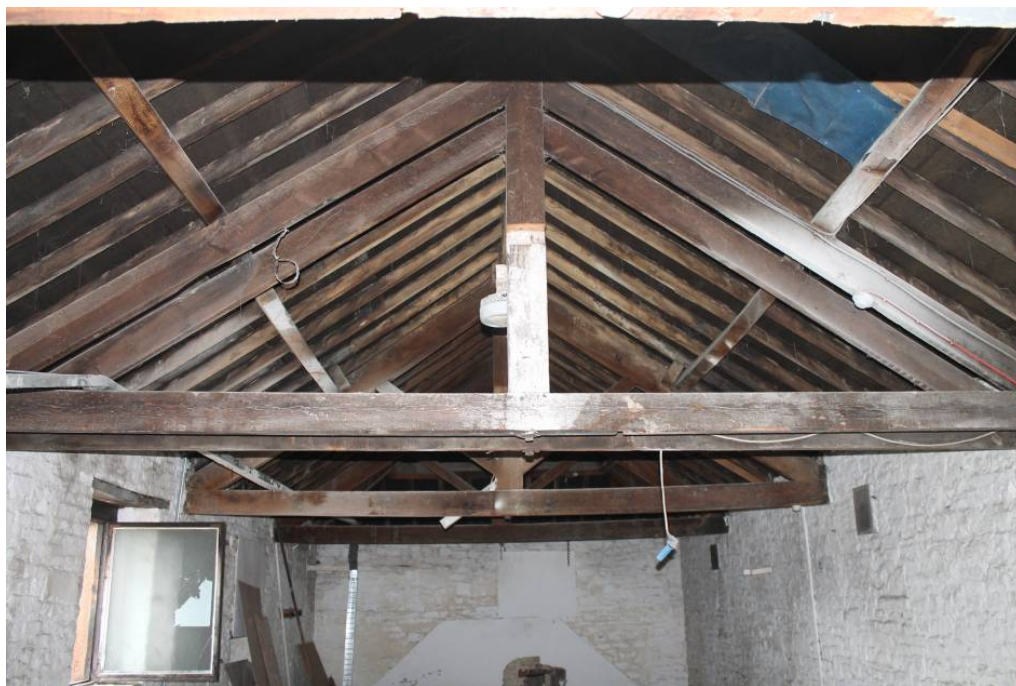
been less altered than the ground floor (Plates 11 and 12). The roof structure consists of three king post trusses, two of which are of nineteenth century appearance with bolted members and braces.

Plate 12: The roof trusses in Building 3
