WILMSLOW TO ALDERLEY EDGE PIPELINE,

Archaeological Watching Brief- Supplementary Report

January 2011

United Utilities

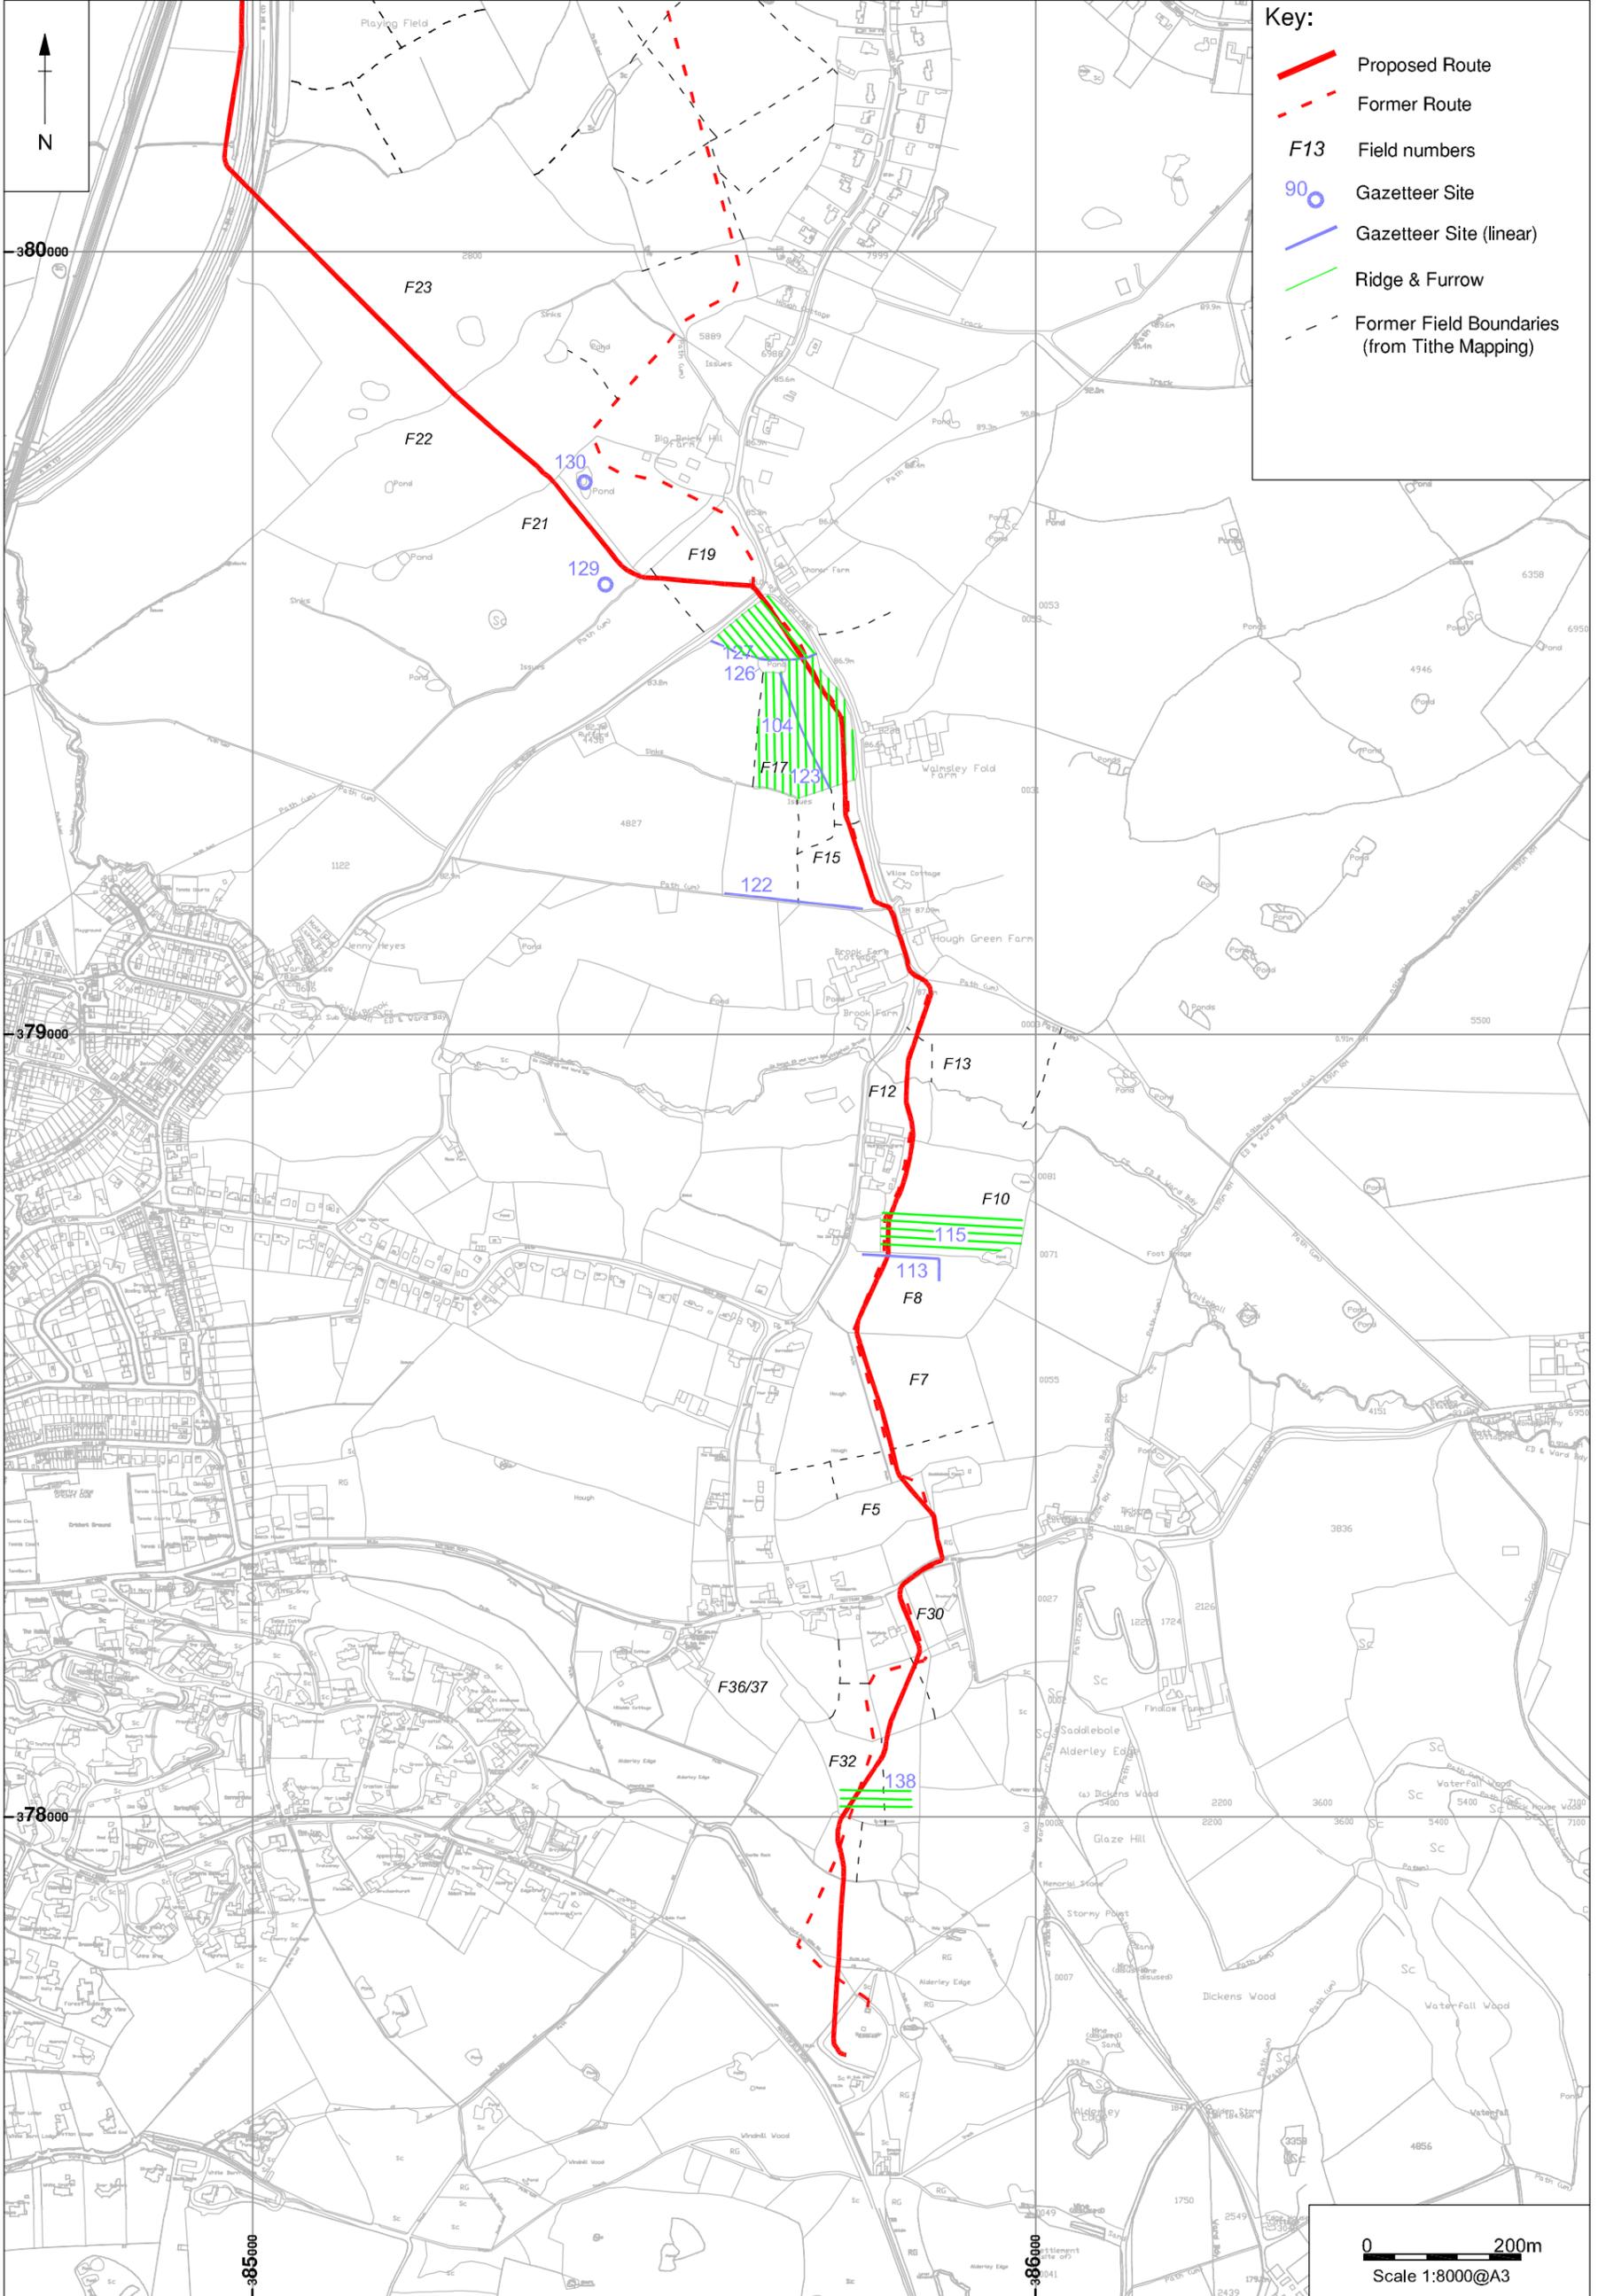
Figure 2: Location of Fields and Gazetteer sites subject to the Watching Brief

3.1.1 In total, sixteen fields (Fig 2) were subject to the watching brief during the partial stripping of topsoil down to subsoil, which was undertaken in advance of the excavation of the pipe trench. Site numbers relate to the gazetteer in the 2009 report.

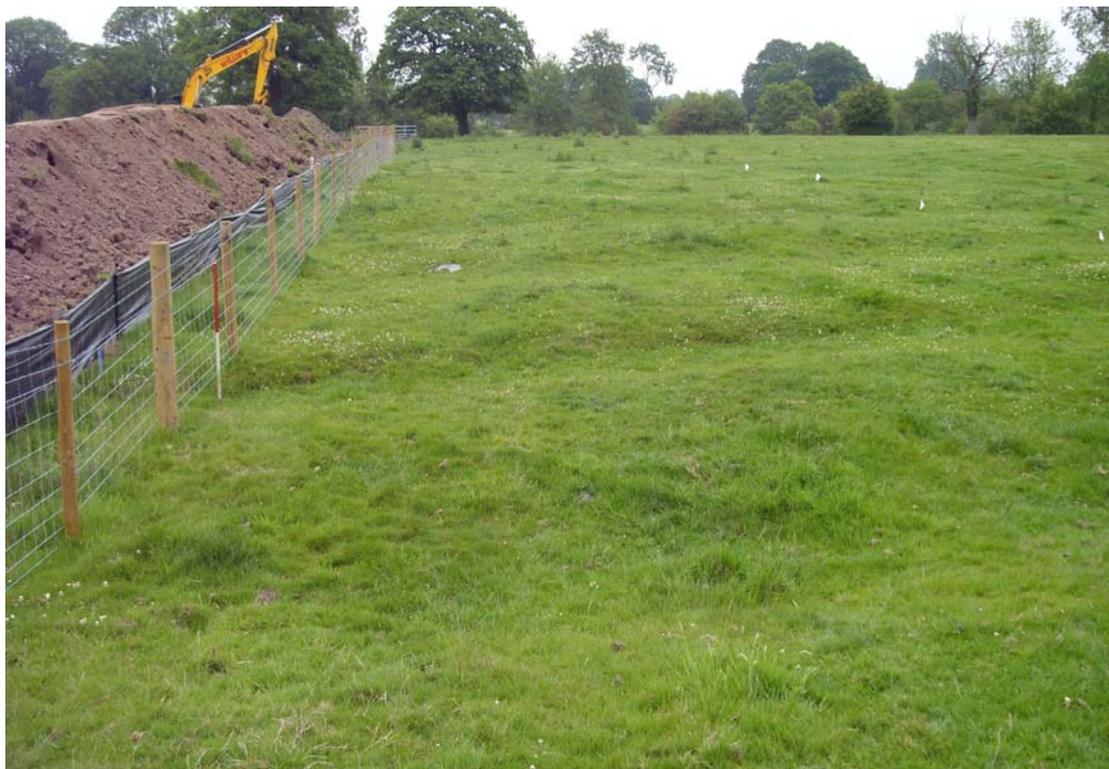
3.2.4 **Field 10:** topsoil, **180**, a medium bluish grey friable sandy-silt overlay a dark blackish brown friable sandy-silt subsoil (**181**). Beneath this, was a light whitish brown friable silty-sand natural, **182**, with patches of medium yellowish brown silty-sand. Located in the southern half of the field was Site **115**, an area of ridge and furrow (Plate 1). It measured approximately 6m wide from crown to crown and was aligned north-east/south-west, but did not respect the east/west aligned extant field boundary. Generally, the field was extensively drained, with ceramic pipes utilising the furrows in the southern part of the field. One of these was excavated in an attempt to determine an approximate date for the drainage system. The cut for the drainage pipe, **184**, measured 0.24m wide by 0.67m in depth. The fill, **183**, was a mixture of topsoil, subsoil and natural. The ceramic pipe was cylindrical, handmade, and with an internal diameter of 2 inches (500mm), and probably dates from the first half of the nineteenth century.

3.2.5 Ridge and furrow was also present in the northern half of the field, although this was narrower, measuring only 2m from crown to crown. Ceramic drainage pipes were present every 4m in this part of the field. A deposit of peat, **185**, was encountered at the northern end of the field, measuring approximately

Plate 1: View to the north alongside the easement in Field 10, showing and post-medieval ridge and furrow (Site 115)

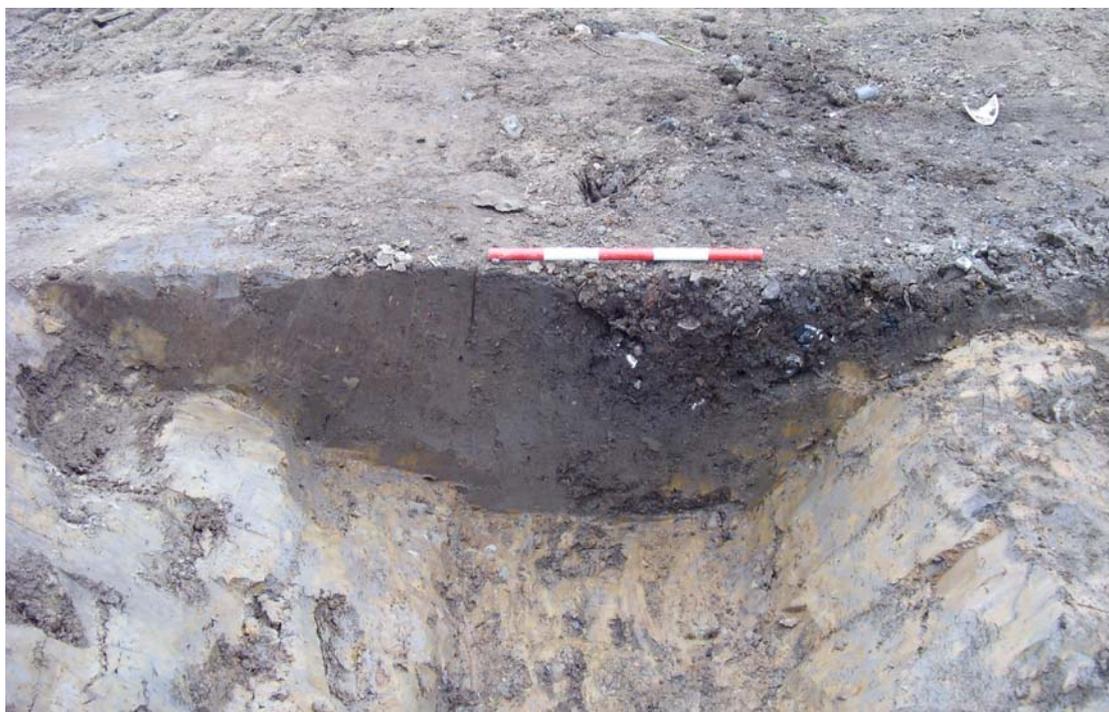
- 3.2.9 **Field 17:** this field contained a number of gazetteer sites, which were considered likely to be affected by the pipeline works. The sites comprised ridge and furrow (Site **104**), bank and ditch (Sites **123** and **127**), and a pond (Site **126**). Neither the ridge and furrow nor Site **127** was observed, but the bank and ditch (Site **123**) was visible just to the west of the easement. The pond was silted-up. Stripping of the topsoil, **155**, a medium greyish brown friable sandy-silt exposed a spread of modern demolition rubble, **157**, between Hough Lane and the silted-up pond. At the southern end of the field a ditch, **154**, was aligned parallel with the boundary to Field 15. The ditch was filled with clayey-silt, **153**, being mid bluish grey brown, and above this, a dumped deposit, **152**, of late nineteenth and early twentieth century material was present (Plate 2).

Plate 2: Cross-section through ditch 154 in field 17. This is typical of the drainage ditches encountered along the easement.

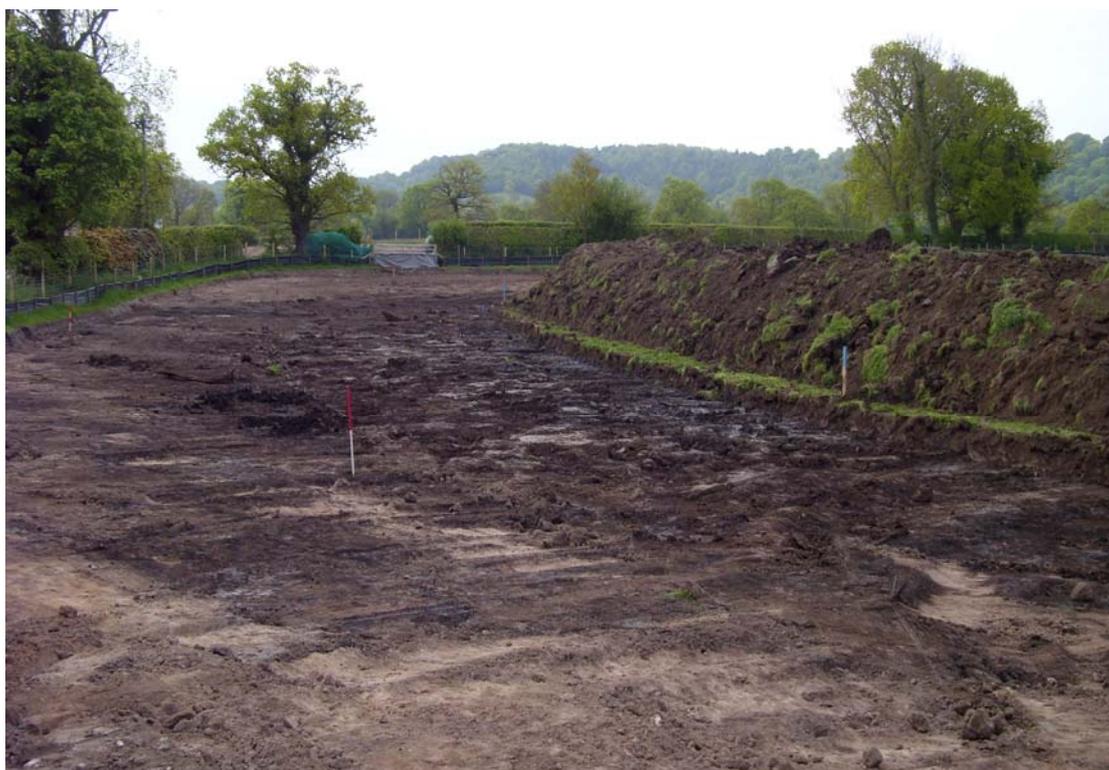
- 3.2.12 Following the topsoil stripping in the eastern portion of the field, a small peat basin was exposed (Plate 3). The peat, **135**, began as a thin layer, approximately 3m from the eastern side of the easement, and was observed to be in excess of 1.5m deep in a slot located approximately 10m from the easement edge. A core, approximately 4m in depth, was extracted from the centre of the basin for assessment purposes. A number of tree trunks and roots, **138**, measuring up 2.65m long by 0.27m wide, were observed within the peat (Plate 4).

Plate 3: View to the south in Field 19 looking towards the peat basin (135)

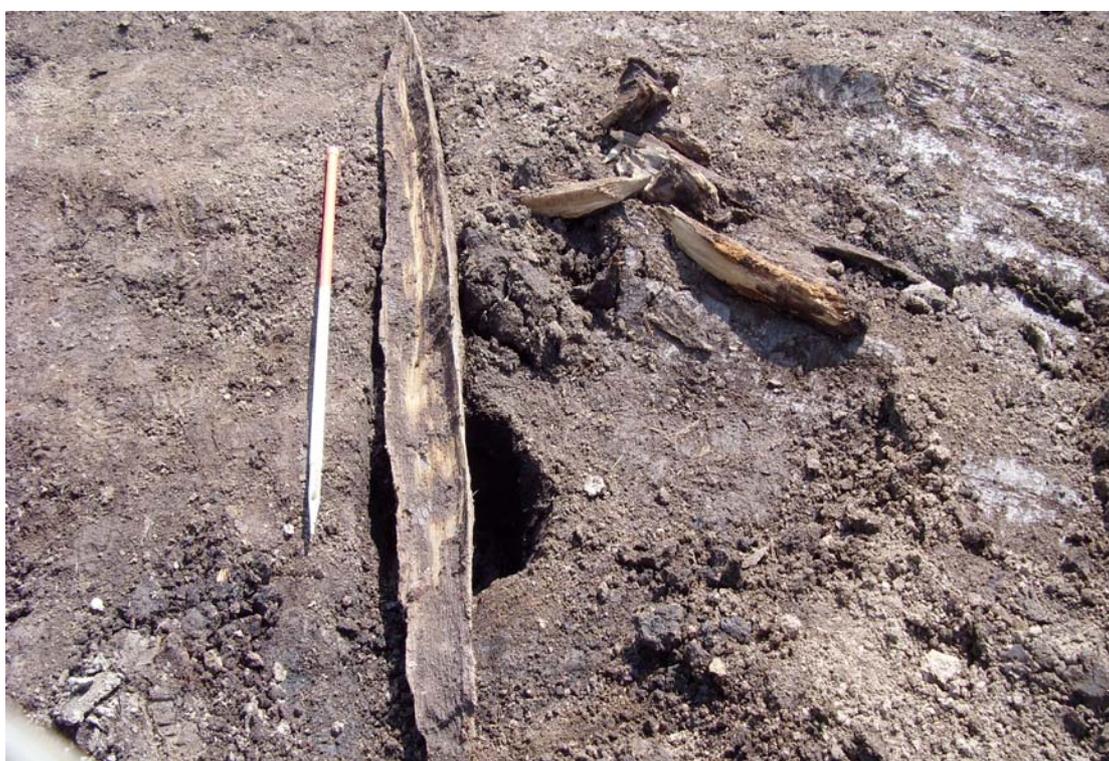
Plate 4: View in Field 19 of a section of tree trunk and roots exposed in the peat basin

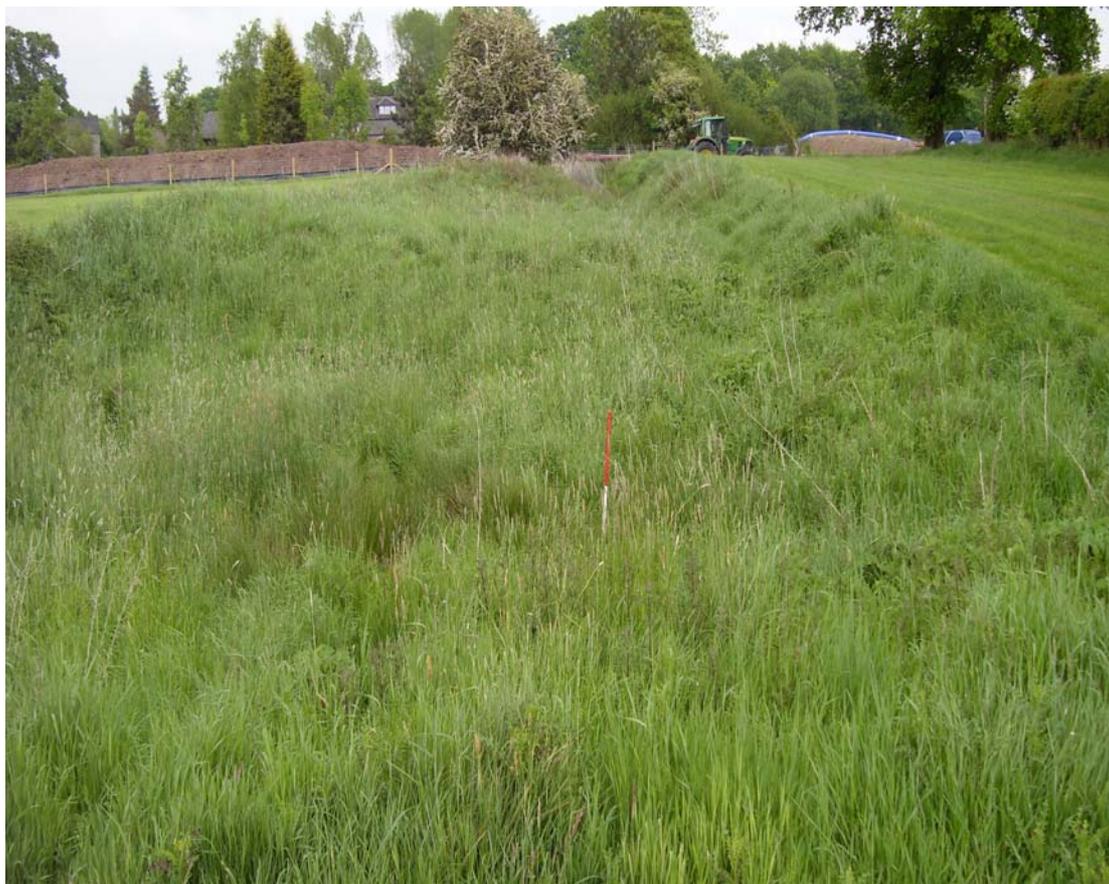
- 3.2.13 **Field 21:** gazetteer sites considered likely to be affected by the pipeline works within this field were a hollow (Site **129**), and a pond (Site **130**). Stripping of the topsoil, **177**, a mid yellow brown clayey-sand revealed an area of peat, **179**, in the north-east corner of the field, which extended eastwards towards the pond. The peat was approximately 0.3m deep, and therefore not suitable for sampling. A spread of modern demolition material filled the hollow (Site **129**).

Plate 5: View in Field 21 looking east towards the easement, showing a former clay extraction hollow (Site 129)
