Hallthwaites WwTW, Hallthwaites, Millom Without, Cumbria

Rapid Desk-Based Research and Walkover Survey

Oxford Archaeology North

April 2009

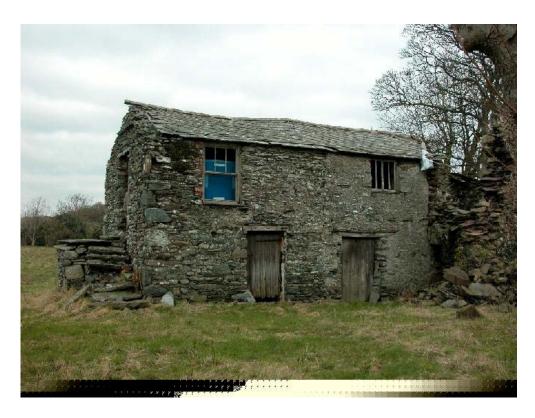
Plate 1: The Dye House, Hallthwaites

- 3.2.1 The origins of the Dye House (Site **03**; Plate 1) at Hallthwaites are obscure, but it is evident that it was part of a complex of buildings making and finishing woollen cloth. Dyeing associated with blanket manufacture was possibly carried out at Hallthwaites from at least 1829. There are a few specific references to the buildings making up the complex, such as one which states that between the 5th and 6th of December 1879, the cold weather stopped the walk mill wheel from turning (DH 322/2).

Edition map, 1867. The two-storey west wing still retained its roof in 2004, whereas the eastern wing and attached north-south range have fallen into a state of complete disrepair. In 2005 a Level III building survey was conducted following a rapid desk-based research in advance of its grant-aided restoration. Six phases of building and alteration were identified. Initially, a small, twostorey building constructed between 1771 and 1829, the structure was continually expanded throughout the nineteenth century and formed part of a complex making and finishing woollen cloth in the village. The Dye House ceased production in 1939 when it was sold to poultry farmer (OA North 2005). A watching brief was maintained during the clearance of building debris from the ruinous Dye House. The original cobble and flagstone floors were observed together with structures that would have facilitated the dying process. This included two large sandstone blocks set into the floor, possible for supporting a tank or large item of equipment., a semi-circular pit or tank with a flagstone lid possible used for soaking or washing wool and a pad-stone that may have supported a column for a roof truss. A total of 68 finds was recovered from the debris, the most significant being an oval stamped sheet label for an early washing machine patented in 1868 (OA North 2007).

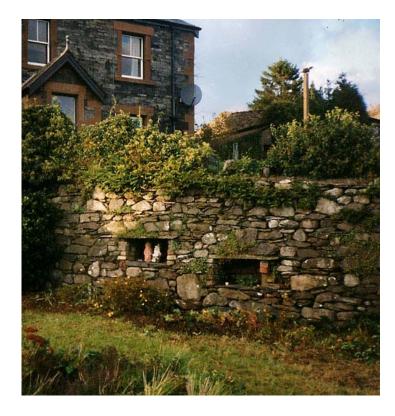
Plate 2: The Bee Boles in the garden wall of New Arnaby House, Hallthwaites

- 3.2.8 The hamlet of Arnaby, to the north of Stile Hill has two properties listed in the Historic Environment Record, Cumbria. New Arnaby Farm (Site **10**; Plate 2) is a late nineteenth/early twentieth century house but the garden wall contains

bee boles dated to the eighteenth century. These may belong to an earlier property or may be associated with Tarn Bank to the south. Bee boles comprised a row of recesses, often in a south-facing garden wall. Each recess was big enough to hold a skep, the coiled-straw hive, used by beekeepers in Britain before the introduction of the modern wooden hive in the late nineteenth century (www.ibra.org.uk).

3.2.9 At New Arnaby, (Bee Boles Register number 1278) there are two external recesses of rectangular shape within the stone, south-facing garden wall. The back of the recesses is flat and they are 0.29m apart (Plate 2). At Fellgate, Strands (Site 12; Bee Boles Register number 1250), a house constructed in the seventeenth century has a stone/cobble south-west-facing garden wall containing two rectangle-shaped recesses. The recesses have a flat back and are 0.96m apart, the base is slate and the lintel is sandstone; they are of unknown date (Plate 3)

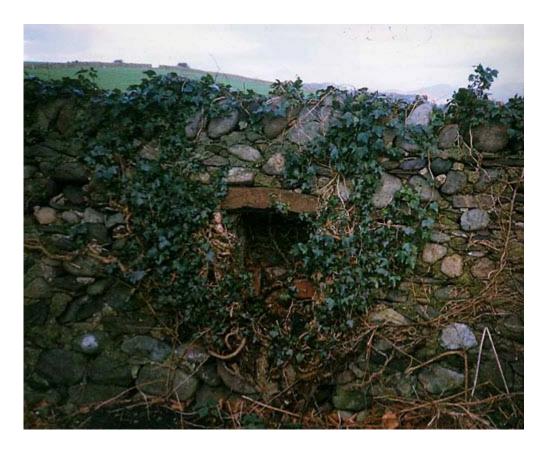
Plate 3: A Bee Bole in the garden wall at Fellgate, Strands

Sources The IBRA Bee Boles Register; Fellgate Strands No. 1250 www.ibra.co.uk **Description** The house was built in the 1600s and was in a poor condition in 1998. The

garden wall contains two bee boles of unknown date.

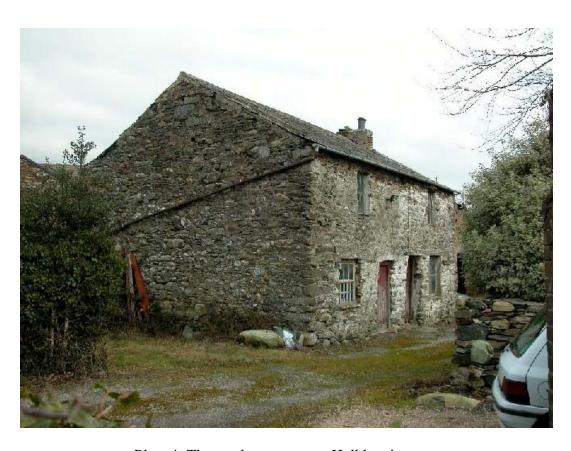
Plate 4: The workers cottages, Hallthwaites

Description A pair of workers cottages, shown on the Ordnance Survey First Edition map

of 1867, located on a plot of land to the south of The Woollen Mill (HER 12295) and possibly providing accommodations for its workers. Externally,

the buildings are in a good state of repair, though disused in 2004.

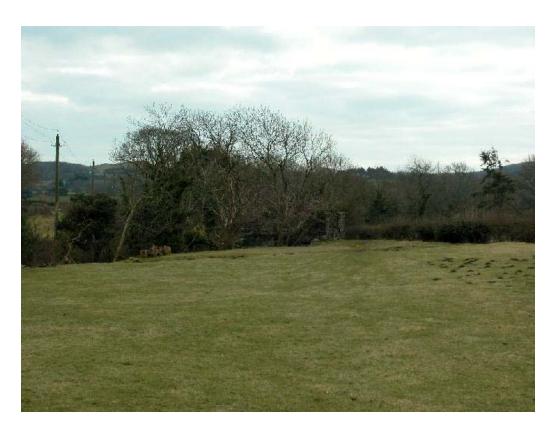
Plate 5: Earthworks at Walk Mill, Hallthwaites

Survey map of 1867. The mill was powered by water channelled from The Woollen Mill (HER 12295) to the north and emptied back into Black Beck to the south. These channels survive as dry earthworks. The mill has lost its roof

and all of its internal fixtures and fittings.

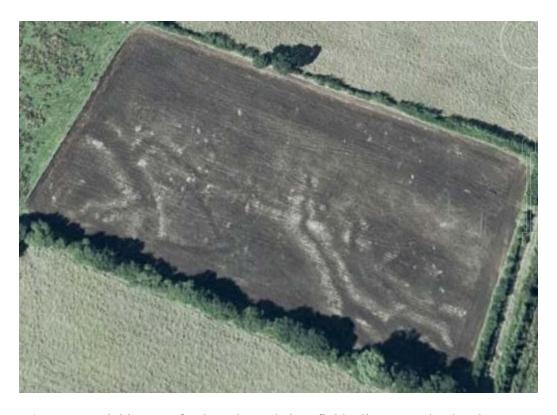
Plate 6: A recent aerial image of palaeochannels in a field adjacent to the development site

Description A series of palaeochannels in a field to the west of the railway. The field also

contains a large, possible ditch and a recti-linear feature which appear to be

man-made.

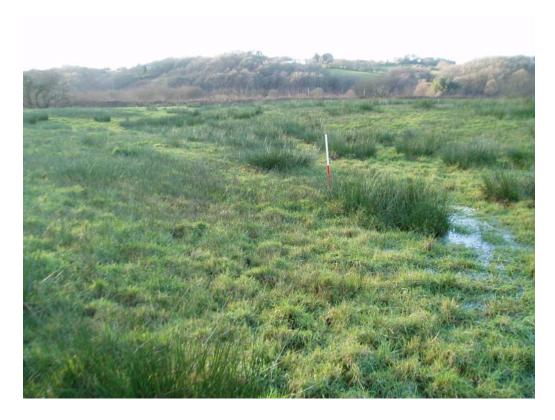
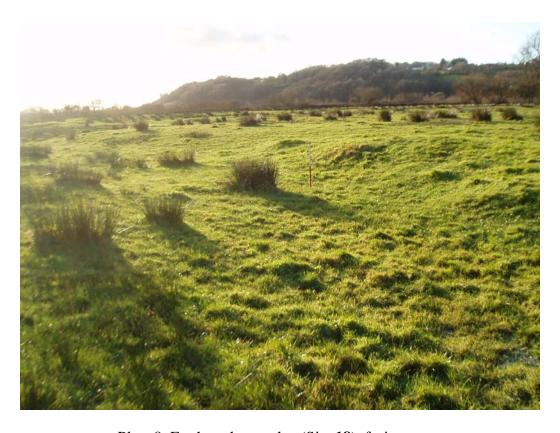
- 4.2.1 The walkover survey identified a further two sites (Sites **18** and **19**), which have been added to the gazetteer (*Section 5*). The extensive complex of earthworks (Plates 7 and 8) within the field adjacent to Black Beck (Site **18**) are most probably relict water channels. The field in which they are located is also heavily waterlogged. The gatepost (Site **19**; Plate 9), comprises a large upright worked stone at the south-eastern corner of the field.

Plate 7: Earthwork complex (Site 18), facing south-west.

Plate 8: Earthwork complex (Site 18), facing west.

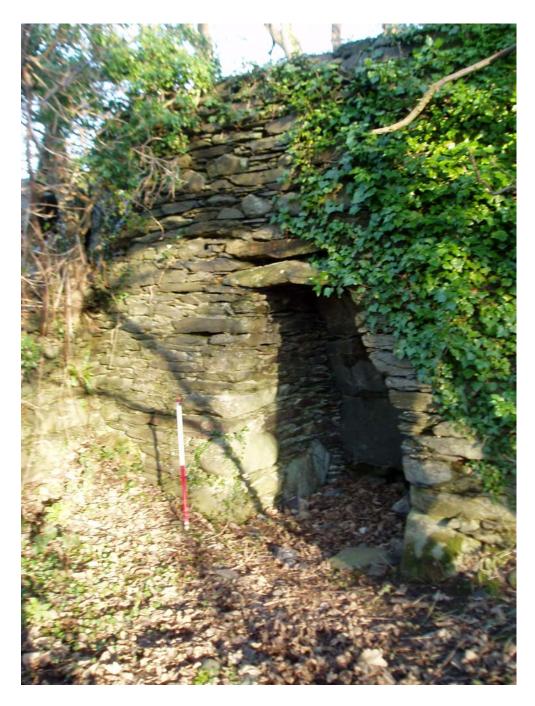
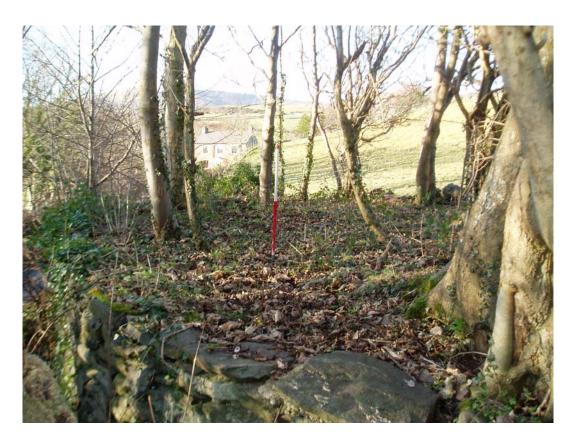
- 4.2.2 The Lime Kiln (Site **08**; Plates 10 and 11) was as described in the HER entry (Section 5), although it should be noted that the density of trees growing on the kiln has increased, increasing the potential for damage caused by root action. The site of the disused gravel pit (Site **09**; Plate 12) was not detected by the walkover and presumably lies beneath the road.

Description A single chambered lime kiln of local stone built into the natural slope of the

ground at the road junction and now hidden by trees. The structure measures 5m wide x 3.2m high and is approximately 12m in length. The kiln top is 2m in diameter with two trees growing inside which had not, in 2006, disturbed the stonework. The frontal chamber, half-ovoid in shape is 2m high x 1.6m wide x 2.1m in length at its base. The top forms a level platform with the Arnaby road and the frontal chamber is level with the lower road to the

Plate 10: Limekiln (Site **08**), facing north-east.

Plate 11: Top of Limekiln (Site 08), facing north-west

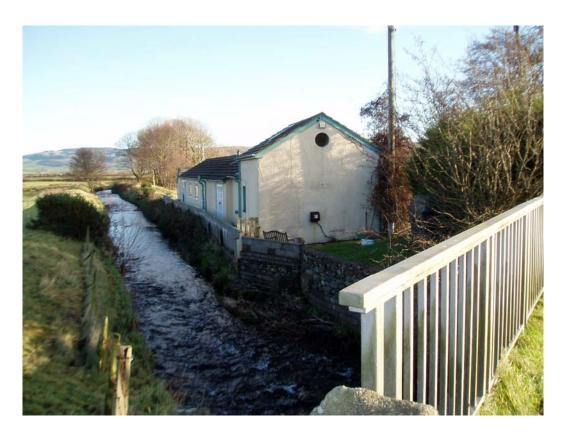
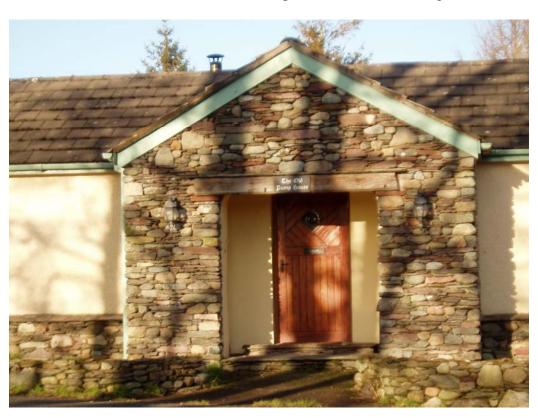
- 4.2.3 The pumping station (Site **14**; Plates 13 and 14) at the southern limit of the development would appear to have been incorporated into a current dwelling. Any activity in the immediate vicinity could disturb the foundations of earlier phases.

Plate 13: Probable location of Pump House (Site 14), facing east.

Plate 14: Residential building with slate plaque engraved "Pump House", facing north-east.
