Chalfont Viaduct Buckinghamshire

Historic Building Recording

Chalfont Viaduct (M25)

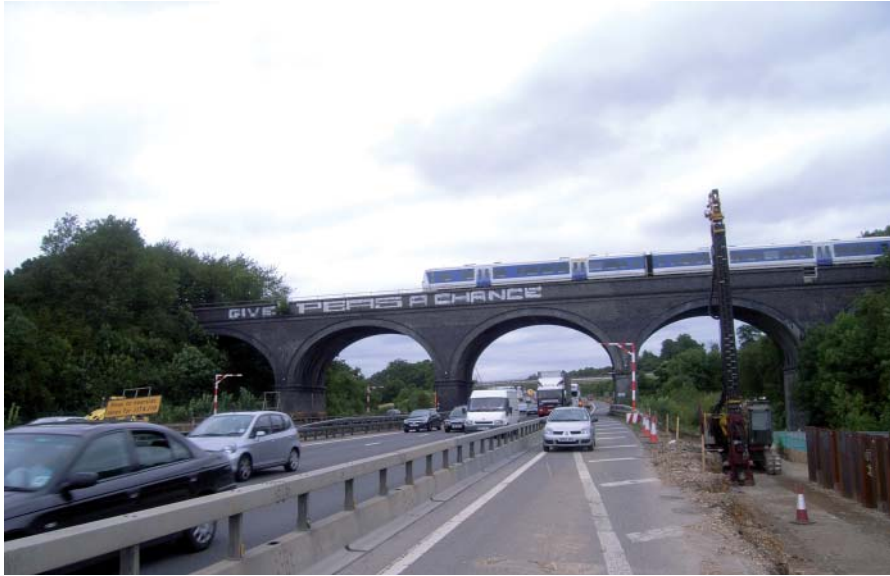
Plate 1: View of south facing elevation from M25 hard shoulder

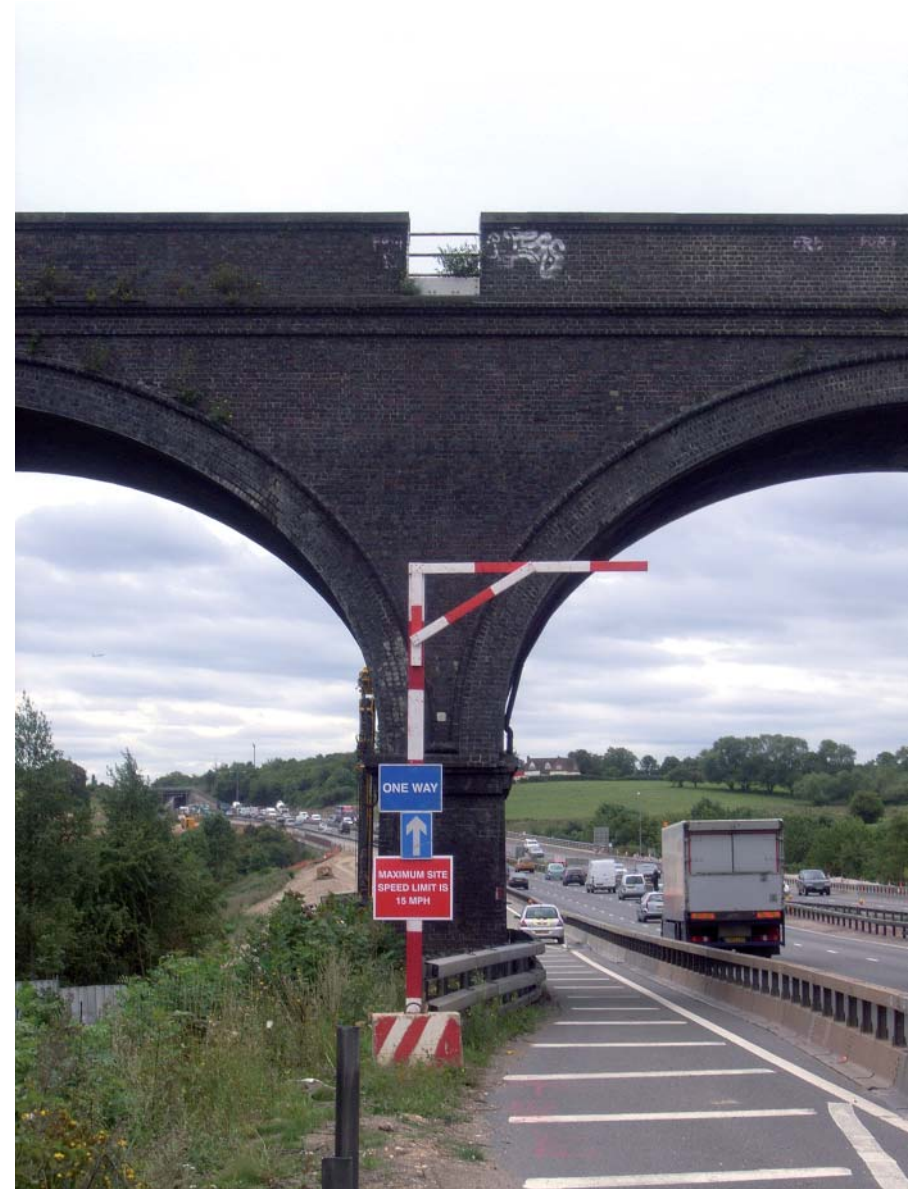
Plate 3: View of pier on north facing elevation

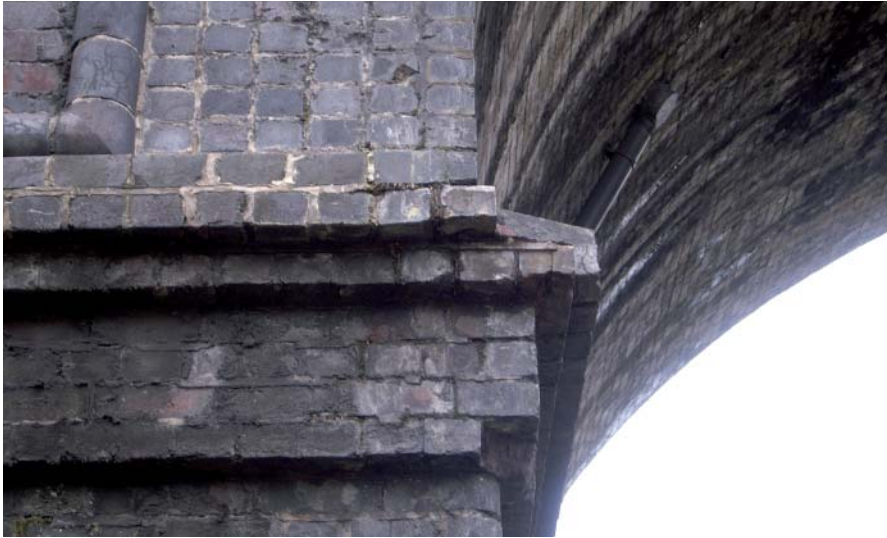
- 3.1.3 There are variations in the colour of the bricks with a large quantity of visible stretchers now showing a brownish colour, this is probably due to weathering. Overall the bricks are in good condition however there are large areas of calcification and organic growth on the brickwork, particularly to the eastern end of the north elevation. The westernmost arches show large amounts of re-pointing and the brickwork has less calcification than on the eastern side, possibly brushed off during the re-mortaring works. Some bricks have fallen out of the south elevation impost of the pier above the hard shoulder of the anti clockwise carriageway.

Plate 4: Detail of damaged stepped brickwork on north facing elevation

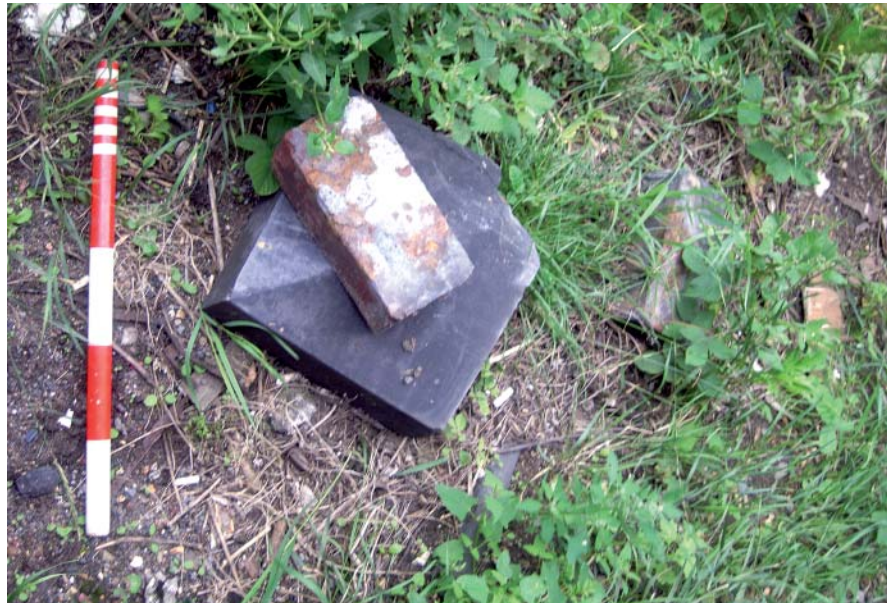
Plate 5: Detail of fallen bricks from north facing elevation

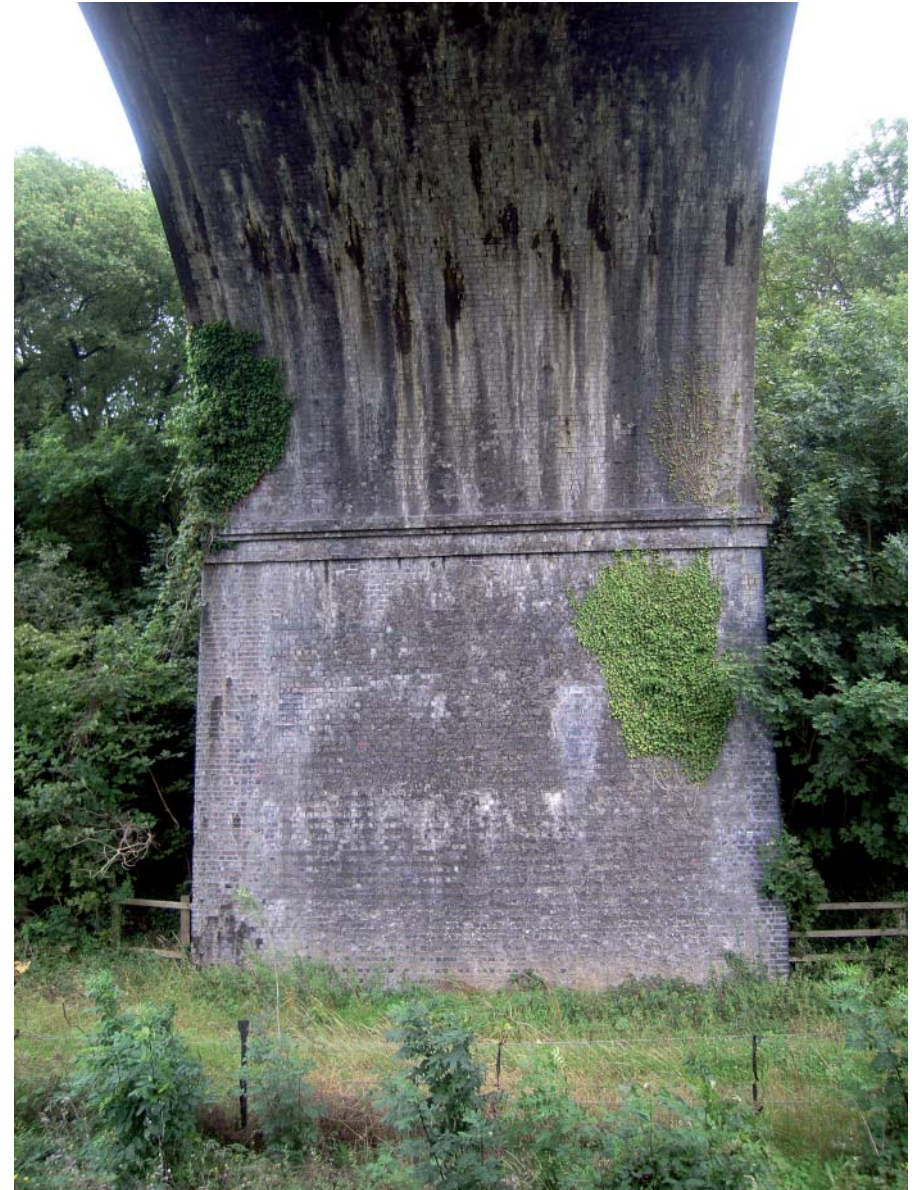
Plate 6: View of east elevation of pier

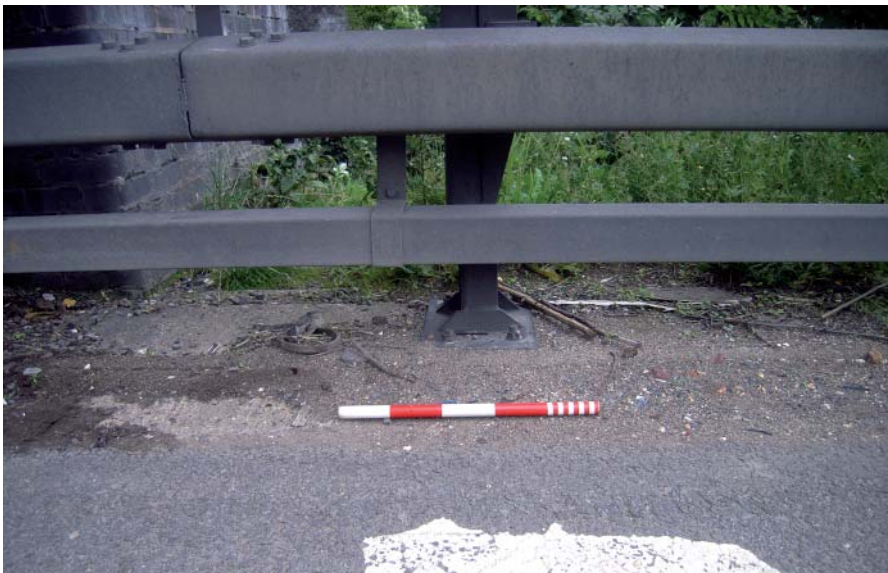
- 3.1.8 The piers adjacent to the motorway carriages have steel crash barriers of a type generally seen along motorways. These barriers are approximately 1.2m high and consist of metal barriers fixed to metal posts which in turn are fixed into rough concrete flooring adjacent to the asphalt covered road surface. At time of survey, the crash barriers on the westernmost pier had been removed and the construction of the replacement barriers was in progress. The works included the addition of steel reinforcement covering the base of the pier which had been set within a rough cement base. The majority of the brickwork behind the reinforcement is protected by boarding and could not be seen.

Plate 9: Detail of crash barrier ground surface

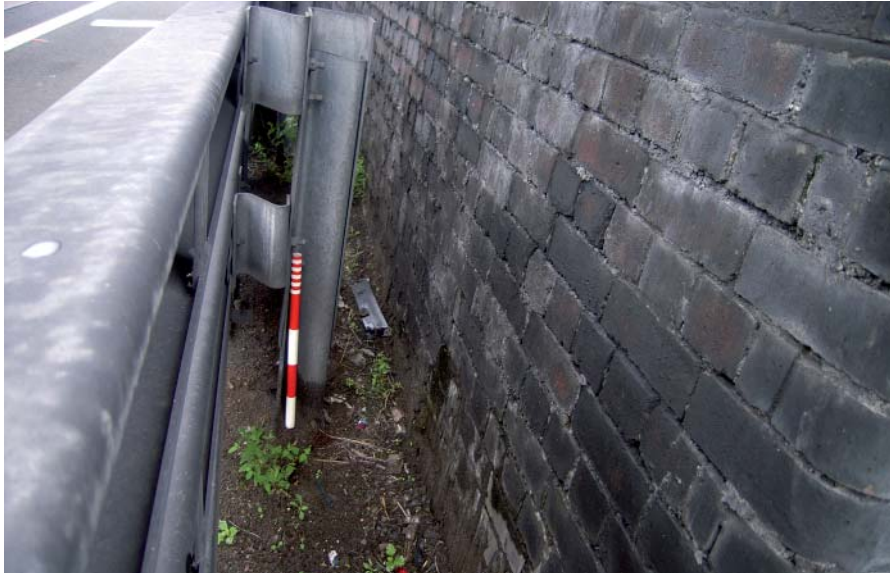
Plate 10: Detail of crash barrier

- 4.1.3 Works to expand the M25 at this point will include the replacement of the crash barriers and removal of the hard shoulder, thus allowing the motorway to have four lanes in each direction running beneath the viaduct. New crash barriers fixed to the base of the piers adjacent to the motorway will be narrower and provide the viaduct with protection.

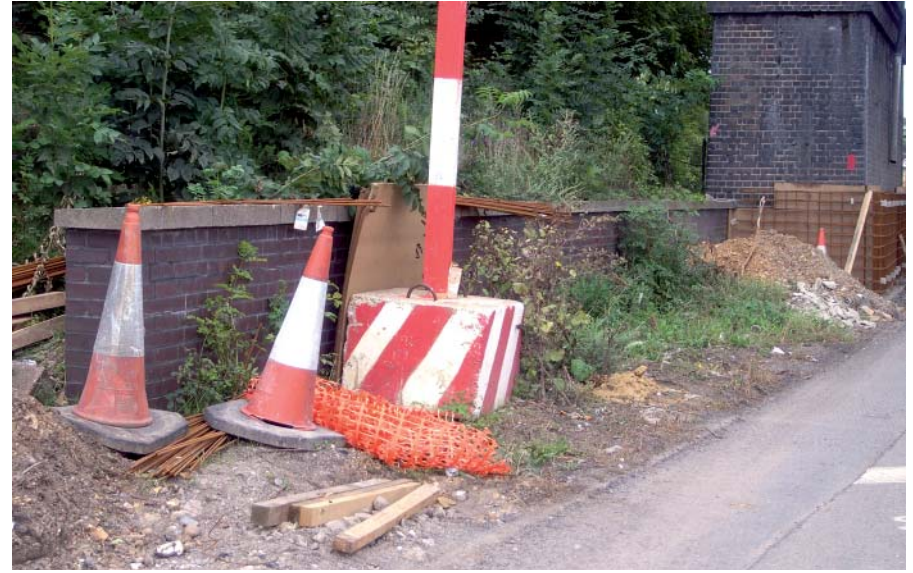
- 3.1.7 To the eastern and western ends of the viaduct are tracks used for access to adjoining farmland. The western end in particular has seen changes following the insertion of the M25 motorway including a low brick retaining wall which projects outwards from the north and south elevations of the westernmost pier. The wall is 32.5cm deep and is constructed of brownish coloured bricks with concrete coping stones (39.5cm deep). The bricks measure 210 x 100 x 65mm and are laid in an English bond with thick mortar. The height of the wall varies with the adjacent ground levels. The wall has areas of cracking in the brickwork which has been repaired. Above this wall runs a farm track and to the other side of this track is a low retaining wall constructed of concrete posts which forms the base of an embankment and above the concrete supports is a simple wooden fence. It seems likely that this track was rerouted through the westernmost arch which involved the cutting of the embankment at this point. The 1980s work also included the re-routing of the River Misbourne through concrete culverts and the ground level in the road area was raised c. 0.5m.

Plate 12: View of low brick wall

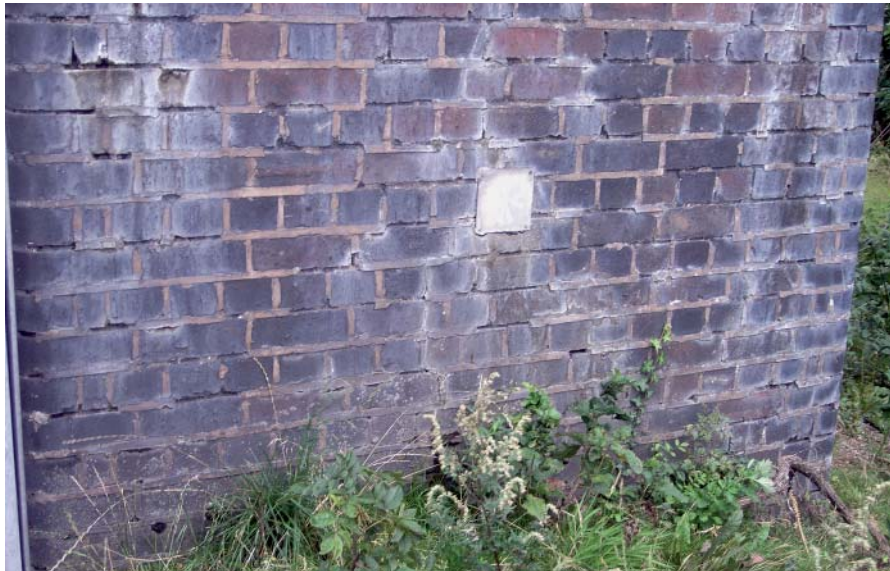
- 3.1.4 The bricks are mostly bonded with Portland cement mortar used in the original construction phase, however there are areas of flat ribbon re-pointing using a modern sand coloured cement mortar on the lower parts of the piers. This re-pointing mostly occurs adjacent to the carriageways and probably dates to the insertion of the M25 beneath the viaduct in c.1982/85.

- 4.1.2 The viaduct remains largely as constructed, despite the addition of the M25 motorway beneath its central arches in the mid 1980's. These works included the raising of the ground level for the carriageway and the re-routing of the River Misbourne through concrete culverts beneath ground level. A low brick retaining wall was added to the westernmost pier to provide stability for a farm track. Further concrete supports are used on the other side of the track to support the adjoining embankment. It is likely that the bases of the piers were re-pointed with ribbon pointing using sand coloured cement mortar during these works although the re-pointing is now failing in parts.

Plate 11: Detail of brickwork showing failing re-pointing

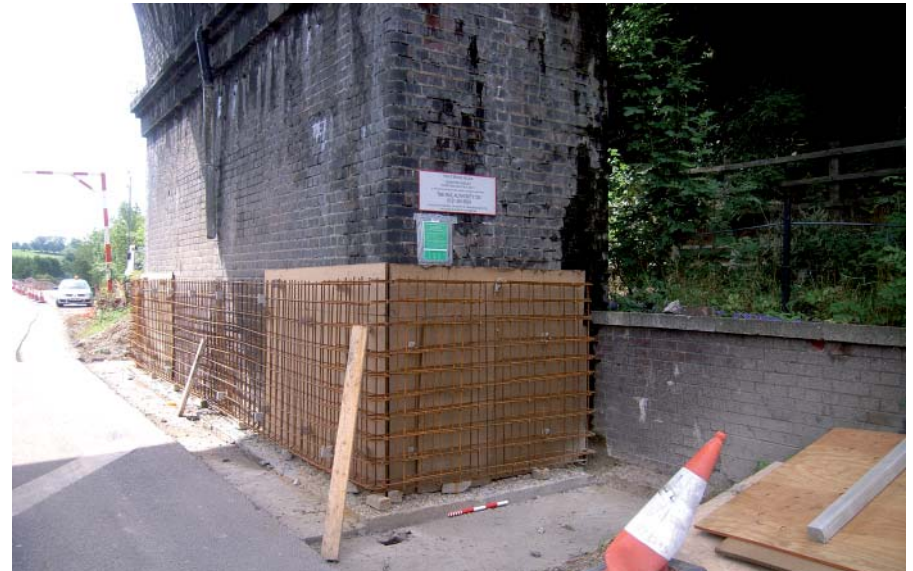
Plate 13: View of pier following removal of crash barrier and prior to construction of concrete barrier replacement

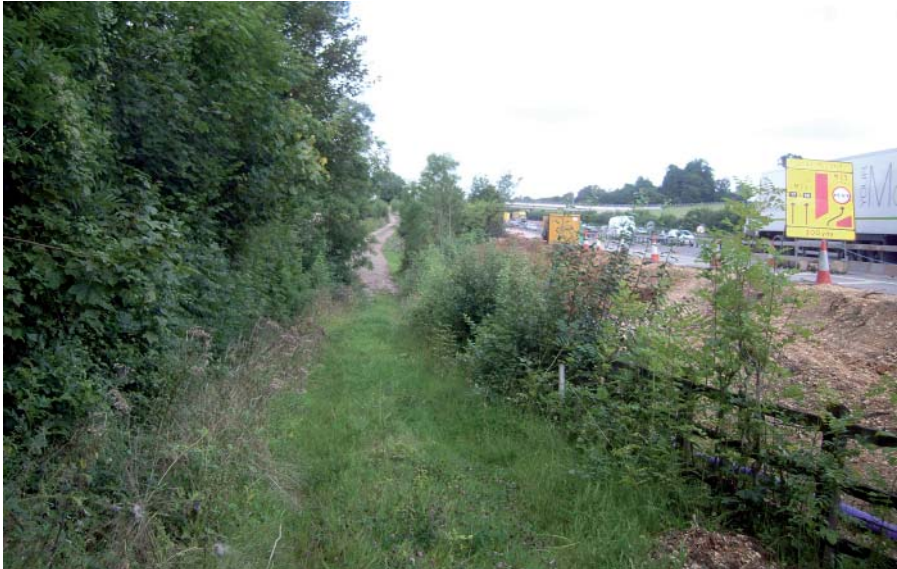
Plate 14: View of track to western end of viaduct

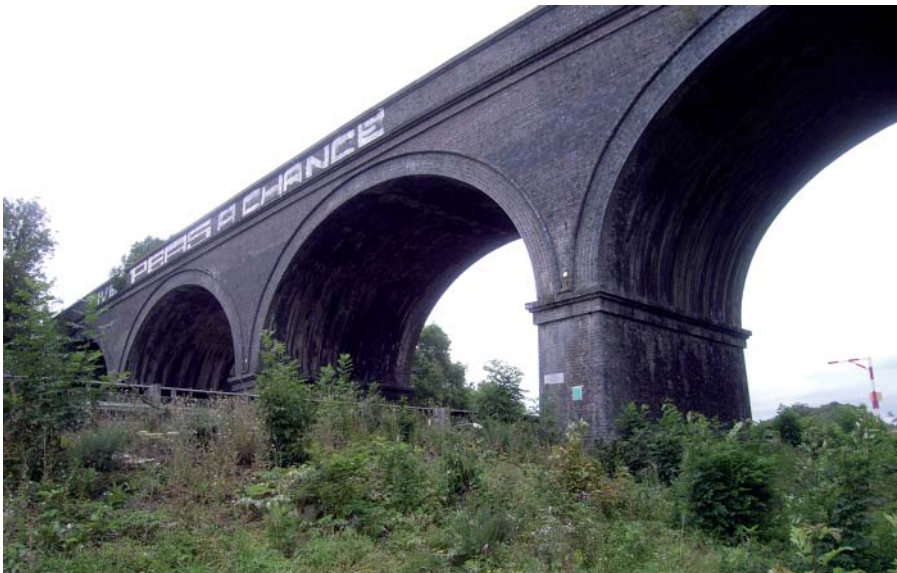
- 3.2.1 As with most railway bridges the viaduct has occurrences of graffiti on both the south facing and north facing elevations and these are limited to the parapet walling where access could be obtained from the rail line. No graffiti could be seen at road level. The south facing elevation has large painted graffiti on the parapet wall over the three westernmost arches. This has been painted in two stages, the first being the the word 'PEAS' in stylised capitals. Later the word 'GIVE' has been added in front of the 'PEAS' and 'A CHANCE' has been added after. This later graffiti is less stylised although there is an attempt to match the style used on 'PEAS' and the paint used has weathered and run in places.

- 3.2.2 'PEAS' is the tag of a London graffiti artist and his tag can be seen in many other locations, particularly on bridges. The additional text changing the graffiti to read 'GIVE PEAS A CHANCE' is thought to refer to his continual arrests. The common misinterpretation of the inscription makes bridge a interesting landmark to users of the M25.

Plate 15: View of graffiti on south facing elevation

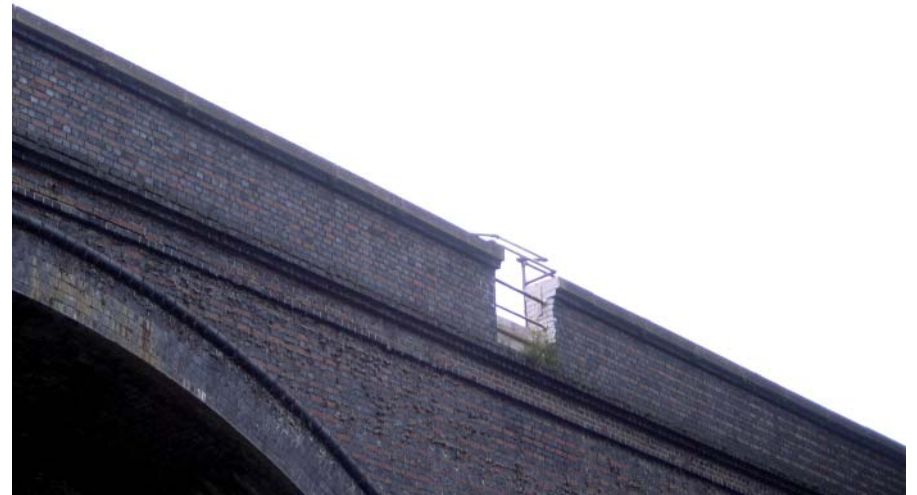
- 3.1.5 The parapet wall is topped with stone and both elevations include openings within the parapet wall which have metal bars across. The south facing elevation has openings above the outer piers and the north facing elevation has openings above the two inner piers. These are possibly refuges for the gangers and platelayers, allowing them to step clear of the tracks when trains approached, however the design is different to that seen on some of the other viaducts constructed on this line at this time, which have projecting brick refuges.

Plate 16: View of railing on parapet wall

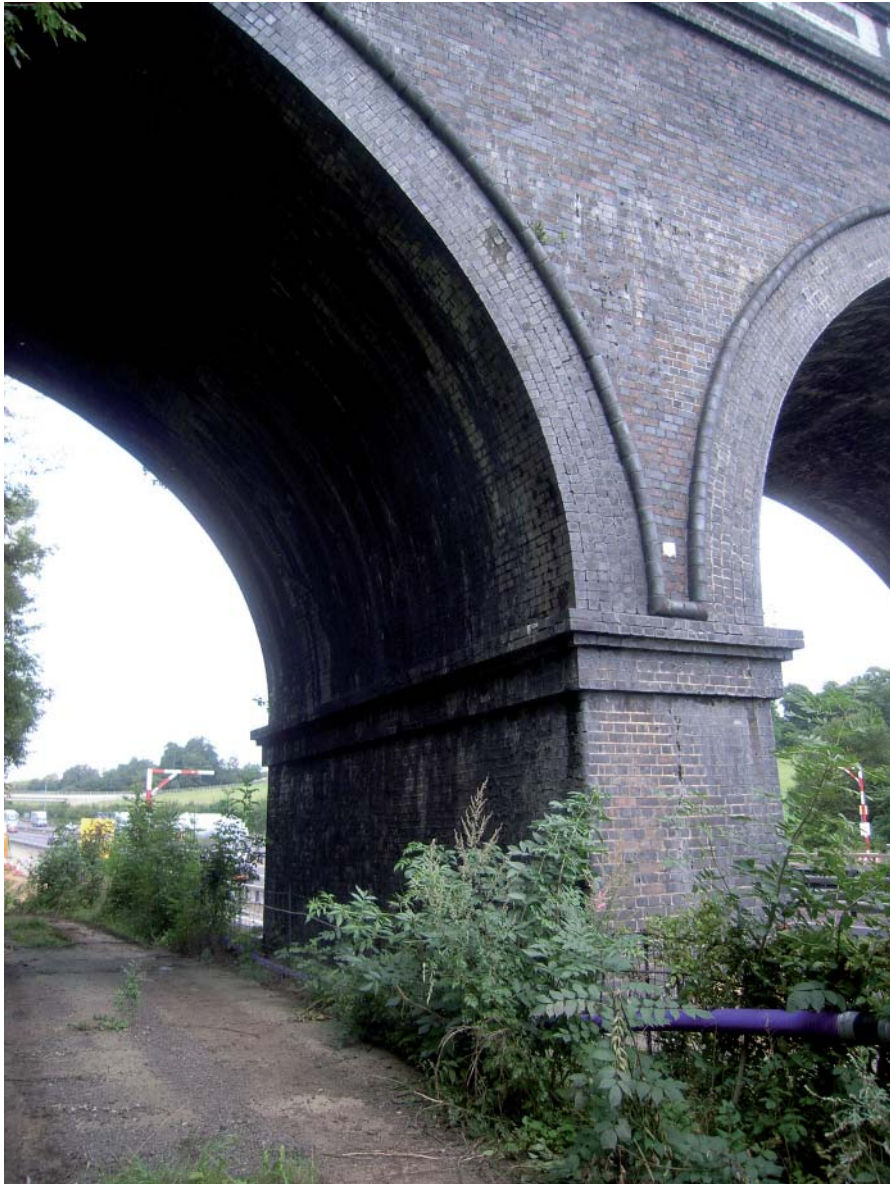
Plate 17: View of the track under the western arch of the viaduct

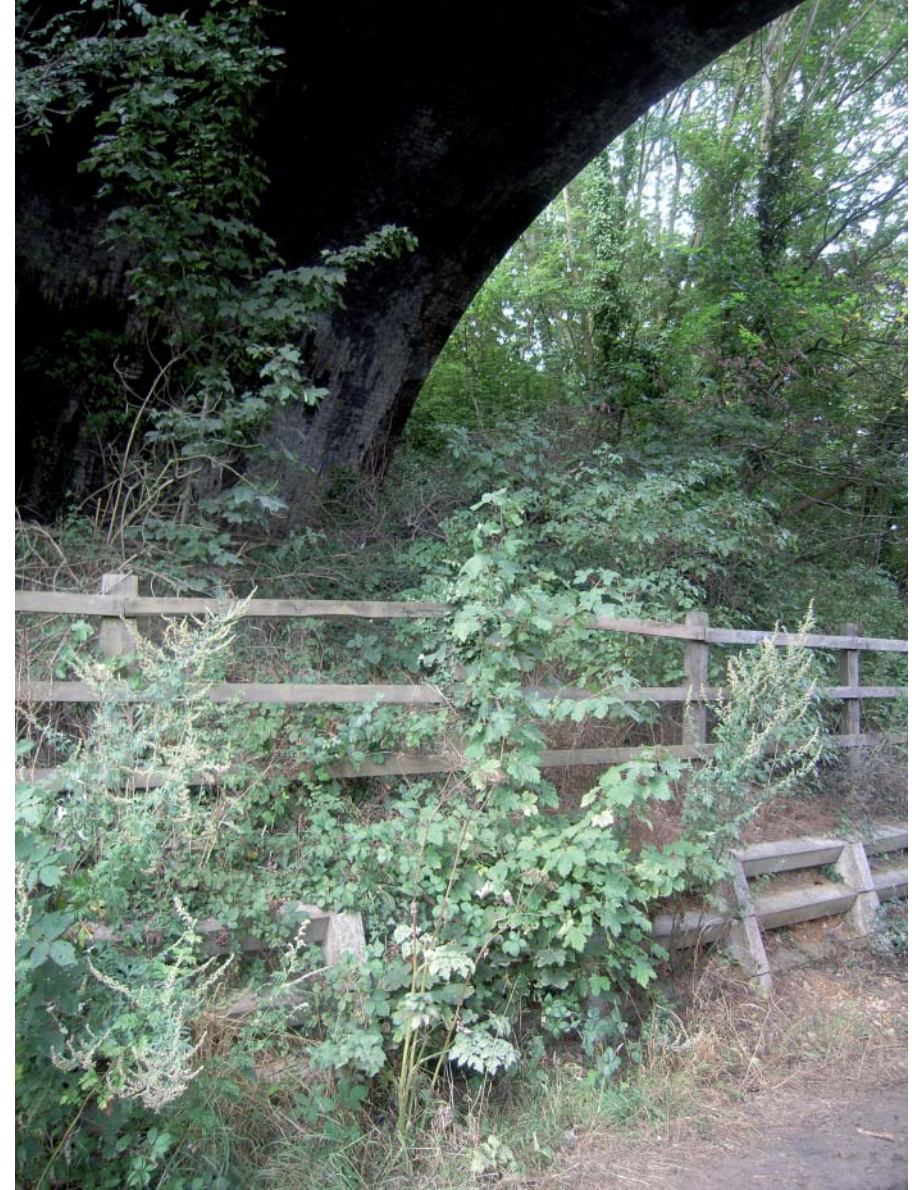
The viaduct remains largely as constructed, despite the addition of the M25 motorway beneath its central arches in the mid 1980s. These works included the raising of the ground level for the carriageway and the re-routing of the River Misbourne through concrete culverts beneath ground level. A low brick retaining wall was added to the westernmost pier to provide stability for a farm track. Further concrete supports are used above the track to support the embankment.

Plate 18: Detail of concrete retaining wall under the western arch of the viaduct
