Archaeological Test Pit Evaluation at Wimpole Park, Cambridgeshire

Archaeological Evaluation Report

OA East Report No: 1598

Report Number: 1598
Site Name: Wimpole Park
HER Event No: ECB 4098
Date of Works: January 2014
Client Name: The National Trust
Client Ref: 16231
Planning Ref: N/A
Grid Ref: TL336510
Site Code: WLPWIP14
Finance Code: WLPWIP14
Receiving Body: CCC Stores, Deep Store

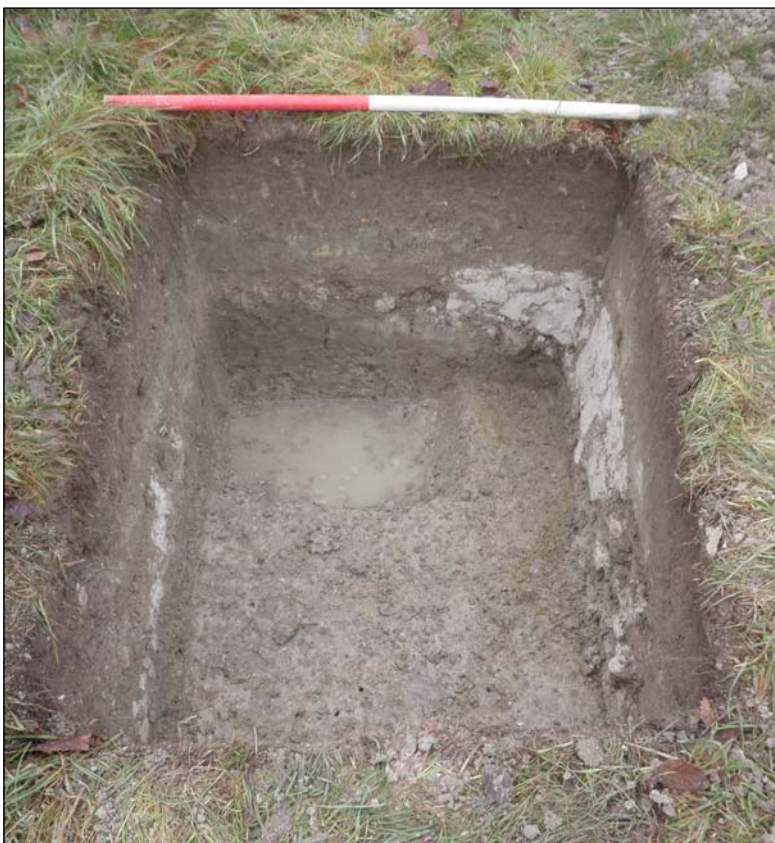
Plate 1: Test pit 3A174

- 3.4.2 Cobbling found in Test Pit **3A176** suggests that there were also mettled yards or pathways associated with these small buildings. The large pieces of clunch found in the section of Test Pit **3A174** allude to the fact that the buildings were of at least partial stone construction. None of the ceramic building material recovered during the evaluation was diagnostic but the tile found within some of the test pits in this area does suggest that some of the buildings had tiled roofs. The ceramic building material and pottery found within Test Pit **3A047** are related to the demolition of Hill House.

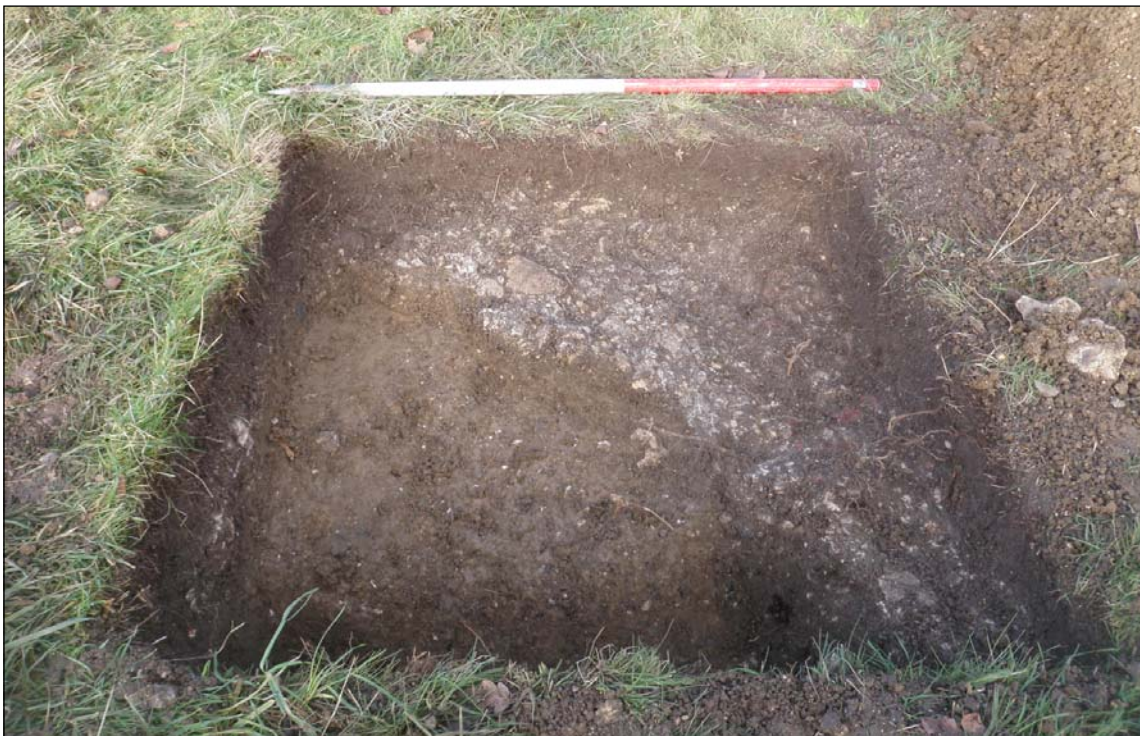
Plate 2: Test pit 3A047

- 3.3.2 Test Pit **3A047** revealed a compressed chalk or clunch layer, up to 0.08m thick, that had been truncated by a tree throw. This was interpreted as part of a pathway leading towards Hill House.
- 3.3.3 The pathway would have been made up of layers of gravel and chalk, which may have originally been capped by stones or a mettled surface. The finds from the test pit were restricted to the backfill of the tree throw (3A047.8) and consisted of ceramic building material, glass and 19th century pottery. It is probable that these finds were associated with the demolition of the building.

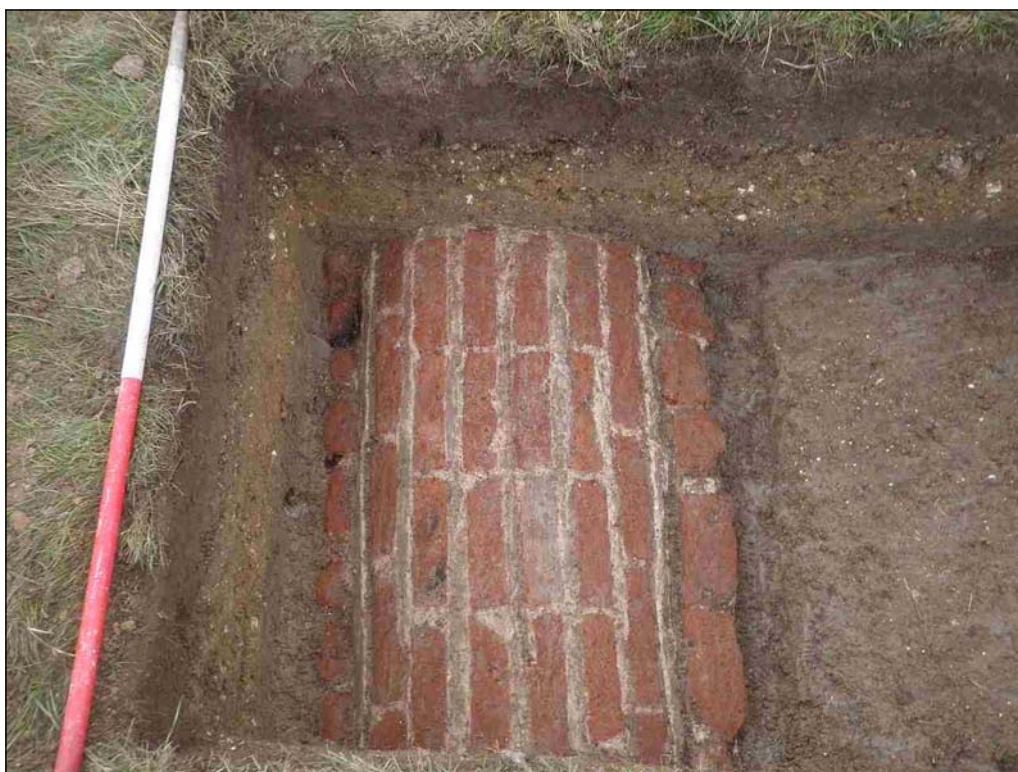
Plate 3: Culverted drain TP 3A139

- 3.2.6 The drain was discovered at a depth of 0.40m (fig 8, plates 3 & 4) on a north–east to south–west alignment. It was horseshoe shaped in profile and consisted of three courses of bricks laid as stretchers, with six courses laid face to face to complete an arched top. A further row of bricks ran alongside the drain as a form of buttress in an attempt to give added strength to the structure.

- 3.2.7 The bricks themselves were hand made red bricks that would have been produced on the estate. Although there was some variation in size, they typically measured 23mm x 0.10mm x 0.12mm. The lime mortar between courses averaged 5mm and again would have been locally produced in lime kilns on the estate.

- 3.2.8 A yellow gravel layer (**3A139.2**), that was up to 0.20m thick and consisted of well sorted small stones, had been compacted over the drain and would have afforded some protection to the culvert. The gravel layer is possibly the earlier remains of the Arrington drive which is shown on late 18th century map by William Emes.. The area was capped by a layer of topsoil and turf (**3A139.1**).

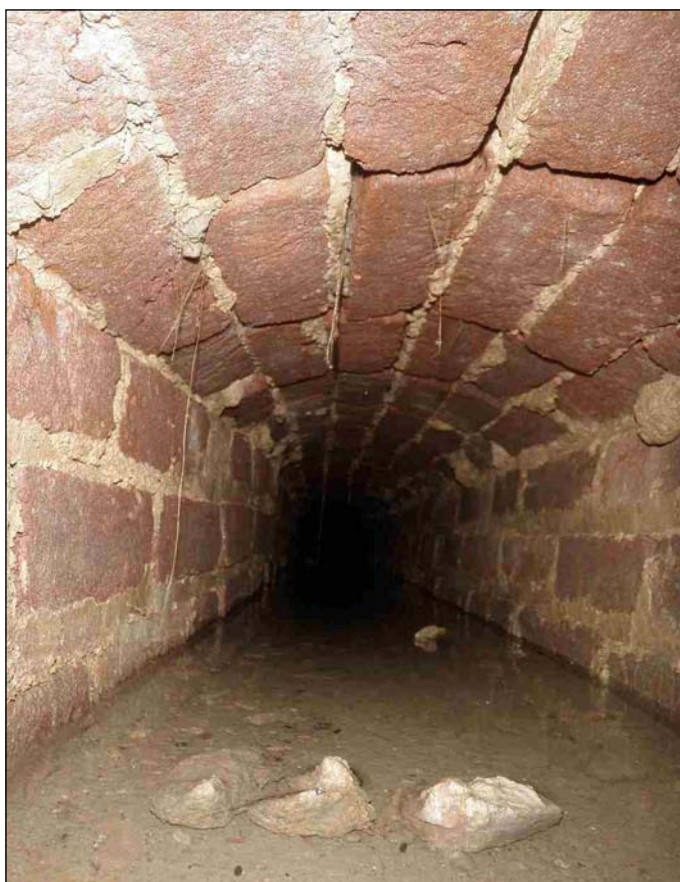
Plate 4: Interior of culverted drain TP 3A139

- 3.2.11 A small amount of water was noted with in the drainage culvert but not enough to ascertain an indication of the direction of flow. This may have been possible if the excavation had taken place during a spell of significant rainfall.

- 3.2.13 Photographs taken of the interior of the drain (Plate 4) show that water still flows along the course of the culvert and it is relatively free from blockages and silts even after three hundred years.
