# MILLTOWN, GLOSSOP, DERBYSHIRE

## Archaeological Building Assessment

Revised April 2007

**Glossop Land Ltd**

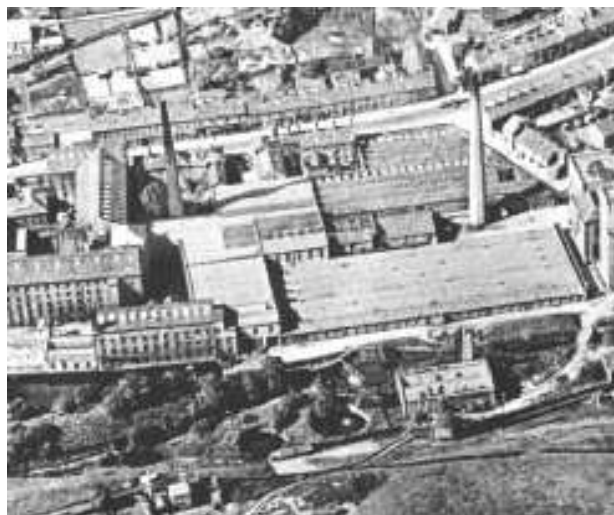
*Detail of Yorkshire Street infilling from 1925 photograph* Yorkshire Street and of the rows of housing either side being removed and replaced with what appears to be a two storey structure with multiple span north-light roof. The chimney to the immediate west, within an open space, is probably shown on the 1894 map, although it could easily be misidentified.

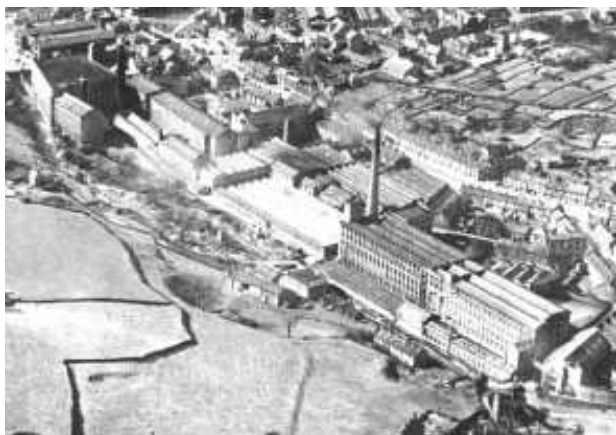
*Extract from aerial photograph, 1949*

(Plate 2). This is far more oblique, and hence less detailed, than that taken in 1925, but it does illustrate the size and importance of the complex in relation to the town and its other mills. Two features appear to differ from the earlier photograph, with the area formerly occupied by the gas works apparently derelict by this date. The chimney to the east of Yorkshire Street has also been reduced in height to that of the adjacent three storey buildings, suggesting significant alterations to the power plant around this date.

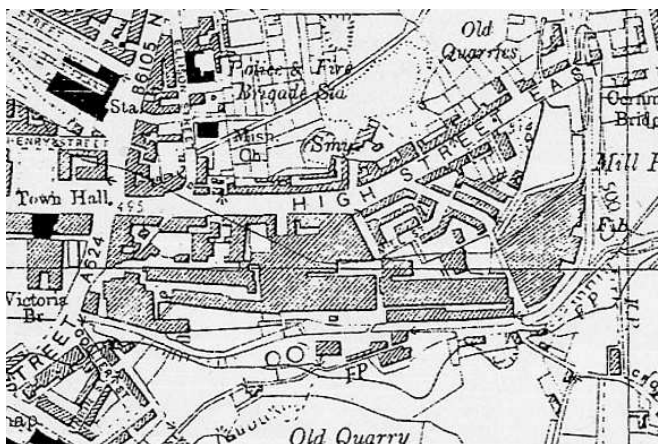
this edition highlights the difficulties of reliance upon map regression, as it appears to show an almost identical layout to that of the 1938 map. However, the 1949 photograph shows differences which are not readily shown in the mapping. Unlike earlier maps, the complex is not named, neither are any of the elements within. It is most probable that this map represents the maximum extent of the Howard Town Mills complex, very shortly before its rapid decline.

*Extract from OS 6":1 mile map, published 1951*

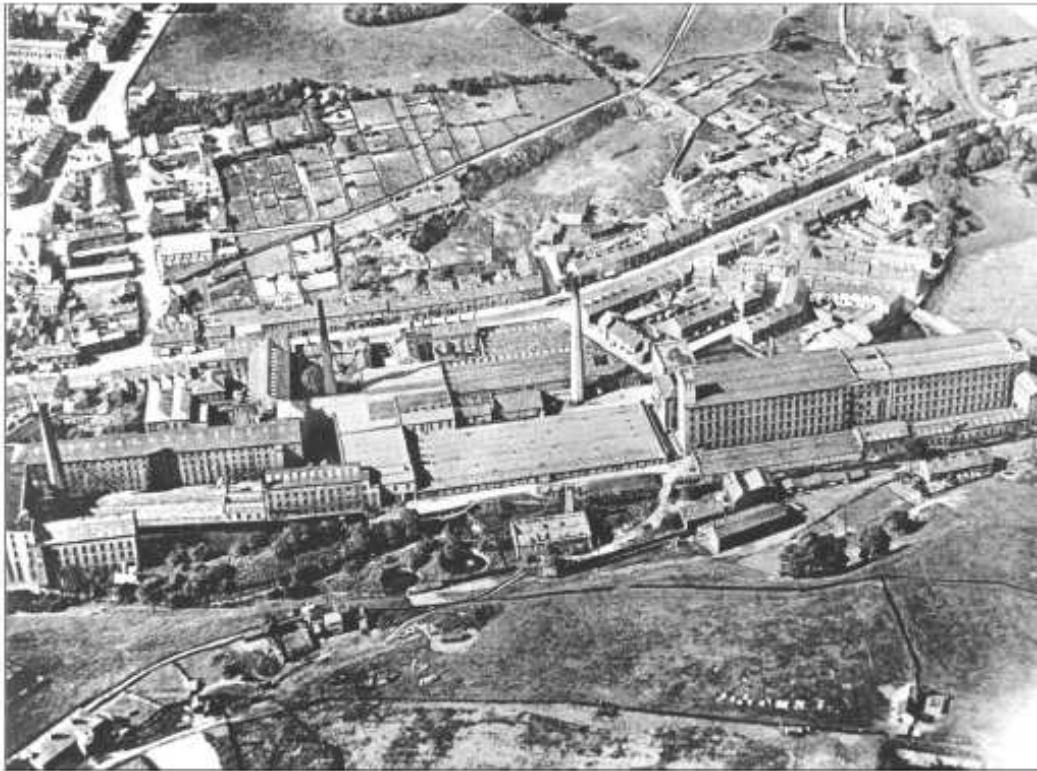
3.3.5 **Aerial photograph, dated 1925:** an oblique view of the site, taken from the south, shows the majority of the complex, with the exception of the eastern and western extremities (Plate 1). The eastern part of the site appears externally similar to the plan of 1894, with the only visible structural alterations taking place in the centre of the complex. This comprised the incorporation of

Plate 1: Aerial view of Howard Town Mills from south, 1925

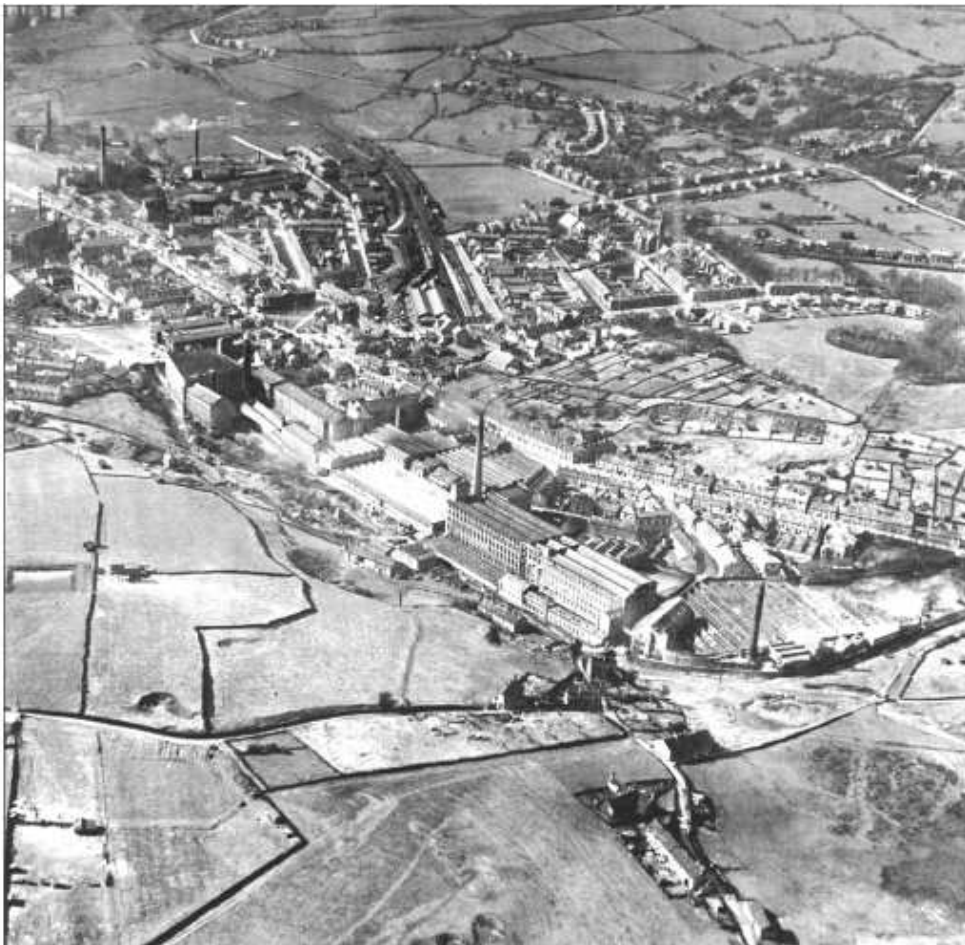
- 3.3.8. **Aerial photograph, dated 1949:** an oblique view of Milltown, taken from the south-east, shows the whole complex in relationship to the town of Glossop

Plate 2: Aerial view of Howard Town Mills from south-east, 1949

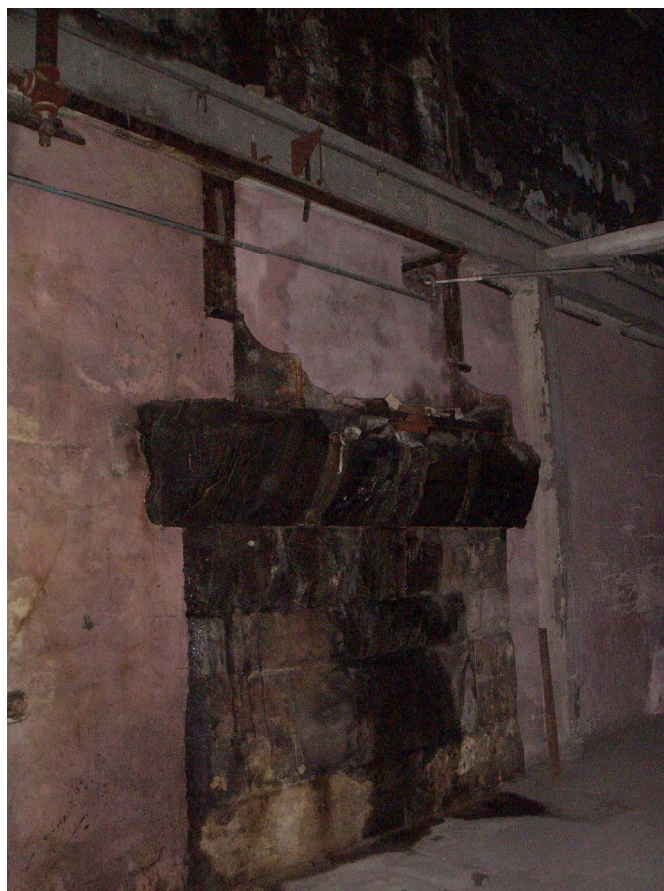
Plate 8: Footstep bearing for vertical driveshaft, Building 1

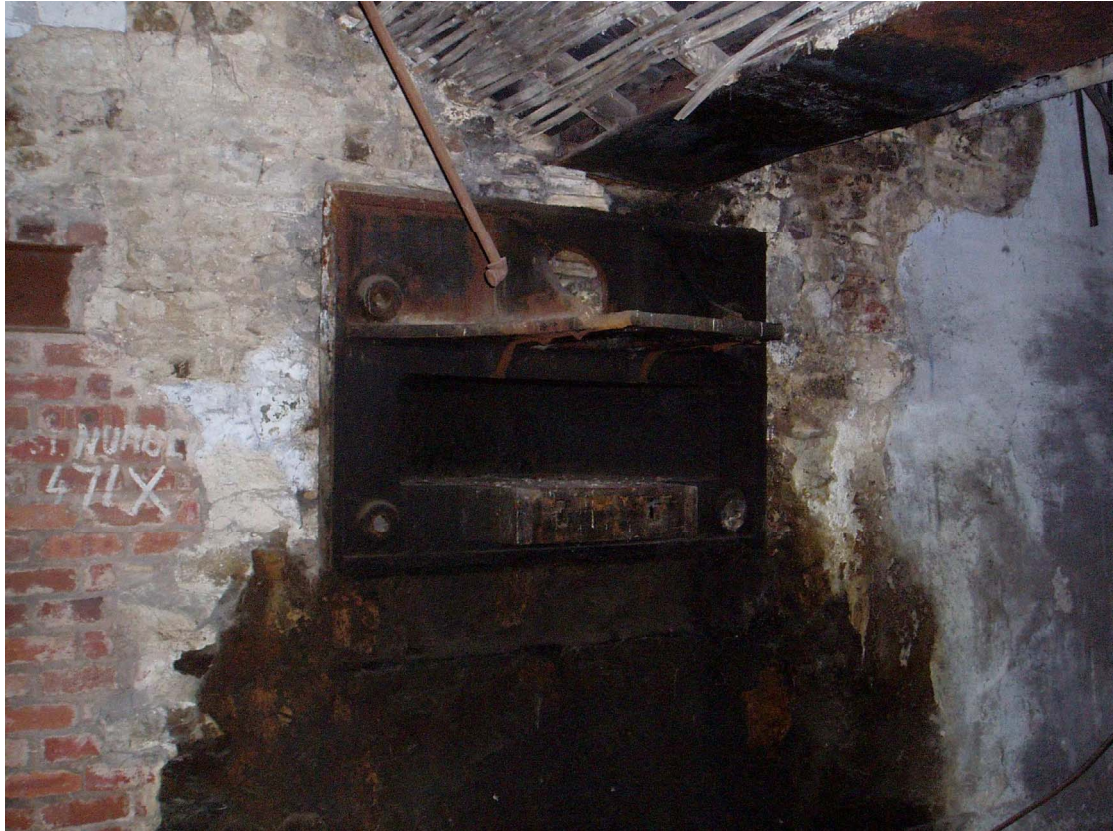
Plate 9: Top steady bearing for vertical driveshaft, Building 1

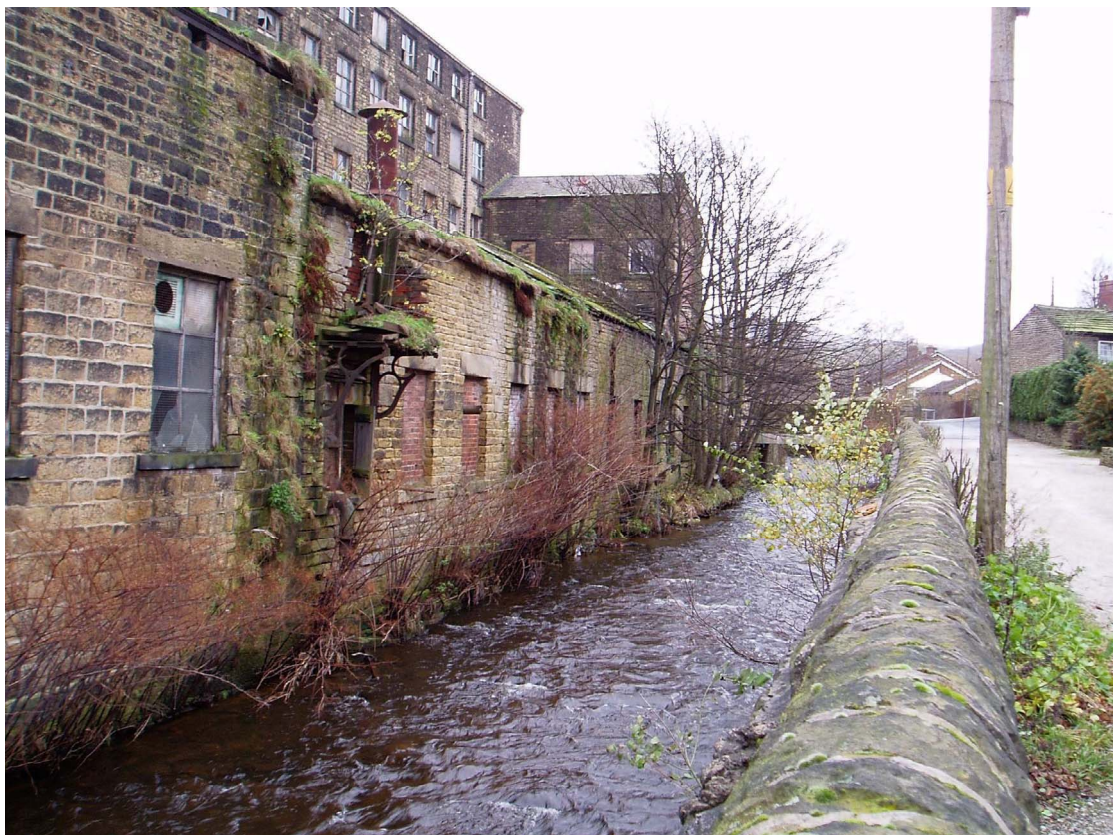
- 4.1.5 **Building 3:** this comprises a range of 1½ storey sheds on the northern bank of Glossop Brook (Plate 14), forming the southern boundary of the narrow courtyard along the south of Building **1**. The structure, which is of roughly coursed rubble with an east/west aligned pitched slate roof appears to be of at least three phases, although differentiation is unclear without a detailed examination. The eastern six bays appear to be part of the structure which replaced the southern bay of Building **2**, but only differ from the bays to the immediate west in that they have no windows in the south elevation and have projecting corbels at wall head height for guttering (Plate 15). They also have dressed stones at the wall base, but these may relate to a late repair, mainly using concrete, to protect the structure from the flow of the brook immediately to the south. The central section of nine bays appears to have a drystone foundation in the southern elevation, which is overlain by the dressed sandstone base of a six bay shed to the west, below a vertical butt joint between the two phases of construction (Plate 16). Both these phases contain windows in the south elevation, all brick blocked. Above the western window is a brick-sided platform, projecting over the brook. It is supported on

Plate 14: General view from south-west, Building 3

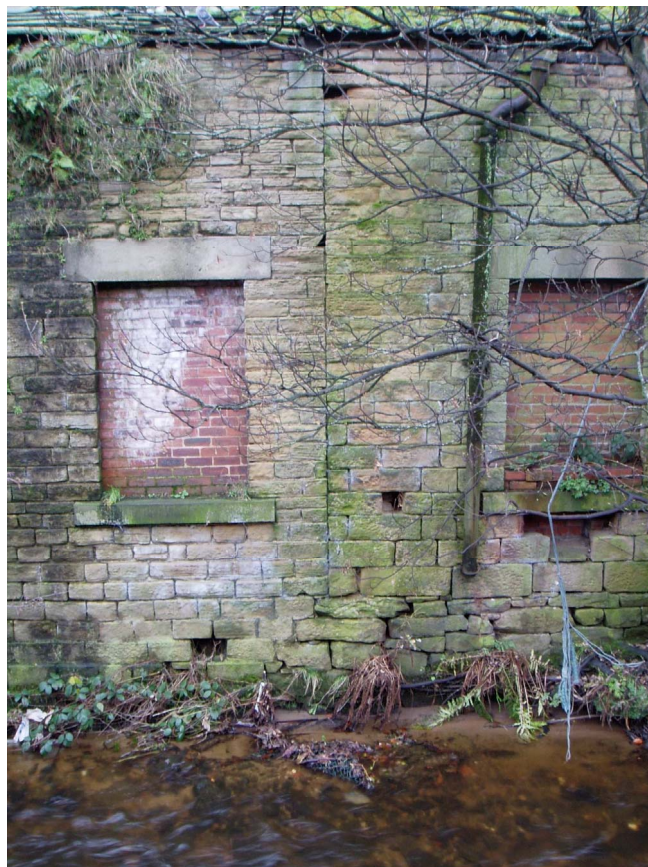
Plate 16: Butt joint between phases, Building 3

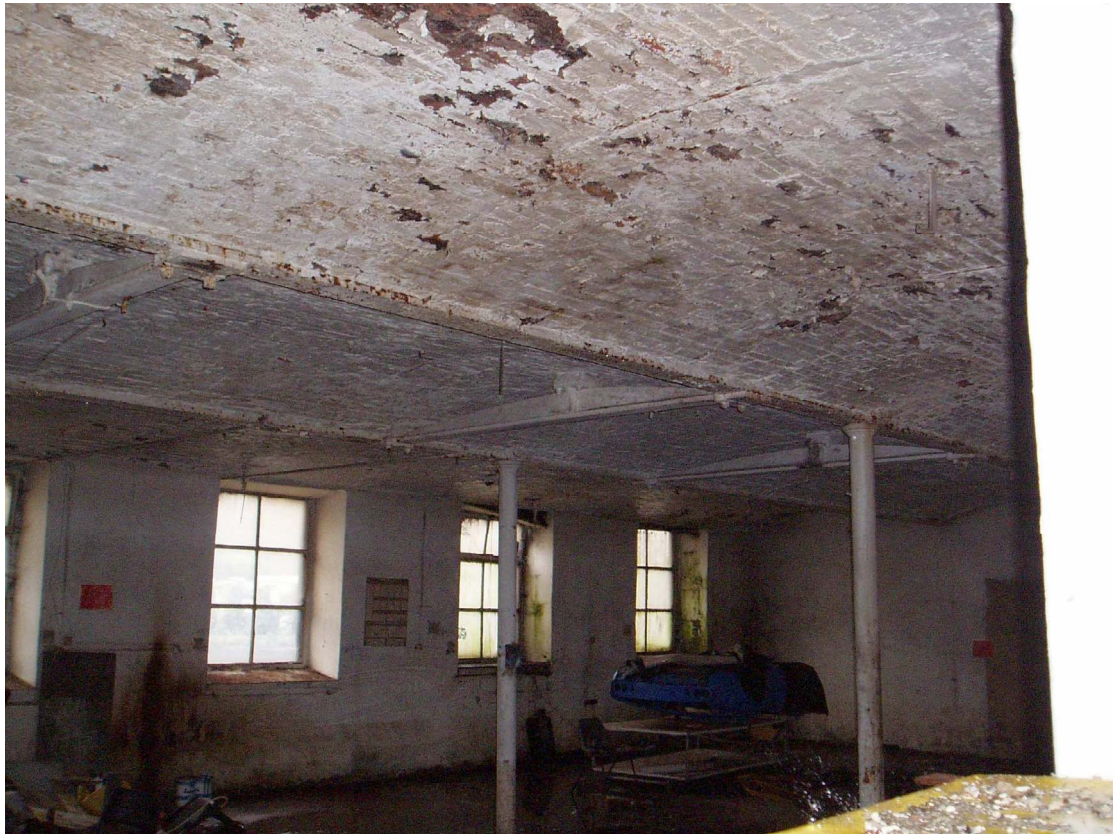
Plate 19: Fireproof ceiling, Building 4

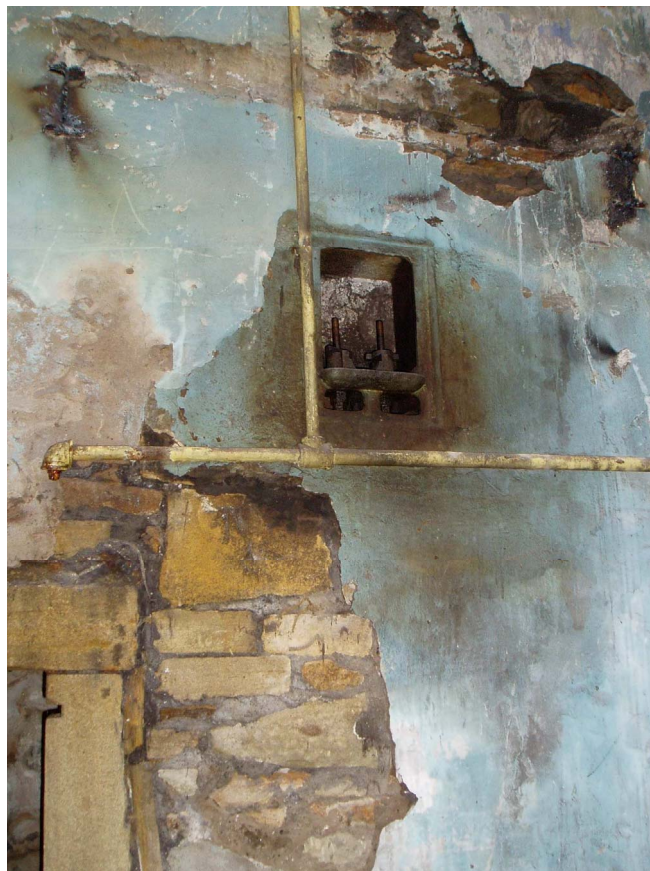
Plate 24: End-carrier bearing for lineshaft, second floor, Building 6

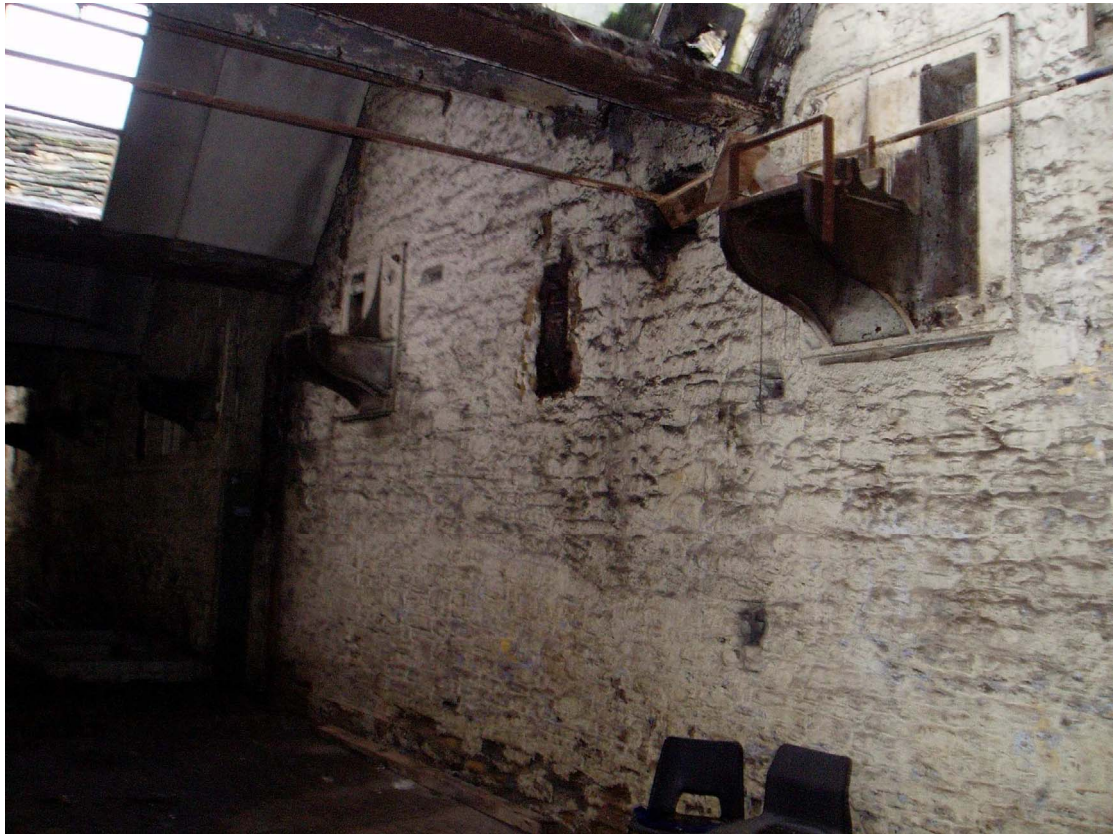
Plate 27: Lineshaft-carrier bearing, east elevation, Building 7

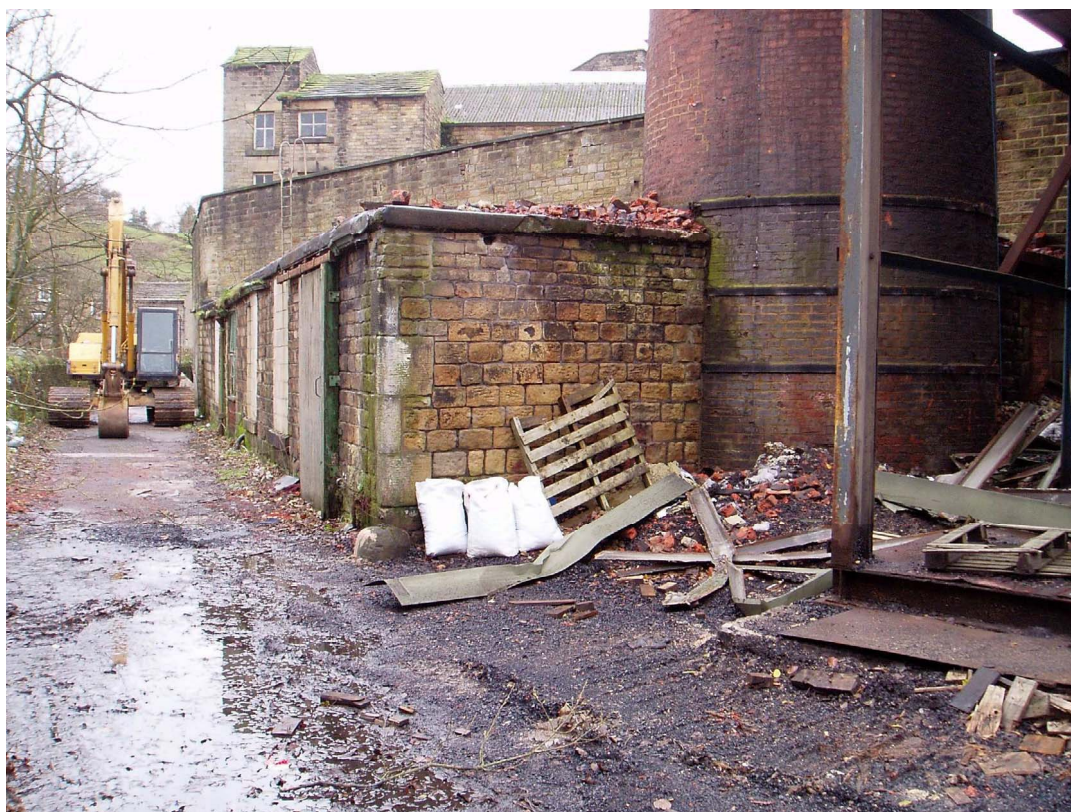
- 4.1.13 **Building 8:** a small single storey, five bay stone shed, is located immediately to the north of an inserted concrete and steel-fronted, brick-lined loading passageway at the southern end of Building 7. The shed has a flat roof, but a missing quoin at the top of the north-east corner of the front wall suggests it may have been re-roofed. It has concrete-blocked vertical windows in each of the southern four bays, and a sliding metal door in the northern bay. Detailed

Plate 29: General view from north-east, Building 8

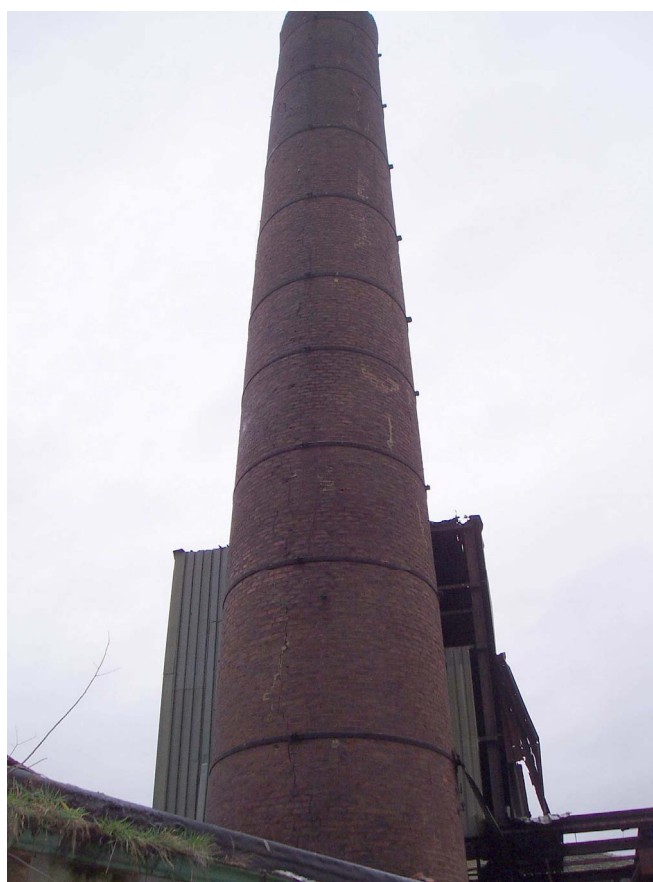
- 4.1.14 **Building 8A:** brick chimney, circular in plan, with tapering stack and flared head. It has no decoration, although the brickwork bonding is slightly unusual, comprising a variation on English Garden Wall bond, with the course of headers being replaced with alternating headers and stretchers. It is supported by 12 iron bands (Plate 30), nine above the height of the weaving shed (Building 7), with a further three below, supporting the base of the stack (Plate 29).

Plate 30: Detail of chimney 8A

- 7.2.19 **Building 8A:** the chimney is the only surviving example of its type within the complex, and although it is probably later than those serving engine houses originally to the west, is a significant local landmark. It has increased group value, as the associated boiler house and engine house survive intact, providing a rare example of a 19th century power generation plant, and giving additional relevance to the chimney. It is proposed that the chimney is retained within the development, and it is therefore recommended that it is recorded to English Heritage Level II standard.

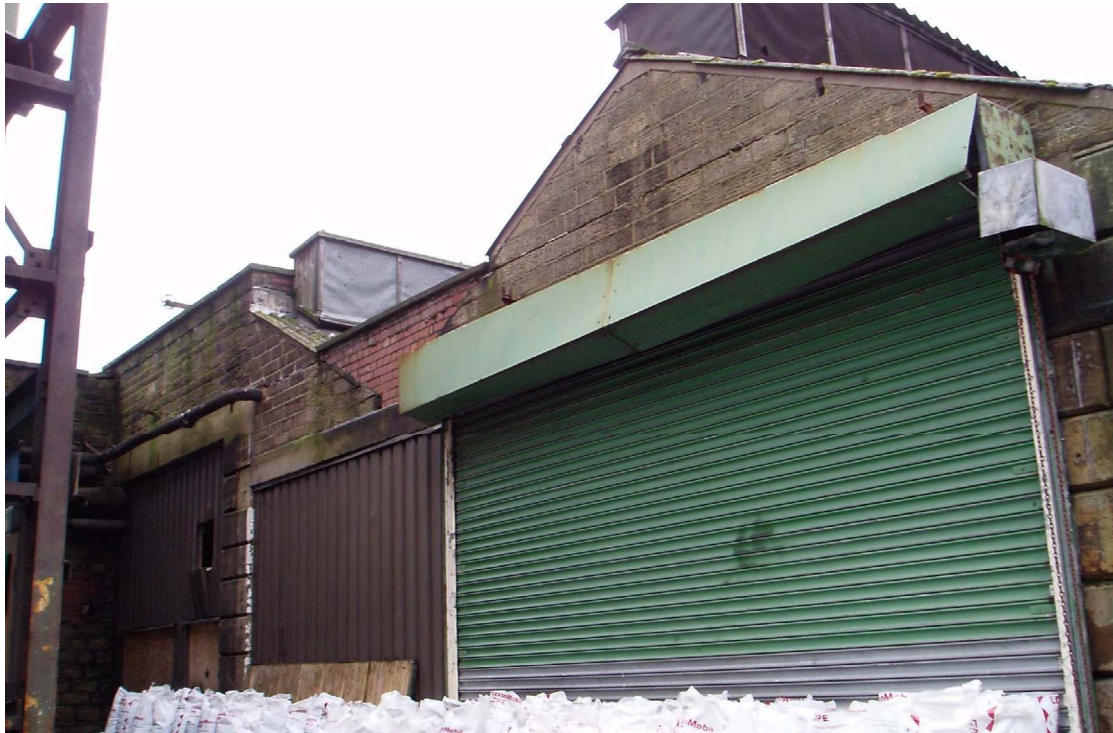
- 4.1.16 **Building 10:** comprises a two bay detached boiler house with double-span gabled roof with raised ridge louvre. Large rusticated quoined openings were observed in the south elevations, now closed with roller-shuttering, with corrugated sheeting between (Plate 32). Brick infill of valley to parapet, and concrete-blocked doorway in east elevation, precluding internal inspection. The size of the structure suggests that it housed two Lancashire boilers.

Plate 32: Dressed entrance to boiler house 10

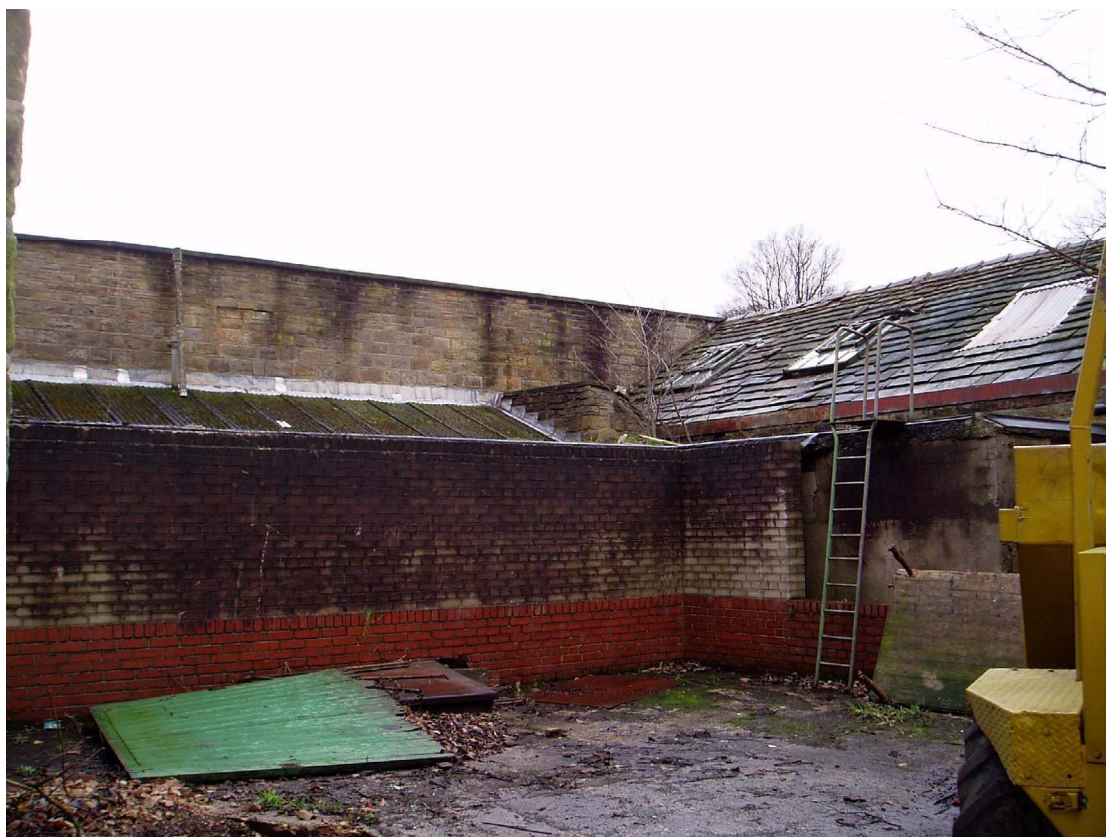
- 4.1.18 **Building 12:** comprises a three bay east/west aligned single storey shed with double-span pitched and gabled roof with skylights. No apertures were observed in the east elevation and no internal access afforded (Plate 34). It probably functioned as a storage facility.

Plate 34: General view from east, Building 12

- 7.2.25 **Building 12:** this late structure documents the increased reliance on road transport by the final stages of the mill, with the need for a petroleum store. However, it detracts from the visual impact of the weaving shed and associated structures, and should, therefore, be removed. Prior to this, a minimal English Heritage Level II standard survey is recommended.

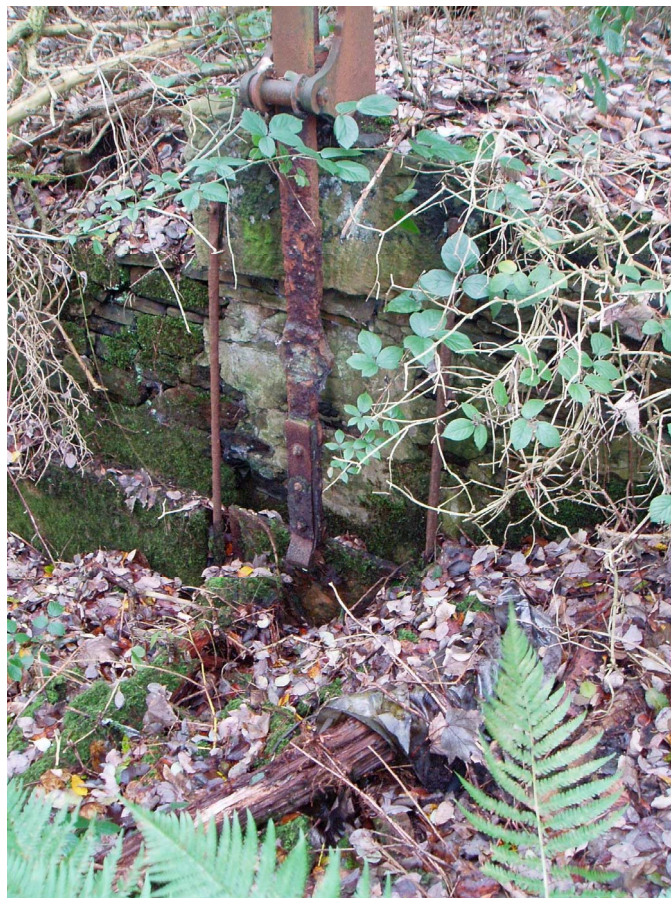
Plate 50: Remains of sluice gate, central mill pond

- 7.2.41 **Water courses:** a detailed topographic survey of the extant, but partially infilled mill pond, to the north of Building 1, is recommended in order to identify and record it and any associated features.

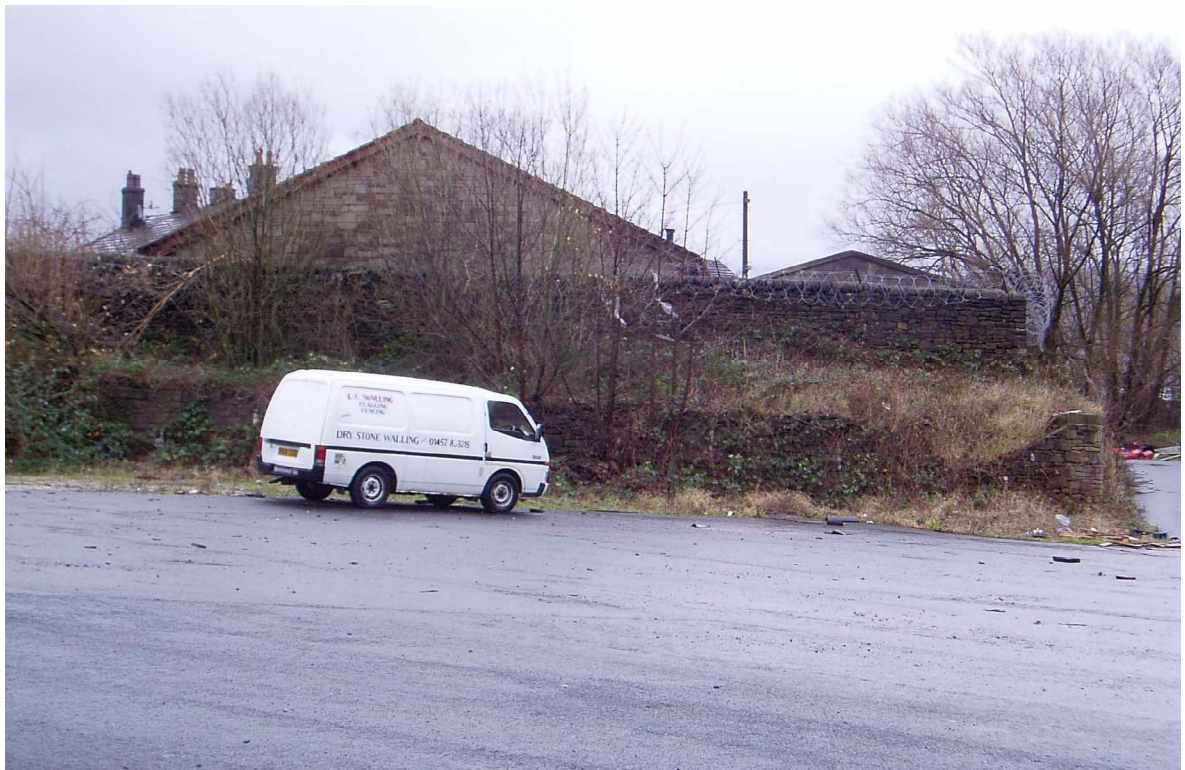
Plate 52: Probable mill wall remnant, west of Buildings **16** and **16A**

- 7.2.42 **Other Structures:** evidence of cobbled streets and courtyards were observed across the site, and large sections of walling relating to demolished structures within the complex survive to varying degrees of preservation, most especially to the west of Building 16 and between Buildings 17 and 23. It is recommended that these are recorded to English Heritage Level II standard.

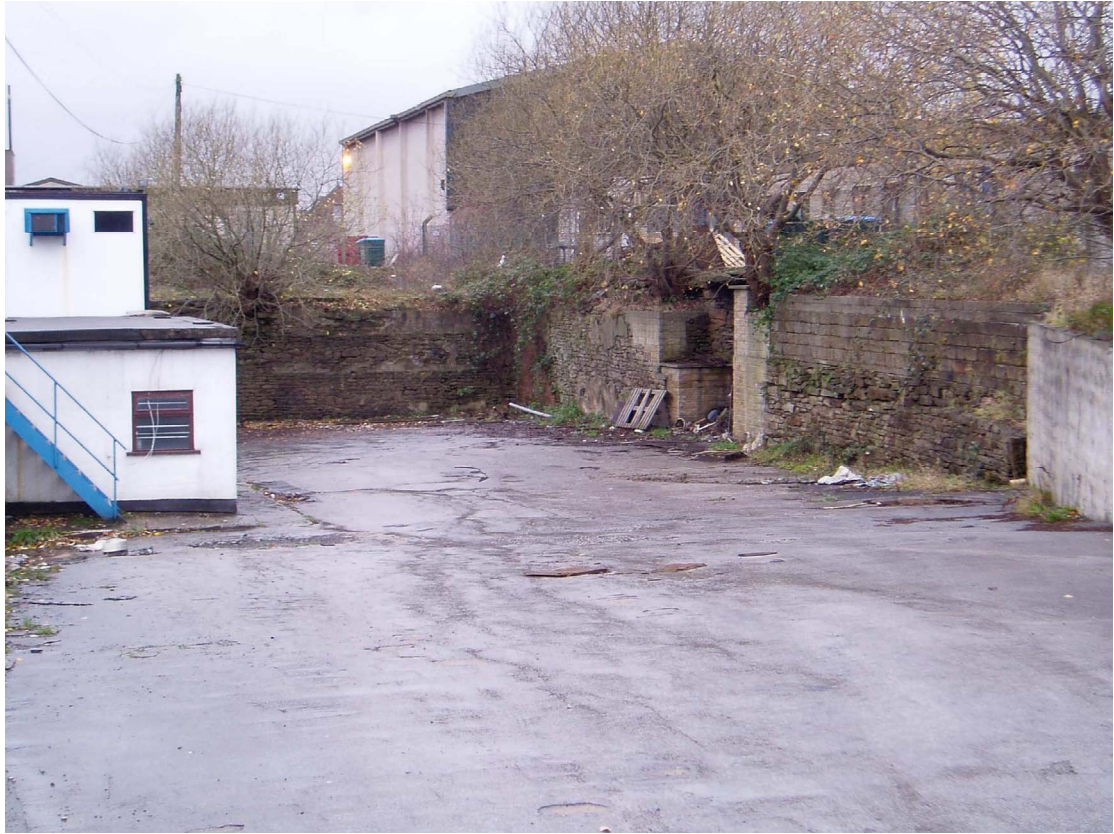
Plate 53: Probable mill wall remnant, between Buildings **17** and **23**
