St Laurence Church South Hinksey Oxford

Archaeological Watching Brief Report

February 2009

Church of St Laurence, South Hinksey, Oxfordshire

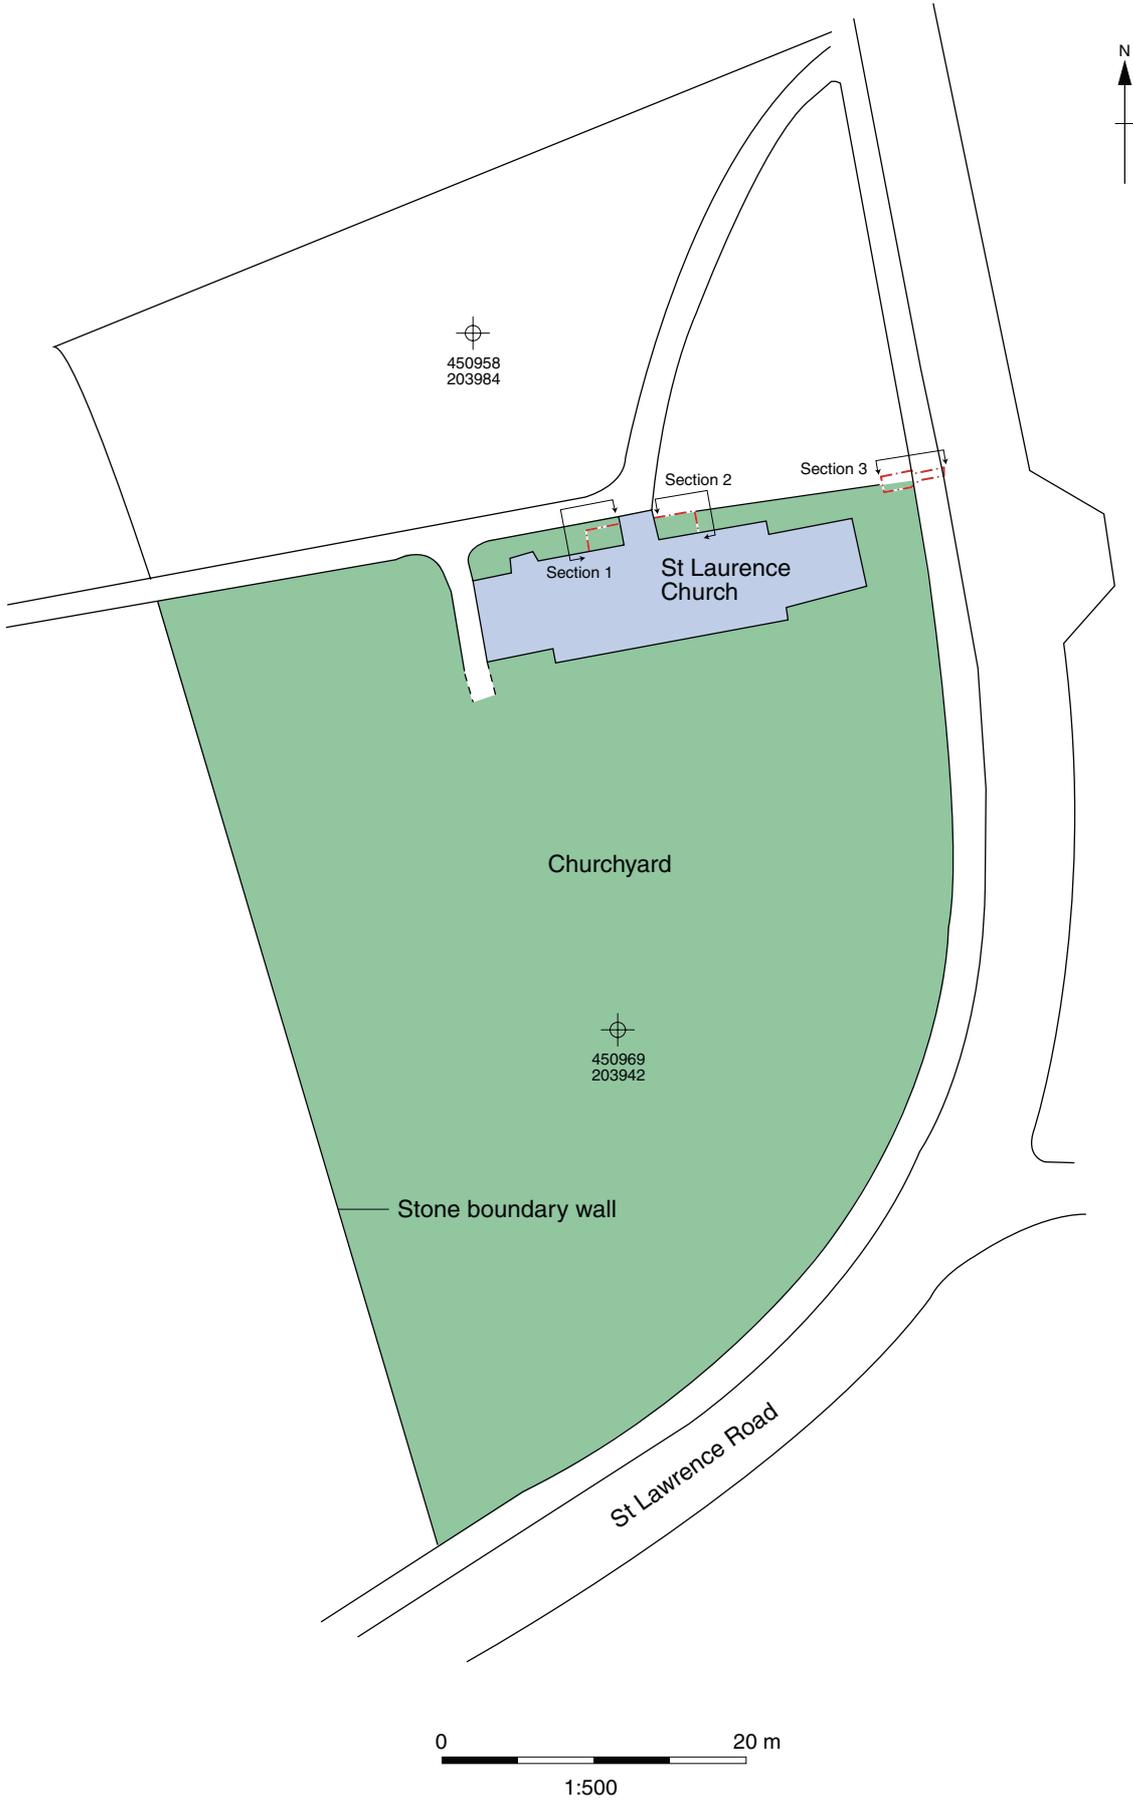
Figure 2: Plan of works

- 3.1.1 This consisted of an excavation 2.4 m long by 1.7 m wide located adjacent to the porch (Fig. 2 and Fig. 3). This was excavated to a depth of up to 1.2 m below the current ground level.

- 3.1.6 This consisted of an excavation also 2.4 m long by 1.7 m wide located adjacent to the porch and a service trench leading to an access chamber adjacent to the churchyard boundary wall (Fig: 2 and Fig. 3). This was excavated to a depth of up to 1.25 m below the current ground level in the area next to the porch deepening to 2.5 m below ground level during the excavation of the access chamber.

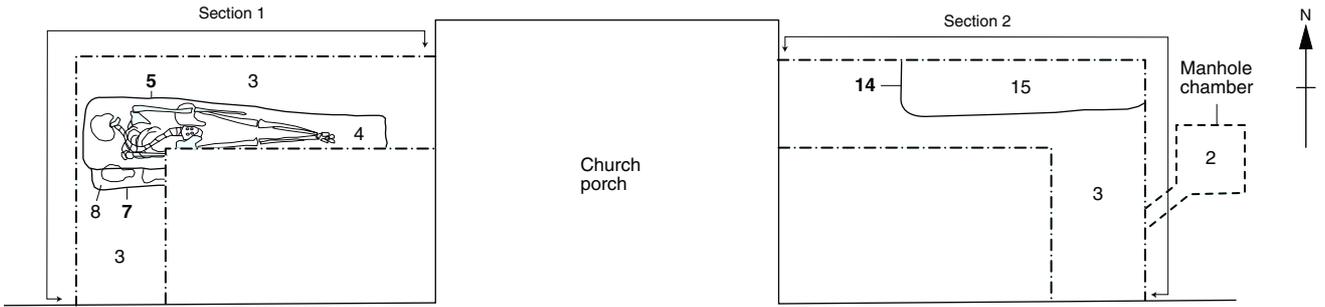
Section 1

- 3.1.2 The undisturbed natural, a red-brown silt clay (3) was encountered at a depth of 0.8 m below the current ground level (Fig. 3, Section 1). This was overlaid by a 0.5 m deep layer of light grey-brown silt clay (2). This contained fragments of 18th and 19th-century clay pipe stems and probably represents a layer of churchyard soil.

- 3.1.3 Cutting this deposit was a rectangular east-west aligned grave cut (7). This contained the skeleton of an adult male (9) and iron coffin fittings suggesting that it probably dates to the 18th or 19th-century. The northern side of this grave cut was truncated by a later grave cut (5). This measured 1.9 m long by 0.45 m wide. This contained the skeleton of an adult female aged 45 plus (6) who showed evidence of severe curvature of the spine (Scoliosis). A number of iron coffin handles and gilt dome head nails were also recovered suggesting that the burial dates to the 18th or 19th centuries. The grave had been backfilled with a grey-brown silt clay (4). Cut into the western part of this deposit was a 0.7 m wide vertical-sided cut filled with a grey-brown clay silt (12) and redeposited bones. Its shape suggests that it represents another probable grave cut.

- 3.1.4 On the northern edge of the excavation a vertical-sided flat bottomed cut (11) was observed in the section also cutting layer 2. This was filled by a dark grey-brown clay silt (10), measured 0.7 m deep and was over 1.5 m in length. Its shape and alignment suggests that it was also a grave cut.

- 3.1.5 Sealing fills 10 and 12 was a 0.3 m deep layer of dark brown silt loam (1), the present day churchyard soil.

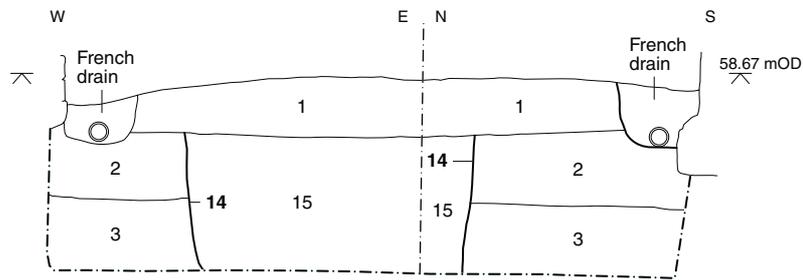
Section 3

- 3.1.8 The excavations for the access chamber measured 1 m by 1.3 m and were dug to a depth of 2.5 m below the current ground level (Fig. 3, Section 3). The natural, 3, was encountered at a depth of 1.2 m below the level of the current churchyard. This was overlaid by a continuation of the earlier churchyard soil (2), 0.8 m deep. Overlying

this was a 0.35 m layer of silt loam (1), a continuation of the present day churchyard soil. No inhumations were encountered during this phase of work.
