Site/Project Name: St Laurence Church, South Hinksey

Site Code: SHSTLC08

Site/Project Type: Archaeological Watching Brief

| Short description of the project | In January 2009, Oxford Archaeology (OA) carried out an archaeological watching brief at the Church of St Laurence, South Hinksey, Oxfordshire (NGR: SP 509 039). The work was commissioned in advance of the construction of a new toilet block, storeroom and associated service trenches. The watching brief revealed deposits of earlier churchyard soil and three 19th-century inhumations. No evidence for any earlier phases of the church's construction was encountered. |

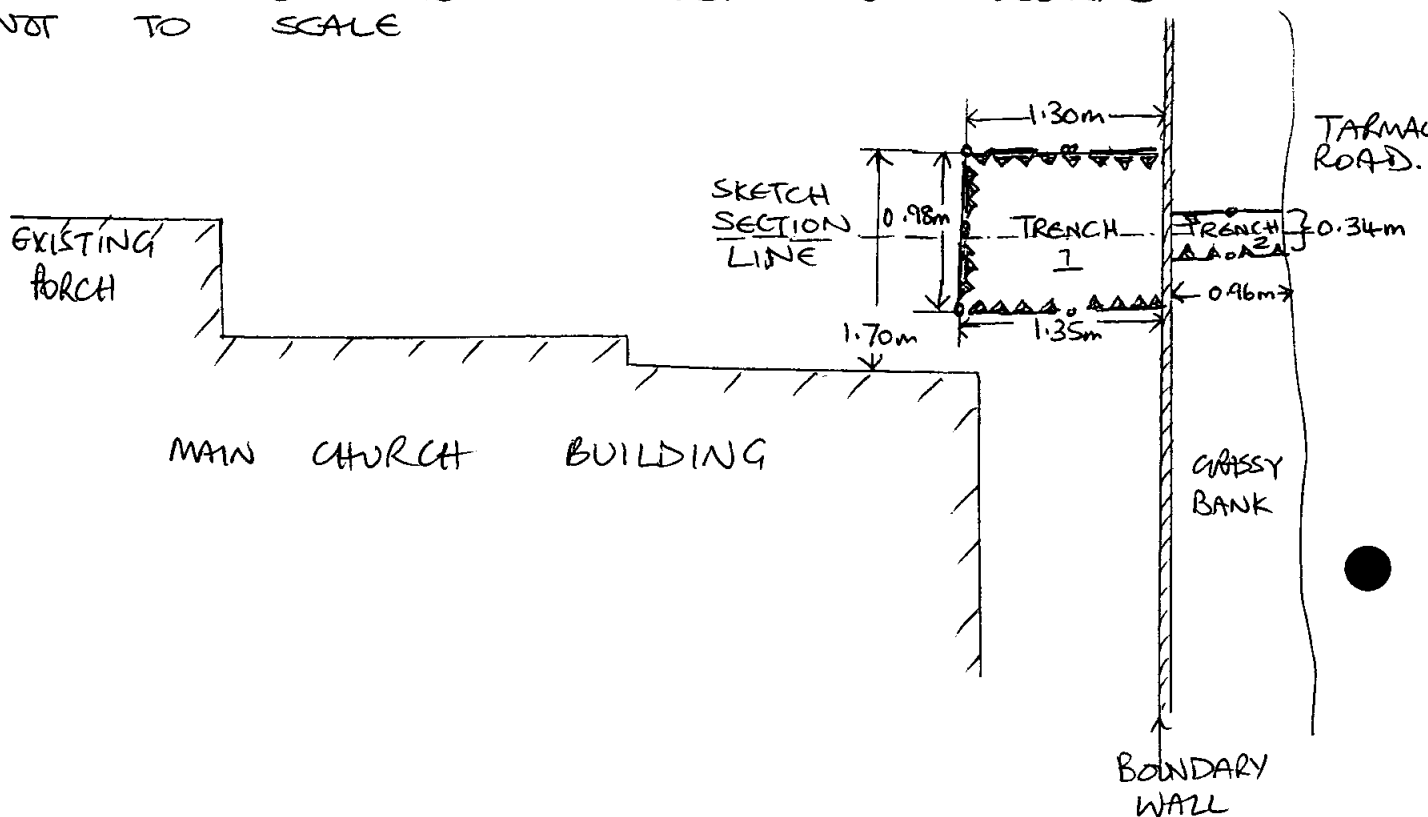
- ① SKETCH PLAN OF ST LAURENCE CHURCH, SOUTH HINKSEY TO SHOW EXTENT OF WORKS.  
NOT TO SCALE

- CONTEXT ① - TOPSOIL . MAX DEPTH : 0.38m EXTENT: <sup>THROUGHOUT</sup> TRENCH
- " ② - SUBSOIL . MAX DEPTH : 0.82 EXTENT: "
- " ③ - NATURAL . <sup>EXCAVATED</sup> MAX DEPTH : 1.30m EXTENT: "

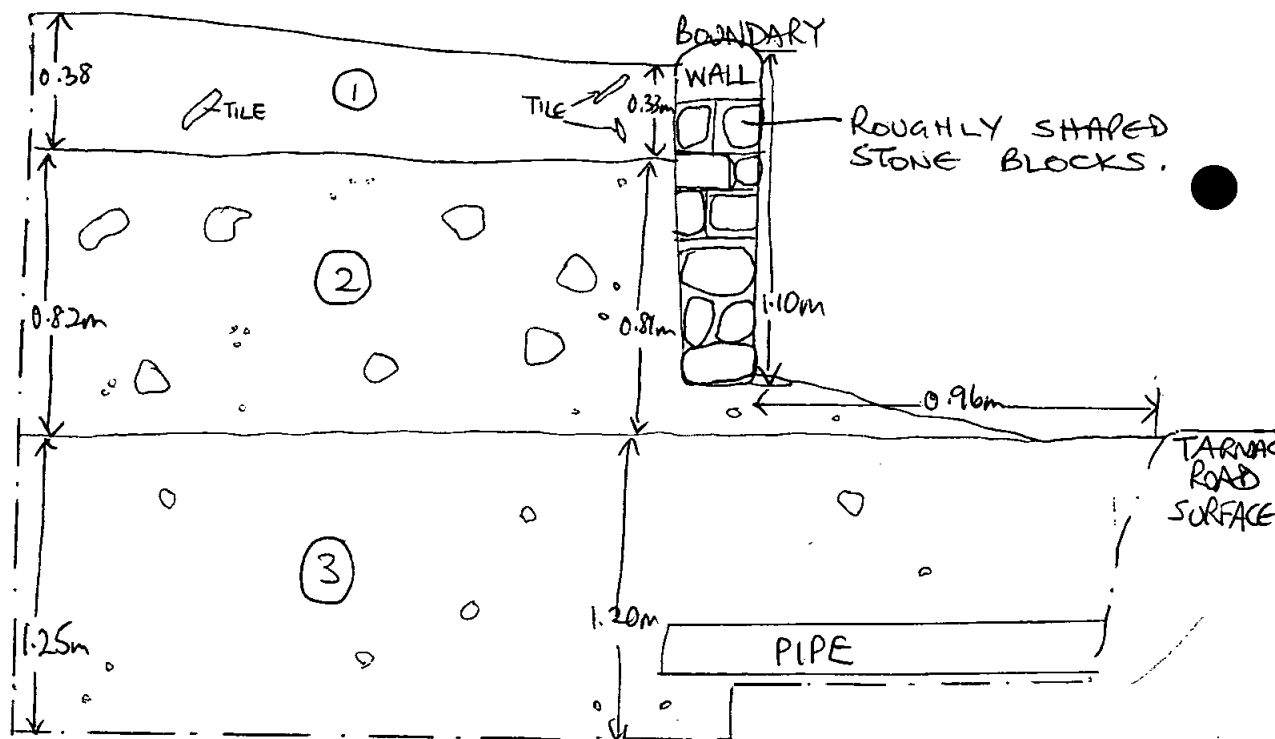
- ② SKETCH SECTION OF ST. LAURENCE CHURCH, SOUTH HINKSEY DROP MANHOLE TRENCH. NOT TO SCALE.

- DUG BY HAND IN COLD + DAMP CONDITIONS, LARGELY OVERCAST.
- ① FRIABLE, MID GREYISH-BROWN SANDY SILT WITH OCCASIONAL FRAGMENTS OF  
ROOF TILE + BUILDING STONE <10%.

- ② FRIABLE, MID ORANGEY BROWN SANDY SILT WITH OCCASIONAL <10%  
FRAGMENTS OF BUILDING STONE + SUB-ROUNDED QUARTZ PEBBLES <sup>MAX 0.02 x</sup>  
0.01 x 0.01m.

- BUILDING STONE POSSIBLY FROM CHURCH CONSTRUCTION - SIMILAR COLOUR <sup>FRAG</sup>
- ③ COMPACT, MID TO DARK ORANGEY BROWN SANDY SILT WITH OCCASIONAL  
c.2-5% SUBANGULAR TO SUB-ROUNDED GBBLES (MAX DIMS 0.12m x 0.10m x 0.08m)  
+ SMALL GRAVELS.

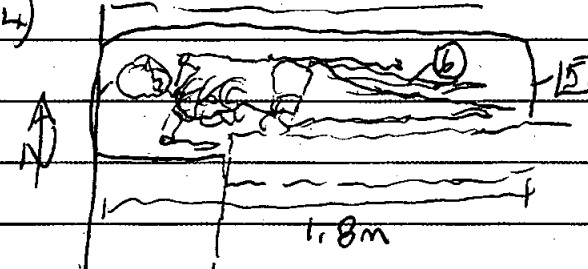
| Description (See check lists):<br><b>1) Rectangular</b><br><b>2) Vertical sides, flat base</b><br><b>3) Depth 1.0m, width 0.6m, length 1.8m</b><br><b>4)</b> | | | <b>STRATIGRAPHIC MATRIX</b><br><div style="text-align: center;"> </div> | | |
| | | | <b>5) s. edge cut by 13</b><br><b>6) Filled by 4 &amp; 6</b> | | |
| Interpretation/Discussion: <b>Grave cut.</b> | | | | | |

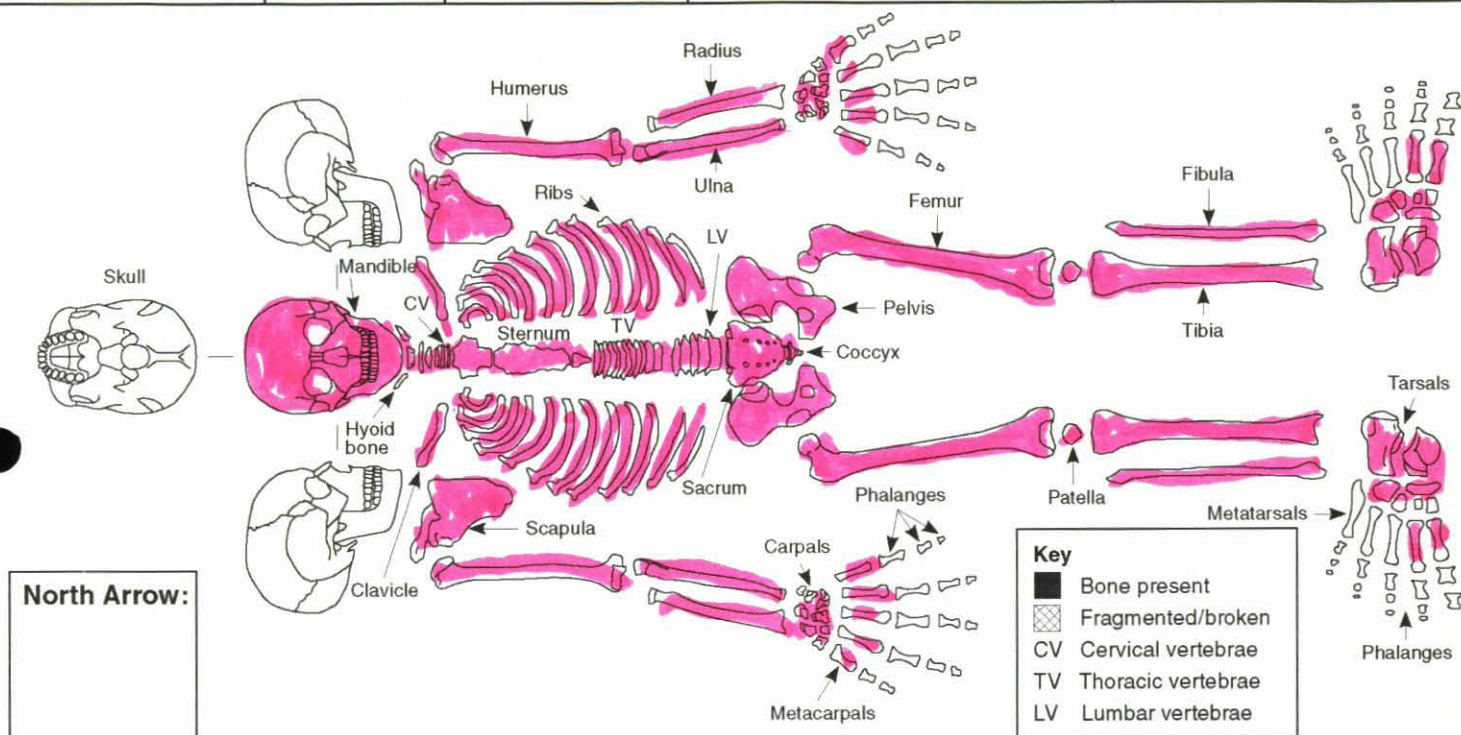
- 1) Body supine
- 2) Head over to left
- 3) Arms straight down leg
- 4) " " " "
- 5) Extending
- 6) " " " "
- 7) Touching
- 8) Good
- 9) Good
- 10) By hand
- 12) lower jaw sockets healed over  
Severe scoliosis of the spine

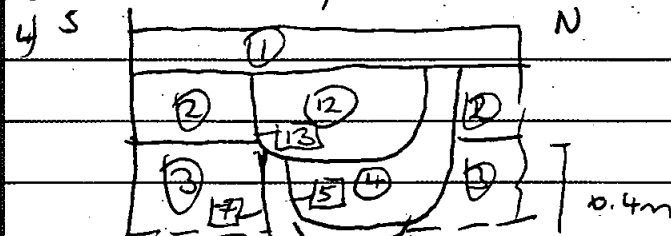
STRATIGRAPHIC MATRIX

- 1) Rectangular
- 2) vertical sides, flat base
- 3) 0.4m deep, 0.6m wide

- 5) 4 c5A by later graves [5] + [13]
- 6) Filled by [8] & [9]

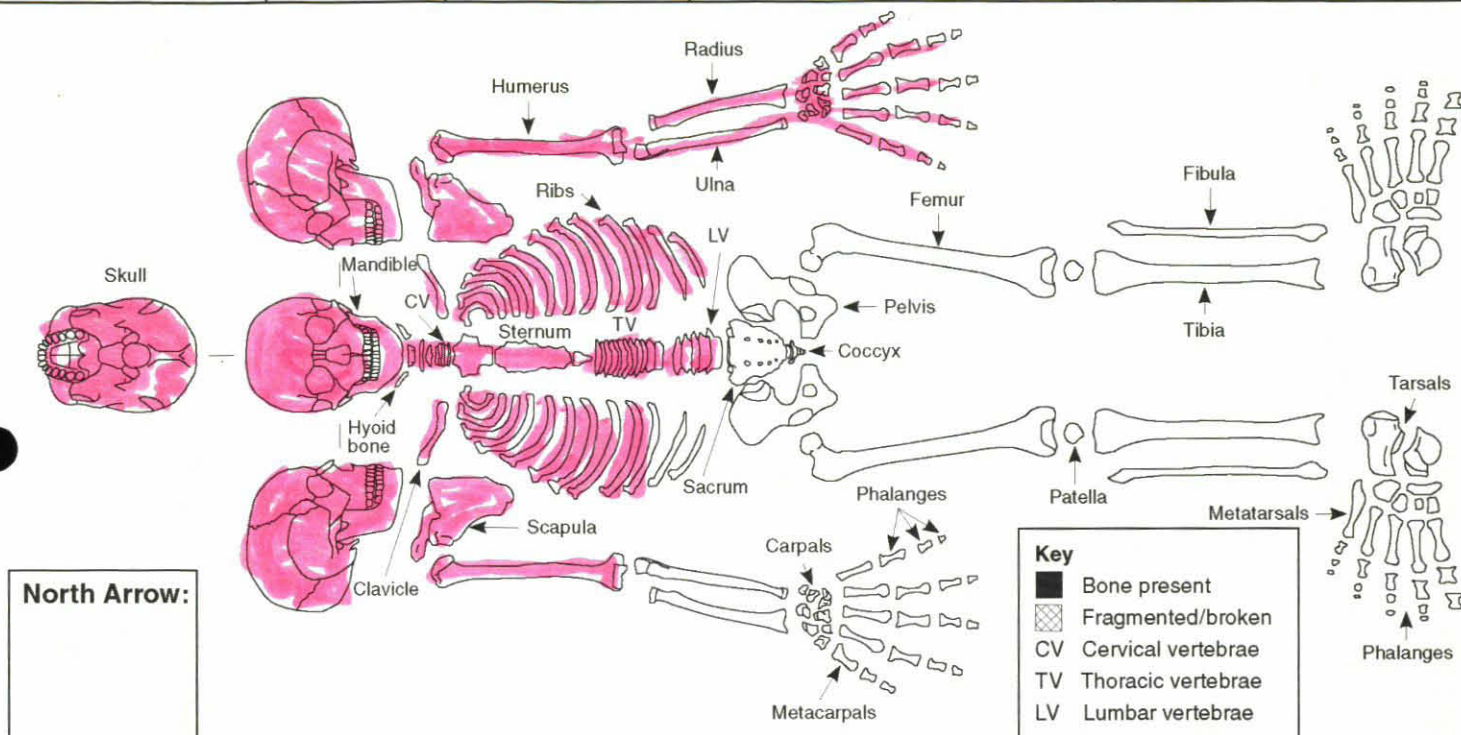
*Supine, basal Arms at side head to W.*  
*Only upper part of body exposed in trench, remainder left in bath.*  
*Bone in good condition.*

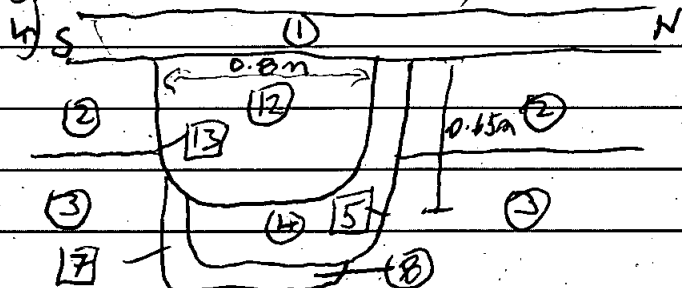
STRATIGRAPHIC MATRIX

- 1) Rectangular in plan
- 2) Vertical sides, flat base
- 3) 0.65m deep, 0.8m wide
- 4) S

5) N.V

6) Filled by (12)

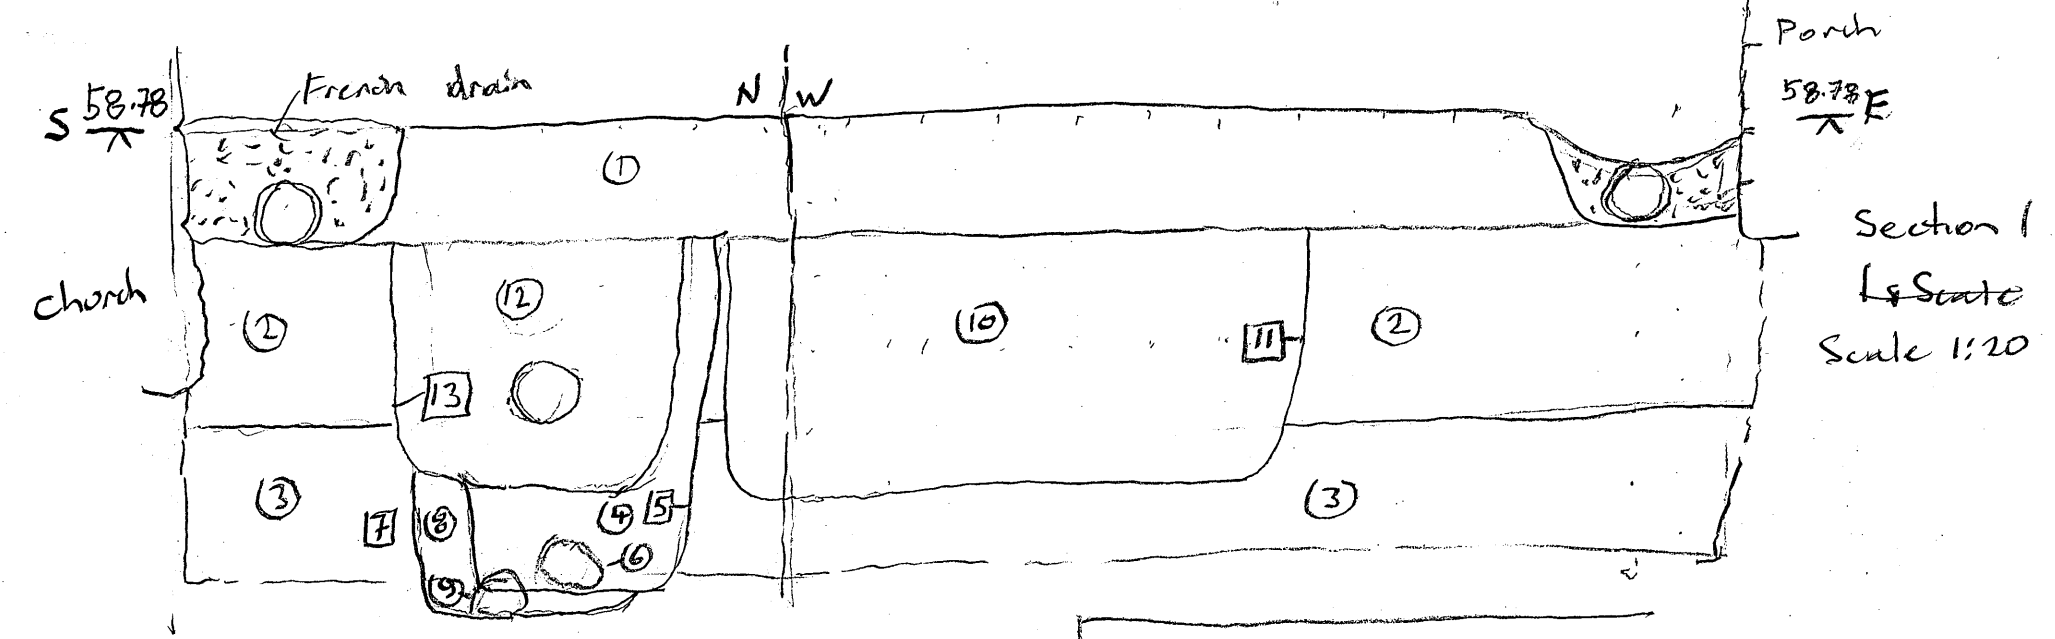
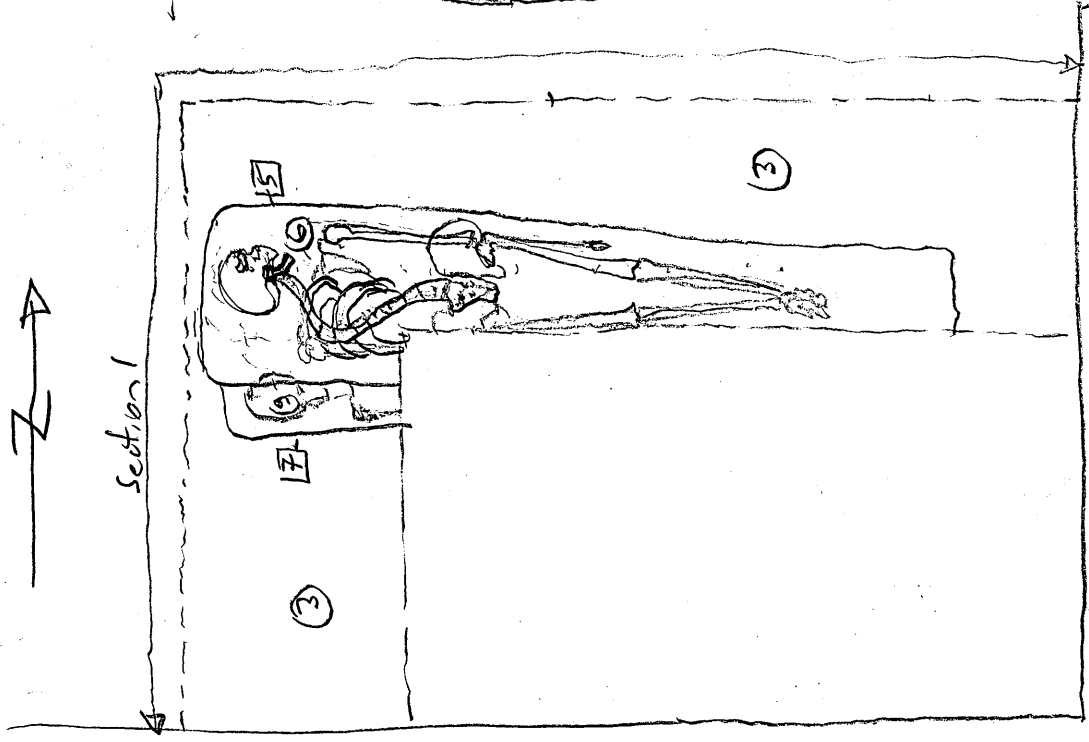
Plan 1

Porch

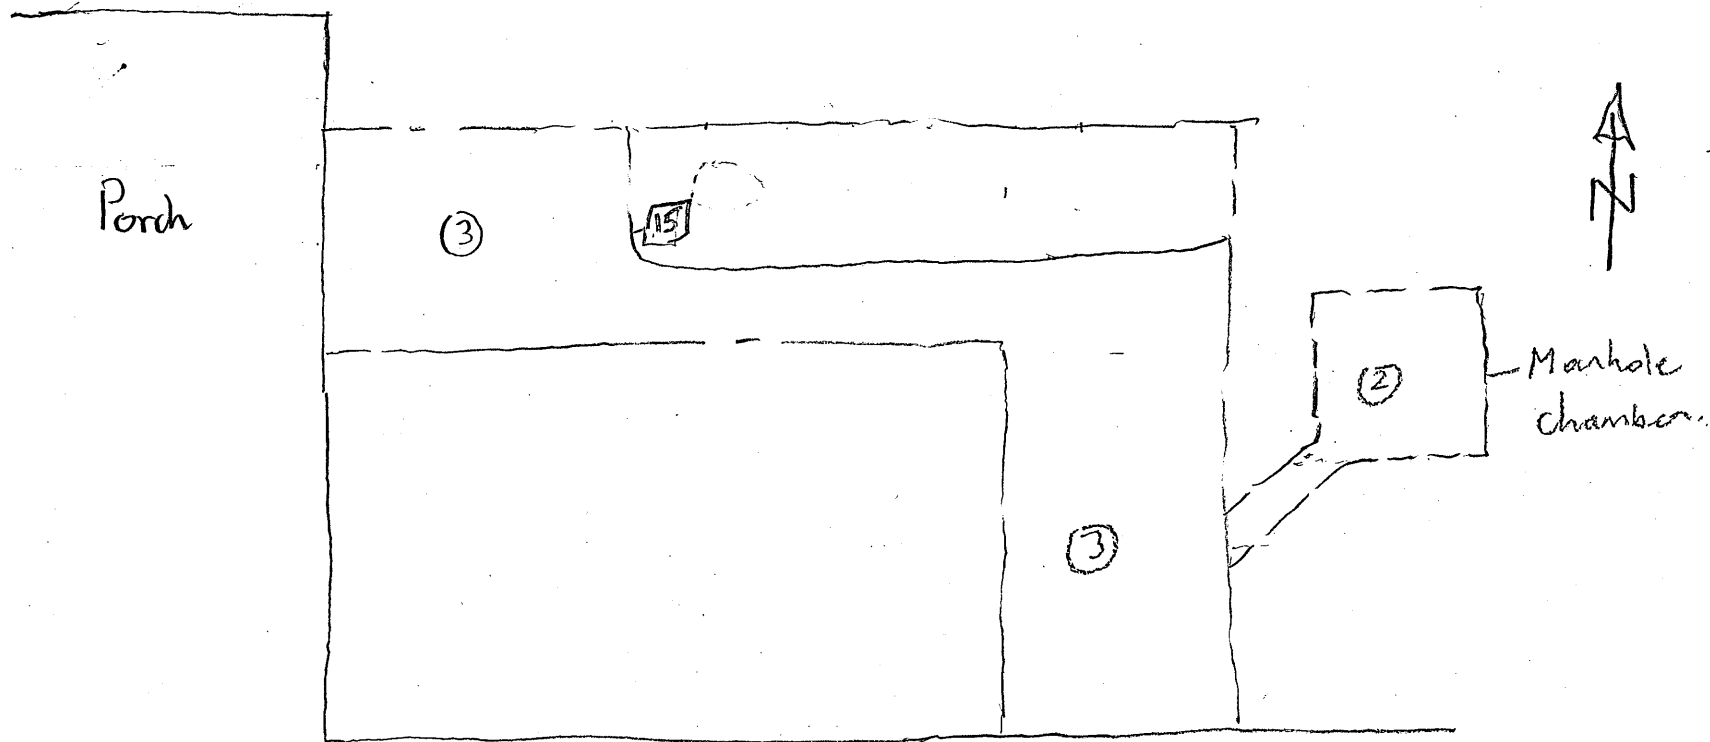
SHSTLC 09  
Plan (2)  
Scale 1:20

Church

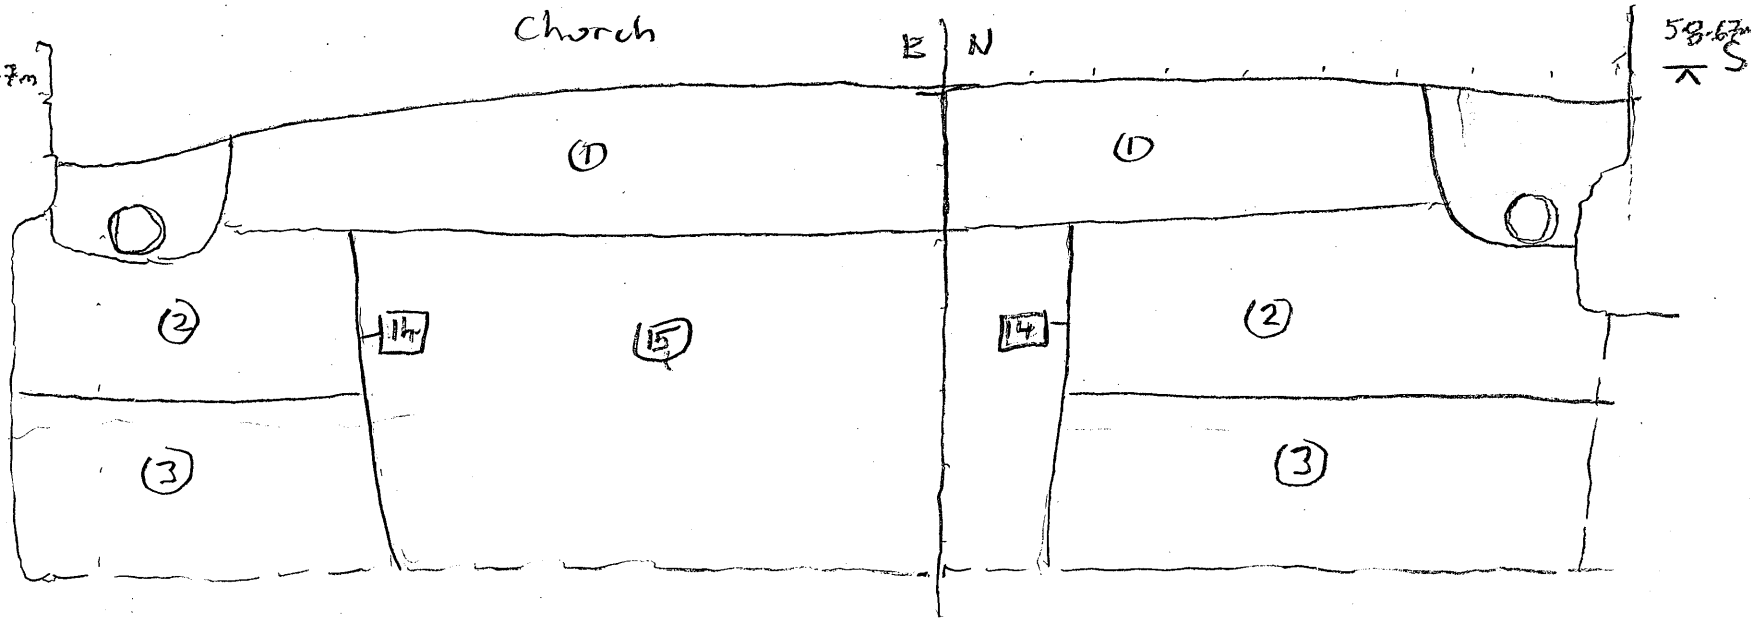
Section 2

Scale 1:20
