Rogerstone Castle Evaluation, Jubilee Park, Rogerstone, Newport

Archaeological Evaluation Report

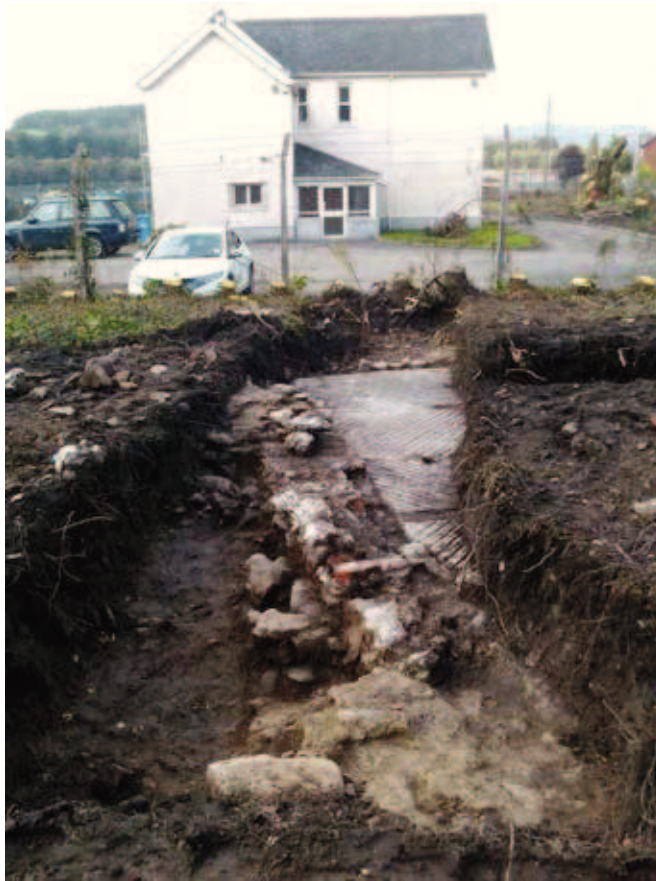
Plate 3: Trench 7, Walls 705, 704 and 703, looking northwest

- 3.5.1 Trench 7 formed a T-shape (Figs. 2 and 3) with north-west to south-east and north-east to south-west aligned arms.
- 3.5.2 Wall 705 (Plate 3) was constructed from large rough limestone blocks, ranging from 0.25m to 0.4m in maximum dimensions and bonded in a mid yellow brown lime mortar. The wall was broadly aligned west-east, and only the top course of this wall was visible within the trench. The length of the wall could not be established as the Tree Preservation Order prevented an extension to the south-east. Within the confines of the trench the wall measured 1.2m by 1.6m. The wall had been subject to partial collapse towards the south. Wall 705 was the earliest structure identified within the trench, and was cut into deposit 702 which was equivalent to deposit 601 within Trench 6. There was no relationship within the trench between wall 705 and any of the floor surfaces.

- 3.5.3 Wall 703 abutted the western edge of wall 705, and was linear and also orientated broadly west-east. The wall survived to a maximum of four courses, constructed from well hewn limestone blocks bonded with a mid greyish yellow lime mortar (Plates 3 and 6). The wall was faced on both sides, well finished and measured 2.1m long by 1.3m

- 3.5.4 At the east end of wall 703 was a section of wall, 704, constructed of both bricks and stone, which were not keyed into the main stone work (Figure 4, section 704), creating a near vertical break in the stone coursing. This probably represents the blocking up of a doorway. The brick recovered from 704 showed the blocking to be 19th to early 20th century date.

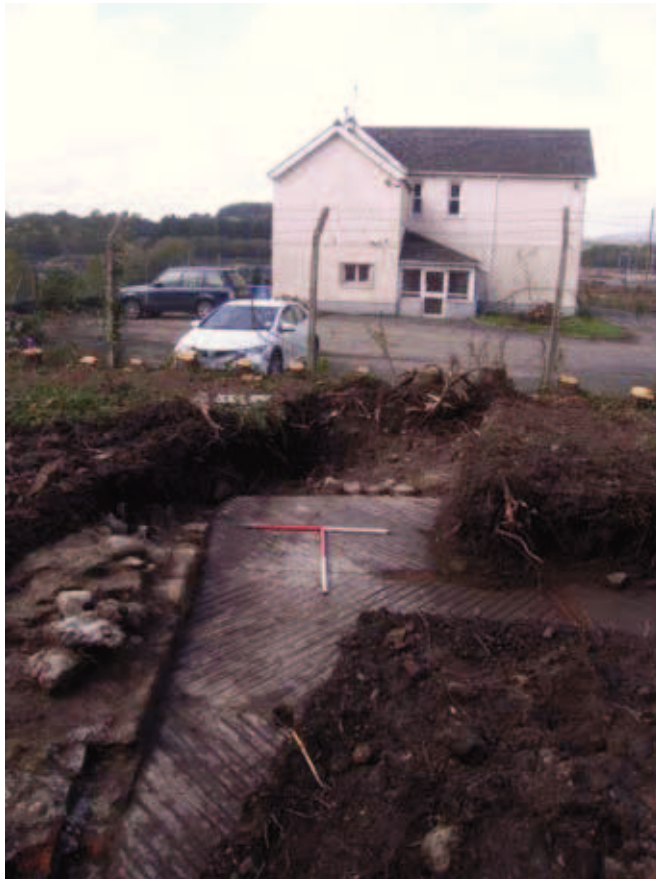
Plate 4: Trench 7, Floor 709, looking west

- 3.5.6 Floor, 709, was constructed from engineering brick dated to the late 19th to 20th century, which had been laid in rectangular sections, each measuring 2.4m by 1.6m (Figure 3 and plate 5). One section was completely exposed within the trench and a further five sections were partially exposed. The bricks had a squared grooved moulded design and, when laid, formed a herringbone pattern (Plate 8), with each section having opposing grooves. This is a classic construction for stable floors to drain waste.

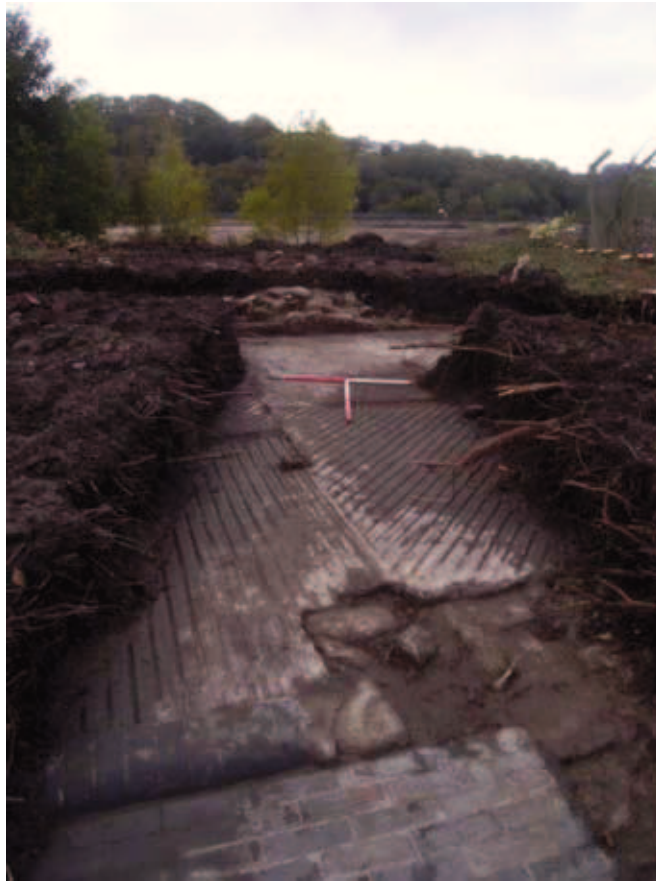
Plate 5: Trench 7, Stable floors 709 and 710, view to the southwest

- 3.5.8 A later wall, 708, had been inserted through the northern extent of floor 709, and formed an 'L' shape within the confines of the trench (Plate 11). The wall, which was constructed of well faced limestone blocks bonded in a cream lime mortar, was abutted by brick floor 710 to the north. Wall 708 and floor 710 represent an extension of the building to the north within the 19th or 20th centuries.

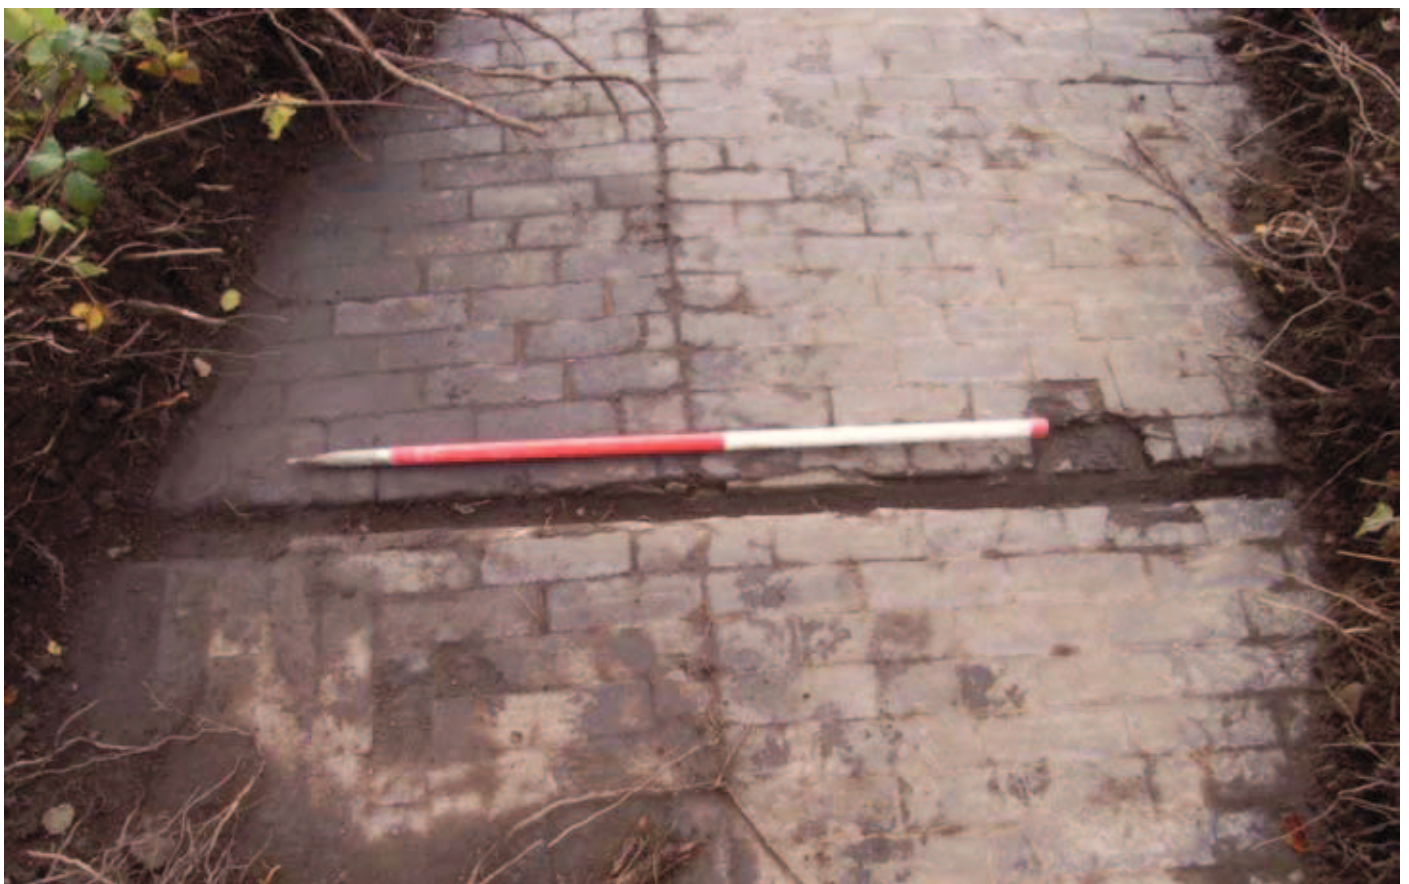
Plate 10: Trench 7, Floor 710, view to south

- 3.5.9 The engineering bricks in floors 709 and 710 were very closely bonded with cement mortar. Brick floor 710 was truncated at the north-east end, probably during the construction of the adjacent road.
