Archaeological Test Pit  
Evaluation and Photographic  
Building Survey at Anmer  
Deserted Settlement, Norfolk

**Archaeological Evaluation  
and Building Survey Report**

**Client: Sandringham Estate**

OA East Report No: 1439

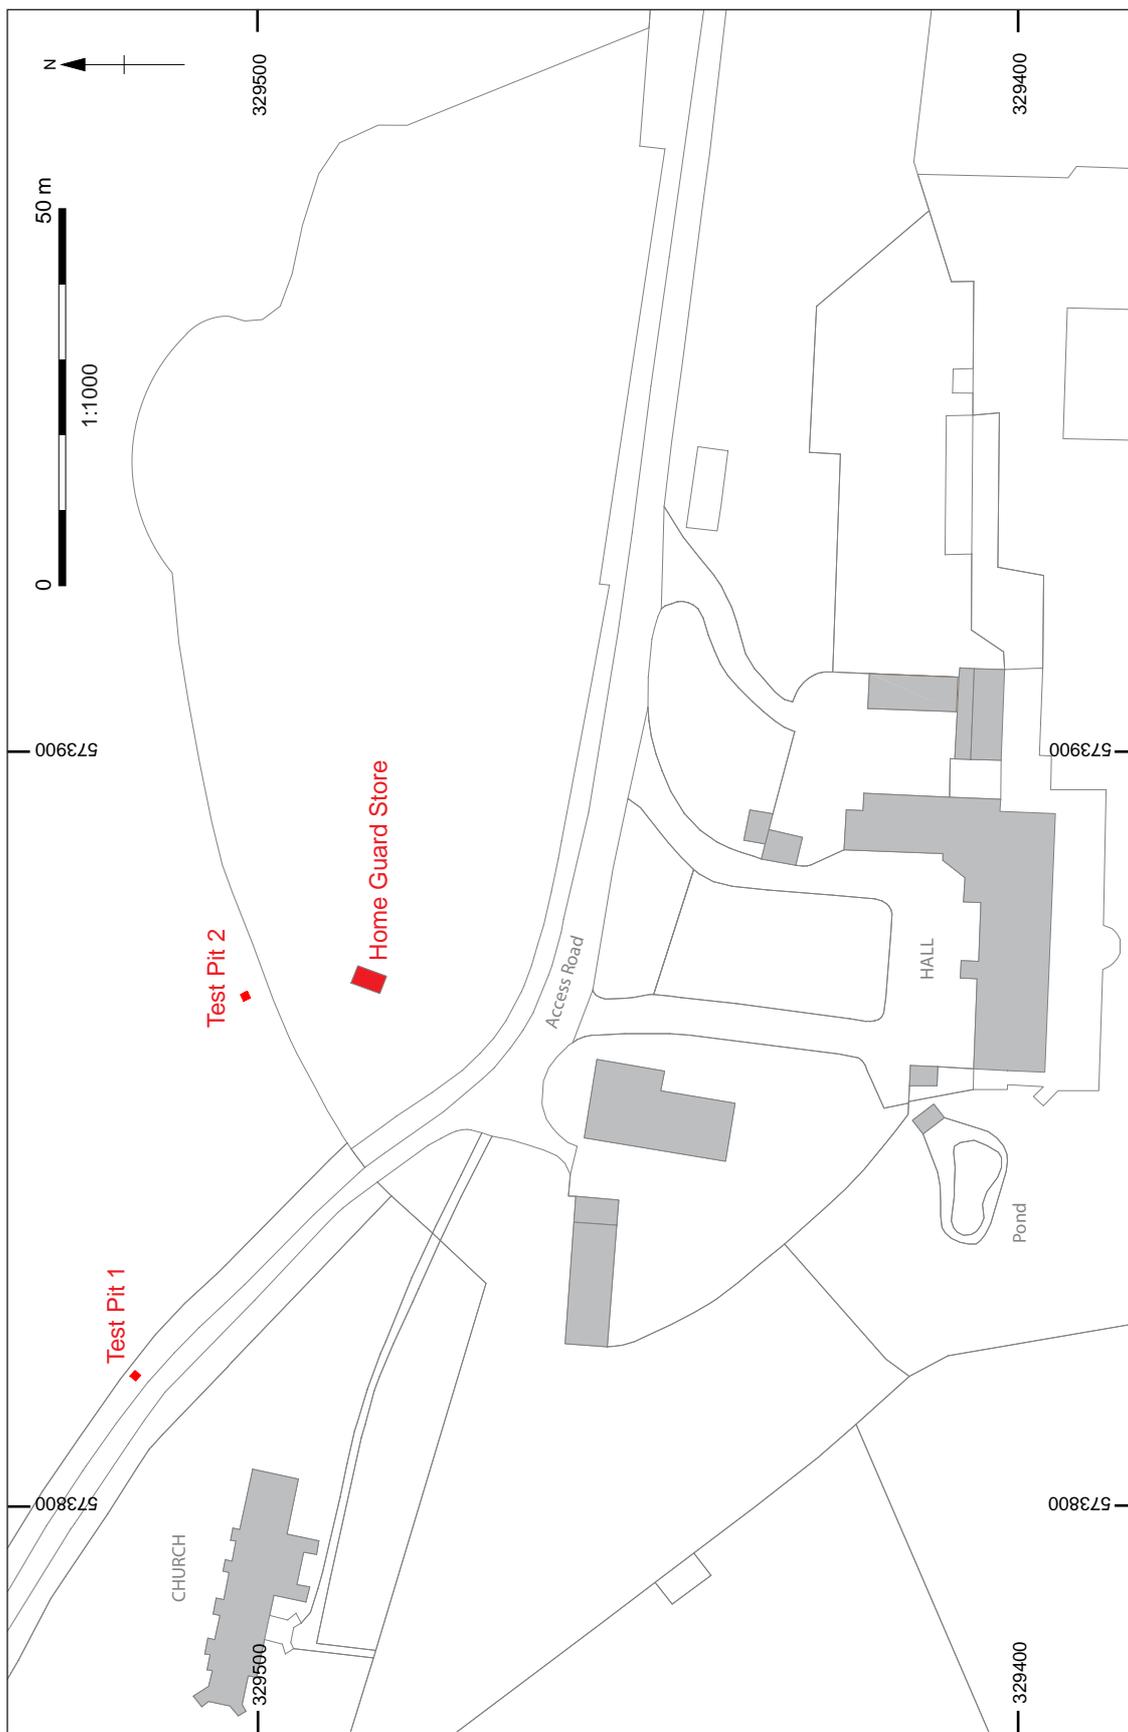
Figure 2: Location of test pits and home guard store

3.3.1 Test pit 1 was located on the bank of the lane or hollow way leading to the rear of Anmer Hall and opposite St Mary's Church (see fig 2). It measured 1m x1m and was dug to a maximum depth of 0.80m. The western half of the test pit contained a substantial flint wall (106) (see plate 1). This wall consisted of a rough flint core faced on the eastern edge by carefully sorted and dressed flint. The wall extended beyond the edge of excavation. The depth of the wall was recorded at 0.70m from ground level. A sloping construction cut **104** (see fig 3) for the wall was visible in section and two phases of backfill were evident 103 and 102, both contained ceramic building material and small amounts of chalk or clunch within the grey brown sandy silt back fill. A small piece of Border ware type pottery was also found within fill 103.

3.4.1 Test pit 2 was located to the west of a small brick built structure (see below) and to the north of the current road way leading to Anmer Hall and within a field currently used for grazing. The position of test pit 2 (see fig 2) was re located slightly to the south west due to an area of flooding. This was done after consultation with David Robertson the Historic Environment officer at Norfolk county Council. It measured 1m x 1m and was dug to a maximum depth of 0.40m. No archaeological features were recorded in test pit 2. A mid to light brown silty sand subsoil (201) was overlain by a dark brown topsoil consisting of a sandy silt topsoil (200). The area of the test pit in common with the rest of the field was capped by rough pasture type grass. A small sondage was dug into the south eastern corner of the test pit to ensure that natural geology had been reached. The contents of this were identical to layer 201.

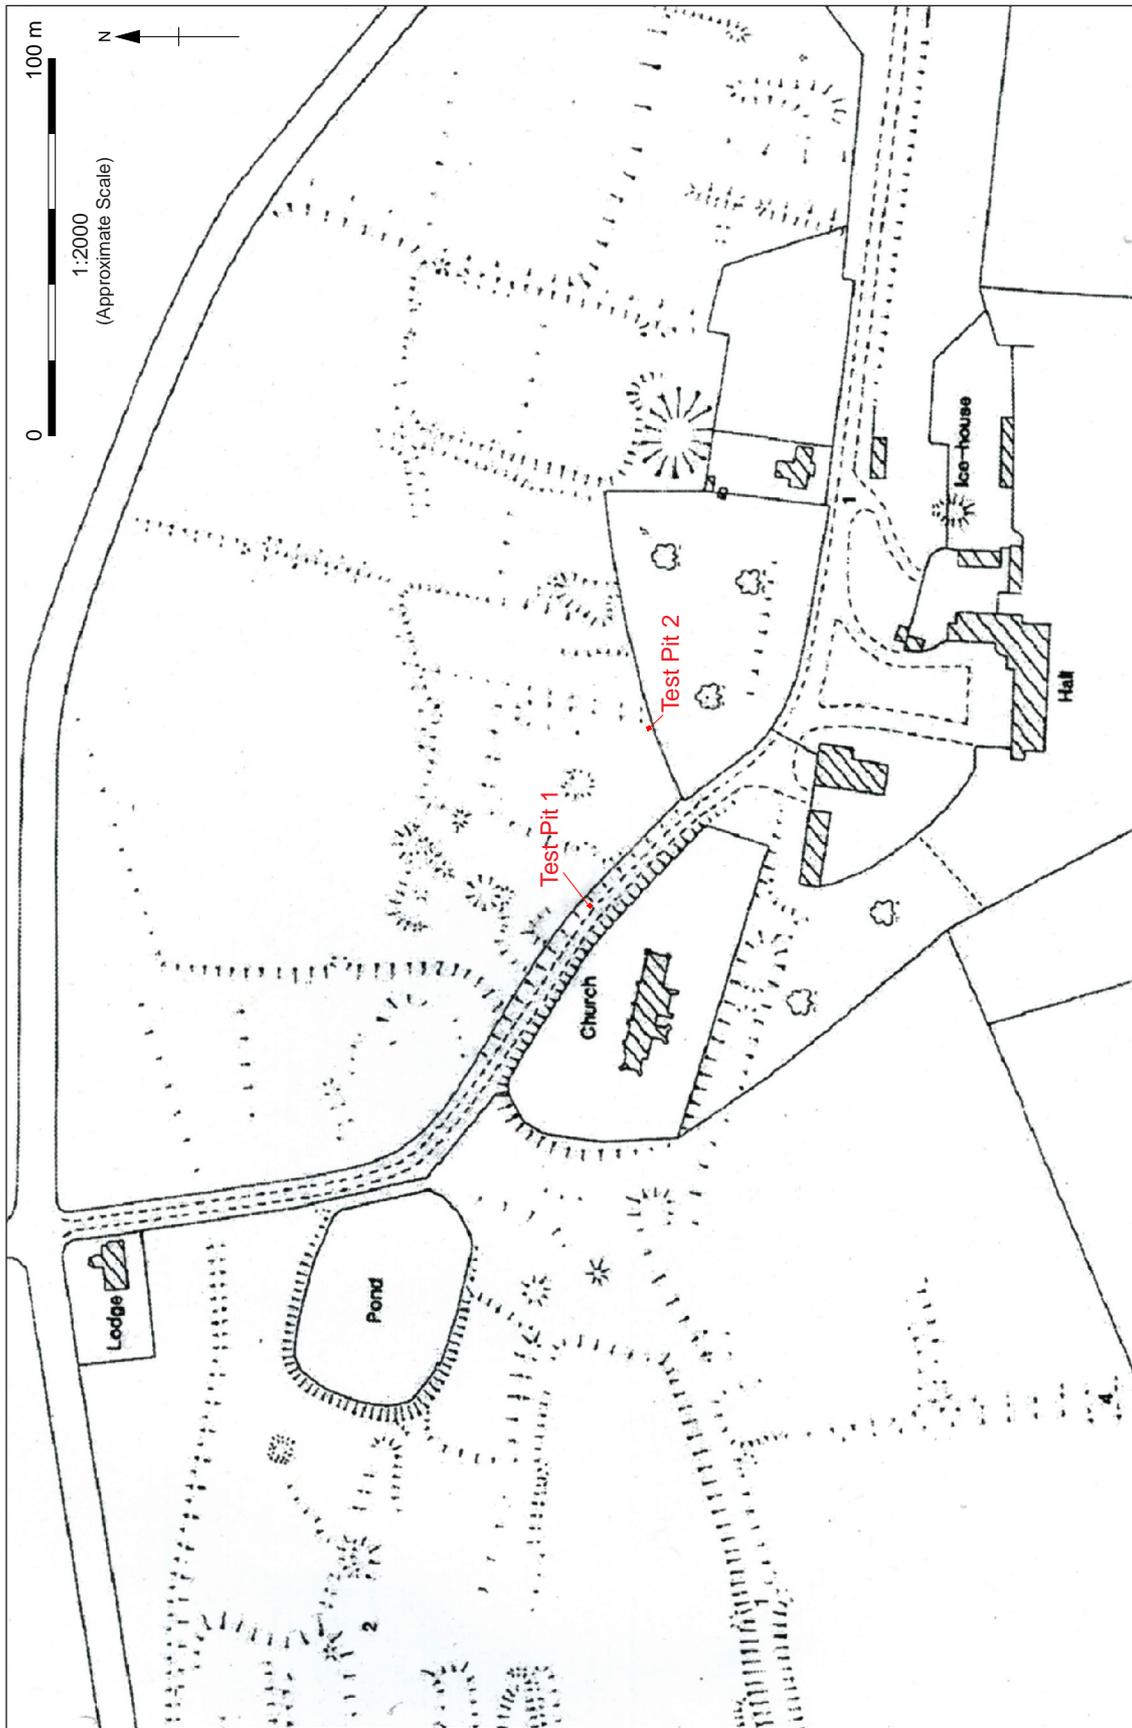
Figure 4: Earthwork survey (East Anglian Archaeology 104) showing position of test pits

3.3.4 The earth work survey map seems to show a possible building platform located close to test pit one. It would seem likely that the wall in test pi 1 confirms the interpretation of the building platform.

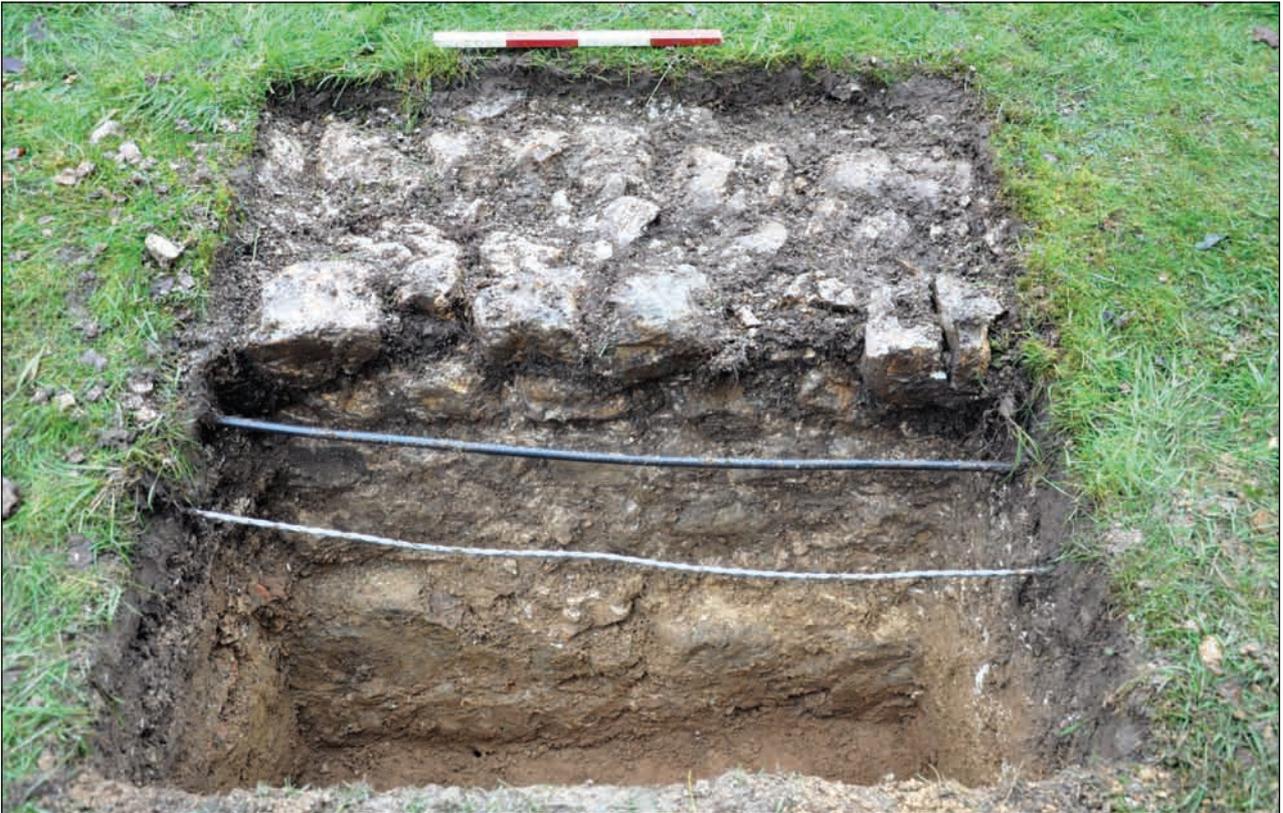
Plate 1: Test Pit 1, looking northeast

3.3.2 A turf line (101) capped the test pit and wall. A parch mark was noted running westwards for approximately 6m and stopped in what appeared to be a turn in the structure or possibly a pier or wall terminus.

- 4.1.1 The test pit evaluation out at Anmer deserted village has shown that there is still good survival of settlement features remaining immediately below the surface of the field, as might be expected by the quality of the earthworks. Only a one metre section of wall was exposed but this was substantial enough to be the foundations of a building that can be observed on the surface as a building platform (upstanding earthwork on fig. 4). Whilst it is possible that the wall may be a boundary wall along the road, or perhaps relates to the church wall opposite, this seems less likely since the construction of the wall differs from that of the church wall.

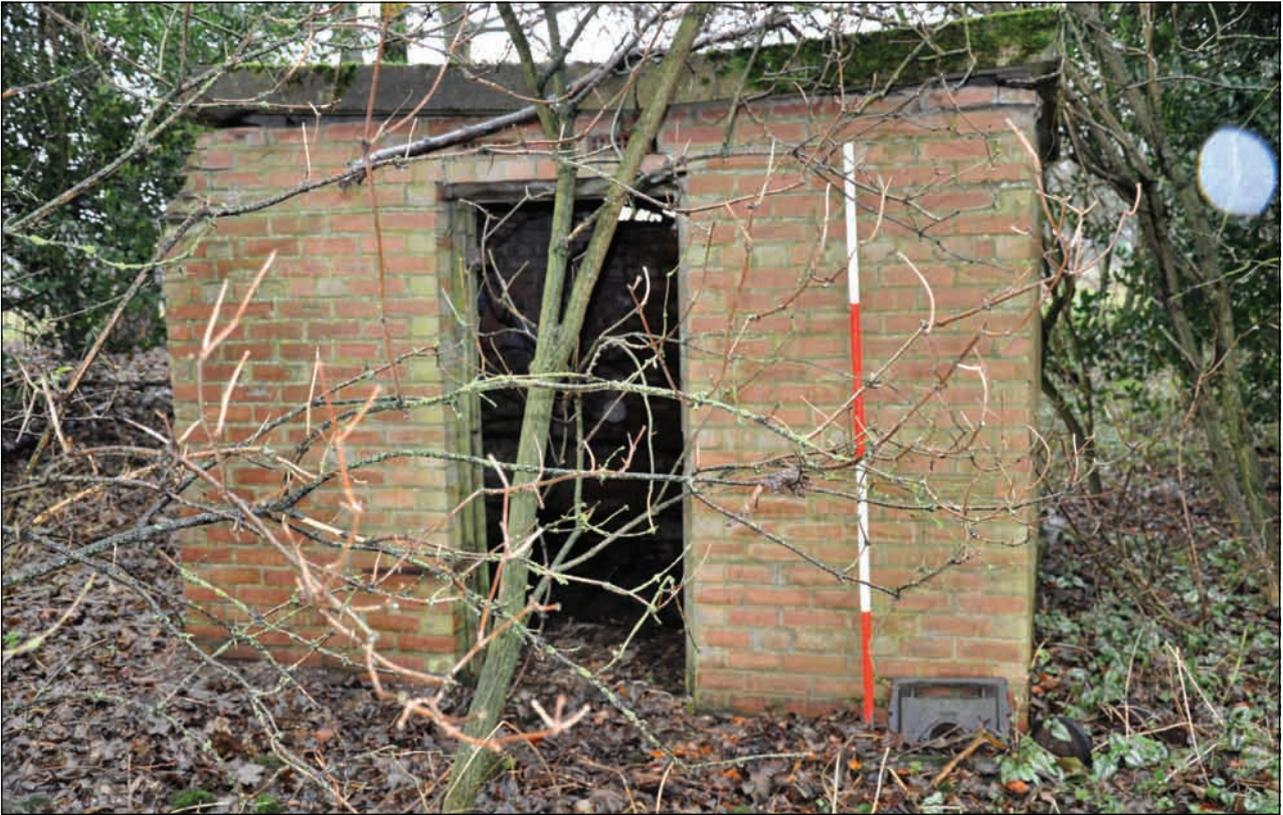
Plate 3: South west facing elevation

3.6.1 A small brick built structure was located Within the wooded area to the north and west of the road leading to Anmer Hall. The structure was constructed of twenty eight courses of machine made ridged bricks with a cast concrete roof and measured 4.30m

x 3.10m with a height elevation of 2.30m. The structure was in poor condition with cracks visible on all sides of the walls. The roof was in a poor condition showing signs of decay and damage. Most of this would have been caused by root disturbance from the trees surrounding the building. This design of building is commonly associated with guard room or sentry post positions. Its location in the grounds near Anmer Hall strongly suggest that it would have been utilised by Sandringham and Dersingham Home Guard Unit and would have been positioned to help defend Anmer Hall. Other similar examples exist in Norfolk at Outwell and Thorpe St Andrew (ID: S0007400) and (ID: 50002142)

3.7.1 A door aperture was located centrally on the south-west facing wall. It measured 1.90m x 0.90m. A wooden door frame was still in situ. The door itself would have been of a simple timber construction held in place by two T shaped hinges one of which remains. Two small ventilation bricks were situated above the door.

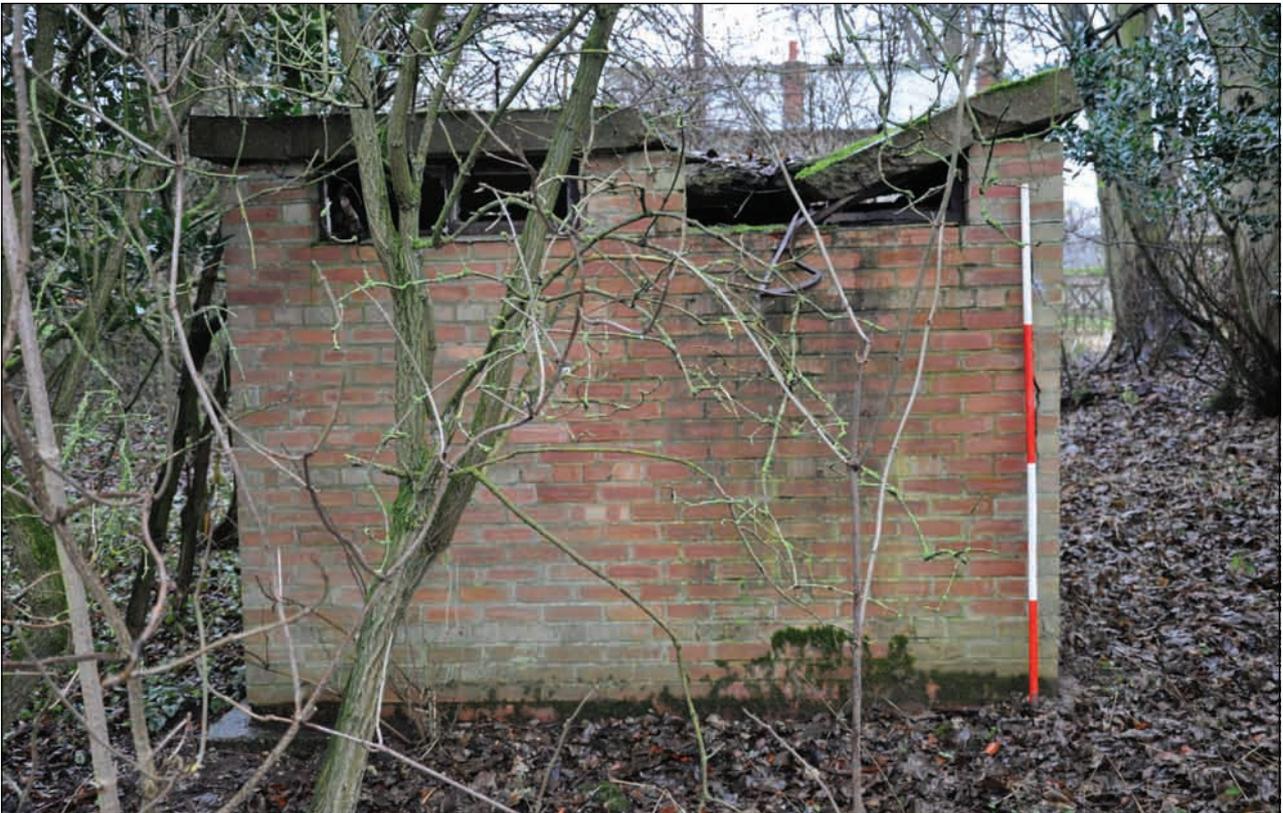
Plate 4: North east facing elevation

3.8.1 Two small windows were located high on the north-east facing elevation directly beneath the concrete roof slab. These were of a relatively small size and measured 0.40m x 0.30m and were probably used for defensive purposes as well as allowing light to enter. The frames were of a simple metal construction and were of a utilitarian design. Some glass was still present in the corners of one of the windows

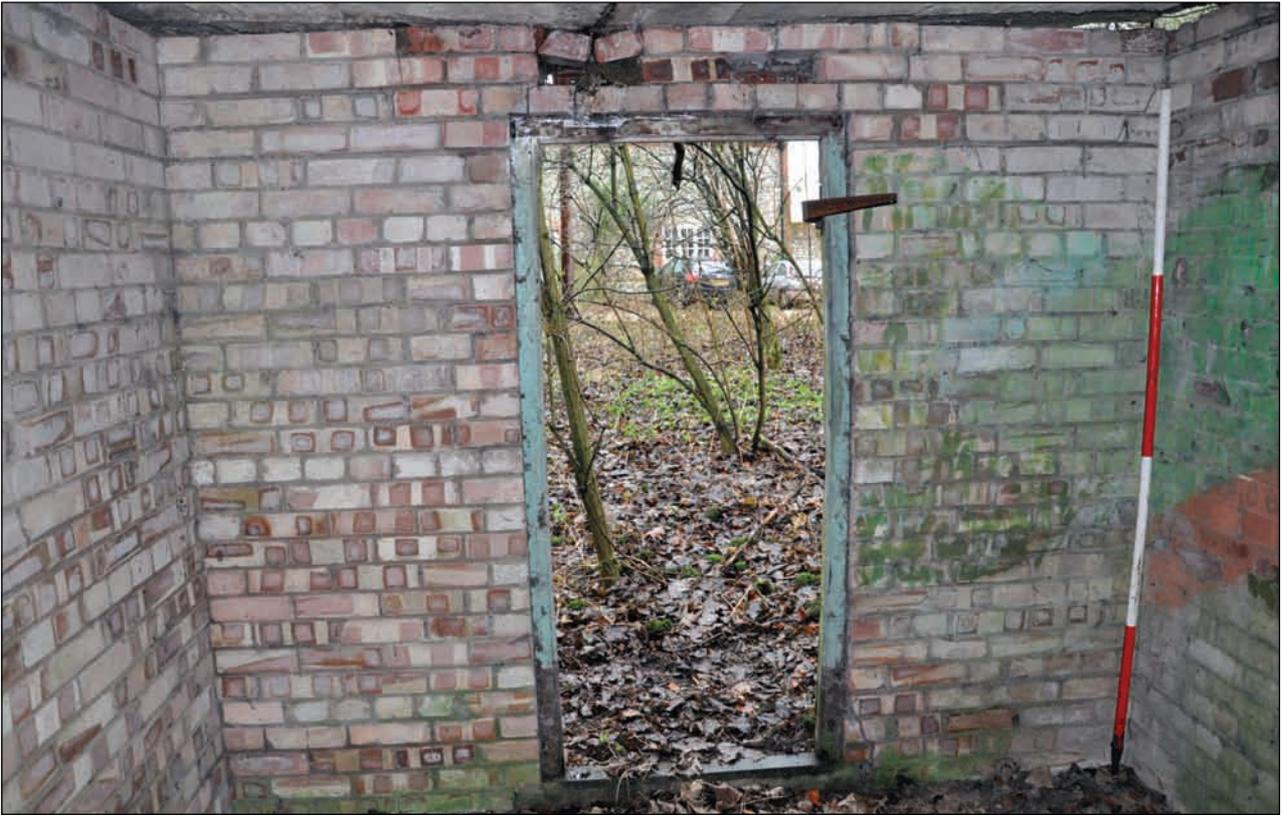
Plate 7: Internal view of brick building

3.9.1 There were no internal features other than the window and door apertures. No signs of a power supply were noted and a later use of the building may have been to store garden machinery, parts of an antiquated lawnmower were located close to the doorway.
