The Old Brewery Newbury West Berkshire

Historic Building Investigation and Recording

October 2009

**Client: Michael F. Wilson-Doyle
Architectural & Planning Consultant**

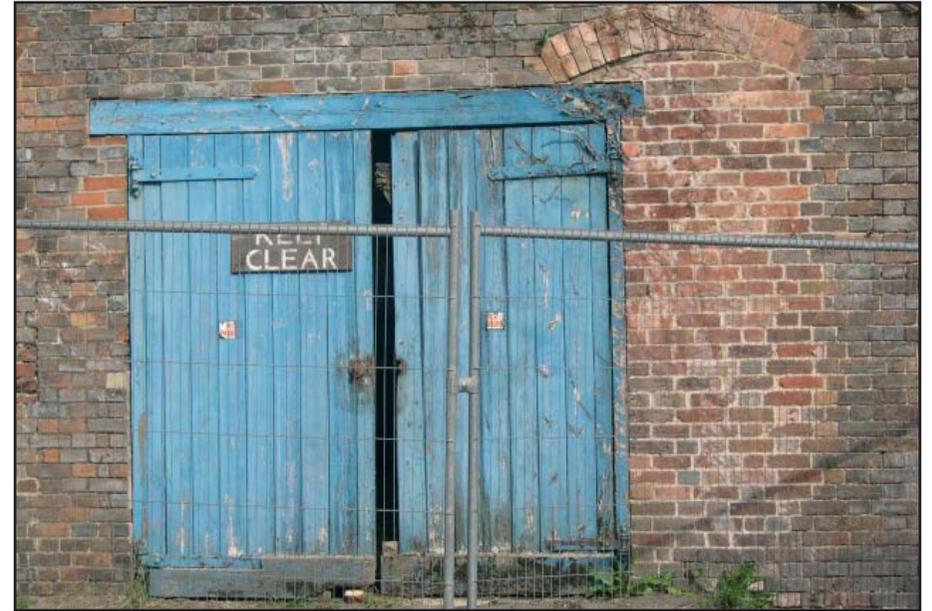
Plate 2: West elevation, three storey range

- 5.2.2 The three storey range of the west elevation dates from the 19th century and the primary red and charcoal stocks (0.21 m by 0.06 m) remain largely *in situ* (Plate 2).

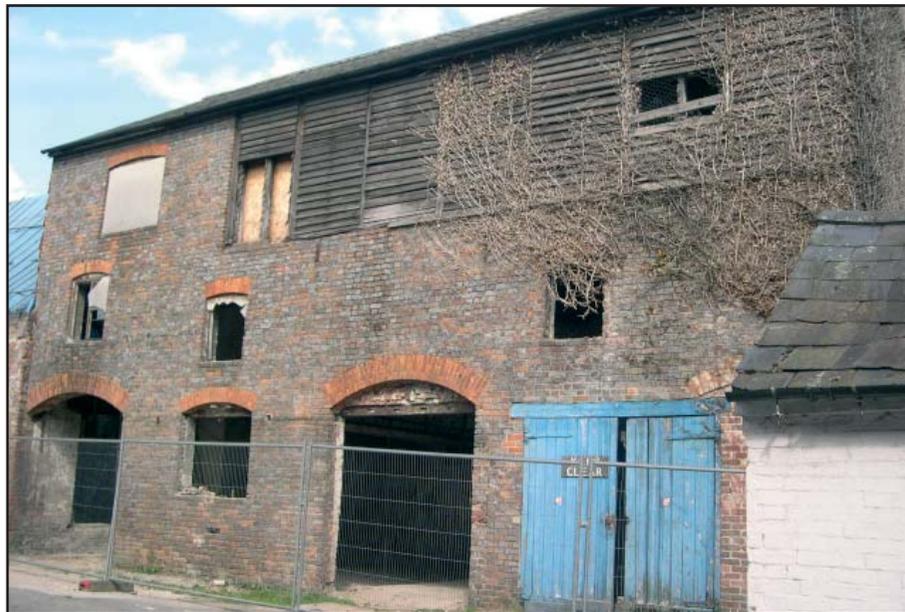
Plate 3: West elevation, three storey range, north door

- 5.2.3 At ground level there are three double **doorways** although the only one which retains the doors themselves is that situated furthest to the north. This is a vertical panel door with long hinges, painted blue with a wood lintel (Plate 3). This door is a later modification and partially overlies a primary single door which has now been infilled with late 19th/ early 20th century stocks. The segmental arch above the former opening is primary and illustrates that this was a single entrance door. The other two ground floor doorways are also primary, shown by their segmental rubbed brick arches, but these were each double doors for cart access. The arched area above the central door has been infilled with late 19th/ early 20th century red stocks (Plate 4). This overlies a timber lintel with six small mortices. This later infill is thought to have been as a result of an insertion of a later door, which is no longer extant.

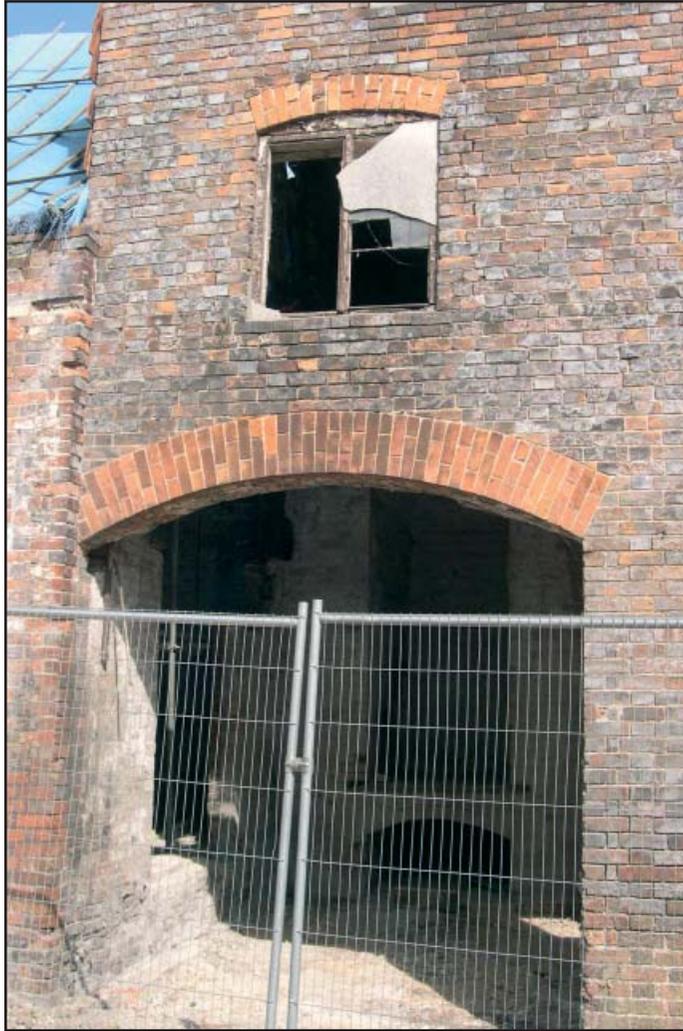
Plate 5: West elevation, three storey range, south door and window

- 5.2.4 In uniform with the primary doors the **windows** of the three storey range all have rubbed red brick segmental arch openings although none of the windows survive fully intact. There is one window at ground floor level, three small windows at first floor level and a further larger window at second floor. Although none of the windows are intact the first floor window situated to the north retains the primary wood frame, together with some of the original glazing bars and glass (Plate 5). This would have been in two divisions of six by four lights. The central first floor window likewise retains its primary wood frame, although these features are no longer extant on the remaining windows (the second floor window is now boarded up).

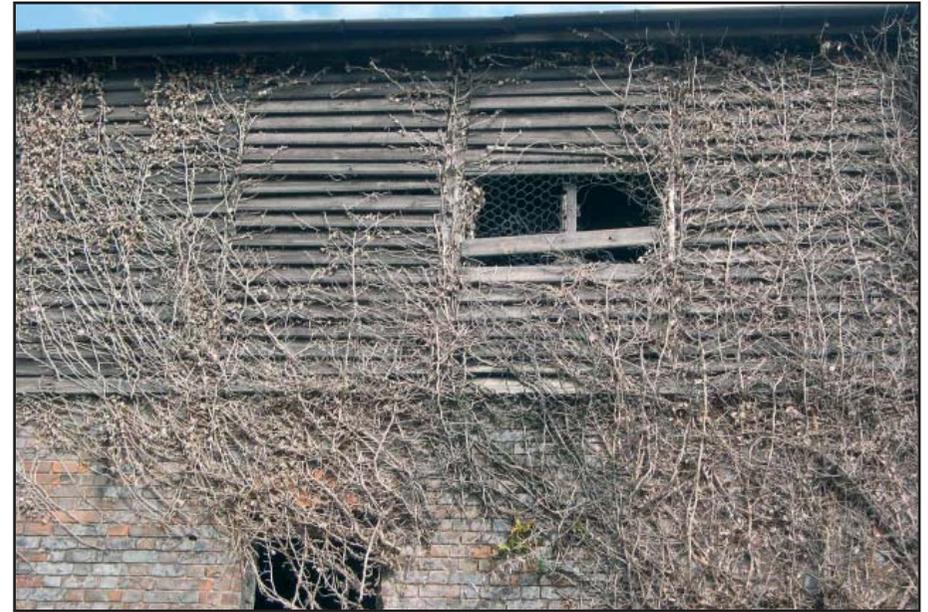
Plate 6: West elevation, wood louvres

- 5.2.5 There are wooden louvres to the north end of the west elevation, accommodating an area of c. 9.7 m by 2.2 m (Plate 6). These are in seven panels with eighteen horizontal slats. These would have been opened to allow ventilation into the upper floor and they are a good reminder of the industrial activities undertaken within the building. Many of the processes in brewing require ventilation so the slats do not provide a conclusive diagnostic indication of the activities undertaken in this area but it is likely that the top floor housed the mash tuns.

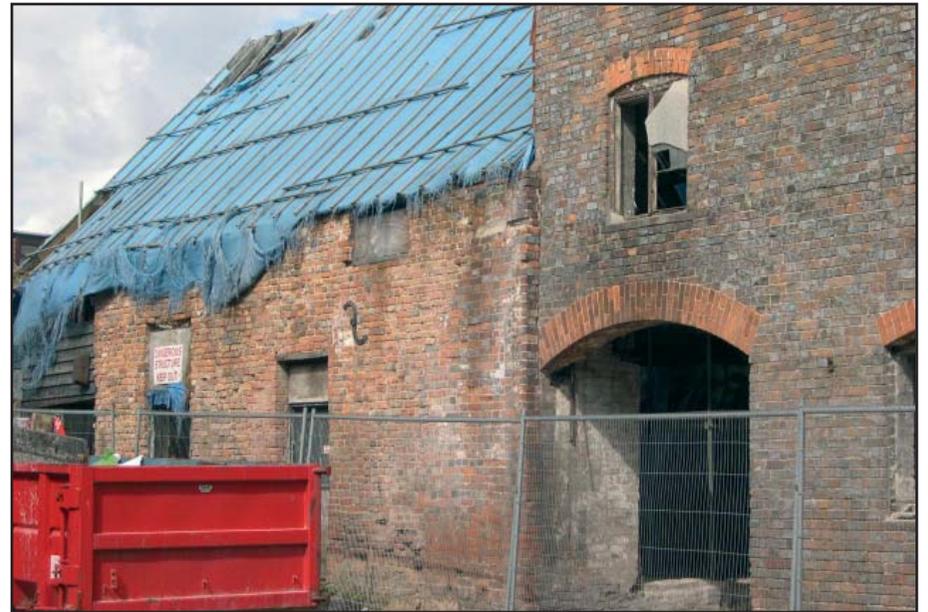
Plate 7: West elevation, two storey range

- 5.2.7 The two storey range of the west elevation probably dates from the late 18th century, and consists of red stocks measuring 0.22 by 0.05 m (Plate 7). It is fairly crudely constructed with inconsistent courses and breaks in the brickwork. There is a clear area of rebuilt at the south end of the range, of 19th century red stocks. These lie adjacent to the three storey range, and it may be that this occurred at the same time as the construction of the three storey range. As detailed in the historical background above it is believed that the two storey range was originally constructed against an east to west range which is shown on a map of 1768. This large patch of rebuild may originate from when the adjacent building was demolished. A nail is extant at the centre of this rebuild and an arched scrape indentation. A device thus once rotated in a circular motion at this point, although it is difficult to determine its exact nature.

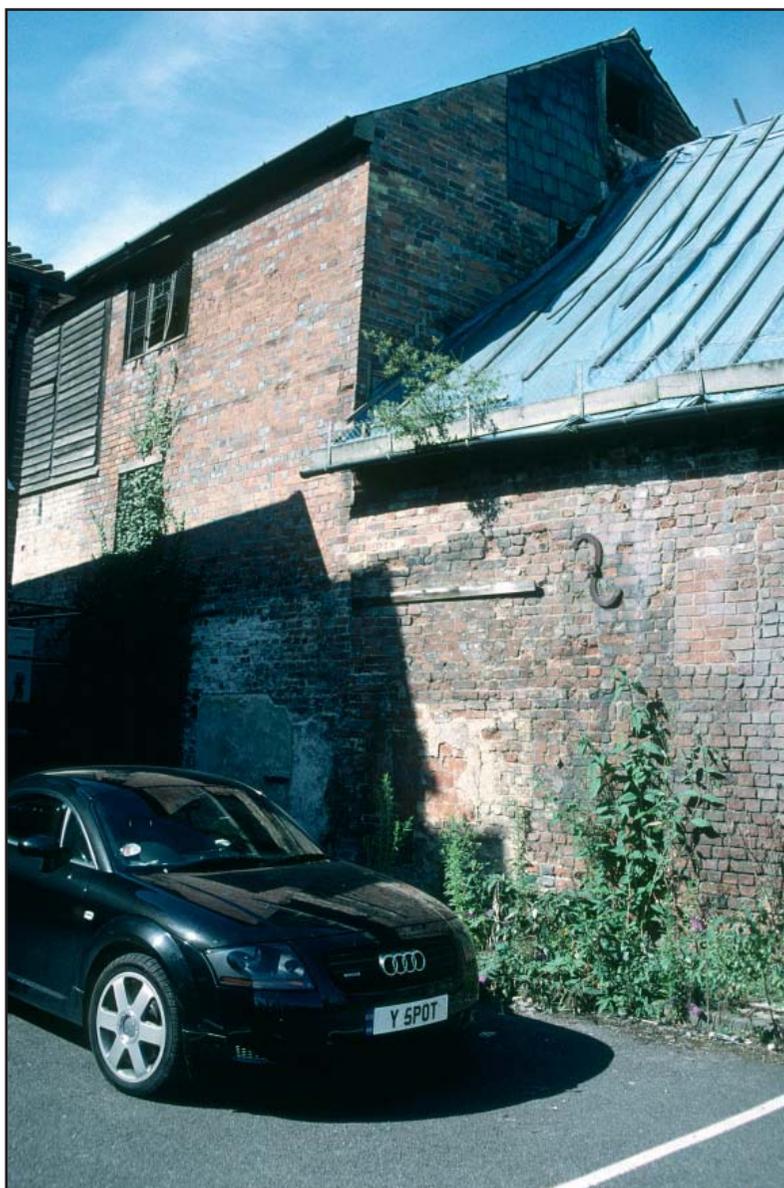
Plate 10: East elevation, three storey range

5.3.4 There is wood louvering to the top floor of three-storey range measuring c. 9.6 by 2.2 m in area (Plate 10). These match those in the west elevation and would clearly have allowed the upper storey to be well ventilated.

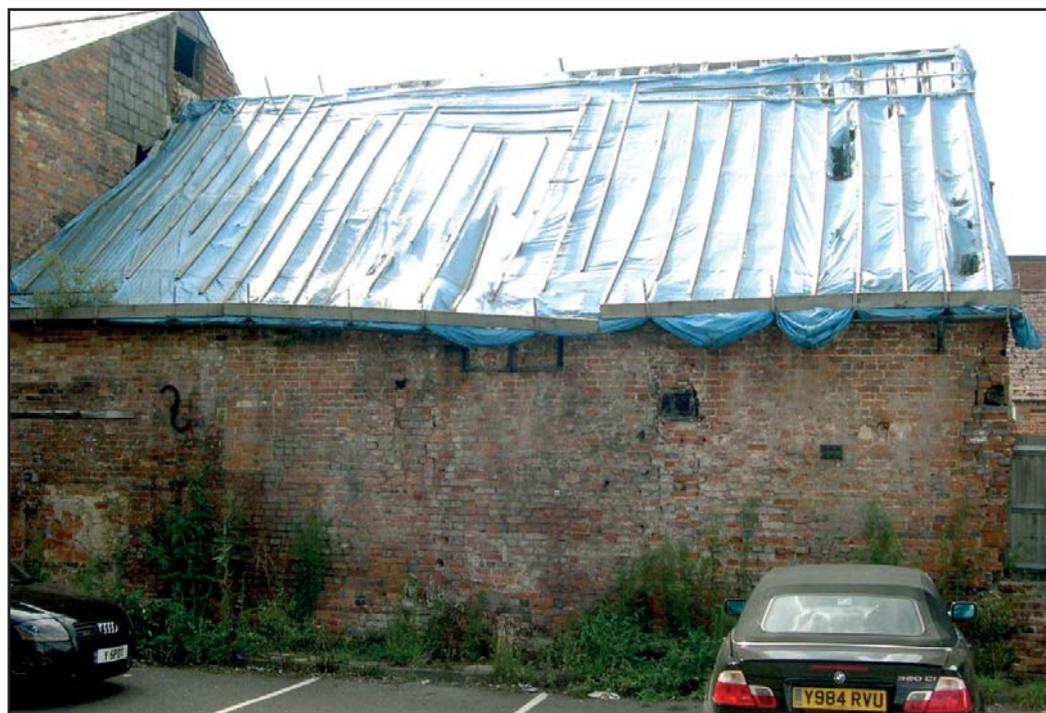
Plate 11: East elevation, two storey range

5.3.6 The east elevation of the two storey range has been subject to considerable repair and patching in a crude manner (Plate 11). There are three patches of infill dating from the late 19th to early 20th century. In particular to the south at ground floor level is an area of infill consisting of large red bricks measuring c.0.21 by 0.11 m. An exposed tie beam and small metal flue are also visible to the north of the elevation.

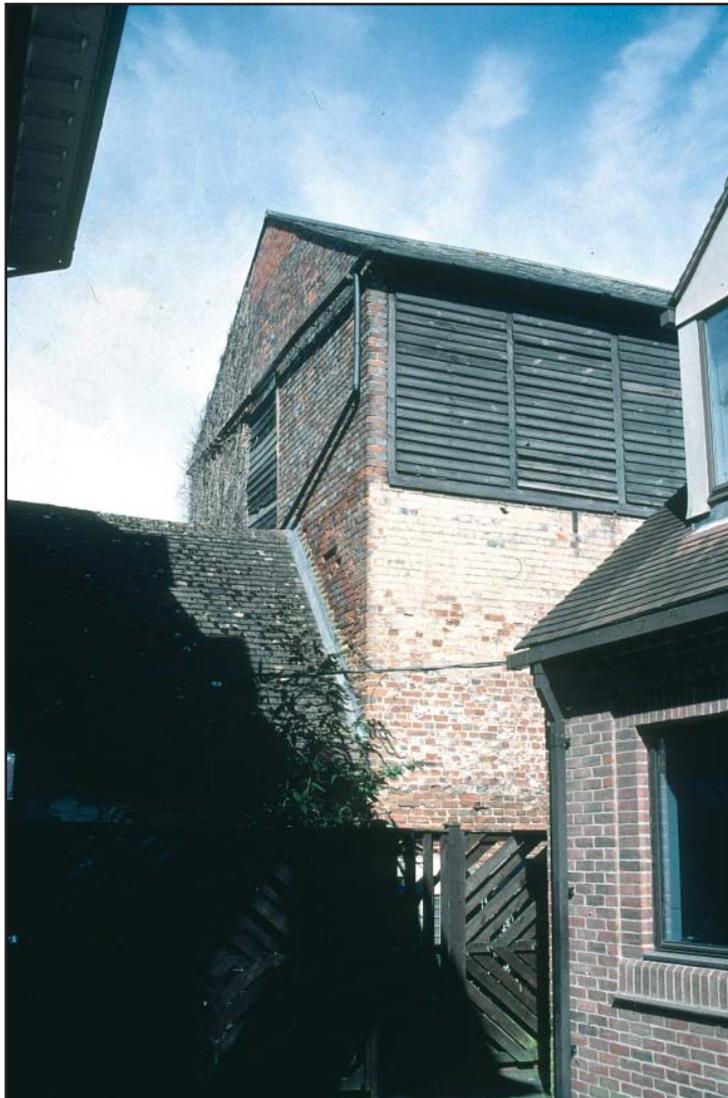
Plate 12: South elevation

5.4.1 The south elevation of the three storey range has an adjoining building to its lower part and only the upper half is visible. Within this upper section is an opening with horizontal wooden slat louvres (Plate 12). At the apex of the roof the brickwork has been repaired in the late 19th/ early 20th century.

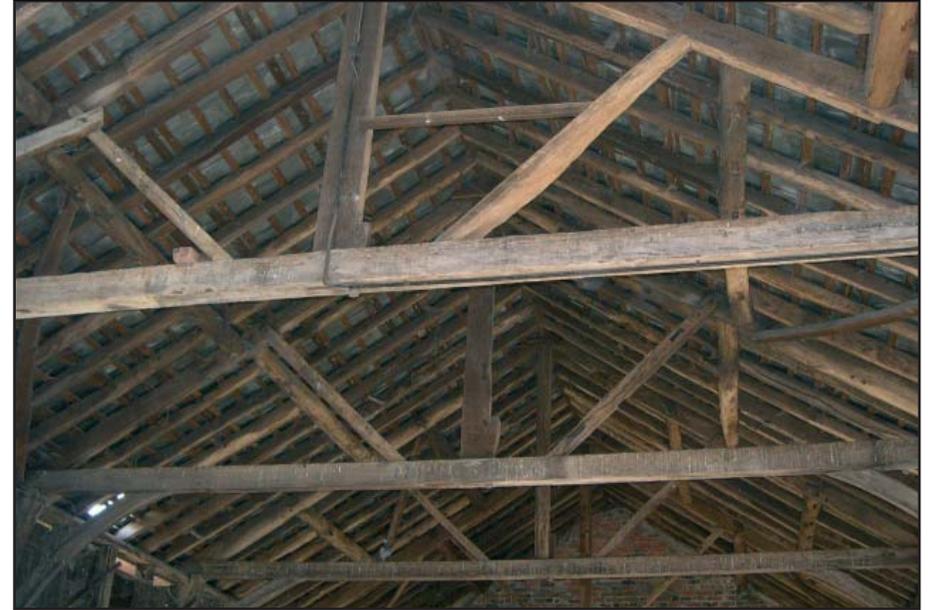
5.7.3 The roof of the three storey range strongly appears to be of 19th-century date although elements of it suggest a date towards the end of the century rather than at the start of it. As the building itself is believed to date to the very early 19th century the roof may therefore have been reconstructed with many reused timbers. The roof is supported by four trusses each of which has a long-span tie-beam, a king post (without joggles), two raking struts and yokes which support the ridge piece. The main characteristic feature suggesting a later 19th century date (or even early 20th) are the long, spindly nature of the members and the relatively crude construction. The purlins are set horizontally (ie at an angle to the rafters) and they are arranged in a stepped formation so that there are alternating bays with single and double purlins. There is an irregular arrangement of straight wind braces. The posts are jowled and they support thin curved braces beneath the tie-beams.

Plate 15: Roof of 3-storey range from north end

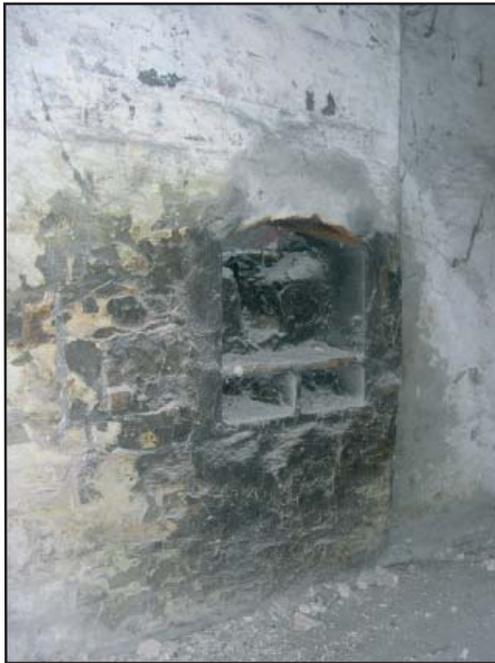
- 5.6.6 At ground floor the brick structure also has important evidence relating to the building's former use as there is a full depth shelf at c.1m above ground level supported by a segmental brick arch. On the north wall, immediately above this shelf, is a cast iron bearing box for a power shaft which would have passed through the wall into the two storey range. There is a circular hole in the wall at the centre of the bearing box and widespread oil staining and scarring around the box confirms that the box would have supported a shaft through the wall. On the north side of this wall (immediately inside the north range) is a shallow circular recess for a larger belt wheel.

- 5.6.7 Brewing is not the sort of manufacture which would automatically require a power shaft for its main processes and it is likely that this shaft would principally have been for transferring sacks and other items between floors using a hoist based in the two storey range. The shaft would probably have been powered by a small diesel or electric engine (which would have been a secondary addition) although the location of this is not clear. There is evidence for a former structure within the tall chamber next to the shaft bearer and it may have been in here although that would have necessitated a complex arrangement for extracting the engine fumes. This evidence comprises the scar from what appears to have been a sloped canopy or roof over the shaft and possible engine and a recess (blocked opening?) in the north wall adjacent to the 'engine' location.

Plate 16: Shaft bearing box at north end of 3-storey range

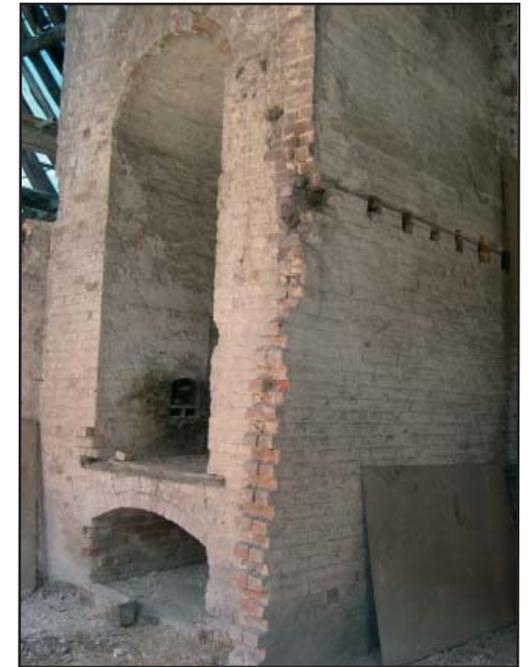
5.6.5 The north-western room which formerly housed the foot of the stairs is to the west of a large brick structure which rises through the full height of the building and provides the most significant surviving features relating to the former use of the building. This structure has three sides around a tall void or 'chamber' which opens to the west. This chamber has a semi-circular brick vaulted top which forms a solid base above second floor on which the list description speculates that the brewhouse copper formerly stood. The description refers to the whole brick structure as 'the brewhouse furnace'. Unfortunately access to the upper part of this structure has not been possible in the current works but it is known that there is a small fireplace or furnace in the south face of the structure at second floor level and the list description refers to a firebox surviving in-situ. This would clearly have provided the heat for the copper (or other vessel) on top of the brick stack. The second floor immediately to the south of the furnace appears to be of concrete (or with a concrete surface) supported by common joists and this is the only section of the upper floors that survives in-situ. The list description states that

Plate 17: Brick structure which supported brewhouse furnace at top

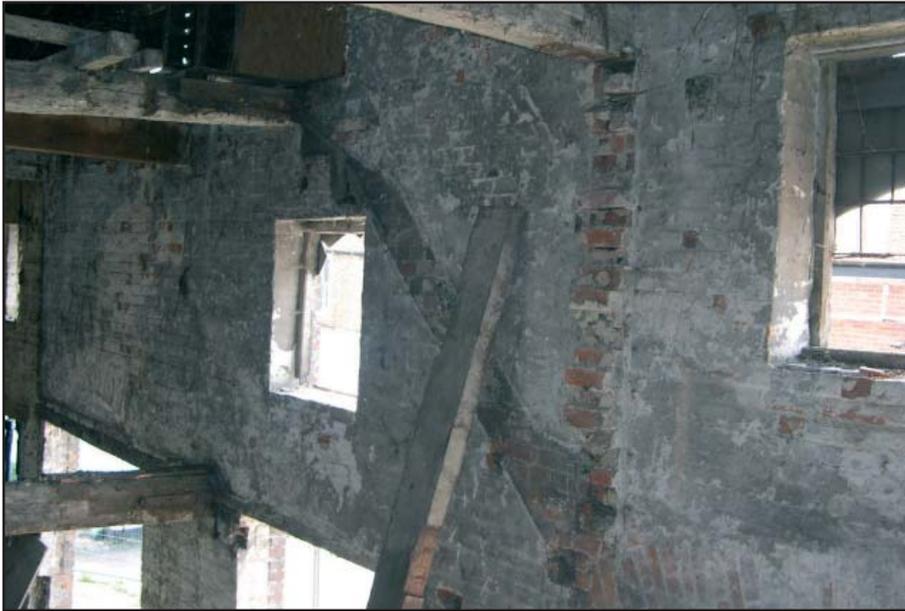
5.6.4 Prior to the clearance of the building there was a straight-flight, wooden staircase against the west wall towards the northern end of the range. This comprised two separate flights which provided access between the ground and first, and the first and second floors. Imprints against the west wall from the stair trimmer confirm their former location. Each flight opened off a separate room at the north-west corner of the block and although the walls at ground and first floor which separated this block from the rest of the range no longer survive there are scars against the west wall which confirm their former location.

Plate 18: Imprint of former stairs at north-west corner of 3-storey range

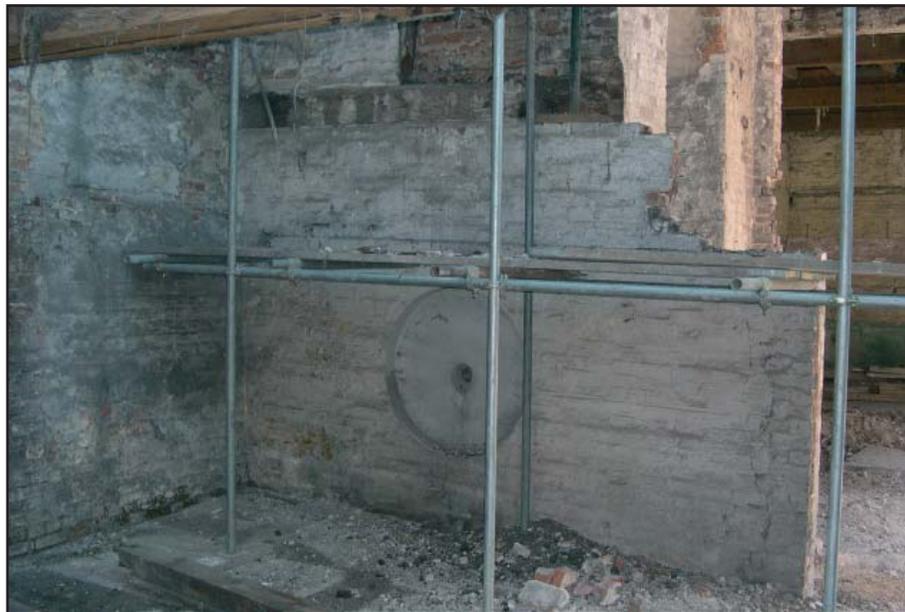
Plate 20: South end of 2-storey range with imprint from former drive wheel

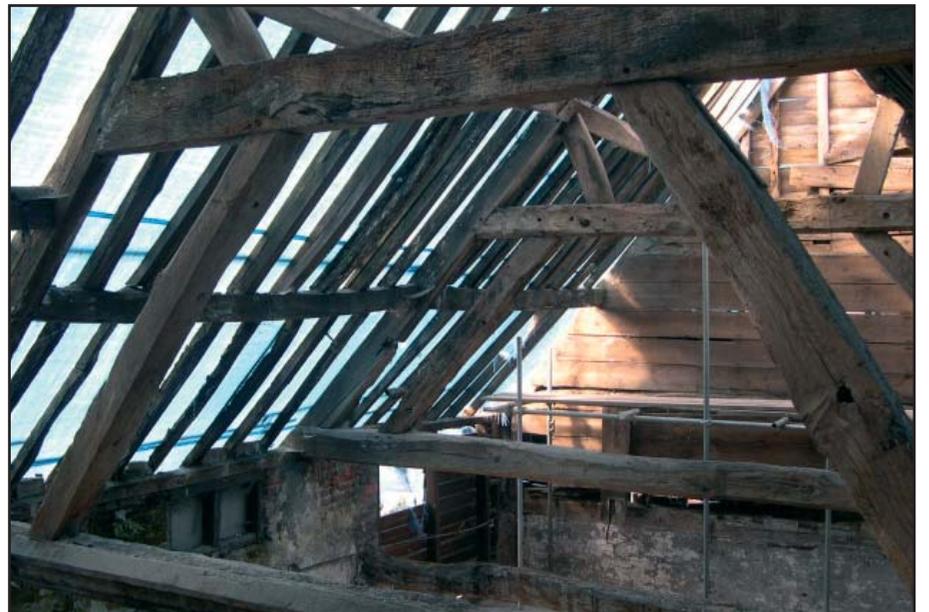
5.7.6 The roof of the two storey range is also crudely constructed with many timbers having been re-used from elsewhere and considerable patching up. There are two main trusses within the building although there are also partially surviving trusses at each end in the gables. The best surviving of the two internal trusses comprises a tie-beam, a collar, a pair of inward raking struts beneath the collar (parallel to the rafters) and a pair of shorter raking struts above the collar which support the upper tier of purlins. The ridge piece is thin and the trusses, although tenored, are crudely built. The members differ in form again suggesting that these have been reused, a number of which are moulded and previously from a high-status building. At the south-east corner a large section of rafters are modern below the lower purlin.

Plate 21: Roof structure in 2-storey range from south end
