Broadfield Hall Stables, Hertfordshire

Historic Building Recording

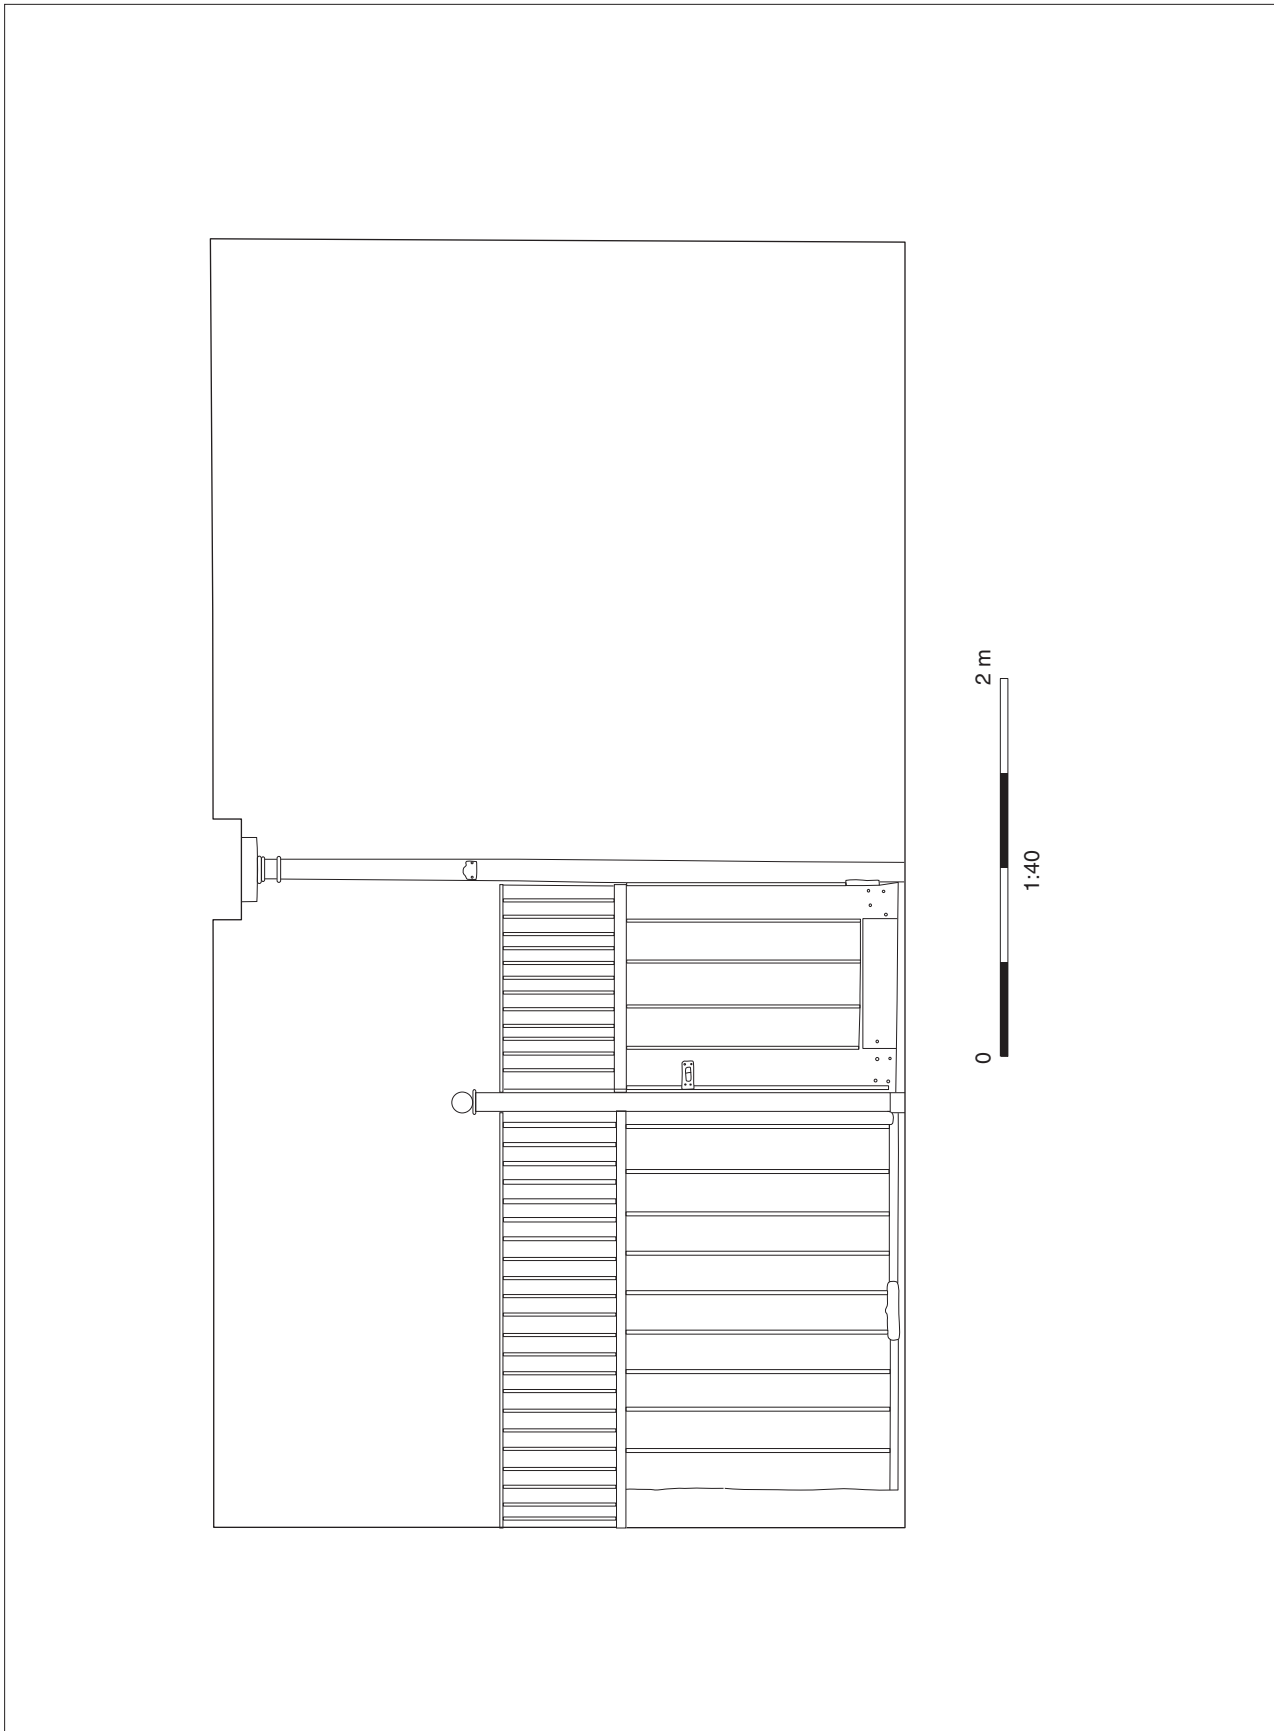
Figure 23: Elevation 5, Cross-section of G1 showing loose-box detail

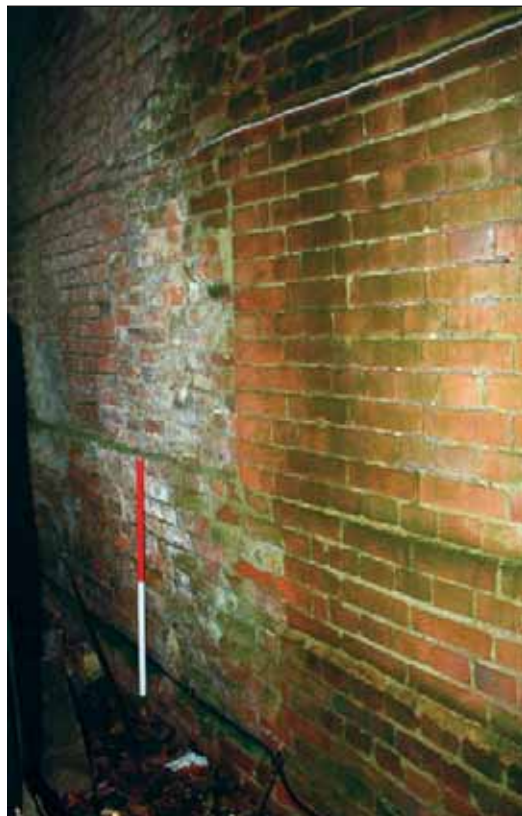
Plate 9: Detail of blocked up window and repair to brickwork on north-facing elevation

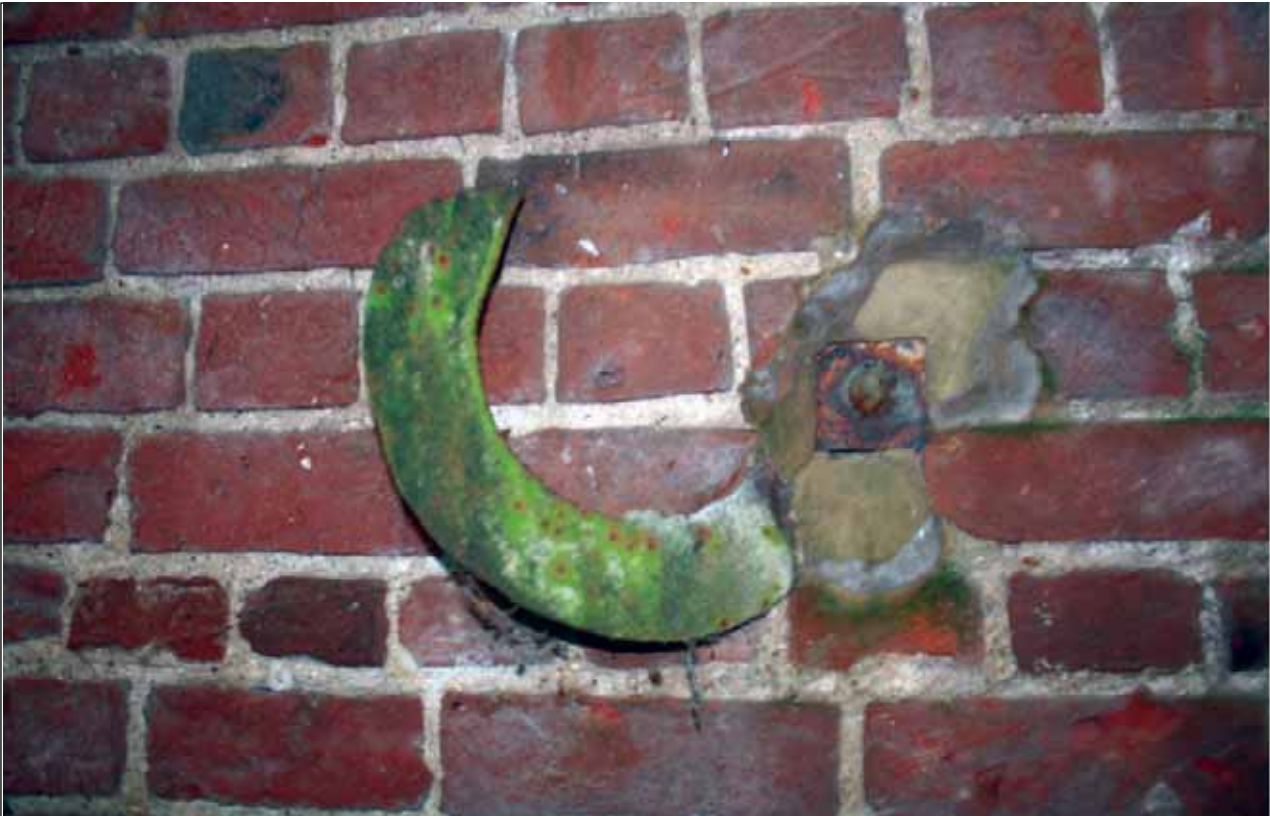
Plate 10: Iron structural tie on north-facing elevation

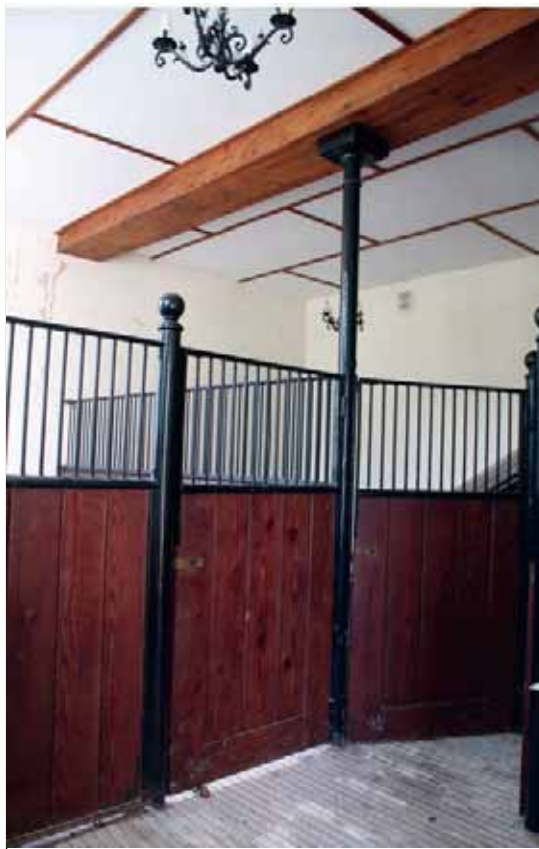
Plate 21: Internal view of G1 showing loose-boxes, ceiling joist and iron support post

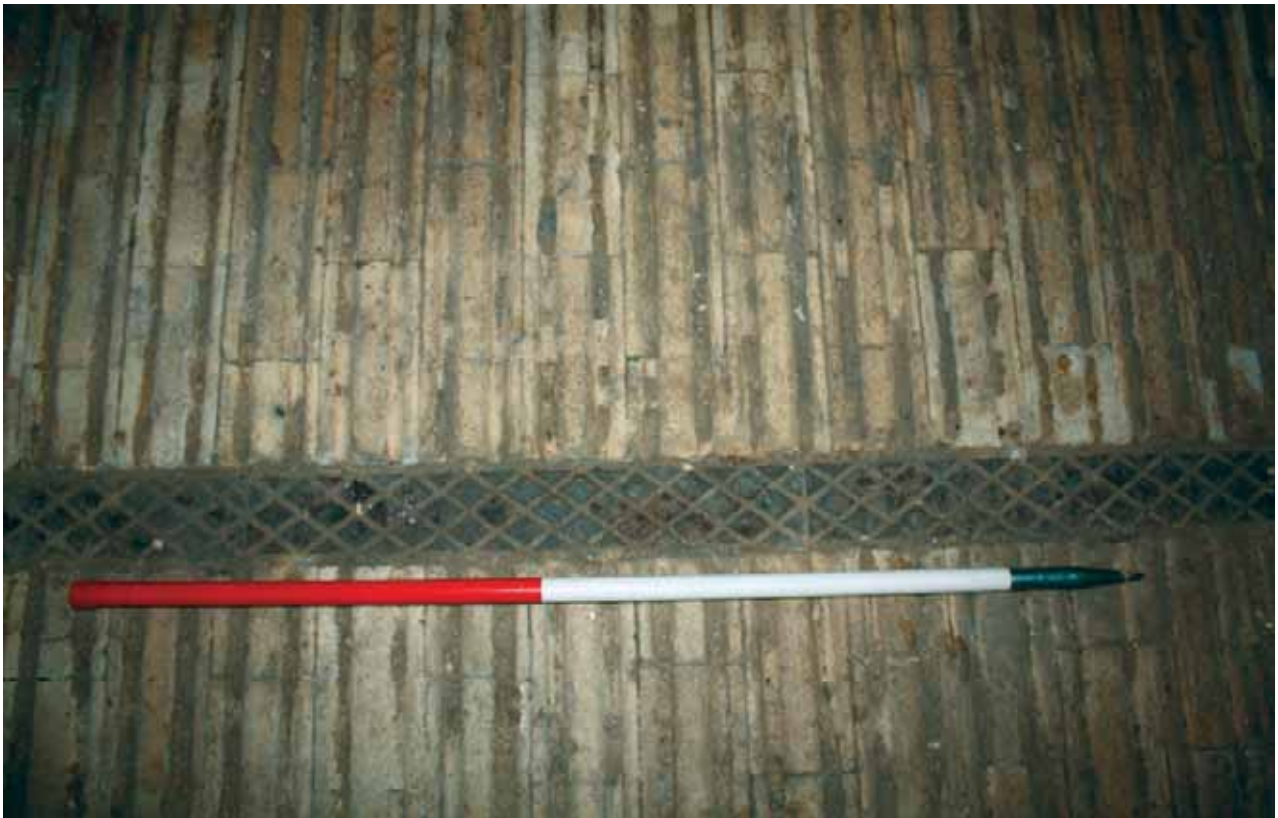
Plate 22: Detail of grooved floor tiles, G1

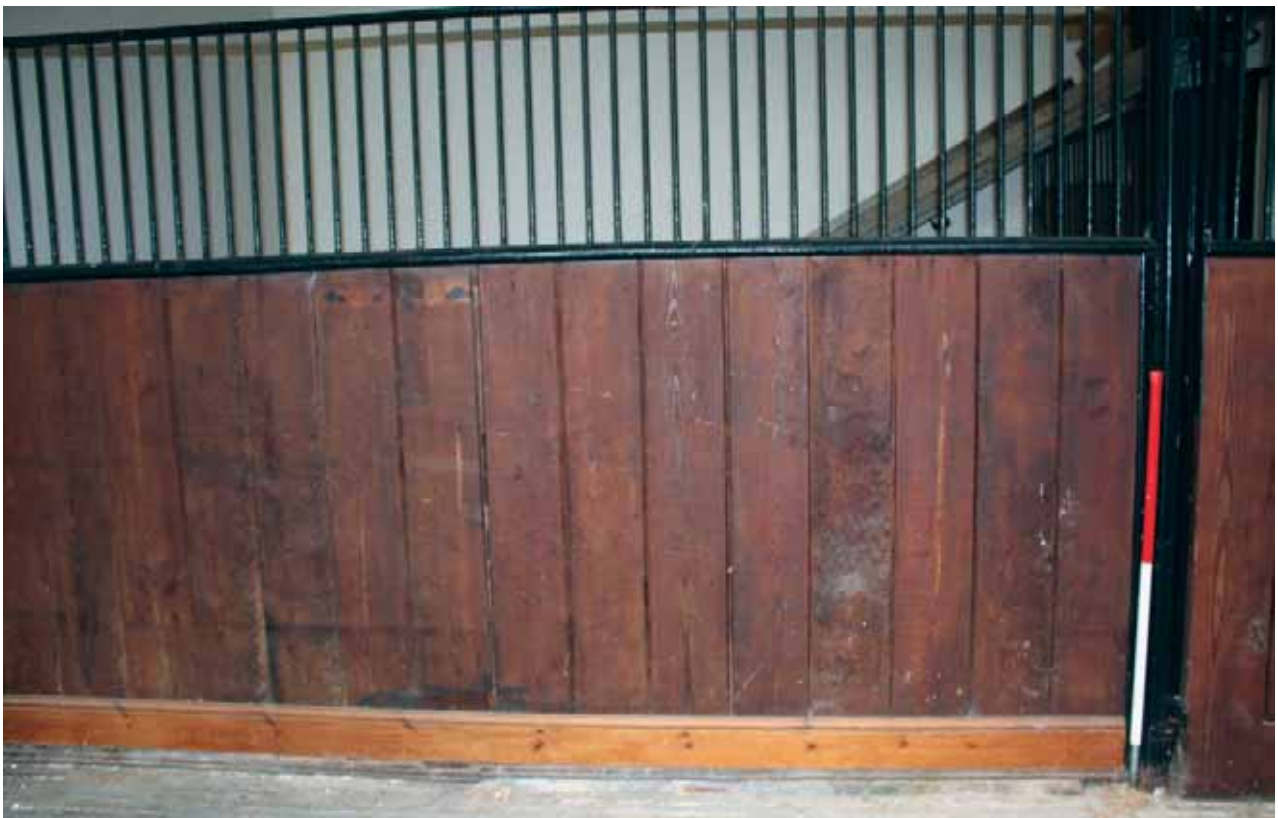
Plate 23: Detail of loose box screen, G1

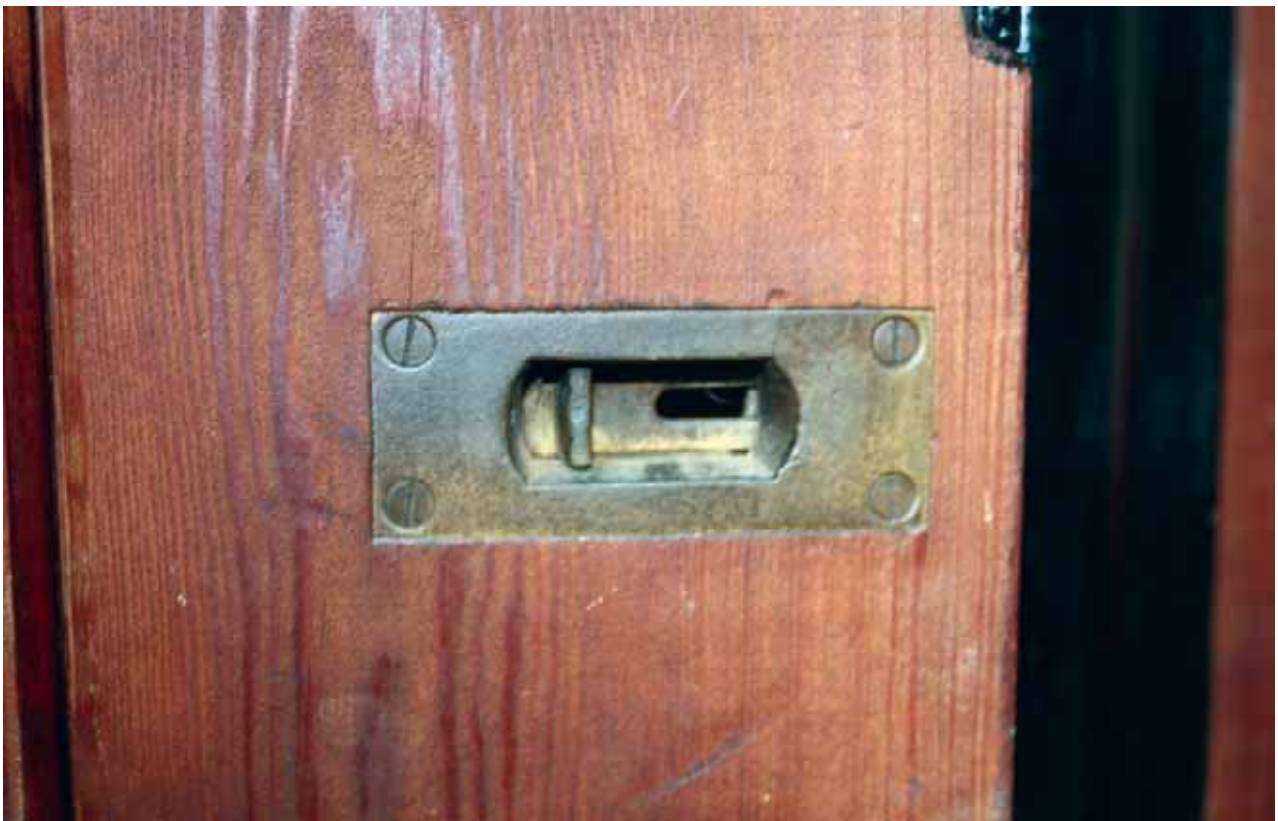
Plate 24: Detail of loose box sliding lock, G1

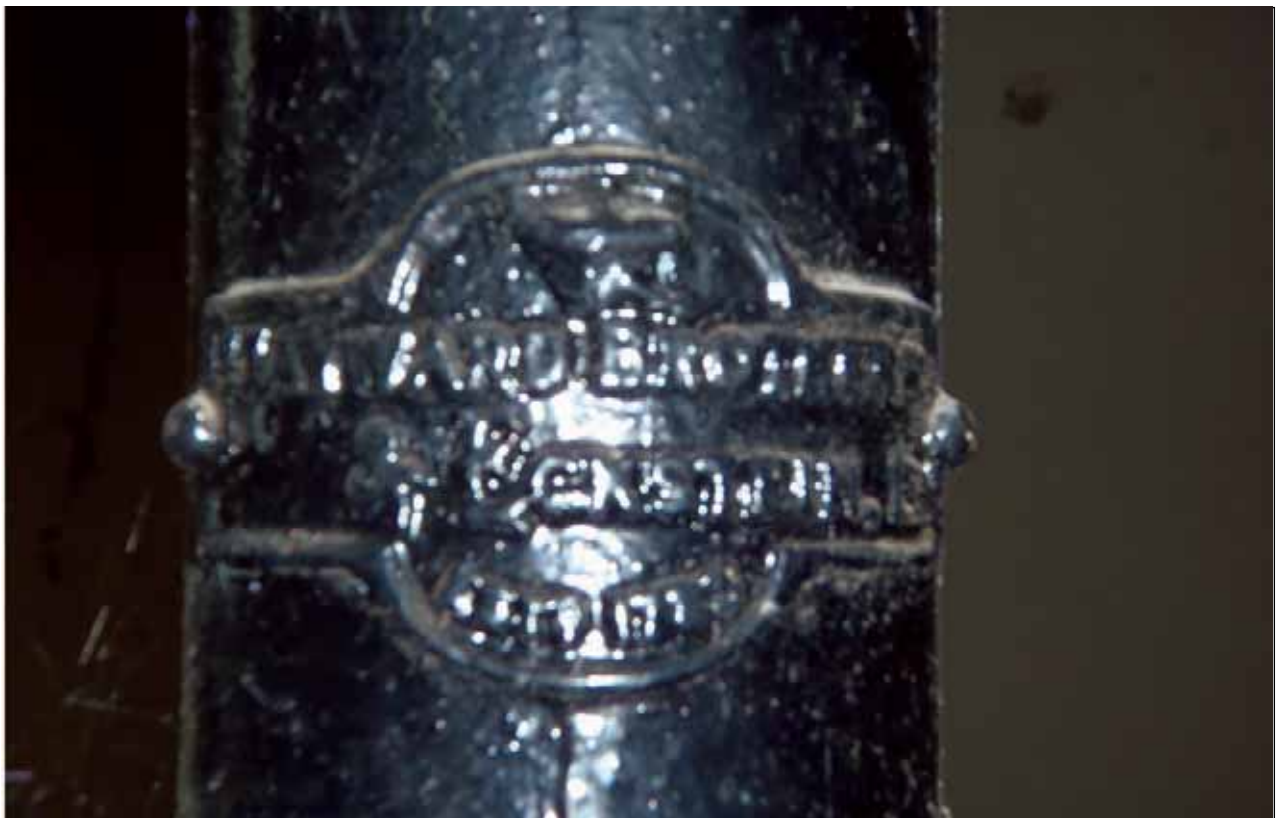
Plate 25: Manufacturers plate on iron post, G1

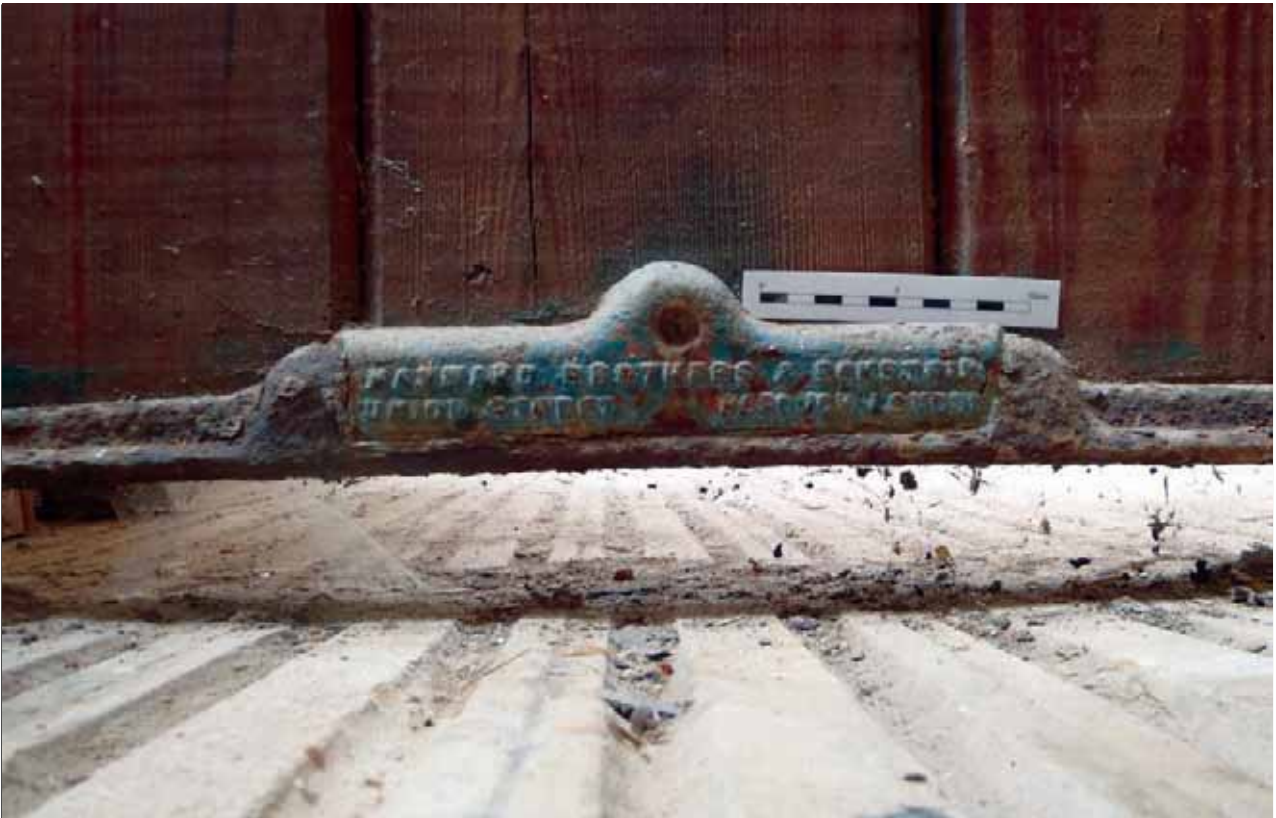
Plate 26: Detail of manufacturers name plate at base of loose box screen, G1

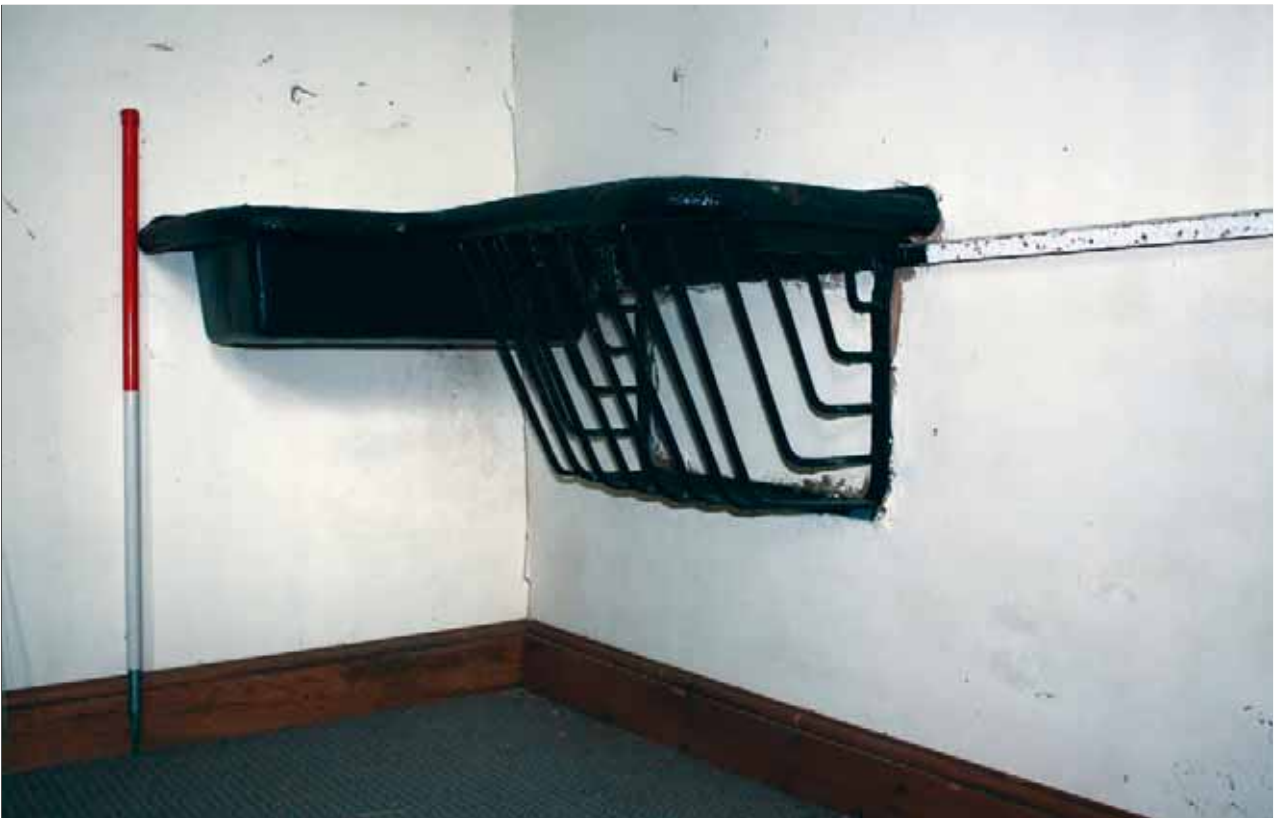
Plate 27: Manger in corner of loose box, G1

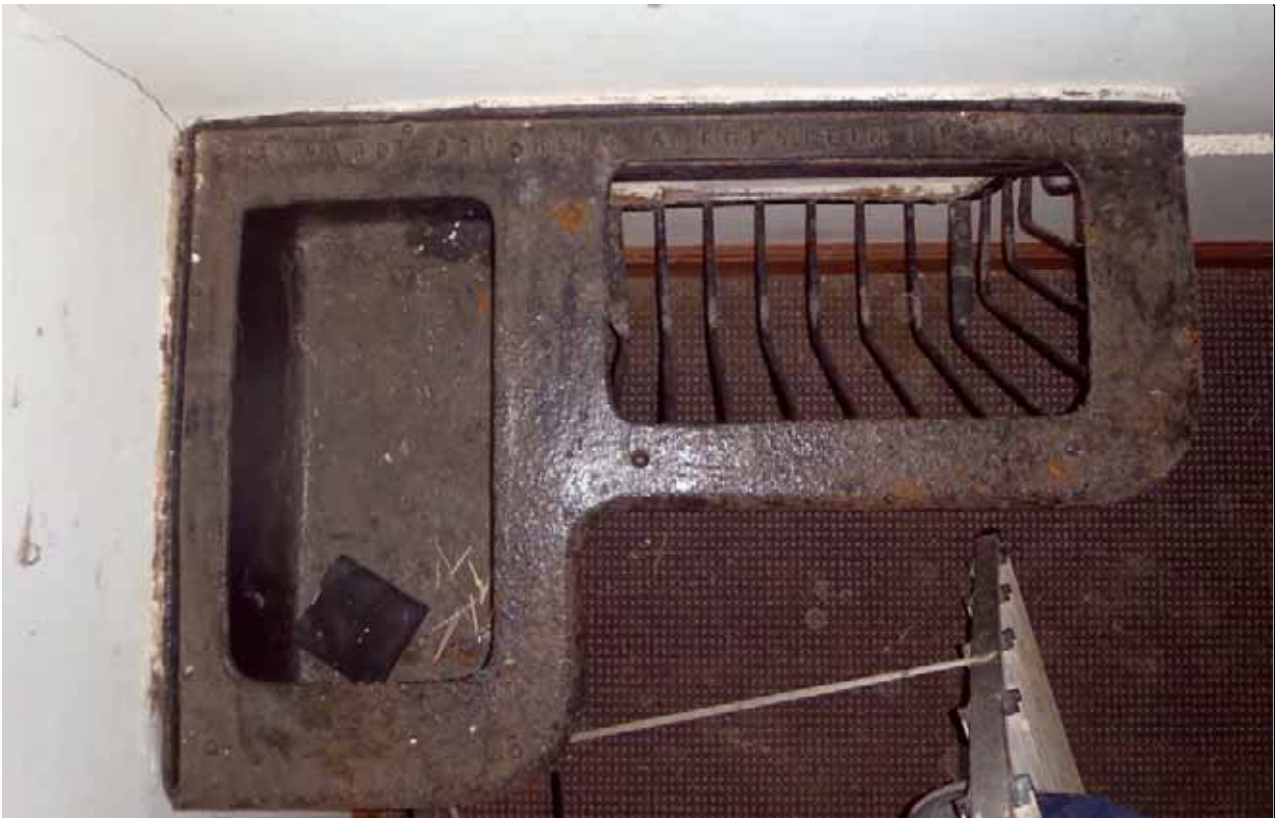
Plate 28: Manger in corner of G1

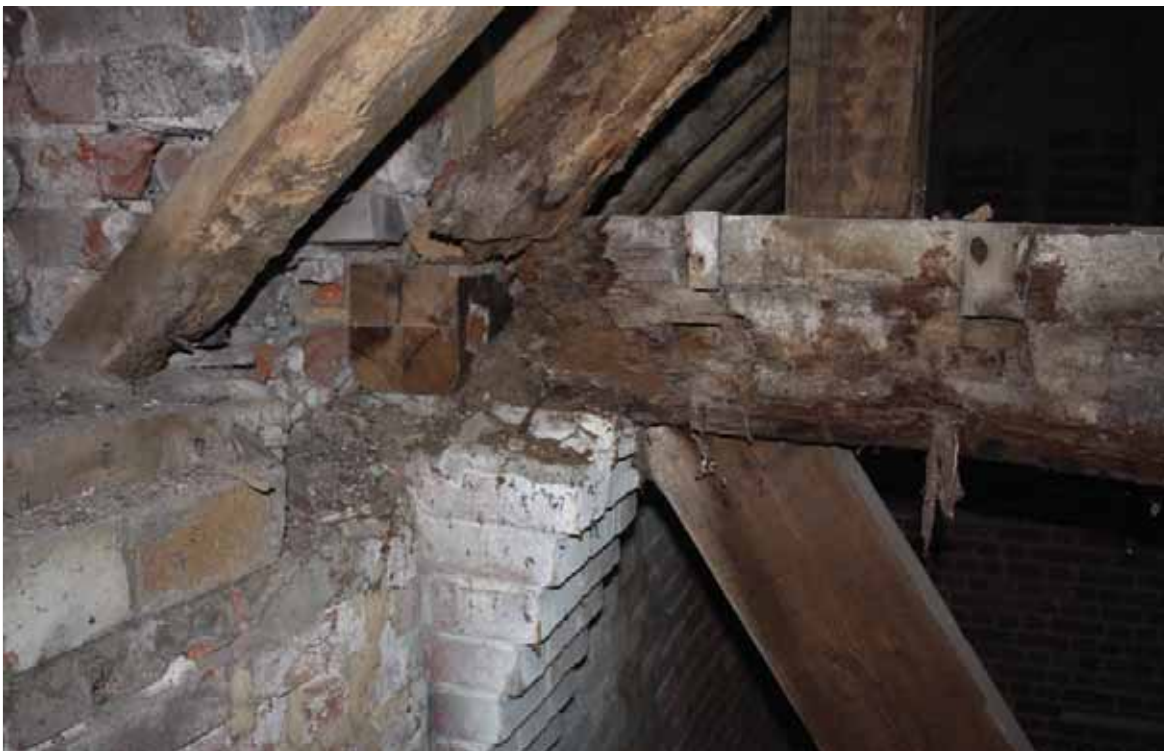
Plate 37: Detail of rotten tie-beam, principal rafter, modern brick support and replaced wall plate, G4

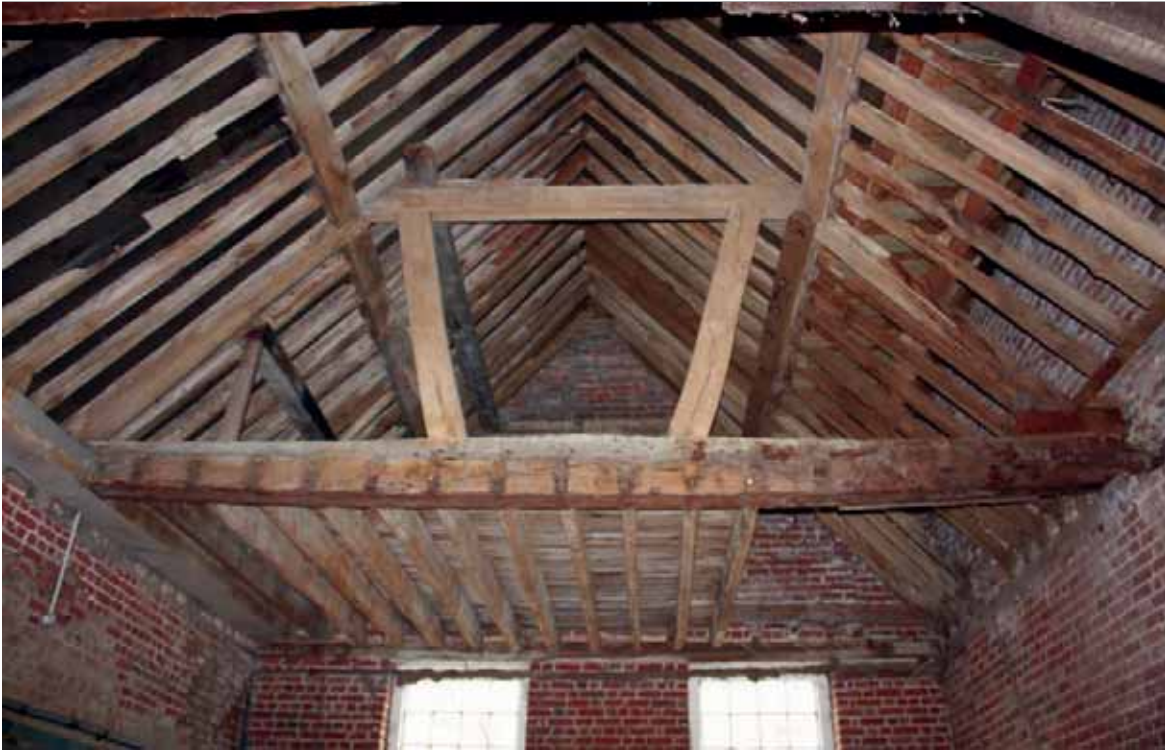
Plate 38: Queen post roof, G4

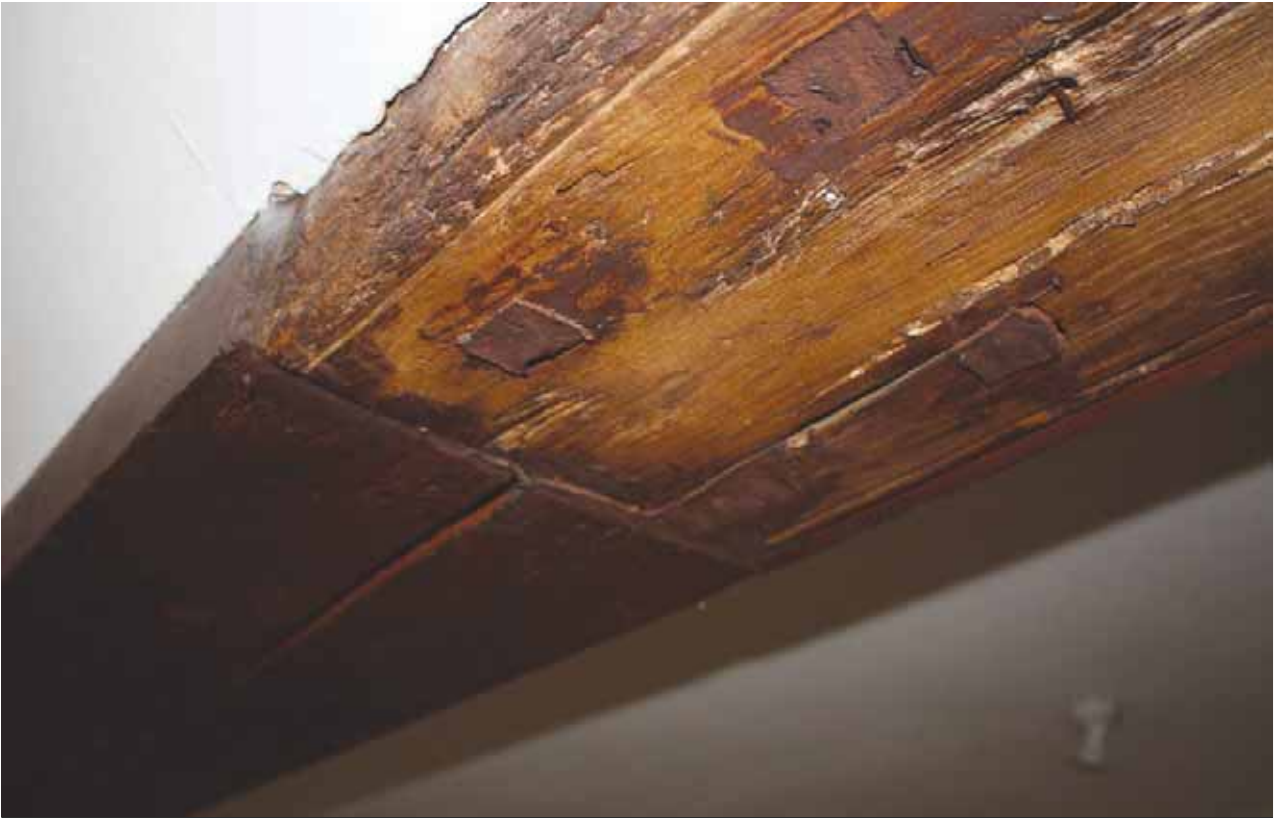
Plate 56: Detail of repair/replacement of moulded tie beam and filled square peg holes

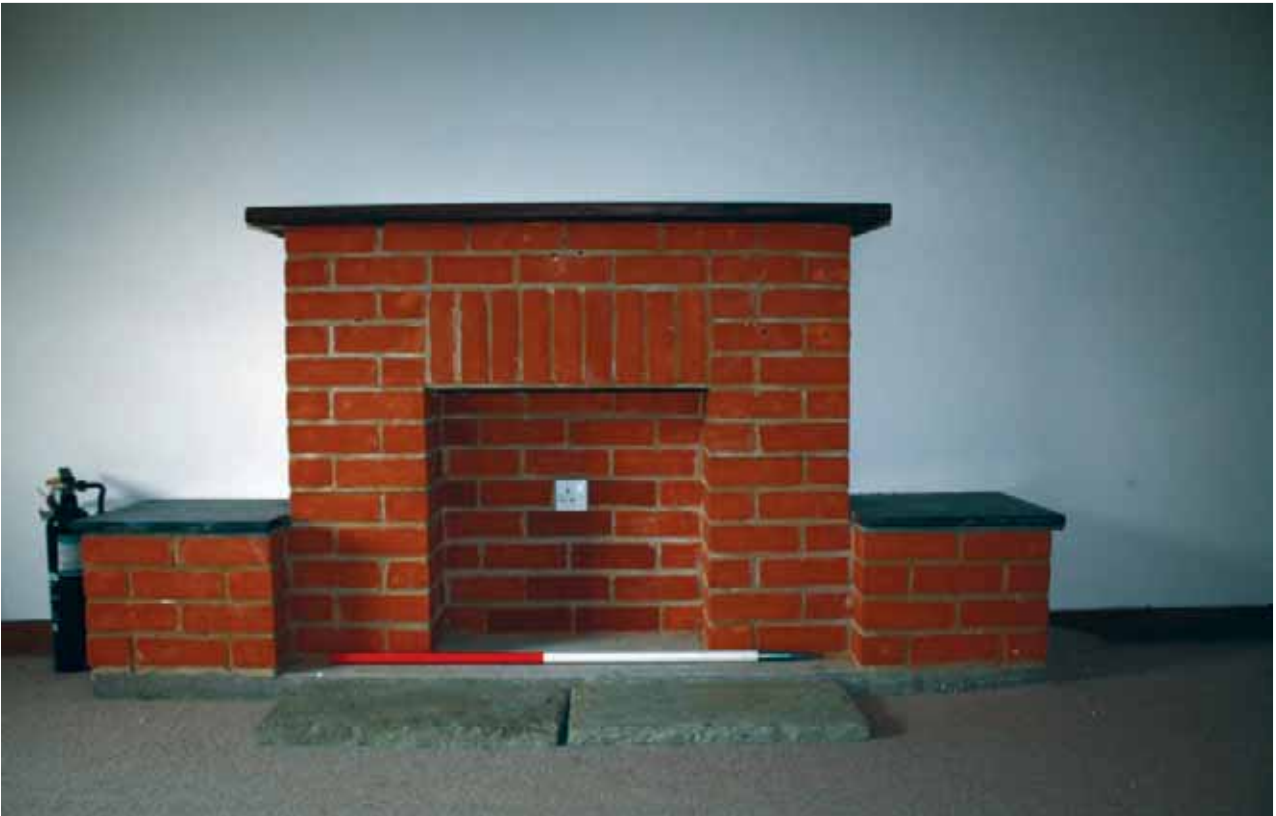
Plate 57: 20th Century fireplace, F3
