St Mary-le-More Wallingford Oxfordshire

Archaeological Watching Brief Report

Church of St Mary-le-More, Wallingford, Oxfordshire

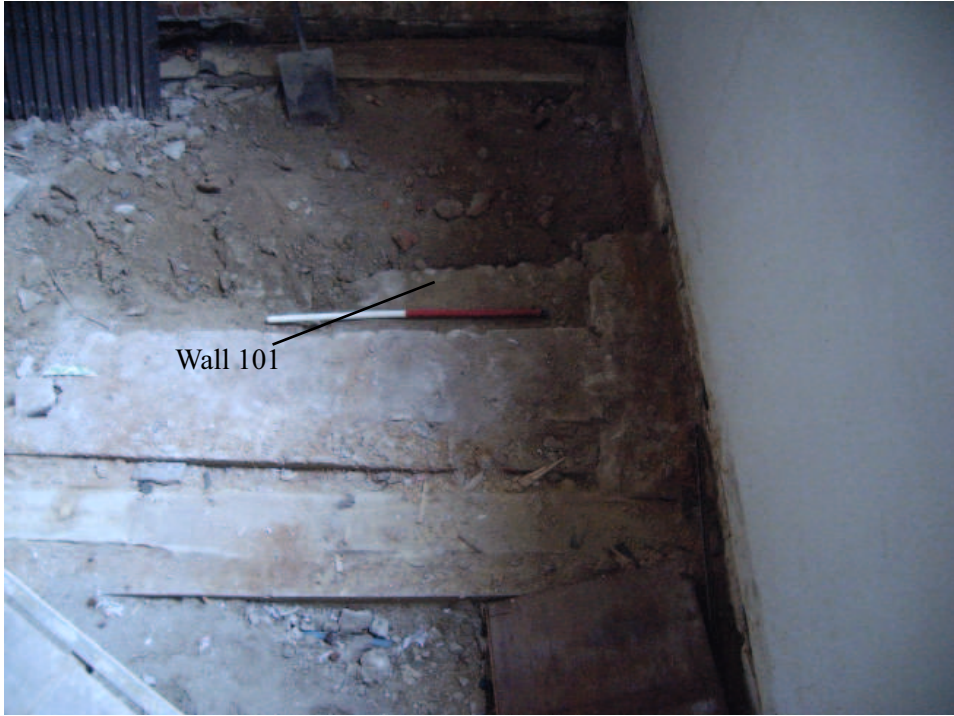
- 3.1.1 Following the removal of the pews, flooring and floor beams the earliest deposit revealed was the south wall of the medieval church (101), previously seen in the 1995 watching brief. The wall was west-east aligned and located within the south aisle (Fig. 2; Plates 1 and 2) and survived to a height of 49.86 m OD. Only the upper course of the wall was exposed, which was 0.8 m wide and over 15 m long. The wall was constructed from faced limestone blocks and flint fragments, measuring 0.3 m by 0.2 m by 0.2 m. The wall was seen to return to the north in the 1995 watching brief but excavation was not as deep during the more recent works and the return was not seen. The medieval wall was abutted by a rubbly brown, silty clay loam levelling deposit (107). The deposit contained 19th-century glass and earlier redeposited pottery. A testpit to the north-west of wall 101 demonstrated that 107 was at least 0.6 m thick.

Plate 1: Medieval church wall 101, western section looking south

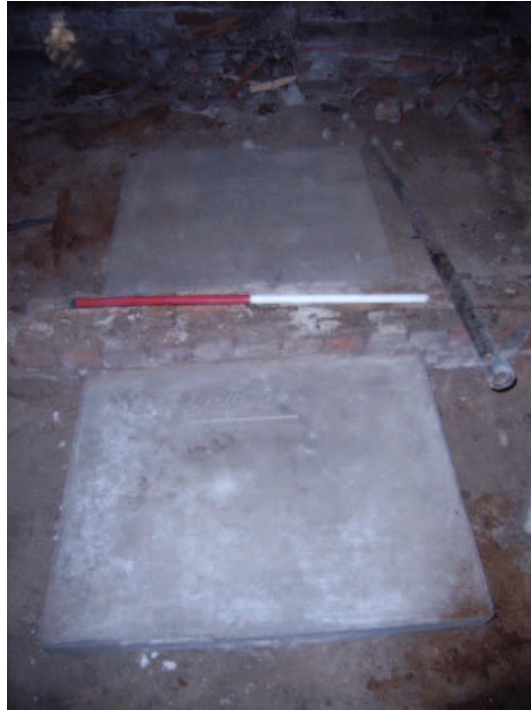
- 3.1.2 Church wall 101 was abutted by a probable burial vault on its north side. A rectangular cut (108) measuring 2.5 m long by 1.5 m wide was filled with a loose grey brown silty sand (109). This sand was thought to overlie a collapsed burial vault, which had been filled in during the 19th-century renovations.
- 3.1.3 An intact vault was revealed within the choir vestry. The top of the vault measured 2.70 m long by 1.17 m wide and was constructed from a double skin of red bricks, each measuring 0.23 m x 0.11 m x 0.08 m. The vault was overlain by a limestone gravestone (100; Plate 3) measuring 1.80 m x 0.95 m x 0.10 m. The stone was inscribed:

SACRED
to the memory of
Sarah
The wife of William B. Sheen
Solicitor of this Place
who died Jan. 30th 1833
Aged 49
Also of the said
William Howell Sheen
who died Nov: 1835
Aged 56

Plate 3: Grave marker 100

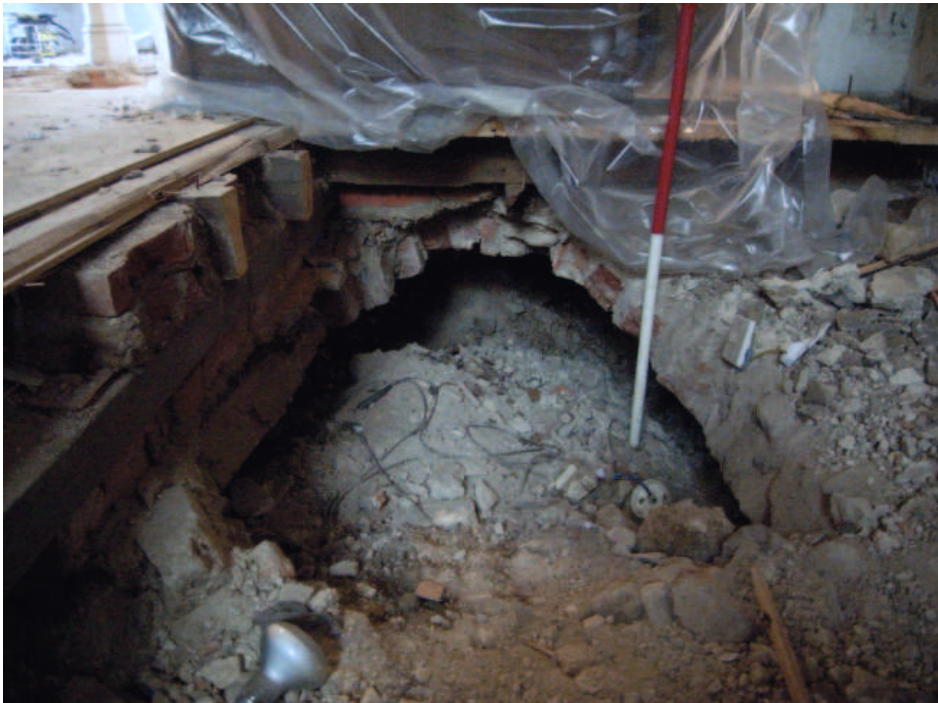
- 3.1.4 Two infilled brick-lined vaults (121) were revealed below the chancel floor and the foundations of the north chancel wall (Fig. 2; Plate 4). The tops of both vaults had collapsed and the structures had been backfilled with rubble and levelled for the laying the timber floor supports. The eastern vault was aligned north to south and measured 2.5 m x 2 m. The western vault was aligned west to east and measured 2 m x 1.75 m; its western end had been rebuilt during the construction of the heating duct 106 (see below). Both structures were constructed of a single skin of bricks, each measuring 0.22m x 0.11 m x 0.07 m. Charnel bones were observed in the backfill of the western vault, presumably a result of the disturbance of a burial during the construction of the 19th-century heating duct.

Plate 4: Vault 121, looking north

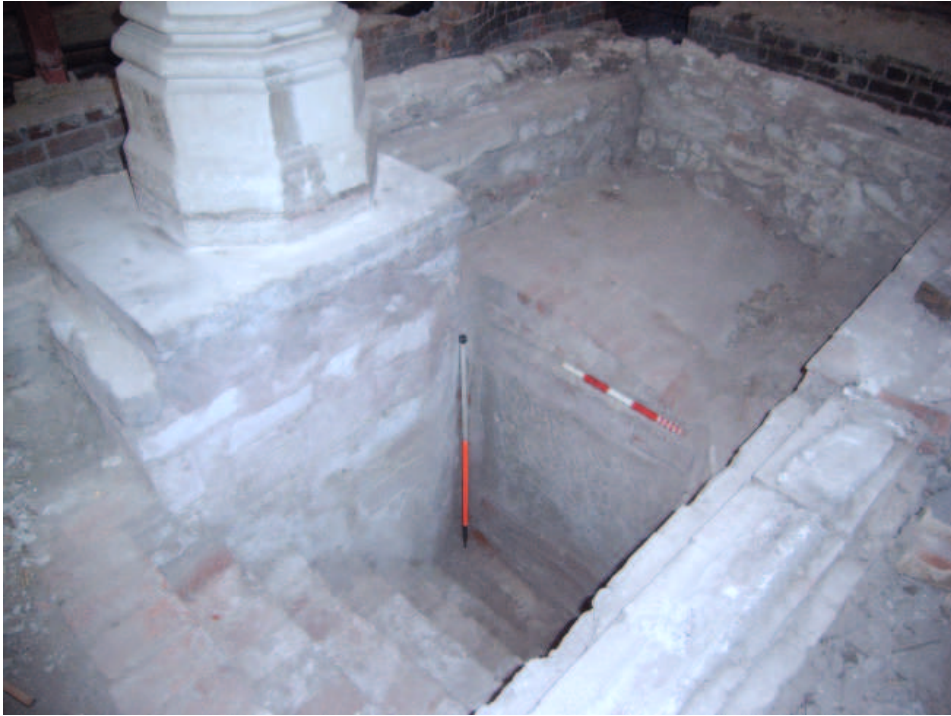
- 3.1.5 The most ornate vault (105) was previously observed in the 1995 watching brief (Fig. 2; Plate 5). It comprised a red brick vault measuring over 2 m by 2 m, but possibly truncated by later heating ducts, with a flight of five brick built steps measuring 1 m long, 0.25 m wide and 0.2 m high. A roughly dressed limestone slab blocked the entrance to the vault and bore the inscription: W, VII, NT, probably a mason's mark (Plate 6).

Plate 5: Brick vault 105, looking north-east

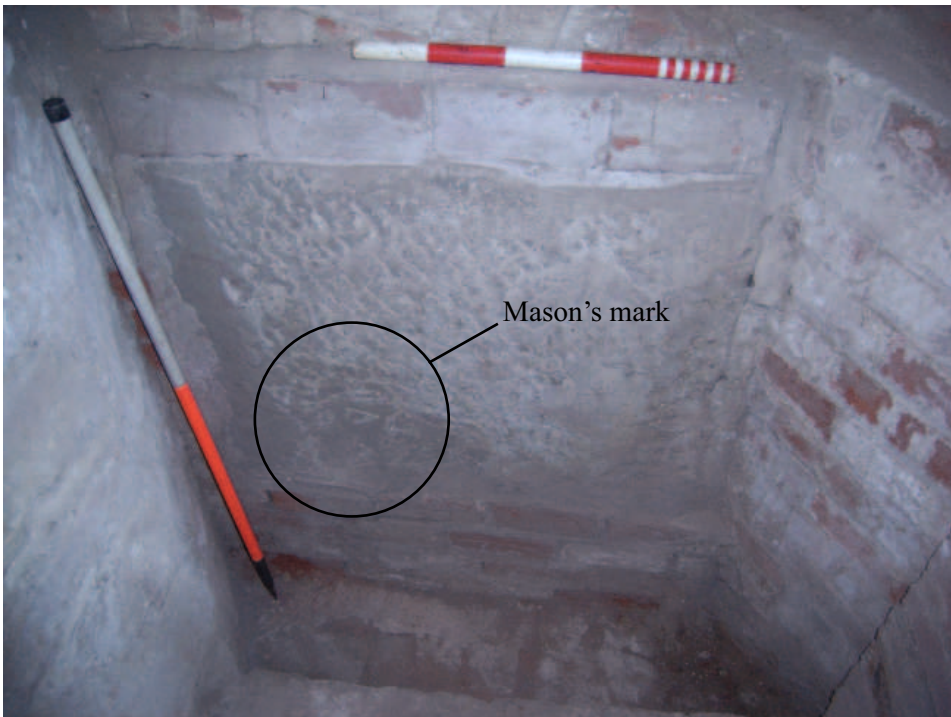
Plate 6: Brick vault 105 Mason's mark

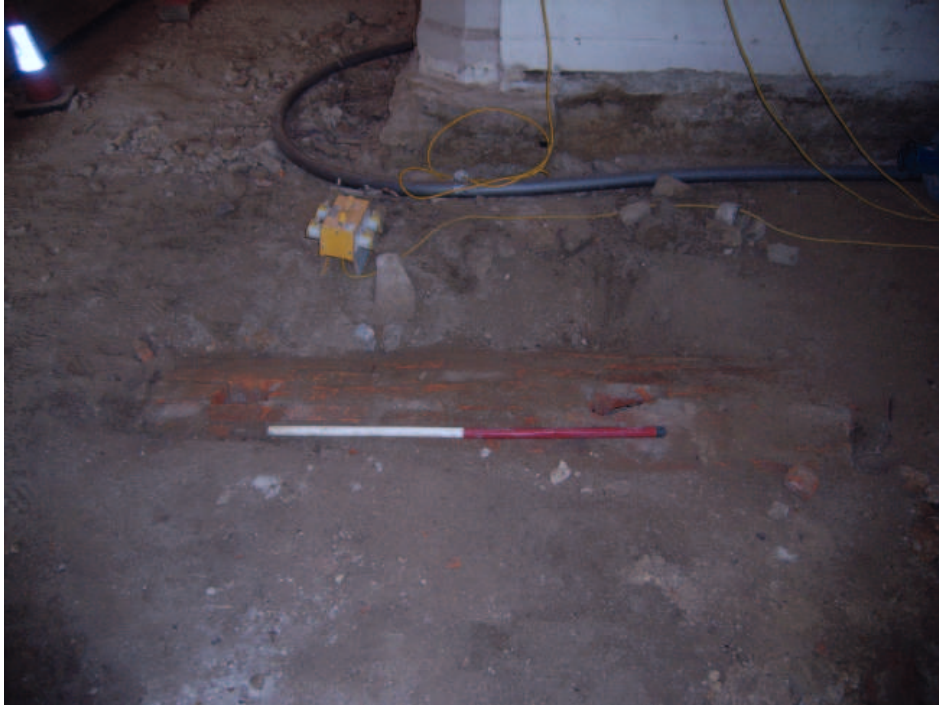
- 3.1.6 A rectangular west-east aligned, brick vault (122) was located in the west end of the north aisle. The structure was trench built and measured 1.95 m x 0.75 m x 0.94 m with a low barrel vaulted top (Fig. 2; Plate 7). The remains of a coffin were present within the vault, which were overlain by the curved wooden frame used to construct the vault's roof (Plate 8).

Plate 7: Brick vault 122, looking south

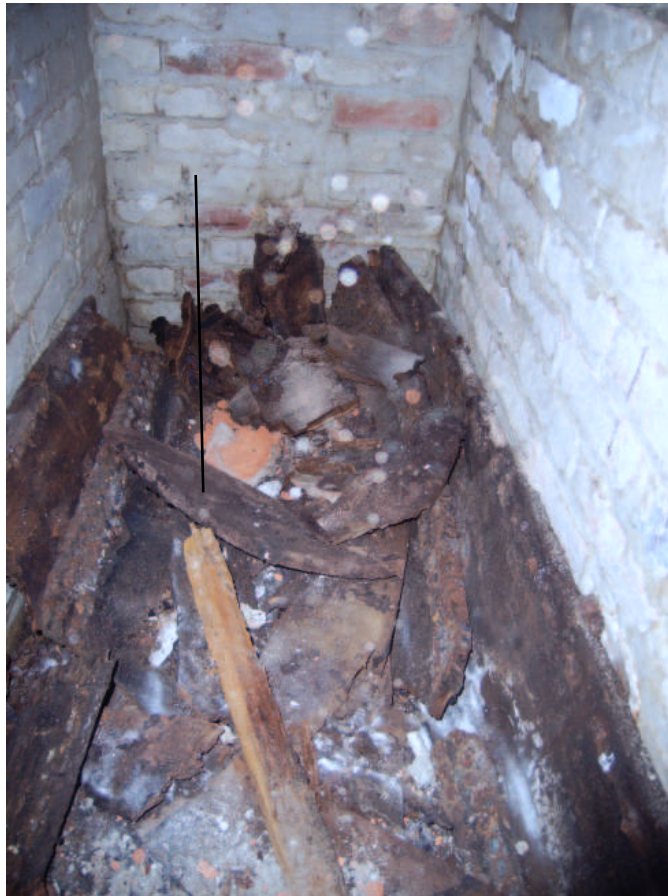
Plate 8: Brick vault 122, internal view

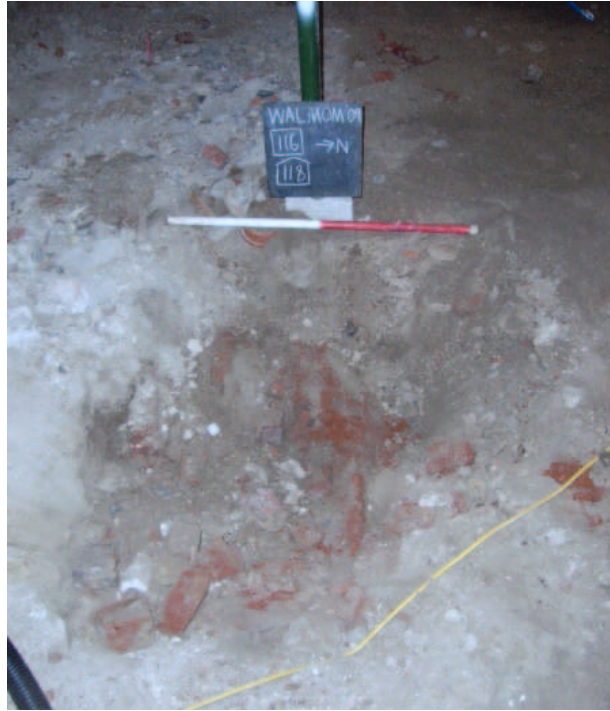
- 3.1.7 Two trenches were excavated through the floor of the Rector's Office to enable column supports to be constructed. The collapsed east end of a brick vault (118) was revealed within the southern trench; the vault was backfilled by loose brick rubble (Fig. 2; Plate 9).

Plate 9: Brick vault 118, looking west

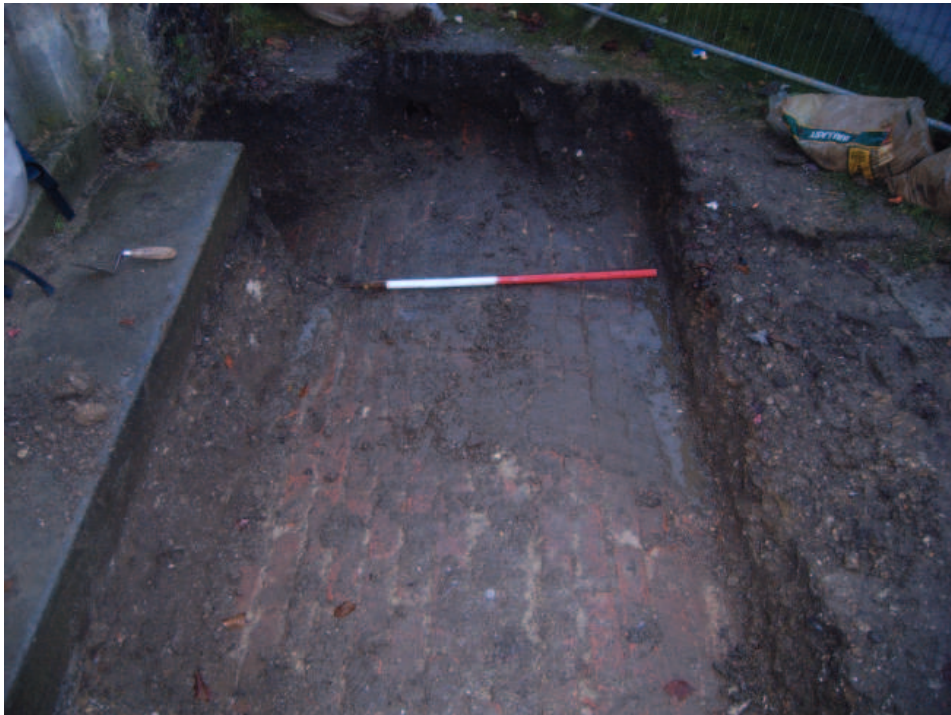
- 3.1.8 A vault (124) was revealed outside the north porch of the church during the construction of a wheel chair ramp (Fig. 2; Plate 10). The vault was intact and measured over 2.30 m long and 1.20 m wide. It was constructed from red bricks measuring 0.22 m x 0.11 m x 0.07 m in a yellowish sandy mortar bond. The vault was overlain by a 0.45 m thick buried graveyard soil and the stone paving of the existing church path.

Plate 10: Brick vault 124, looking west

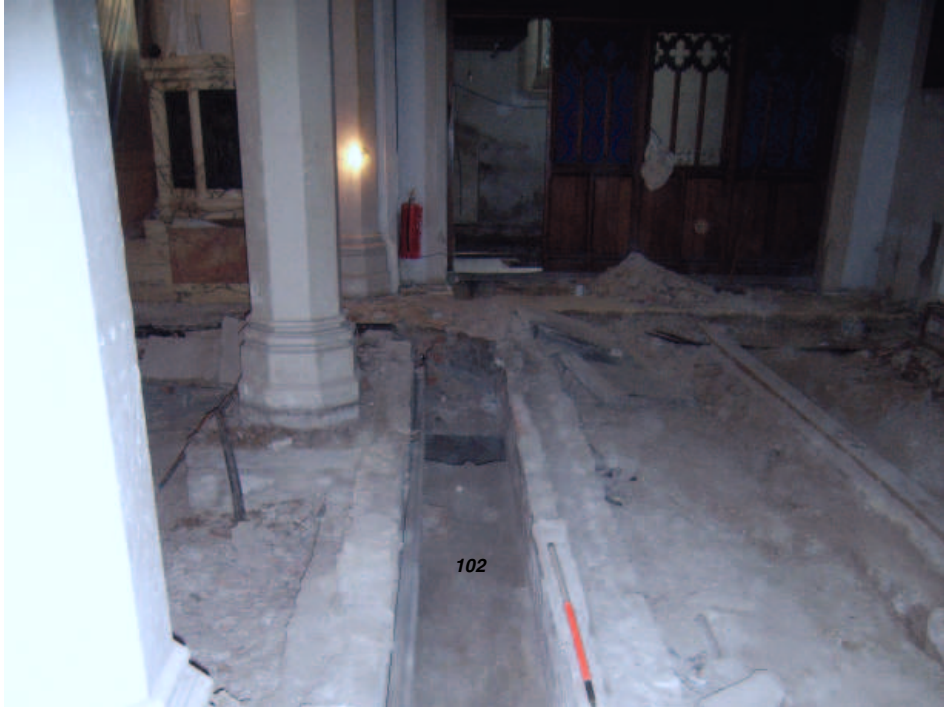
- 3.1.9 Three east-west aligned brick lined heating ducts (102-104) were revealed within the centre of the church (Fig. 2; Plate 11). The ducts connected to a north-south aligned duct (106), which led from the boiler room. The structures were over 7 m long and 1.2 m wide, and were constructed from two brick walls, each four courses high and overlain by a course of peg tiles. The bricks measured 0.22 m by 0.08 m by 0.07 m and the base of each duct was constructed from limestone slabs. Where ducts 104 and 106 joined, an upper stone floor was inserted, presumably to aid circulation of the warm air (Plate 12).

Plate 11: Brick heating duct 102, looking east

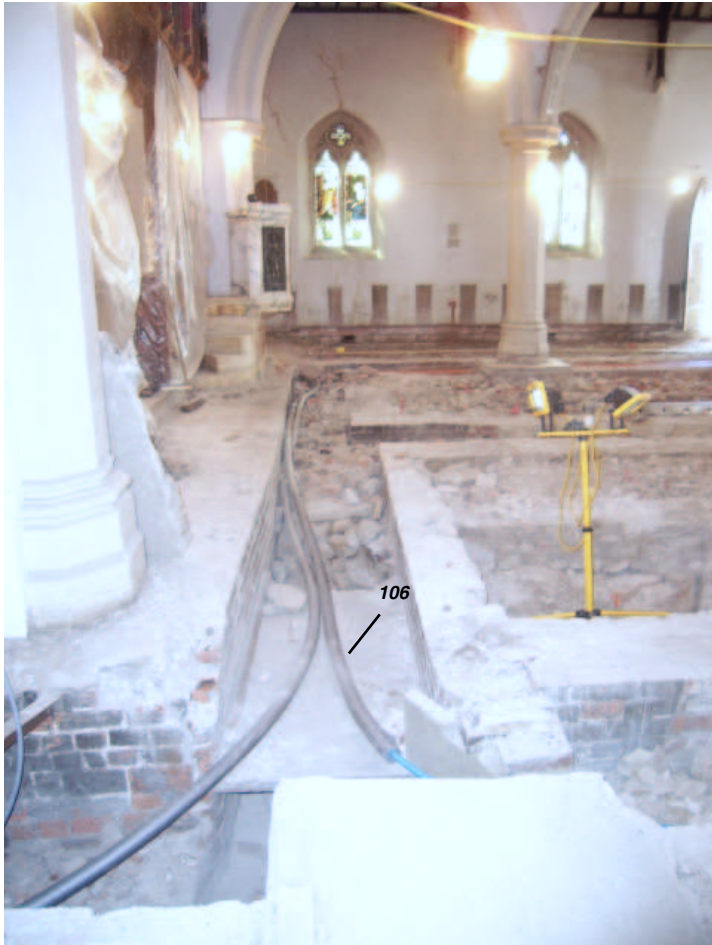
Plate 12: Brick heating duct 106, looking west

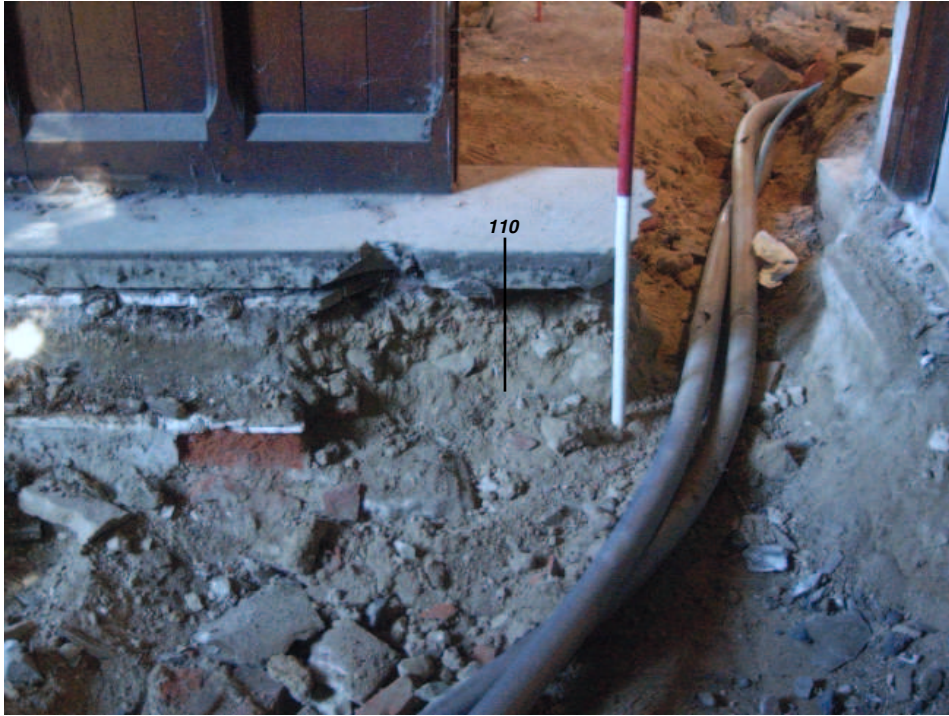
- 3.1.10 A north-south aligned wall foundation was revealed within an excavation for a service trench to the east of the pulpit. The foundation (110) was constructed from rough limestone blocks and measured 0.7 m wide and over 0.2 m deep (Fig. 2; Plate 13). It is possible that the wall formed part of the medieval church, but the absence of flint and its location directly beneath the vestry door makes a 19th-century date more likely. The structure probably formed a foundation for the vestry wall.

Plate 13: Vestry wall foundation 110, looking west

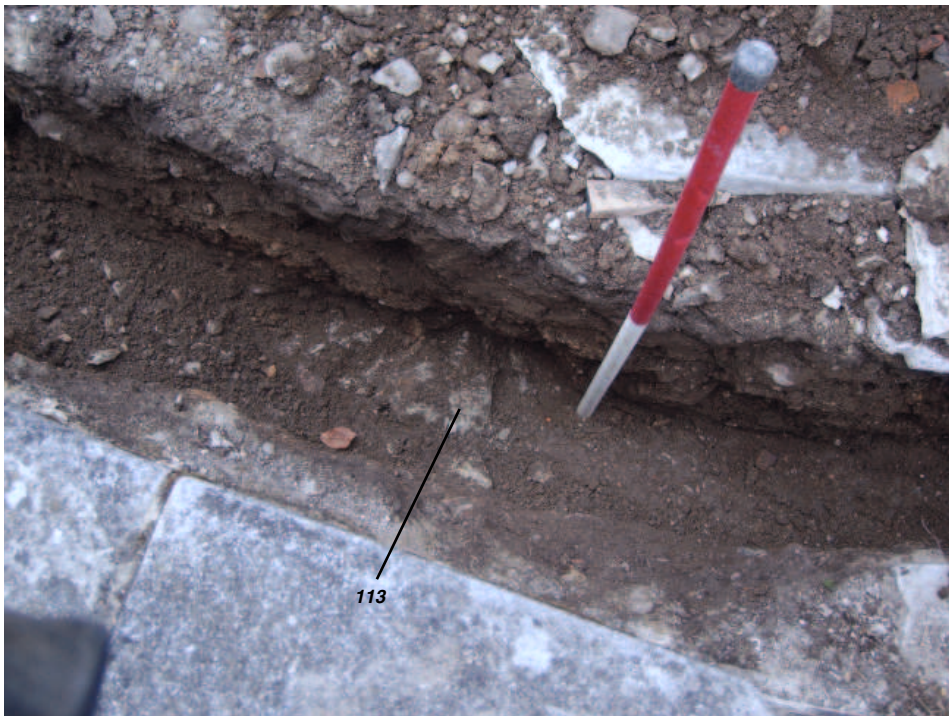
- 3.1.12 A service trench was excavated around the north side of the church. The trench was 0.40 m wide and 0.60 m in depth and was cut through a 0.45 m thick buried soil (112; Fig. 2). This soil had been cut by a construction trench (114) for an old boundary wall (113), the trench measured 0.45 m wide and 0.50 m deep and the wall footing was constructed of chalk fragments in a light brown clay bond (Plate 14). Only the top of the wall foundation was observed and it was overlain by a light brown silty sand backfill (115). The deposits were overlain by the existing stone surface of the churchyard (111).

Plate 14: Wall footing 113, looking south
