Estate Manager's Wall Hampton Court Palace

Statement of Significance

September 2012

Document Title: Estate Manager's Office Wall, Hampton Court Palace

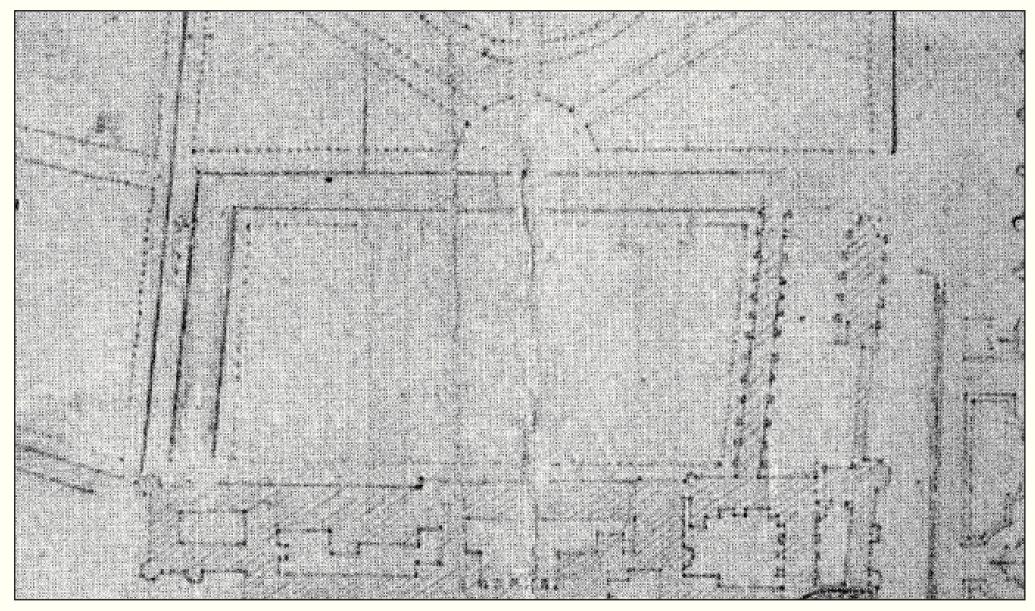
- 3.1.7 An early plan by Hawksmoor from c. 1689 (Figure 3) clearly shows the moat, bowling alley and tennis court (a replacement for the Tudor one was constructed in 1660/61) but there is no detail in the area where the wall is located (Figure 4). By 1686 the orchard to the north of the dry moat had been changed into a garden which eventually becomes the 'Wilderness', a large woodland garden where the planting and layout was less structured than other formal planted gardens. The former privy orchard located within the dry moat by this time was used as a kitchen garden.

Figure 3: Extract from plan by Hawksmoor (c. 1689)

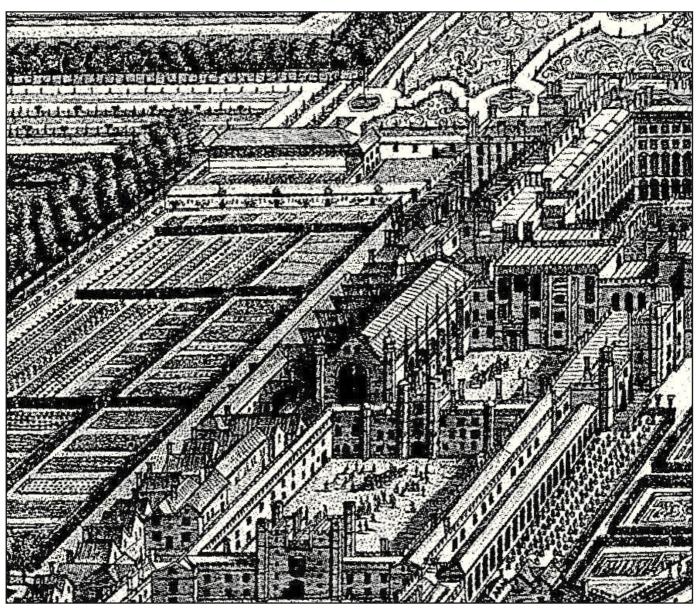
- 3.2.1 A view of Hampton Court from the West by Knyff (1707) is more detailed indicating a wall connecting the tennis court and the bowling alley (Figure 4). The dry moat is surrounded by trees which extend to the tennis court. The area within the moat is shown divided into kitchen gardens and forcing grounds. The Charles Bridgeman plan of 1711 (Figure 5) makes reference to this area as the 'Melon Ground'. The moat can still be clearly seen to the north and west sides of this area and an L shaped building is depicted to the north end of the area between the bowling alley and tennis court although this appears to correspond with the cranked section of wall separating the tennis court garden from the glasshouse garden.

Figure 4: Extract from 'Hampton Court from the West' by Knyff (1707)

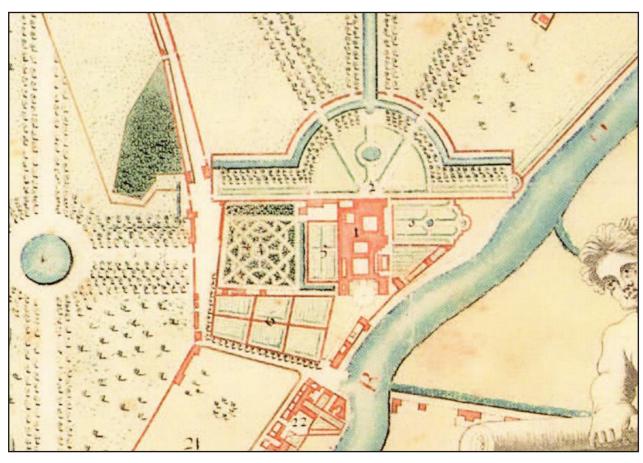
1711	Charles Bridgeman plan of 1711 shows the former privy orchard now as the 'melon ground', a garden area for the cultivation of melons, cucumbers etc under glass. The dry moat ditch is clearly still in situ as are the tennis court and bowling alley. A small L shaped building is depicted centrally to the north of this.	Bridgeman plan 1711
c.18thC	A plan of Hampton court at ground floor shows no detail of the melon ground but does show the tennis court and bowling alley and a brick wall which presumably is the inner wall for the dry moat.	PRO 34/43
1736	A detailed plan of the gardens by John Rocque for Frederick, Prince of Wales clearly shows the moat in detail. The dry moat terminates before the bowling alley which is still in situ. The melon ground is divided into different beds with a wall surrounding this running adjacent to the moat. There are openings within the wall at the east and west end of the eastwest wall. The L shaped building previously shown is not depicted and there is no other detail within the area of the Estate Manager's office.

Figure 5: Charles Bridgeman's A General Plan of Hampton Court Palace Gardens and Parks, 1711

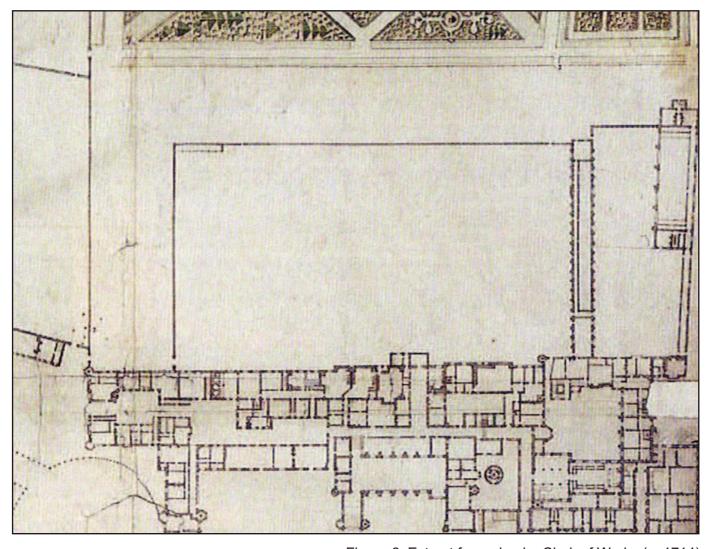
- 3.2.2 A slightly later plan by Clerk of Works in c. 1714 makes no reference to the moat or the L shaped building (Figure 6) but shows the bowling alley and tennis court in some detail as well as the wilderness gardens to the north of the site. Another detailed 18th century plan by John Rocque (1736) again depicts the moat, which clearly terminates before the extent of the bowling alley with what appears to be brick walling (Figure 7).

Figure 6: Extract from plan by Clerk of Works (c. 1714)

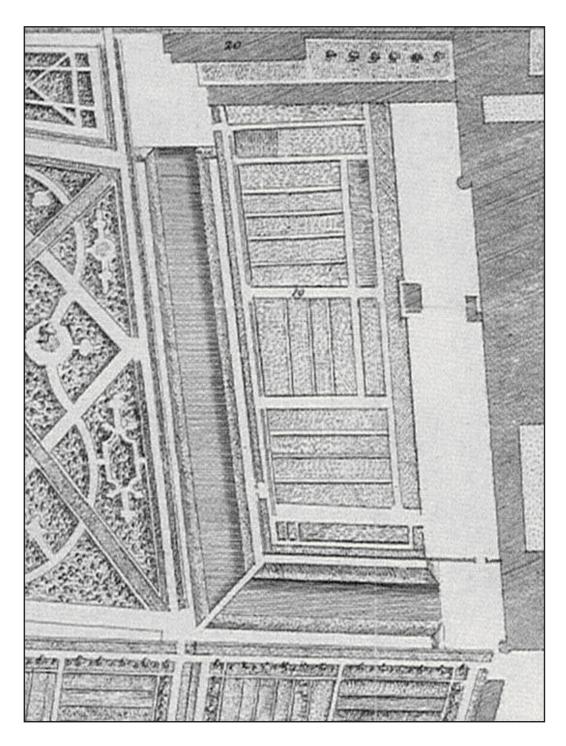
Figure 7: Extract from plan by John Rocque (1736)

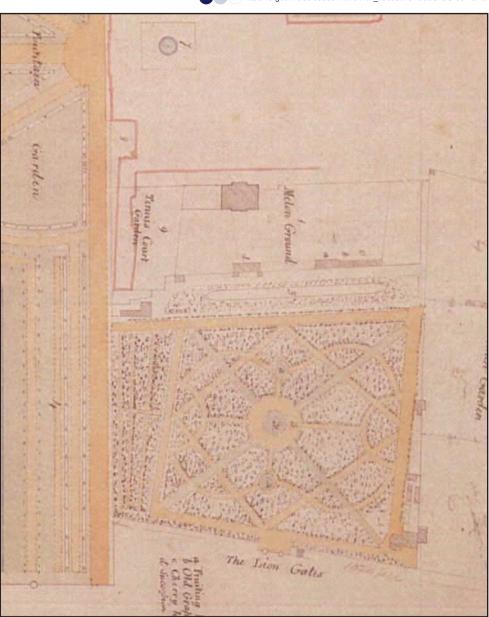
- 3.2.3 A plan of the gardens from c.1805 shows the buildings within the melon ground and details of the Palace gardens (Figure 8). The bowling alley is no longer in situ but the L shaped building to the north of the tennis court is shown. A further small square building to the north of the former bowling alley location is also shown. This plan shows the moat partly infilled and the Estate Managers wall now appears to be in situ having been constructed using **Type Q** bricks (late 18thC/19thC).

Figure 8: Plan of Hampton Court Gardens c.1805

c. 1805	This plan shows the buildings within the melon ground and details of the Palace gardens. The bowling alley is no longer in situ but the L shaped building to the north of the tennis court is shown. A further small square building to the north of the former bowling alley location is also shown. This plan shows the moat partly infilled and the Estate Managers wall now appears to be in situ having been constructed using Type Q bricks (late 18thC/19thC).	PRO LRRO/1/2030
1813	Phillip Hardwicke plan of 1813. No other detail for this area although a small building is depicted to the west of the tennis court.	SD85/5 (RIBA)
1841	The Sayers plan of 1841 shows the moat is now fully infilled and replaced by planting. The Estate Manager's Wall is in situ. A series of small buildings are depicted to the north of the tennis court and also within the melon grounds.	PRO WORK 34/1349
Late 19th Century	The Estate Managers office is constructed on raised ground adjacent to the wall.

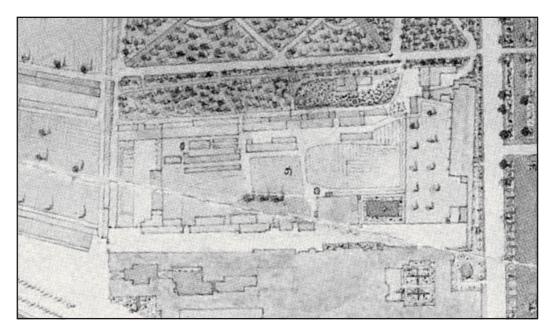
- 3.2.4 The moat was eventually fully infilled in the early 19th century, a plan by Phillip Hardwicke dated 1813 shows the moat partially still in situ but by 1841 the moat had been infilled and partly replaced by planting as shown on the plan of that date by Henry Sayer (1841).
- 3.2.5 The Estate Managers office is a later 19th century addition to the area and is constructed on the raised area adjacent to the retaining wall. There appear to have been few changes to the office and the adjoining wall in the 20th and 21st centuries.

Figure 9: Extract from plan of the Hampton Court Estate by Henry Sayer (1841)

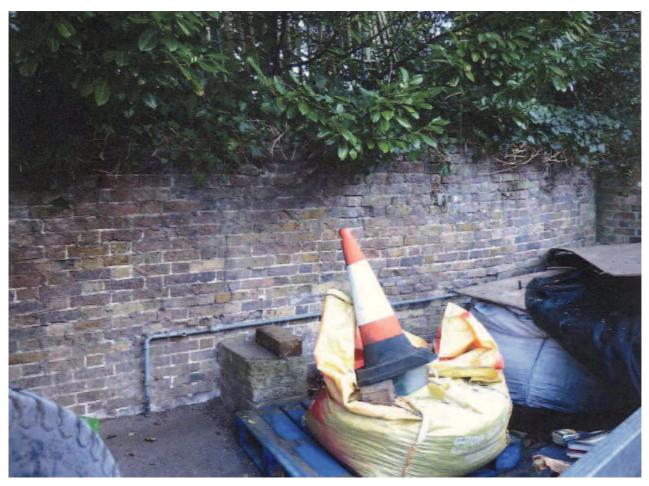
- 2.1.1 The description of the wall as it stood is taken from observations by Emma Simpson of SBC Ltd who examined the brickwork prior to the demolition of the wall (Plate 1).
- 2.1.2 The wall formed a short section of retaining wall backing onto the Wilderness. To the east end the wall abuts another wall at right angles and to the west end the wall adjoins a section of dry stone walling which forms the retaining wall for a garden area outside the Estate Managers office.
- 2.1.3 The wall was 177cm high and 570cm long and is constructed with 23 courses of mixed bricks laid in a Flemish bond. The bricks measure 222-229 x 100-108 x 64-70mm and are regular in shape with creasing on the faces but defined arrises. The bricks are a mix of colours very similar to those seen elsewhere within the Palace. The colours vary and include red, pale pink, yellow, gold, purple and wine shades.

Within the Hampton Court Brick Typology, these appear to bricks correspond with **Type Q** bricks which date to the late 18th century to 19th century. This brick type consists of a mix of different bricks which results in the variation in colours seen on the elevation. The mortar used was an off white coloured lime mortar with joints measuring between 6-12mm. On top of the wall there was Portland stone coping with drip. The coping measures 460mm wide x 40mm deep and projected approximately 40mm from the face of the wall.

2.1.4 A redundant pipe ran across the length of the wall. Two later blocks of brickwork five courses high abutting the wall probably formed a base for a now removed piece of equipment (possibly water tank?).

Plate 1: Wall before dismantling (Photo: Emma Simpson, SBC Ltd)

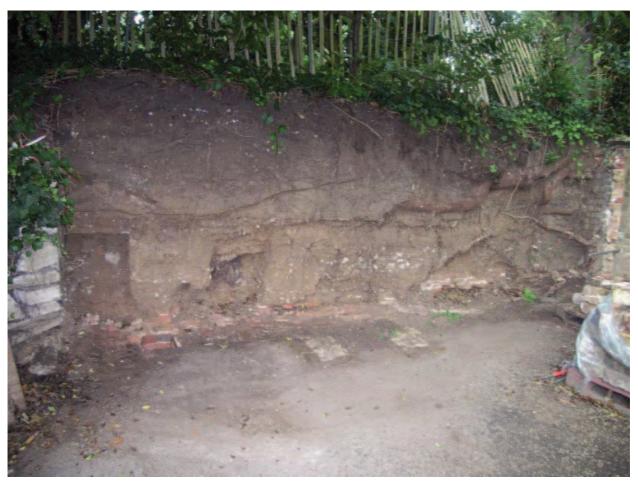
- 2.2.1 Following demolition it can be seen that the wall brickwork was bonded into the adjoining east wall (Plates 4 & 5). The coursing of both brick walls were unevenly matched, the brick type also varied slightly suggesting the walls were constructed at different times. The footprint of the removed wall was revealed as well as infill patches of brickwork to the rear of the retaining wall (Plates 2 & 3).

Plate 2: View of wall footings following dismantling

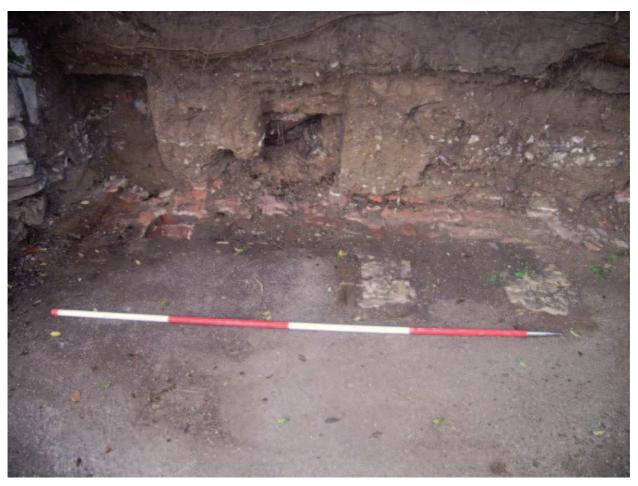
Plate 3: Detail of wall footings following dismantling

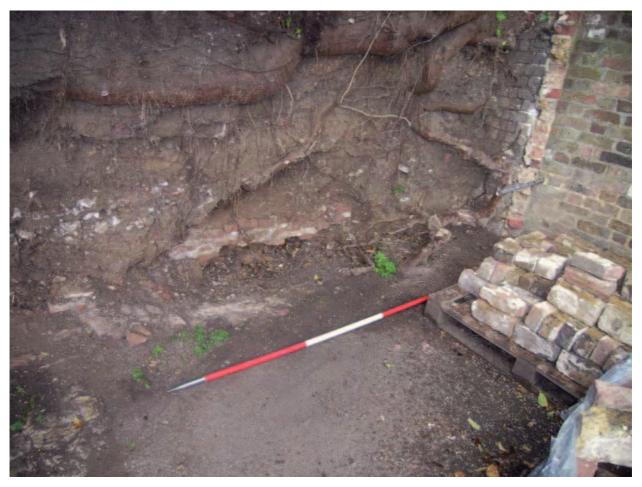
Plate 4: View of wall (east) following dismantling

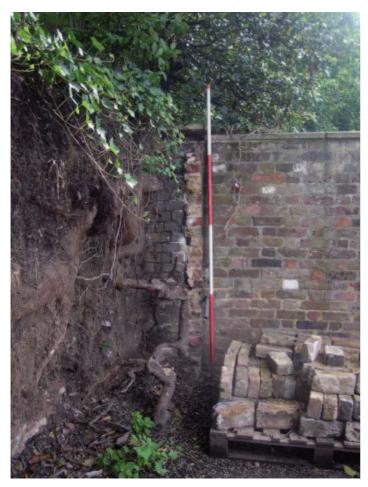
Plate 5: Detail of wall eastern brickwork following dismantling
