# Morpeth Branch Dock, Birkenhead, Merseyside

## Survey Report

**Oxford Archaeology North**

April 2010

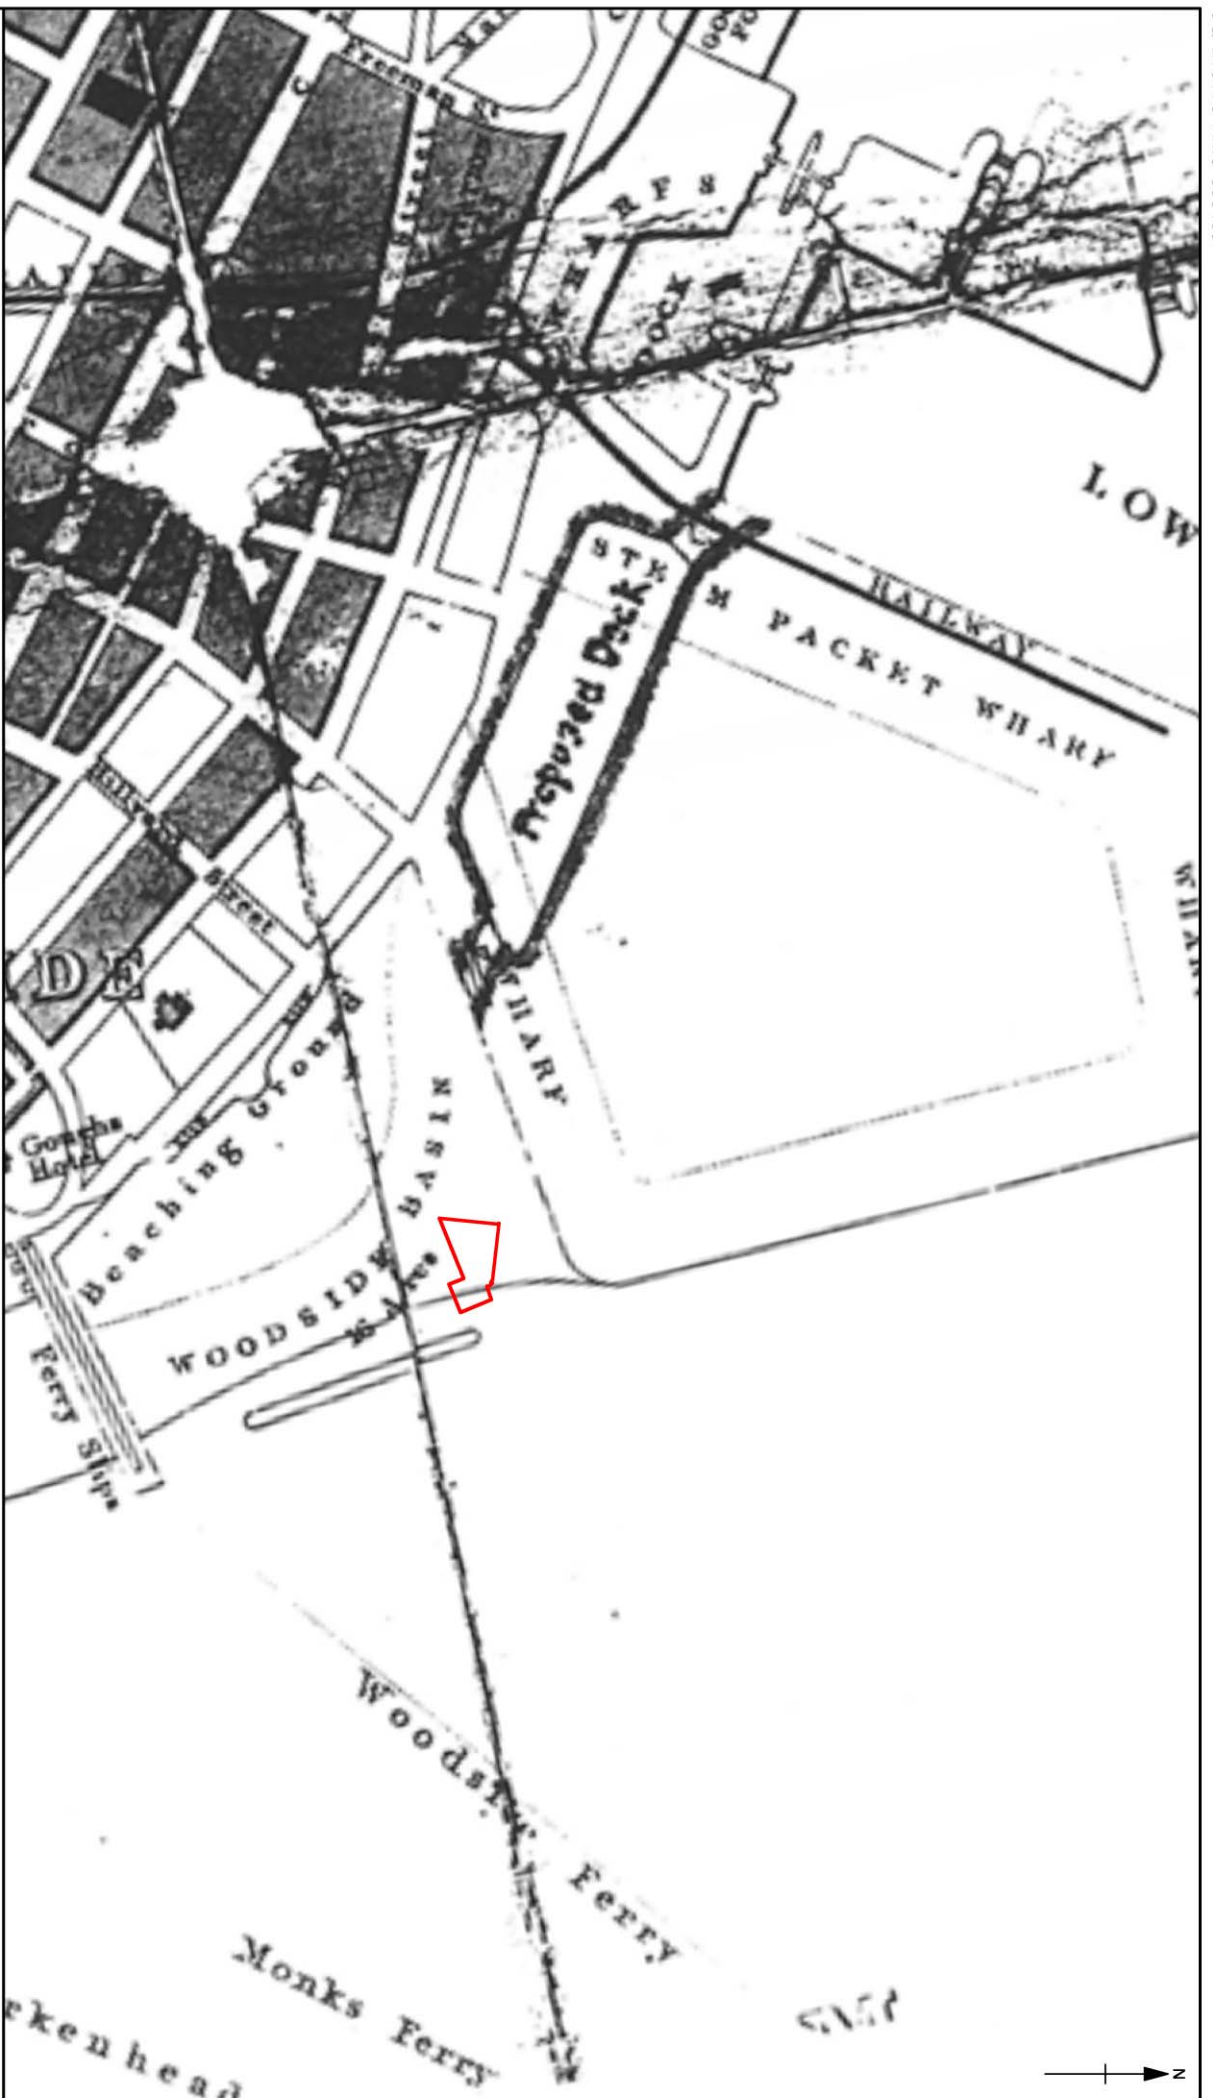
**Figure 2: Plan of the floating dock and other works at Wallasey Pool, 1843 (B/808/A1)**

- 3.3.3 ***Plan of Floating Dock and other works at Wallasey Pool, 1843 (B/808/A1) (Fig 2)***: a new proposal for an expanded dock in the Wallasey Pool had been made by the Birkenhead Improvement Commissioners in 1843, which had received Royal Assent in 1844. This map was produced by JM Rendel, the engineer, and showed the whole of the Wallasey Pool area. The proposed docks included the Great Low Water Basin and 'intended dam'. An arm of the basin branched to the south-west towards Corporation Road, where a smaller dock was proposed to the east of a lime works, and was in the position of what was to be the Egerton Dock. To the north-west of the basin was a wharf and pier head adjacent to a 'small works'. The plan shows a proposal for a basin, adjacent to a ferry pier, in what was to become the Woodside Basin; however, the shape of the basin was slightly irregular and significantly larger than that depicted on the earlier proposal (B808/1).

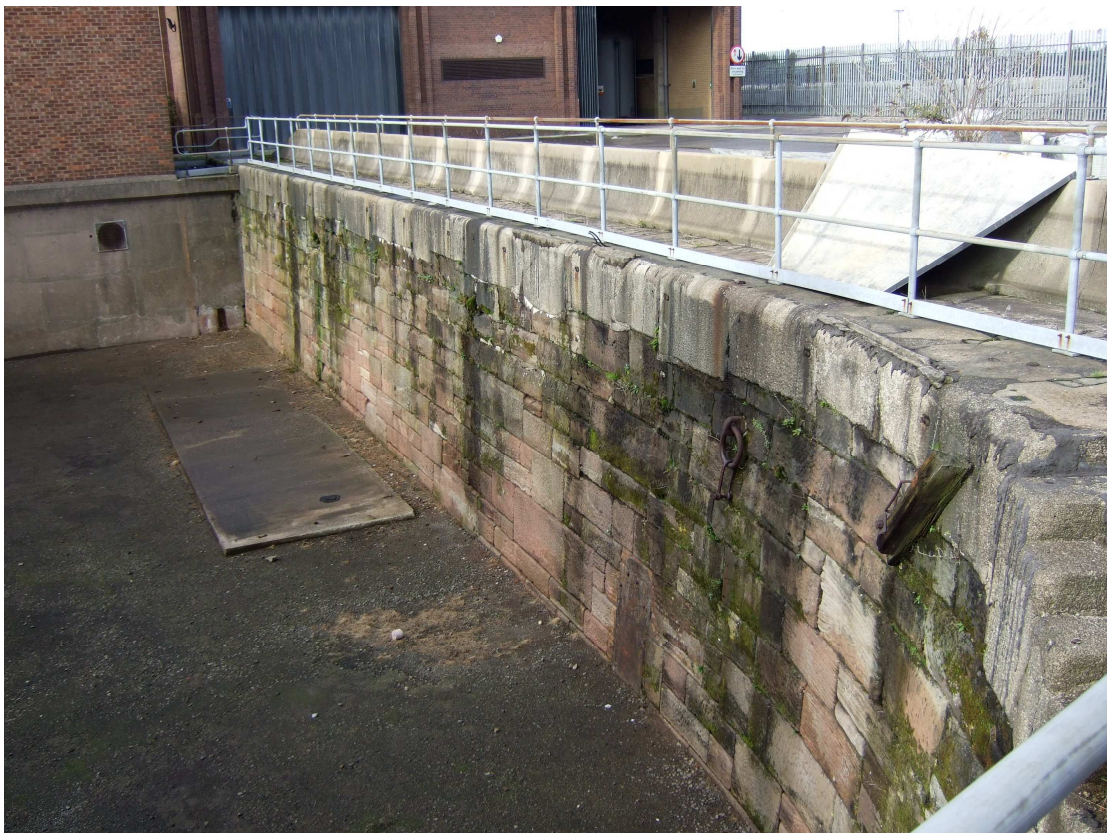
- 4.1.5 The steps were of a similar dressed limestone as the northern coping (Plates 6 and 7). Covering the top eight steps is a layer of concrete which evidently reflects a later repair of damaged step surfaces. Set into this is a brick structure which was probably intended to block off the steps. Below this brick 'blocking' the steps are in good condition.

Plate 6: North side of the dock - corresponding with Elevation 1

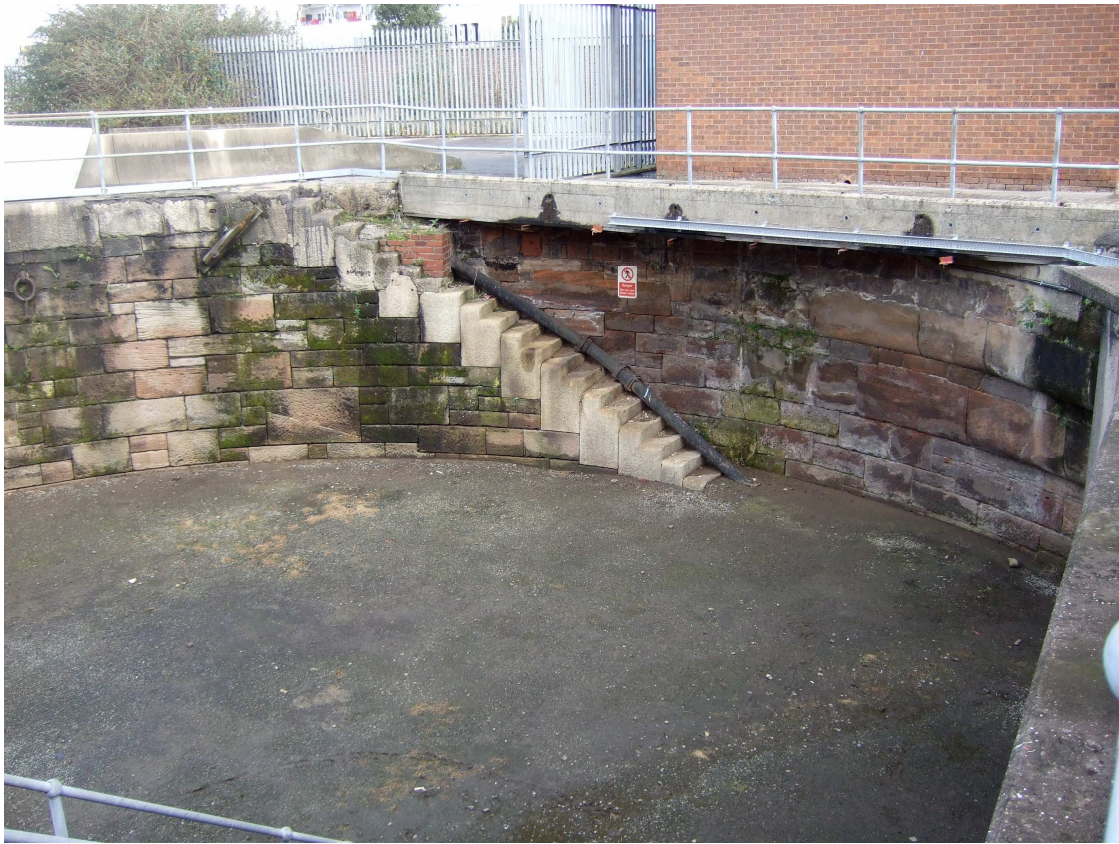
Plate 7: Eastern end of Morpeth Branch Dock

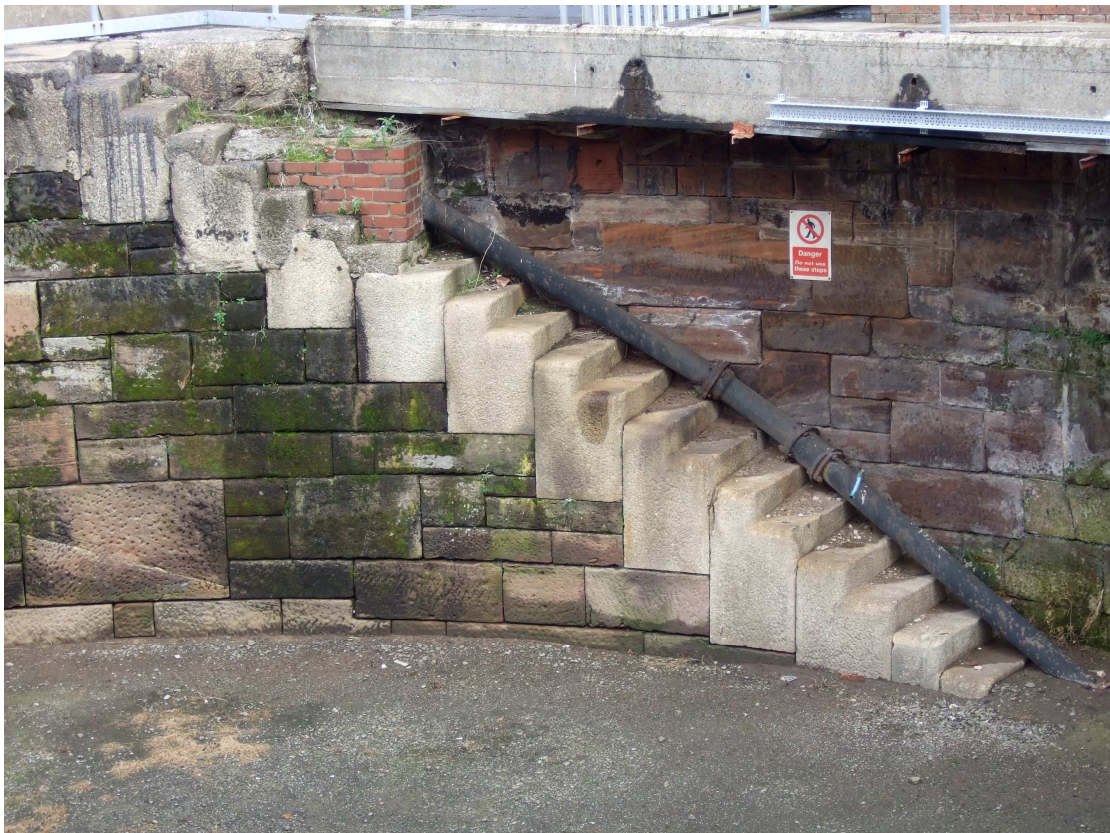
Plate 8: Access steps at the eastern end of the dock

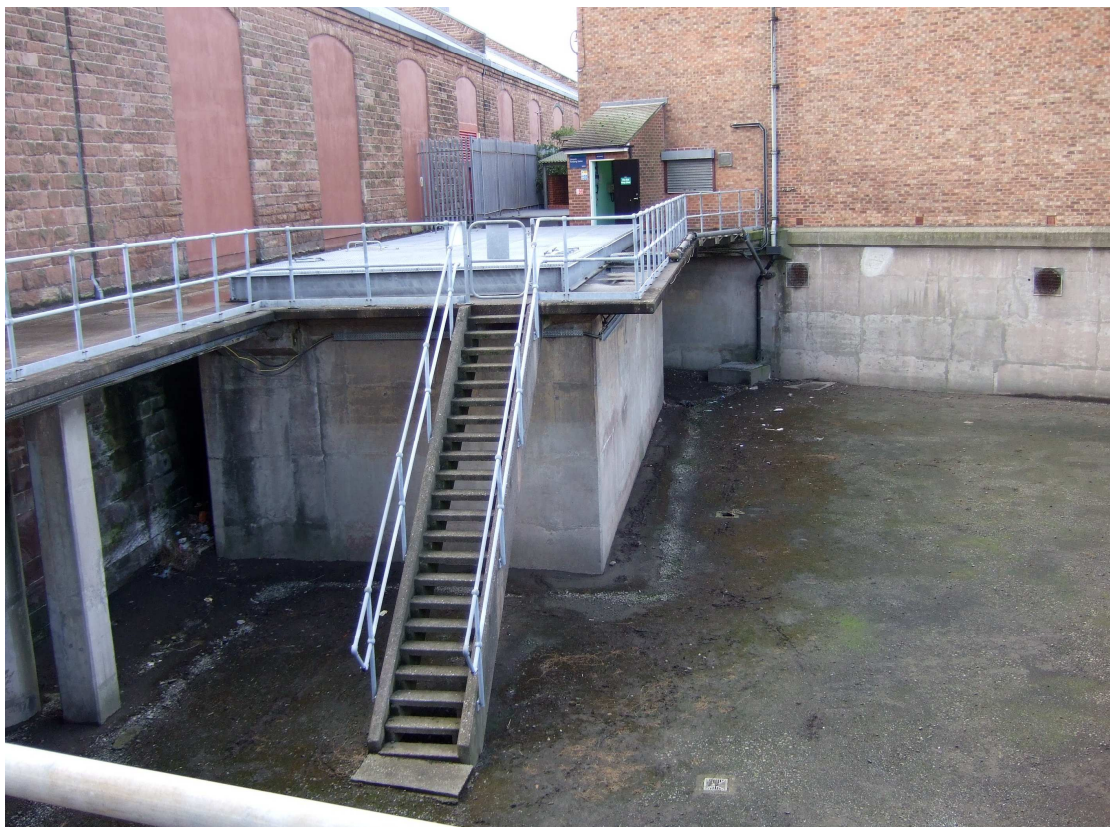
Plate 10: Detail of tidal flap chamber against the southern side of the dock
