# **Proposed Lay-by, Cowdale Quarry and Limeworks, King Sterndale, Derbyshire**

## **Impact Assessment**

**Oxford Archaeology North**

September 2014

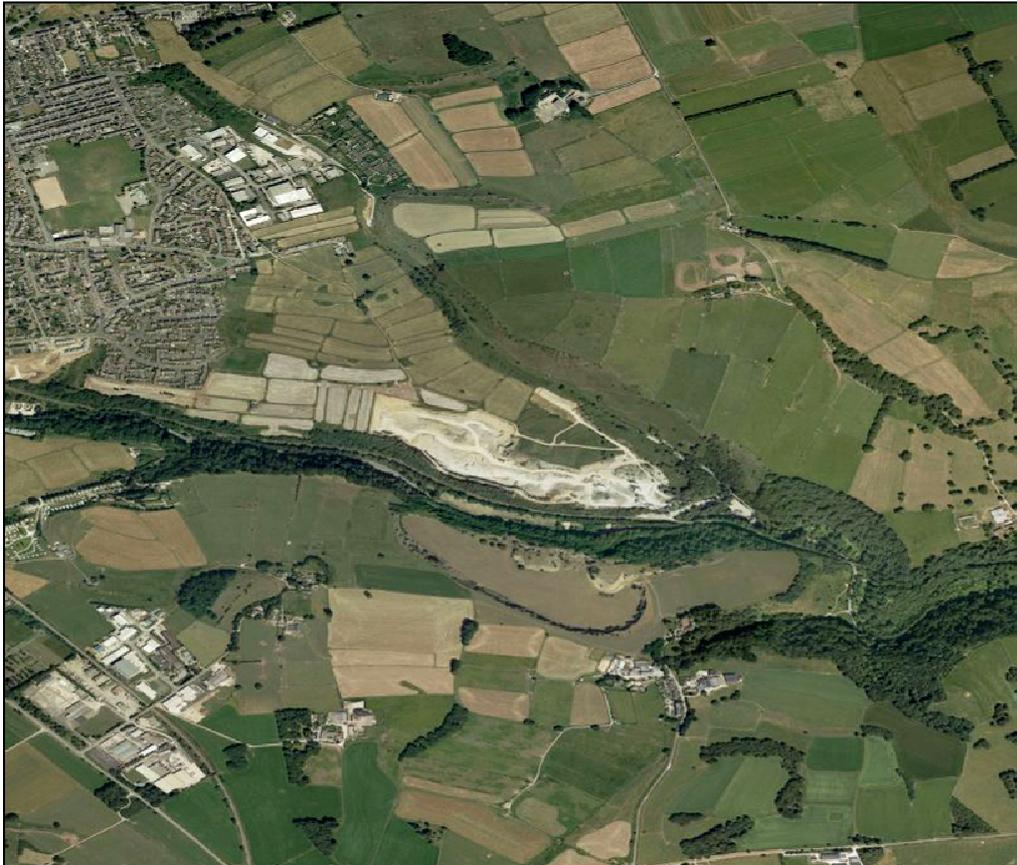
*Plate 1: Recent aerial view across Cowdale Quarry*

1.2.2 The limeworks complex is bounded by the river and adjacent A6 to the north, and the quarry to the south (Plate 1); the main components of the limeworks were built into or against a vertical quarried face *c* 20m high, with the top of the kiln battery and crushing plant level with the quarry floor, and the base of both components at the bottom of the rock face on a narrow linear platform. The quarry extends *c* 750m east/west, by a maximum of 340m north/south, whilst the limeworks complex extends *c* 550m east/west.

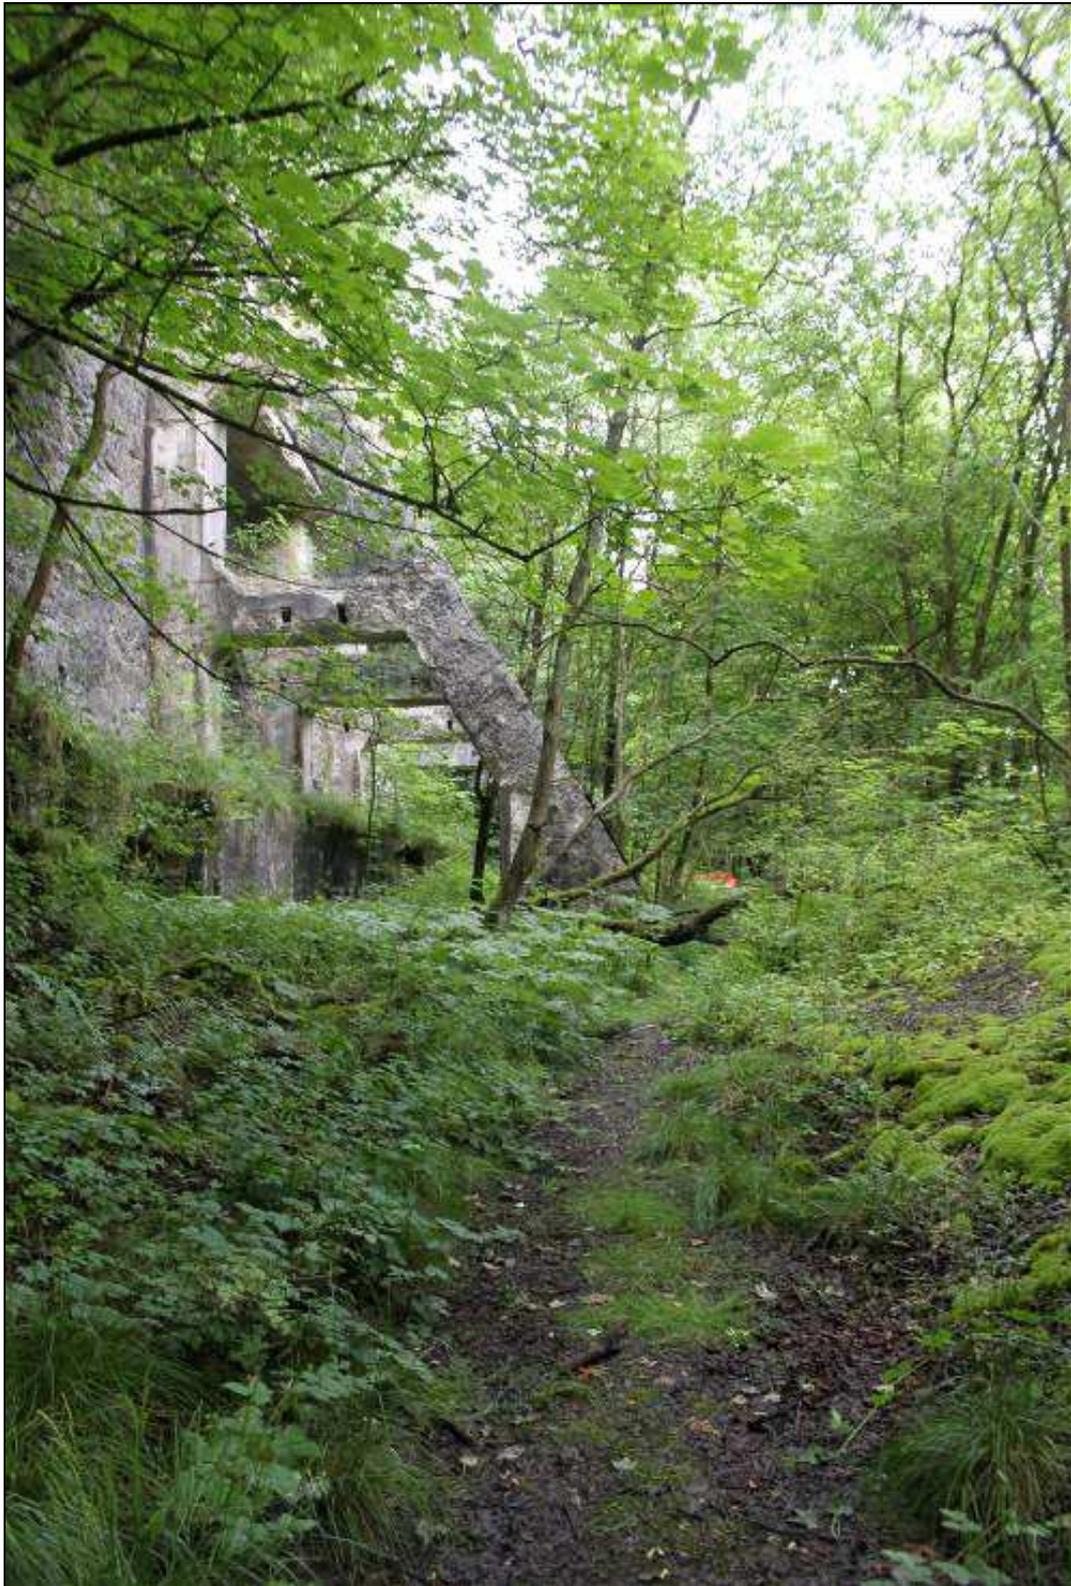
*Plate 2: The kiln bank (Site 07), looking west along the track*

<b>Site number</b>	<b>07</b>
<b>Site name</b>	Lime Kiln Bank
<b>NGR</b>	407894 372475
<b>Site type</b>	Lime Kilns
<b>Period</b>	Industrial
<b>SMR No</b>	-
<b>Statutory Design</b>	Scheduled
<b>Sources</b>	Cowdale Quarry and Limeworks, Kings Sterndale: Conservation Management Plan (Johnson, 2013)
<b>Description</b>	A bank of four substantial concrete built lime-kilns located on the terrace above the lower slope. The kilns were filled from the upper tier with a loading platform on the tier below to carry away the calcinated lime on railway tracks.
<b>Assessment</b>	The site lies beyond the proposed development area and is unlikely to sustain any direct impact, but its setting is likely to be affected.

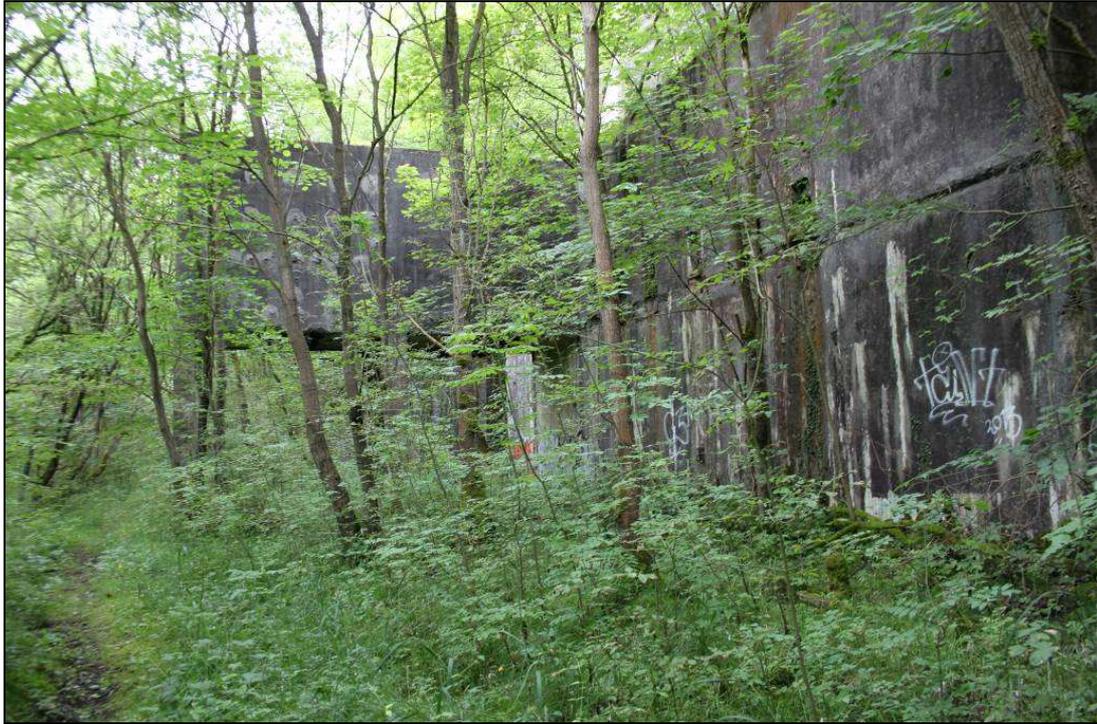
*Plate 3: Looking east towards the loading gantry at the base of the crushing plant (Site 06)*

<b>Site number</b>	<b>06</b>
<b>Site name</b>	Crushing Plant
<b>NGR</b>	408030 372444
<b>Site type</b>	Quarry Structure
<b>Period</b>	industrial
<b>HSMR No</b>	-
<b>Statutory Design</b>	Scheduled
<b>Sources</b>	Cowdale Quarry and Limeworks, Kings Sterndale: Conservation Management Plan (Johnson, 2013)
<b>Description</b>	A massive rectangular concrete structure constructed over three tiers and designed to crush, sort and load the limestone. It was filled from the upper tier with the crushed stone and carried away via the loading gantry, which projects northwards on concrete piers onto the track above the lower slope.
<b>Assessment</b>	The site lies beyond the proposed development area and is unlikely to sustain any direct impact, but its setting is likely to be affected.

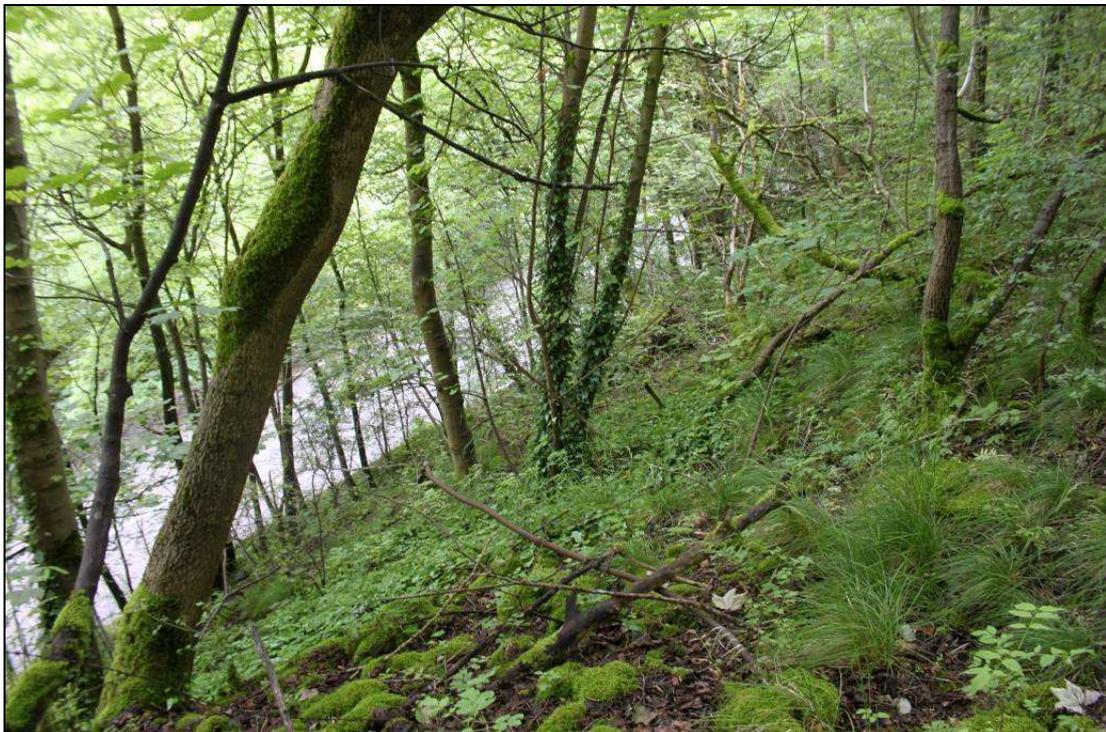
*Plate 4: Looking north from the kiln bank, with the A6 visible at the base of the slope*

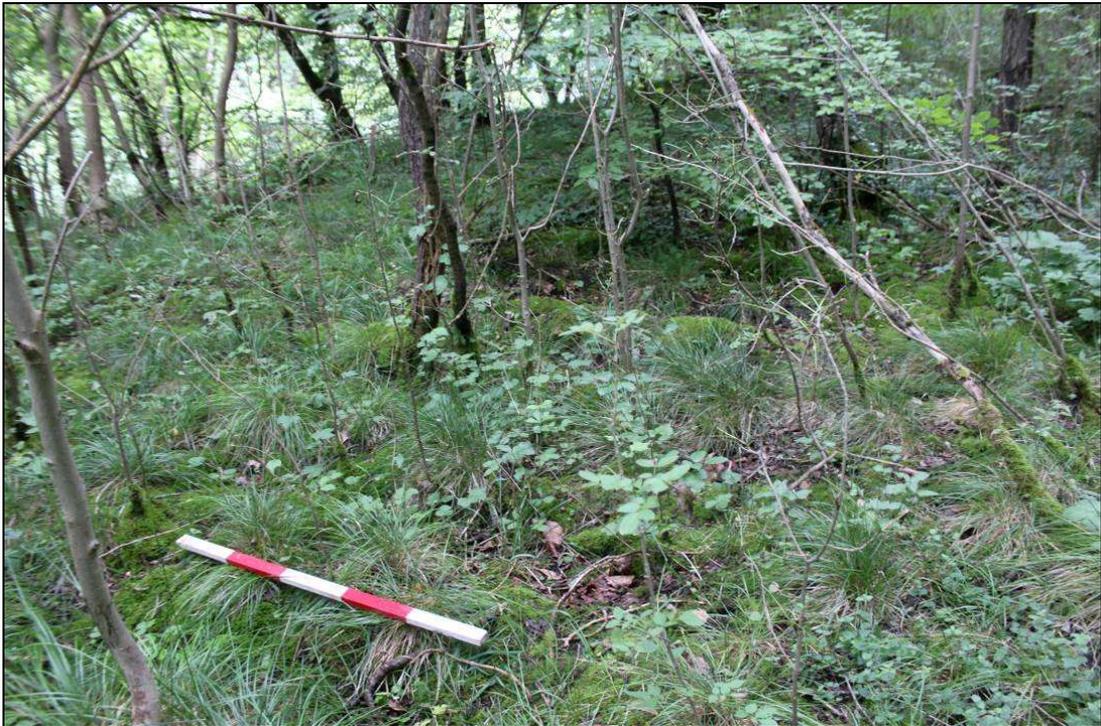
*Plate 5: The in-situ railway sleepers (Site 05), just visible as overgrown linear tufts. 1m scale*

<b>Site number</b>	<b>05</b>
<b>Site name</b>	Railway Sleepers
<b>NGR</b>	408232 372460
<b>Site type</b>	Railway
<b>Period</b>	Industrial
<b>SMR No</b>	-
<b>Statutory Design</b>	-
<b>Sources</b>	Cowdale Quarry and Limeworks, Kings Sterndale: Conservation Management Plan (Johnson, 2013)
<b>Description</b>	The sleepers of at least two separate lines were identified on the terrace above the slope. Both lines were heavily overgrown and appeared to have lost their tracks. The northernmost line lay within 2m of the edge of the present slope.
<b>Assessment</b>	The site lies close to the proposed development area and may potentially be affected by the works.

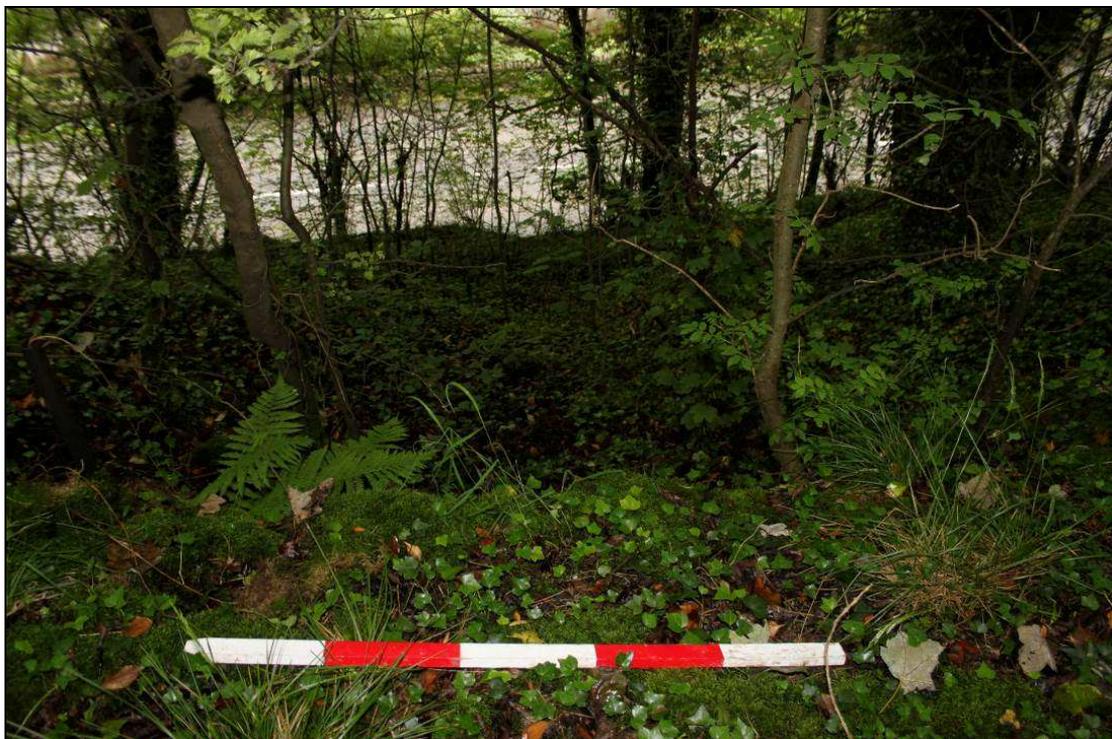
*Plate 6: The possible drainage gully from the top of the culvert exit (Site 01), looking north towards the road. 1m scale*

<b>Site number</b>	<b>01</b>
<b>Site name</b>	Drain/ Culvert
<b>NGR</b>	407958 372478
<b>Site type</b>	Drain
<b>Period</b>	Industrial
<b>SMR No</b>	-
<b>Statutory Design</b>	Scheduled Monument
<b>Sources</b>	-
<b>Description</b>	A linear depression running from south to north down the slope of the bank was identified approximately 44.6m to the east of the kiln battery. It had a depth of up to 1.2m at the top of the slope, becoming increasingly shallow towards the base of the slope where it became harder to identify. At the top of the bank the depression was 5m wide, again narrowing quickly to the north, and there may have been a culvert exit, identified via a sharp change in angle. The position of the feature on the steep slope overlooking the A6 prevented further examination.
<b>Assessment</b>	The site lies beyond the proposed development area and is unlikely to sustain any direct impact, but its setting is likely to be affected.

- 6.2.6 **Survival/Condition:** the condition of the possible Drain/Culvert (Site **01**) is presently unknown, and the level of vegetation may have protected or damaged any structural remains. The remaining structures relating to the quarry are generally in poor condition and in need of conservation, but none appear to be in imminent danger of collapse. Several structures have been subjected to vandalism. Even in their current condition, however, the survival of the quarrying complex is exceptional.

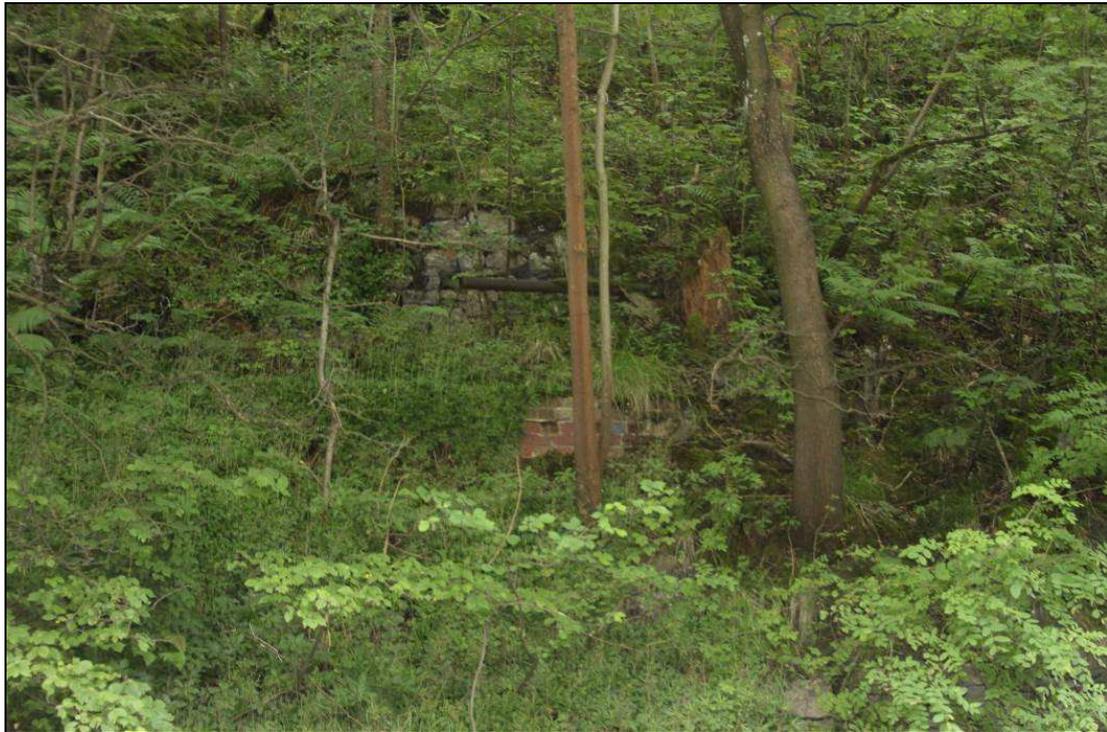
Plate 7: The brick and stone structure (Site 02) on the lower bank, looking south, viewed from the road

<b>Site number</b>	<b>02</b>
<b>Site name</b>	Brick and stone structure
<b>NGR</b>	408014 372476
<b>Site type</b>	Structure
<b>Period</b>	Industrial
<b>SMR No</b>	-
<b>Statutory Design</b>	Scheduled Monument
<b>Sources</b>	-
<b>Description</b>	Two sections of parallel wall, one of red brick the other of stone, were identified towards the base of the slope, approximately 2m south of the road. The brick wall was E-W aligned, about 0.5m high and 2.5m long. The stone wall was approximately 1m high, 2m long and 2m to the south of the brick wall. An iron pipe ran E-W between the two and the structure was heavily obscured by vegetation. A second pipe of similar dimension is visible at the top of the slope protruding northwards from the bank.
<b>Assessment</b>	The site lies beyond the proposed development area and is unlikely to sustain any direct impact, but its setting is likely to be affected.

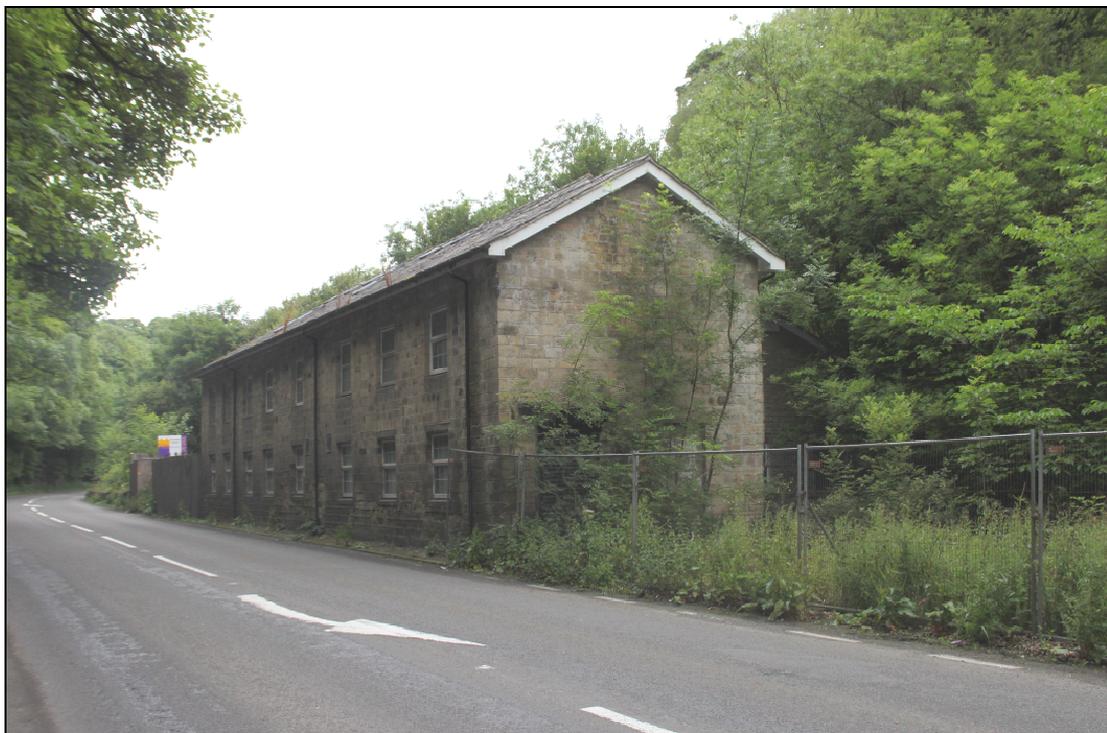
Plate 8: The disused Devonshire Arms (Site 03), looking west along the A6

<b>Site number</b>	<b>03</b>
<b>Site name</b>	Devonshire Arms Pub
<b>NGR</b>	408142 372486
<b>Site type</b>	Mill
<b>Period</b>	Industrial (pre 1880)
<b>HSMR No</b>	-
<b>Statutory Design</b>	-
<b>Sources</b>	1879-1880 OS map
<b>Description</b>	A two-storey narrow gabled rectangular, stone built building on the northern side of the road. The building is aligned to the river upon its northern side and appears to be disused. A building of similar dimension is depicted on the 1879-80 OS map.
<b>Assessment</b>	The site lies beyond the proposed development area and is unlikely to sustain any direct impact.

- 6.2.7 **Fragility/Vulnerability:** the buildings of the quarry in particular are subject to vandalism, as well as potential damage caused by vegetation and neglect. As a disused and unoccupied building the former Devonshire Arms must also be judged as vulnerable to vandalism and decay.

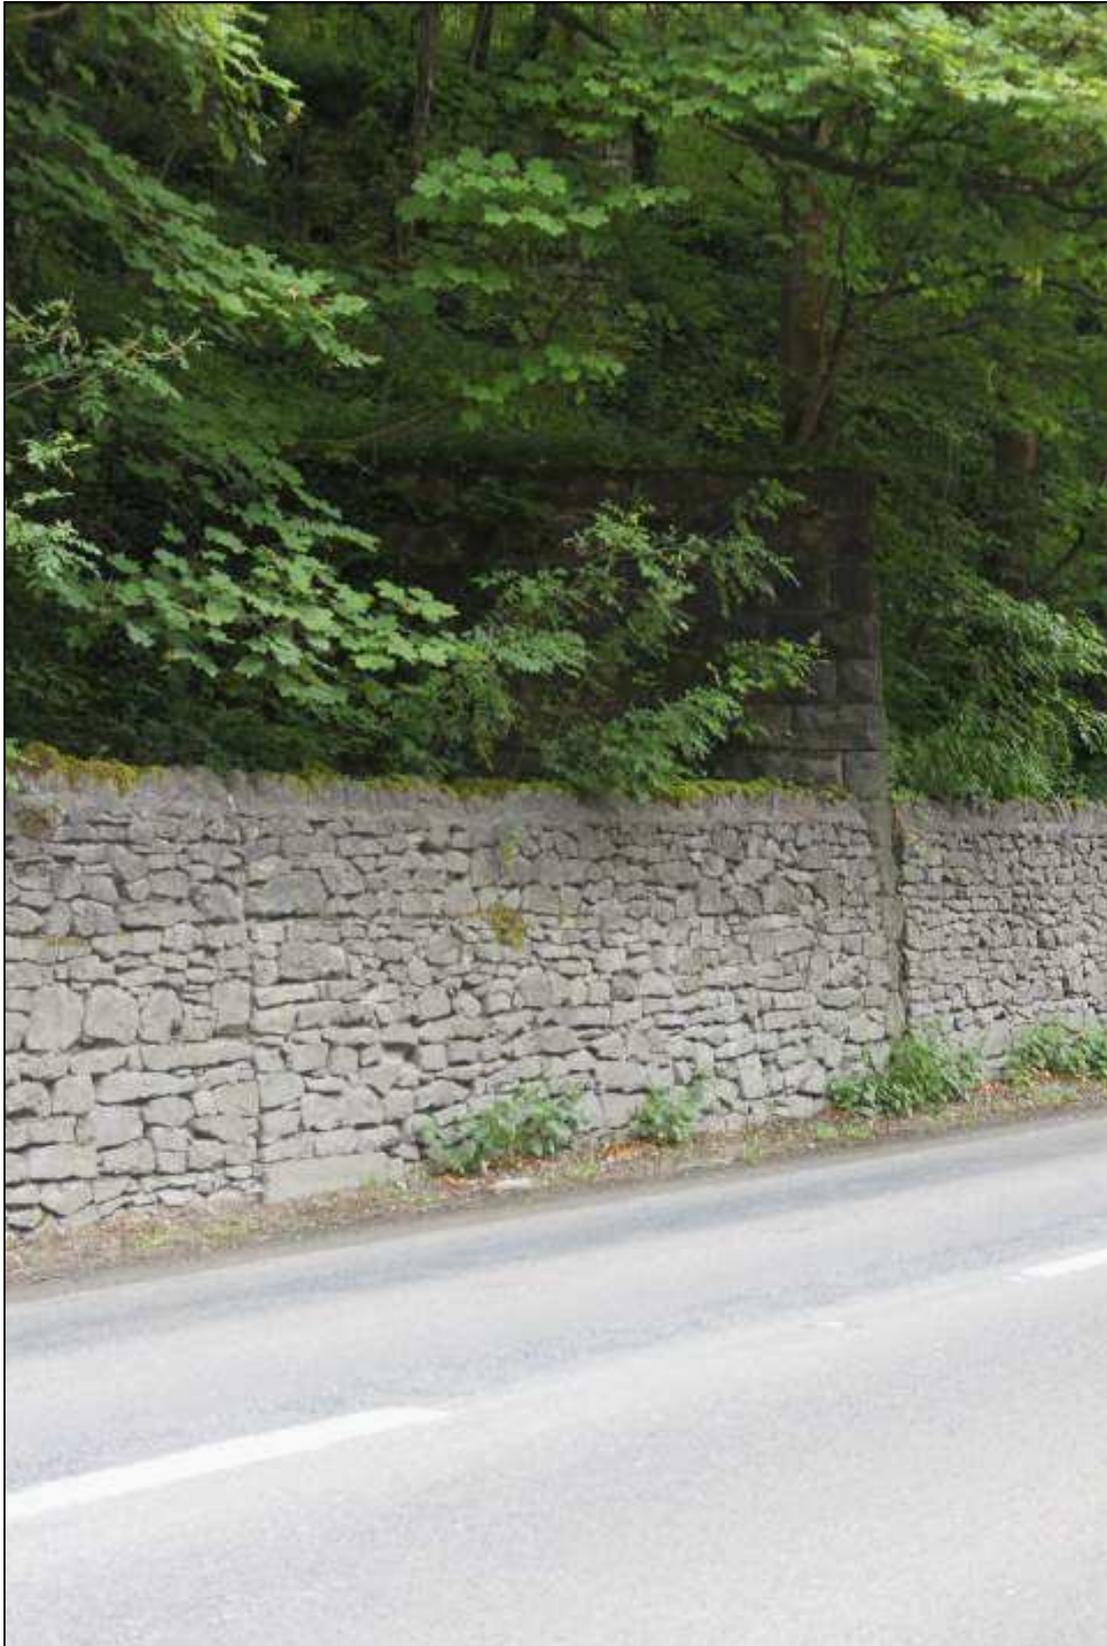
*Plate 9: The lower bridge abutment (Site 04), looking south-west across the A6*

<b>Site number</b>	<b>04</b>
<b>Site name</b>	Bridge Abutments
<b>NGR</b>	408148 372468
<b>Site type</b>	Structure
<b>Period</b>	Industrial
<b>SMR No</b>	-
<b>Statutory Design</b>	-
<b>Sources</b>	Cowdale Quarry and Limeworks, Kings Sterndale: Conservation Management Plan (Johnson, 2013)
<b>Description</b>	The remains of two stone-built bridge abutments, formerly designed to carry what was probably an iron railway bridge across the road. Each abutment measured approximately 3m square and was finished in coursed rusticated stone.
<b>Assessment</b>	The site lies within the proposed development area and is likely to be affected by the works.

8.2.3 The construction of the proposed lay-by is likely to cause damage to the former bridge abutments (Site 04), although this could perhaps be mitigated by further archaeological investigation. Pending final design proposals, and specifically the extent to which the rock-face will need to be cut back, there is some potential for substantial direct impact on a former railway line within the limeworks complex, and also on the crushing plant and loading gantry. Any direct impact on these designated structures would clearly constitute substantial harm that would be very difficult to justify in the context of creating a new lay-by.

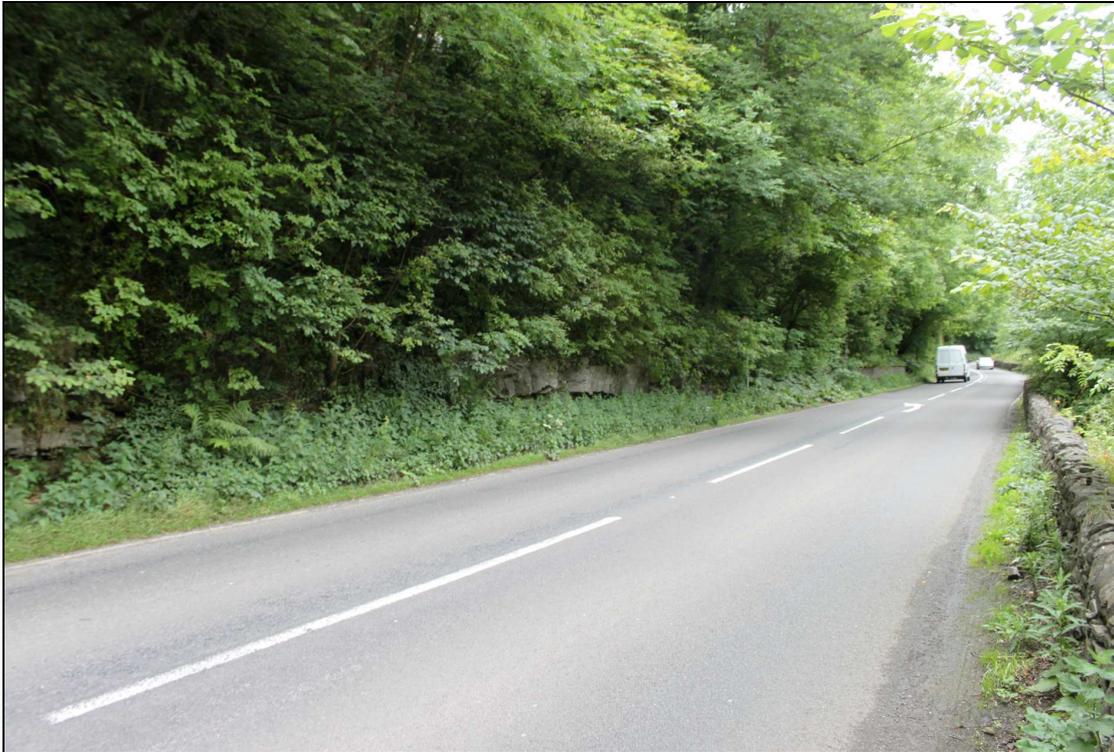
- 7.2.2 Views towards the heritage assets from the roadside are heavily obscured by the tree cover (Plates 10 and 11), and it is likely that the majority of people passing by are unaware that the quarry and associated structures exist. The roadside is not pedestrian friendly, with the speed of the traffic, blind corners and occasional sections of narrow pavement producing an intimidating and dangerous environment for walkers and cyclists alike.

*Plate 10: View along the A6, looking west across the proposed location of the lay-by*

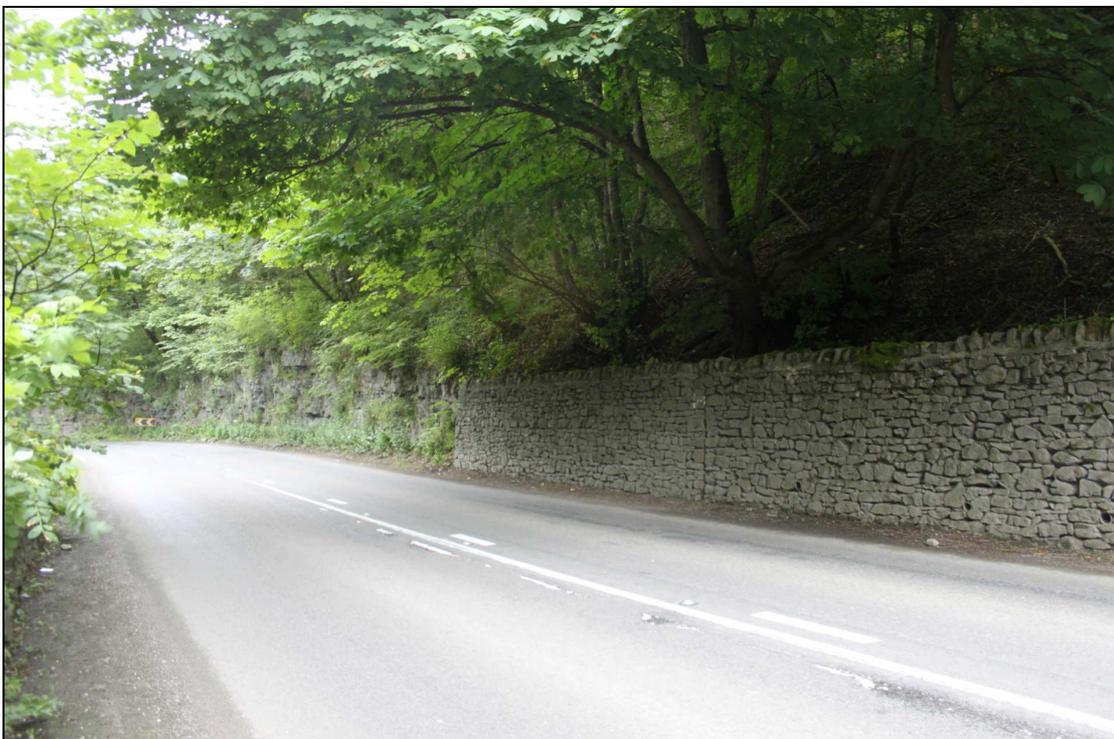
*Plate 11: View along the A6, looking east to the south of the proposed location of the lay-by*

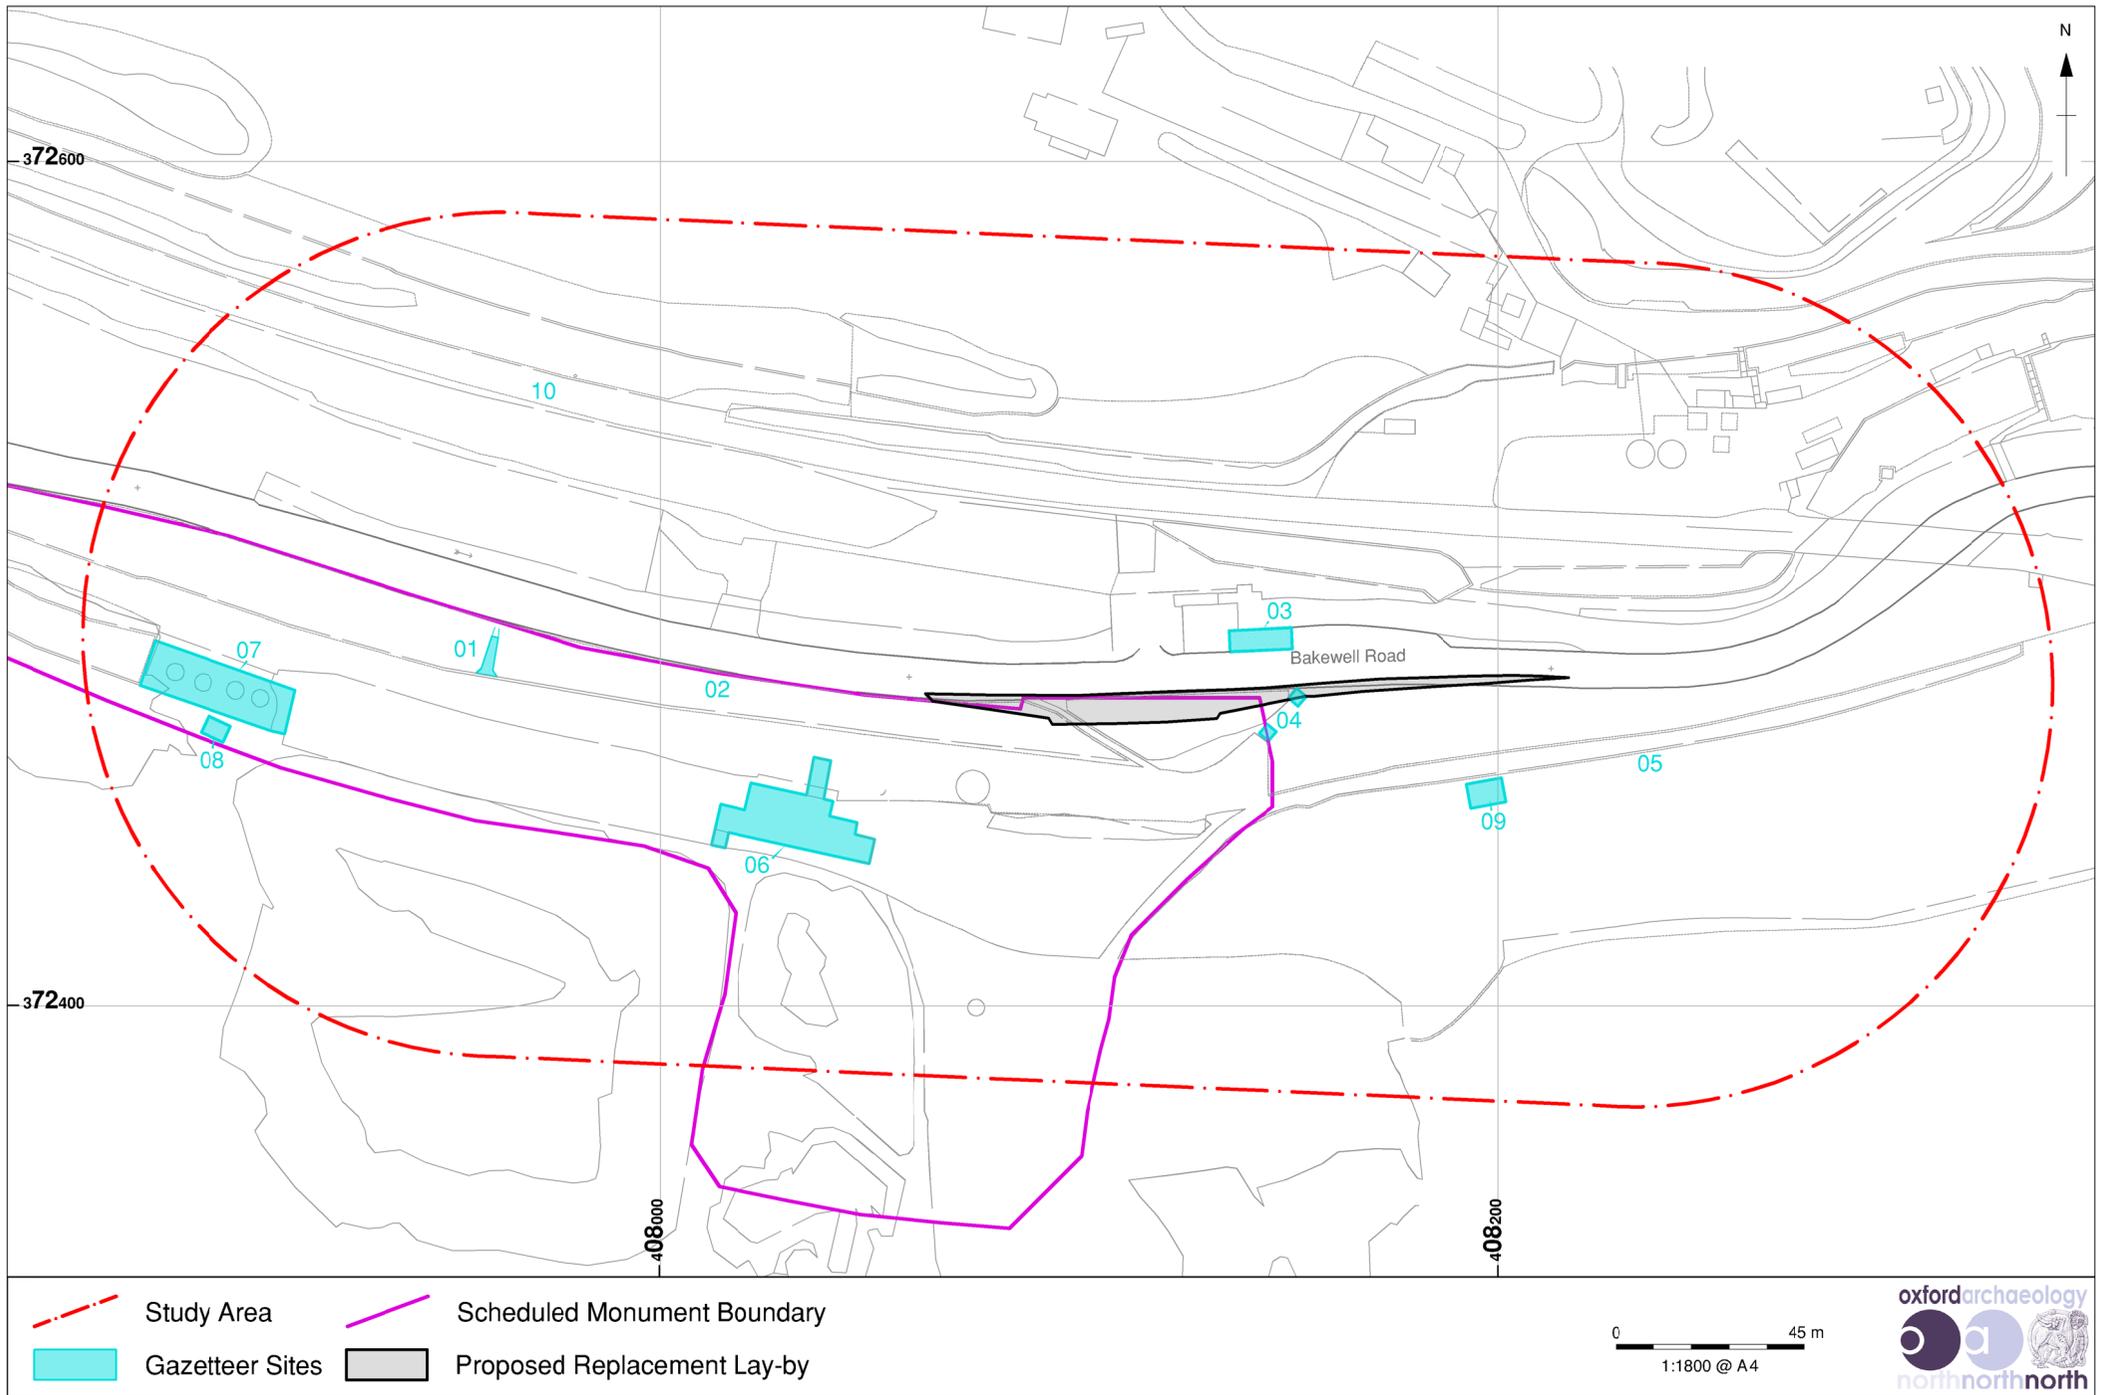
Figure 2: Plan showing the locations of the gazetteer sites, and the preferred location for the replacement lay-by

- 8.1.1 Following consultation with Derbyshire County Council, the most viable location for the replacement lay-by straddles the north-eastern boundary of the Scheduled Monument, a short distance to the north-east of the Crushing Plant (Fig 2). The preferred option for the lay-by allows for a length of 37m, with 30m long splays at each end.
