Hulton Heys, Cutacre, Little Hulton, Bolton

Archaeological Evaluation

Oxford Archaeology North

October 2014

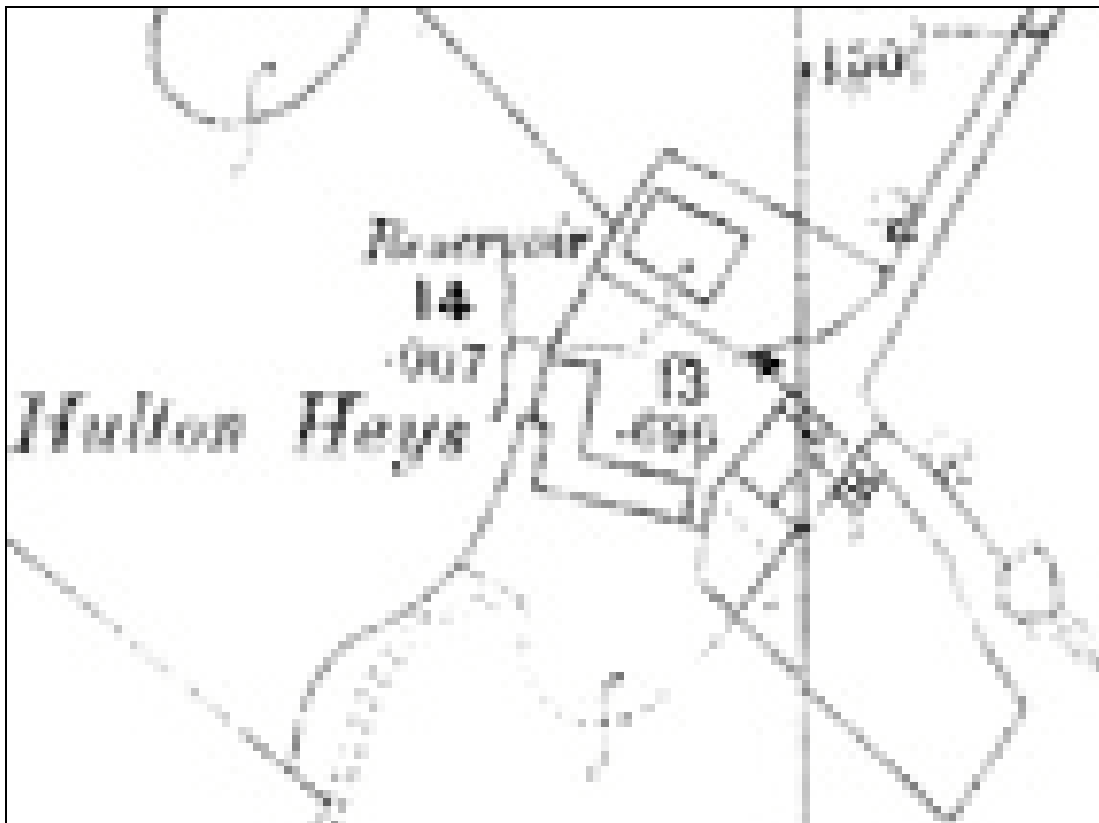
- 1.3.9 In terms of cartographic evidence, a farmhouse and barn are depicted at Hulton Heys on a *c* 1772 Bagot Estate plan, and these are also plotted on the 1849 Ordnance Survey (OS) map (Plate 2). An undated mid-nineteenth-century plan (MA L5/4/1/1-2) indicates by the time of this survey a cartshed and stables had also been erected, which directly adjoined the barn. The survey book accompanying this plan lists the farmstead as comprising ‘House, Cottage, Outbuildings, Yard, Garden & Road’, leased by William Newton (*ibid*). Census returns show two households at the farm in 1841-81, at which period the farmhouse appears to have comprised a main house and a cottage (Table 1). The farm complex is shown fully developed on the OS maps of 1893 (Plate 3).

Plate 3: Hulton Heys as depicted on the 1893 OS 25":1mile map

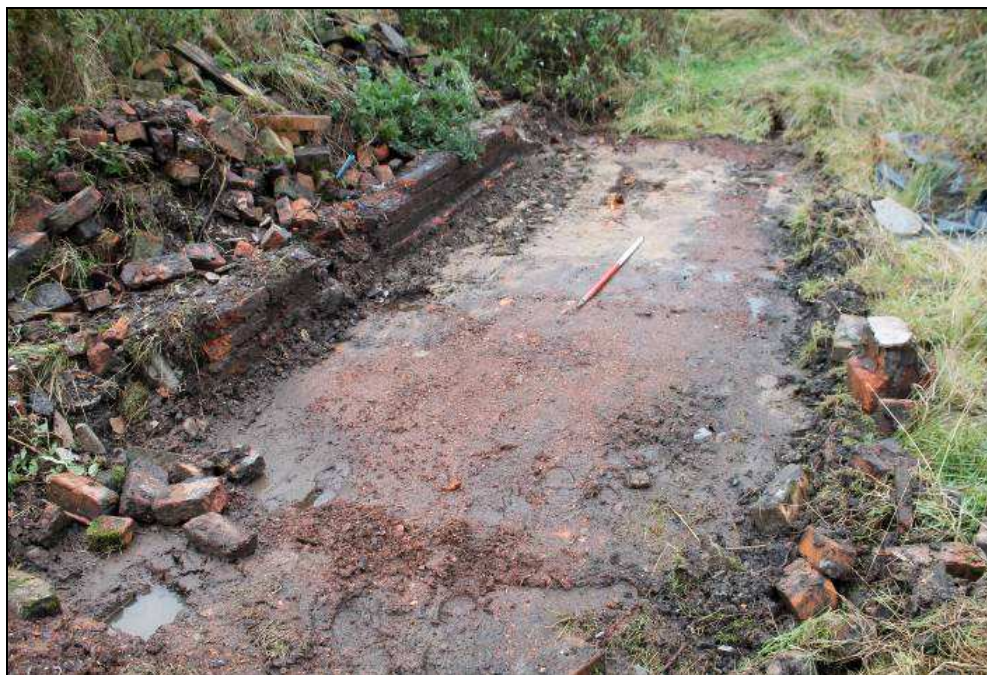
3.2.2 At the southern edge of the trench a machine-made brick wall (**101**) bonded with white mortar, was evident (Plate 4), which probably dates to the late nineteenth or early twentieth century. This wall was aligned east/west, extending for a distance of 3.8m, with a southerly return at its eastern end.

Plate 4: Trench 6 general view, wall **101** on left, looking south-west

3.2.3 The position of wall **101** indicates that it represents the northern wall of the former barn. Moreover, its location indicates that it formed the exterior wall of a later addition to the original late eighteenth-century barn, which was noted when the extant building was described in 1991 (bay 4; *Section 1.3.10*). At the western end of the wall was a stone block (**103**; Plate 5).

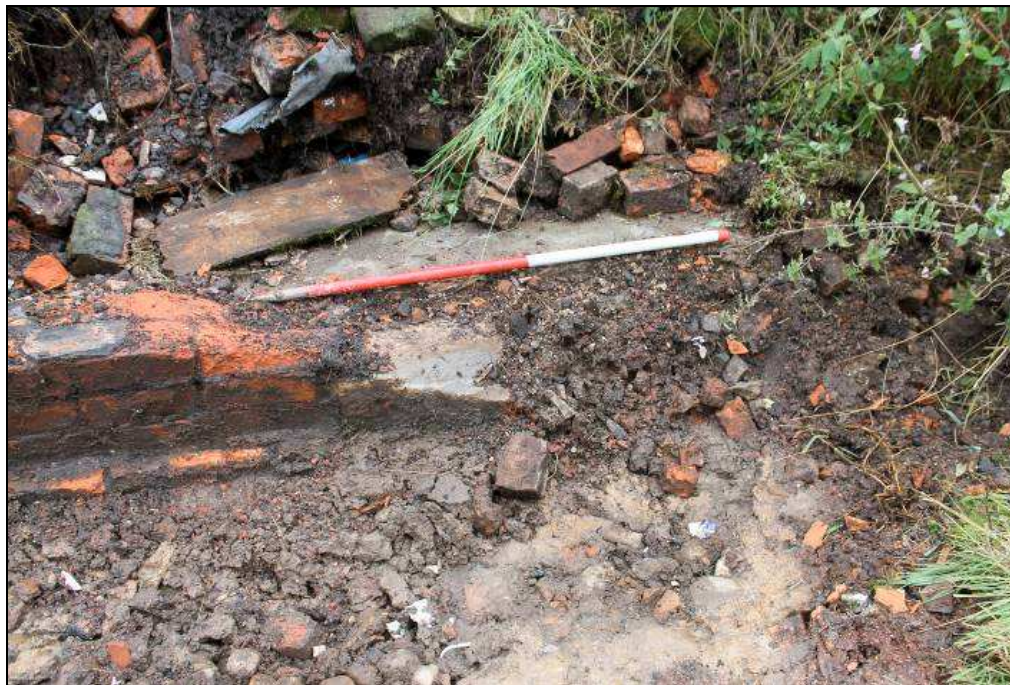
- 3.2.4 This possibly formed part of a wall foundation or was perhaps a threshold, denoting the position of a doorway at the end of the later addition to the barn. To the south of these features was a concrete floor surface (**102**), which was positioned within the interior of the later addition to the barn.

Plate 5: Stone block 103, looking south

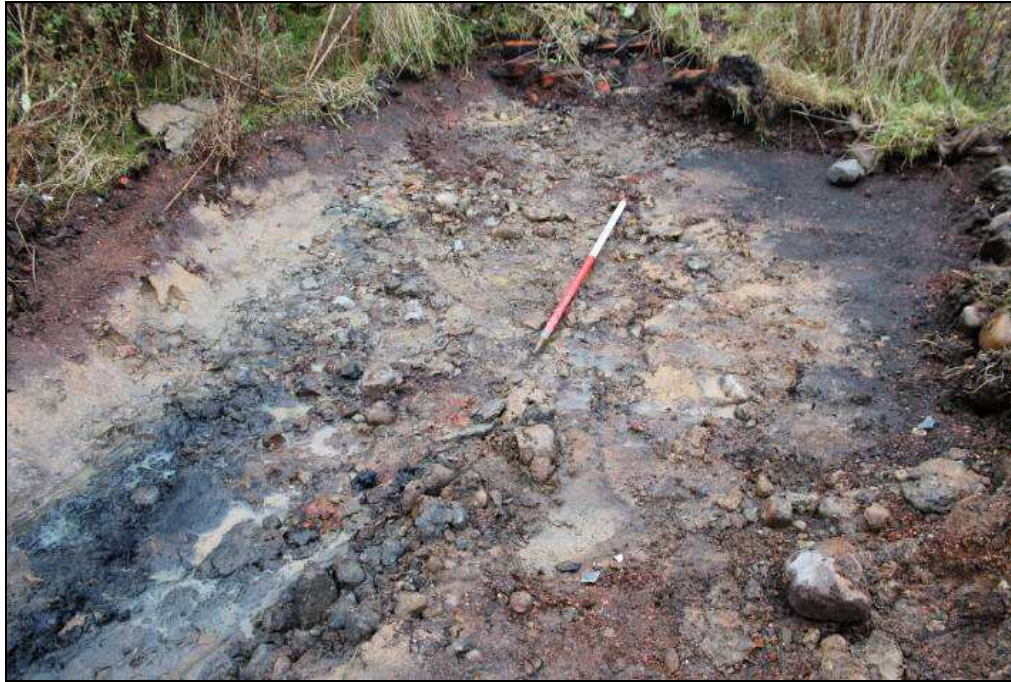
- 3.3.2 The earliest remains encountered in this trench included a metallised surface and a stone wall. The metallised surface (**206**; Plate 6) consisted of very compact small pebbles of varying sizes, set into a layer of clay, and it may well represent an early floor or yard surface. It was very roughly made and lay partially below a later cobbled yard surface that was positioned to the north of the cartshed/stables.

Plate 6: Metalled surface 206 , looking west

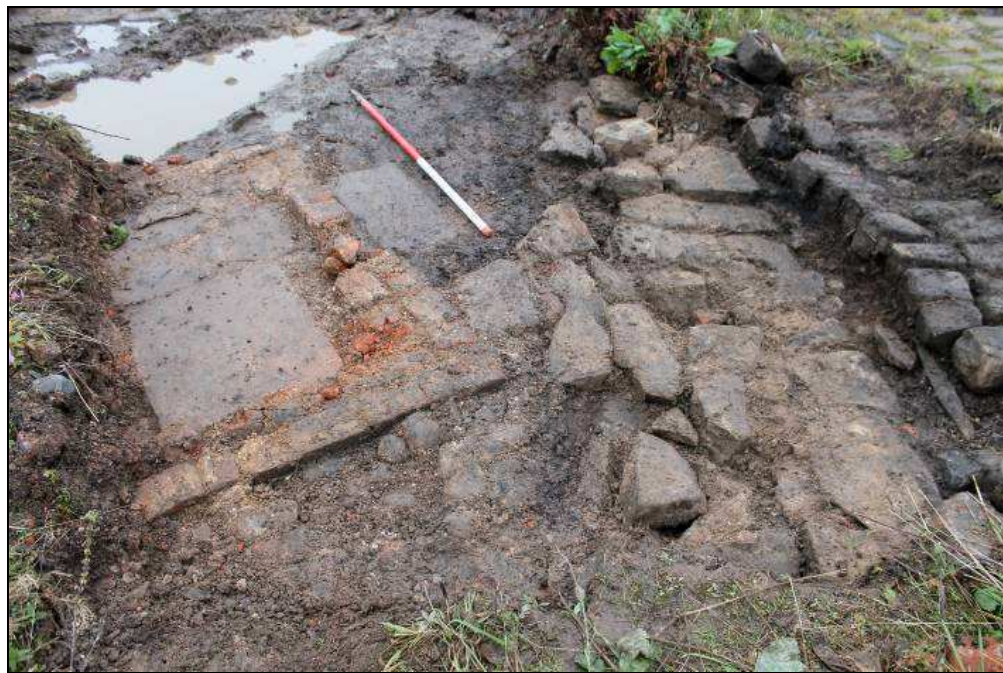
- 3.3.3 The wall (**205**; Plate 7) was 0.87m wide and was orientated north/south. It comprised a stone-core foundation with no apparent mortar. Its composition and relationship to other features in the trench suggest that it might represent a comparatively early feature.

Plate 7: Stone wall 205 (right) with brick structure 204 (left), looking north

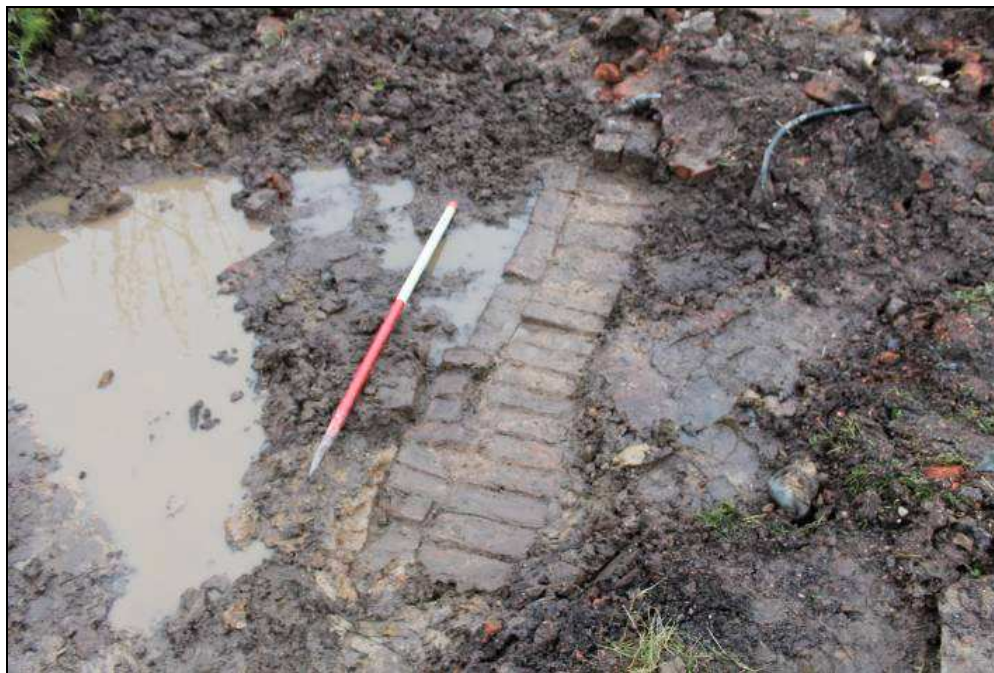
- 3.3.4 A later feature encountered in this trench was a stretch of brick walling (**203**; Plate 8). The fabric of the wall comprised hand-made bricks, bonded with white lime mortar, and was one header- and one stretcher-course wide. It had been cut into natural boulder clay (**207**), and appeared to be the foundation for the northern wall of the cartshed/stables. As such it probably dates to mid-nineteenth century (*Section 1.3.9*).

Plate 8: Hand-made brick, wall 203, looking west

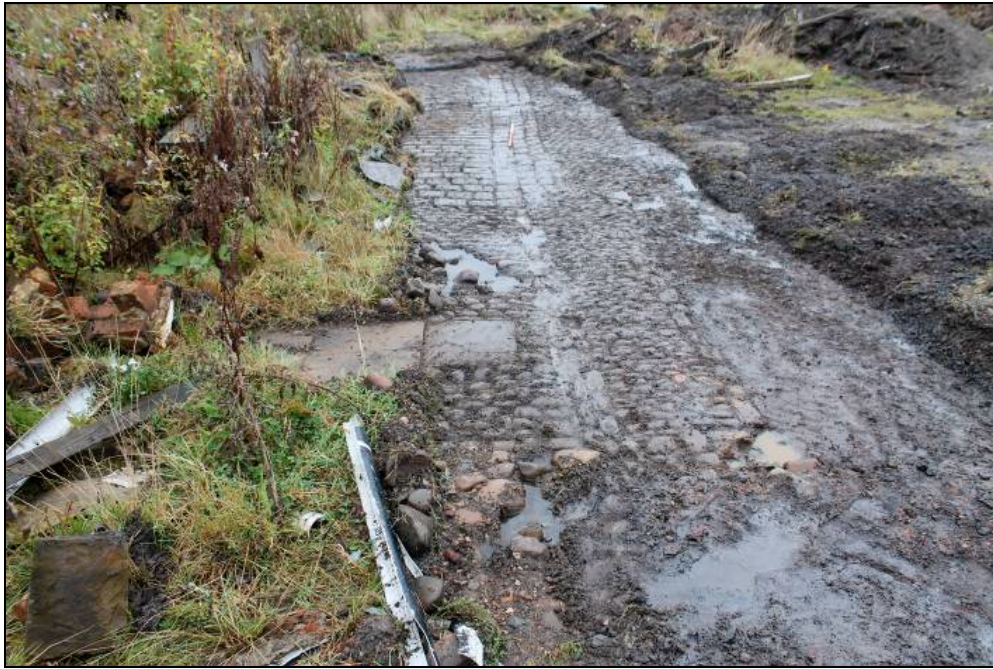
Plate 9: Cobbled surfaces **302**, **303** and **304**, with flags to left, looking south-west

- 3.4.3 Later features were encountered across the main part of the trench and included a cobbled yard surface (Plates 9 and 10). This surface contained a north-east/south-west-aligned drainage run composed of large, 0.23 x 0.21m, stone sets. At the south-western end of the drainage run was a cast-iron grid (**306**). To the east and south of the drainage run was a surface of large stone sets (**305**), whilst to the west was a surface of smaller cobbles (**304**). These also extended to the north of **305** in a 0.68m-wide line boarded by larger narrow cobbles. To the east of this line of small cobbles was a surface of moderately sized cobbles (**303**) with stone flagging to the east, visible within a small extension to the trench edge. At the north end of the trench, the surfaces had been destroyed by an area of later disturbance (**301**).

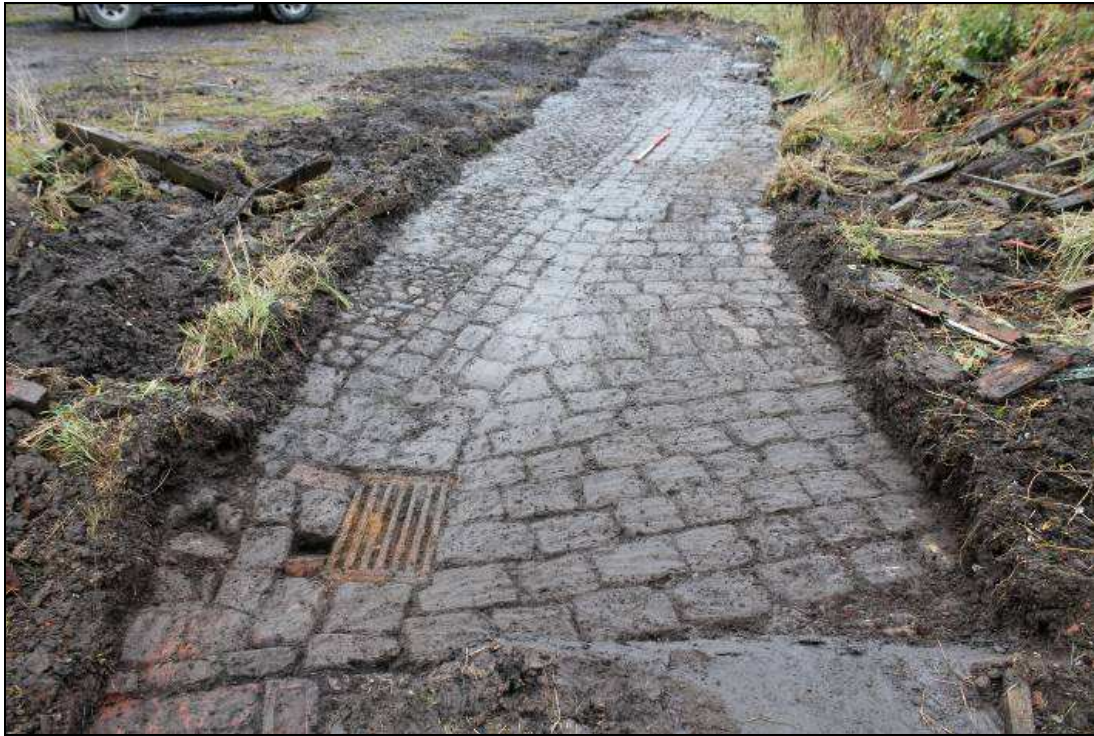
Plate 10: Set surface 305 with grid 306 at the end of the drainage run, looking north-east

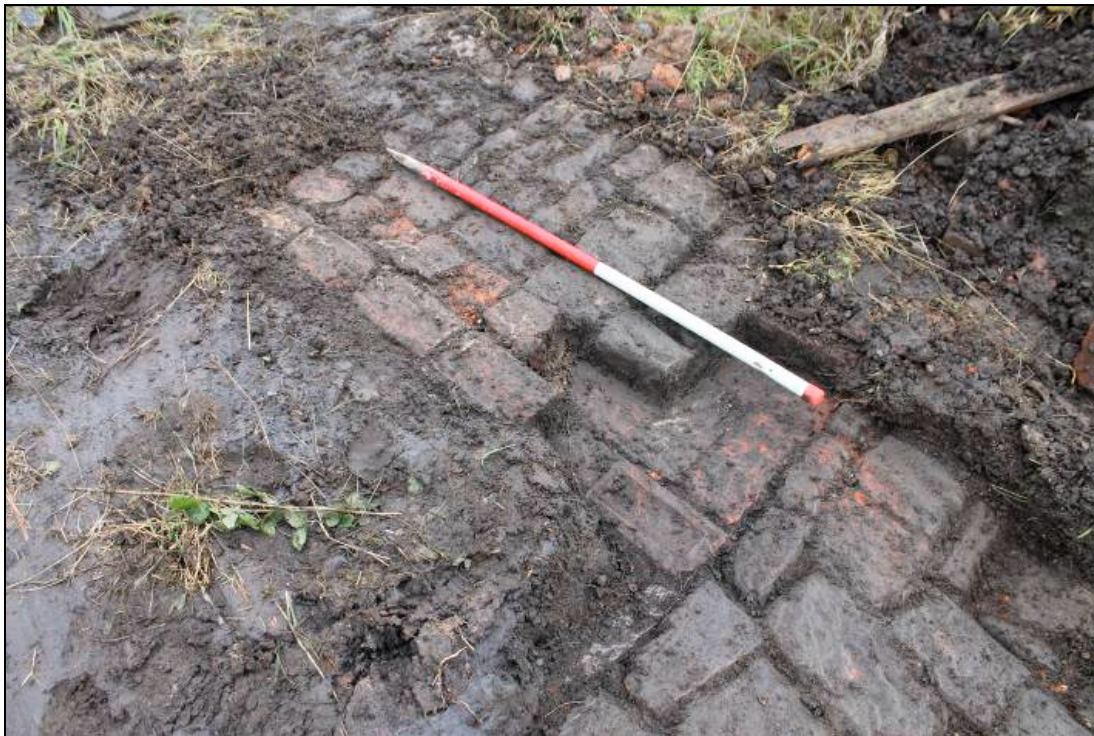
- 3.4.4 To the south of cobbled surface **305** was a right-angled stretch of machine-made brick wall (**307**), bonded with hard dark cement (Plate 11). This was two-stretcher-courses wide and ran north from the southern trench edge, before turning to the west. This wall aligned with wall **203** in Trench 2 (Section 3.3.3) and it is possible that it represents a later rebuild of the eastern end of the stables/cartshed. To the west of this, within the building, was a floor surface (**308**) composed of large sets.

Plate 11: Brick wall 307 with set surface 308 in background, looking north-west
