Adlington WwTW to Bonis Hall Lane Rising Main, CHESHIRE

Rapid Walkover Survey, Watching Brief and Evaluation Report

Oxford Archaeology North

January 2008

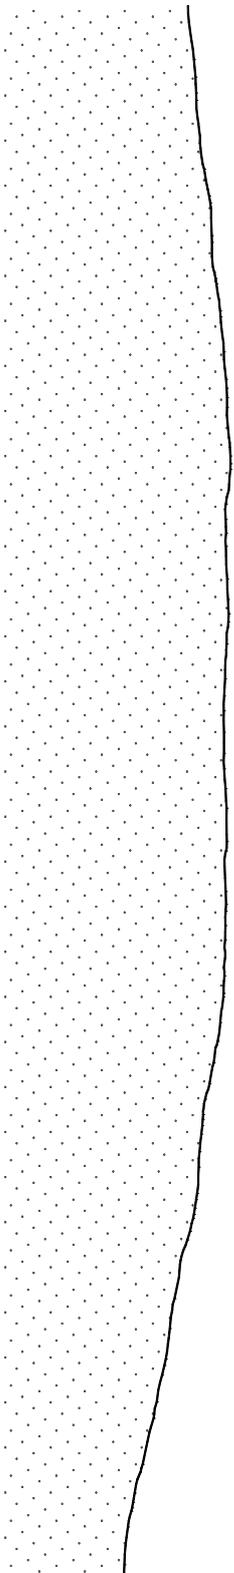
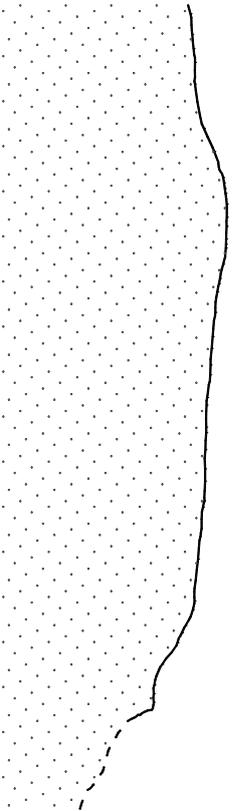
Figure 3: Profiles of sites 31 and 37

Profile of Site 31 (trackway near Adlington Hall)

Profile of Site 37 (post-medieval earthwork)

- 4.2.5 Within the Adlington Estate is a wooded area known as ‘The Wilderness’ containing several earthwork features. An earthwork bank (Site **31**) follows the line of a trackway leading into ‘The Wilderness’ on the 1st Edition Ordnance Survey map, 1882. A hollow way or pathway (Site **33**) crosses ‘The Wilderness’, comprising two banks, which may represent one of several such planned pathways. Two possible marl pits (Sites **34** and **35**) occupy the south-eastern corner of ‘The Wilderness’; Site **35** is marked on the 1st Edition Ordnance Survey map. A pond (Site **38**), situated immediately outside of the wooded area, can be matched with a pond shown on the 1st Edition Ordnance Survey map, which lies partially outside of ‘The Wilderness’.

- 4.2.6 To the east of ‘The Wilderness’ is a tree-lined bank (Site **37**) aligned north-east/south-west. This appears to be the current boundary of the Adlington Estate, and the trees seem to have been deliberately planted along the bank. The bank follows the course of a stream, which lies to its south-eastern side.

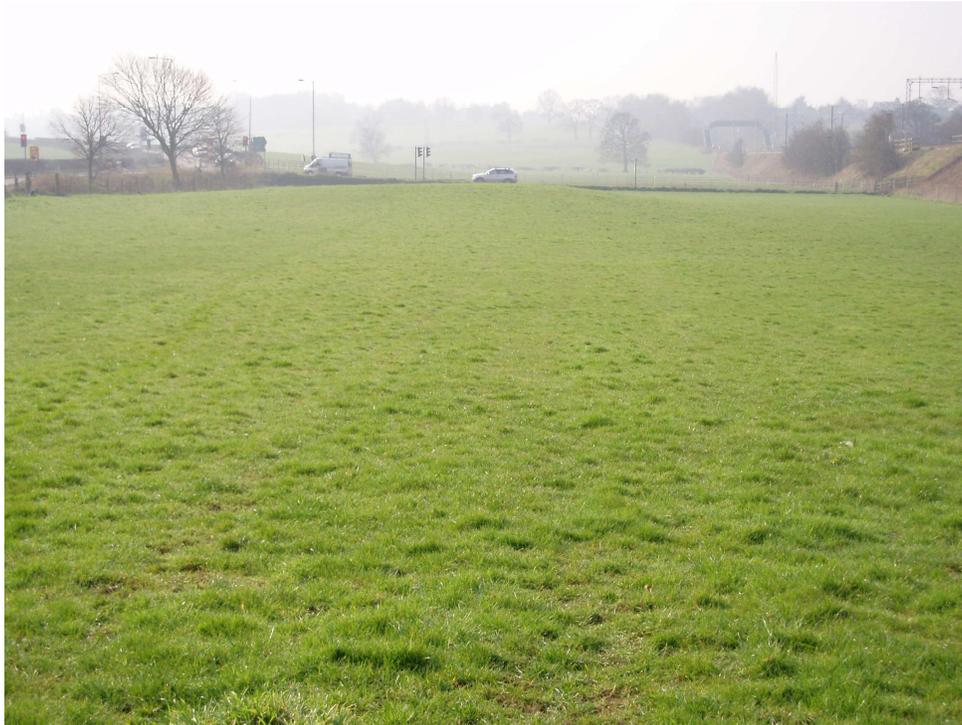
Plate 1: Site of Barrow (Site **02**), visible as an earthwork

- 4.2.3 **Prehistoric Burial Monuments:** a Bronze Age barrow (SM No 22578) survives in the form of a low earthen mound (Site **02**). There are no signs of the kerbstones or cairns which were mentioned by JD Saniter in 1878. The barrow is located in the field opposite the nursery on London Road (A523) (Plate 1). Site **1** may represent the same feature, albeit with an erroneous grid reference.

According to the HER, this is the site of the probable barrow, discovered and partially excavated in 1808. The site was made up of a collection of cairns, some enclosed by circles of large stones covered by a large earth mound. One cairn was opened and contained an urn and burnt bone, covered by a flat stone, with further associated bone fragments and pieces of copper (Sainter 1878). The urn, which was of Abercromby type 1 and had Irish affinities (Bu'lock 1961), is now lost and the precise location of the barrow is not known, although earthworks on this spot may correspond to it (Plate 1).

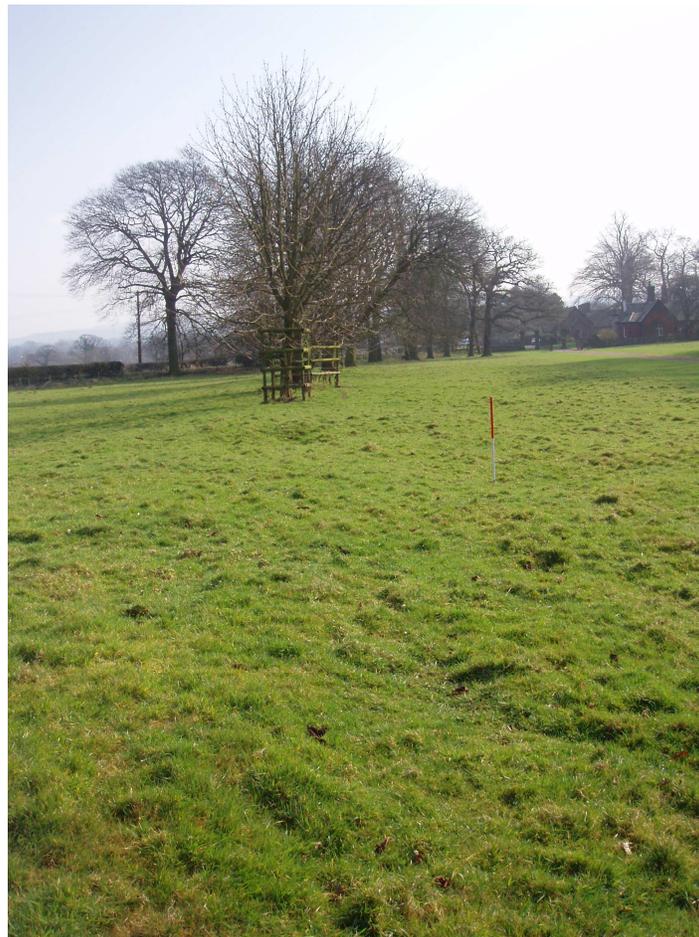
Plate 2: Possible tree-lined avenue (Site **30**) in the Adlington Hall Estate

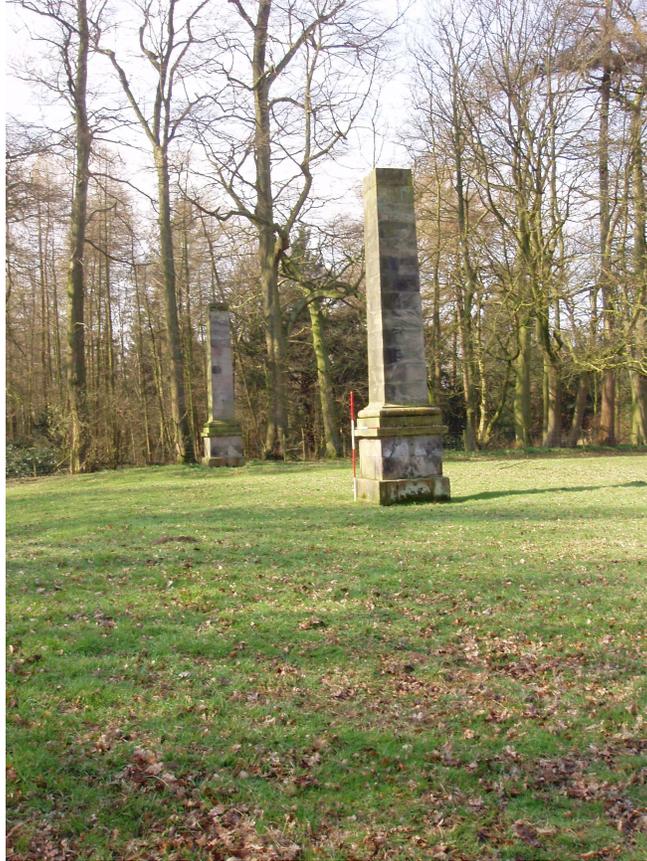
Plate 3: Disused gateposts (Site **32**) for the Adlington Hall Estate

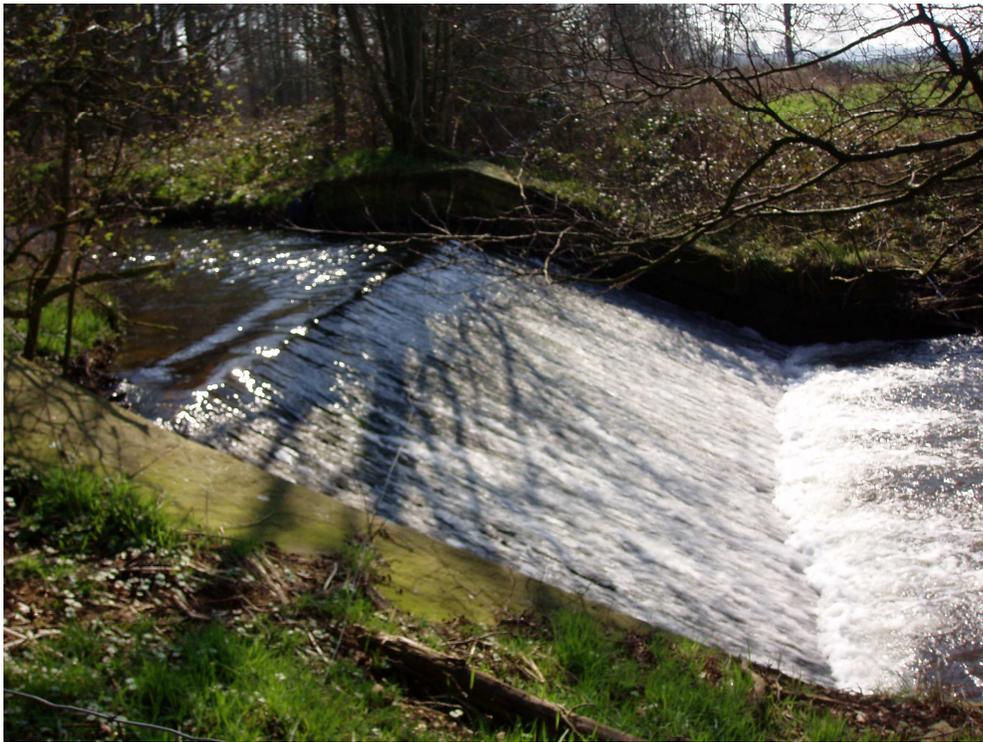
Plate 4: Sandstone weir (Site **40**)

- 4.2.12 **Miscellaneous Sites:** a stone weir (Site **40**) with an associated stone channel to the north is located in Issue Wood. The stone channel at the northern head of the weir has grooves indicating that a sluice gate was once present. The channel is fed by a ditch to the north, which runs along the edge of Issue Wood.

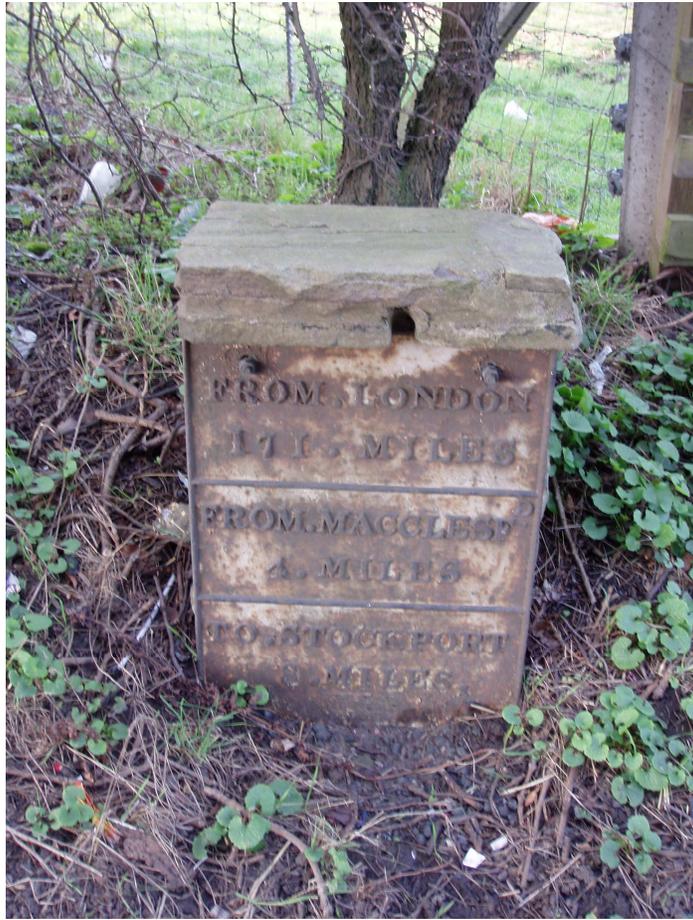
Plate 5: Milestone (Site 44) next to London Road

- 4.2.14 A milestone (Site **06**) was identified on the north-western side of the railway bridge above London road. The milestone is shown on both the 1st and 2nd Edition Ordnance Survey maps accompanied by distances to London, Macclesfield and Stockport.

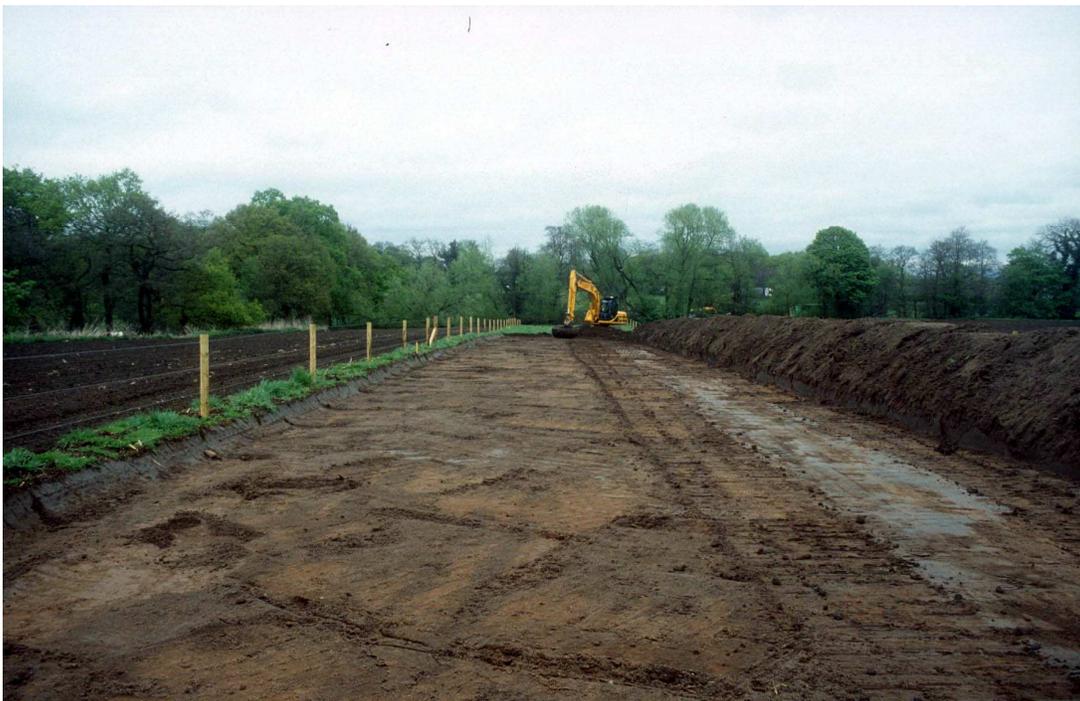
Plate 6: Topsoil strip to the north of Mill Lane (Field 1)

Field Number	Location	Description
1	North of Mill Lane, west of the A523 and near the sewage works.	Removal of <0.30m of topsoil (1) revealed an underlying light brownish-orange, clayey-sand (2) (Plate 6). A number post-medieval pottery sherds were recovered from the topsoil layer (1) but no archaeological features were observed.
2	To the south of Mill Lane; south-west of Field 1.	No topsoil stripping took place. Site 30 (the tree-lined avenue) had a flat profile in this area.
3	To the north of Brook House Farm access road to the west of the A523; south of Field 1.	Bank/earthwork (Site 37) and the north-east end of a post-medieval trackway/boundary (Site 31) near Adlington Hall were observed in this field. Both of these sites were located outside the easement.
4	To the south of Brook House Farm access road to the north of the River Dean; south of Field 3	No topsoil strip was undertaken in the evaluation excavation area near Site 10.

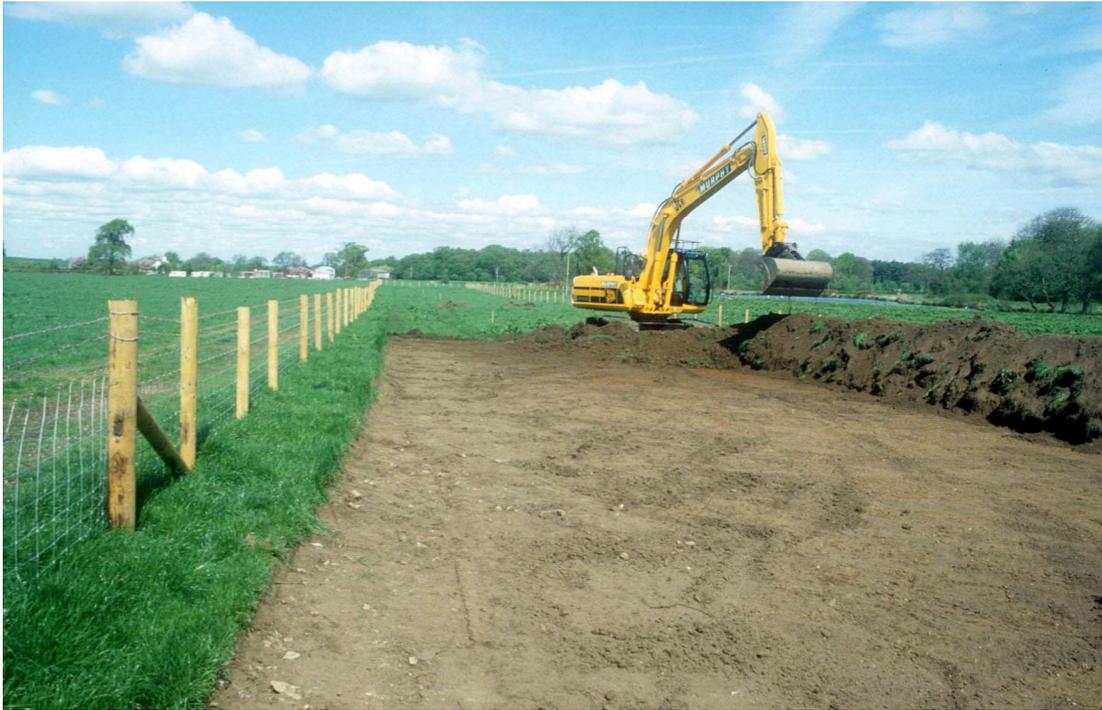
Plate 7: Topsoil strip north of Mill House (Field 5)
