STOREY INSTITUTE, MEETING HOUSE LANE, LANCASTER

Archaeological Building Investigation and Test Pit Evaluation

Oxford Archaeology North

June 2008

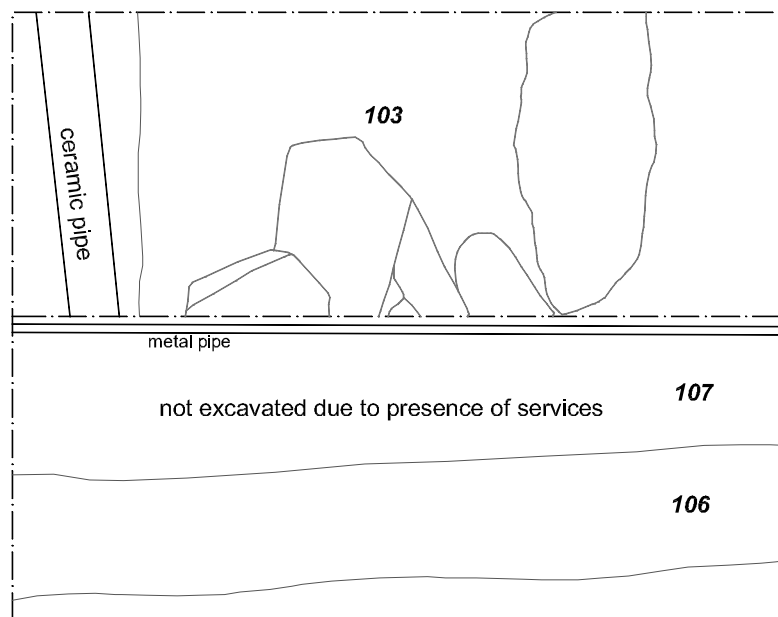
Figure 3: Plan of test pit 1

- 5.1.1 Test Pit 1 (Fig 2 and 3) was located in the courtyard to the Storey Institute. Due to issues of access to the building the test was reduced in size to 2m by 1.60m. The current ground level lay between 28.48m OD in the south and 28.48m OD in the north. The test pit was excavated down to a depth of 1.08m (27.26m OD). The natural was located some 50mm below the present surface between 28.17m and 28.12m OD. Due to the presence of live services the working width of the test pit was reduced a 1m wide strip on the west side.

- 5.1.2 The basal deposit within test pit comprised several large sandstone and limestone boulders (**104**), the largest of which measured 0.70m by 0.45m. These boulders were located on the west facing section within the middle of the test pit. It was unclear whether they were part of a natural glacial deposit, or whether they formed part of a terrace used as a foundation for the building to the immediate west.

- 5.1.3 Sealing the boulders was a 0.70m deep layer of orange-brown clay (**103**). Again it was unclear whether this was a naturally deposited clay or whether it was part of the posited foundation for the Storey Institute. This was in turn sealed by a 0.18m thick cobbled surface (**102**) with a clay basal layer. The south end of this deposit had been cut by a 0.65m deep service trench containing a east/west aligned 6" (153mm) cast iron pipe. The top of this service trench had been later cut by several more recent service trenches (**106** and **107**) running in a north/south direction and occupying the whole of east side of the test pit. The entire area was then sealed below a thin (50mm) layer of grey-brown clay (**101**), which had been used as a foundation layer for the stone setts, which formed the surface within this part of the Storey Institute.

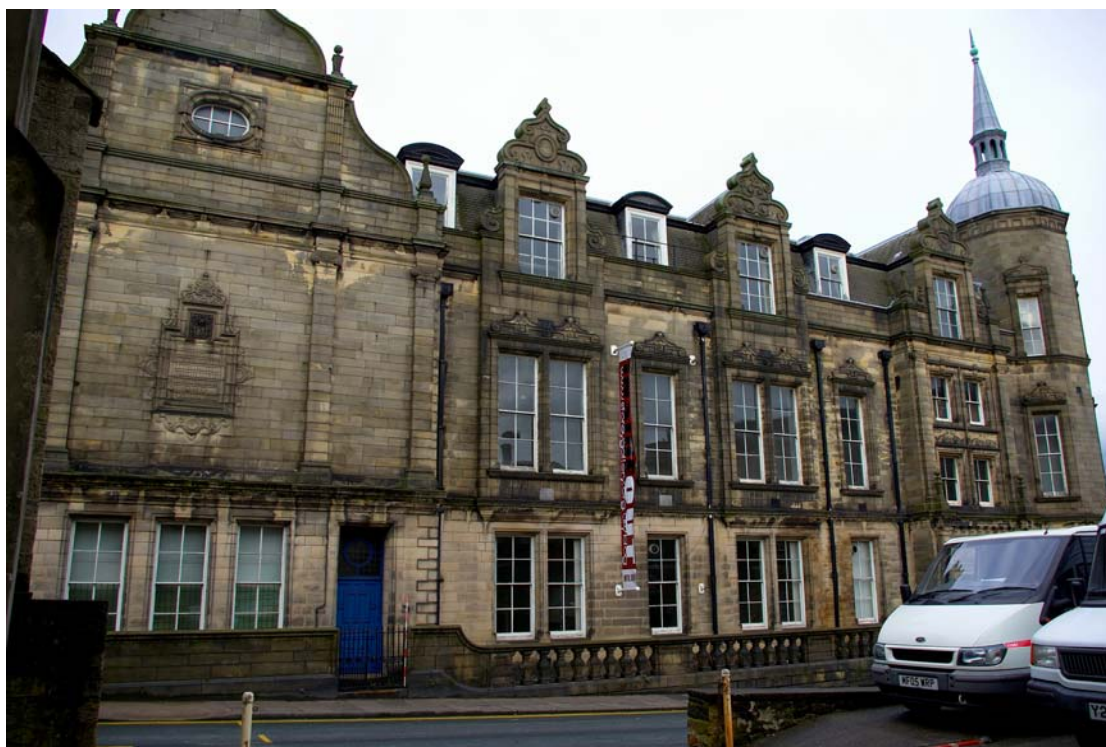
Plate 1: The south elevation of the Storey Institute

- 4.2.1 The main façade of the building lies on the north side of Meeting House Lane, and stands at three bays long, with an octagonal tower to the right of the elevation (Plate 1). To the west, there is a projecting gable facade for the Art Gallery, and a single storey studio and attic, which has a curved section of wall featuring a gateway into the attached gardens. The principal fabric is ashlar sandstone with rusticated quoins on the dressings and margins, whilst plain string-courses feature above the ground and first floors. On the shaped gable of the Art Gallery, there are two pairs of Ionic pilasters, of which, the

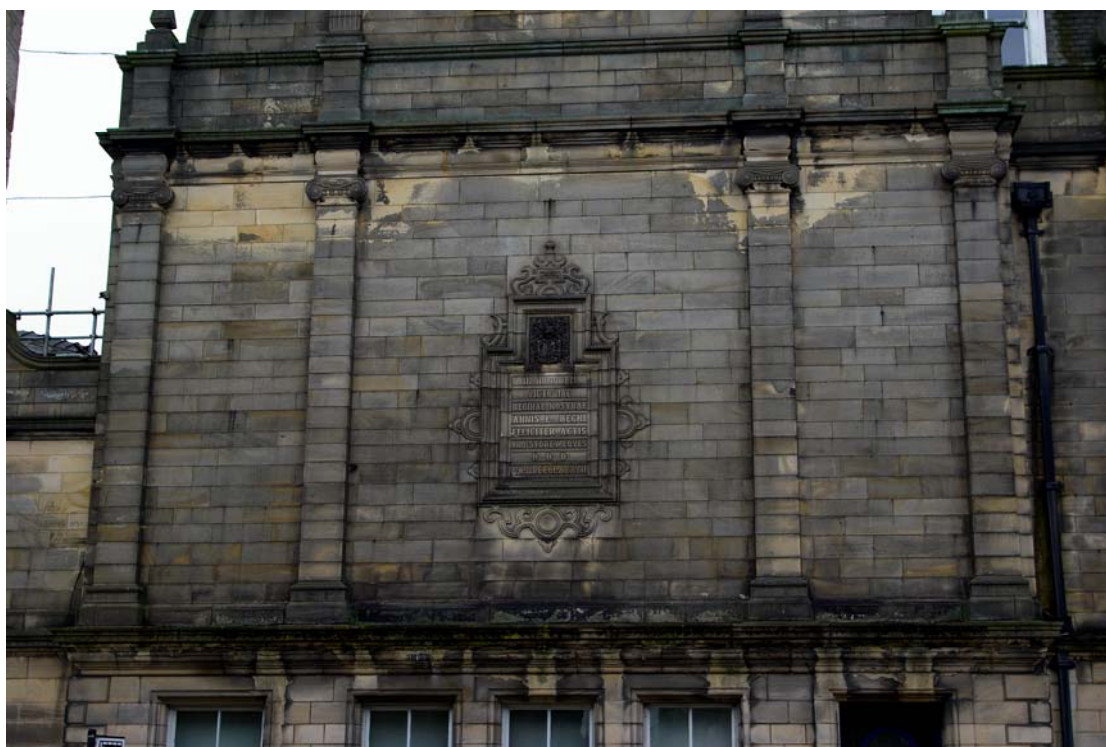
Plate 2: Plaque commemorating the opening of the building, with a dedication to Queen Victoria

- 4.2.2 In the centre of the Art Gallery facade, there is a bolection-moulded plaque, decorated with strapwork motifs and inscribed with the following: 'IN HONOREM VICTORIAE REGINAE NOSTRAE ANNIS L. REGNI FELICITER ACTIS THO STOREY EQVES D.D.D. A.D. MDCCCLXXXVII (Plate 2).

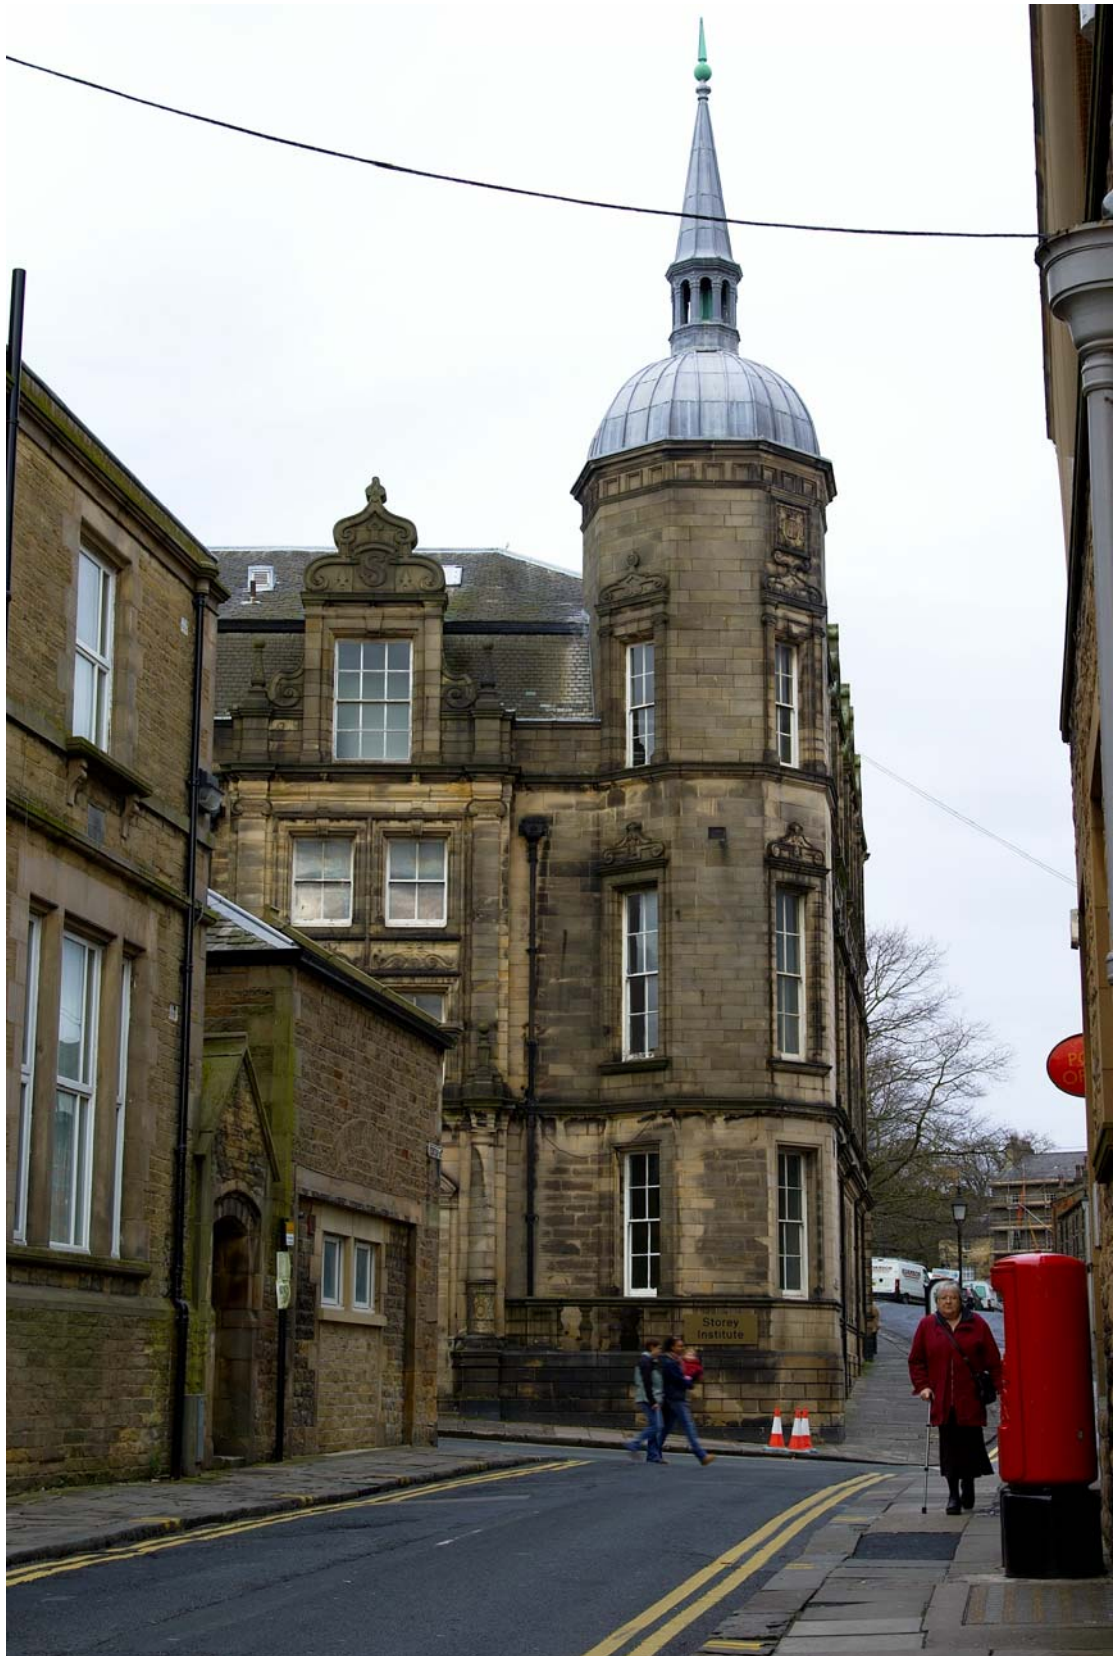
Plate 3: The Tower on the south-east corner

- 4.2.3 The main mansard roof and the small gablettes are laid with regular courses of Welsh slate and leaded ridges, whilst the octagonal turret at the south-east corner of the building is surmounted by a cupola and porticoed spire laid with lead (Plate 3).

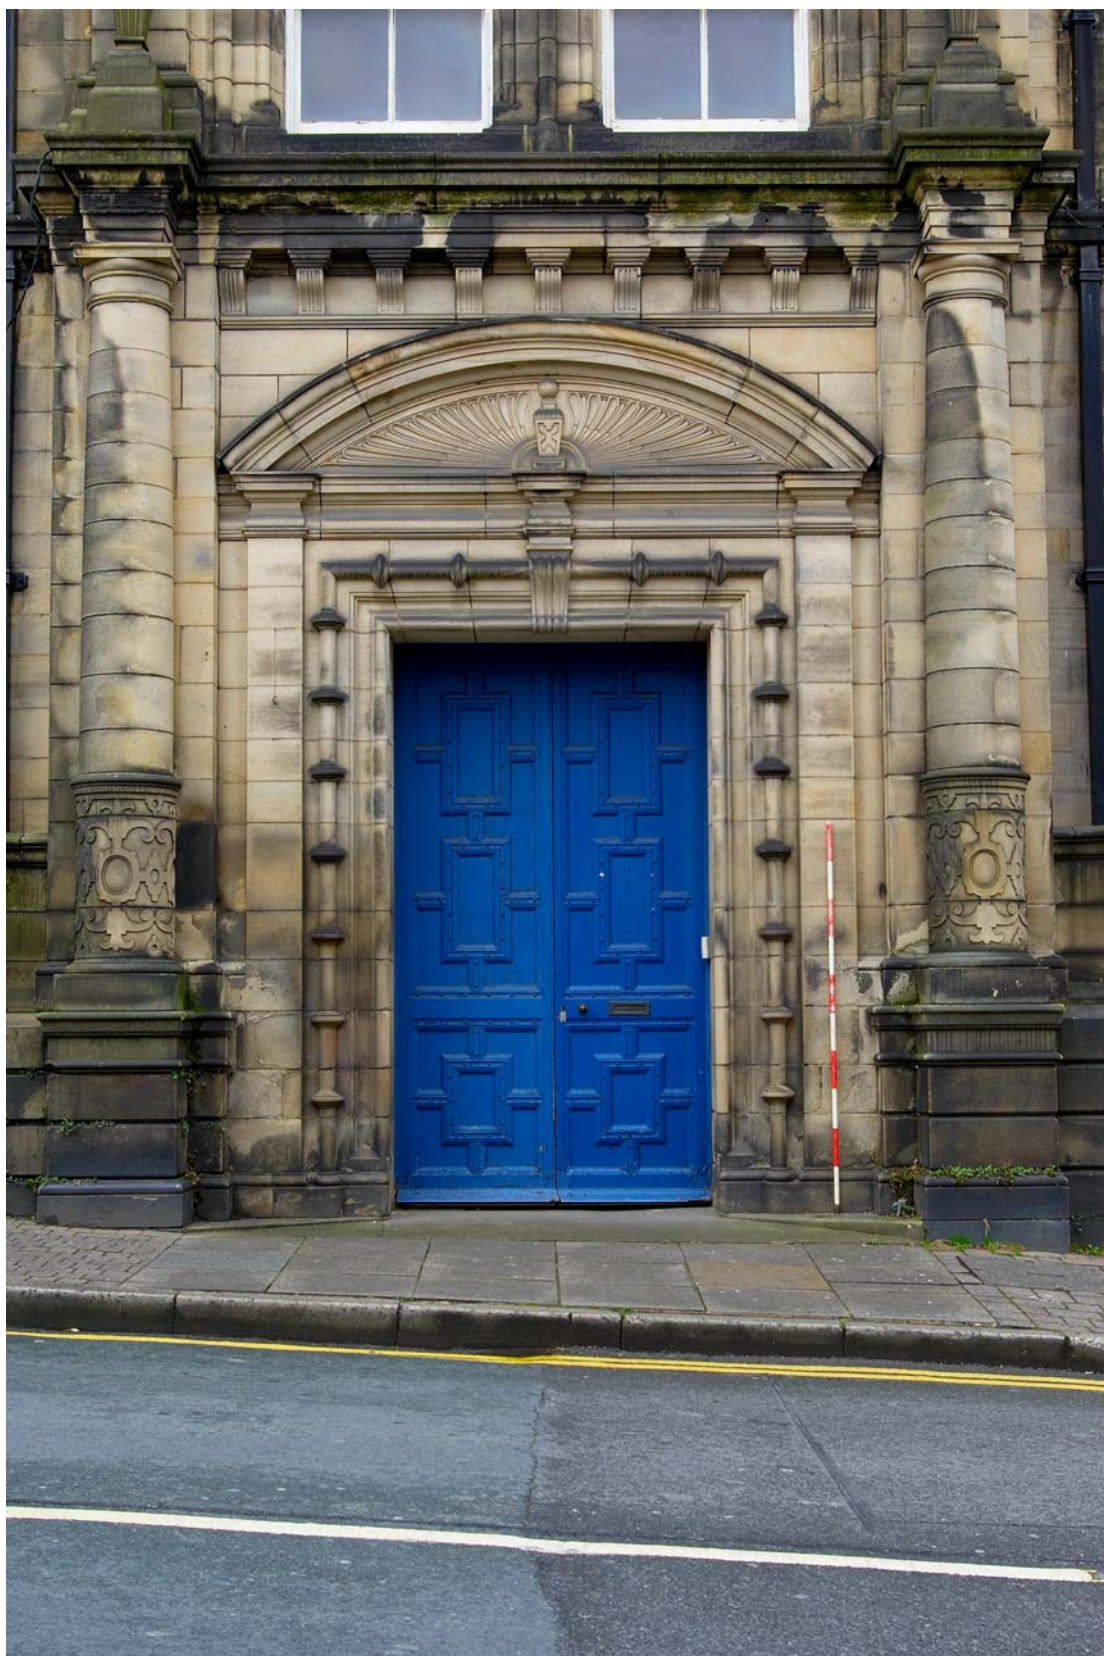
Plate 4: The formal entrance to the Storey Institute on Meeting House Lane (south elevation)

- 4.2.4 Access to the building is provided by a formal aedicular doorway on the right of the elevation (Plate 4), which has a bolection-moulded architrave with an outer roll-moulding embellished with shaft rings. To either side of this architrave, there is a pair of pilasters flanked by engaged Tuscan pillars that feature strapwork decoration around the base of their shafts. The pilasters rise to a closed, segmental fronton, which is decorated with a peacock's tail, and a fluted keystone/console supporting a saltire motif and globe finial. The Tuscan pillars rise to first floor height and are surmounted by globe finials with tapered, fluted bases. Additionally, a corbel course underpins the string course directly above the fronton of the door, whilst towards the west end of the facade, a smaller, more modest panel door affords access into the Art Gallery (Plate 5). Above the door, there is a plain leaded light, whilst the architrave is a simple roll-moulded affair. A gateway through the curved section of wall at the extreme left of the elevation affords access into the gardens to the west of the building. This has a segmental, bolection-moulded, round-arch and scrolled, wrought iron gate.

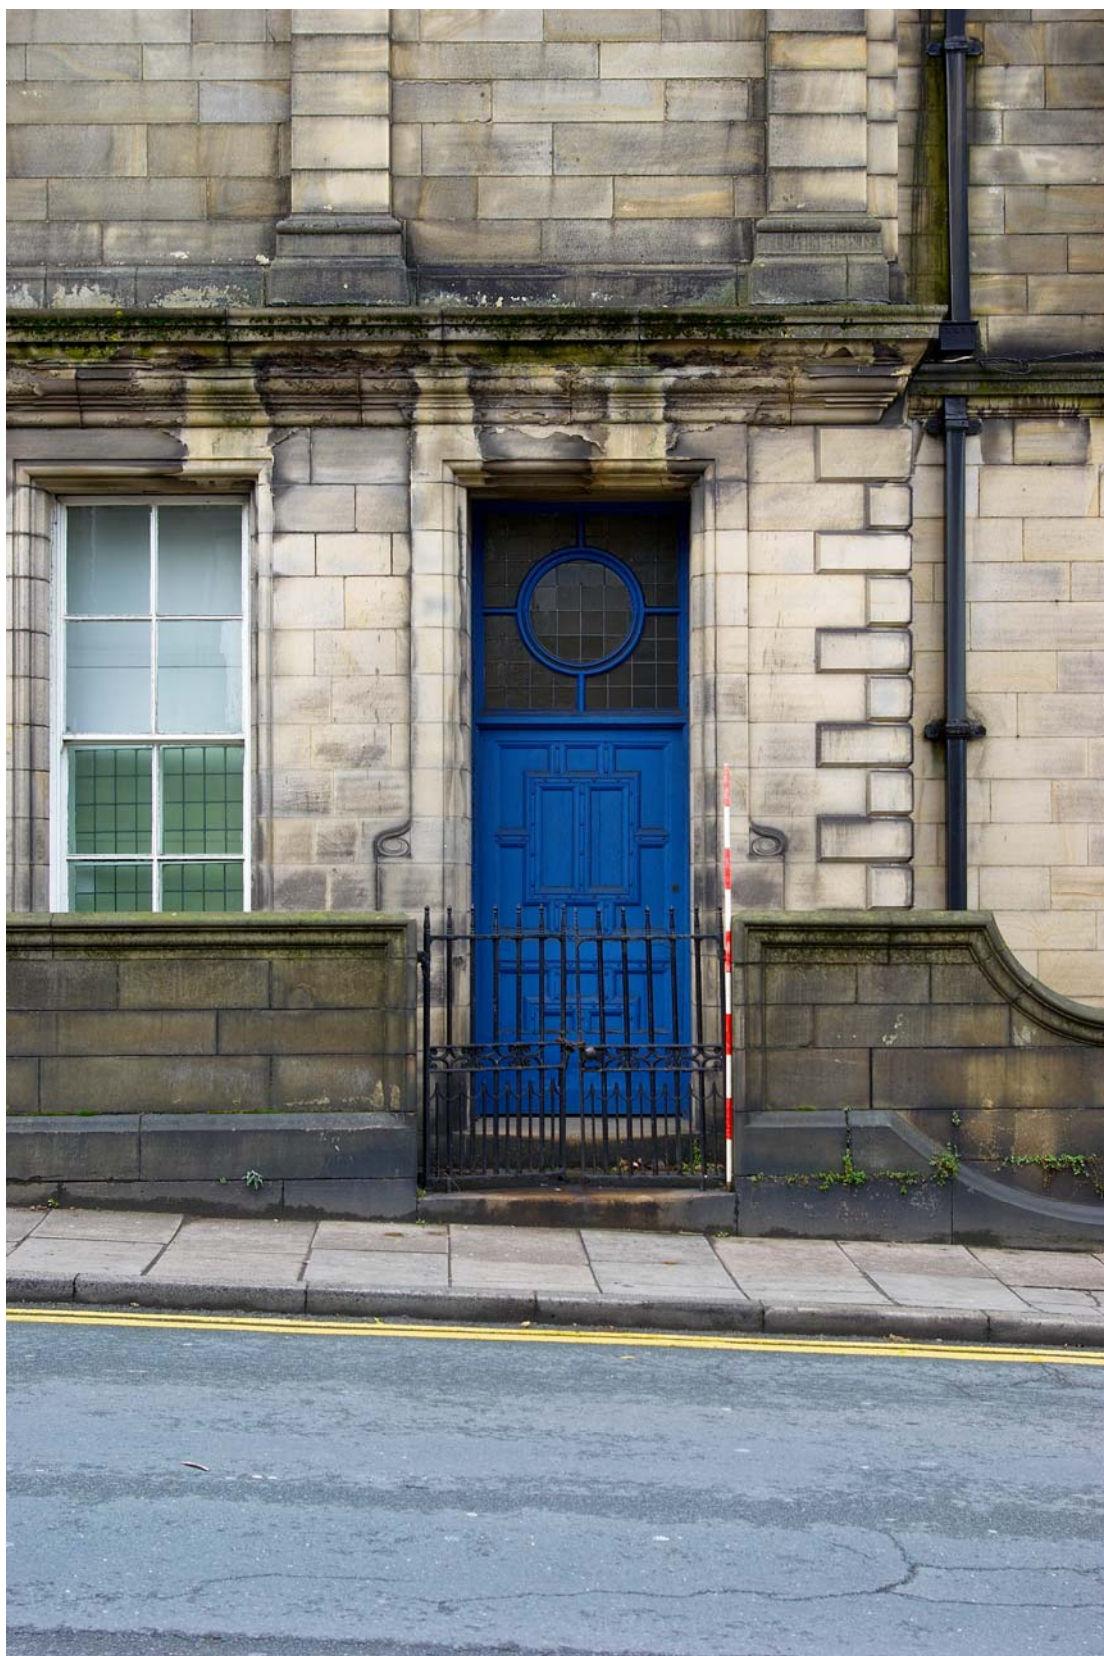
Plate 5: Entrance to the Art Gallery on the south elevation

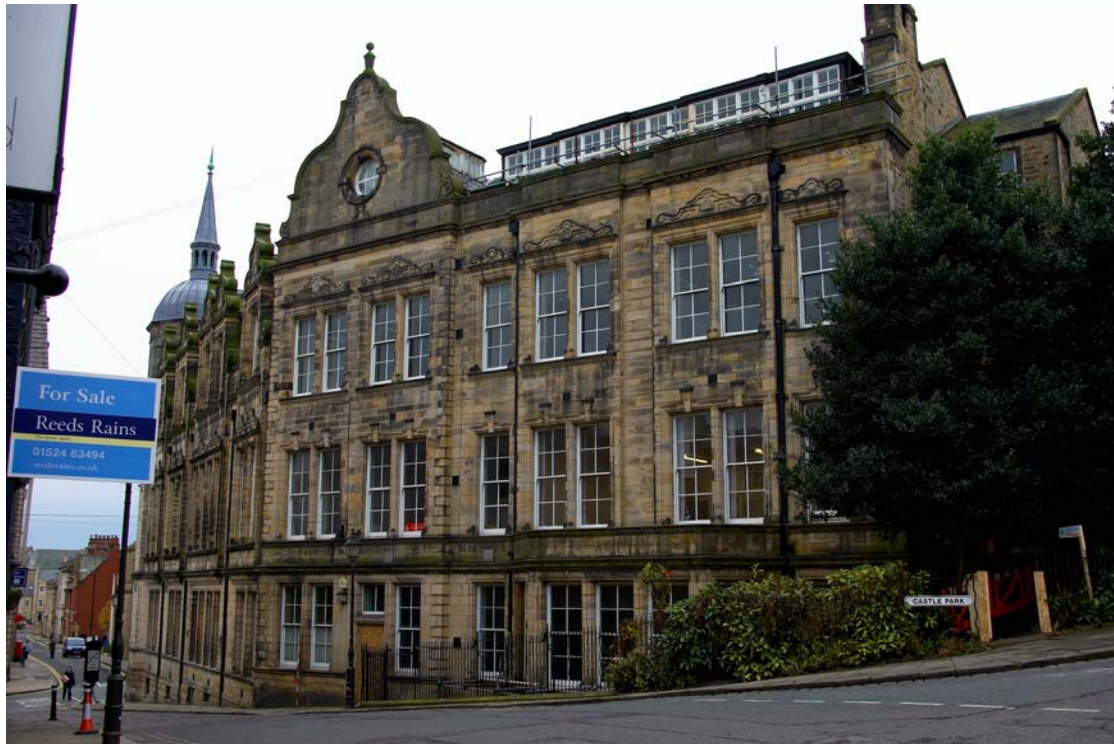
- 4.3.1 This canted elevation is of comparable design to the south elevation and consists of the original four bays, with a further canted façade dating to the early twentieth century (Plate 6). This later extension has six bays, with the outer pairs of bays projecting forward, whilst the left pair rise to a shaped gable. On both the original phase and the extension, the windows are comparable to the horned sashes on the south elevation, and feature roll-moulded surrounds, with strapwork and key stone decoration. Similarly, the original phase of the elevation has five four-over-four sash dormers with strapwork frontons, which are again divided by smaller horned sashes with segmental heads. In contrast, the canted extension has a long timber attic dormer, which is set back from the corniced parapet, whilst the shaped gable has an oculus comparable with that on the gable of Art Gallery.

Plate 6: The canted 1906 extension on Castle Hill (east elevation)

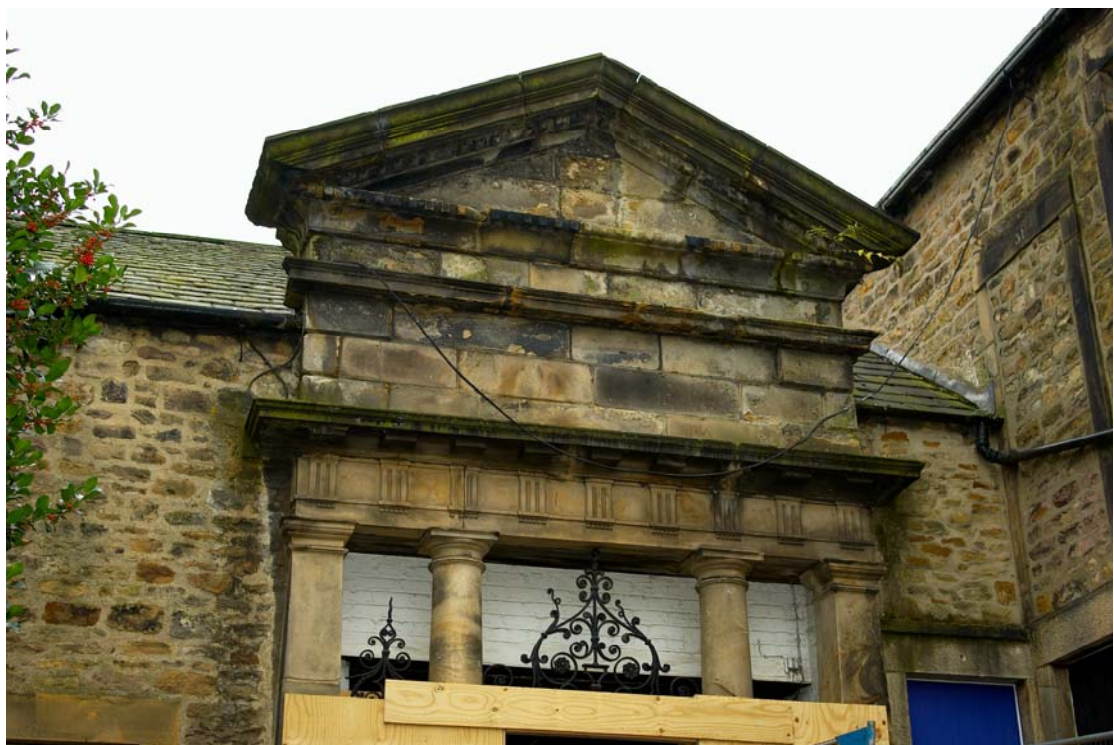
- 4.4.2 The door to the rear (north) of the Storey Institute is a plain panel door, but features an *ex situ* segmental hood, which is supported by corbels decorated with acanthus leaves, and an additional well-cut flush lintel and quoins. This was part of the building that originally stood on the site, prior to its demolition and the erection of the present building in 1906. The windows are four-over-four horned sashes, with stone mullions, well-cut lintels and projecting sills.

Plate 7: The *ex situ* pediment, which originally adorned Cawthorne House

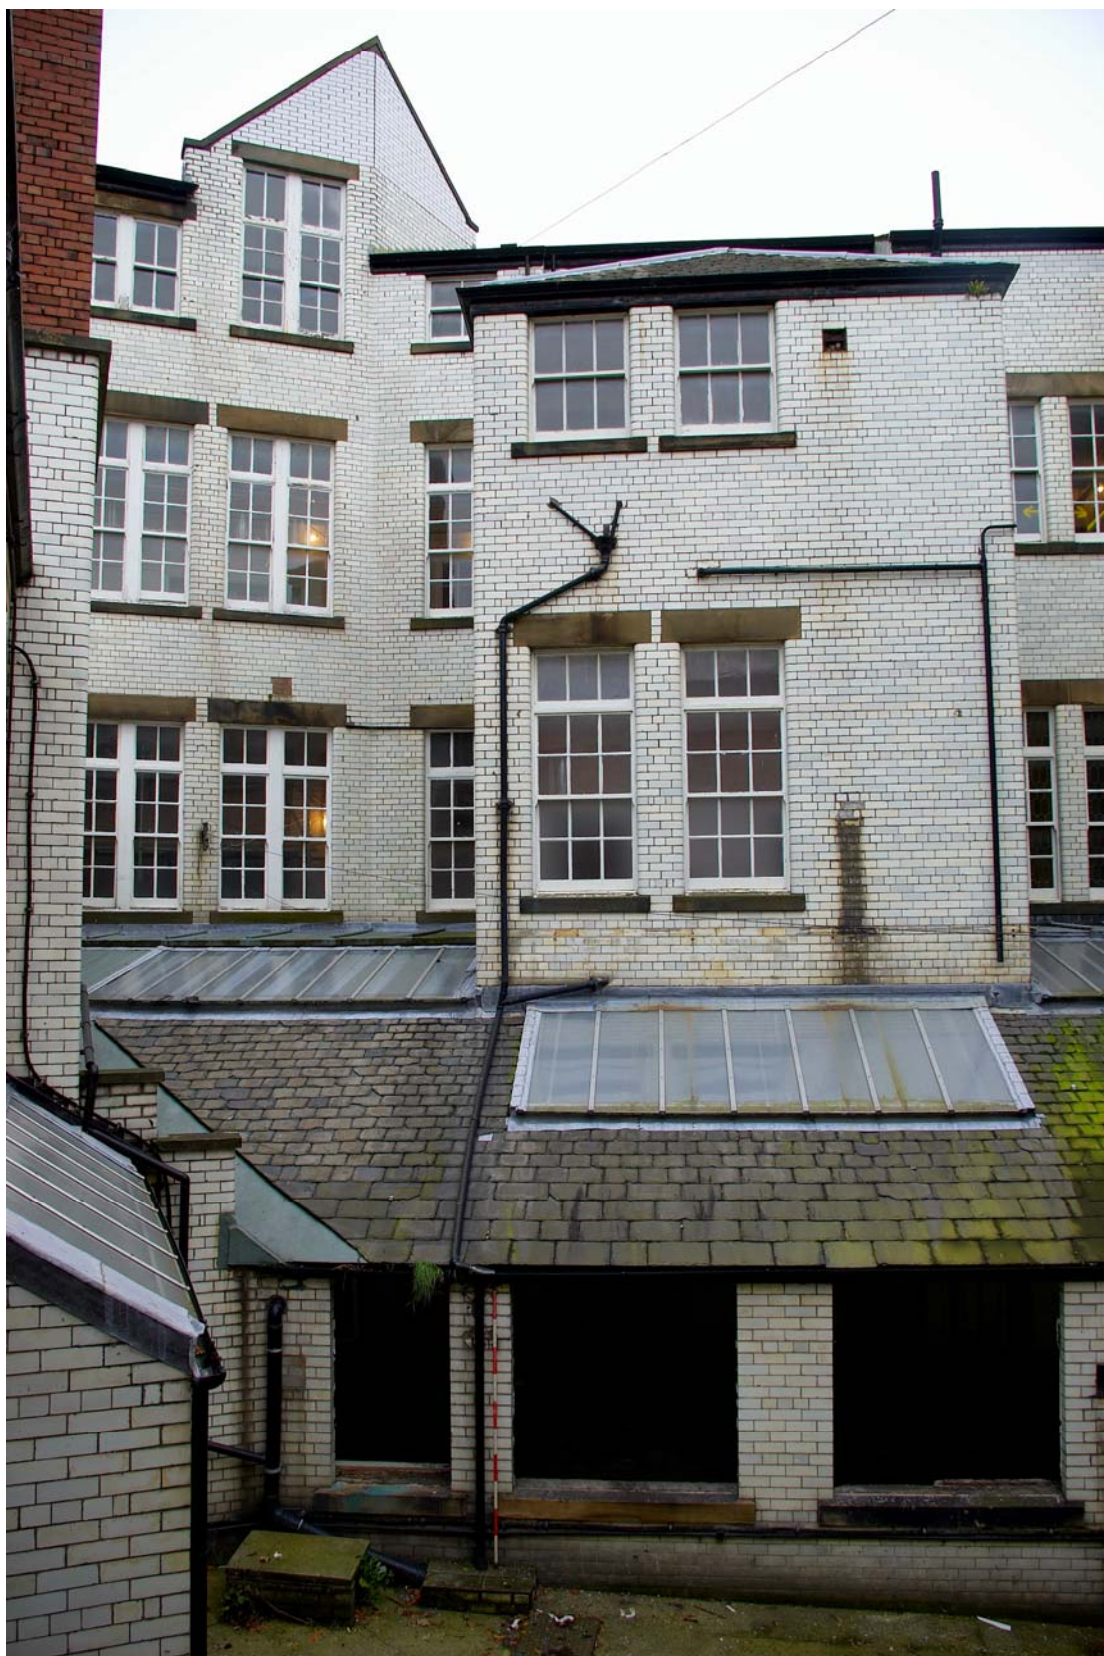
- 4.5.1 The west elevation comprises the rear of the original phase and the canted 1906 extension, with the former being built mainly of dressed stone and the latter, white glazed brick (Plates 8 and 9). In addition, there is a projecting single storey extension, which has a chamfered west elevation and shallow pitched roof in diminished courses of Welsh slate, that rises to a pavilion roof. The courtyard formed by these two phases of building is located at basement level with access provided by a set of stone steps with iron railings. Within this enclosed courtyard, there is a single-storey extension in white glazed brick and diminished courses of Welsh slate, which appears to be contemporary

Plate 8: The west elevation of the canted extension dating to 1906

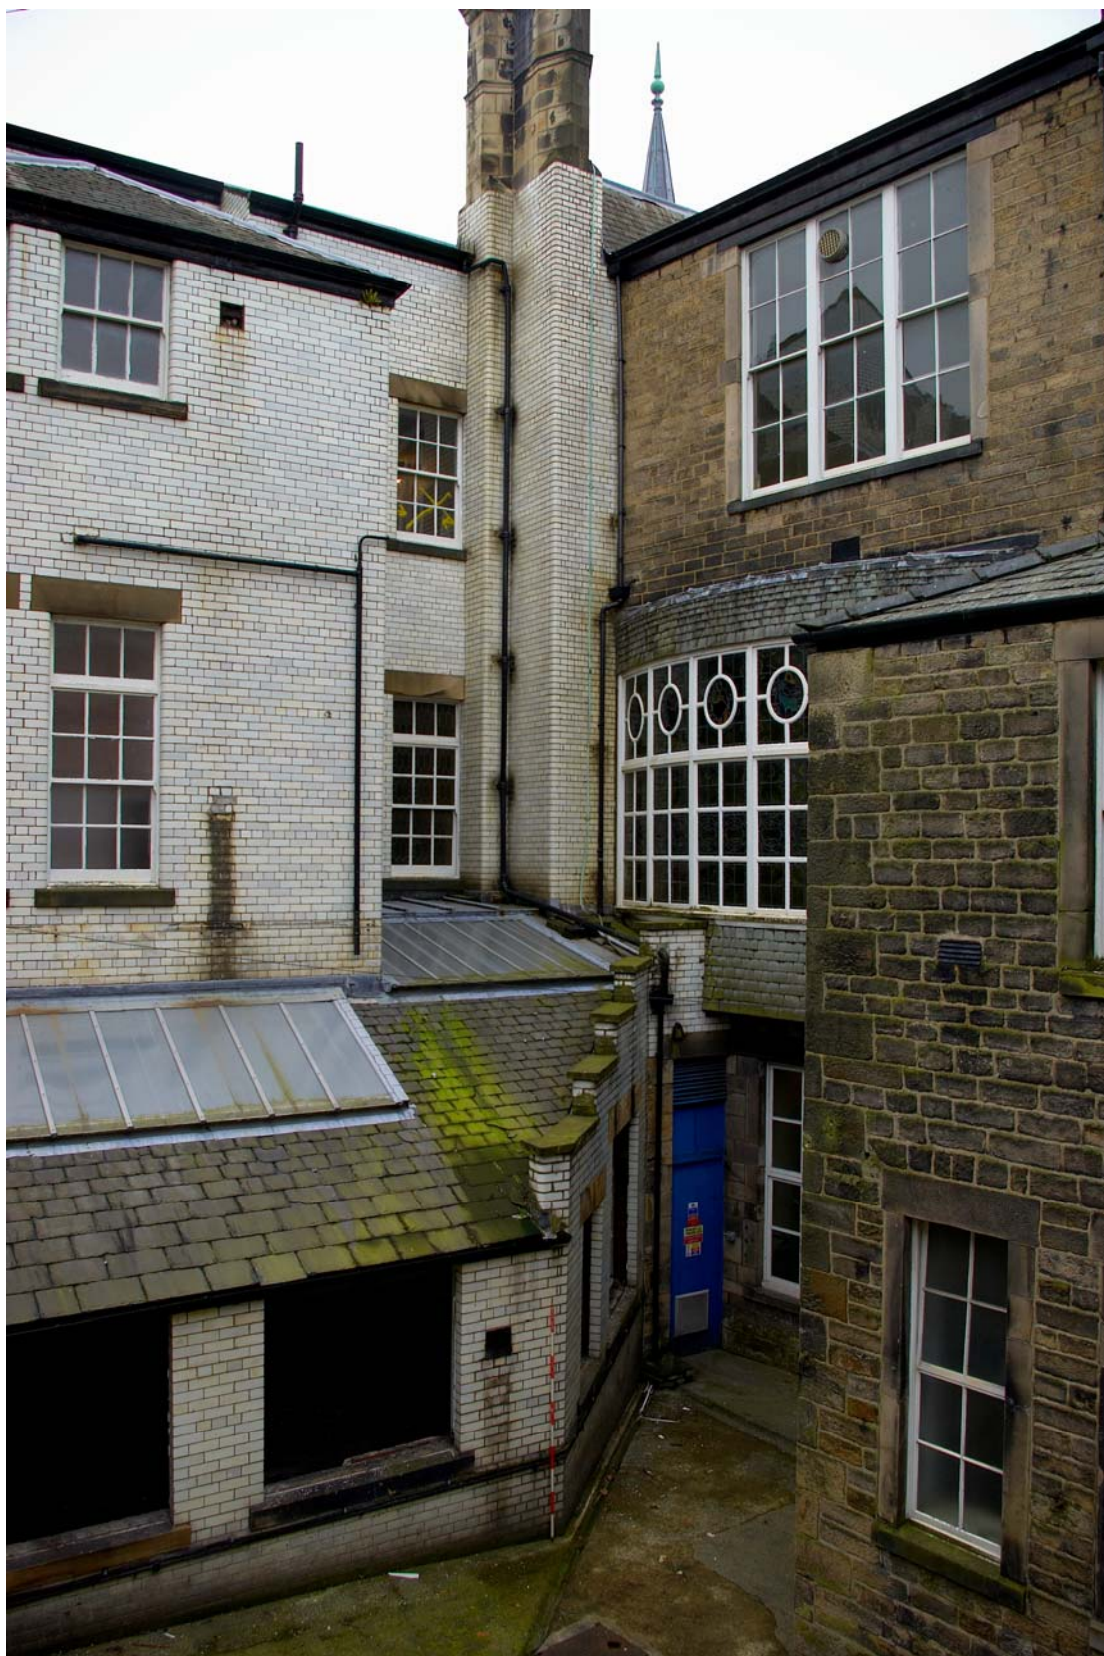
Plate 9: The original phase of the building (to the right) and the later 1906 extension.
Note the bay window on the ground floor

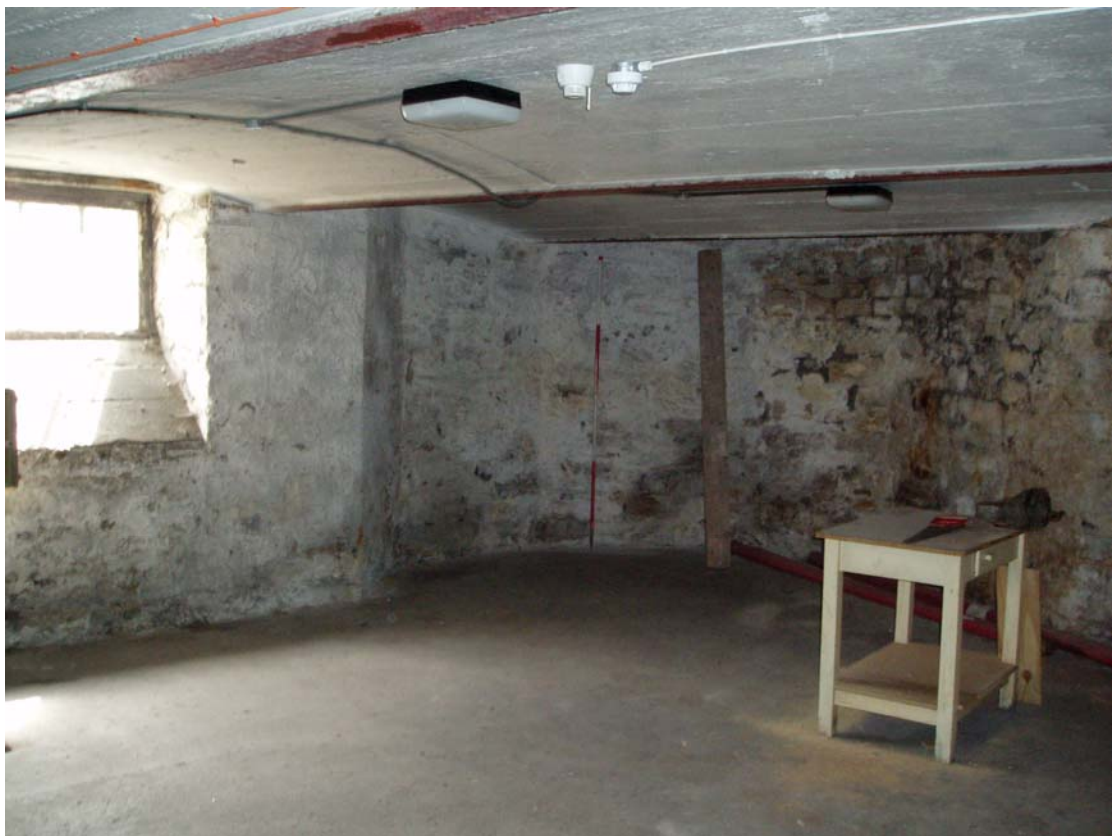
- 4.6.2 The majority of rooms on the ground, first, and second floors are for the most part uninspiring and utilitarian, being uniformly decorated with plain plaster and papered walls, plainly-moulded dado rails, skirting boards and timber-panelled dados (Plates 10–12). The ceilings are similarly painted plaster, whilst the floors are carpeted or laid with parquet, with the exception of the sub-basement, which is laid to concrete (Plate 13).

Plate 13: General view of one of the rooms within the sub-basement

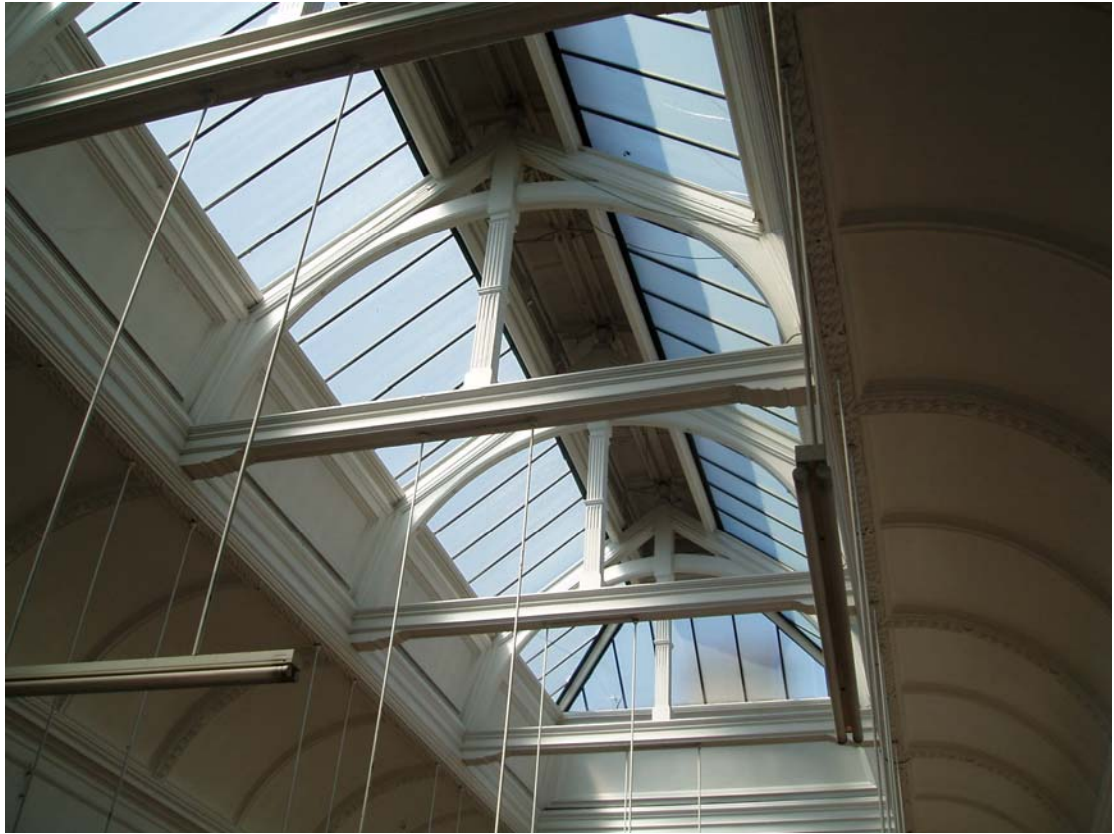
- 4.6.3 Notwithstanding this, several rooms, particularly at the south end of the building are of interest, because of their elaborate design, and are worthy of note here. The most attractive room within the building is the main gallery space of the building, which lies to the west end of the ground floor and is, therefore, part of the original phase of building. It has a vaulted ceiling, with struts decorated with a foliate design that rises to a glazed raised ridge (Plate 14). The walls are decorated with both a moulded picture rail and cornice, whilst the doors are aedicular in design with pectinated pediments finished with an oak leaf motif (Plate 15). Additionally, at the north end of the room, there is a substantial niche, which has a round arch trimmed with egg-and-dart moulding, a scrolled and foliated console, and fluted pilasters (Plate 16). To the flanks of this arch, there are further fluted pilasters dressed with Ionic capitals, whilst in the centre of the niche, there is a sculpture of Queen Victoria and Prince Albert, which is mounted upon a greyish-white marble plinth that itself sits upon a red marble dais.

Plate 14: Detail of the ceiling within the gallery

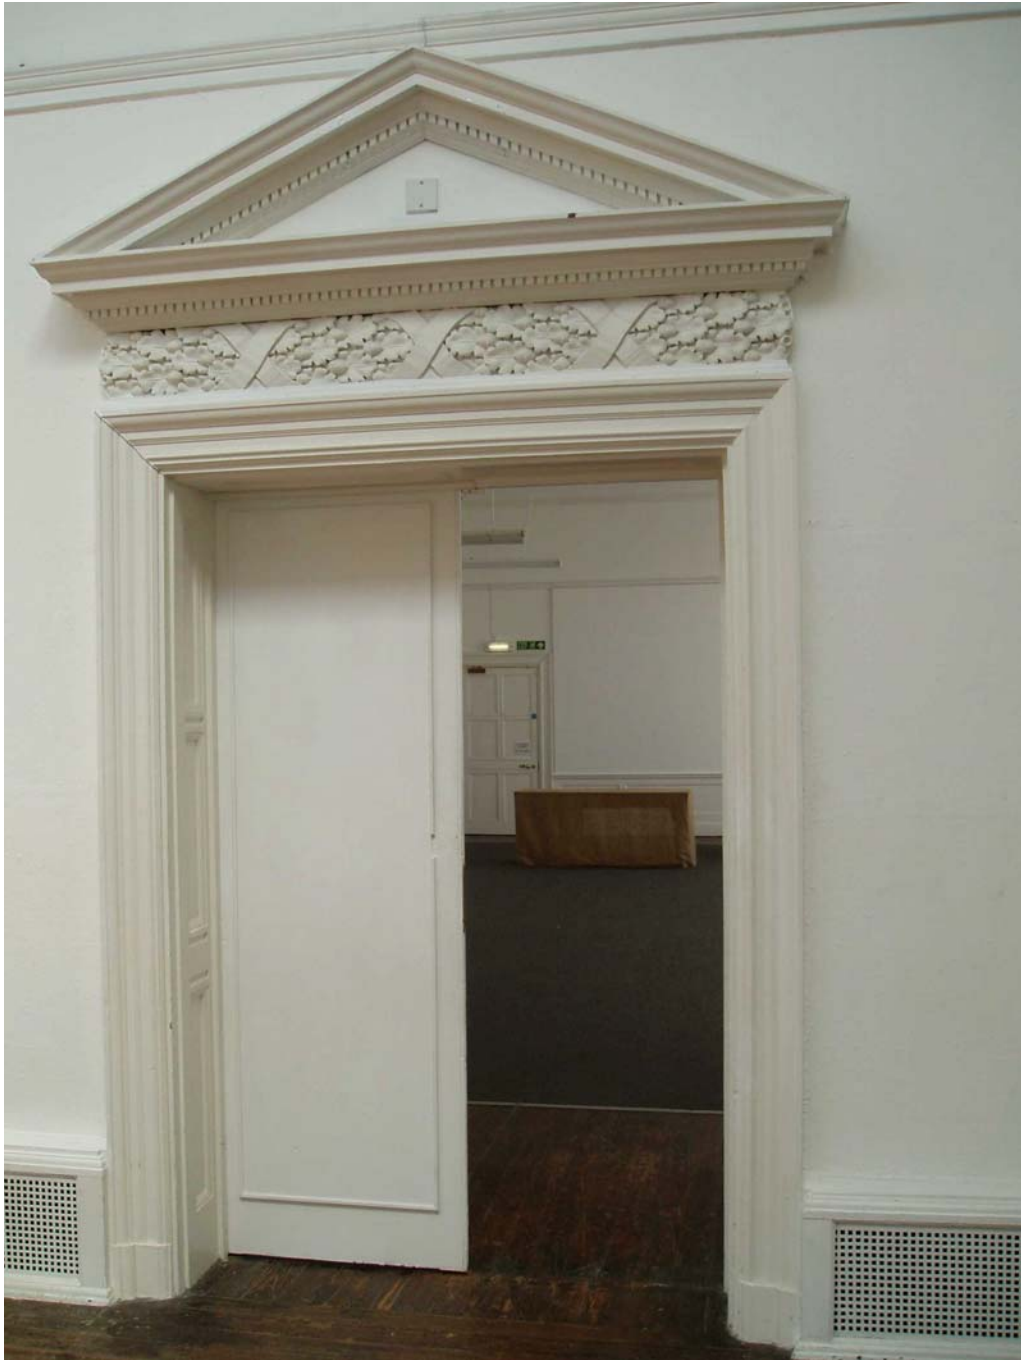
Plate 15: Detail of one of the aedicular doors within the gallery

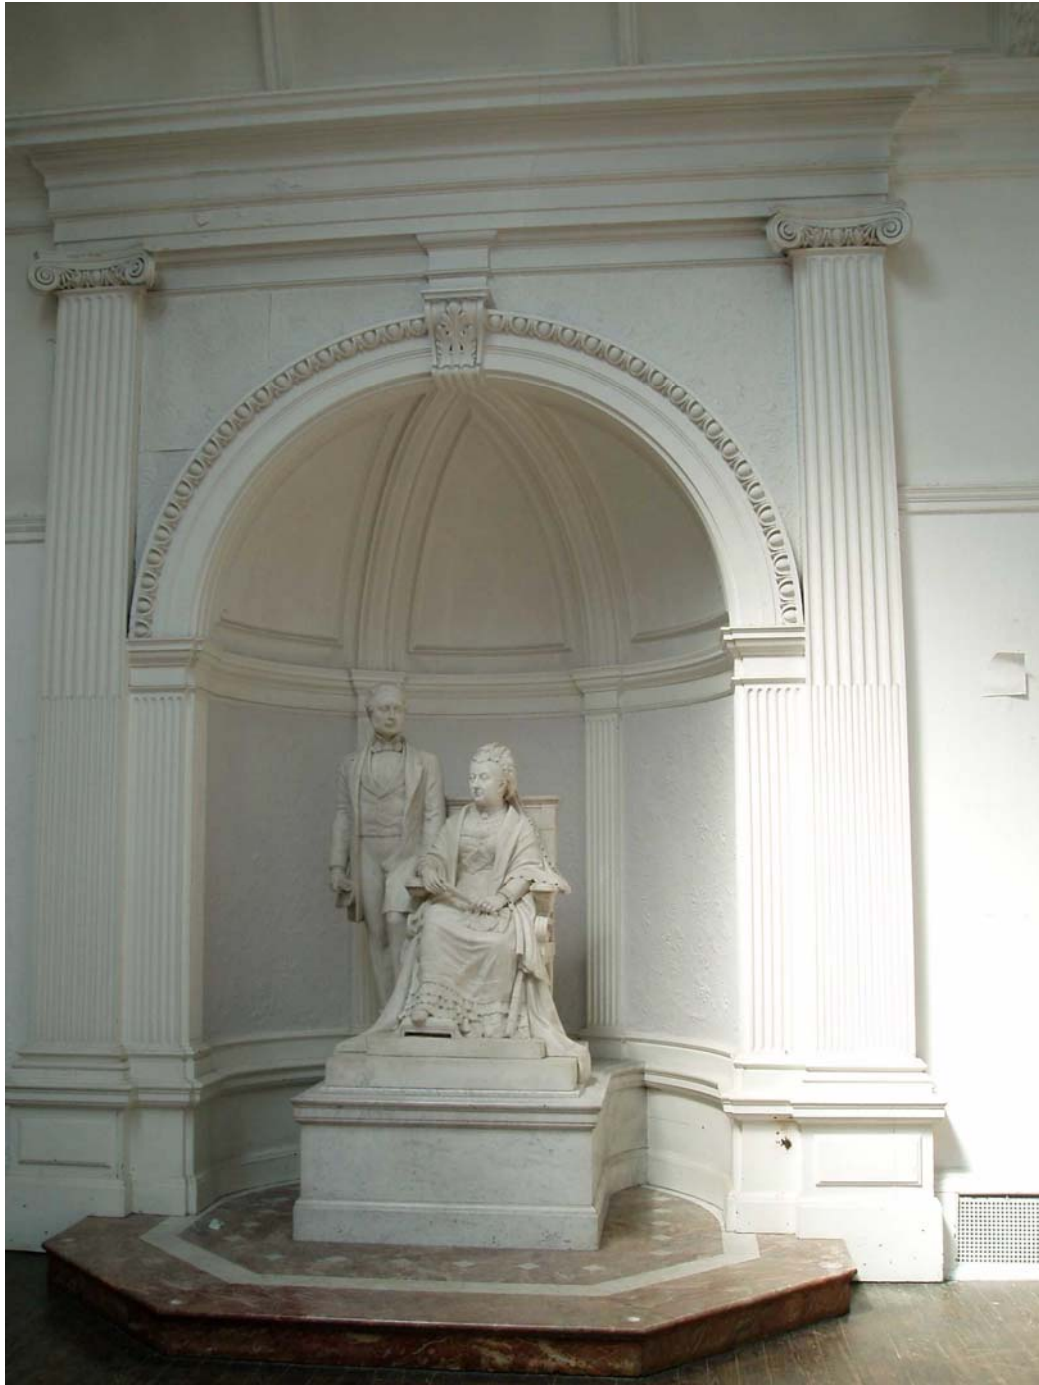
Plate 16: Detail of the statute of Queen Victoria and Prince Albert at the north end of the gallery

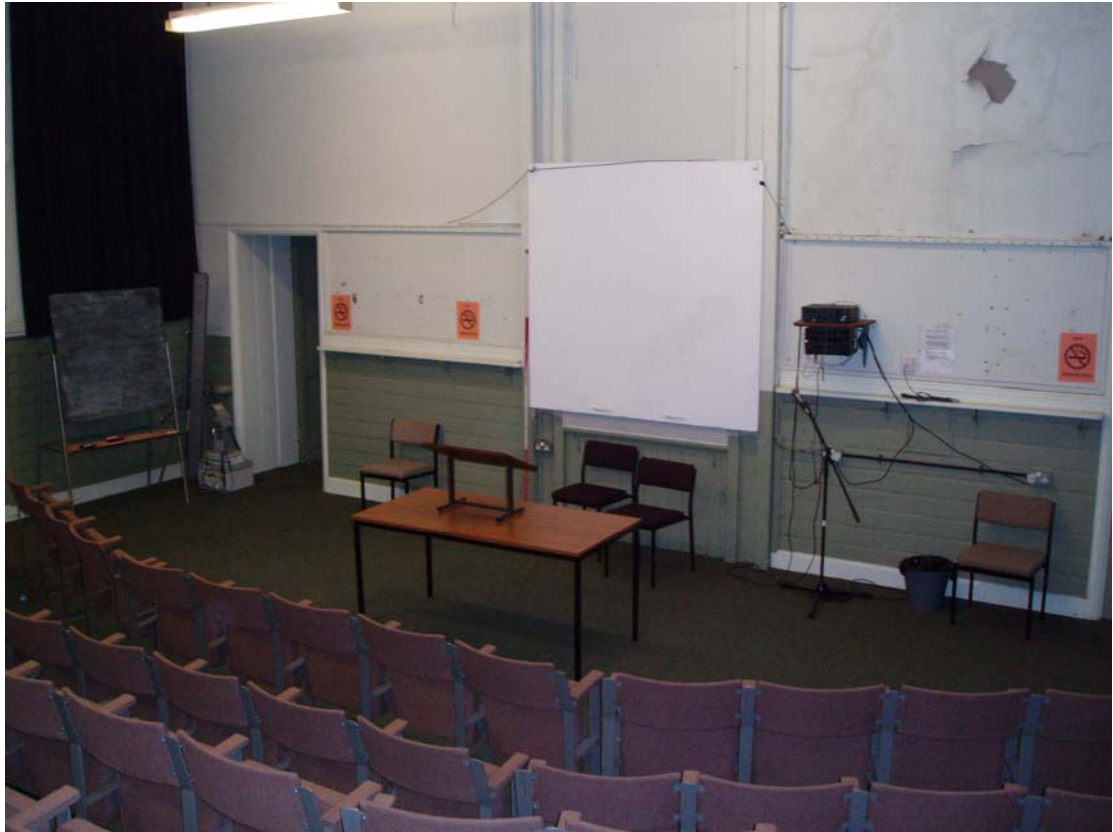
- 4.6.4 The rooms along the front of the ground floor are of a similar style, albeit more restrained, whilst the space to the south-west corner of the building is interesting in that it was designed as a lecture theatre and appears to be still used in that capacity (Plate 17).

Plate 17: The lecture theatre at the south-west corner of the building

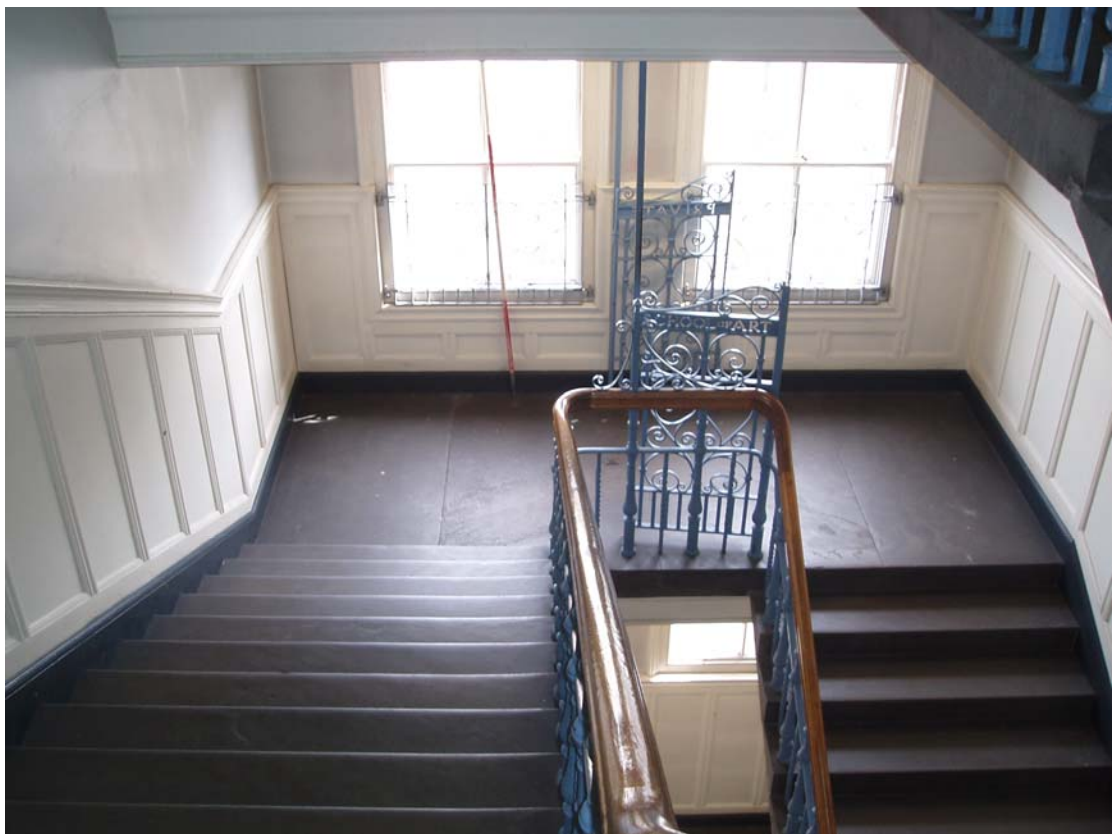
- 4.6.5 Of additional interest is the staircase at the front of the building, which has cast iron railings, a timber banister, and which is laid with high-quality, polished sandstone, which is possibly Haslingden (Plate 18). The ceiling on the second floor is trimmed with a bolection moulding and is vaulted with a central stair light of leaded glass, flanked by two ovoid plaster mouldings.

Plate 18: Detail of the staircase in the original phase of the building
