THURLAND MILL, CANTSFIELD, LANCASHIRE

Archaeological Building Investigation and Watching Brief

Oxford Archaeology North

January 2006

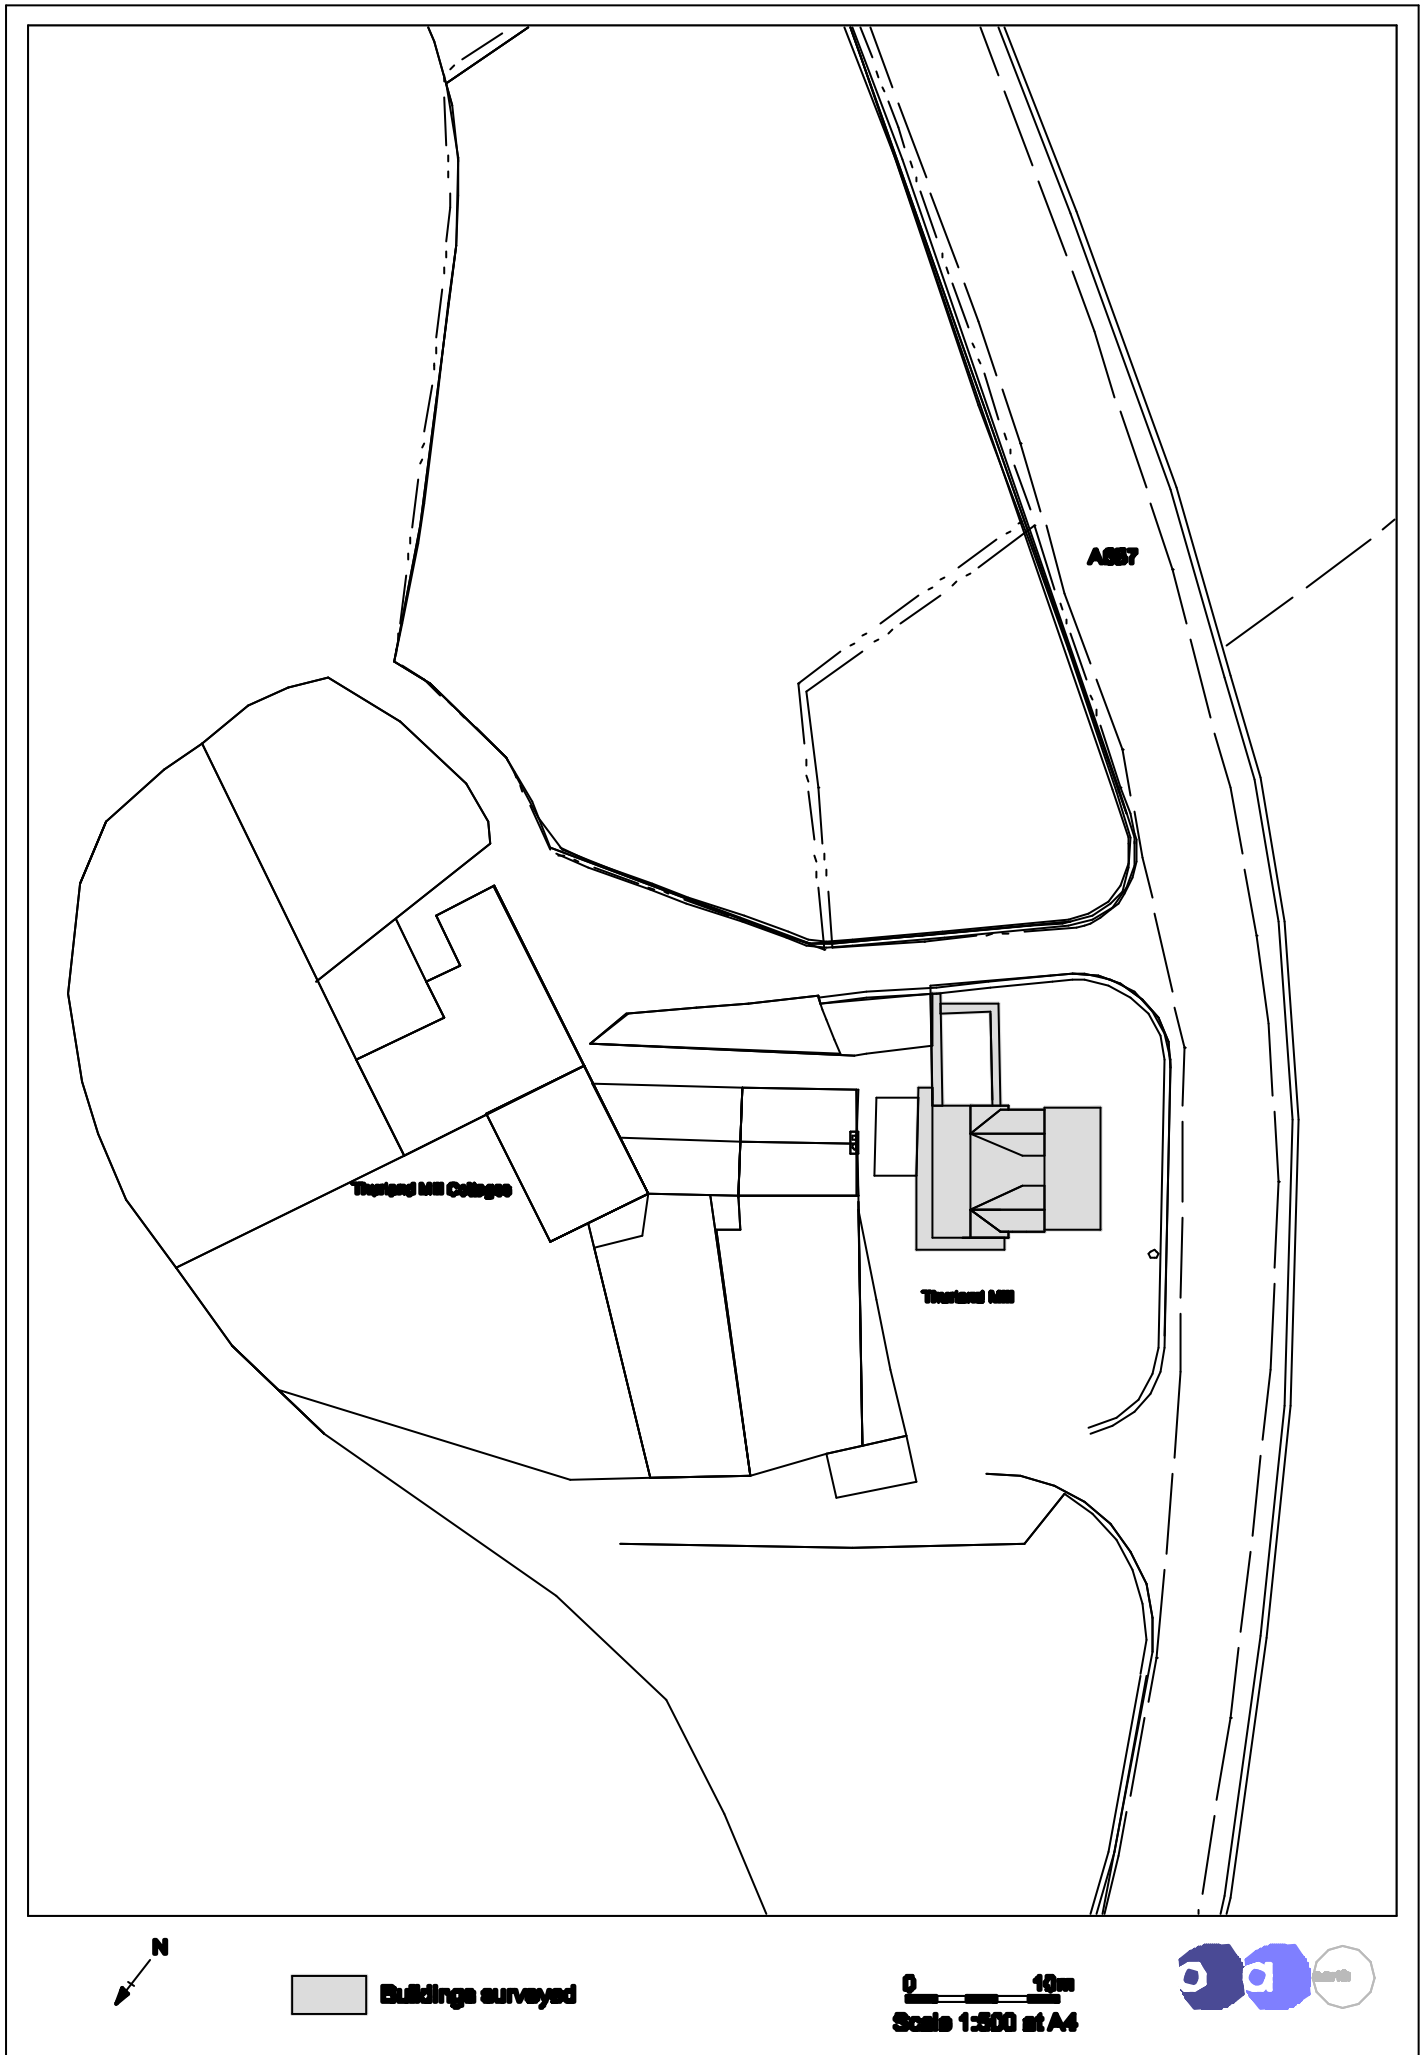
Figure 2 : Thurland Mill Complex

- 3.1.1 Thurland Mill is located to the south of the village of Tunstall, Lancashire. The building lies adjacent to the main A683 Lancaster to Kirby Lonsdale road (Fig 2).
- 3.1.2 The Lune valley is generally gently sloping and undulating. The solid geology is composed of Millstone Grit with an overlying drift of till and gravels (Countryside Commission, 1998).

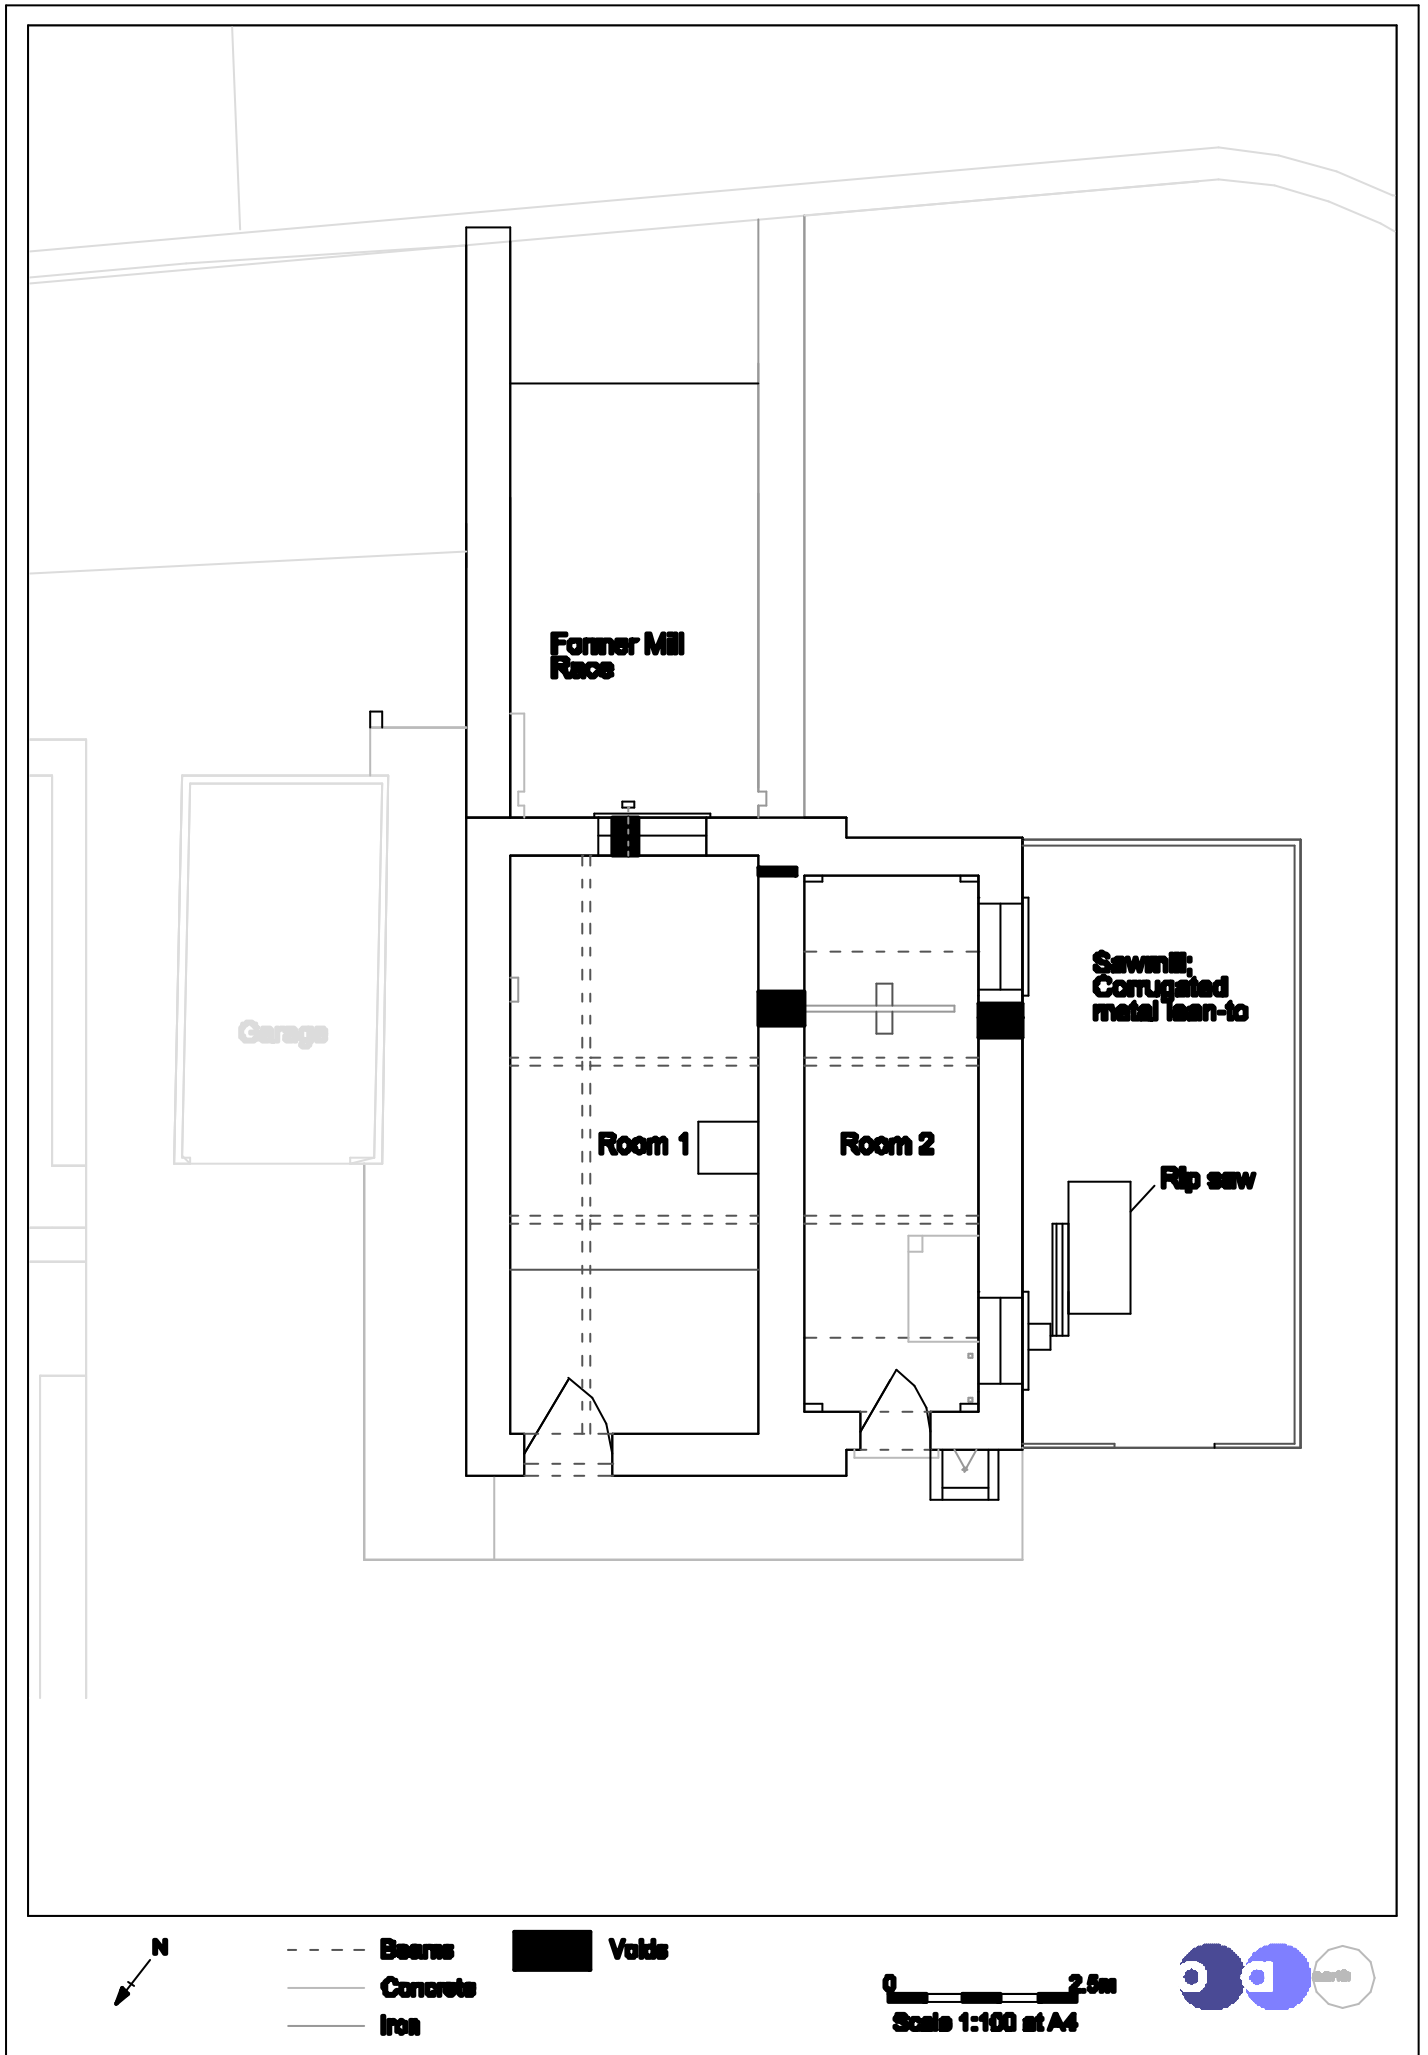
Figure 3 : Plan of Ground Floor

- 4.3.1 Above ground the mill comprises two single-storey rectangular rooms of unequal size which are aligned parallel to each other on a north-west/south east axis (Fig 3). Both rooms have a single door located in the west elevation. Below the main northern room (Room 1) is another 'room' (Room 3) of similar proportions which forms the lower ground floor (Fig 4). This area probably housed a wheel mechanism and forms part of the mill leat. The eastern end of this room is open and forms the water entry route. The leat extends beyond the east elevation of Room 1 in the form of a tank-like structure. Both ground floor rooms are undivided and are separated from each other by a solid rubble stone wall. A sloping walkway is located around the north and west sides of the building. This provides access from the car park to the west, which is lower than the main building. The roof is of pitched construction with two pitched wings located above Room 2 at right angles to the main roof (Fig 5). The angle of pitch of the main roof is shallower between the wings. A single sandstone chimney stack is located centrally on the south slope of the main roof. The corrugated steel lean-to is built along the entire southern elevation of Room 2.

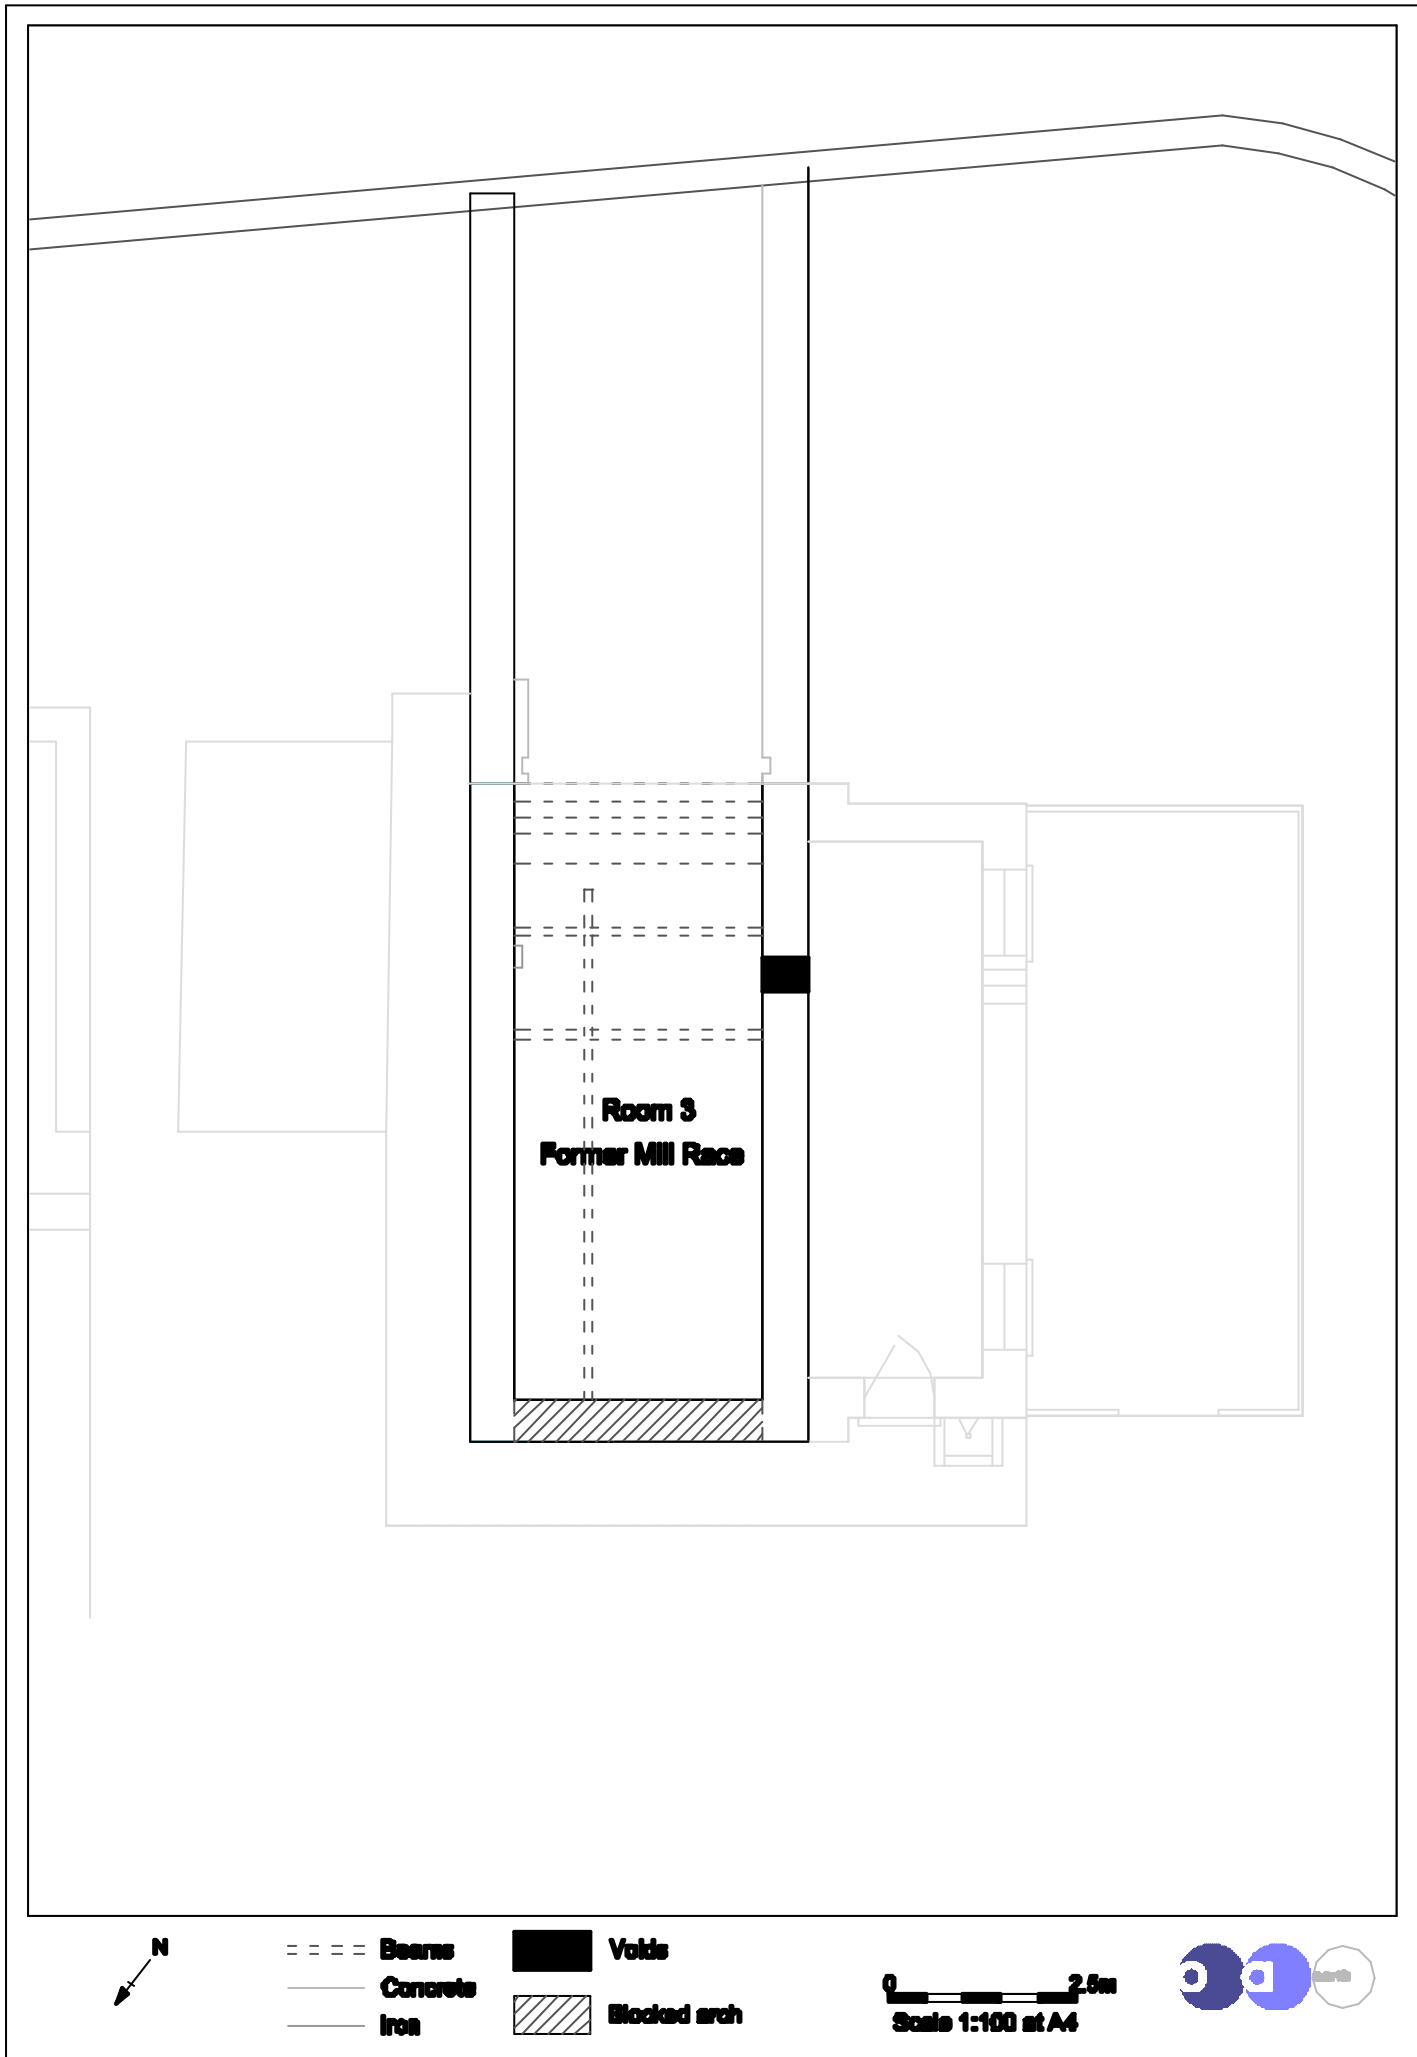
Figure 4 : Plan of Lower Ground Floor

- 4.5.4 **Lower Ground Floor, Room 3:** this room forms part of the mill leat, which passed under room **1** and has the same footprint. It was waterlogged at the time of survey and access was limited. It is mainly constructed of random-coursed sandstone with pointing that is smeared over each stone. The eastern half of the room has been lined with concrete. The west elevation of the room comprises a stone arch (Plate 12). The arch is made up of stone headers similar to the ones in the east elevation. It has been blocked using different random stone, some of which appear not to have been pointed. The ceiling comprises massive timber planks and rolled steel joists and supports the floor of Room **1** above. Through this, and fixed into the north wall, passes an iron ladder as noted in Room **1**, *Section 4.5.2* (Plate 13). An iron bearing box, the same as those already described-is inserted in the south elevation at ceiling level. The top of the box cannot be seen as it is partially obscured by the ceiling.

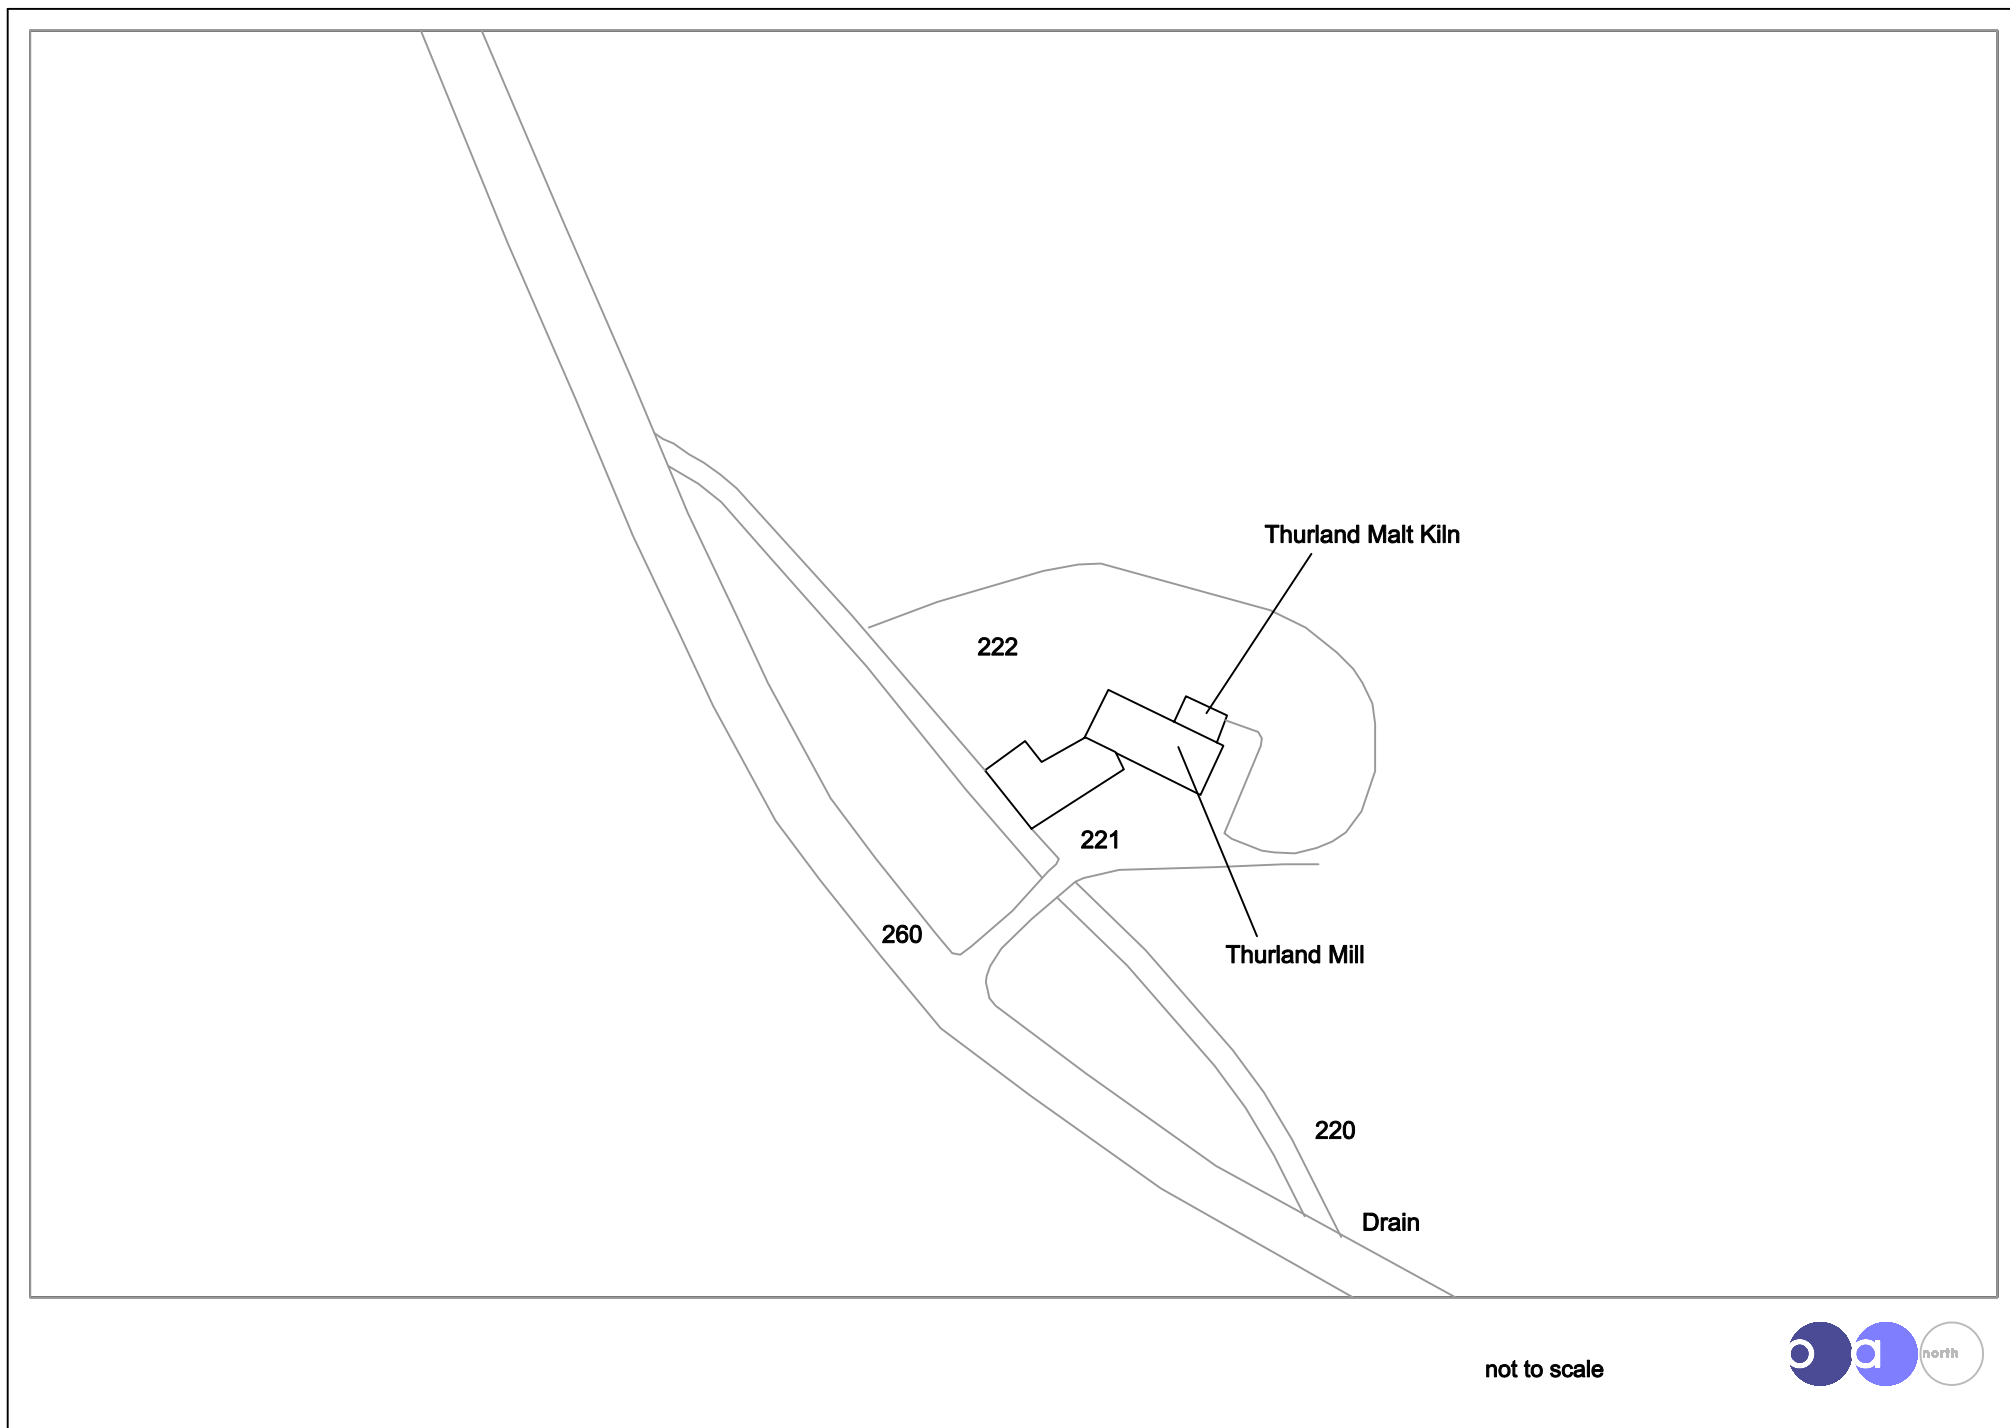
Figure 6 : Part of the Tithe Map of 1846

- 3.2.3 **Map regression:** the earliest detailed map of the site is the Tithe Map of 1846. This shows the mill with a wheel on the south-west end of the range of buildings, situated in the millrace, which is to the south, and a malt kiln attached to the north-east end of the buildings (LRO(P) DRB 1/34 1846; Fig 6). The entire site is described as being owned by Richard Toulman North Esq, and the mill is occupied by a William Hayhurst and comprises a mill house, outbuildings and malt kiln (LRO(P) DRB 1/34 1849). The First Edition 6": 1 Mile Ordnance Survey map of 1847 shows the same situation and the buildings are described as a malt kiln and corn mill (Ordnance Survey 1847). The present mill building, and the subject of this investigation, does not appear until the 25": 1 Mile Ordnance Survey map of 1891 (Plate 1). This shows a slightly larger complex of buildings with the current mill building occupying a site to the south-west of the rest, and the walkway around the north-east and north-west sides is visible (Plate 1). There has also evidently been some alteration to the water supply system, as the millrace is divided at the present mill building by a pond, with one branch passing through the mill and another

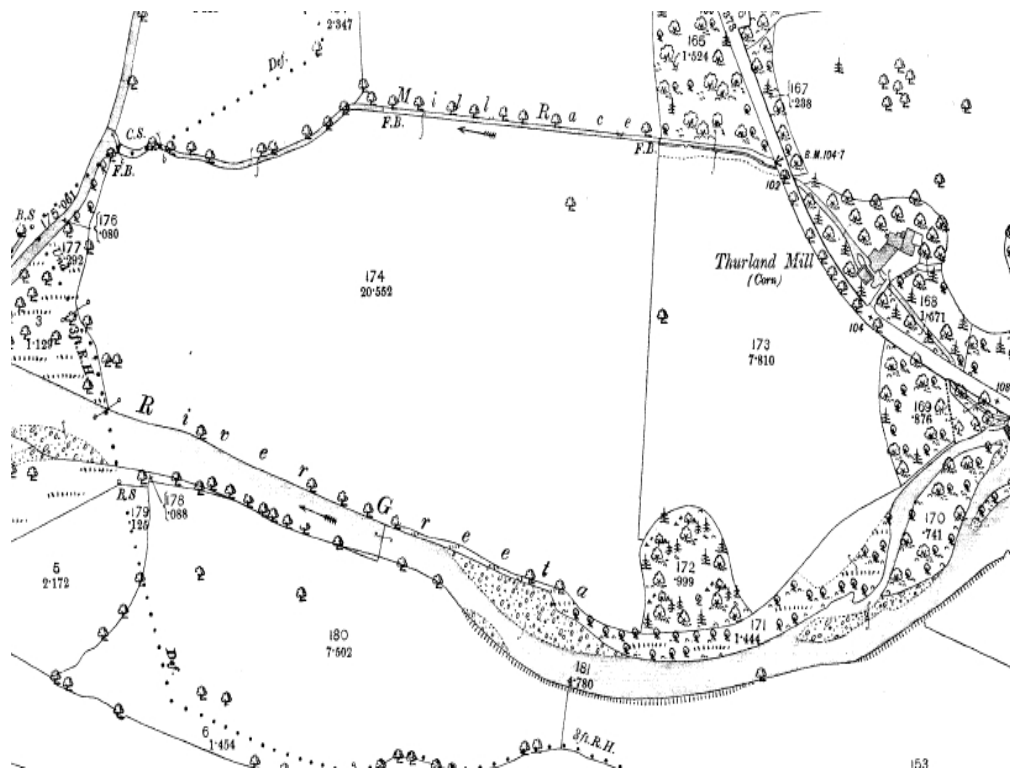
- 6.2.1 **Phase 1:** the First Edition Ordnance Survey map of 1891 shows a complex of buildings with what is probably the current building occupying a site to the south-west of the complex (Plate 1). Indeed, the walkway discussed in *Section 4.3.1* appears to be visible on this map. Room 3 with its blocked archway in the west elevation may relate to the tailrace exiting the building as noted on the map. The main race is shown as running in between the current mill and the house to the north-east. At the time of the building investigation a concrete garage occupied this area but the corbel and vertical sluice guide discussed in *Section 4.4.2* may be the remains of the sluice arrangements evident on the Ordnance Survey map of 1913. The small aperture also discussed in *Section 4.2.2* may represent the axle socket of the main wheel. The race (now infilled) would have carried on through the current car park. It is possible that a smaller, secondary wheel was located within Room 3 and that the floor of Room 1 was limited to the western side in order to accommodate the wheel. The cast-iron ladder described in *Section 4.4.2* would have been the only access into the pit. The MDF-covered section of floor may cover the original flooring arrangement. The chimney is probably contemporary with the rest of the building. The stone trough and wrought-iron bracket may be contemporary with the earliest phase.

Plate 1: Location of Thurland Mill and the Leat (Ordnance Survey 1891)

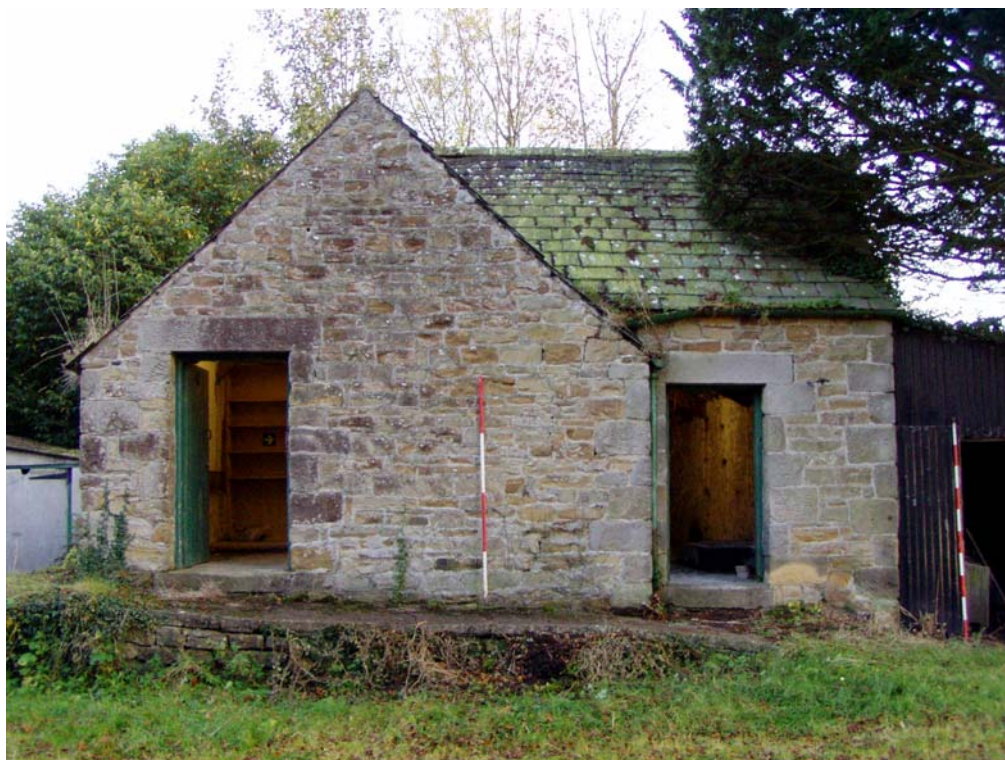
- 4.4.1 **West (front) elevation of mill:** this comprises the west elevations of both Rooms 1 and 2, together with the west elevation of the lean-to (Plate 2). The wall of room 1 (which forms the gable of the main roof) is composed of random-coursed sandstone with lime mortar joints, which contains small pea gravel inclusions. Room 2 (west wing) comprises generally random-uncoursed sandstone and is stepped back slightly from room 1. The sandstone quoins and door lintels are grey in colour and the quoins are roughly squared-off, vary in size and some exhibit working in the form of tool marks. Two doorways are present which provide separate entry to both rooms. Both of these doorways have grey sandstone lintels, which exhibit picked decoration and furrow toolmarks on their undersides (Plates 2 and 3). The doorway into room 1 has a slightly worn sandstone threshold whilst room 2 has a concrete threshold. The doors are constructed of twin layers of beaded planks, vertical outside and horizontal inside and have large T-shaped hinges. The door into Room 1 has a circular vent located above the top hinge and a cast-iron handle with leaf-shaped flanges (Plate 3). The other door has a large octagonal knob. Both doors have simple beaded surrounds. To the south of the door into room 2 a wrought-iron 'clamp' has been inserted into the wall 2.1m above a stone trough measuring 0.9m x 0.64m. A cast-iron 'eye' is located 1.07m from the floor in the quoins on the south-west corner of the building. A sloping walkway runs along the length of the wall, which continues around the corner to the north elevation. This provides access to both rooms from the car park. The walkway is constructed of random-coursed sandstone with a concrete screeded surface. The rainwater goods comprise a single cast-iron gutter and down pipe located in corner where the two rooms join. To the south of the main elevation is the corrugated lean-to, which has a sloping roof and double doors.

Plate 2: The west elevation

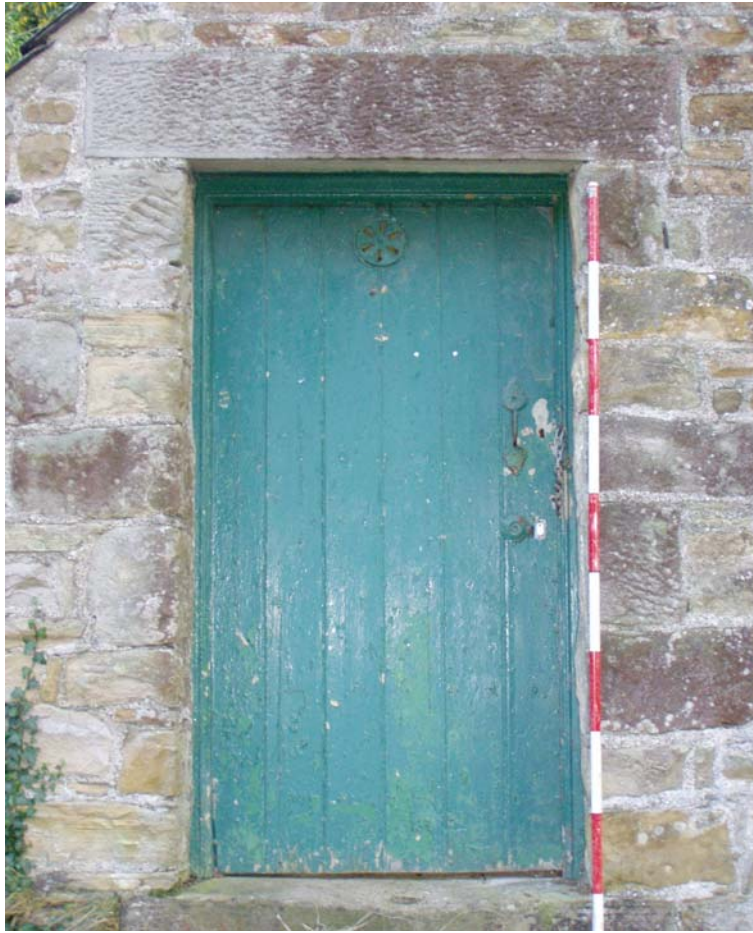
Plate 3: The door into Room 1

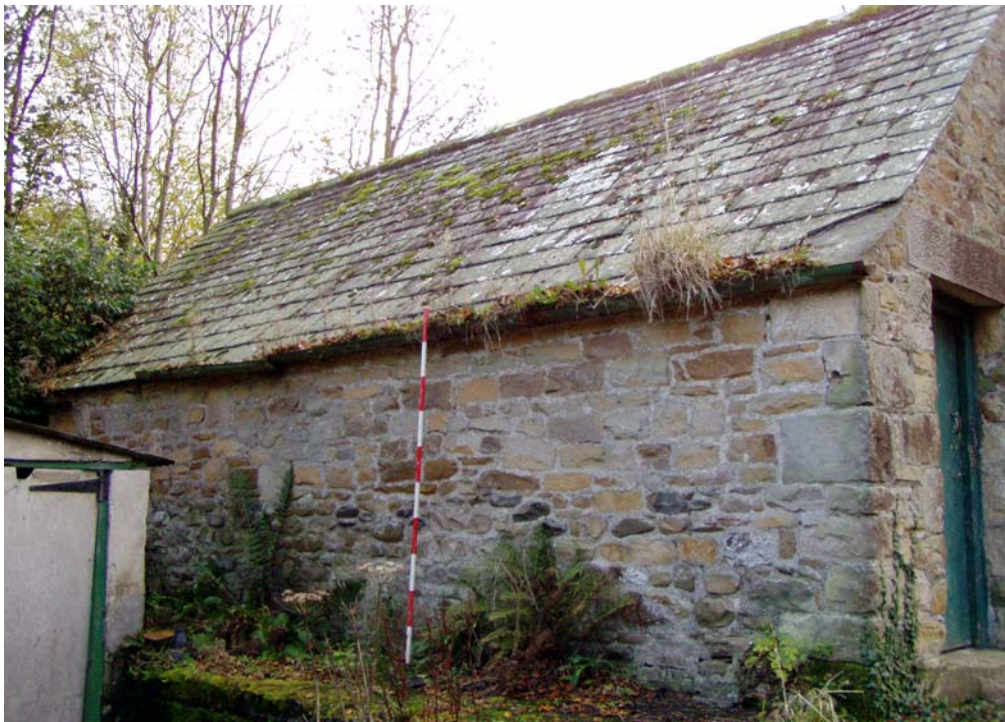
- 4.4.2 **North elevation:** this is composed of the same construction as the west elevation with a cast-iron gutter at the base of the north slope of the main roof (Plate 4). There is no evidence for any blocked openings. The walkway runs along the entire elevation and steps up by 0.14m 7.28m from the north-west corner of the building and continues beyond the east end of the building for approximately 1.23m. At the north-east corner of the walkway is a projecting sandstone corbel exhibiting picked toolmarks, together with a vertical timber with a central groove, which appears to be a guide for a vertical board or gate (Plate 5). At the western end of the walkway in its north vertical rendered face is an aperture measuring 0.26 x 0.26m of unknown purpose.

Plate 4: The north elevation

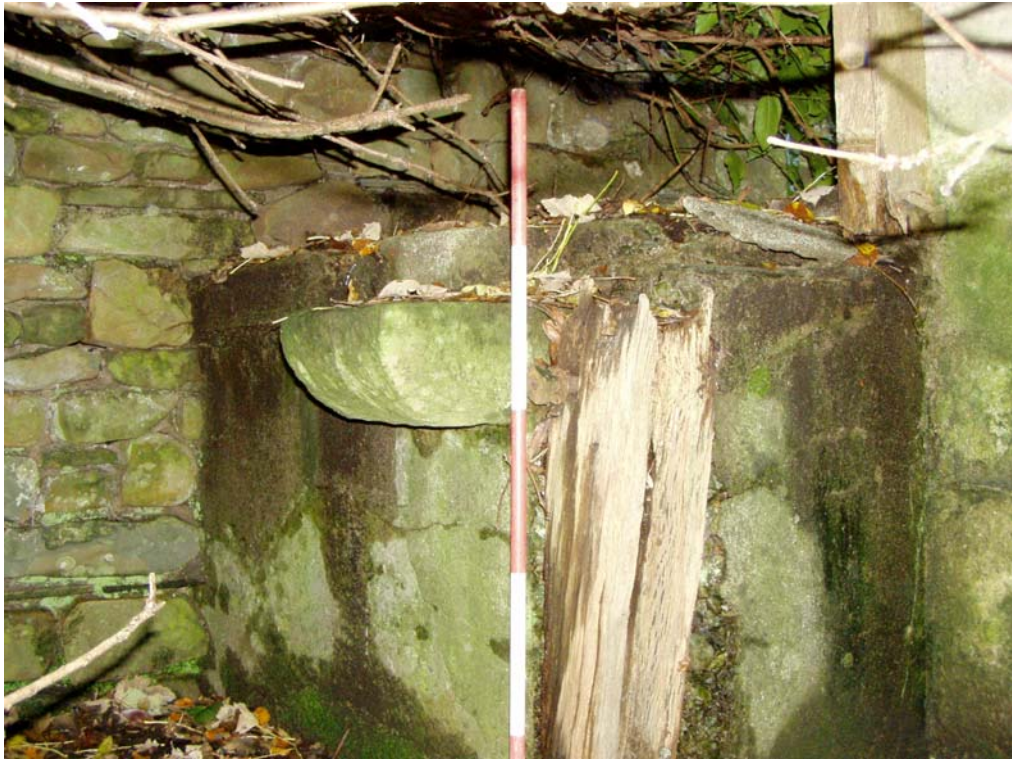
Plate 5: Corbel and post at east end of walkway

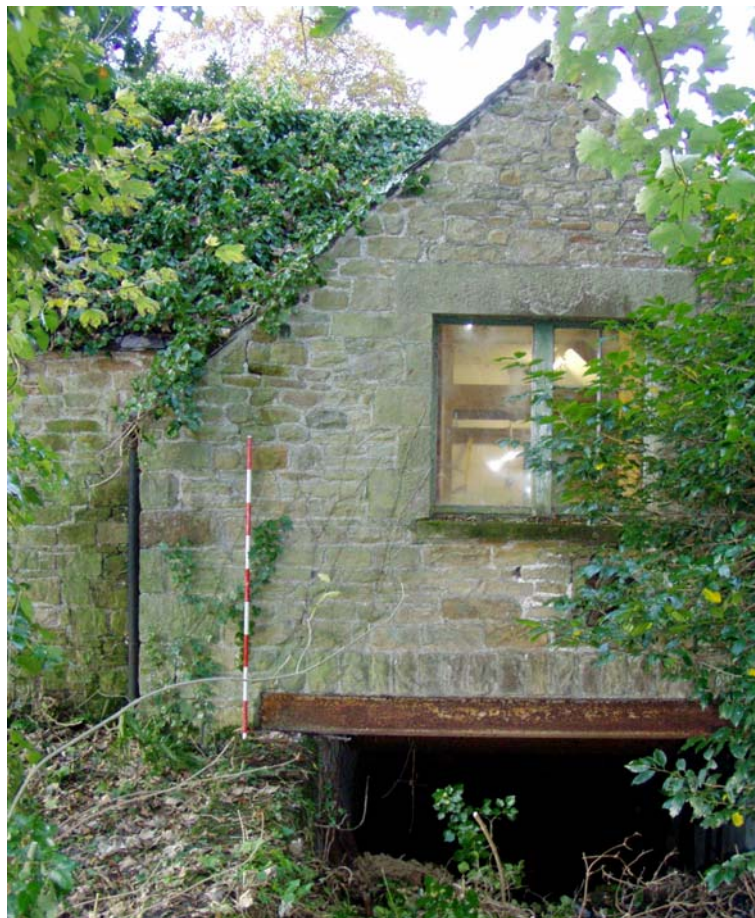
- 4.4.3 **East elevation:** this is constructed in exactly the same manner as the west elevation except for the area above the window, which is random-uncoursed sandstone. The window located in the gable of Room 1 is a timber mullion (Plate 6). It has a sandstone lintel, which is similar to the door lintel on the west elevation. It also has a slightly fine-grained sandstone projecting sill which exhibits diagonal furrow tool marks. The glazing comprises a six-paned, side-opening casement on the right hand side together with a single 'perspex' sheet on the left; both sides are separated by a timber mullion. Below the window is a timber bearing box (Plate 7) measuring 0.34 x 0.34m through

Plate 6: The east elevation (part)

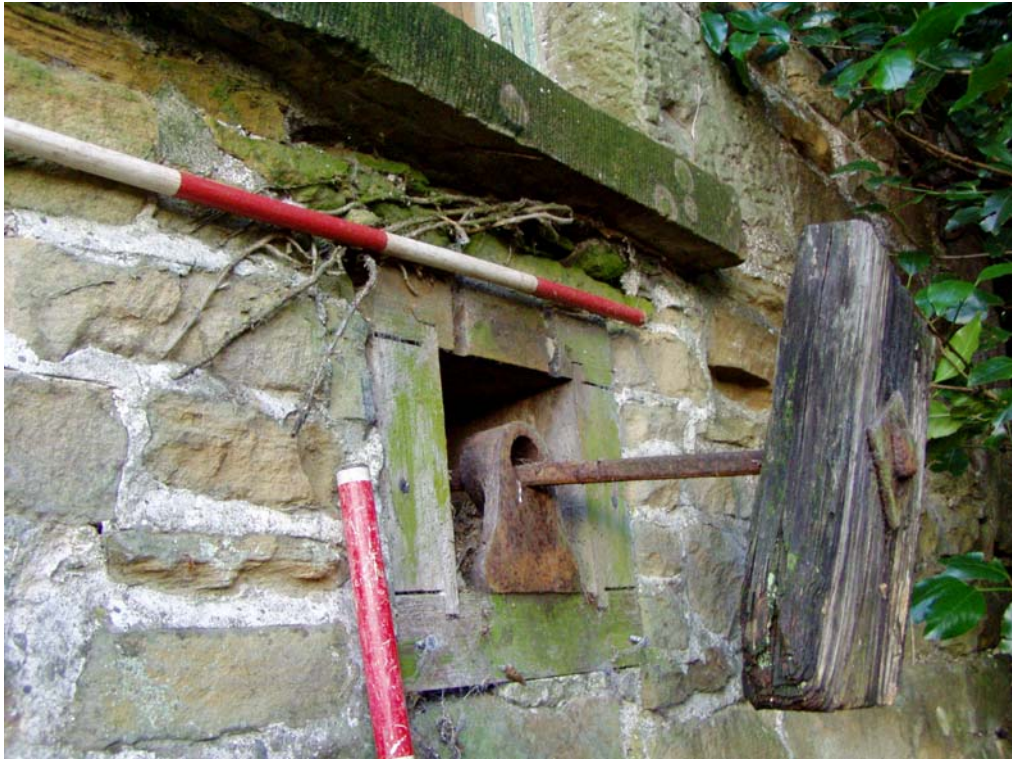
which projects an iron-square section rod located in an iron inverted bell-shaped bracket. This rod is bolted to a short vertical length of timber. At the base of the wall is a horizontal rolled steel joist below which is the millrace opening into room **3**. Header stones are laid on top of the joist and the whole arrangement may be the replacement for an arch. The bottom of the mill leat is 2.4m below the joist. The corrugated lean-to is located to the south of the east wing.

Plate 7: Bearing box beneath window on east elevation

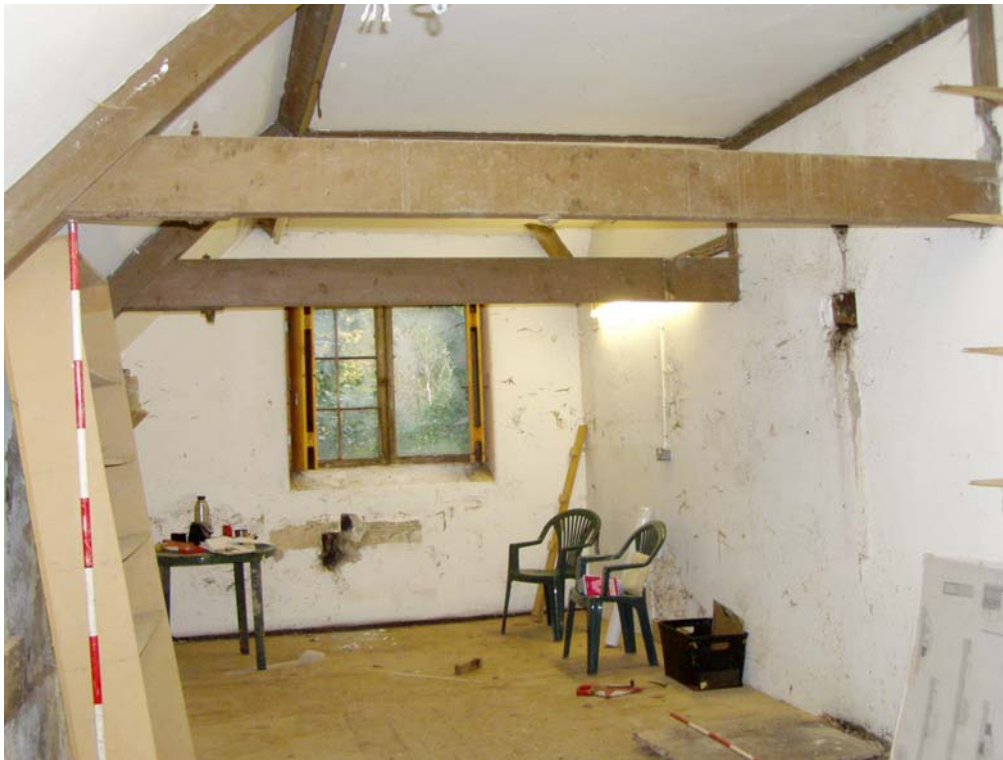
- 4.5.2 **Ground Floor, Room 1:** this is the main room of the mill (Plate 9). The room is lime-plastered, rectangular and has one door, one window and evidence for a heating stove. The western part of the floor comprises 6.5" wide wooden boards with a 9" concrete skirting. Slightly out from the west wall the floor steps up 0.09m and comprises medium-density fibreboard (MDF) planks. Consequently, the ceiling height changes from 2.97m to 2.86m. The roof space has a partial ceiling with exposed north/south beams, which exhibit no decoration and are bolted and plated to the principal rafters. The only access into the room is via the doorway in the west elevation as described in *Section 4.4.1*, which has a lath- and -plaster lintel. The window in the east elevation (as described in *Section 4.4.3*) has a sloping sill and a simple iron catch on the opening casement. Modern pine shutters appear to have been recently installed. Below the window in the east wall is a hole, which passes through to the exterior elevation. The iron bar described in *Section 4.4.3* passes through this and into the room. At floor level the east wall curves under slightly and traces of the rolled steel joist described in *Section 4.4.3* are visible. Located in the south elevation of the room is the evidence for the heating stove. A flagstone measuring 0.8m x 0.68m, which forms the hearth has been inserted into the MDF and laid on top of the floorboards underneath. A circular hole, probably for the flue pipe is visible, underneath which is a cast-iron cleaning access door with 'BRADFORD Co LONDON & MANCHESTER' in relief. The top of a cast-iron ladder, which leads down to room 3, is set into the north elevation wall. Also in this wall an area of missing plaster may be the location of a previous electrical fuse board, as wooden ducting fixed to the wall terminates here.

Plate 9: Room 1 facing west

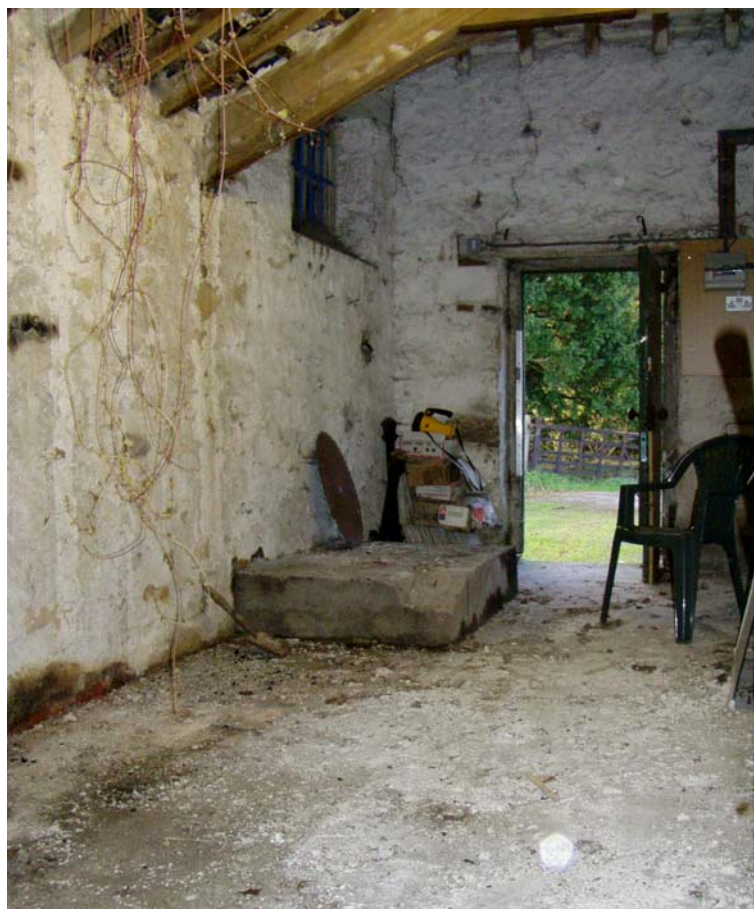
- 4.5.3 **Ground Floor, Room 2:** this room is not plastered but has been whitewashed (Plate 10). It is slightly smaller than Room 1 and the floor is slightly lower. There is one door, two windows and no evidence for a fireplace. The floor is concrete. The room is open into the roof space that has exposed rafters, the spaces between these being filled with lime plaster. The southern end of the roof trusses noted in *Section 4.5.3* are visible and exhibit the same plates and bolts. The beams exhibit circular saw marks. The only access into the room is via the doorway in the west elevation as described in *Section 4.4.1*, which is identical to the one in Room 1, except this doorway has a chamfered timber lintel. The windows located in the two gables of the wings are as described in *Section 4.4.4*. Their lintels are timber and appear to have been reused. The windows are centrally-hinged pivoting twin casements with four lights (eight in total) separated by a timber mullion and have sloping sills. A bearing box, similar to the one described in *Section 4.4.4*, is located close to the floor in the north elevation. The aperture within which it is inserted passes right through the wall into the top of Room 3. The horizontal iron shaft noted in *Section 4.4.4* is connected to a lever and the shaft rests on a timber bearing block, which has two vertical studs and is located on the floor half way between the walls (Plate 11). The shaft would have passed through the corresponding hole in the south elevation through to the exterior of the building. A large (concrete) machine base is located in the south-west corner of the room, which appears to show evidence for a belt drive. To the west of this are two vertical iron rods 2" in diameter. In each corner of the room is a small ledge measuring 0.25m x 0.1m approximately 0.85m from the floor. An iron pipe is fixed to the

north wall approximately 0.8m above ground level. There is a crack running up the east elevation wall.

Plate 10: Room 2 facing east

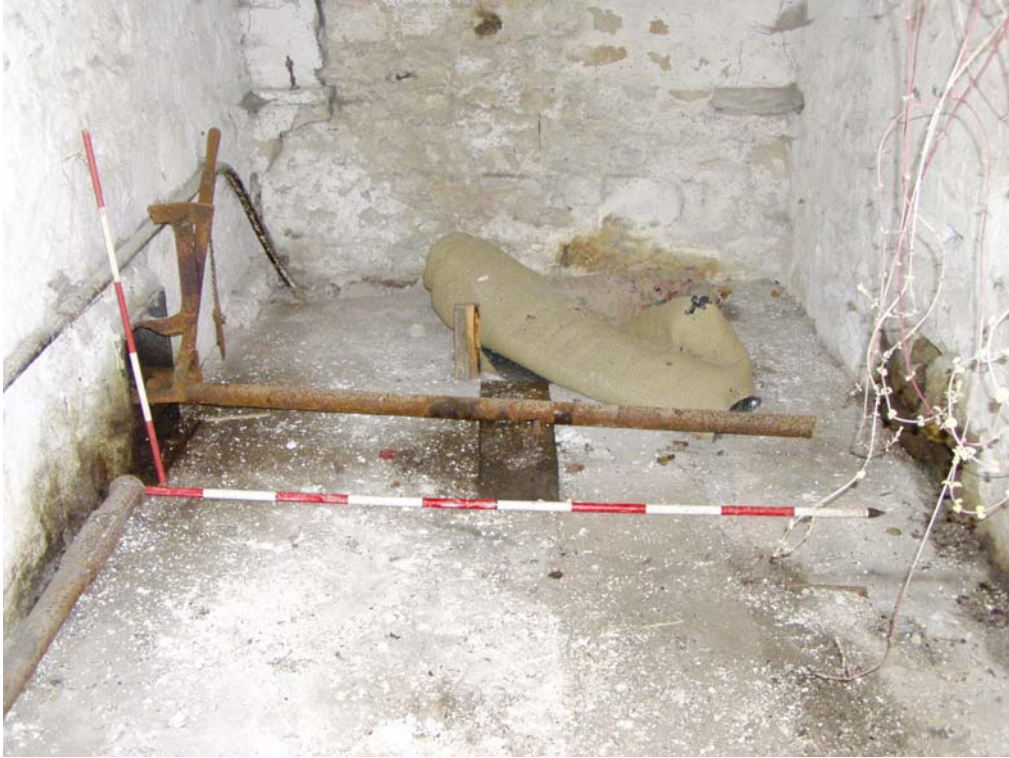
Plate 11: Shaft in Room 2 facing east
