THURLAND MILL, CANTSFIELD, LANCASHIRE

Archaeological Building Investigation and Watching Brief

Oxford Archaeology North

January 2006

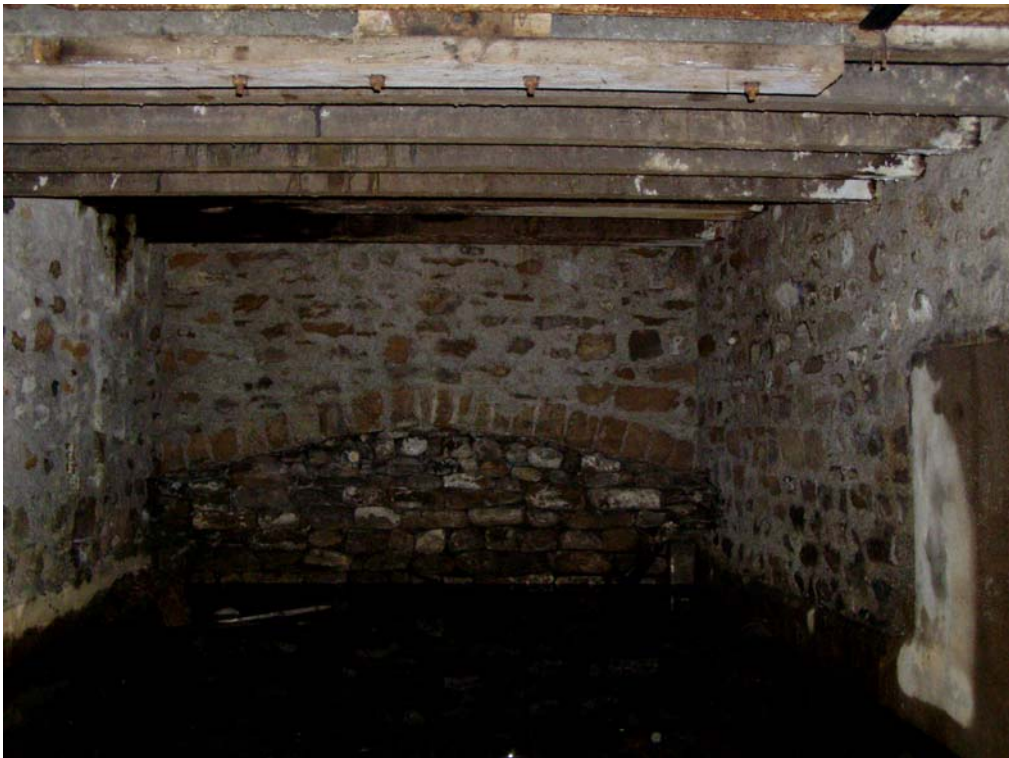
- 4.5.4 **Lower Ground Floor, Room 3:** this room forms part of the mill leat, which passed under room **1** and has the same footprint. It was waterlogged at the time of survey and access was limited. It is mainly constructed of random-coursed sandstone with pointing that is smeared over each stone. The eastern half of the room has been lined with concrete. The west elevation of the room comprises a stone arch (Plate 12). The arch is made up of stone headers similar to the ones in the east elevation. It has been blocked using different random stone, some of which appear not to have been pointed. The ceiling comprises massive timber planks and rolled steel joists and supports the floor of Room **1** above. Through this, and fixed into the north wall, passes an iron ladder as noted in Room **1**, *Section 4.5.2* (Plate 13). An iron bearing box, the same as those already described-is inserted in the south elevation at ceiling level. The top of the box cannot be seen as it is partially obscured by the ceiling.

Plate 12: Room 3 facing west

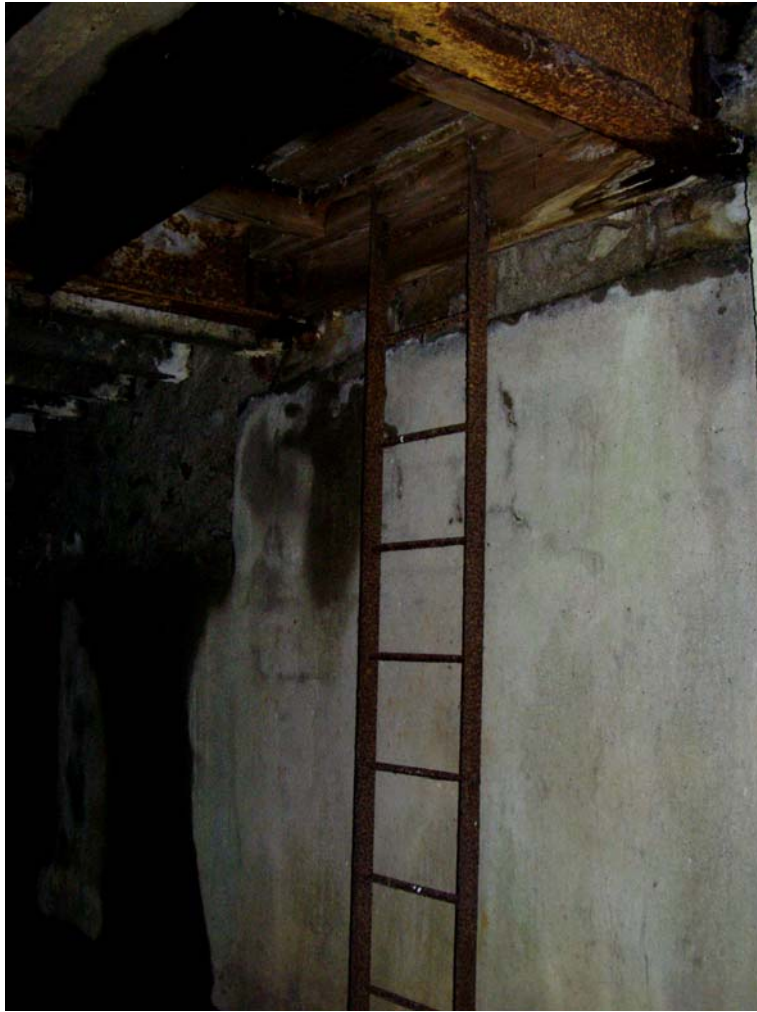
Plate 13: Ladder connecting Rooms **1** and **3**

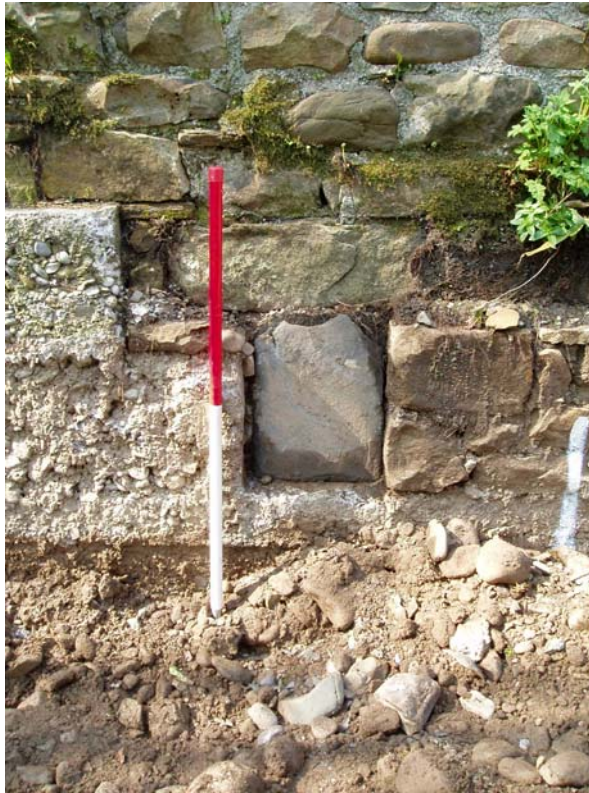
Plate 14: Blocked aperture in the east elevation of the mill, uncovered during the watching brief

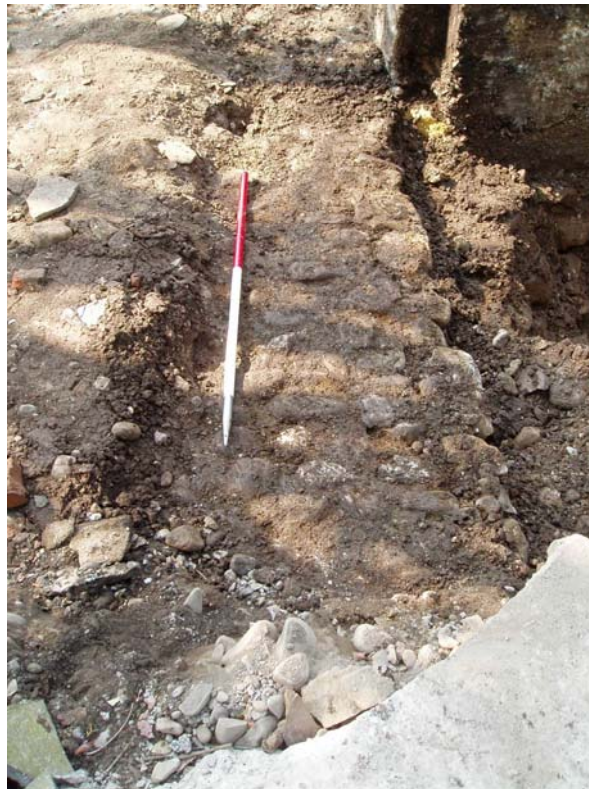
- 5.2.3 The excavation of the foundations to the east of the mill revealed a number of features. Below the thin layer of concrete and gravel and loose gravel that covered the entire area was a layer of overburden (**101**) containing a large amount of stone, as well as fragments of brick and ceramic drainpipe. Beneath this, at the south end of the excavated area, was a thin layer of dark-brown sandy-clay (**102**), which overlay a layer of cobbles in a mid greyish-green sandy-cement (**103**; Plate 15), which were bedded in a layer of firm pale brown clay (**105**). These cobbles butted a wall comprising dressed sandstone blocks orientated east/west (**104**), which turned northwards at its east end,

Plate 15: Cobbled surface *103*

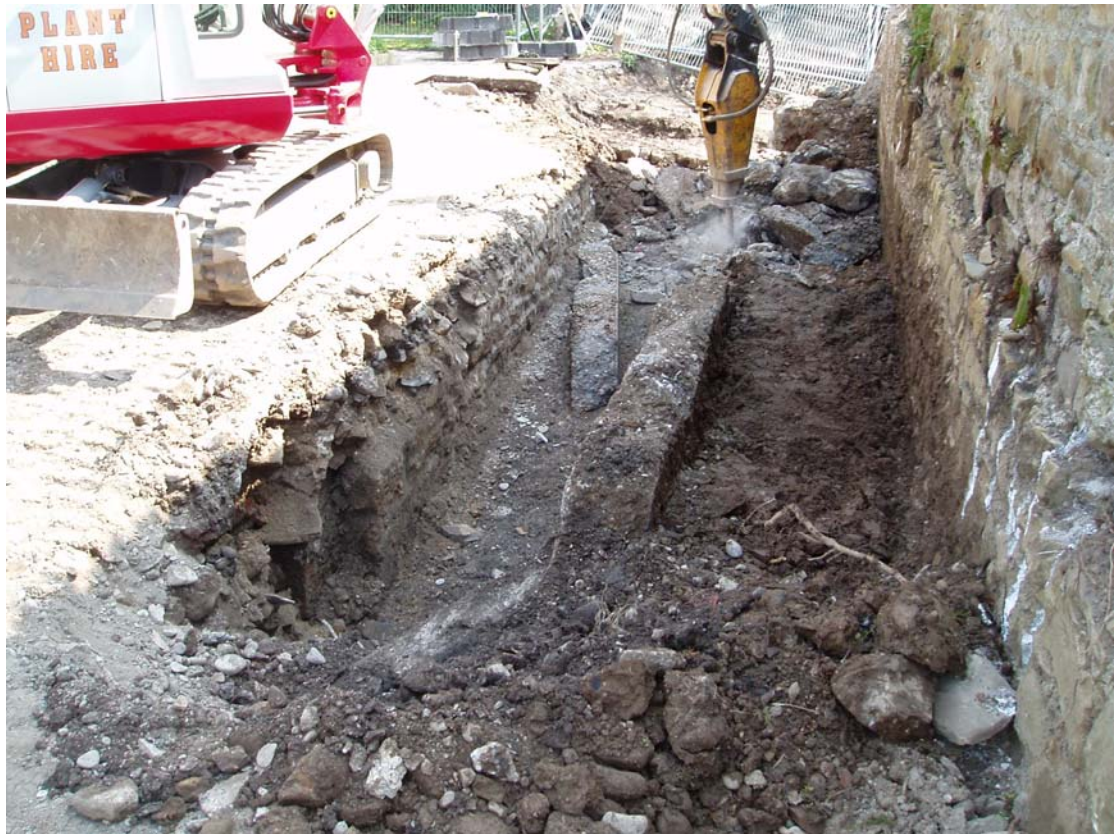
- 5.2.4 To the north and west of this wall was a concrete wall (**106**; (Plate 16)), the southern part of which was associated with **104**. The concrete wall had a narrow, 0.3m wide, section orientated north/south, to the east of which was a concrete ramp. This was within a narrow channel (Plate 16), the east side of which was formed by a wall of roughly-dressed sandstone blocks with extruded grey mortar (**109**), which formed the opposing surface of wall **104** (Plate 16). To the west of **106**, between the north/south orientated wall and the east wall of the mill, was a deposit of sandy clay-gravel (**108**), probably re-deposited natural. The concrete making up **106** was related to a rebuilding of the foundations of the east elevation of the mill, also in concrete, which extended below ground for over two metres. Deposit **108** extended to a similar depth along the east elevation of the mill, although the lower part of it may have been part of the underlying natural geology (**113**).

- 6.3.2 The construction of walls **106** and **104/109** was evidently a single event, and formed a ramped channel orientated north/south, turning north-east at its north end. The cobbled surface (**103**) to the south may have been associated with this, although it may have been an earlier feature that was cut by the walls. The construction of this ramped channel undoubtedly coincides with the extensive alterations seen within the building, particularly Room **3**. These would appear to have been brought about by a change in the power supply within the mill.

Plate 16: The concrete and stone-lined channel (*106* and *109*) during excavation
