# **SIZERGH CASTLE, CUMBRIA**

## **Archaeological Recording of a Culvert and Well**

**The National Trust**

Issue No: 2006-7/570

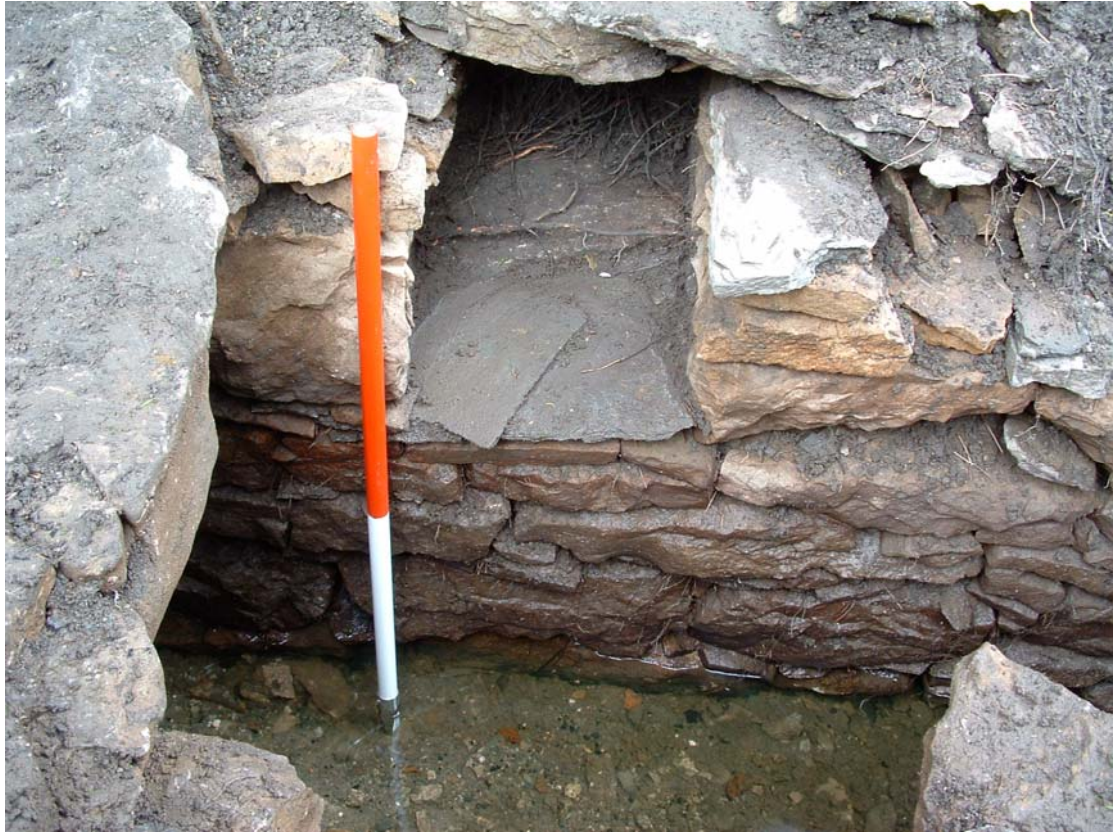
Plate 3: South-west-facing view of southern side culvert

- 3.1.2 The culvert was aligned north-west/south-east, with two apparently perpendicular side culverts built opposite each other and joining the main culvert at the south-eastern end of the area of the removed slabs (Plate 3). The main culvert was constructed of unmortared roughly-finished limestone blocks, averaging 0.3m long by 0.15m thick. The base, within which water ran, was likely to have been of slate construction, similar to that of the side culverts (see below) but, at the time of recording, it had been obscured by a layer of large pebbles and gravel that were introduced as a result of collapse associated with the present groundworks on site. The side culverts were of identical construction and measured 0.32m wide by 0.3m deep, with their slate-lined bases 0.6m above that of the main culvert. The south-western side culvert appeared to be heading towards a well, located against the wall of the North Wing, whilst the north-eastern side culvert was running off towards the rock garden. The entrances to at least four other, probably parallel, north-eastward culverts were visible when a torch was shone down the north-western part of the culvert. However, at the time of recording, these culverts lay beyond the area of collapse and could not be more fully described.

- 4.1.1 The culvert was built to a high standard and remains in good working order, although its ultimate source is unknown. The opposing side culverts are somewhat enigmatic, although it seems most likely that the south-western one ran from the well against the north wall of the North Wing, probably acting as an overflow for the well. The function of the north-eastern side culvert is suggested by the presence of the parallel culverts observed running from the north-west section of the culvert prior to the roof collapse; these side culverts are highly likely to have carried excess water from the main culvert to the area of the limestone rock garden, to reduce the possibility of flooding to the main house. It is also possible that these north-eastern side culverts were designed to provide irrigation to the adjacent garden areas although the water in the main culvert would have to be far deeper to flow out of this side culvert (during the course of the present investigation, which occurred after two days of heavy rain, the water was only 0.1 m deep in the main culvert). The internal recesses, observed in the north-western part of the enclosed culvert, may have been a turning space to allow individuals undertaking internal maintenance to turn round.

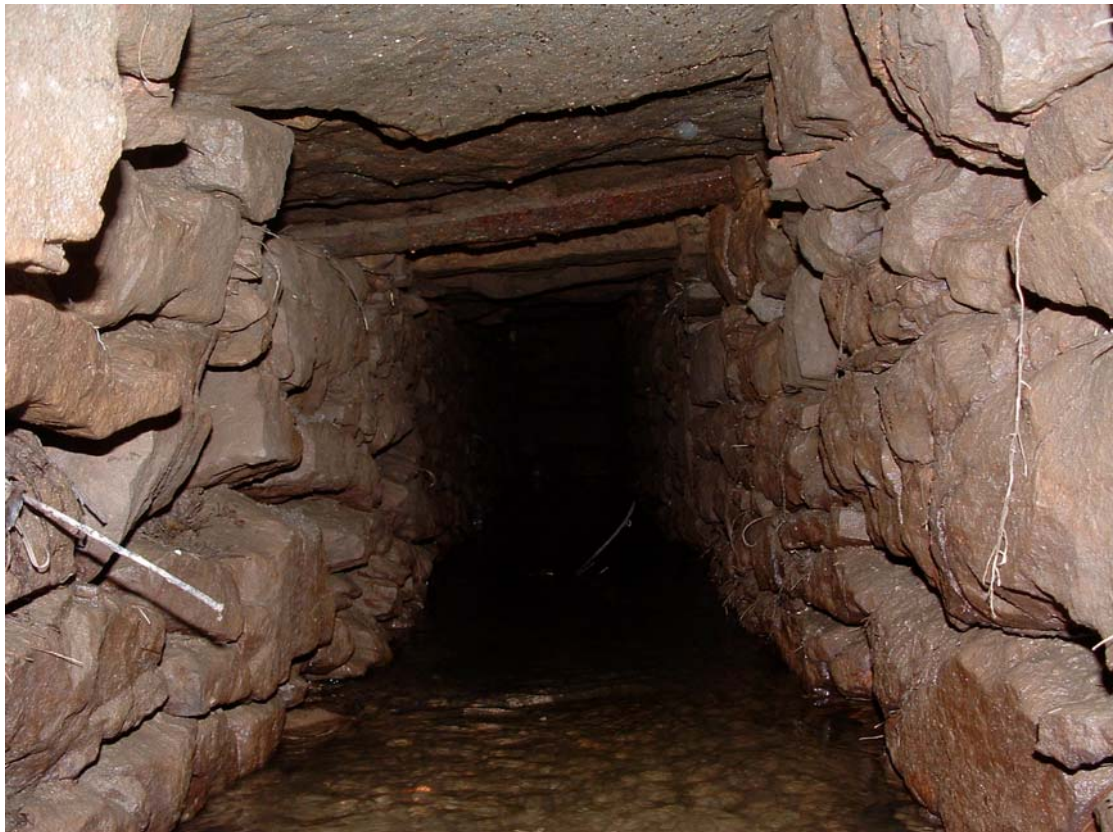
Plate 4: South-east-facing view inside culvert

- 3.1.3 Health and Safety constraints meant it was not possible to enter the culvert, although the area of the removed slabs afforded the opportunity to examine the internal features of the culvert. To the south-east the culvert continued for 7.7m (measured by laser distance meter), before abruptly reaching an apparent dead end (Plate 4). This was where the line of the culvert met the eastern end of the central range of the Castle, confirmed by surface survey. A metre to the north-west of the area of the removed slabs, two recesses were observed opposite each other in the side walls (Plate 5); that on the north-eastern side was substantially larger than the recess on the south-western side. No further internal features could be seen to the north-west, due to an area of recent collapse, although prior to collapse, it was estimated that the culvert stretched at least 25-30m to the north-west (Jamie Lund *pers comm*).
