The Old Station, Silloth, Cumbria

Archaeological Building Investigation

Oxford Archaeology North

April 2007

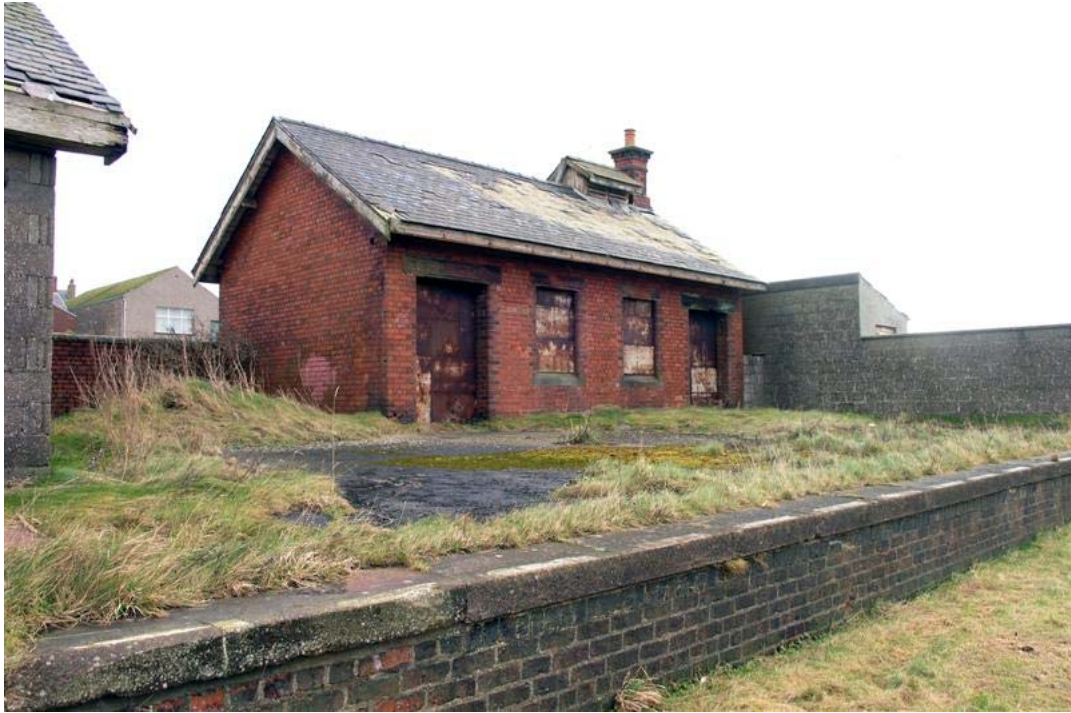
Plate 1: General view of the old station building

- 3.3.14 The station platform is located 8.8m to the west of the workshop and comprises a brick (EGW bond) base with a sandstone block kerb (Fig 3; Plate 1). This has been patched in places and some of the kerb stones have been replaced with concrete blocks. The platform itself is laid down to a mixture of asphalt and grass.
- 3.3.15 ***Interior Details:*** there was no access to the interior of the workshop at the time of survey and, therefore, the interior remains uninspected.

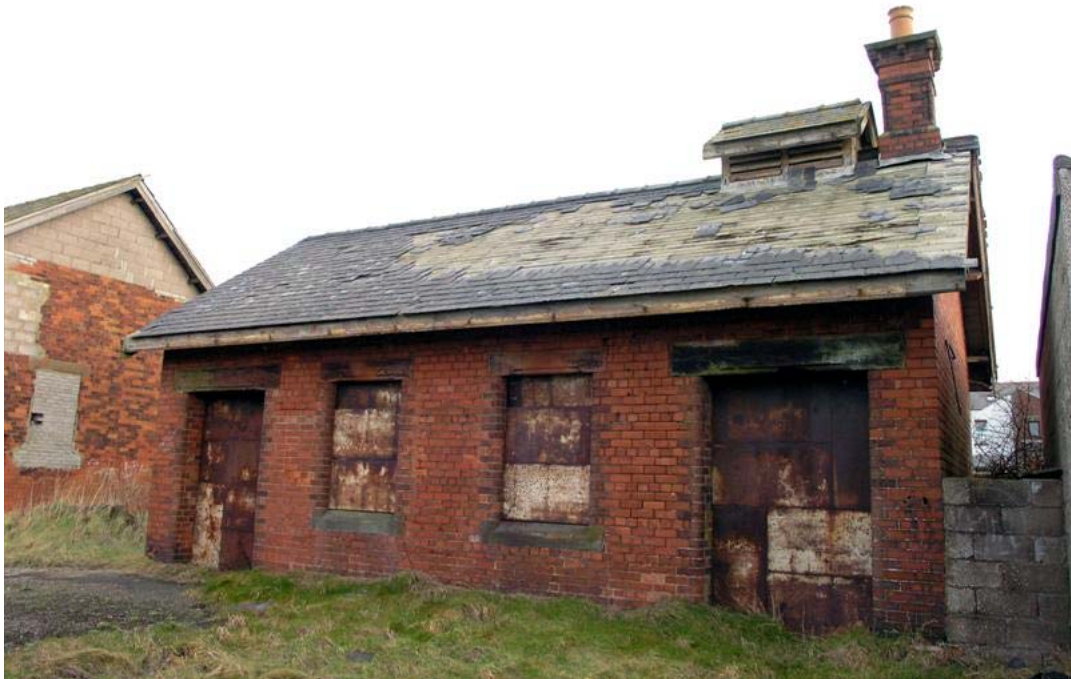
Plate 2: Front (west) elevation

- 3.3.3 **The West Elevation:** as already stated, this elevation faces the surviving platform, and contains two doors and two windows, all of which are blocked with substantial steel sheets (Plate 2). The elevation is symmetrical in design.

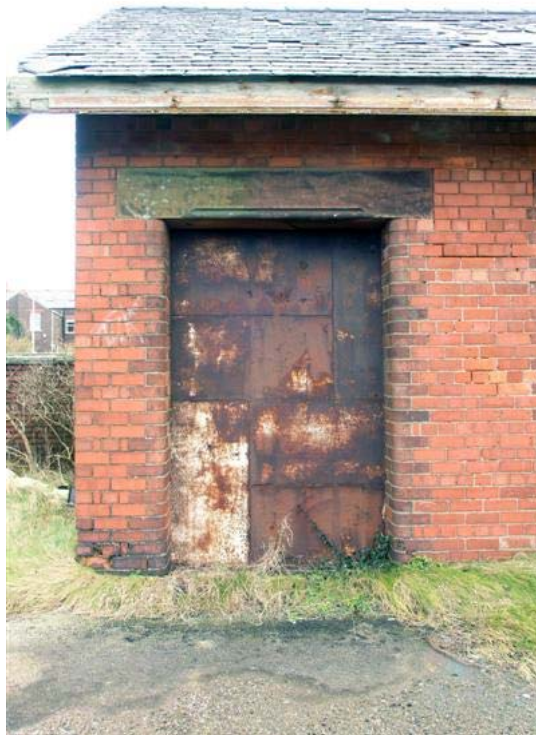
Plate 3: Example of door on west elevation

- 3.3.4 The two doorways open out onto the platform and both share identical features, namely bull-nosed jambs and red sandstone lintels. The lintels exhibit diagonal furrow toolmarks and bead moulding (Plate 3). The doorways are

both five feet wide (1.5m).

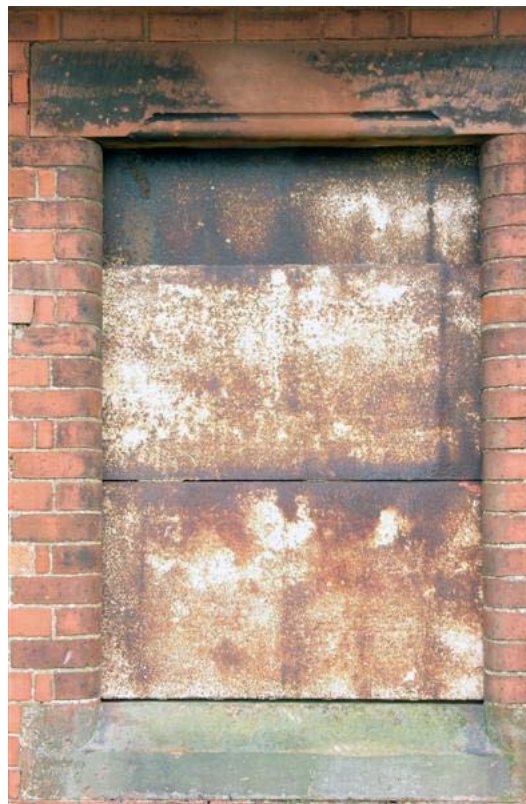
Plate 4: Example of a window on west elevation

- 3.3.5 The windows exhibit similar features to the doors, such as the bull-nosed jambs and lintels. They have sloping sandstone sills of similar dimensions to the lintels (Plate 4).

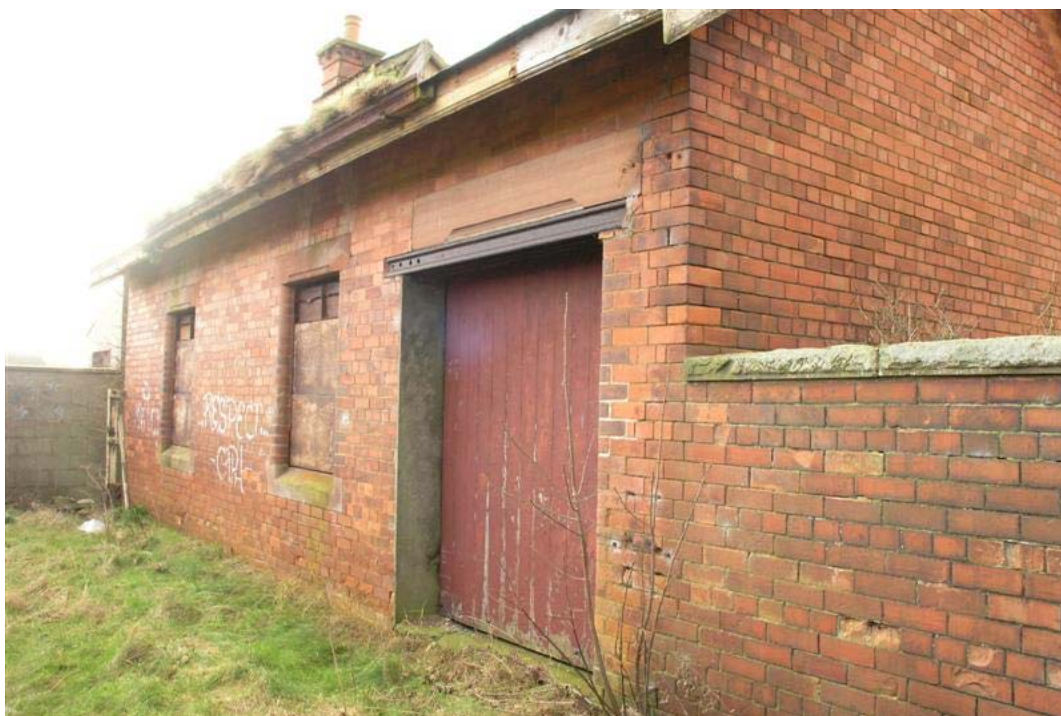
Plate 5: Rear (east) elevation

- 3.3.6 **The Rear (East) Elevation:** this elevation has a single door and two windows (Plate 5). The windows are identical to those on the front elevation (Section 3.3.5) but the doorway differs slightly. It appears to have been widened by 14 inches (0.35m) at some point, and a reused section of track has been inserted to serve as an additional lintel below the original lintel (Plate 6). The doorway now slides rather than having a conventional door. All the other details are as described for the west elevation (Section 3.3.3).

- 4.2.3 **Phase 2:** this phase comprises the alteration of the doorway in the east elevation (*Section 3.3.6*). Although it is not possible to attribute an exact date to this alteration, it is reasonable to assume that it was carried out prior to the closing of the line in 1964.

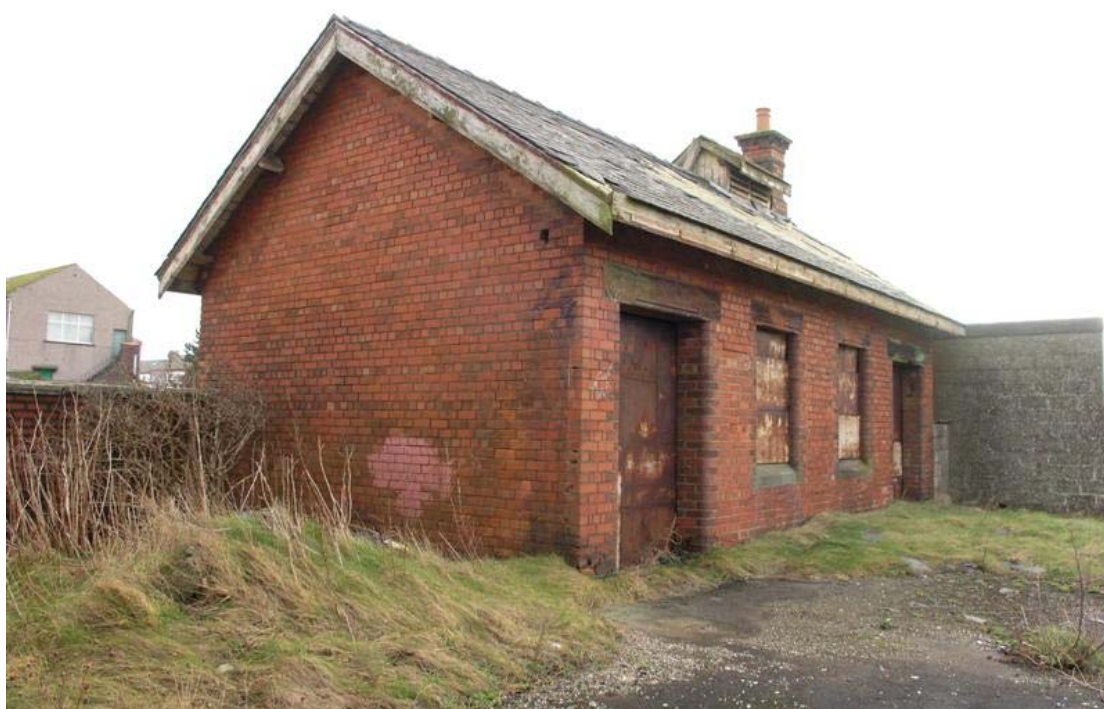
Plate 6: North elevation

- 3.3.7 **The North and South Elevations:** these create the gable ends of the building. The elevations are identical and are plain in detail, with no distinguishing features (Plate 6).

- 3.3.8 **The Roof:** this is of pitched construction with overhanging eaves and projecting verges (Plate 6). The verges have moulded bargeboards and projecting purlins and wall plates. Projecting rafters are visible below the eaves (Plate 7). It would appear that whilst the underlying structure of the roof is original, the covering was replaced in the twentieth century.

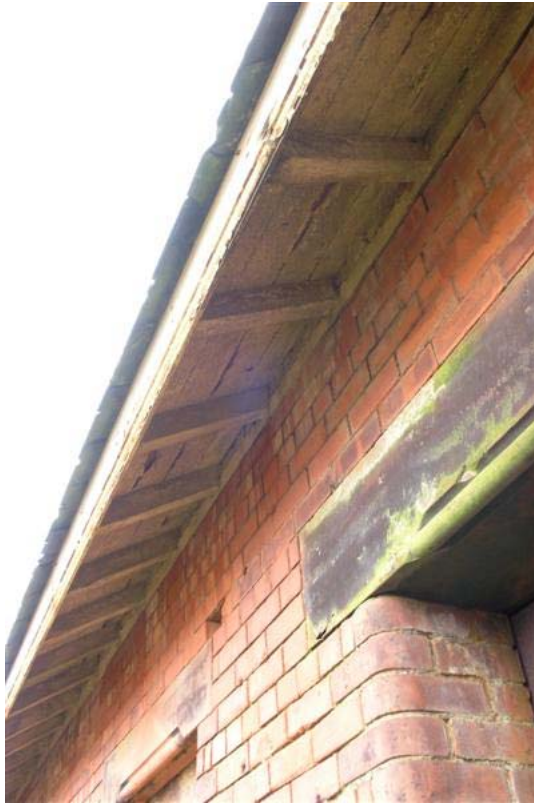
Plate 7: Projecting rafters below eaves

- 3.3.9 The roof is constructed from horizontal planks to which the roof slates are fixed (Plate 8). The planks are also visible below the eaves (Plate 7) and verges. The slates are Welsh and are laid in straight courses. The ridge is of dark grey tile but appears to originally have been of terracotta, with a simple bead moulding. These original ridge tiles are present to the south of the chimney. The slates are fixed to the planks with flat-headed nails.

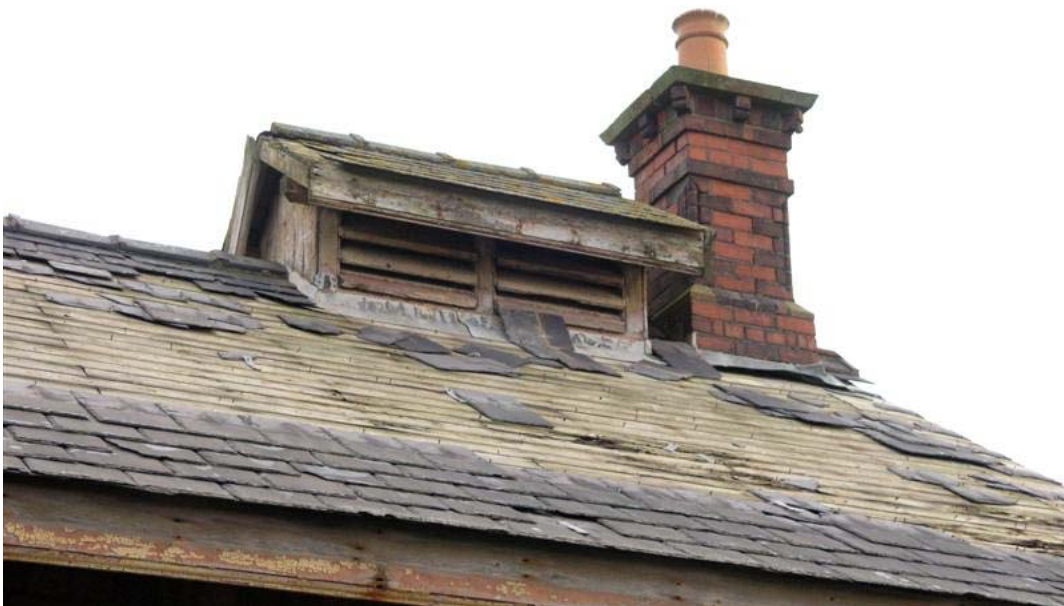
Plate 8: The roof, chimney and ventilation

- 3.3.10 A single chimneystack straddles the ridge at the south end of the roof. It has an oversailing course and moulded dentils. It also has corner bead-moulded bricks and sits on a plinth (Plate 8). The chimney pot may not be the original.

- 3.3.11 To the north end of the roof, adjacent to the chimneystack, is a timber ventilation outlet. This has a pitched roof (Plate 8). Its east and west elevations are louvered, whilst the north and south are of matchboard. Lead flashing seals the gap between the ventilation outlet and the main roof. This would appear to be an original feature.

- 4.2.4 **Phase 3:** it seems likely that the recovering of the roof took place in the later half of the twentieth century. This would appear to be modern repair work.

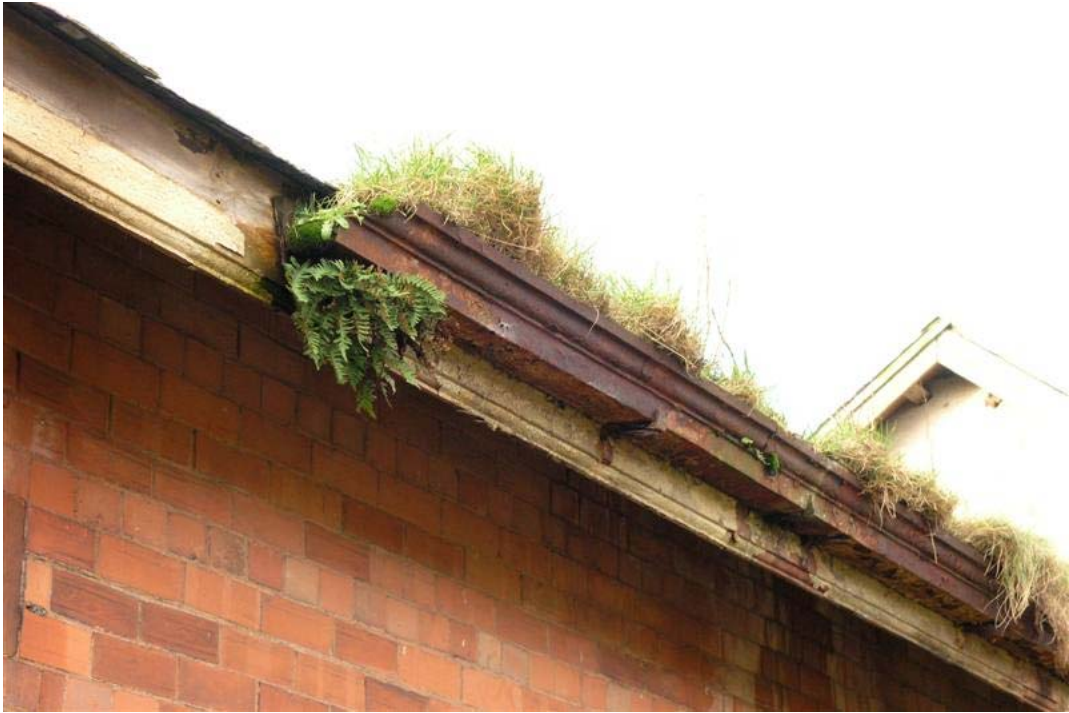
Plate 9: Cast iron gutter on east side

- 3.3.12 A small section of guttering survives at the base of the east pitch of the roof (Plate 9). This is cast iron and has a square section base with cyma-recta moulded upper body, commonly termed 'ogee'. The guttering is fixed to the eaves on wrought iron brackets. It is probable that this dates to the original construction of the building.

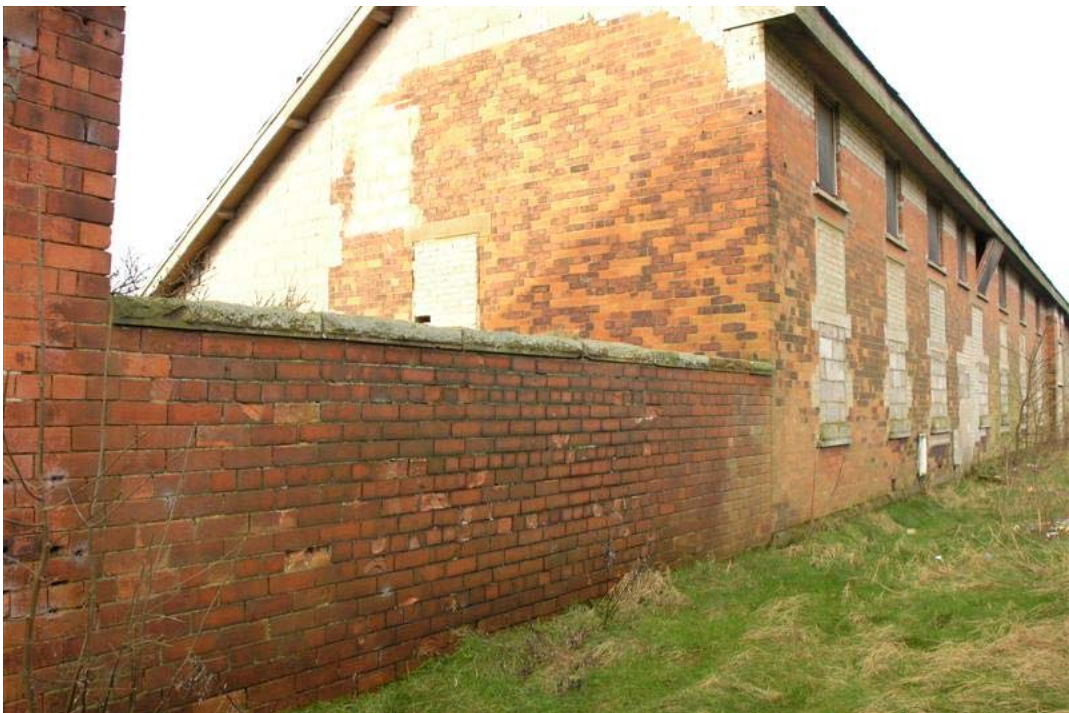
Plate 10: Section of wall between buildings

- 3.3.13 **Other Details:** a short section of wall connects the workshop building to the station building to the north (Fig 3, Plate 10). It is constructed from the same brick (and bond) as the workshop and has darkly weathered sandstone coping with rock-cut rustication. There is a butt joint where the wall meets the station

building.

- 4.2.2 **Phase 1:** the workshop dates to at least 1856 when the railway was opened. It is possible that it is slightly later than the station building (*Section 3.3.13*), and a brief inspection of the station building revealed it to be of a slightly different style.
