# **Southmire Field Barn, Lowgill Lancashire**

## **Archaeological Building Investigation**

**Oxford Archaeology North**

April 2007

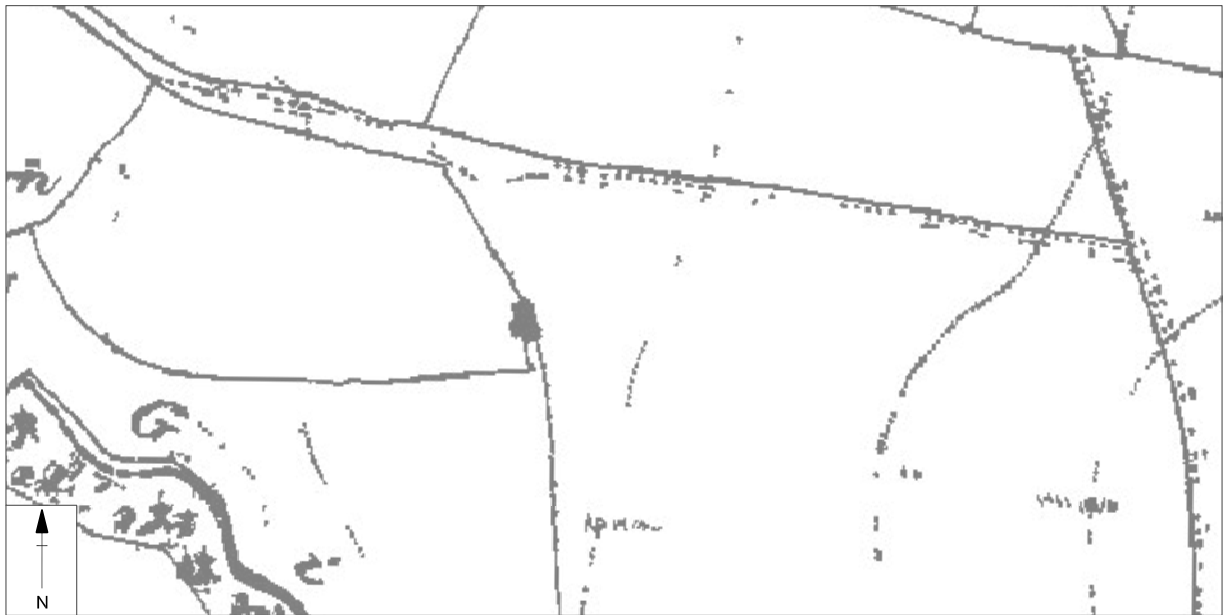
Figure 2: Extract from Ordnance Survey first edition map, 1848

- 3.2.1 **Ordnance Survey first edition 1848** (Fig 2): this is the earliest map that is detailed enough to have Southmire Barn located on it. The barn is shown as a small rectangular shaped structure with a projection on the west elevation to the south of Brackenbottom Farm. Lowgill village can be seen to the north-west, with Ivah to the south-west.

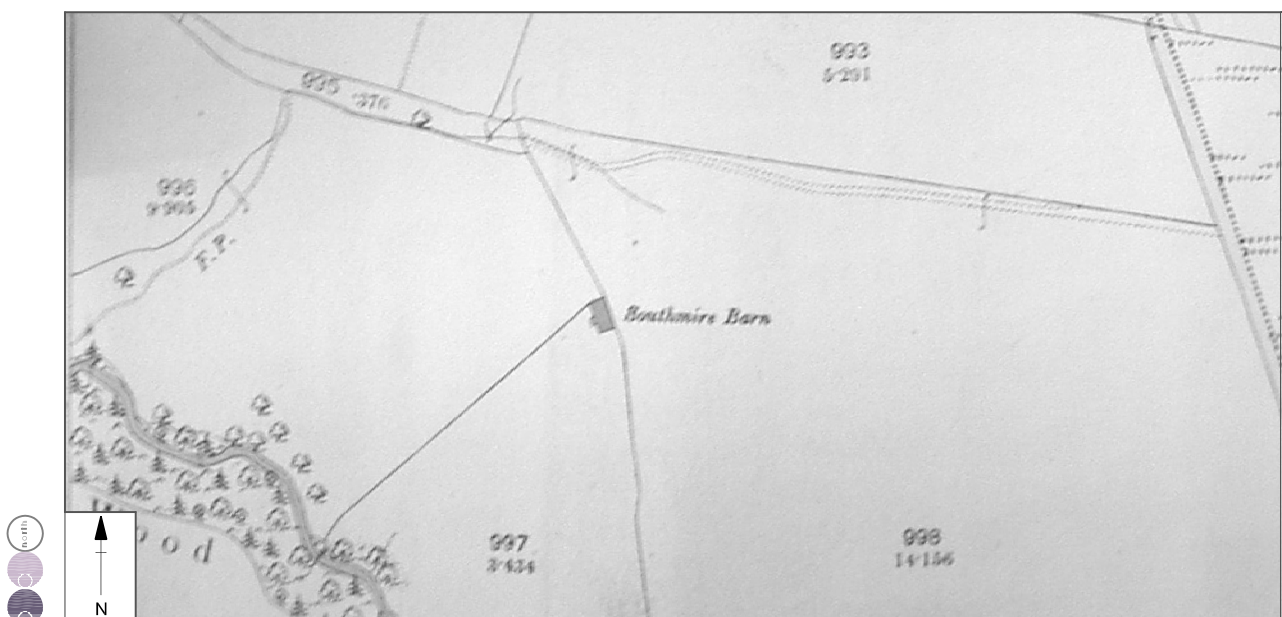
Figure 4: Extract from Ordnance Survey second edition map, 1913

- 3.2.3 **Ordnance Survey 1913 edition** (Fig 4): this edition is virtually identical to the 1891 map, and shows hardly any changes at all to the barn or the surrounding area, with the exception of a slight change in the way the field boundary, first illustrated in 1891, is shown to be attached to the north-west corner of the barn.

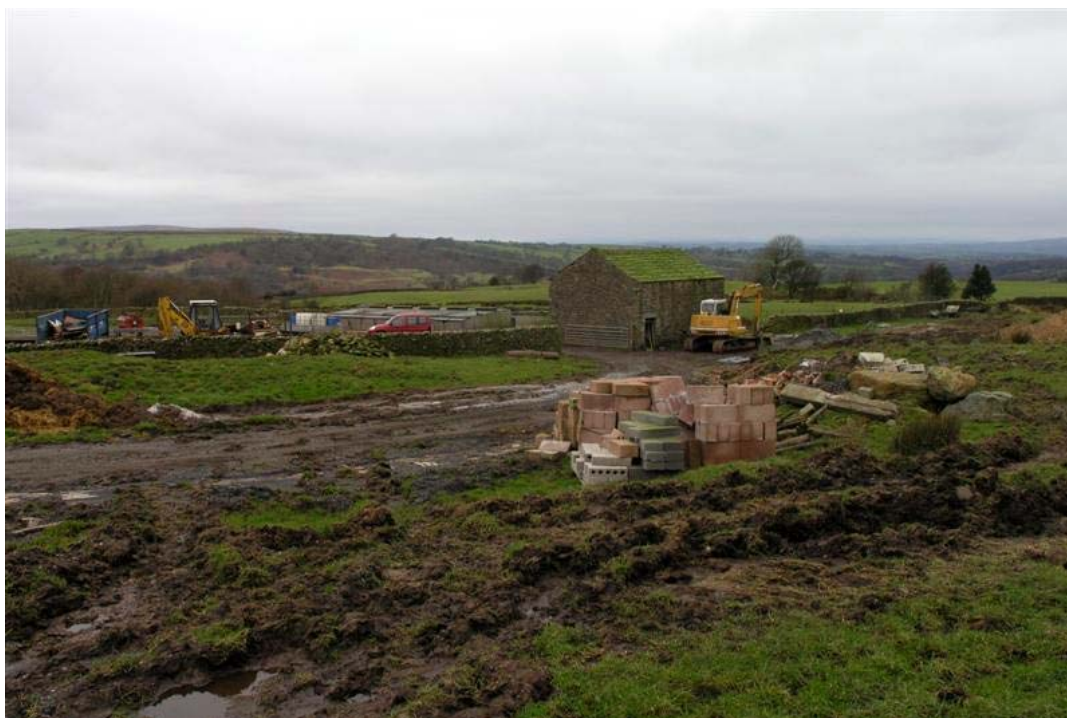
Plate 1: General view showing Southmire field barn

- 3.3.1 **Introduction:** Southmire Barn is a small stone field barn located in a relatively isolated position approximately 0.25km to the south of the nearest farm at Brackenbottom (Plate 1). The barn is 0.25km away from the nearest public road, which lies to the south. It lies adjacent to a dry-stone wall field boundary.

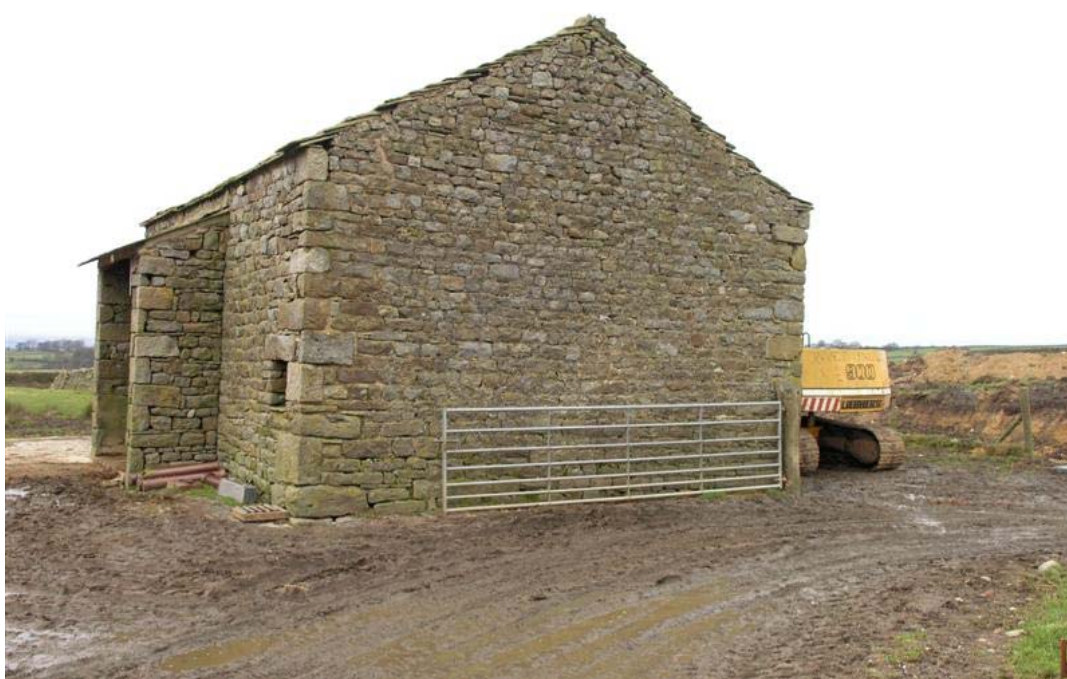
- 3.3.12 **The South Elevation:** this is plain with no distinguishing features and is very similar in appearance to the north elevation (Plate 2).
- 3.3.13 **The Roof:** this is gabled (approximately 30° pitch) and is covered with sandstone flags, which are laid in diminishing courses (Plate 11). Some patching with Welsh slate is evident but most of the slabs are fairly intact. The ridge is sandstone and appears to be contemporary with the rest of the building. The roof has plain verges and slightly projecting eaves, and the slope appears to flatten out close to the eaves (Fig 6).

Plate 2: South-west corner of barn

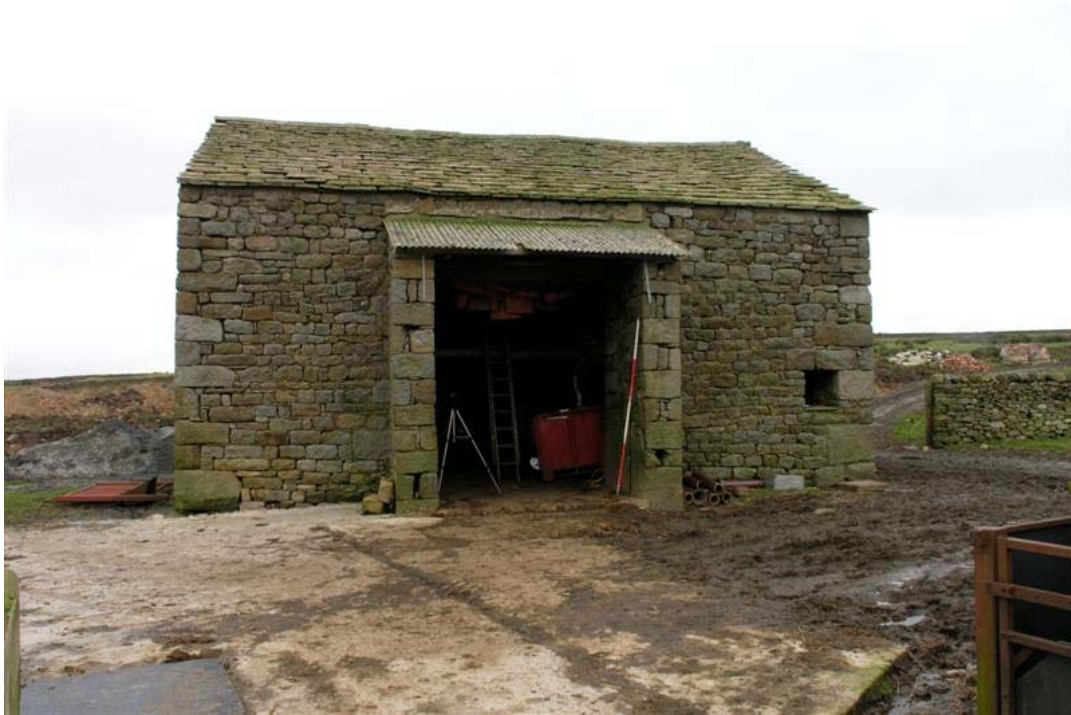
- 3.3.4 **The Main (West) Elevation:** this houses the main entrance to the larger part of the barn and also contains a small window aperture which allows light into the stalls area (Plate 3). The mortar in this elevation is more weathered than the others, which is not surprising considering it faces the prevailing weather. There are large quoins at both corners, which are of random size, some of which exhibit pick mark tooling.

- 3.3.7 The small window aperture (*Section 3.3.4*) is located at the southern end of the elevation (Plate 3) and has a substantial stone lintel (timber internal lintel) which is cracked, and has a flat sandstone sill, which slopes slightly toward the exterior (probably to shed water).

Plate 3: Main (west) elevation

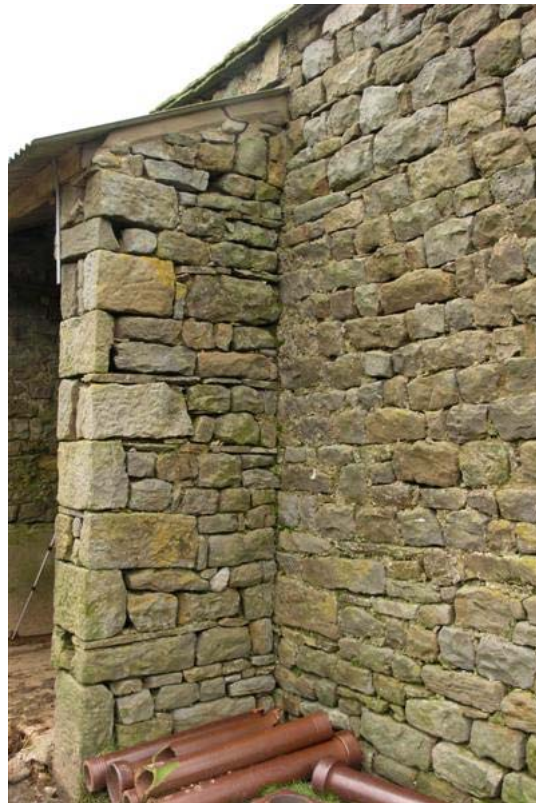
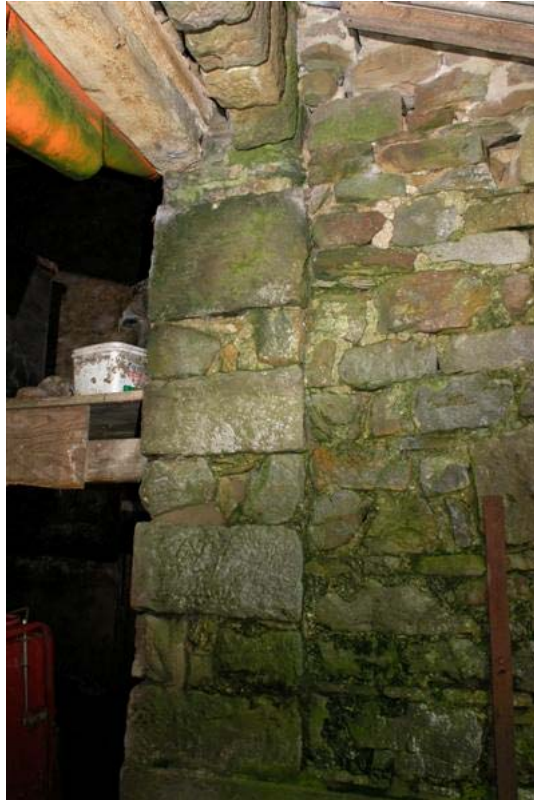
- 3.3.5 The most prominent feature is the large porch which appears to have been added later than and butts against the main elevation (Plates 4 and 5). This is constructed from similar stone to the rest of the building and has similar large quoins. The porch simply consists of two walls or cheeks (not full height) with a sloping asbestos canopy roof, which probably replaced an earlier structure. Some recent cement patching is also evident.

Plate 4: Porch attachment

Plate 5: Porch attachment internal view

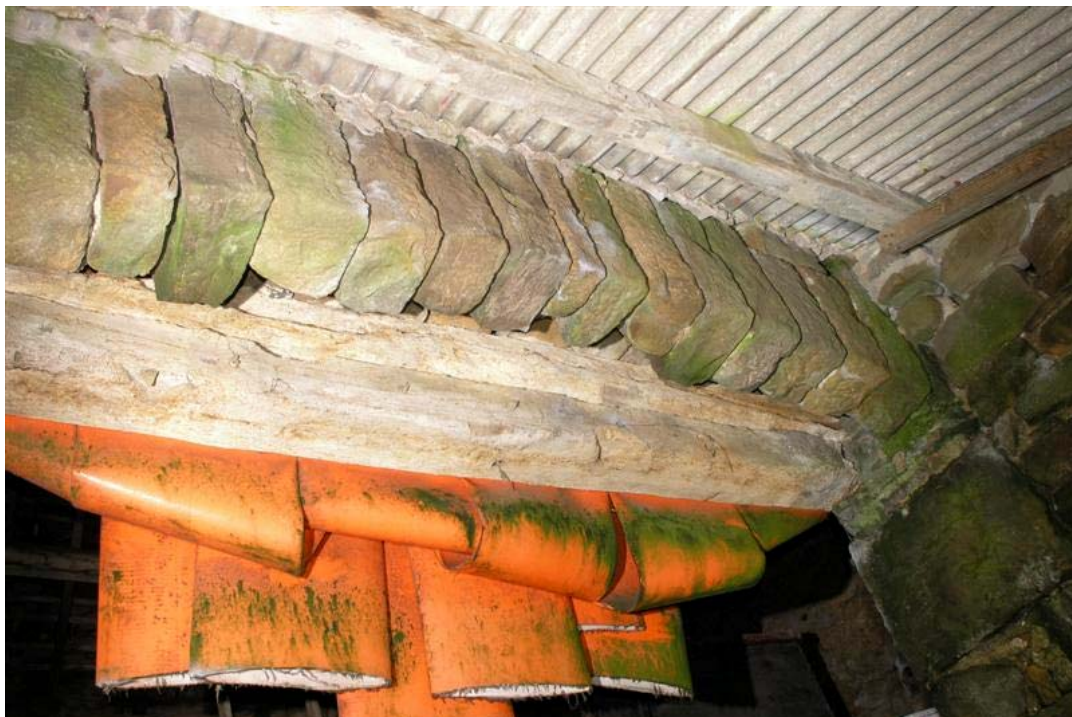
- 3.3.6 Concealed below the roof of the porch the features of the original doorway opening are visible (Plate 6). This comprises a segmental arch and two timber lintels, which support the external and internal parts of the wall respectively. The timbers appear to be oak and exhibit features, such as regularly spaced notches (upside down), which suggest that they are reused and that their previous use was to support a floor.

Plate 6: Arch below porch

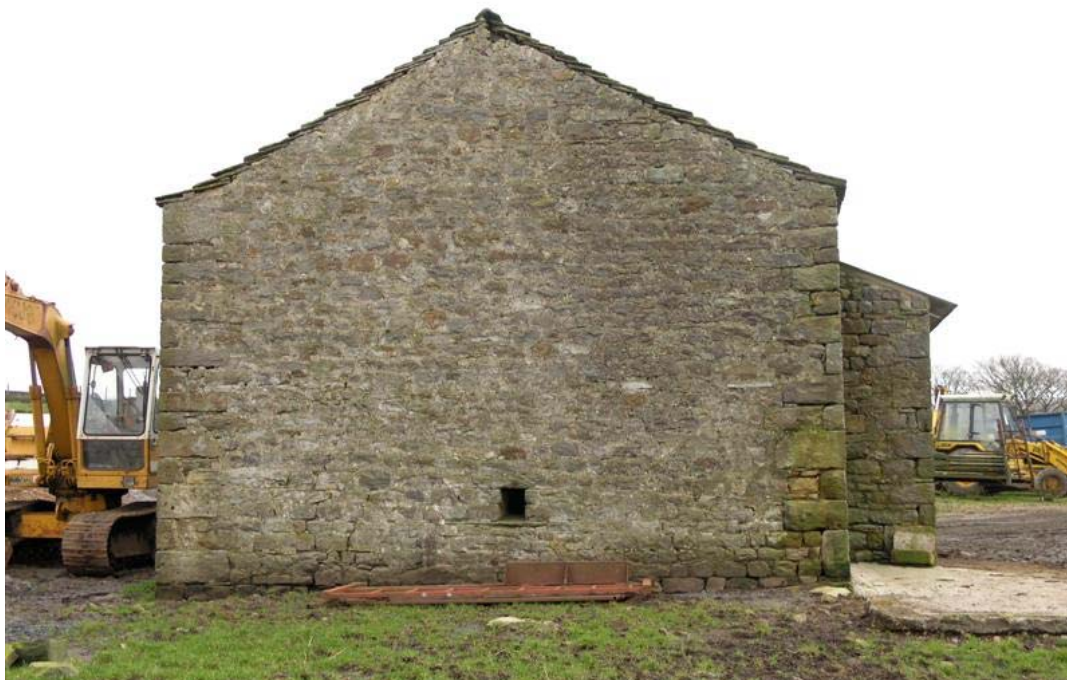
- 3.3.8 **The North Elevation:** this forms the gable of the barn and has the same construction details as the other parts of the building. Unlike the other elevations, the mortar (lime) is smeared over most of the wall (Plate 7). This may be due to differential weathering.

Plate 7: North elevation

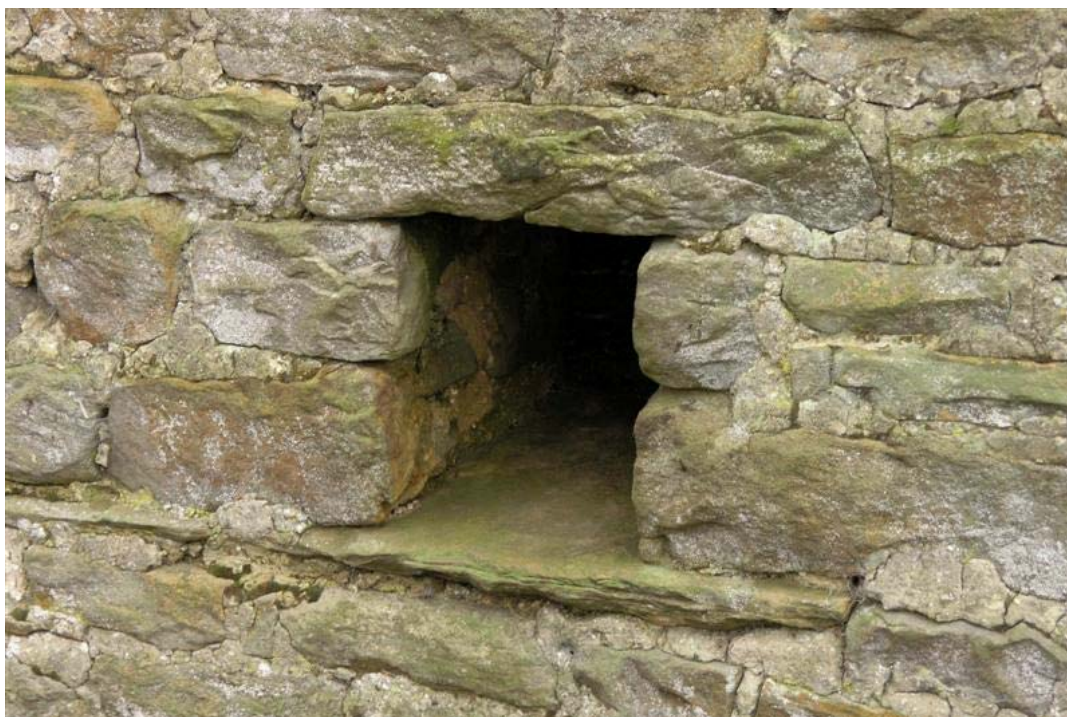
- 3.3.9 A small aperture is present at the base of the elevation, which passes through to the interior and measures 0.45m by 0.4m (Plate 8). This has a sandstone sill and lintel and probably provided some form of ventilation to the interior.

Plate 8: Aperture in the north elevation

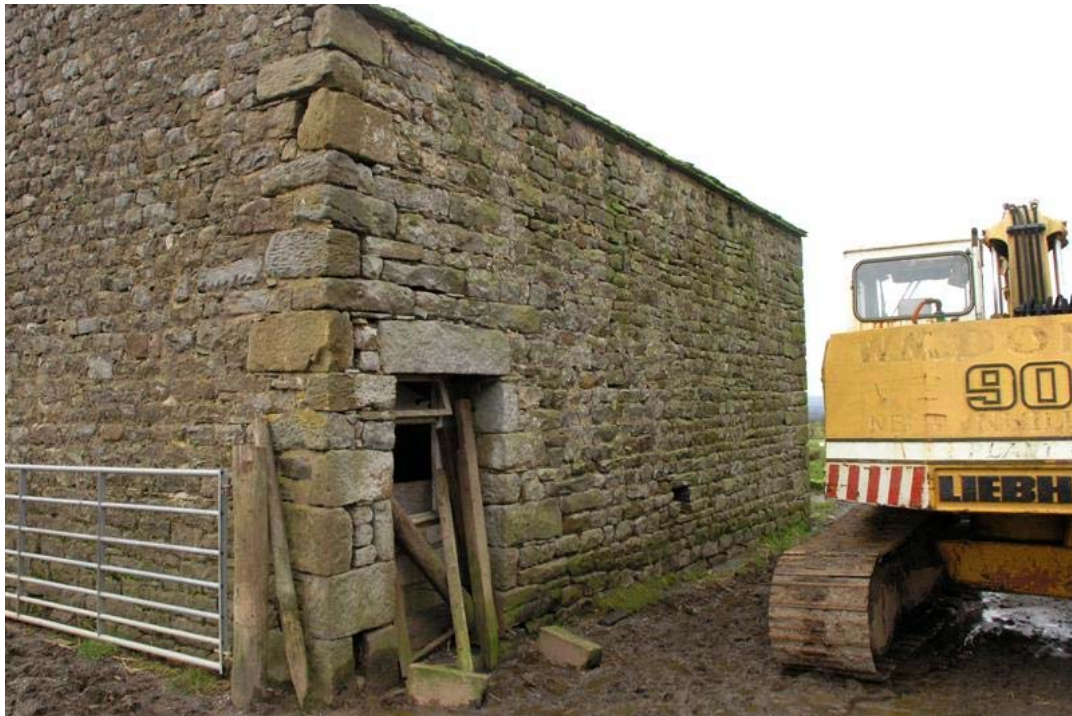
- 3.3.10 **The East Elevation:** again, this elevation is constructed in the same style using the same materials as the remainder of the building (Plate 9). There is a small ventilation hole measuring 0.3m by 0.25m, which has similar features to that already described (Section 3.3.9).

Plate 9: East elevation

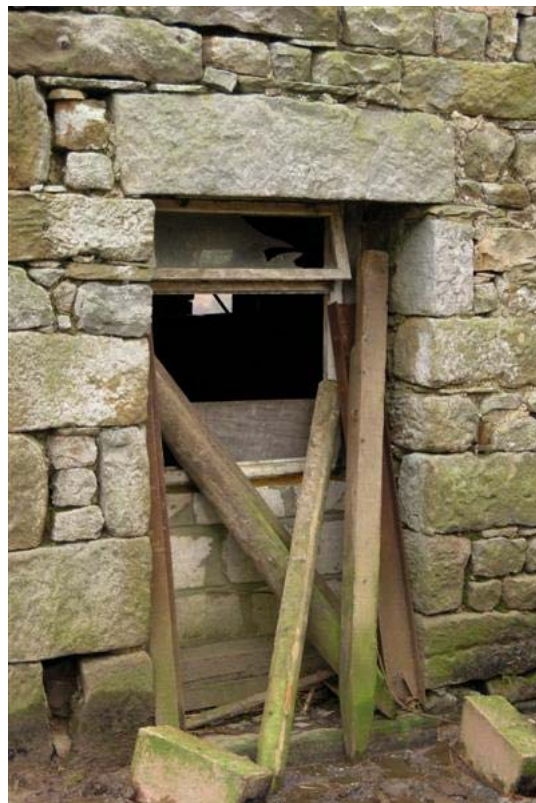
- 3.3.11 A doorway is situated at the southern end of this elevation, which once provided access into the stalls (Plate 10). It is fairly plain and has substantial quoins on both sides and the south jamb is formed by the south elevation. It has a stone lintel and flagged threshold. This doorway has been subsequently partially blocked with cinder block and converted into a window with a modern top-hung casement (this may have been done at the same time as removal of one of the stalls).

Plate 10: Door into the stalls

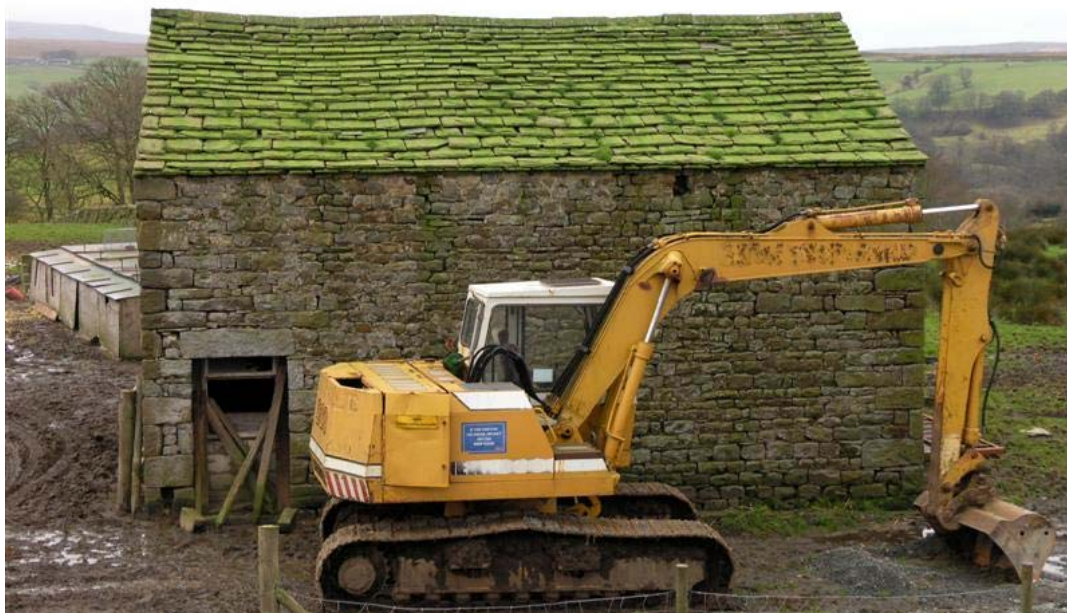
Plate 11: View of the roof from the east

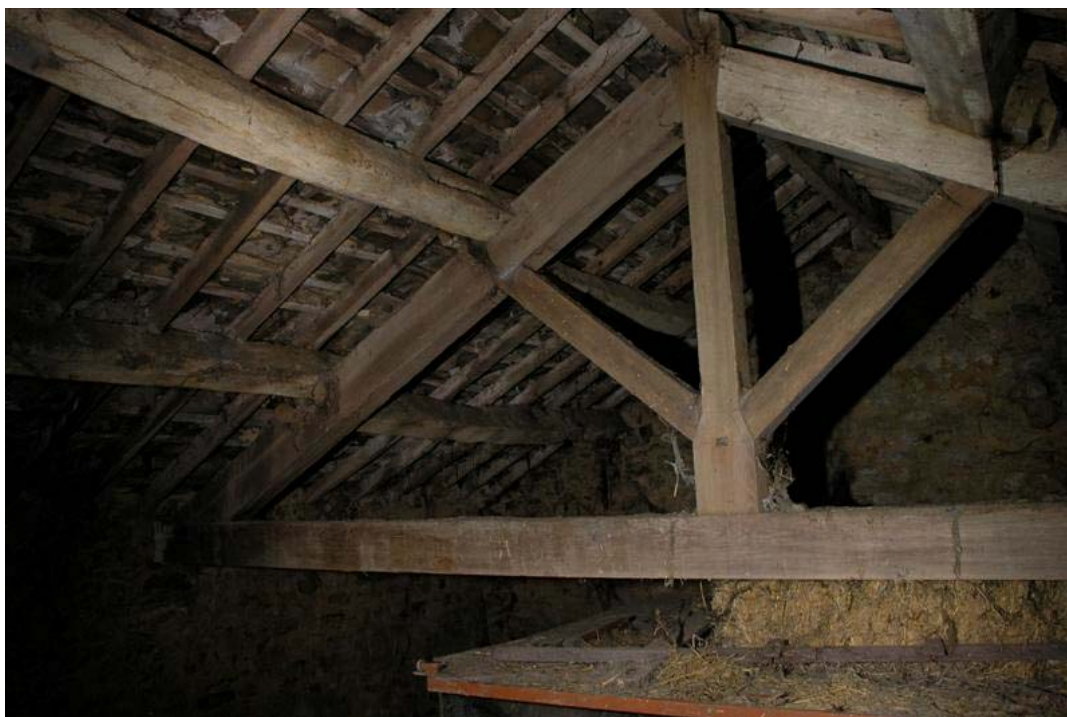
- 3.3.14 Internal inspection reveals the roof to be supported on two identical pine king post trusses which have twin braces (Plate 12). These exhibit circular saw marks and both the king posts and principal rafters are bolted to the tie beams. A single carpenter's mark (I) is visible on the north face of southern truss and carpenter's pencil marks are visible on the north faces of both trusses.

Plate 12: The south king post truss

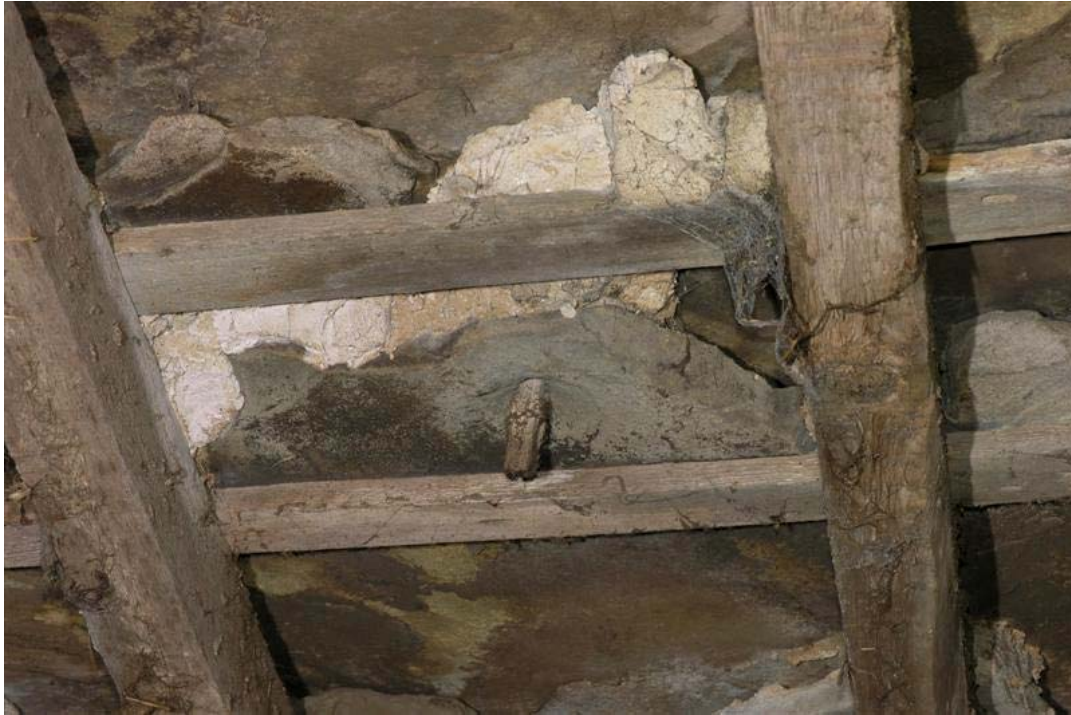
- 3.3.16 Common rafters of pine rest on the purlins, which in turn support oak battens. The rafters exhibit circular saw marks. The sandstone roof tiles contain pegs (Plate 13) which hook over the battens and many of the gaps are filled with lime putty (patched with cement in places).

Plate 13: Pegged roof tile

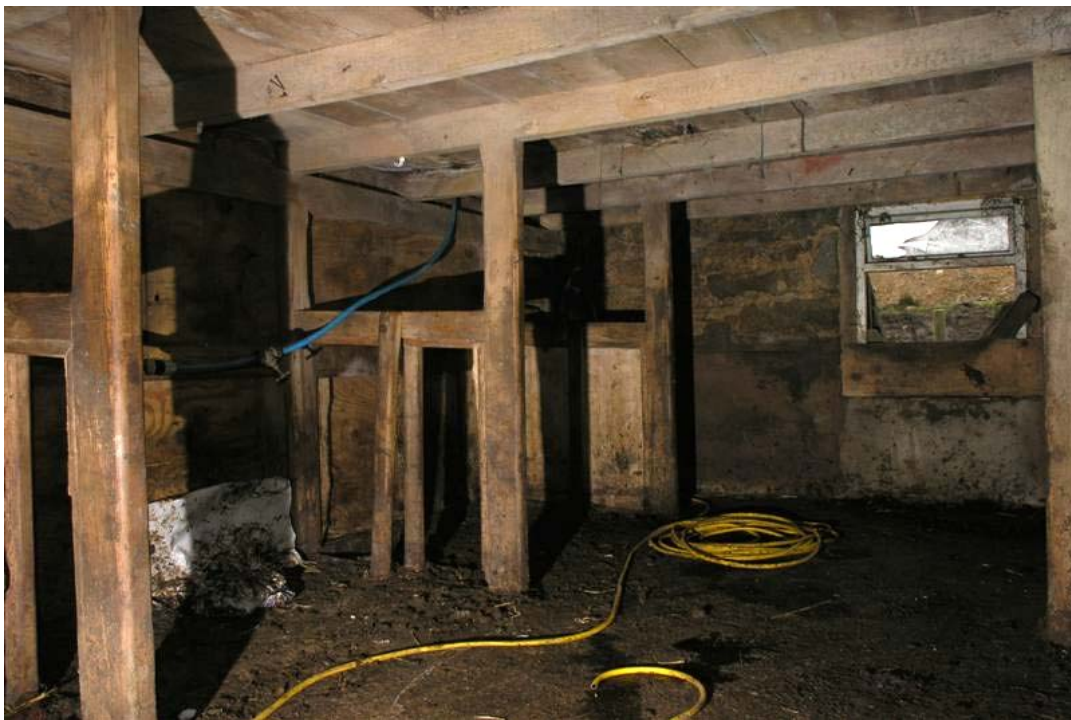
- 3.3.18 **The Shippon:** this (Plate 14) has two remaining stalls, a third having been removed to allow access from the sink mow. A heck (stable) door is present at the east end (now fixed shut) which would have originally allowed access to and from the sink mow. The shippon was originally accessed from outside via the door in the east elevation (see *Section 3.3.11*). This is a dimly lit area with the only available light coming from the small window in the west elevation (see *Section 3.3.7*) and the partially blocked door.

- 3.3.19 The stalls and dividing partition are timber and exhibit run-out stop chamfering, and the dividing wall between the shippon and sink mow is clad with plywood but traces of matchboard are present. The timber shows obvious signs of wear and tear and tether rings are still present at the base of the bars.

- 3.3.20 The floor is concrete and, unfortunately, no evidence of drainage has survived. There is a step up from the sink mow into the shippon. The ceiling (forming the loft floor) comprises eight north/south joists with eight inch wide timber floor boards (Fig 6). For health and safety reasons there was no access into the loft as the floor was in poor condition and contains a large water tank.

Plate 14: The shippon

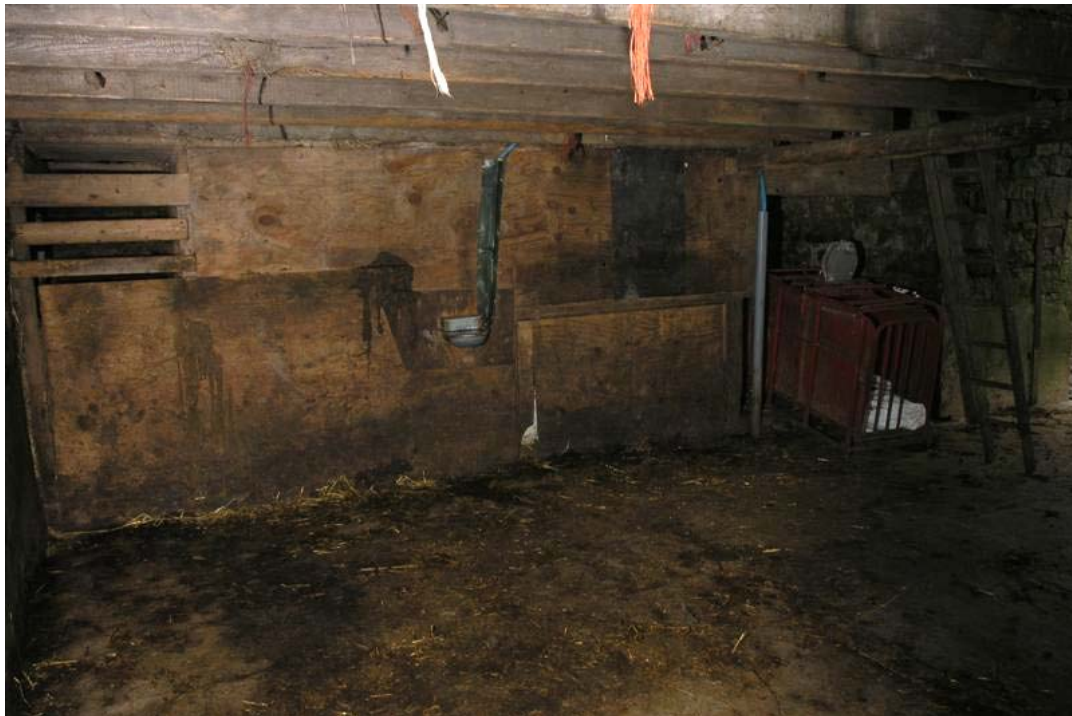
- 3.3.21 **The Sink Mow:** this forms the main part of the barn and is where feed for cattle was stored and subsequently passed up to the loft. It possibly contained a threshing area (Plate 15). It is very plain and contains no apparent features of interest other than the two possible ventilation holes (see *Sections 3.3.9* and *3.3.10*). The ground floor is concrete. Cattle watering apparatus and other farm equipment are present.

- 3.3.22 A loft space has been inserted into this area to form a continuous loft area with the original loft over the stalls. This has been undertaken using telegraph poles and reused timber joists and is modern. Joist slots have been cut into the wall fabric and the joists secured with cement mortar. The floor in the loft comprises rusty corrugated iron sheeting and is in a precarious state.

Plate 15: The sink mow
