Thacka Beck Flood Alleviation Scheme, Penrith, Cumbria

Archaeological Measured Building Survey of Culverts

Oxford Archaeology North

September 2010

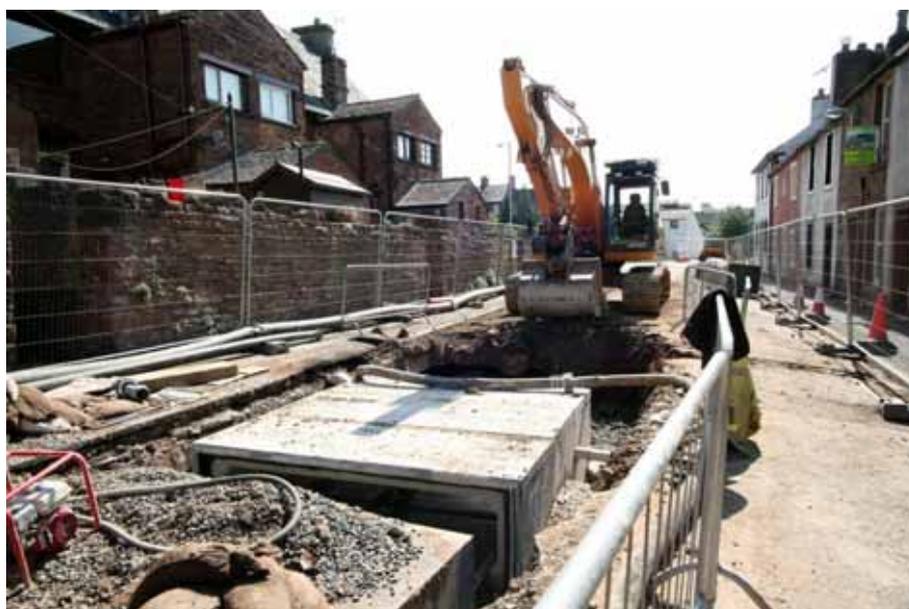
3.2.1 **Watson Terrace:** this site was visited on the 26th July 2010 during replacement of a section of the culvert (Plate 1; Fig 2). The section revealed was representative of the length of culvert along Watson Terrace. The culvert ran down the north side of the street, the apex of the arch being approximately 0.2m below the road surface. During the excavation a short time window was available to inspect the existing culvert, which was found to consist of a narrow opening with a shallow rise segmental arch constructed from red sandstone voussoirs, 1.6m long by 0.1m wide by 0.32m deep (Fig 6). The sides of the culvert are of concrete (Plate 2) and it has been modified and rebuilt and/or strengthened relatively recently. The width of the culvert is approximately 3.25m by approximately 0.7m deep. The floor of the culvert is constructed using cobbles or setts of unknown material, which have been patched and repaired in places and grouted with cement.

Plate 1: Excavation of the culvert in Watson Terrace

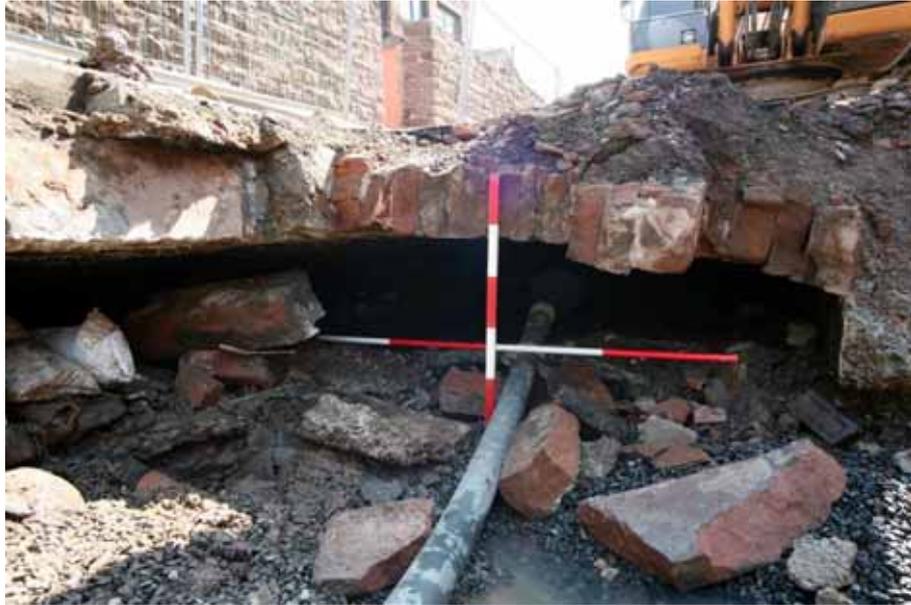
Plate 2: Excavated culvert below Watson Terrace

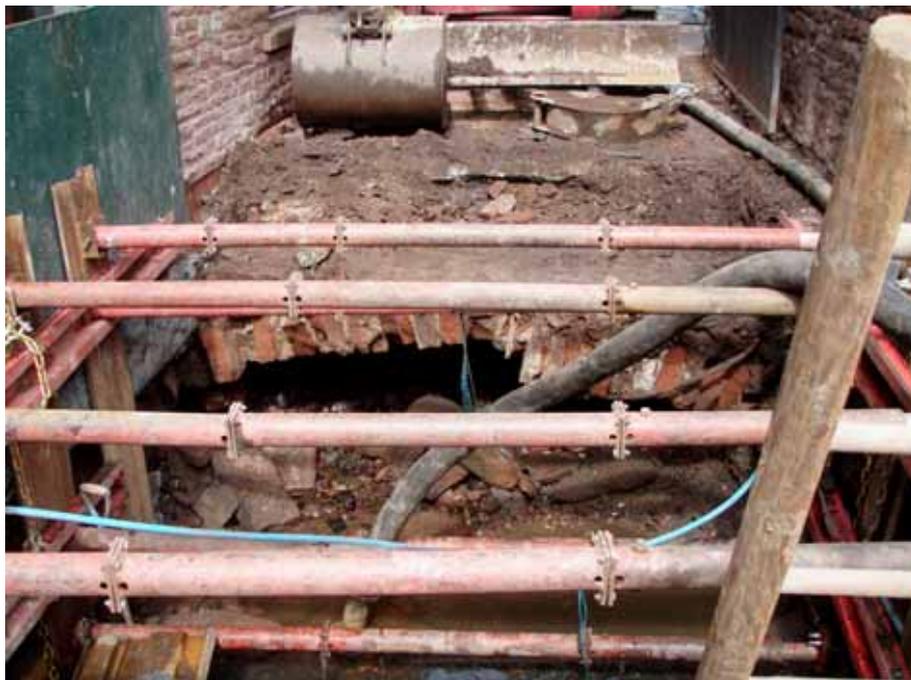
3.2.2 **Sandgate:** this section of the culvert followed a course along a narrow alleyway between two buildings (Figs 3 and 7), and for health and safety reasons, access to the culvert was prohibited. The culvert was recorded on 29th June 2010 and though it was inspected from a safe distance, it was found to span almost the whole width of the alleyway (Plate 3), approximately 3.85m. It has a very shallow segmental arch of similar appearance to the culvert at Watson Terrace constructed using voussoirs of similar dimensions. The arch was a similar depth below the surface as that in Watson Terrace. The remains of sandstone side walls or imposts could be seen, which were three courses high. The floor of the culvert was not visible.

Plate 3: Excavated Culvert in Sandgate

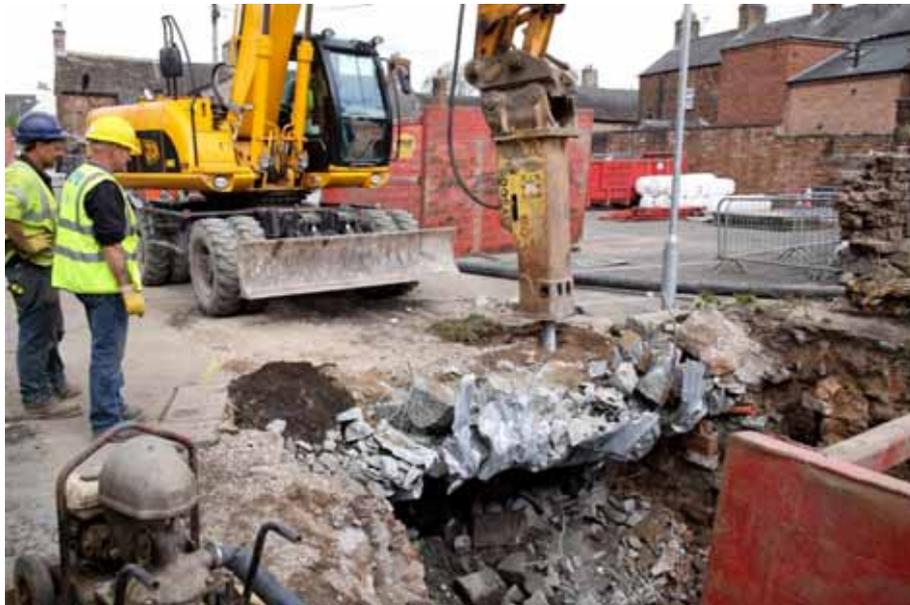
3.2.3 **Rear of Mansion House:** this section of culvert was situated in the car park at the rear of the Mansion House (Fig 3) below sections of listed walls which were recorded by OA North in late 2009 (OA North 2010) and then removed prior to the replacement works. The recording works on the culvert were carried out on 27th May 2010, revealing that this section of culvert was covered by a large reinforced concrete slab, the removal of which was protracted (Plate 4). The culvert is approximately 2.4m wide and 0.85 deep. The arch was situated directly below the slab (which was approximately 0.5m thick) and was of similar appearance to those already described with red sandstone voussoirs which are approximately 0.15m wide and 0.35m deep (Plate 5). The arch was more semi-circular in shape (Fig 8). The side walls or imposts were constructed from random rubblestone of similar red sandstone to the arch and were approximately 0.5m thick. The floor was difficult to observe but appears to be of cobbles of similar appearance to those at Watson Terrace. In common with the other culverts already described, access for recording was severely limited.

Plate 4: Excavation of culvert at the rear of The Mansion House

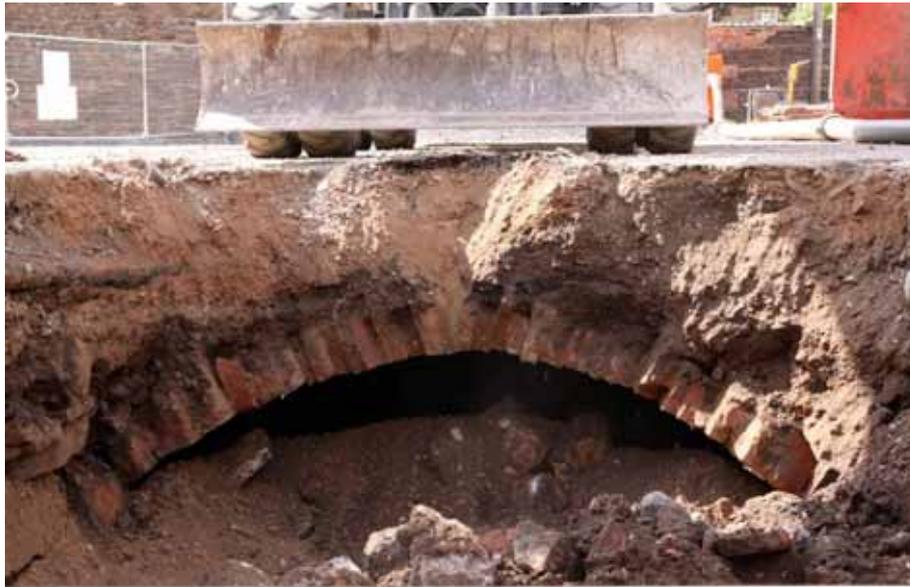
Plate 5: Excavated culvert at the rear of the Mansion House

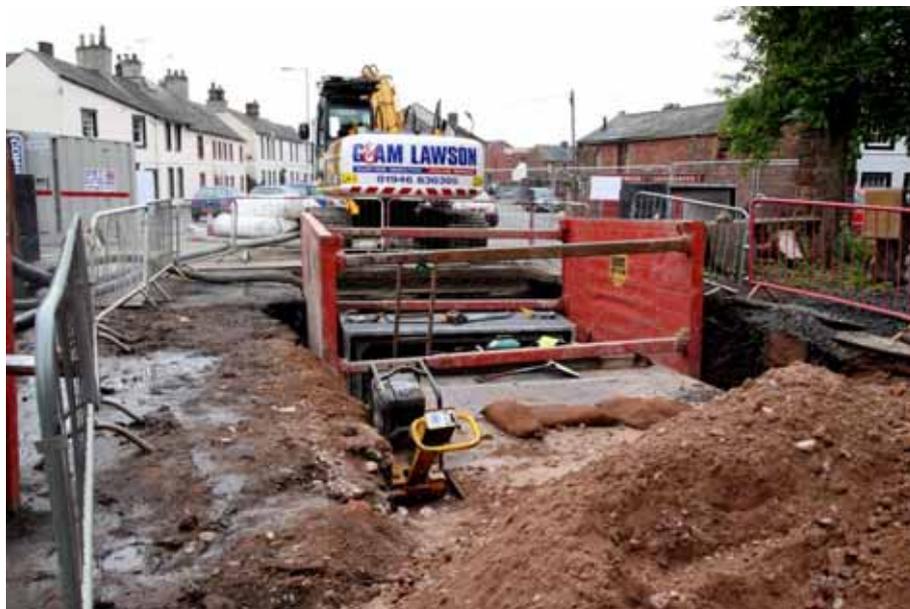
3.2.4 **Front of Mansion House:** this section of culvert lay below sections of the listed walls previously recorded by OA North (OA North 2010) (Fig 3) and was visited on June 11th 2010 when the excavation was very advanced and all of the existing stone culvert was removed (Plates 6 and 7), therefore no recording work was carried out.

Plate 6: Excavation of culvert at the front of the Mansion House

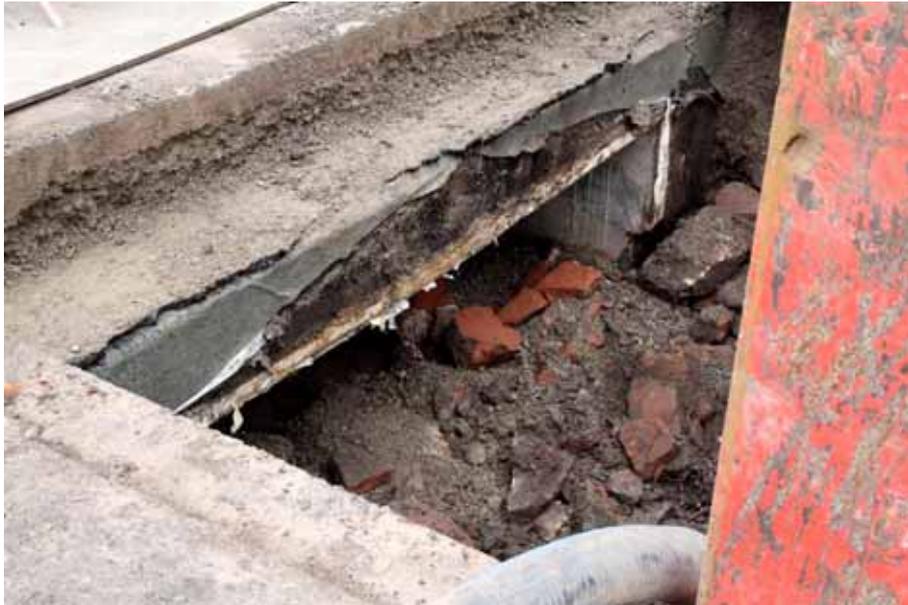
Plate 7: Excavated culvert at the front of the Mansion House

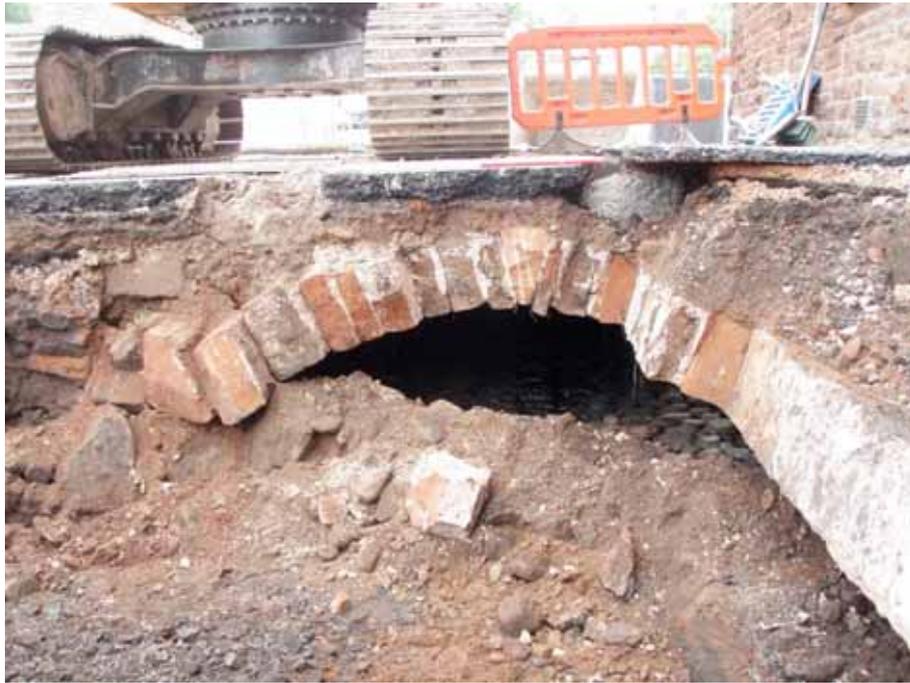
- 3.2.5 **Friargate:** the culvert at this location was visited on the 21st June 2010. The fabric and nature of construction was similar to the culverts already described, which was of red sandstone (Plate 8). The apex of the arch was approximately 1m above the base of the culvert and the arch was approximately 0.30-0.36m thick, each voussoir measuring approximately 0.56m by 0.3m by 0.16m (Fig 8). Unlike the other culverts already described, a triangular keystone was present (Plate 8). The mortar consisted of both cement and lime. The side walls or imposts, of which little could be inspected, stood to a height of approximately 0.24m (three courses) and were constructed from squared red sandstone, each stone measuring approximately 0.47m by 0.90m, although this varied somewhat. The mortar was lime.

Plate 8: Excavated culvert at Friargate

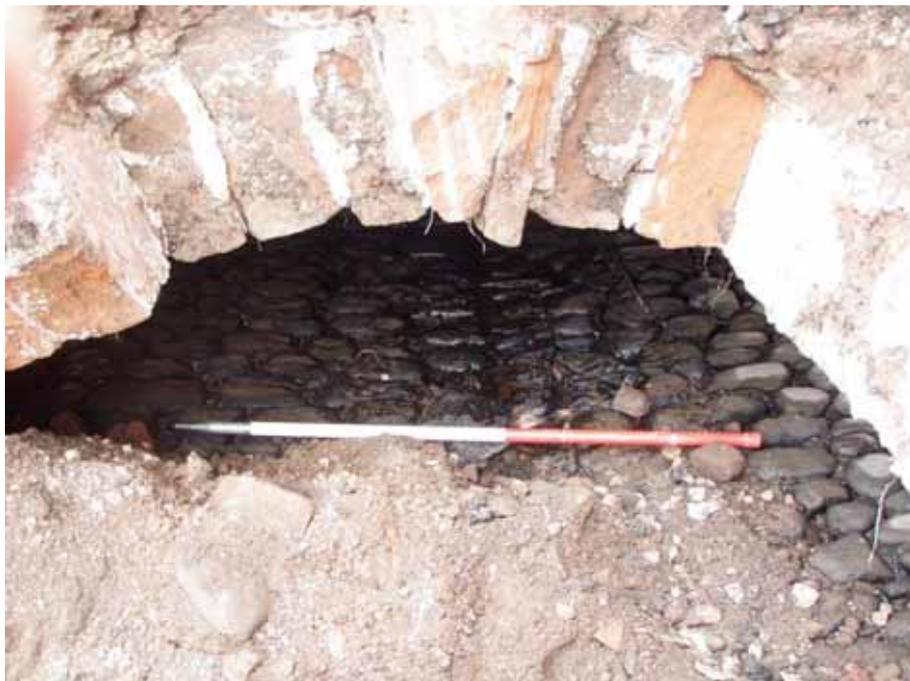
- 3.2.6 The base of the culvert, which measured 2.20m wide, was visible and consisted of rounded cobbles which, on average, measured approximately 0.3m by 0.12m (Plate 9).

Plate 9: Floor of the excavated culvert at Friargate

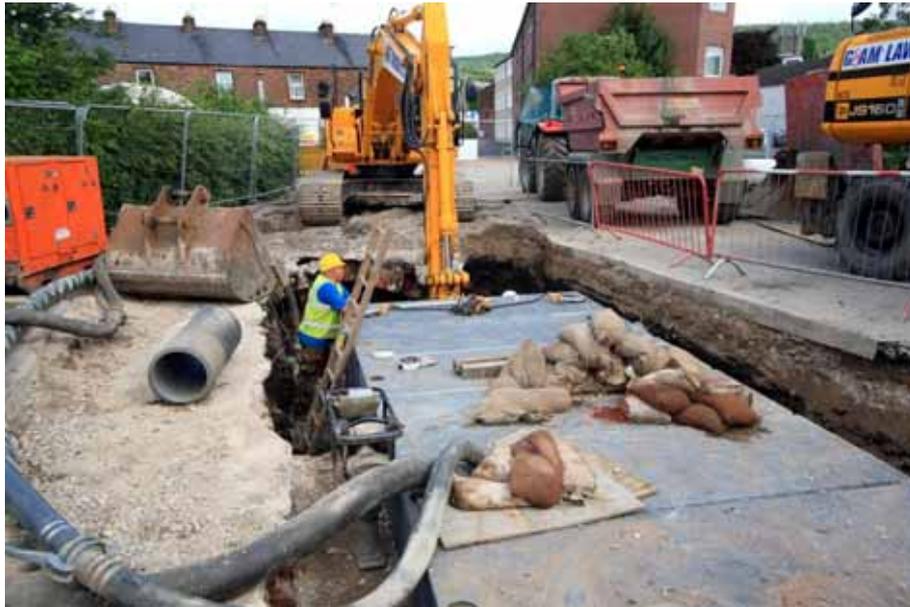
3.2.7 **Somerfield Car Park:** in similar fashion to the other culverts already described, access to this excavation was severely restricted and limited to short periods of access when installation of the new culvert was not taking place. The recording of the culvert took place on 13th July 2010 (Plate 10) and it was revealed to be of similar appearance, construction and fabric to those already described, although a large amount of rubble and debris obscured much of it

Plate 10: Excavation of the culvert at Somerfield Car Park

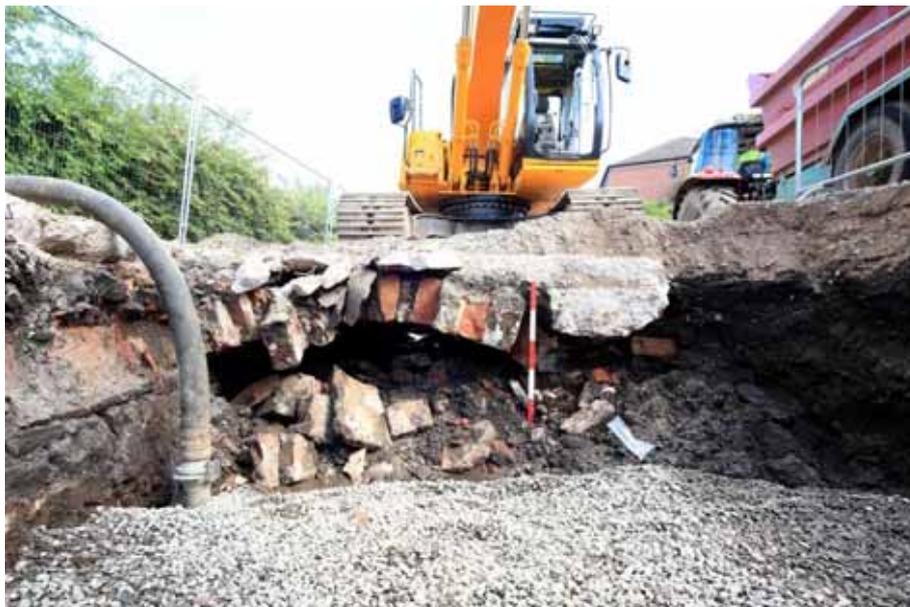
(Plate 11). The apex of the arch was approximately 0.1m below the current ground surface, which comprised a concrete slab. The depth of the culvert from the soffit of the arch to the visible base was approximately 0.5m (Fig 10; Plate 11), although it appears that the original floor may have been lower and the current floor is of later repair and grouting. An eroded section seemed to corroborate this, although no lower floor surface was visible. The width of the culvert was approximately 2.2m, although due to the amount of debris and rubble, this was difficult to ascertain exactly. The imposts were visible and were of the same or similar construction to those present at the Friargate section (*Section 3.2.5*)

Plate 11: Excavated culvert at Somerfield Car Park

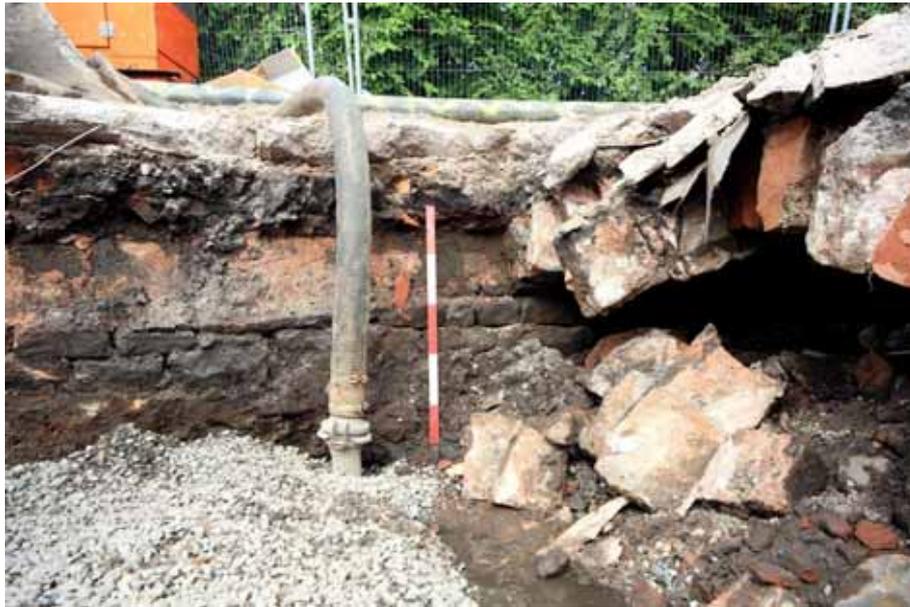
Plate 12: Imposts of the excavated culvert at Somerfield Car Park

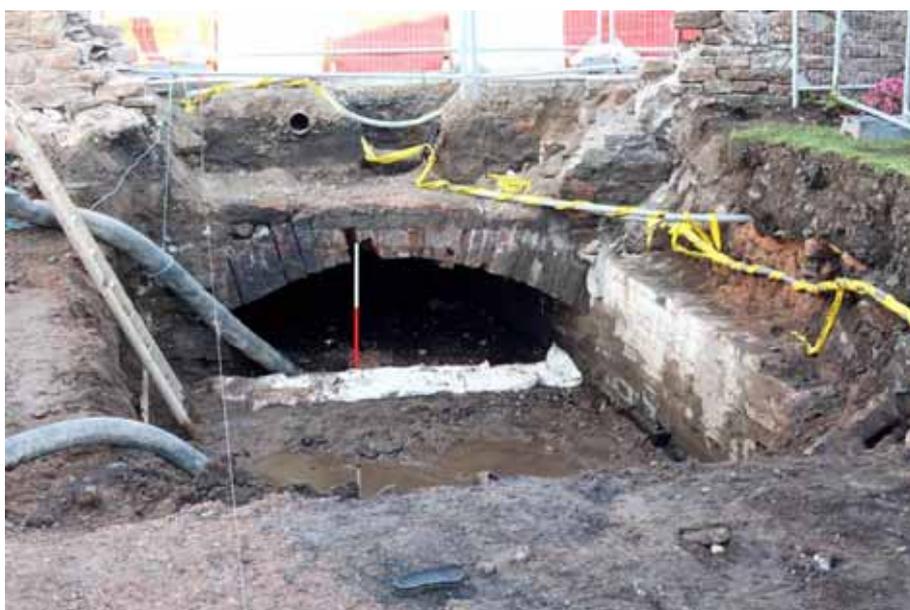
3.2.8 **Roper Street to White House Gardens:** this section of culvert was inspected on 25th August 2010. Access to the excavation was, again, restricted due to health and safety reasons. This section of culvert passes below Roper Street and into White House Gardens before exiting into the open air just to the south (Plate 13). There are two differing sections of culvert in this location; the culvert below Roper Street is to remain *in situ* and is of slightly different appearance to those culverts already inspected (Plate 14); to the south of this in White House gardens, the culvert is of similar appearance to those already described (Plate 15). A later, concrete section of culvert formed the transition between the two sections.

Plate 13: Excavation of the culvert at Roper Street to White House Gardens

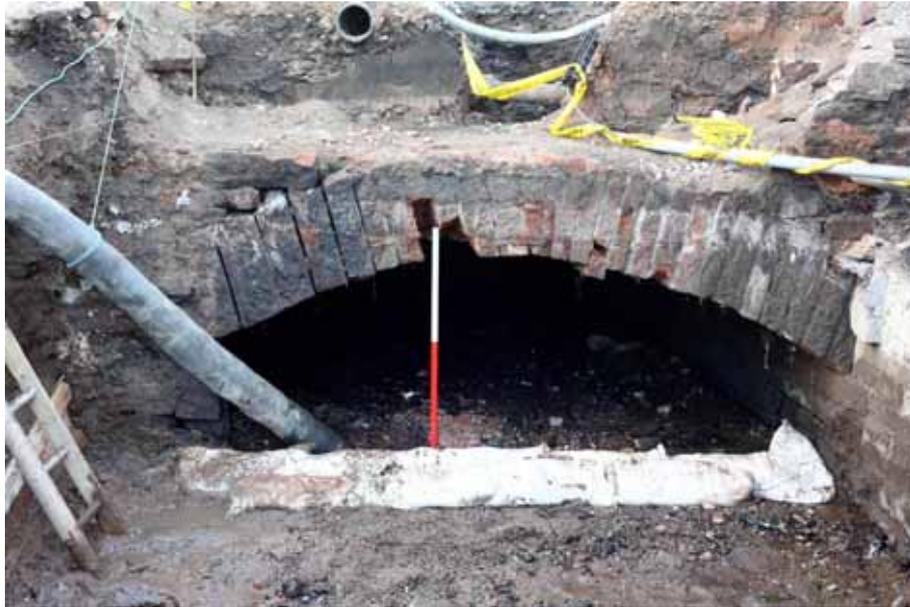
Plate 14: Excavated culvert passing below Roper Street

3.2.9 The overall appearance of the section of the section culvert passing below Roper Street is one of more substantial and higher quality construction. The south-facing section elevation of the arch was revealed to be of tooled squared voussoirs (Fig 11, Plate 14). The cross-sectional depth of the culvert was approximately 0.9m and the internal width was 2.6m. The apex of the culvert was approximately 0.7m below ground level. The floor of the culvert was not visible due to a build up of debris. The arch measured approximately 0.4m thick and each of the voussoirs were approximately 0.1–0.15m wide. The imposts were visible, which were some 0.5m high, and were constructed from squared rectangular sandstone with a more substantial course below. This could not be inspected due to waterlogging.

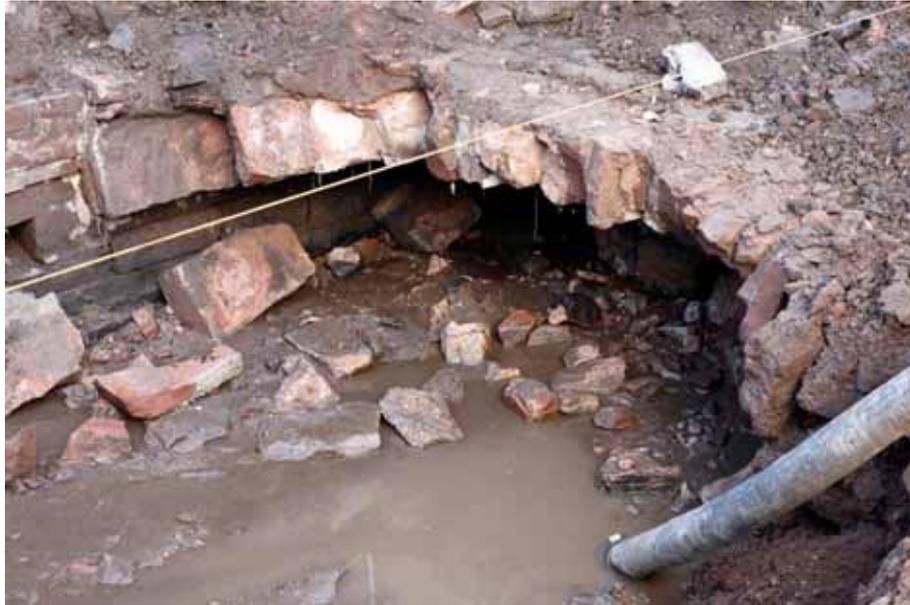
Plate 15: Excavated culvert in White House Gardens

3.2.10 As already mentioned, the southern part of the culvert was of similar construction to those excavated sections already described (Plate 15). The cross-section of the culvert was similar to the Roper Street section and it appears to be of similar dimensions, although inspection was impossible for health and safety reasons. The southern end of the section of culvert at White House Gardens was visited on 26th July 2010 prior to the commencement of culvert replacement works. Thacka Beck exits the culvert and flows through a deep stone-lined channel (Plate 16). The end of the culvert was visible and consisted of a concrete lintel supporting a random, squared rubblestone wall. The lintel was lined with corrugated-iron shuttering. Access to the culvert, in order to take measurements, was unavailable.

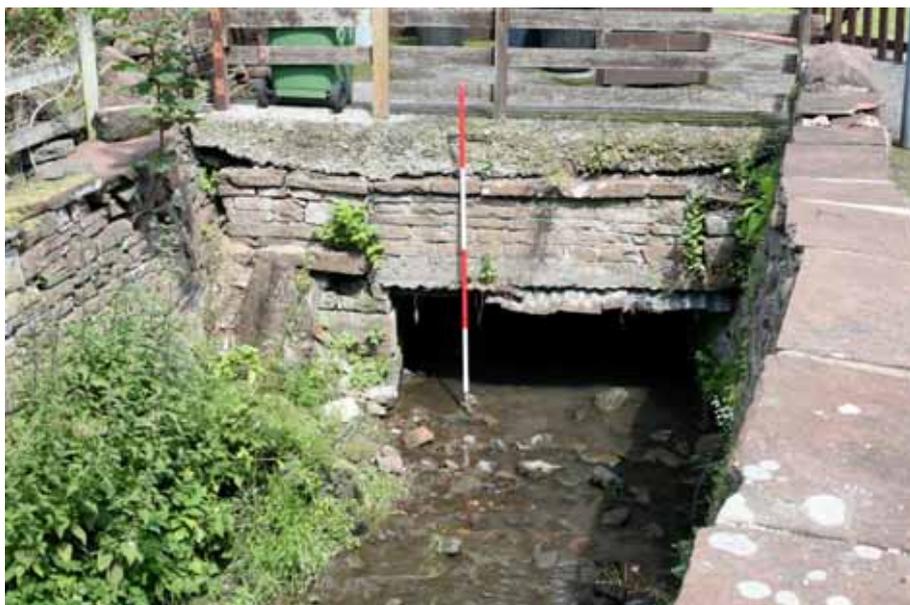
Plate 16: Thacka Beck exiting from the end of the culvert in White House Gardens
