LIVERPOOL LIBRARY, WILLIAM BROWN STREET, LIVERPOOL

Building Survey Report

Oxford Archaeology North

April 2011

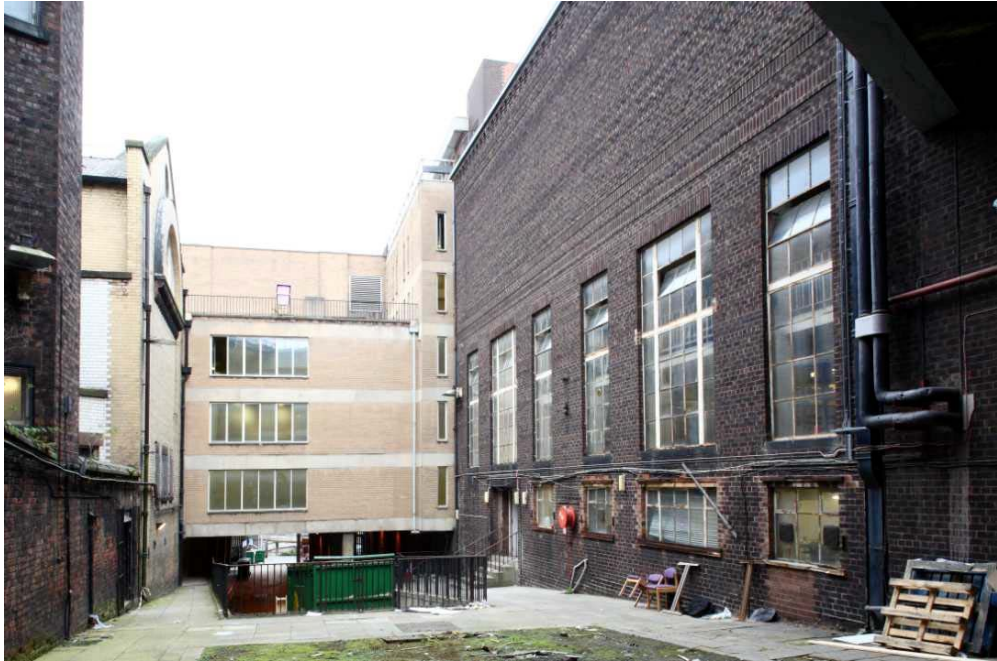
Plate 5: South-facing elevation of Clayton Stack

- 4.3.3 ***Principal elevation (south-facing):*** the main feature of the principal elevation are six tall rectangular Crittal windows. The exterior doorway was a modern fireproof double door opening onto the loading bay area. Access to this door was gained via a set of plain concrete steps with metal hand rails (Plate 5 (below)). A stretcher bond and a band topped by corbels are the only decorative elements on the south-facing elevation.

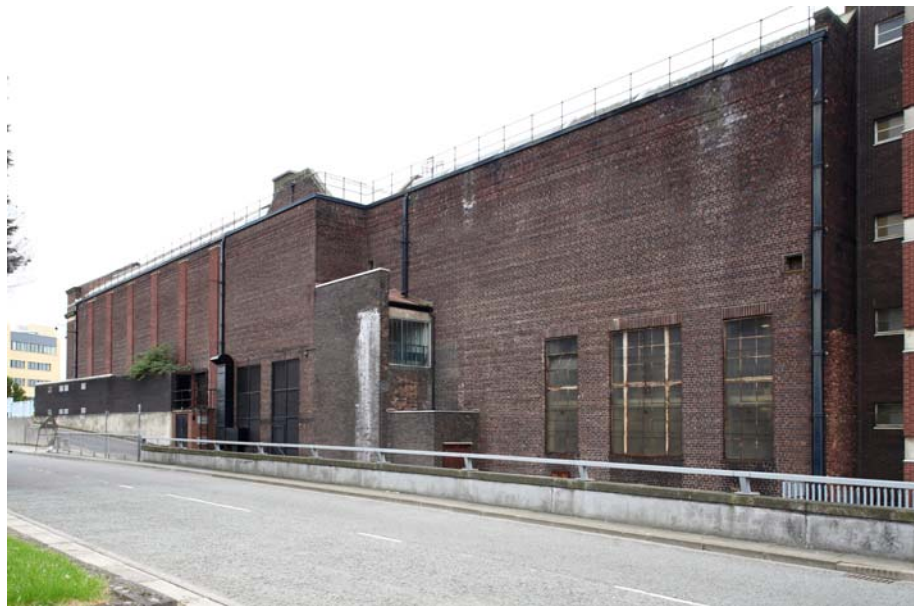
Plate 6: North-facing elevation of the Clayton Stack

- 4.3.4 **North-facing elevation:** the north-facing elevation is characterised by three tall rectangular Crittal Windows located at the western end of the building. Access to the rear of the building is via Cuerden Street and a single fire door; however, this door leads to the upper floor portion of the building occupied by The Walker Art gallery, via a spiral stair. As with the south-facing elevation, soldier bond and a band topped by corbels are the only decorative elements on the north-facing elevation (Plate 6 (below)).

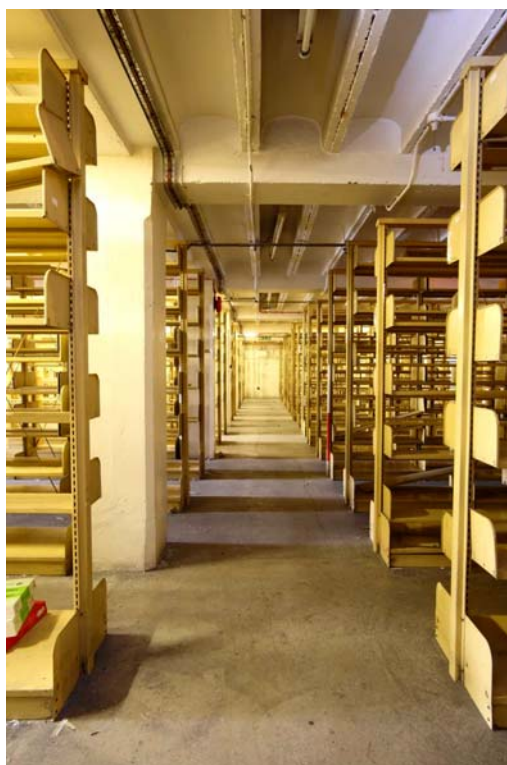
Plate 9: Internal beam/column arrangement on the first floor of the Clayton Stack

- 4.4.3 The walls and floor were uniform through the first and second floors (Figs 4 and 5). Each floor has a sectioned fireproof ceiling comprising inverted 'U'-shaped concrete channels supported on concrete cross beams held in place by concrete columns (Plate 9 (below)). No roof trusses were visible in the areas of the building that were surveyed.

- 4.4.4 Each floor was divided into bays by 15 columns. All of the columns are concrete and each one features four run-out stop chamfers, and each support the east/west orientated plain concrete beams. A slight variation in beam design and orientation was observed on the second floor suggesting that part of this ceiling may have been replaced or repaired. The central east/west orientated line of columns are thicker than the outlying columns.

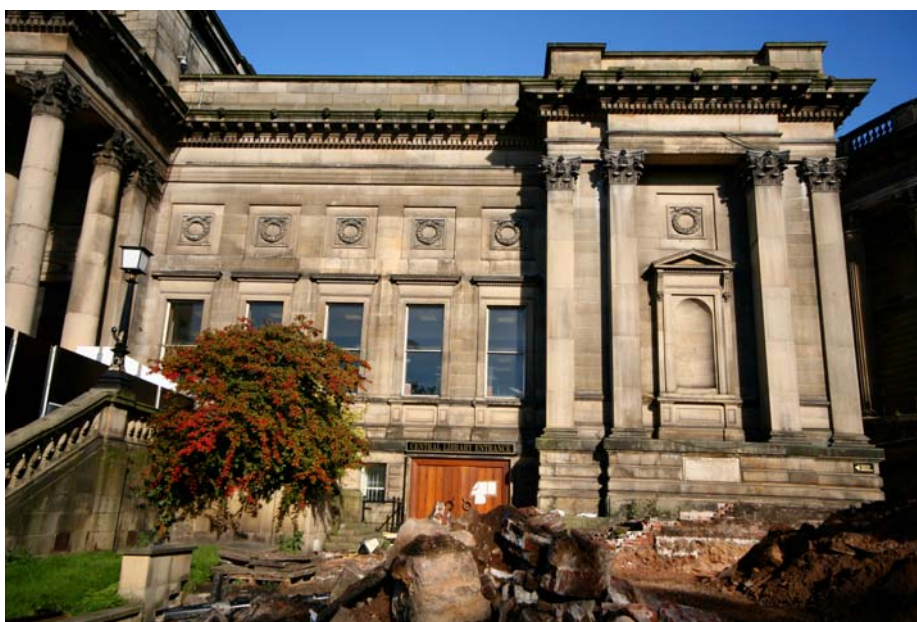
Plate 11: South-facing elevation of the William Brown Library facade

- 4.5.2 **The principal elevation (south-facing elevation):** the facade of the south-facing elevation is an excellent example of Neo-classical architecture and historically the main entrance included a large pediment supported by large sandstone columns with corinthian capitals (Plate 11 (above)) and is on the western side of the library facade. It led into a lobby that is within the footprint of the World Museum building and from there extended into the first floor of the library. The present main library entrance is on the ground floor and is in the centre of the facade, but is less elaborate with sandstone-clad walls and small laurel wreath friezes set in relief. On the east side of the facade is a large niche designed to be occupied by a statue, straddled on either side by two square-sectioned pilasters topped by corinthian capitals. The former principal entrance and the lower entrance both comprise wood panelled double doors with stylised circular wooden handles dating from the 1970s.

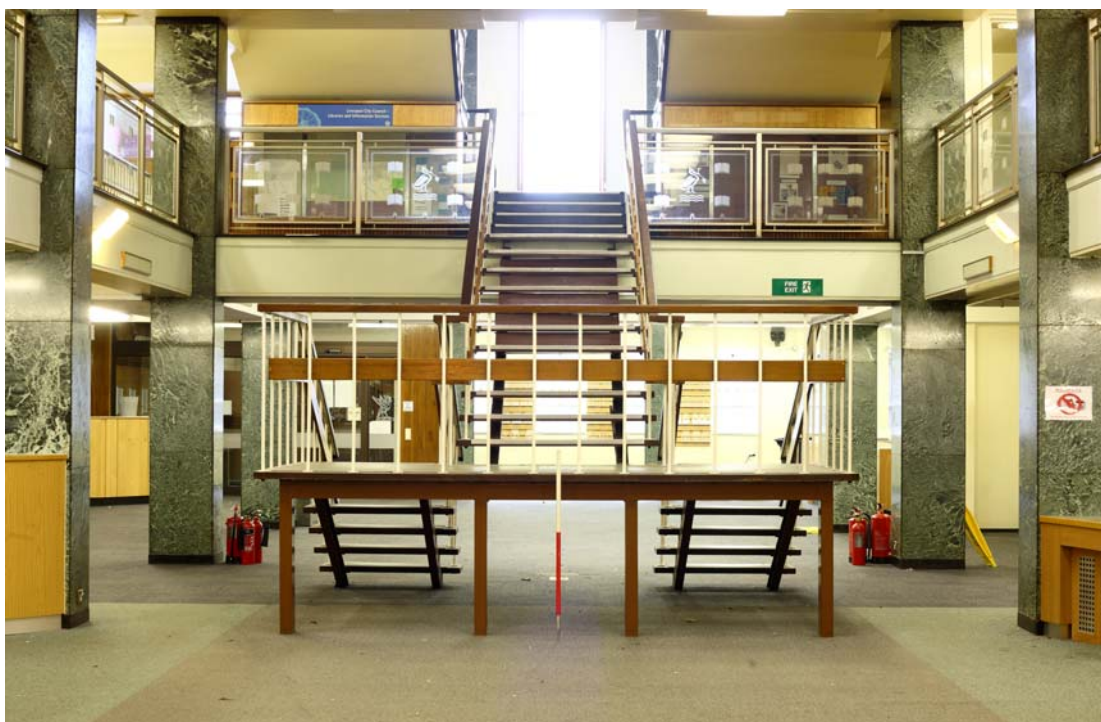
Plate 15: Detail showing mini-empire staircase and ground floor of William Brown Library

- 4.6.3 The carpeting, decorative finishes and light fittings are uniform and include minimal strip lights, or pendant lights, with no variation between the floors. The walls are painted with white emulsion and the floors are covered most recently with blue or green carpet tile which in turn overlays earlier cork tile flooring. The bare minimum of decoration has been applied to the re-built area of the library and this minimalism speaks not only of the functionality of the building but also of the limited post-war finances available to rebuild a city which was so heavily bombed.

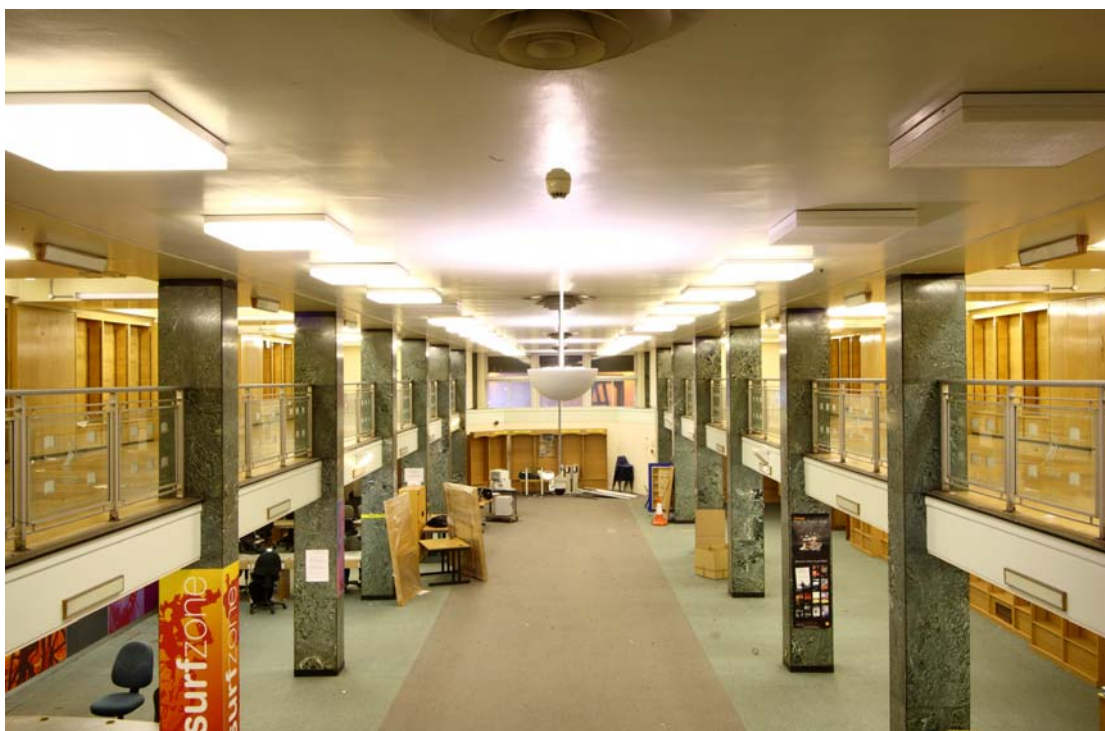
Plate 16: First floor mezzanine style gallery

- 4.6.7 **First Floor Plan:** the first floor (Fig 7) is principally a mezzanine gallery (Plate 16 (above)) from which the ground floor can be seen. The gallery (14) measures 15.6m by 6.2m and is orientated north/south on its long axis. Both the east and west sides of the gallery are lined with bespoke book cases fitted to the walls. The floor above is supported by two rows of nine columns orientated north/south down the centre of the room. The central space between the columns is demarcated by a series of glass panels with metal handrails. The columns are of identical alignment and fabric as those described on the ground floor. Three staircases (two sets of stairs at the north-east and north-west sides of the room, and one set at the south-east side) provide access to the second and third floors. Two doors on the east wall lead to a large adjoining room (15) identical to the audio-visual room on the ground floor which housed a further music and AV catalogue and to a further stair well which extends between the ground floor and the fourth floor. North-east of room (15) is a small two-room suite of offices (19). As with the ground floor, the first floor is devoid of mouldings or décor and has the appearance of a very minimal utilitarian space.

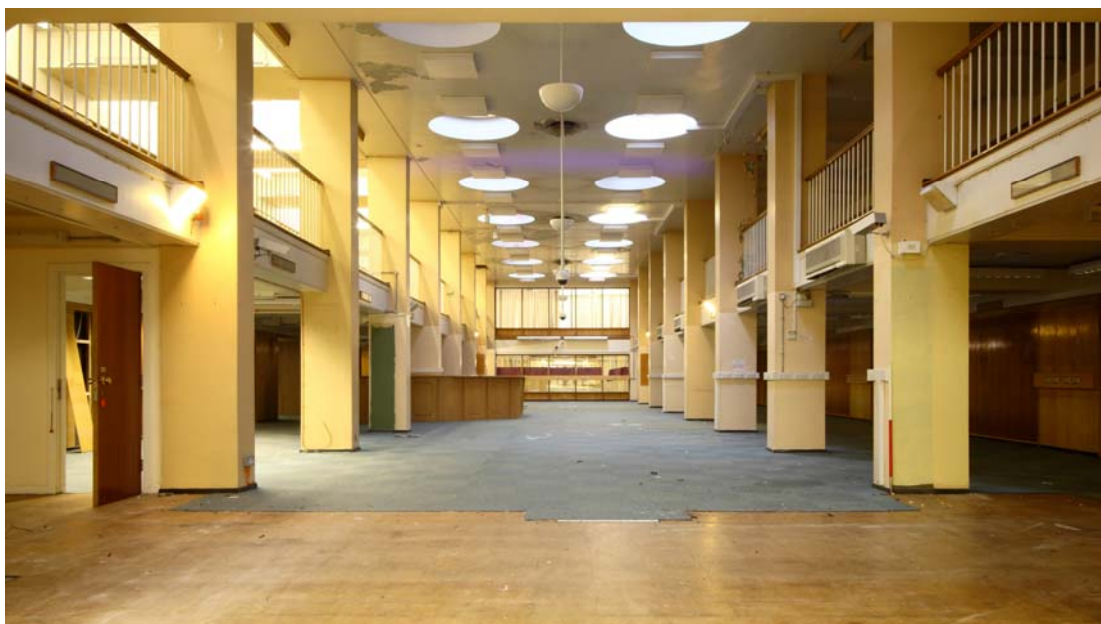
Plate 20: Fifth floor records office with view of circular ceiling lights

- 4.6.17 The main room is divided by two rows of nine columns (all comprising the same fabric and cladding as previous floors), creating three long bays and the east and west-facing elevations are lined by bespoke built-in book cases below which are situated the original heating ducts. At the centre of the room is a free-standing hexagonal wooden information desk installed c1990 (30). The main room is illuminated by 10 circular port hole styled light-wells recessed into the ceiling above the fifth floor gallery and additionally by four half globe-shaped pendant lights (c1970s) suspended on wires between the light wells (Plate 20 (above)). The area beneath the fifth floor gallery is lit by strip lights affixed to the ceiling. A wood-framed, glass-panelled, double door (36) in the north wall provides access to the William Brown Extension.

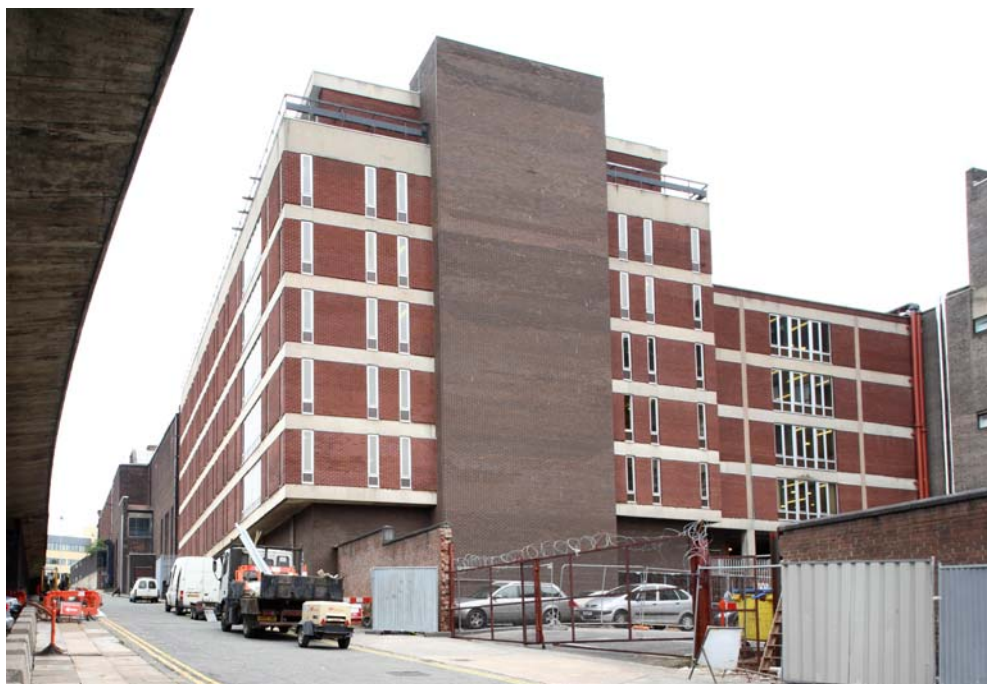
Plate 23: Exterior elevation of the William Brown Extension (view from the north-west)

- 4.7.1 The William Brown Extension was constructed between 1974-6, to provide extra storage space and office space for the existing central library (Plate 23 (below)). The building is seven stories high (including the ventilation/boiler room) with the central section of the building being elevated by concrete stilts so as to provide access to the loading bay, Clayton Stack and the rear of the Walker Gallery (Fig 13). The building is directly linked to the north-facing elevation of the William Brown library and, as such, has no south-facing elevation. All of the floors are uniform in size aside from the seventh floor which is narrower, thus affording space for a walkway along the north and south-facing elevations which allows access to the roof. The additional floor (which spanned elements of the roof of both the William Brown Library and the William Brown extension, but is not the full width of either building) is given over to ventilation and boiler rooms, all of which were still active at the time of this survey and so were not investigated. This floor was most clearly visible from the seventh floor of the William Brown Extension but is not evident from a ground floor perspective.

- 4.7.2 ***The west-facing elevation:*** the exterior of the building is dark red-brick arranged in a stretcher bond with grey/white cement mortar fabric with visible grey concrete bands indicating the level of each floor slab. The stairwell and lift shaft project from the west-facing elevation and take the form of solid towers constructed in a darker-brown brick, also arranged in stretcher bond. There are no windows in the stairwell on the west-facing elevation. Six single light fixed, tall and narrow casement-style windows are present on each floor of the west-facing elevation of the northern part of the building (Plate 23 (above)). A similar design of tall, narrow casement window, but combined into a single six-light widow, is present on each floor of the southern section of the building.

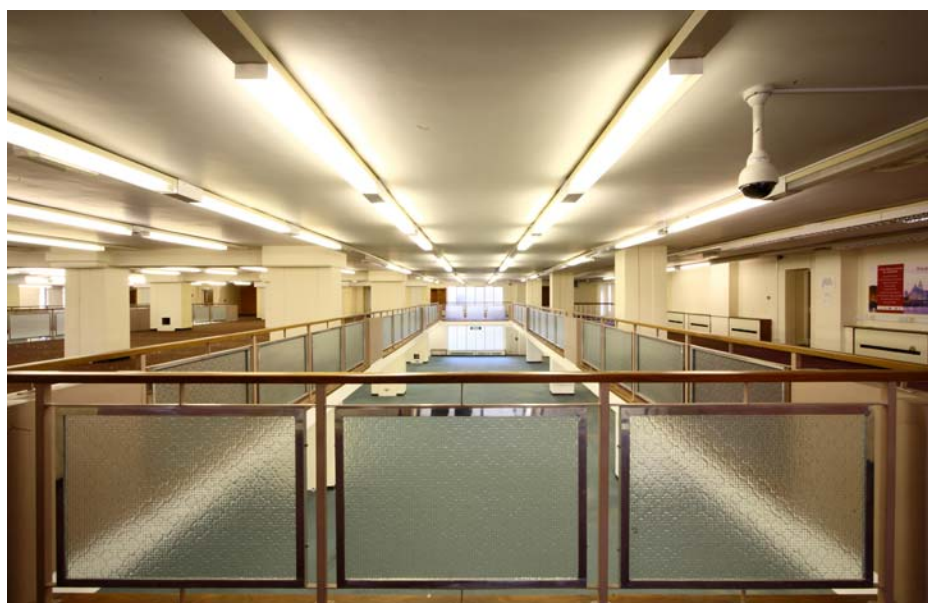
Plate 25: Mezzanine-style floor in the William Brown Extension

- 4.8.4 **Third Floor:** the third floor of the William Brown extension (Fig 16) is a mezzanine gallery with views down to the second floor. The perimeter of the gallery is constructed of glass panels in a steel frame with a wooden hand/guide rail (Plate 25 (below)). This floor was originally open plan (66) however the north-western corner is now partitioned into three small offices (67 - 69) using timber frame and plaster board partitions. These smaller offices are segregated from the main space by corridor (70). An additional interior steel-framed staircase with wooden steps and hand rails provides direct access between the second and third floors only (65).

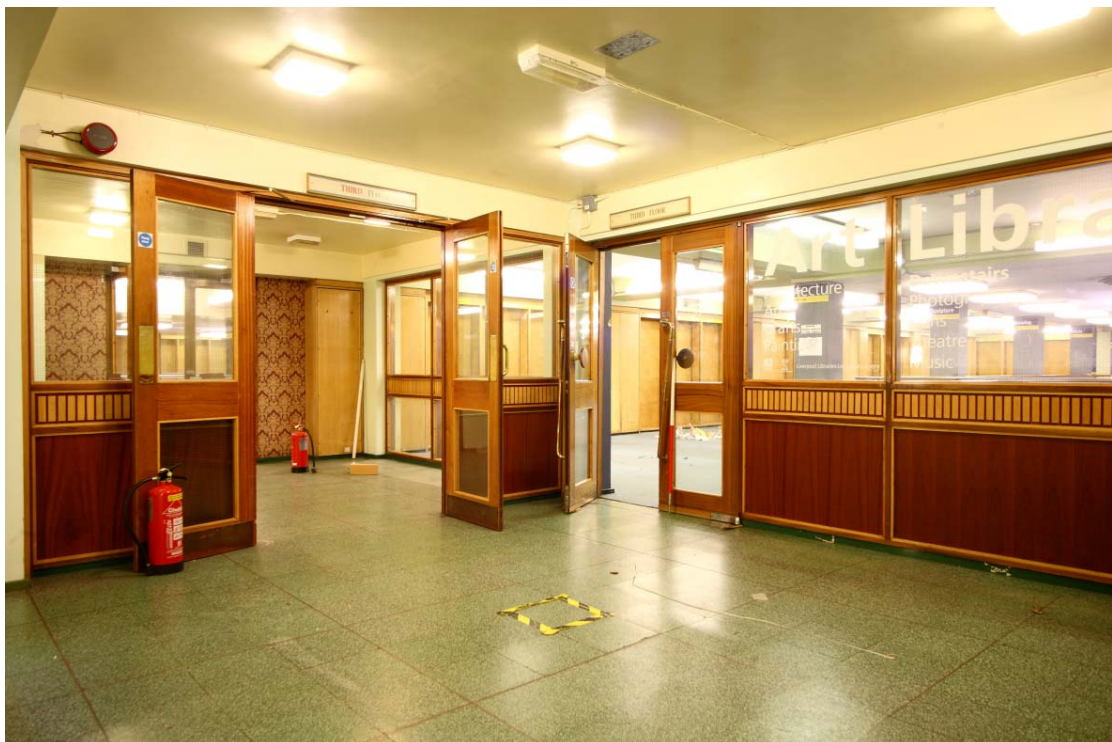
Plate 18: Third floor ante-rooms adjacent to north staircase in William Brown Library

- 4.6.10 **Third Floor Plan:** the third floor also has a mezzanine gallery design (23) (Fig 9), and is almost identical in design and layout to the first and fifth floors (Plate 18). The southern room (24) of the floor functioned as an open plan bookstore with access through a door in the north-east area to a vestibule are leading to the main stair well (11). It was partitioned off from the main gallery by a glass partition in a steel surround (24); the glass is embellished with a frosted pattern in the form of a stylised heraldic motif representing the Liverpool Library Service (Plate 19). The second floor can be viewed from the third floor mezzanine at the centre of the gallery.
