BARN AT BEETHAM HALL, BEETHAM, MILNTHORPE, CUMBRIA

**Archaeological
Building
Investigation and
Watching Brief**

Oxford Archaeology North

January 2008

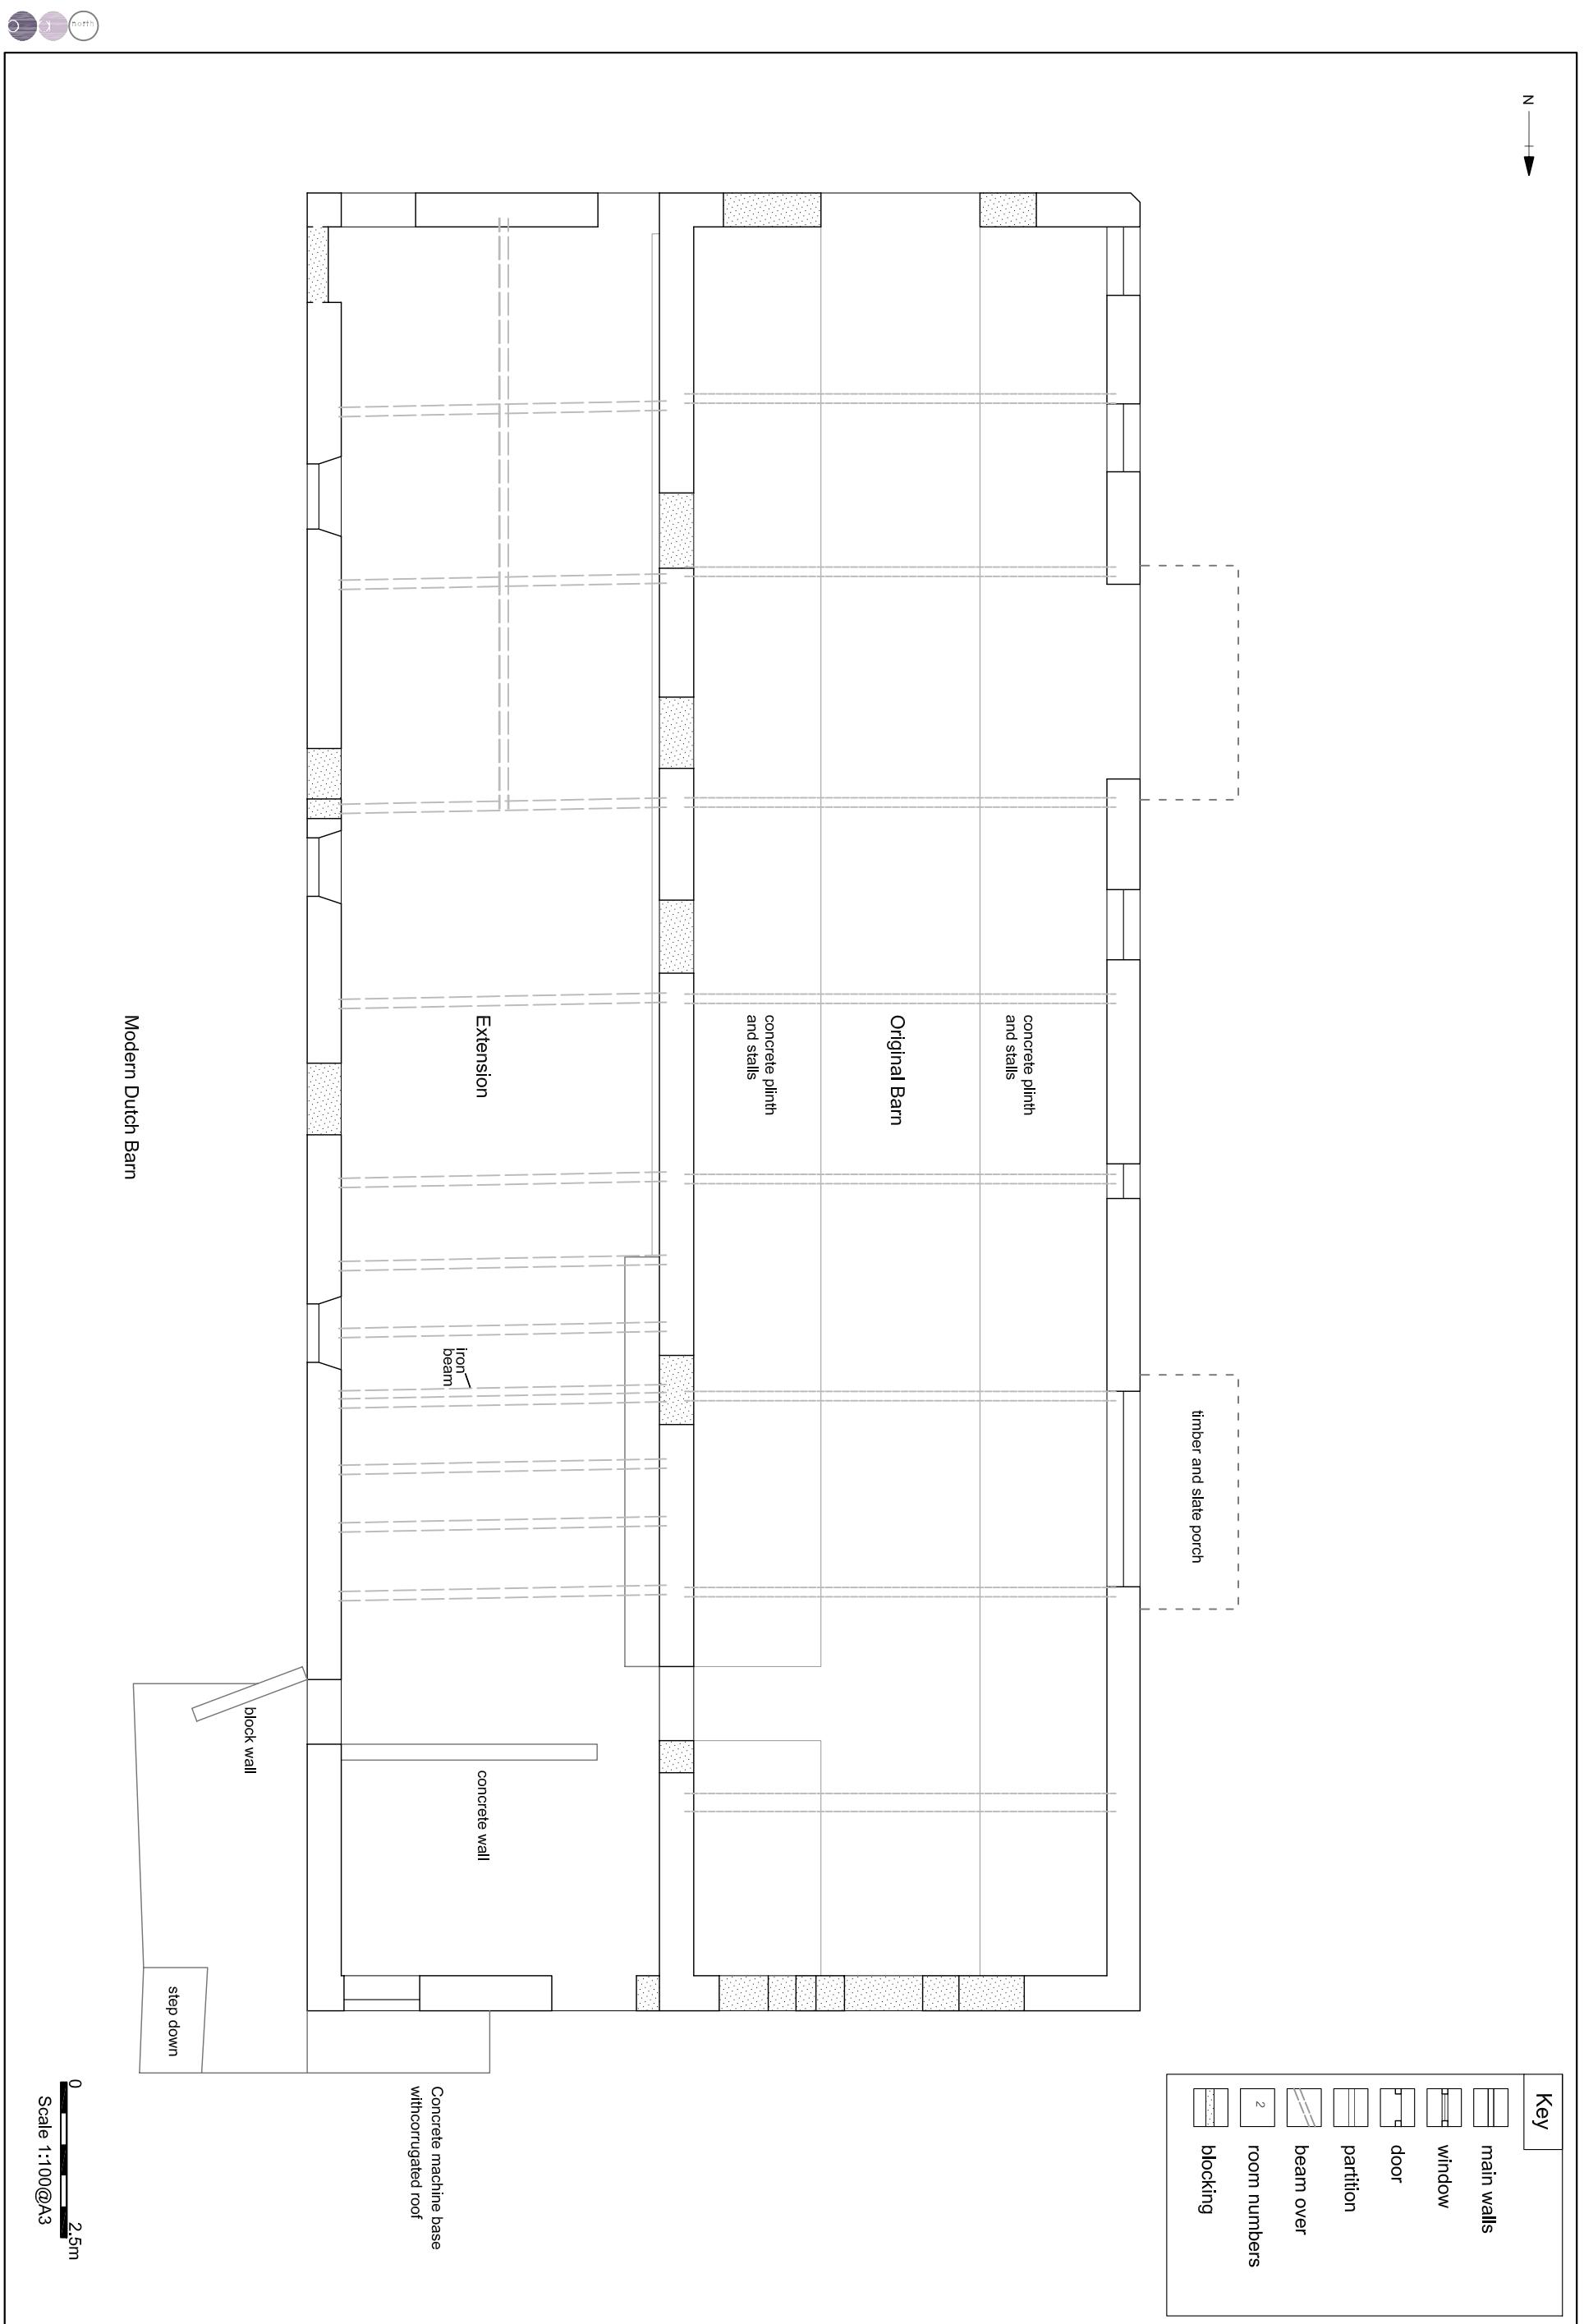
Figure 6: Plan of the Barn at Beetham Hall

- 4.1.1 The barn lies at the north end of the Beetham Hall complex, and is a large, two-storey, stone building comprising a rectangular barn with a later extension added to its east elevation. It is aligned north-west to south-east, but for ease of reference, the building is treated as north/south along its long axis throughout this report (Fig 6).

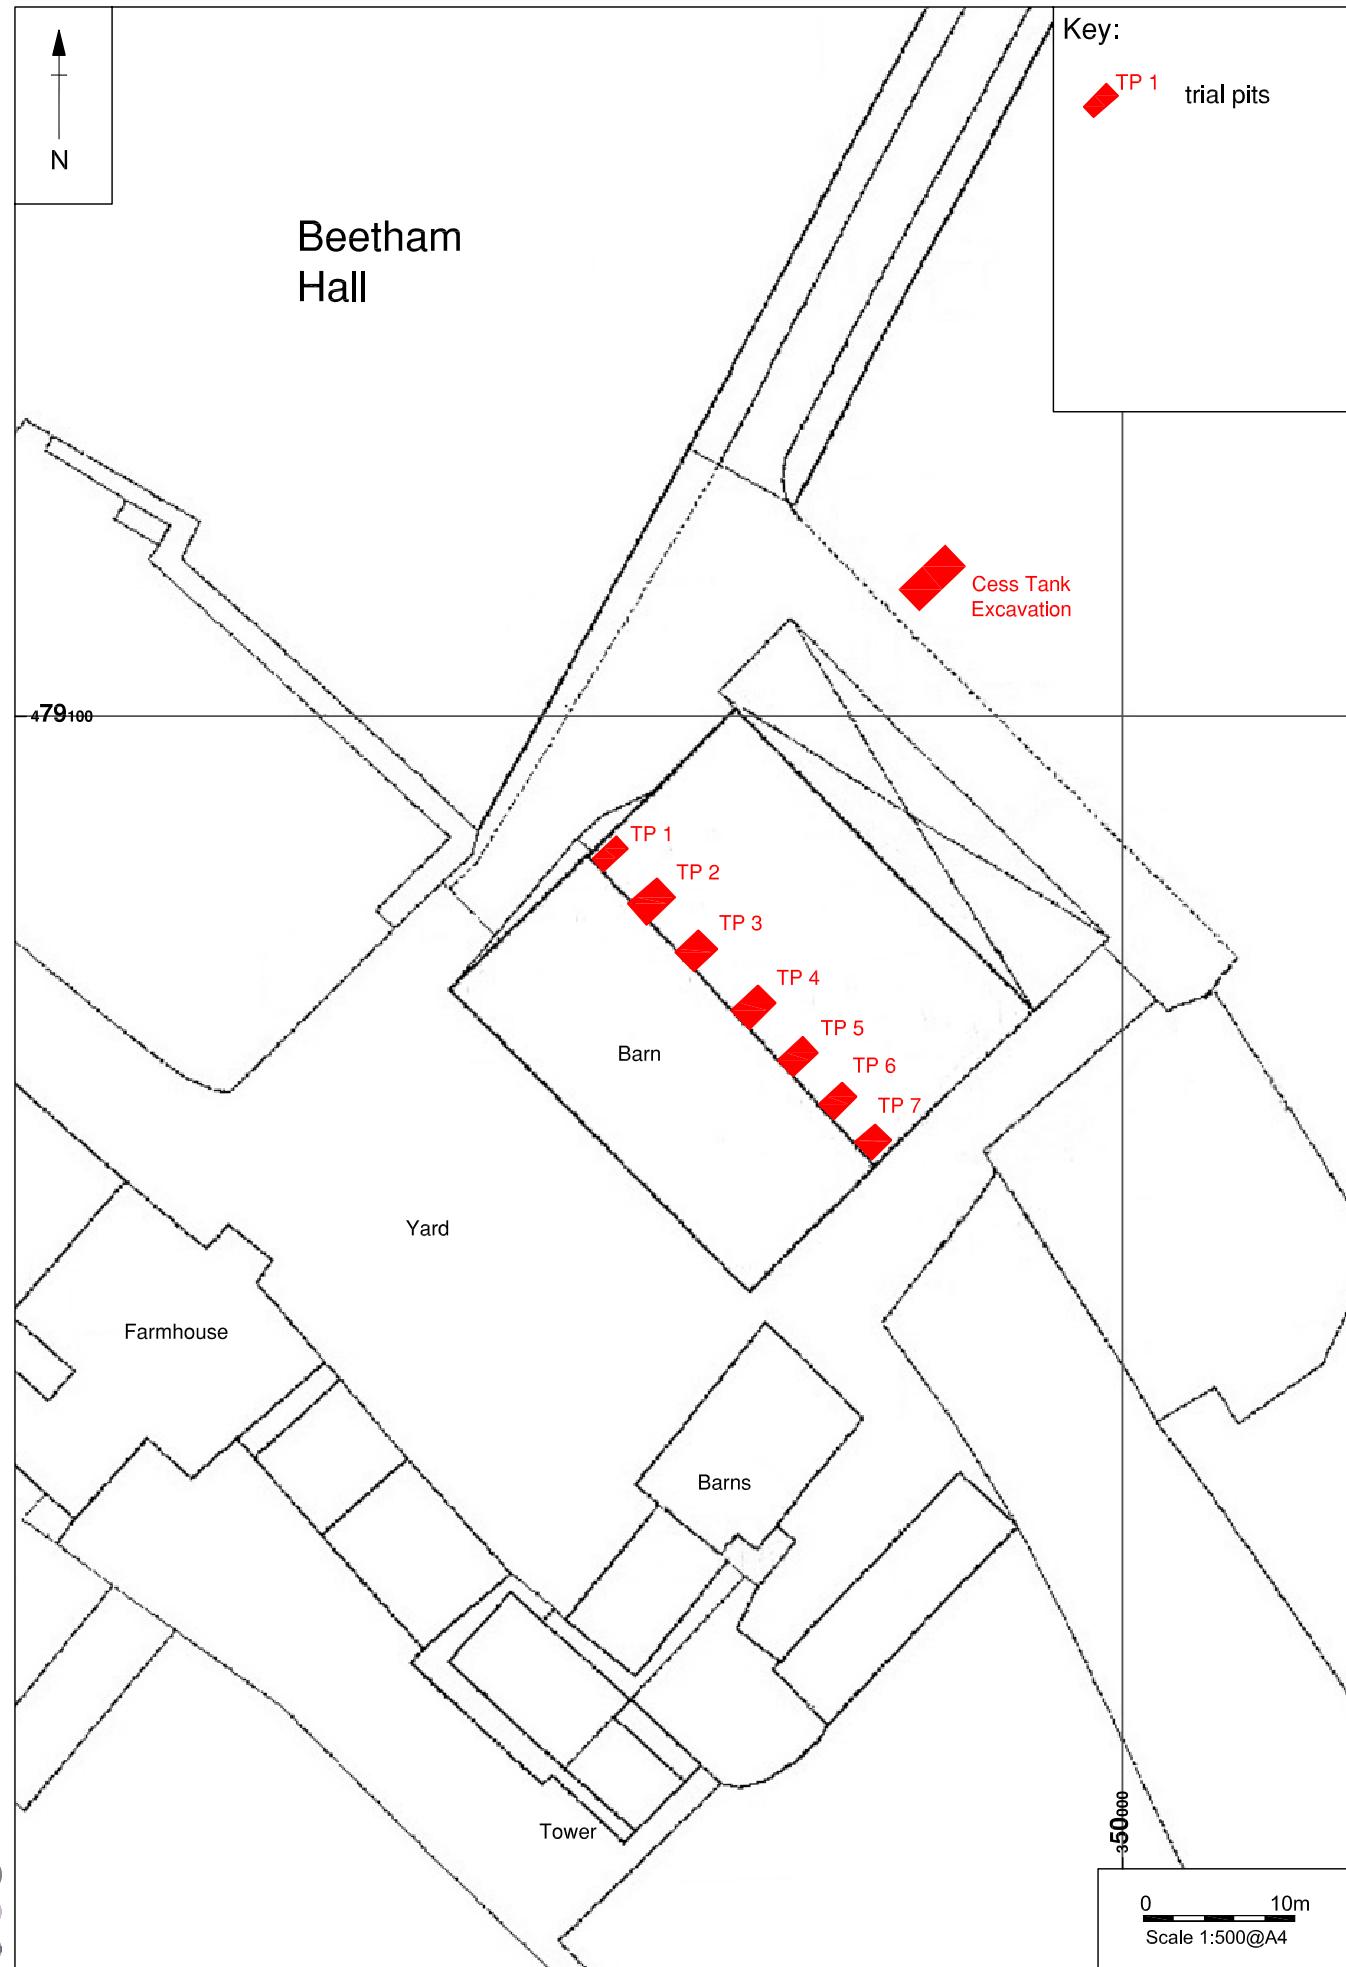
Figure 7: Plan of the Watching Brief Areas

- 5.1.1 An archaeological watching brief was maintained during groundworks undertaken by the developer, as detailed in the methodology. The results of the watching brief are presented in tabular form below. The areas referred to are located in Figure 7.

Groundworks	Results
Excavation of seven holes for stanchions, along the exterior of the eastern wall of the barn (Fig 7).	Seven areas were excavated, a maximum of 2.5m in length and a maximum of 1.8m in width, aligned on an east/west orientation. These effectively formed seven test pits (TP). TP 1 measured 1.24m deep; TP 2 was 0.95m deep; TP 3 was 0.9m deep; TP 4 was 0.8m deep; TP 5 was 0.5m deep; TP6 was 0.5m deep; and TP7 was 0.9m deep (Fig 7; Plates 13 and 14). Each of these was excavated into a glacial till, comprising a mid-grey coarse sand clay till with 25-50% sub-angular and sub-rounded stone inclusions (maximum of 0.13m by 0.10m by 0.07m). Limestone bedrock was located at the base of Test Pits 2 to 7. No deposits of any archaeological significance were located.
Excavation of area for cess tank, in field to the east of the barn (Fig 7).	The excavation for the cess tank measured 4.30m by 2.0m by 0.75m, excavated on a east/west orientation. Topsoil comprised a very dark grey fine sand silty clay, 0.33m thick. Within the upper 0.15m of the soil horizon was a layer of rounded stones, which were of a maximum size of 0.23m by 0.12m by 0.10m (Plate 13). The total area of this stone layer measured 3.5m by 4.3m (Fig 7). The subsoil comprised a dark orange brown fine sandy-silty-clay 0.45m thick. A mid-orangey brown medium sandy-clay till was located at the base of the excavation (Plate 14).

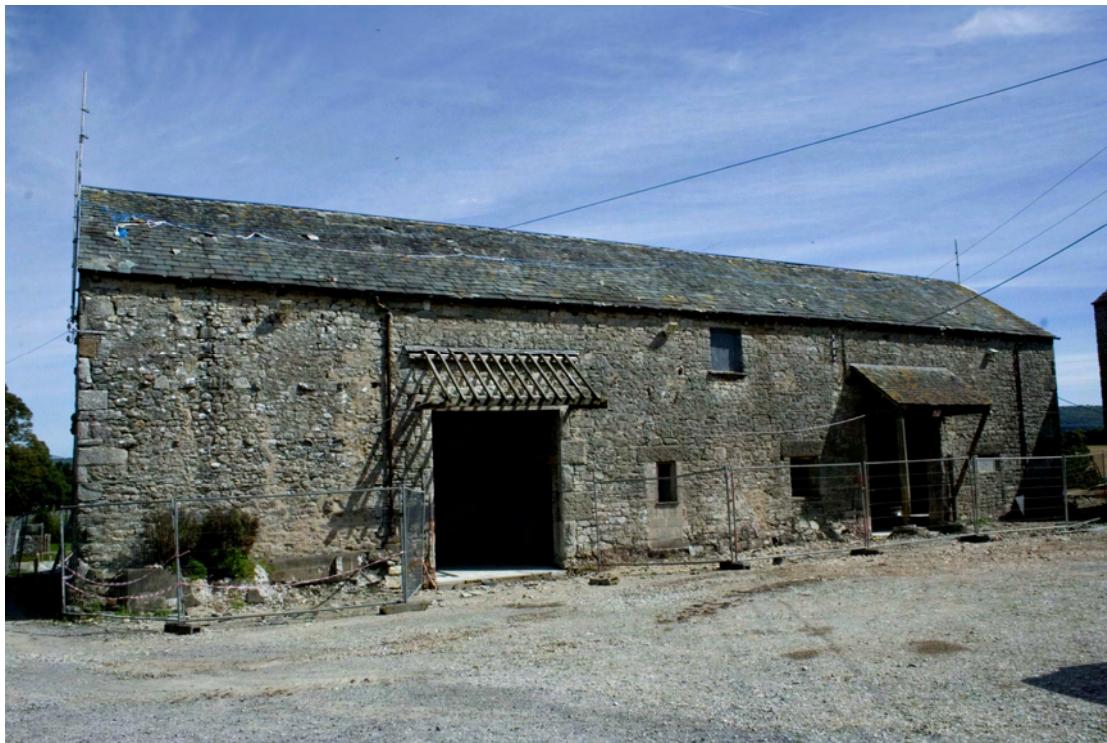
- 4.2.1 The original barn and the later extension are constructed from coursed limestone rubble with well-cut, rock-faced quoins on the dressings and margins (Plate 1), whilst the south-west corner features stop-chamfering on the lower courses of the quoins. There is a distinct uniformity in build between the original barn and the east extension, to the extent that the south elevation appears to be a single continuous build. The north elevation, however, clearly has a distinct butt-joint between the builds of the original barn and its later counterpart.

Plate 1: The west elevation of the barn.

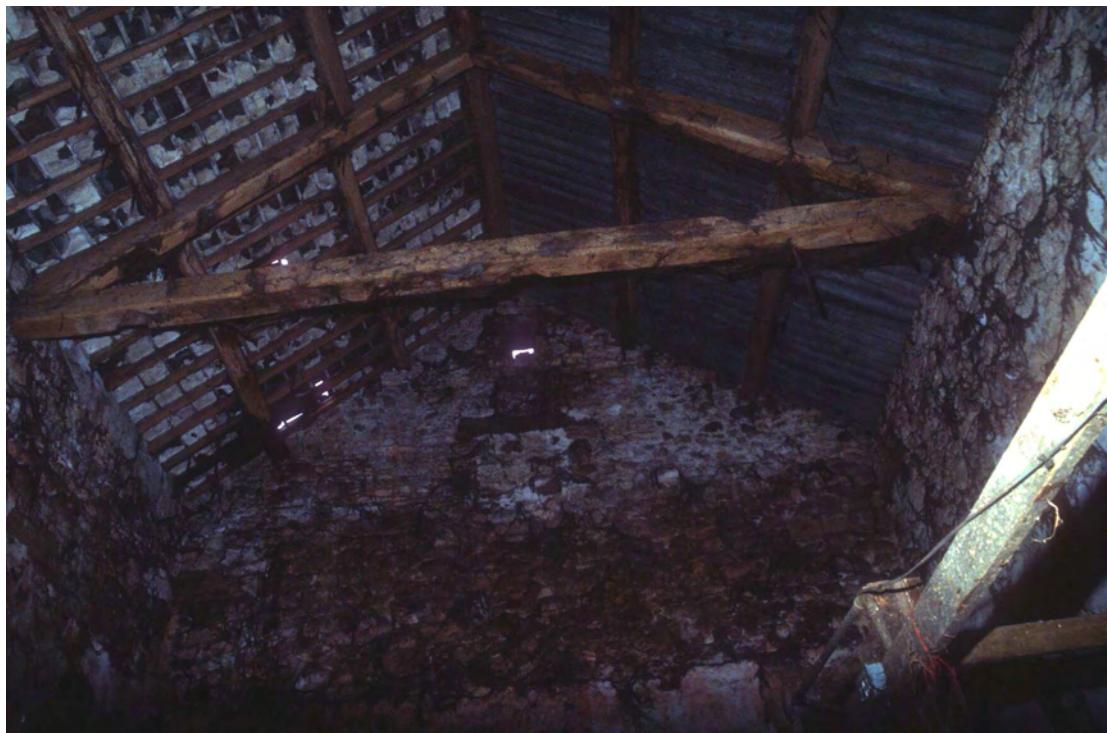
- 4.2.2 The roof is laid with diminishing courses of Cumbrian slate on its west side and corrugated iron sheets inlaid with four perspex skylights on its east side (Plate 2), whilst the roof of the later extension is similarly laid with corrugated sheeting. The internal construction of the roof includes eight roughly-hewn tie-beams trusses, which are more rudimentary at the east end of the building (Plate 2), and which support trenched purlins (two per pitch) and a ridge plate. In the east extension the roof is constructed from half tie-beams with four trenched purlins and a cross-beam that supports the three ties at the south end of the building. An inaccessible loft at the north end of the extension is supported by the tie-beams of the trusses in conjunction with two pairs of steel beams.

Plate 2: Detail of the most northerly truss within the barn.

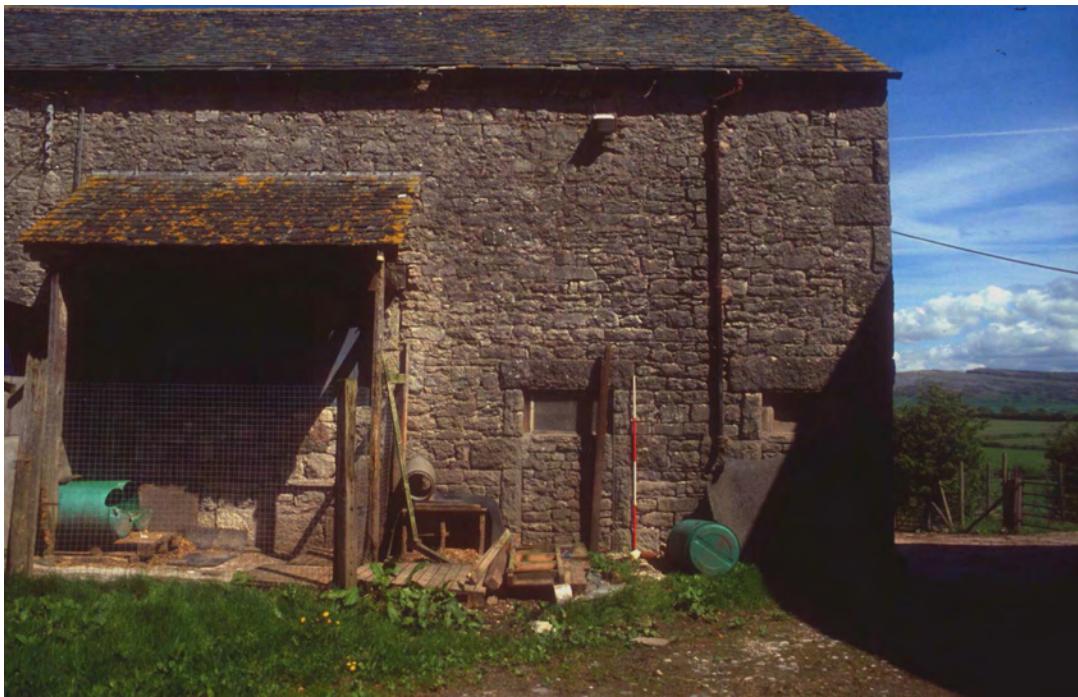
- 4.2.3 On the front elevation (west), there are a pair of large wagon doors sheltered by timber-frame porches laid with regular-coursed Cumbrian green slate (Plate 3), whilst the surrounds feature well-cut, rock-faced quoins, which are typical of the building. The doorways have been partially blocked with infill to create windows, whilst the upper sections of the matchboard doors themselves have been retained as shutters. Similarly, there is a small inserted window between these wagon doors, with a projecting sill of Cumbrian slate, as well as a timber lintel and jambs. Above this existing timber surround, there is a stone lintel from the original doorway, whilst beneath the sill, there is a mixed infill of klinker block and brick. There are also two further blocked doors at the south end of this elevation, which have been partially infilled with rubble and converted to narrow casements (Plate 3).

Plate 3: Detail of the porch and blocked doors at the south end of the west elevation.

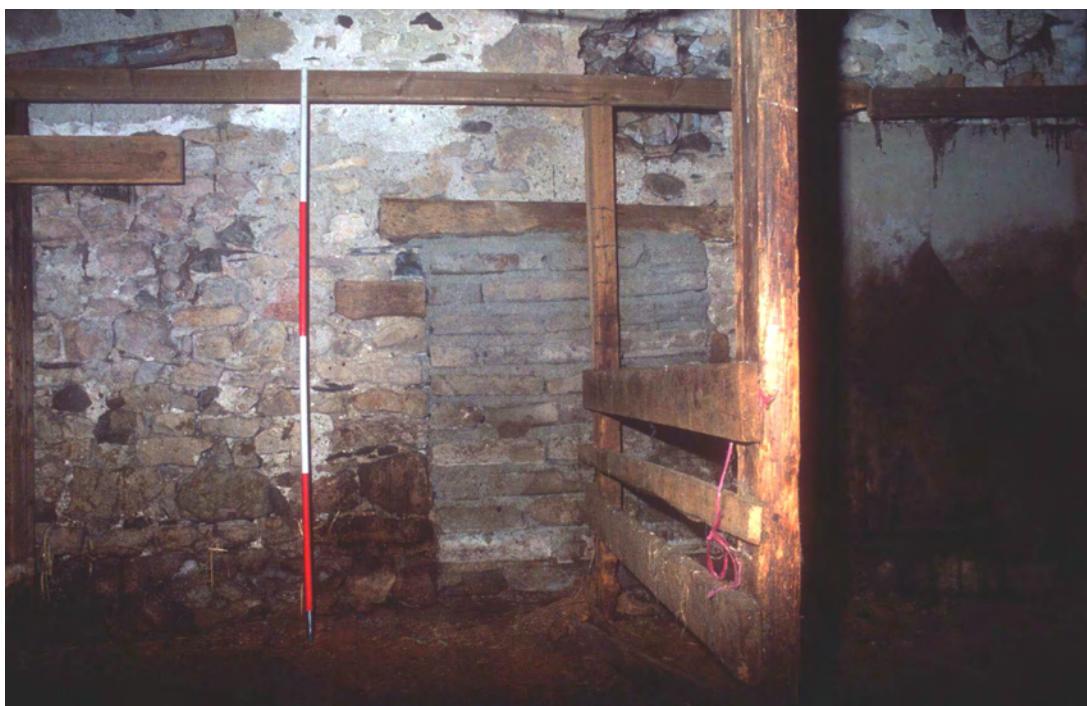
Plate 4: Detail of the stalls and one of the blocked doors on the east elevation.

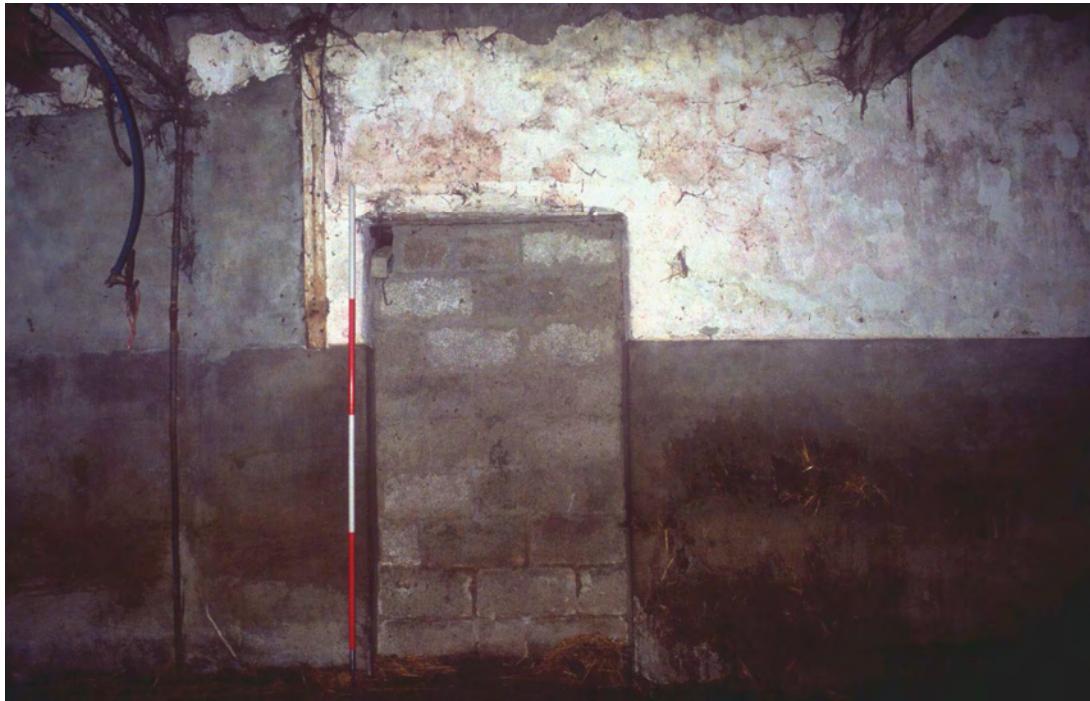
- 4.3.1 The walls of the original barn are covered with a thick limewash render, whilst a series of joist slots along the east and west walls at the south end of the barn indicate the extent of a former hayloft. The floor is laid to concrete with an inclined plinth running down either side of the barn to provide drainage from the timber cattle stalls, which line the west and east walls (Plate 4).
- 4.3.2 On the south wall, there is evidence of the same segmental voussoir, that was noted on the exterior of the building, whilst the blocked door/window is again visible as on the exterior. On the east wall of the original barn, there are four blocked doors, three of which are infilled with stone, whilst the fourth has been blocked with concrete (Plate 4). Only three of these are visible on the obverse of the wall, whilst the fourth is concealed beneath the cement render (Plate 5).

Plate 5: Detail of the blocked doors on the west elevation of the extension.

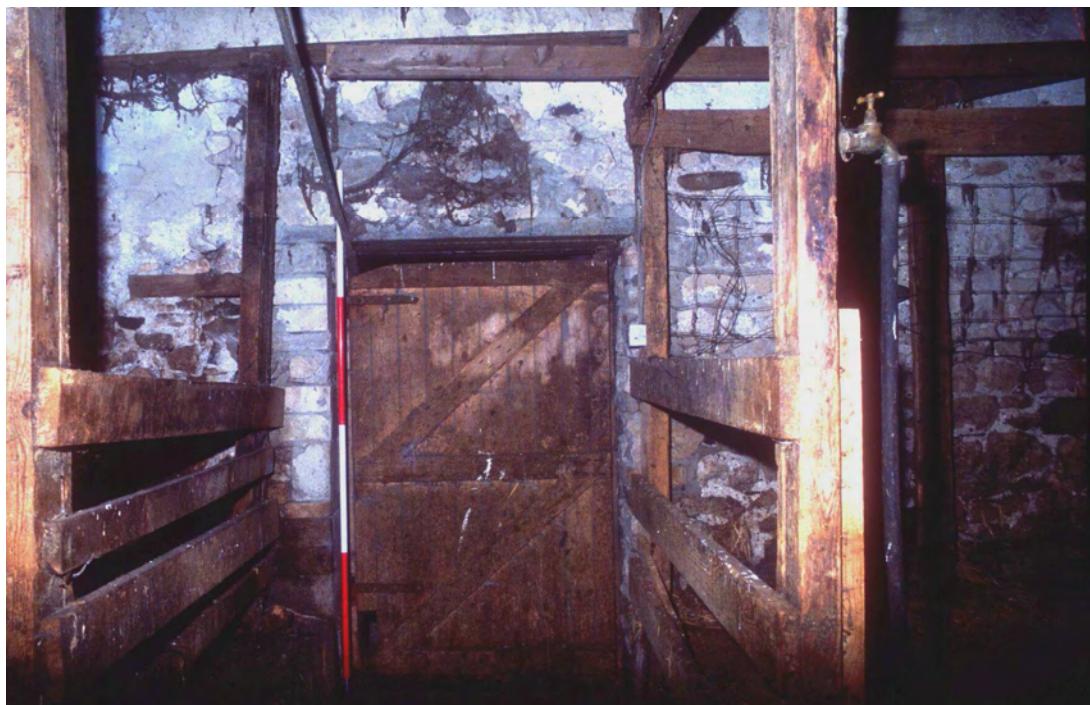
- 4.3.3 At the north end of the barn, there is a small doorway leading into both the east shed extension and the small storage area, which has a modern ledged and braced matchboard door with concrete and timber lintels. It obscures the majority of an earlier/ original aperture, but on the north side of the doorway, there are the remains of a timber lintel and some brick infill (Plate 6).

Plate 6: Detail of the replacement door on the east elevation.

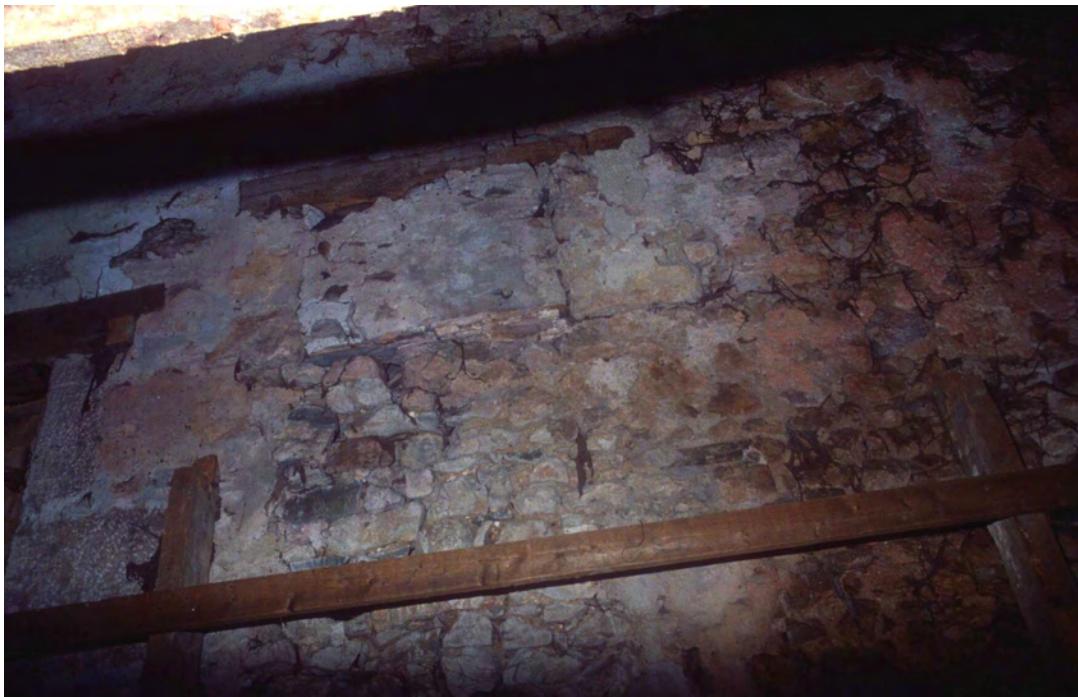
- 4.3.4 On the north elevation there are three, or possibly even four blocked windows. Unlike the exterior elevation, which has a re-used roughly-hewn beam, each window has its own unfinished, deep timber lintel. As on the exterior of the elevation, there is a blocked hayloft access-hatch towards the upper reaches of the elevation, and similarly on the west elevation, there is a further hayloft access, as well as an adjacent blocked hatch (Plate 7).

Plate 7: Detail of the blocked hatch on the west elevation of the barn.

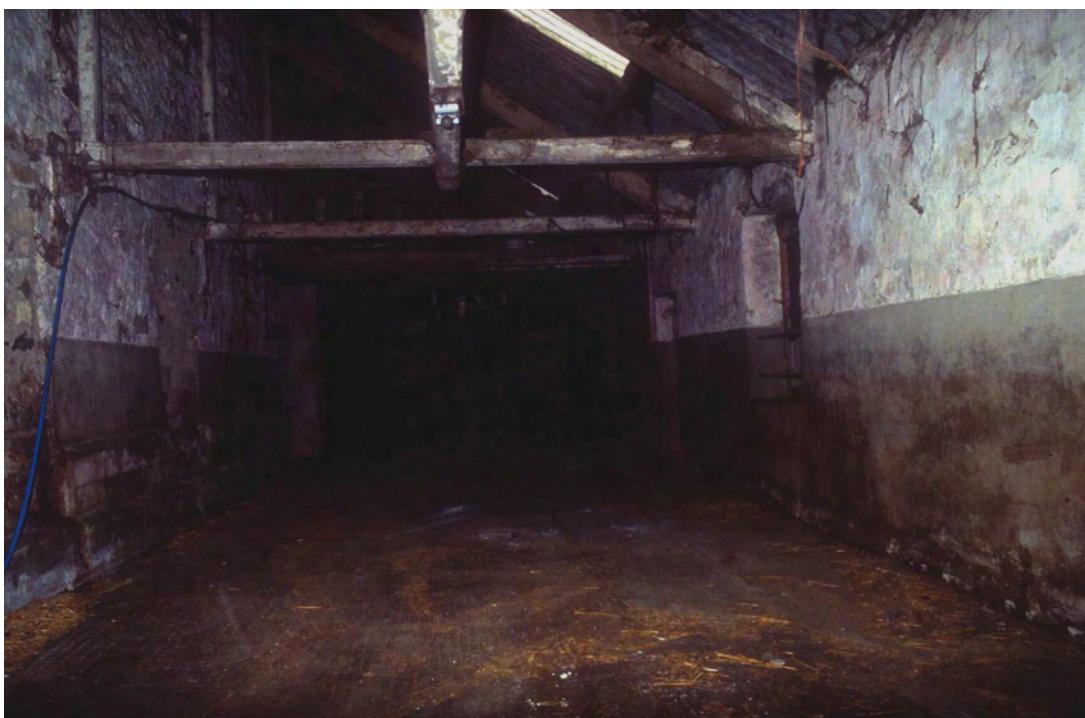
Plate 8: North-facing view of the interior of the east extension.

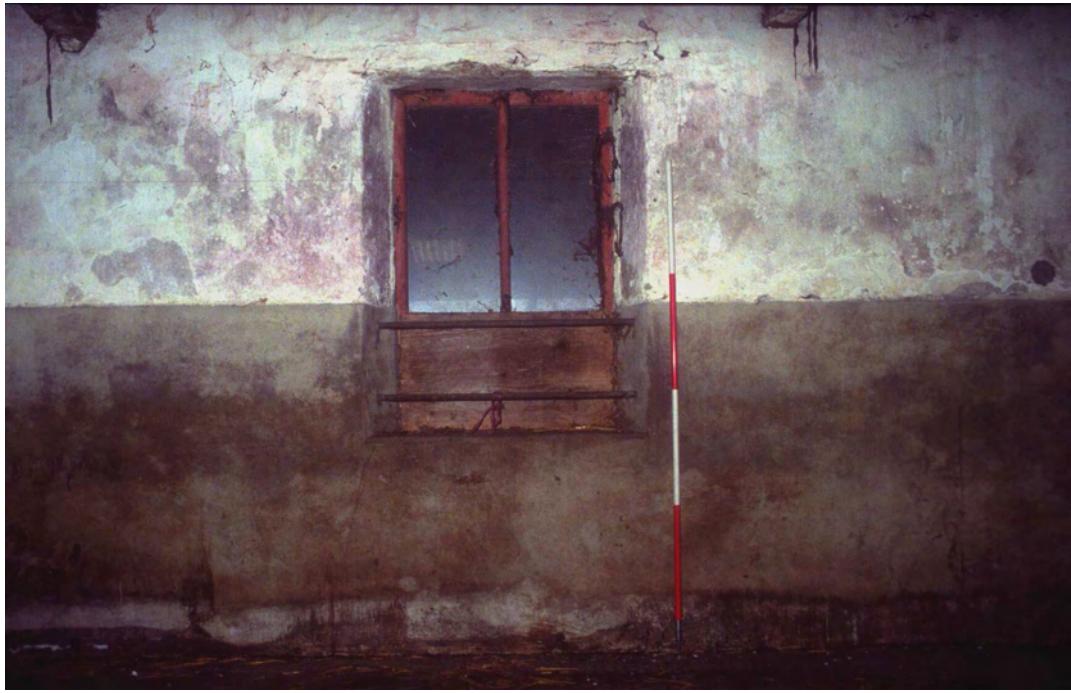
Plate 9: Detail of one of the casements on the east elevation of the extension.

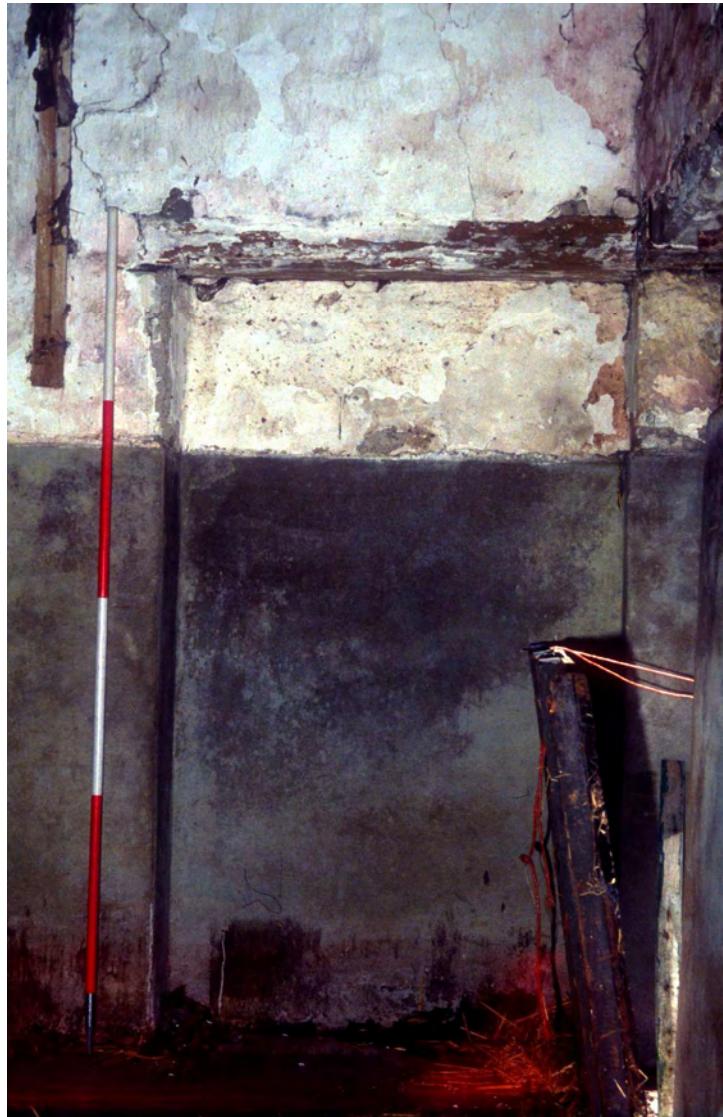
- 4.3.5 The extension to the east has a plain concrete floor with a timber-covered pit for sheep-dipping or a similar activity, whilst the walls are lime-washed with a partial render of cement (Plate 8). Additionally, to the north there is an inserted klinker block wall, which partitions the small storage room, and a low concrete wall/plinth runs along the west elevation. Apart from this, there is little of note aside from a few windows and doors. On the west elevation, there are three barred and partially blocked casement windows (Plate 9), with a further casement on the north wall of the small storage room. Additionally, there are three doors on the west elevation as described above (*Section 4.3.2*), two external doors on the south elevation, and a blocked door on the west elevation (Plate 10).

Plate 10: Detail of the blocked door on the east elevation of the extension.

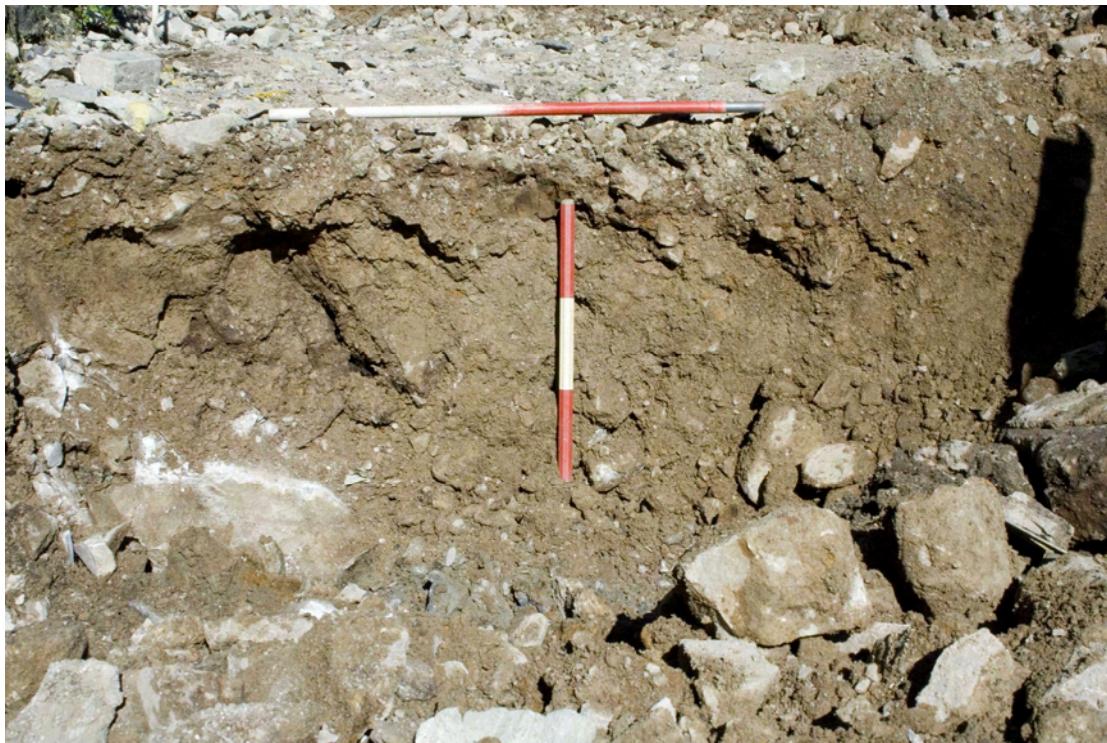
Plate 11: South-facing section of Test Pit 4.

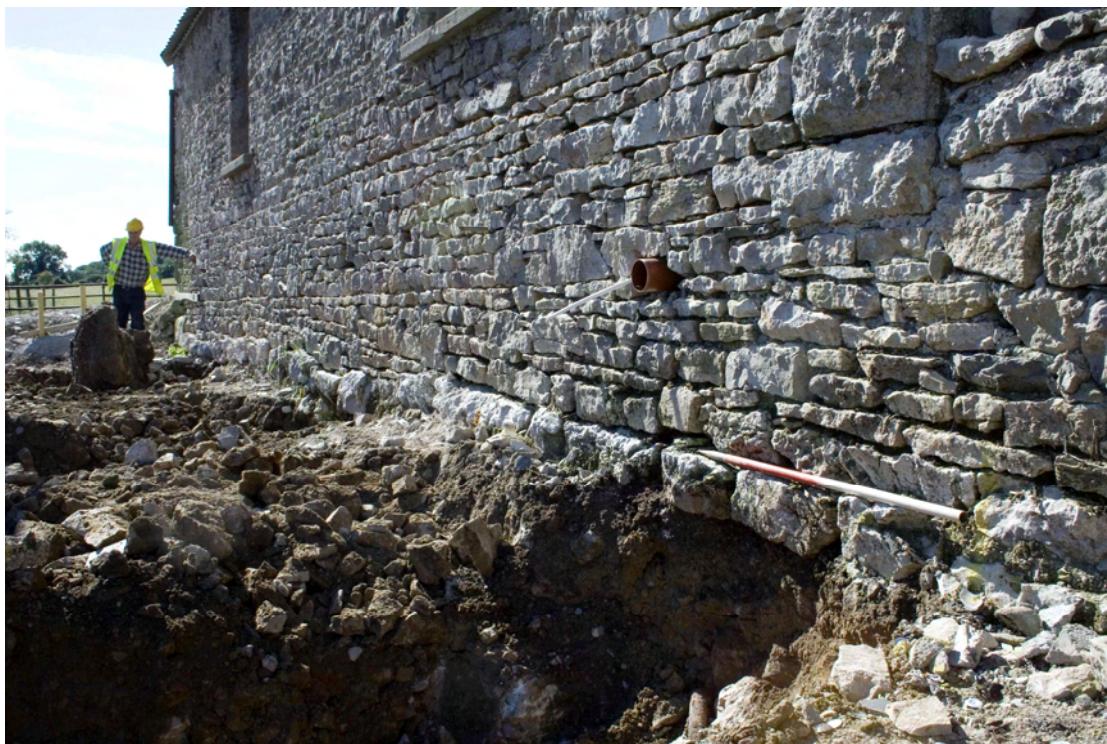
Plate 12: General shot of test pit excavations, looking south-west.

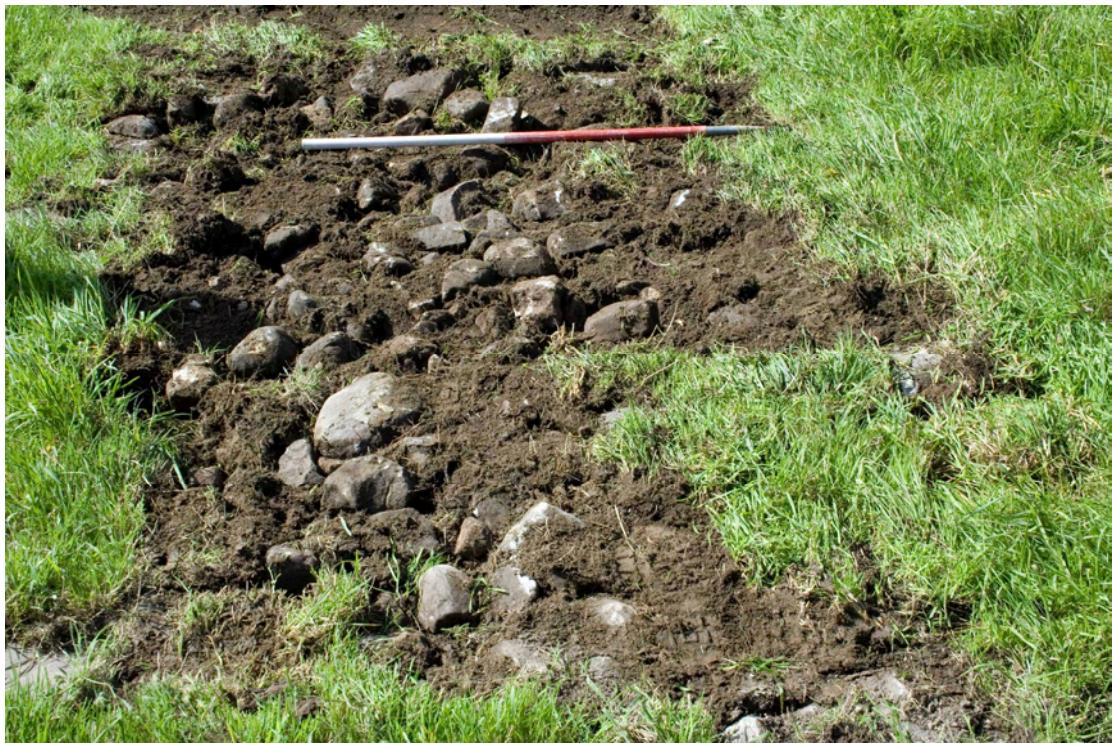
- 5.1.2 The stone located within the soil horizon of the cess tank excavations may have been placed to form hard standing in front of a gateway. Alternatively, it might represent the remains of a stone heap, the stone either being used in construction elsewhere or forming the base of a clearance cairn.

Plate 13: Stone layer located within cess tank excavations, looking west.

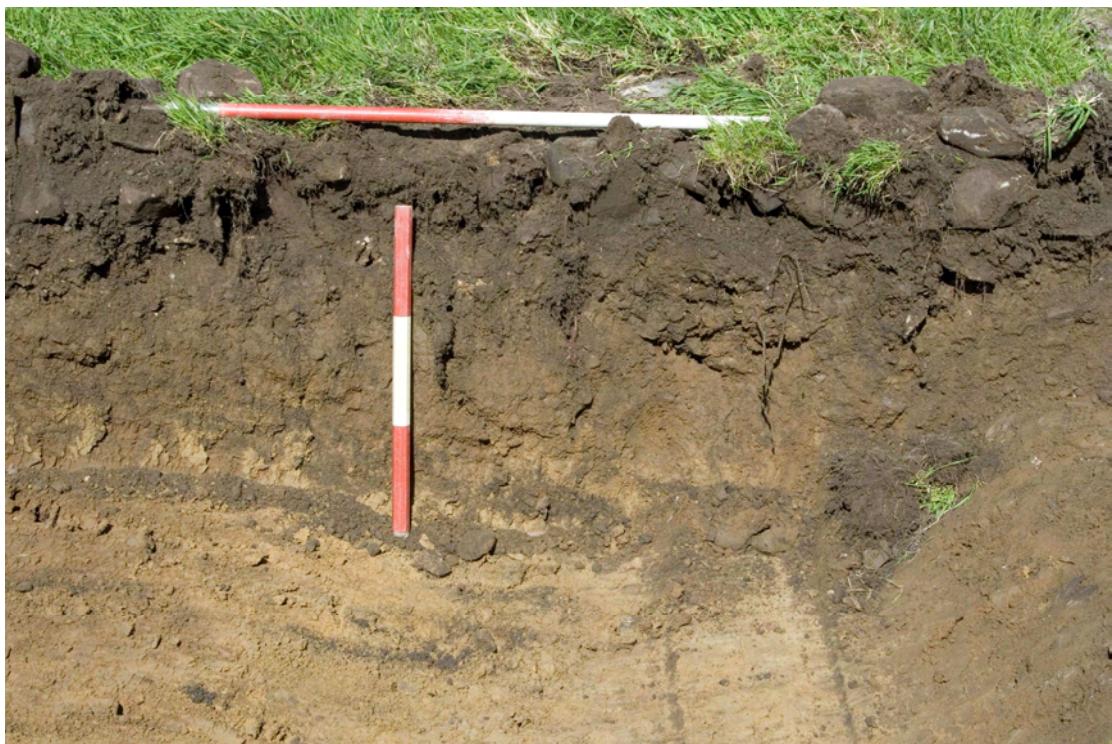
Plate 14: South-facing section of cess tank excavations.
