LANCASTER FORD, ST GEORGE'S QUAY, LANCASTER

Archaeological Survey

Oxford Archaeology North

October 2008

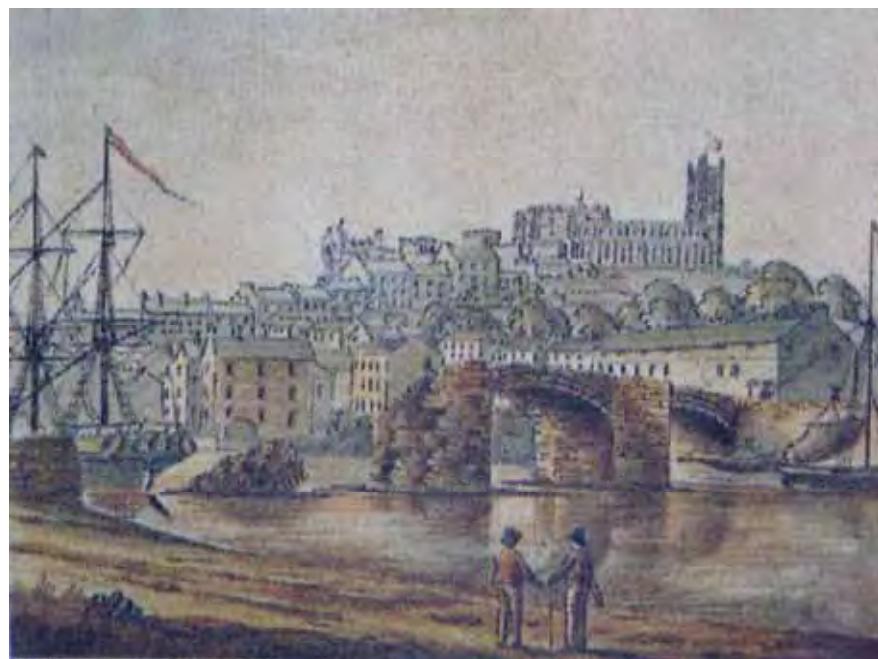
Painting of the partly collapsed bridge by G Yates (1812)

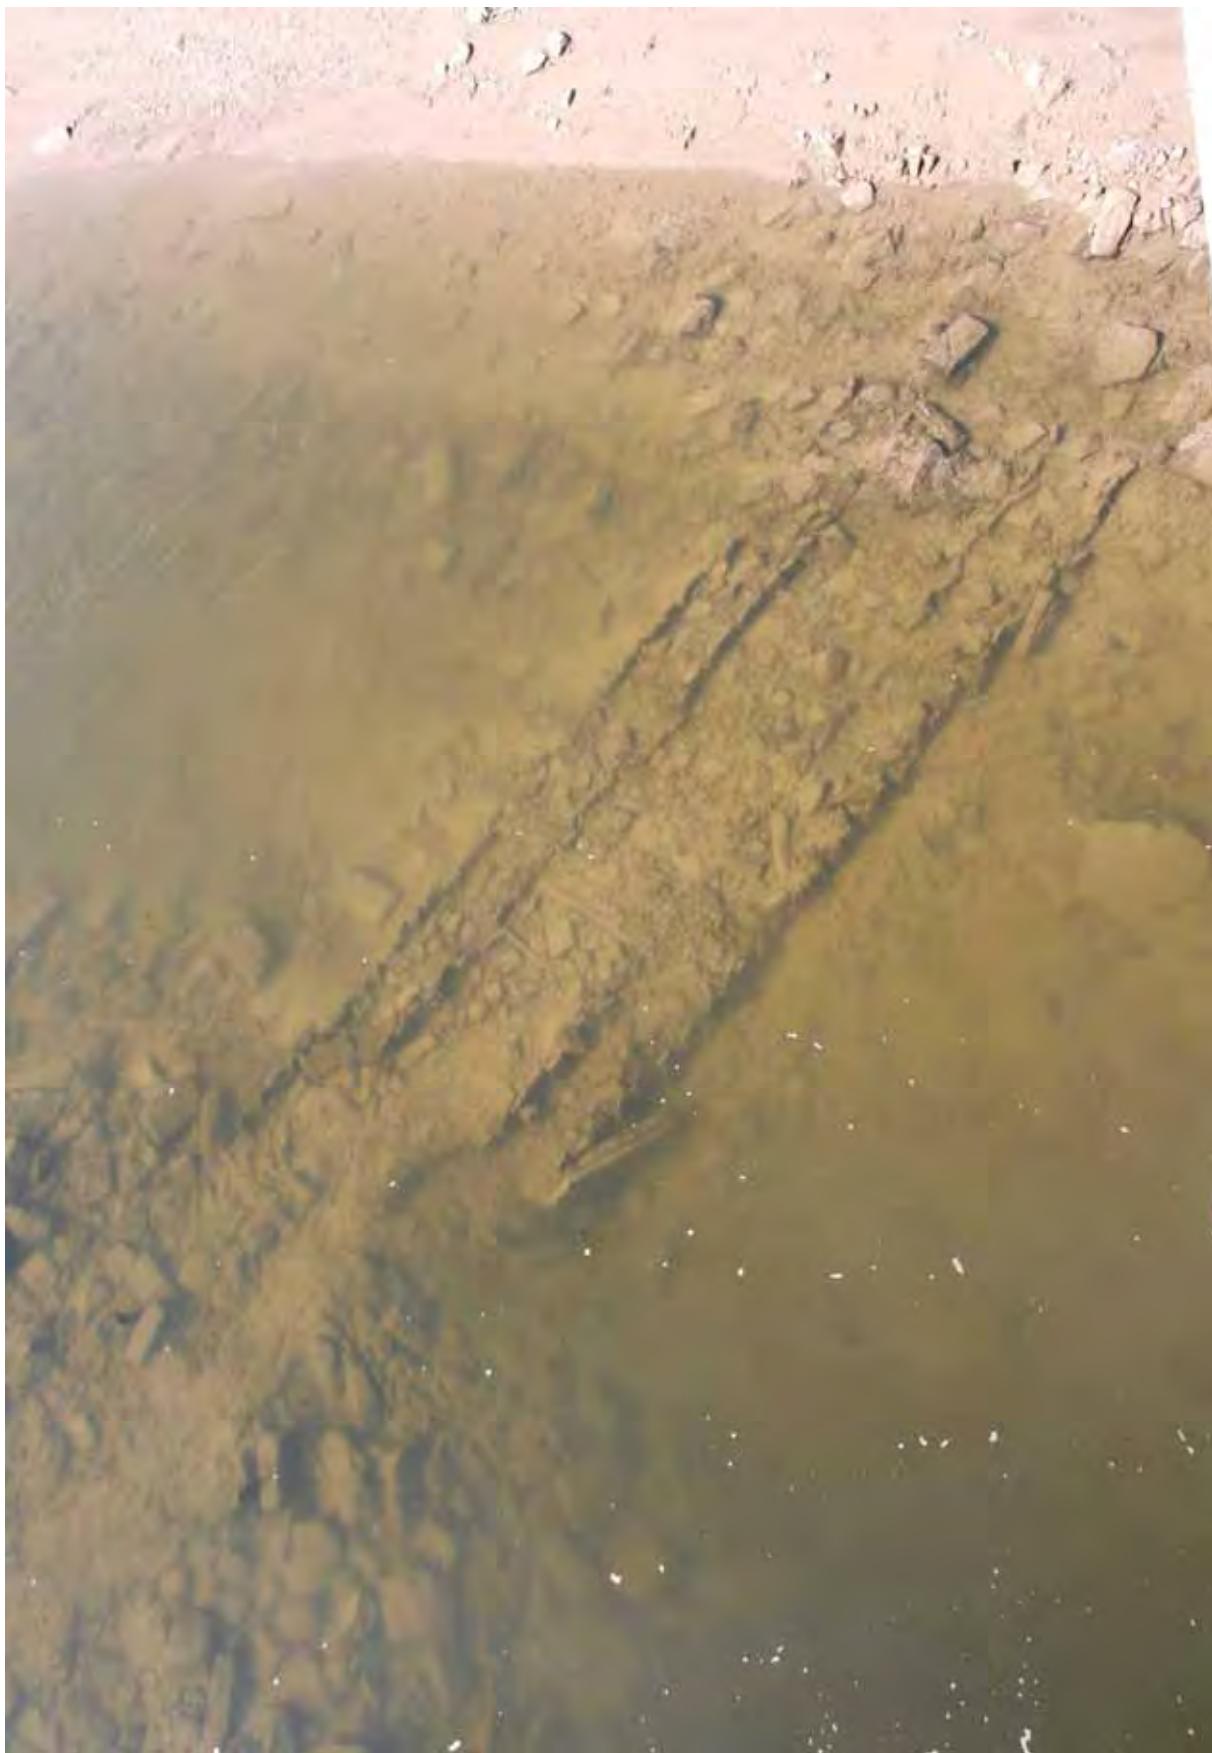
- 4.1.2 **Trackway:** the main, and most striking feature within the site, comprises four rows of vertically set timbers, aligned on an approximately north-east/south-west alignment (Plate 1), leading from the northern bank towards the centre of the channel (Figs 2 and 3). Each row was constructed of vertically-set, rectangular-section timbers, typically 150mm x 60mm in size, positioned parallel to the direction of the feature, generally butting each other, but occasionally with small gaps between (Plate 2). Each appears to extend significantly below the exposed height, which was between 0.05 and 0.2m. During the sampling of a timber in January 2007, they were observed to be completely earthfast, displaying no movement during the process of cutting, suggesting that at least 0.5m survives below the surface of the river bed. Each row extends for over 7m, and the western row extending for a maximum continuous length of 8.7m (Fig 3). Further individual upright timbers were also observed up to 17.5m from the exposed northern end of the feature. The rows are positioned in pairs, 0.6m apart, forming two distinct 'tracks' (Plate 1). The 1.3m space between the two pairs is infilled with water-worn cobbles, of varying size, forming a compacted layer typically 0.1m below the upper edge of the timbers. Towards the northern bank, in the area of best preservation, the area between the two pairs of rows had been infilled with a similar material. Within this packing material, approximately 5.2m from the exposed northern end of the feature, two transverse timbers were observed. Each measured c 45mm wide and spanned the space between the two pairs of 'tracks', set 0.45m apart, and appeared to serve as bracing between the two 'tracks' (Plate 3).

Plate 1: View of the trackway from above

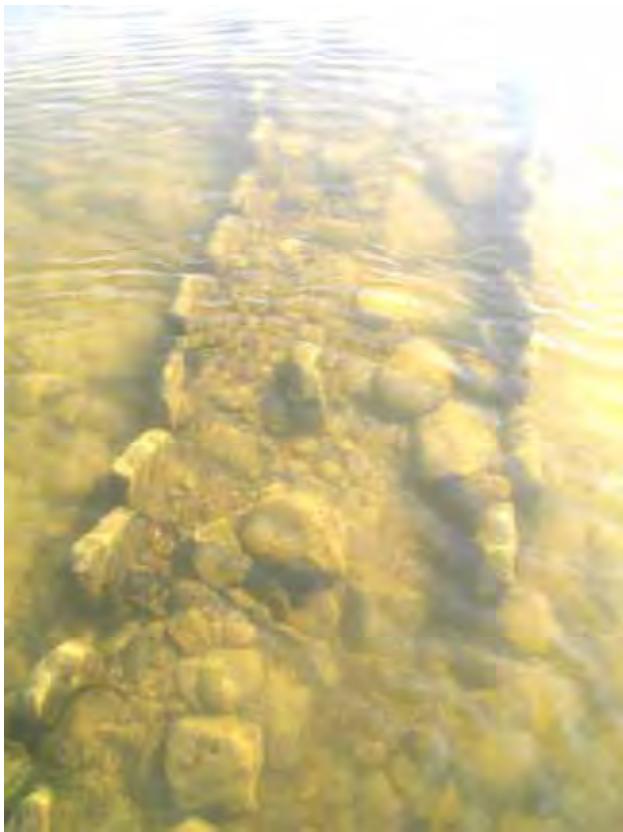
Plate 2: Detail of timber post arrangement

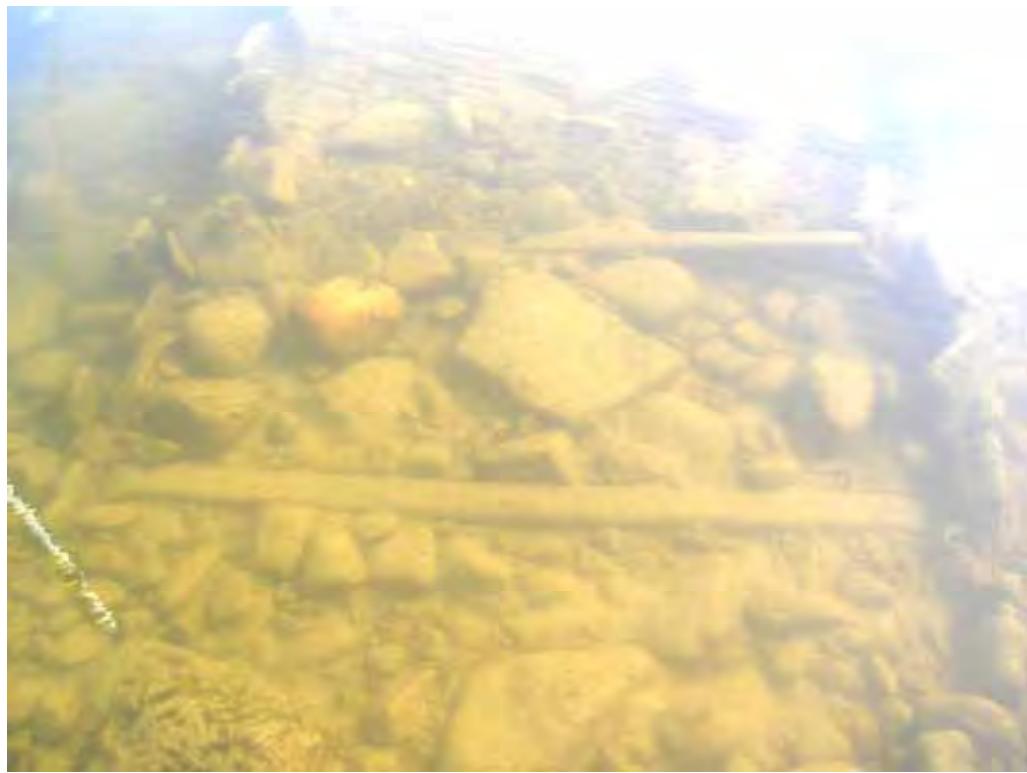
Plate 3: Transverse timbers between tracks

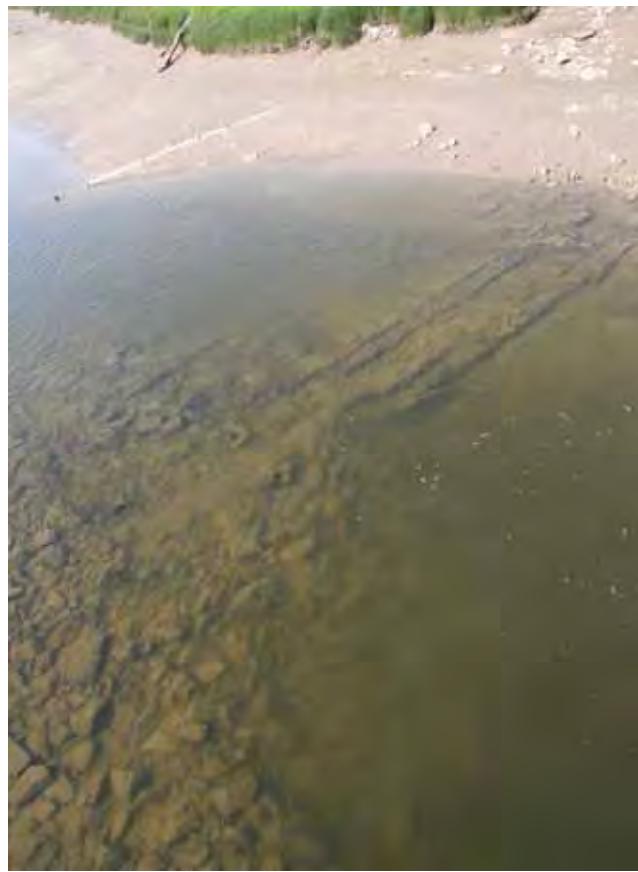
- 4.1.3 The southern end of the well-preserved section of trackway feature was obscured by what appears to be later rubble (Plate 4). The majority of this comprises rough sandstone rubble, but both dressed pieces of sandstone and late twentieth/early-twenty-first debris was also present. However, the central part of the trackway, between the line of the two pairs of timber rows, was devoid of large rubble elements for a distance of about 6m, and appeared to be a continuous, compacted 'surface' (Plate 4). This was most noticeable immediately to the south of the extant timber rows, where the south-eastern edge of it appeared to have been broken away, leaving an obvious continuous edge. The volume of rubble appeared to increase for a further c 5m towards the centre of the river bed, before diminishing again. At this point the apparent central compacted area re-appeared, leading to an area of laid surface. This was raised c 0.1m above the height of the compacted layer, and was formed of distinct blocks of what is either very worn stone or a concrete-like substance (Plate 5). The area of this layer measured approximately 2.3m² and comprised four rows of four blocks, with an additional block extending

Plate 4: Rubble bank to the south of the exposed trackway

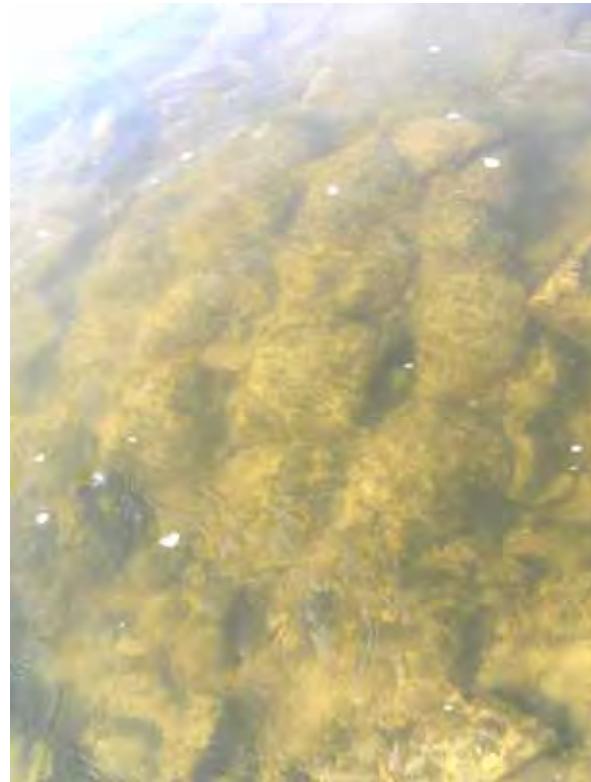
beyond the north-west corner. Each was roughly about 0.3 x 0.3m, with the upper surfaces having water-worn, rounded edges. It appears from the bases of the exposed blocks that they butted together to form a good, although slightly irregular surface.

Plate 5: Blockwork surface within the centre of the river channel

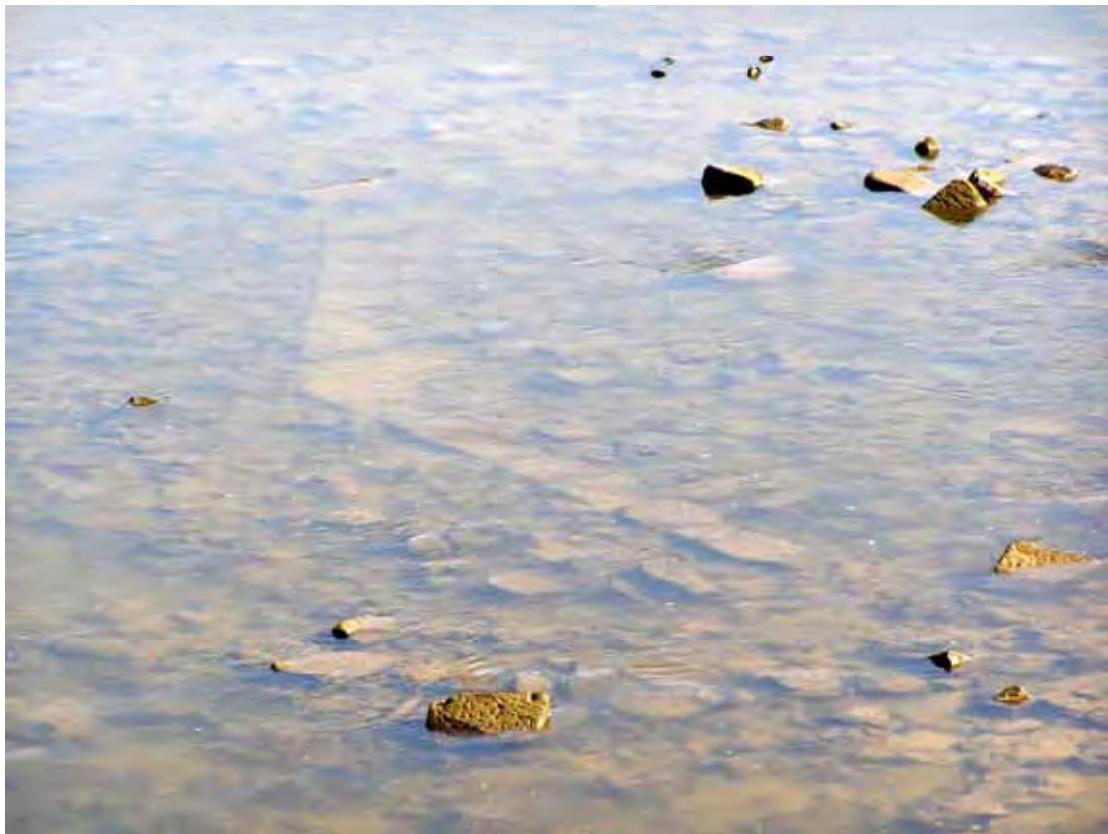
- 4.1.4 **Medieval bridge:** beyond the exposed sections of trackway, within a second bank of rubble, similar to that described above, two lengths of dressed stones were observed, flush with the surface of the rubble, and on the alignment of the trackway to the north. The south-western of the two was by far the better preserved, comprising a length of *c* 7m of *c* 20 dressed sandstone blocks, forming a face on their southern sides. At approximately half way along its length, the angle of the face changes from perpendicular to the direction of the river to an angle of approximately 30° to the north (Plate 6). This shape is similar to that of the cutwaters of the medieval bridge, and it is highly likely that the wall represents the southern edge of one of the cutwaters shown in Yates' late-eighteenth century drawing. A second, less well-defined, row of similar stones was observed to the east, and appears to represent the upstream cutwater of the bridge pier.

Plate 6: Exposed remnant of cutwater from the late-medieval bridge

- 5.4.1 Whilst the impetus for the project was to identify and record the trackway feature which had become visible at low tide within the River Lune, the survey also revealed evidence for the late-medieval stone bridge which crossed the river in this position. This feature is of important local significance, and it is therefore recommended that it is recorded in a more detail. Thus far, only a very cursory glance at the potential documentary sources has been undertaken, in order to set this aspect of the project within its historical context. However, significant documentary, cartographic and artistic information is most probably held within local resources, and should be investigated more thoroughly.

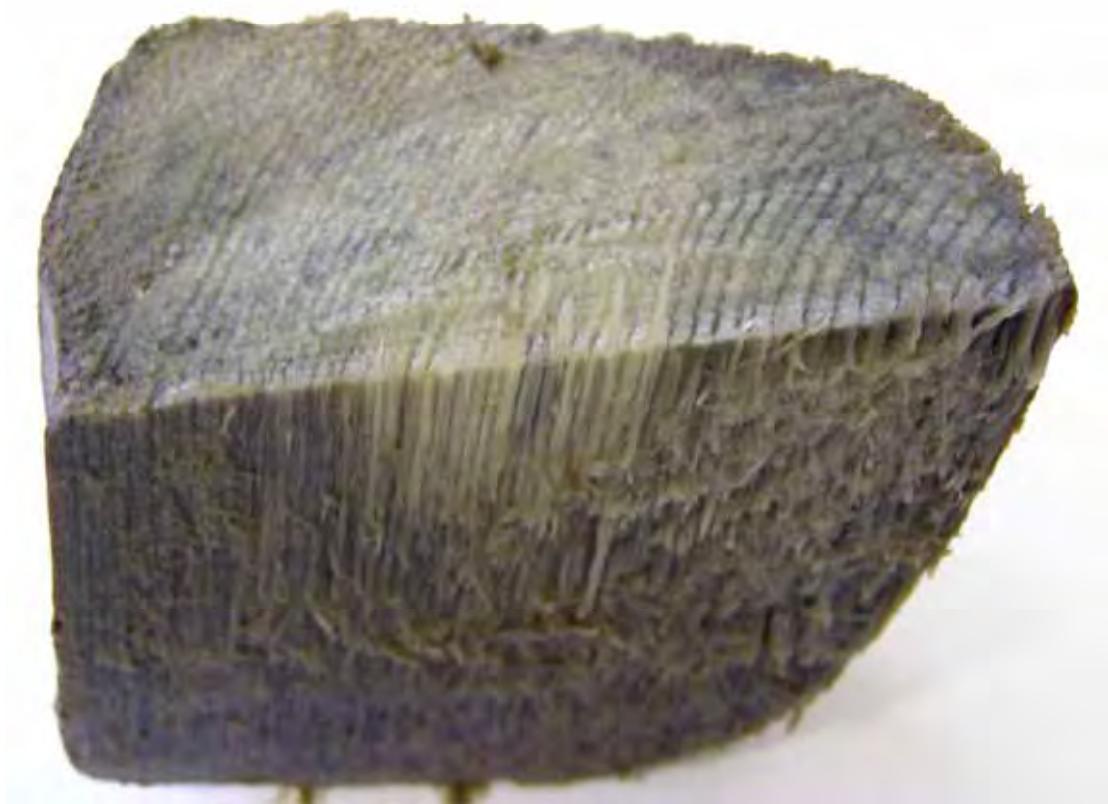
- 4.2.1 **Dendrochronology:** one of the two samples of timber (Plate 7) recovered from the trackway in January 2007 was sent to a dendrochronological expert for assessment as to its suitability for such dating techniques. A brief assessment revealed it to be an unidentified softwood, most probably pine (Ian Tyers *pers comm*), having 69 rings, and was therefore unsuitable for dendrochronological dating. Tyers further considered it to be unlikely of Roman, or even medieval origin, and most probably dated from the seventeenth to twentieth centuries.
- 4.2.2 **Radiocarbon dating:** the remaining sample was sent to the Scottish Universities Environmental Research Centre in March 2007. The sample was dated to AD 1680-1939 cal BC (105+/-35BP, SUERC-16085 (GU-15930)).

Plate 7: Sample of timber from a vertical post
