# **Clitheroe Castle, Clitheroe, Lancashire**

## **Archaeological Building Investigation**

**Oxford Archaeology North**

September 2008

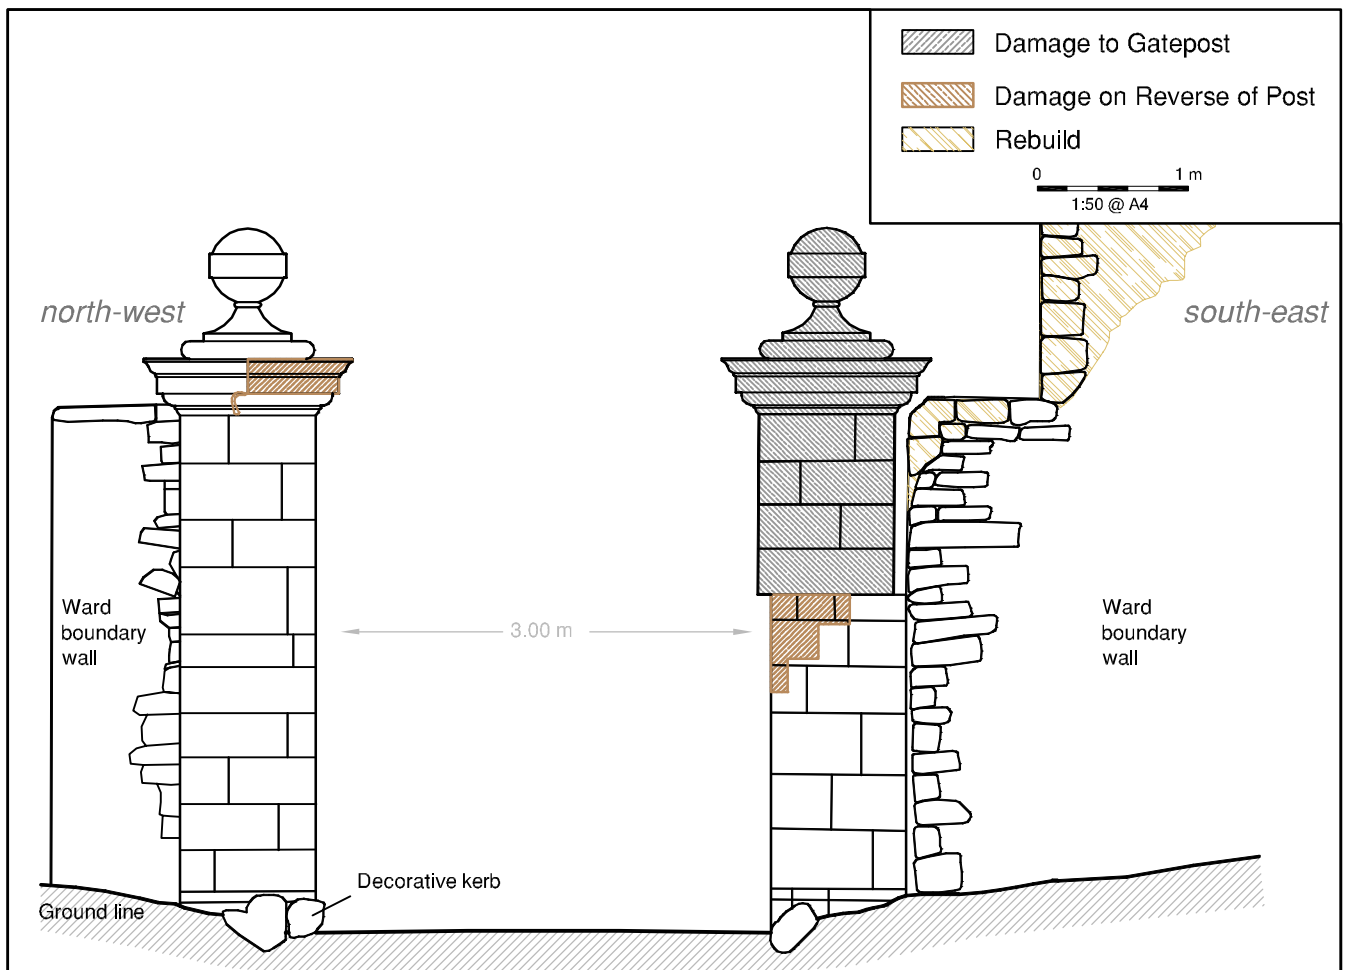
a) Original position of the gatepost showing areas of damage

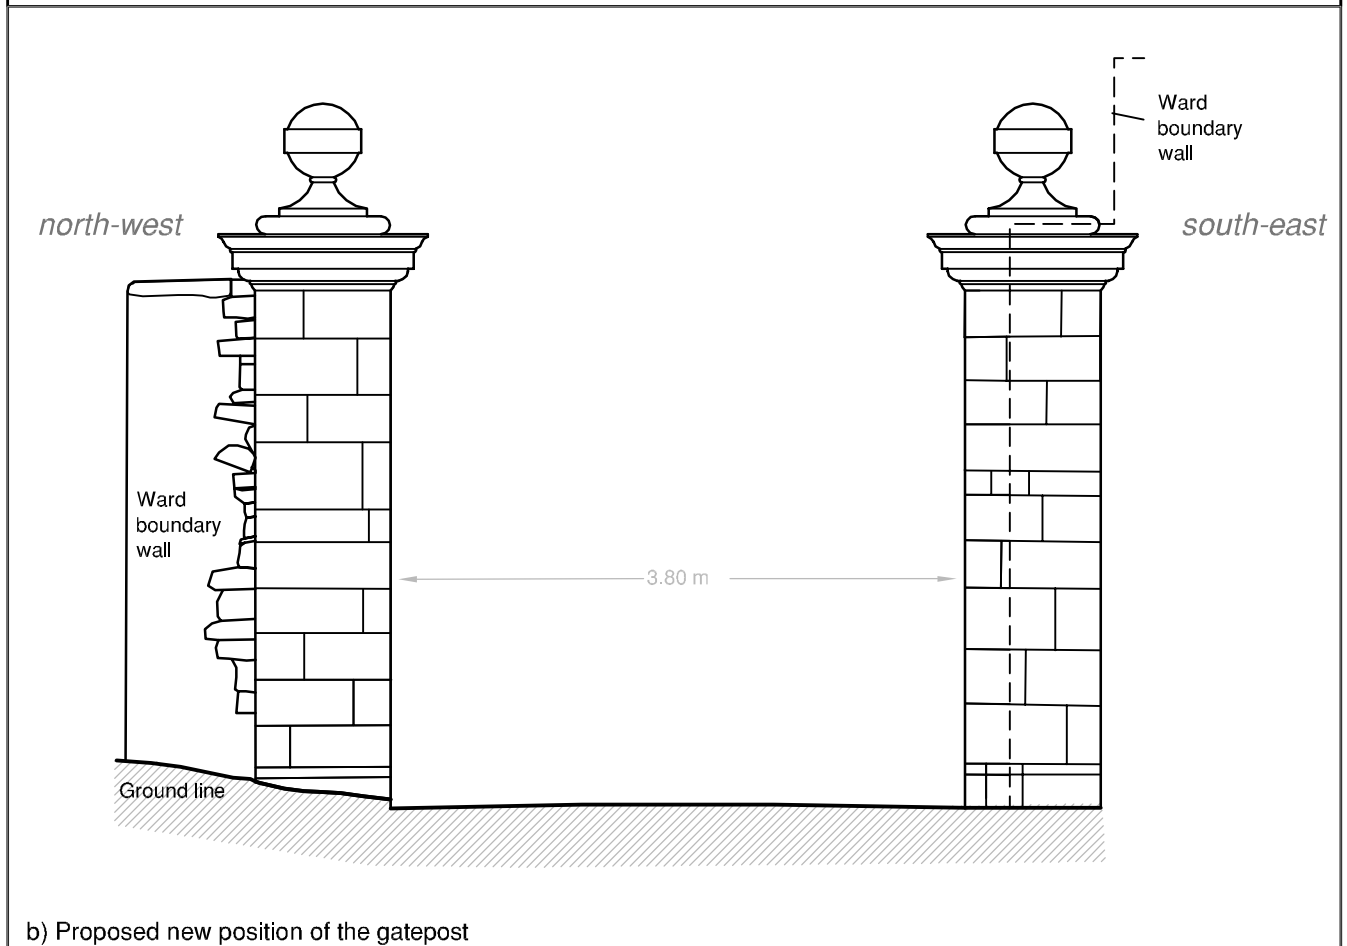
b) Proposed new position of the gatepost

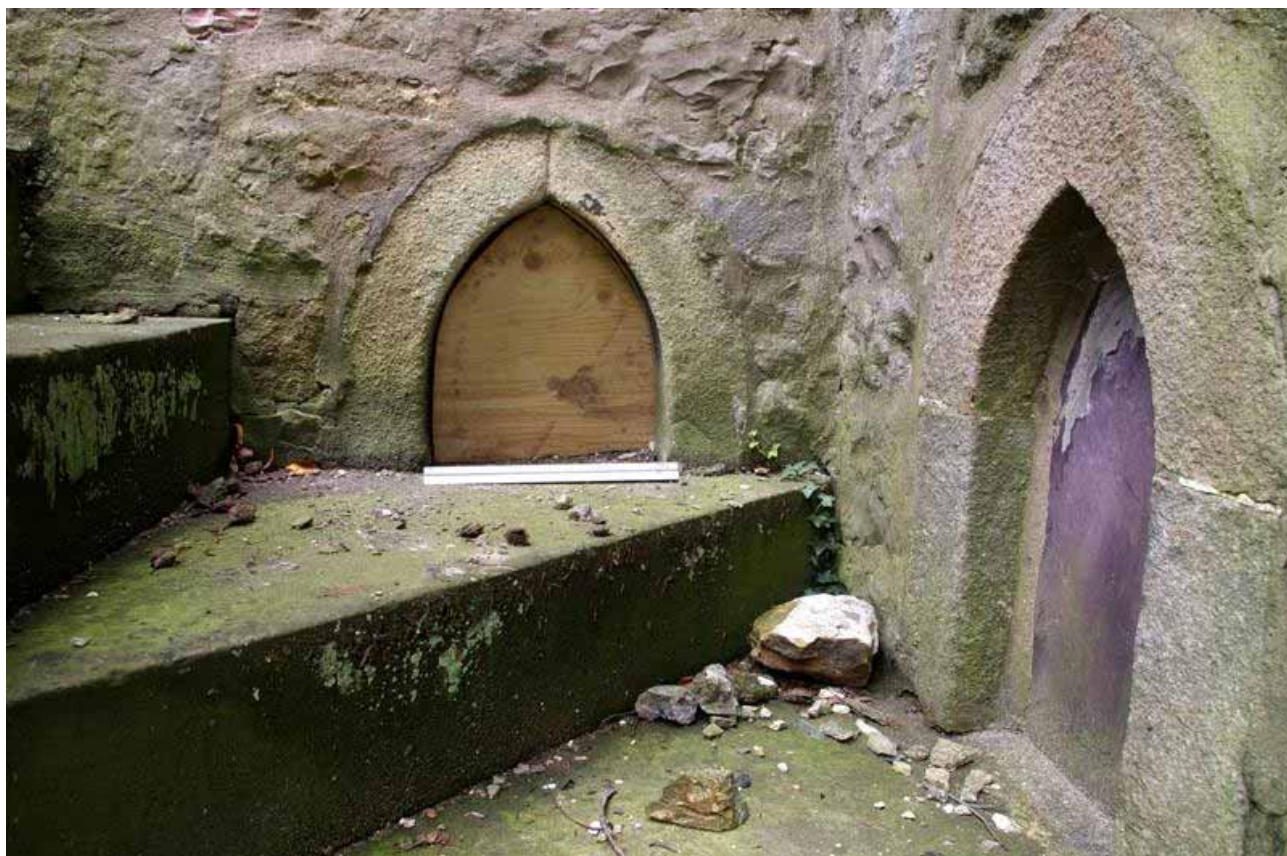
Plate 18: Blocked windows at basement level of the south-east elevation of the Museum

- 4.4.6 The central part of the elevation has six windows across its width and varies between three and four storeys high (including the basement). The south-western part of the elevation is three storeys high; it is part of the rear extension (Plate 15), and it is evident that it has been built against the main building, as quoins are visible within the fabric which show the extent of the original structure (Plate 17). The fenestration is mixed but mainly consists of lancet-arched windows of similar appearance to those already described. Some of the surrounds have been repaired with cement render and one appears to have been recently replaced with new sandstone. A blocked narrow lancet window is partially visible from the steps leading to the balcony (Plate 18; Fig 10).

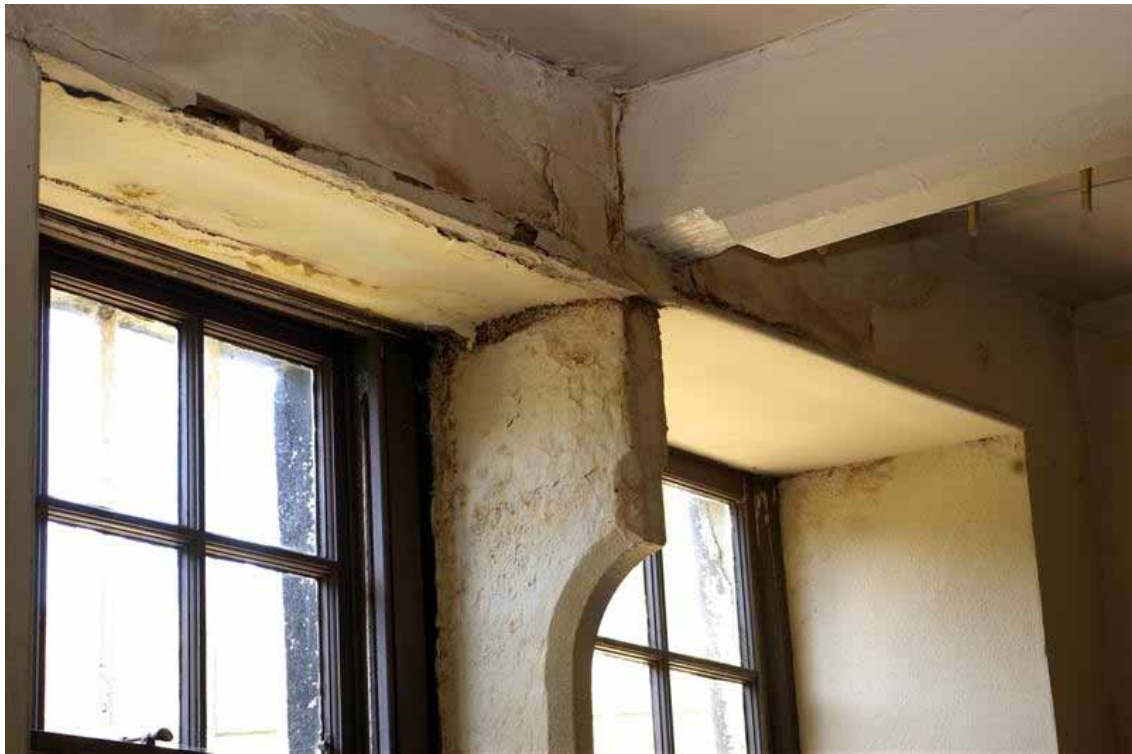
Plate 43: Beam and mullion in **Room E008** illustrating cut-away section

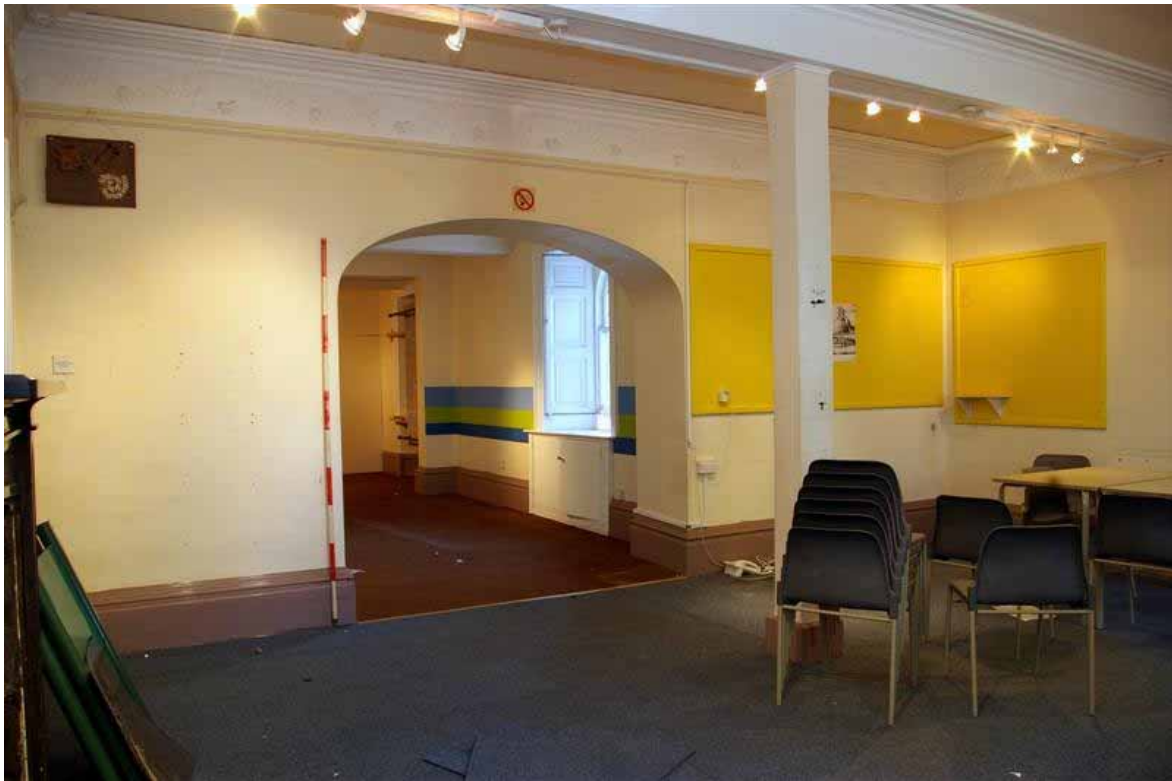
Plate 47: General view of **Room E012** facing south-west

- 4.5.29 **Room E012**: this room was apparently last used as the Museum shop and is one of the most decorative rooms in the building (Plate 47). The most obvious feature is the ceiling which is divided into three by two south-east / north-west beams (Plate 48). Each sunken panel or 'coffer' exhibits a plain run cornice with a decorative fleuron at each corner (Plate 49), which collectively are identical to those observed in **Room E011**. Each beam has a recessed panel running the full length of the soffit and is supported by a single square column which exhibits chamfering with run-out stops, and these appear to be later additions. A decorative plaster frieze surrounds the room which consists of alternate small festoon-like groups of flowers and fruit suspended from scrolls (Plate 50).

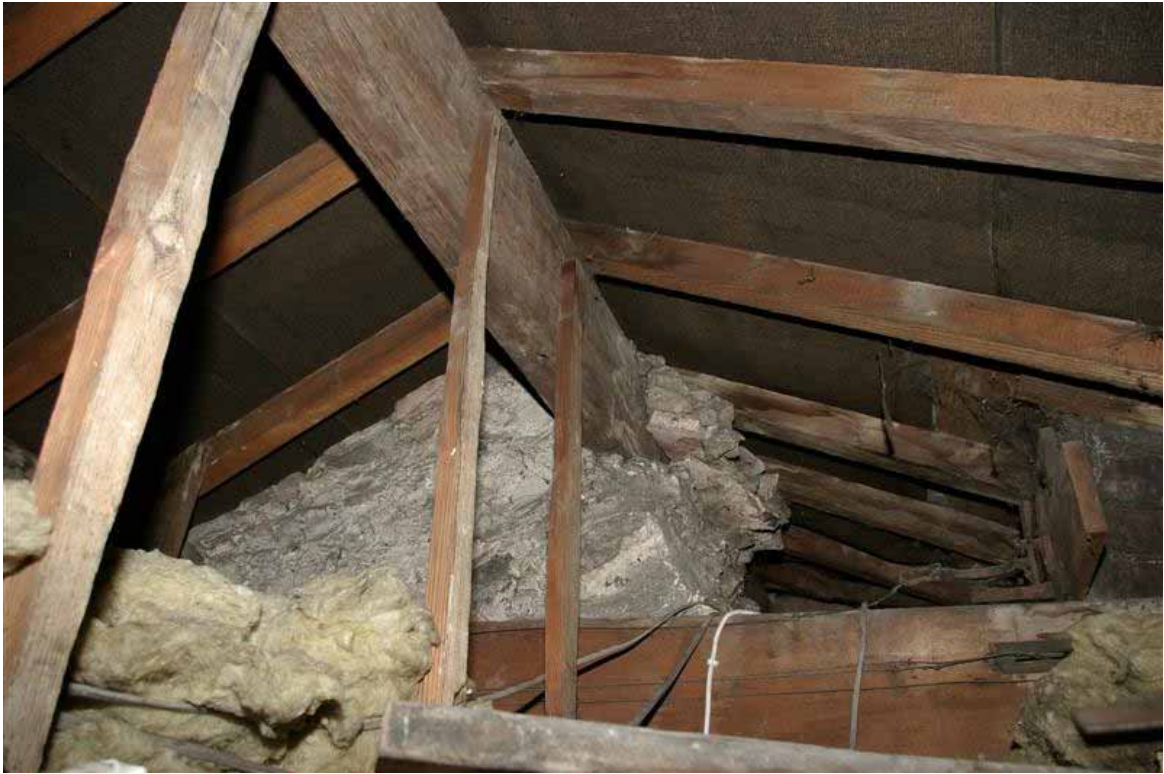
Plate 61: Roof space above **Room U002**

There is a loft hatch which allows limited access to the roof space, which, from limited inspection, appears to have been recently re-covered (Plate 61) and has a breathable textile membrane. All the rafters appear to be recent replacements but the ridge purlin is probably earlier. Part of a communication system of pulleys is visible which consists of wires and levers (Plate 62). Some brick and stone fabric is also visible.

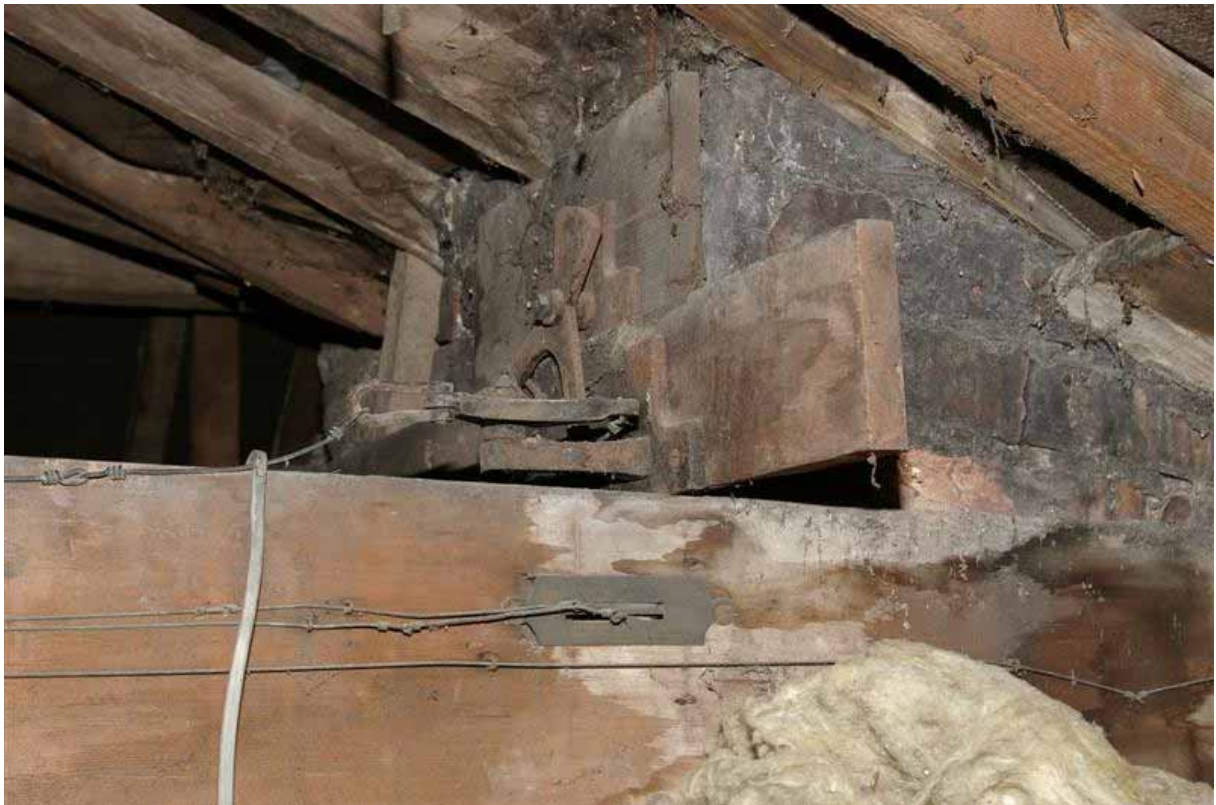
Plate 62: Communication pulleys

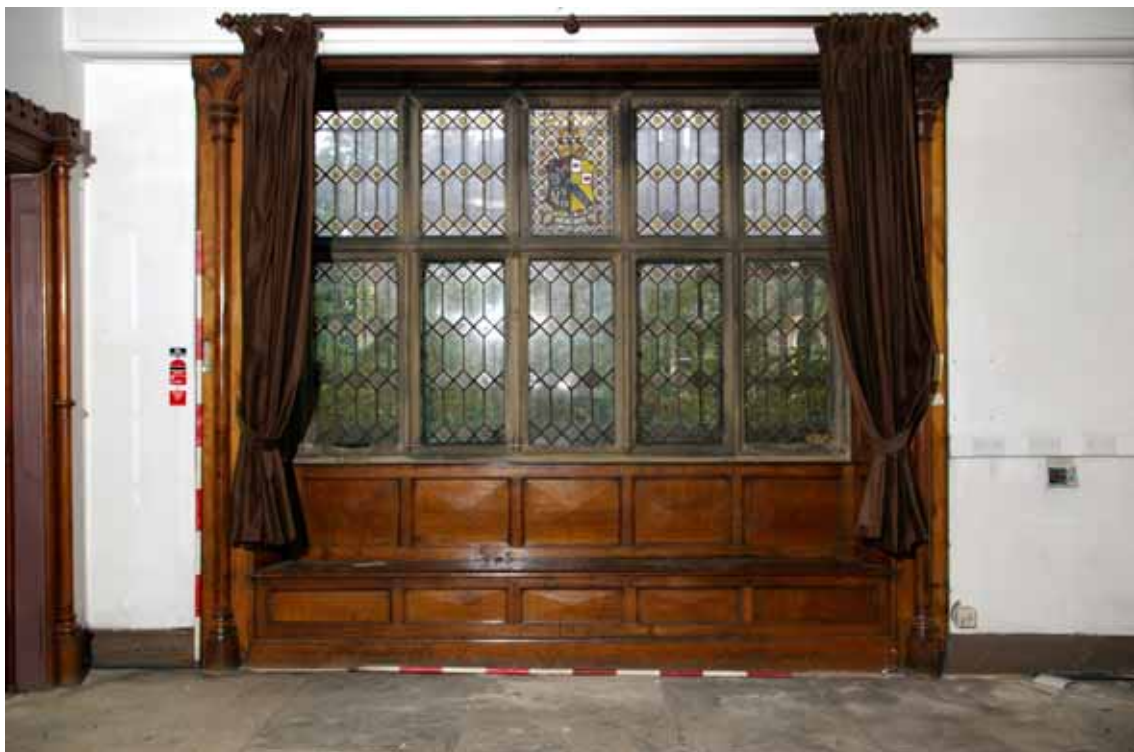
Plate 72: Window in **Room L109** in the Sound Archive

- 4.12.4 The most noticeable feature of this room is the large mullion window located in the east wall (Plate 72), the external characteristics of which have been discussed in *Section 4.10.3*. The mullions are cavetto moulded, while the transoms are ovolo (Plate 73). Each glazing panel has lozenge and diamond-shaped comes containing stained glass of three designs: a rose, a castle with shield and sword; and the initials B Q. A panel with an heraldic device is present in the centre of the window with the letters 'AMO' (Plate 73). The window has a panelled wooden seat and a decorative wooden surround with engaged columns; above the window is a panelled beam.

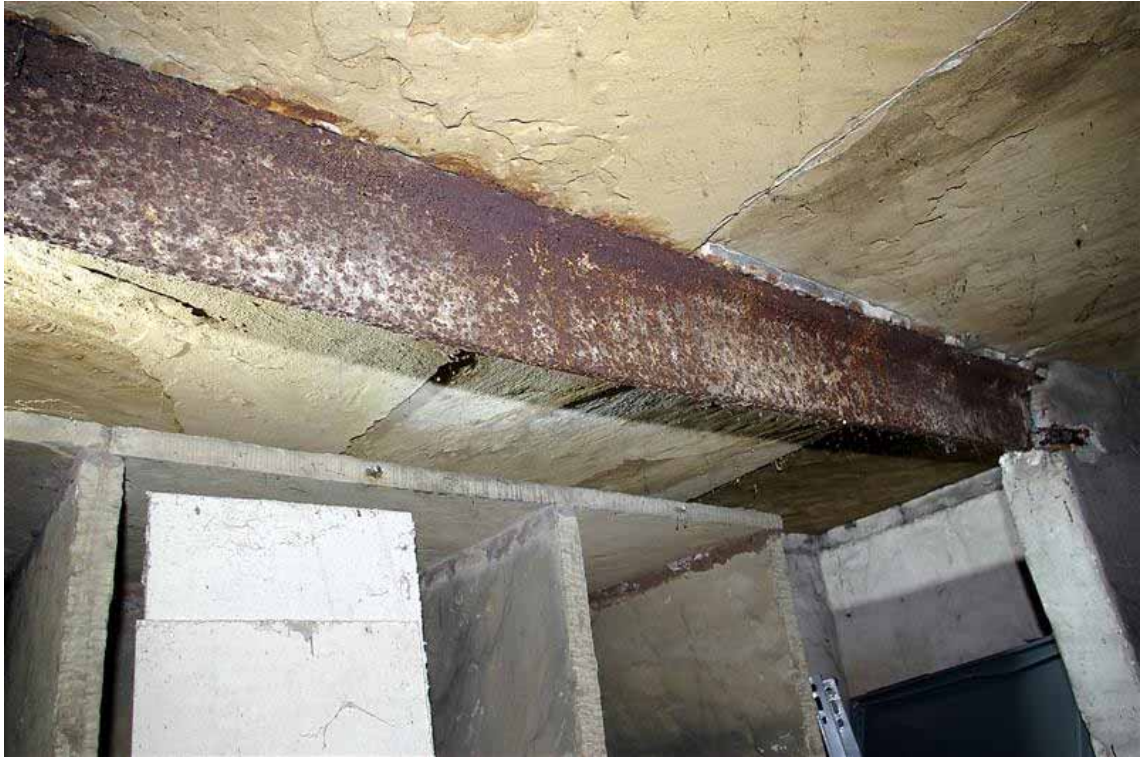
Plate 83: Cast-iron beam in **Room L107** of the Sound Archive

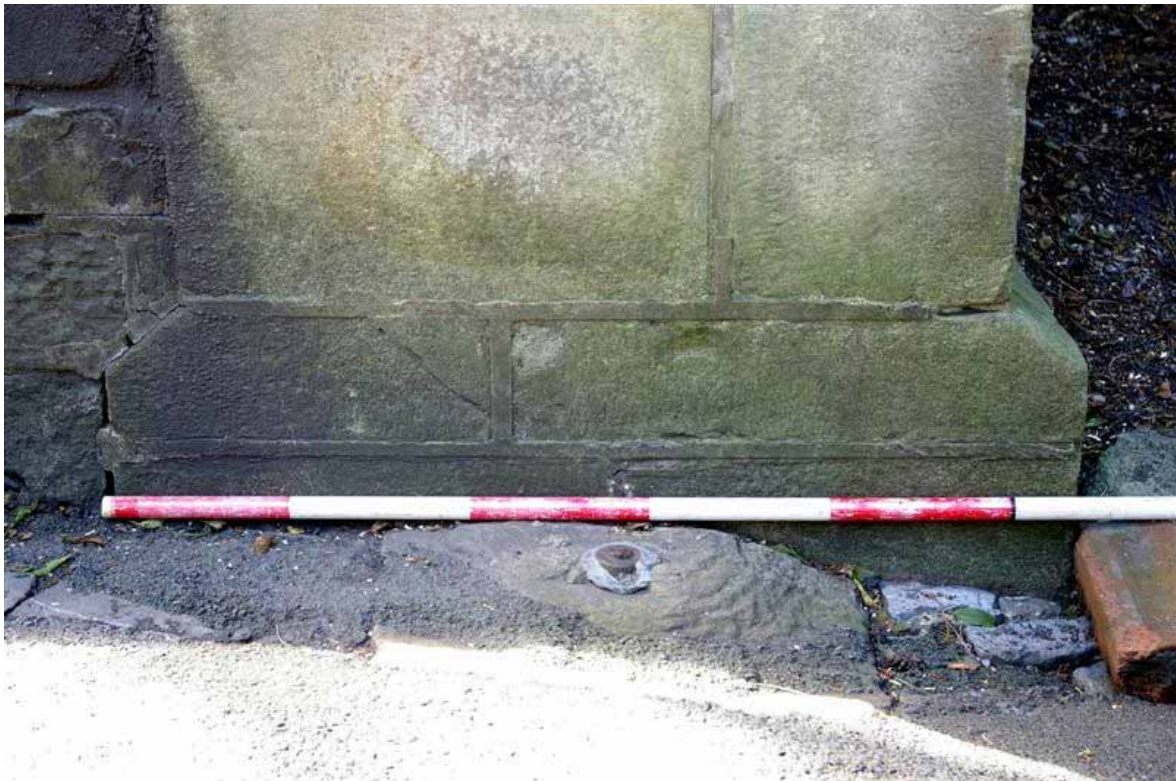
Plate 100: Example of the plinth at the base of the post, together with remnant of the gate hinges

- 4.14.1 There are two square gateposts located at the end of the drive at the north-east corner of the development site (Figs 2 and 15). They are identical and are approximately 4.5m high, and 0.9m thick (square) and 3m apart; the only difference between them is that the western gate has been damaged by a large vehicle (Plate 99). Each is a substantial stone construction of yellow sandstone ashlar, and some of the faces exhibit furrow toolmarks. Most of the courses are approximately 4 inches (100mm) thick, the sixth course (from the base) of each post being six inches (150mm) thick. Both of the posts have been repointed with cement mortar at some time in the past. There are no gates present but the remains of iron hinges in the ground indicate that they formerly supported gates (Plate
