# **Kennedy's Mill, Pollard Street, Ancoats**

**Manchester**

## **Archaeological Investigation**

November 2010

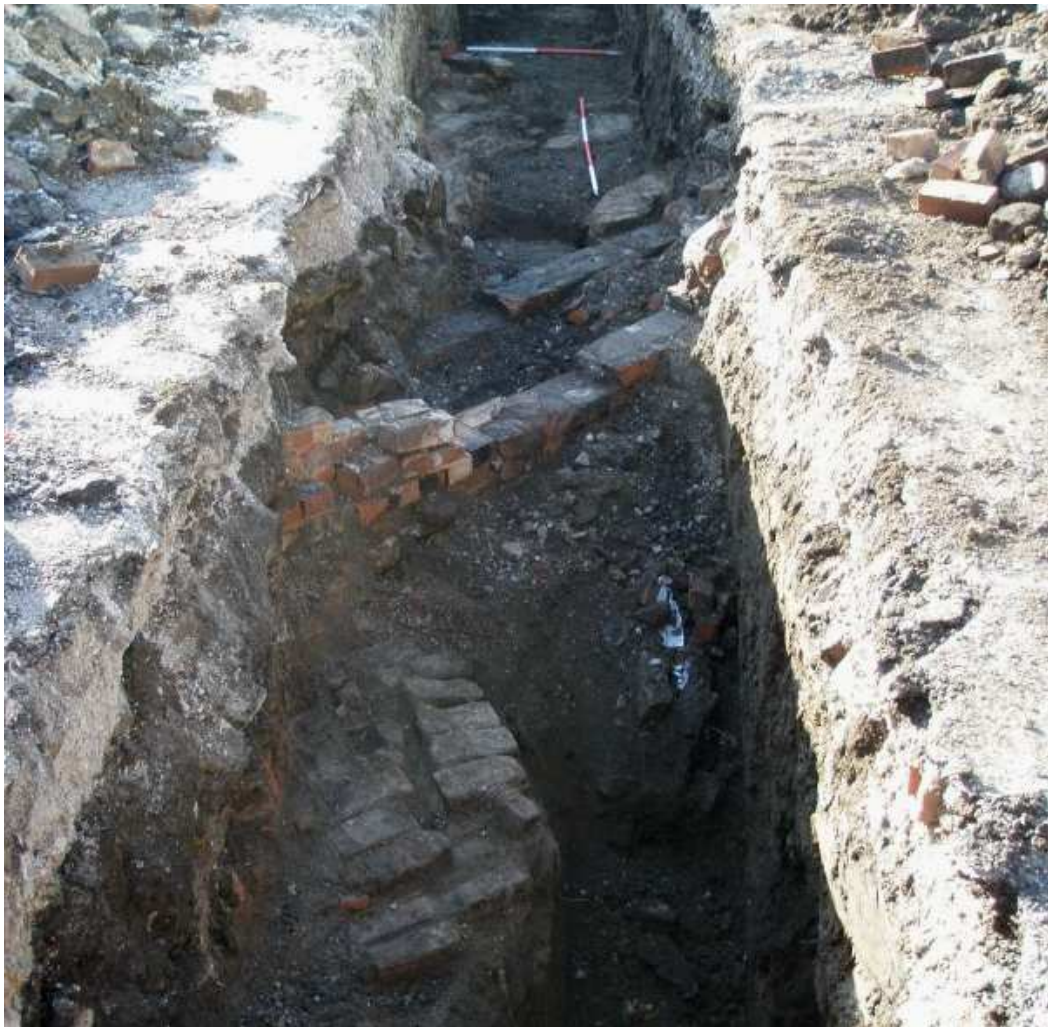
*Plate 7: View of Trench 1, looking south*

- 4.2.1 Trench 1 was aligned north/south across the north-eastern part of the site, and was targeted on the north-western part of the boiler house and the adjacent canal arm. The trench measured 17 x 2m, and was excavated to a maximum depth of 2m within a sondage (Plate 7).

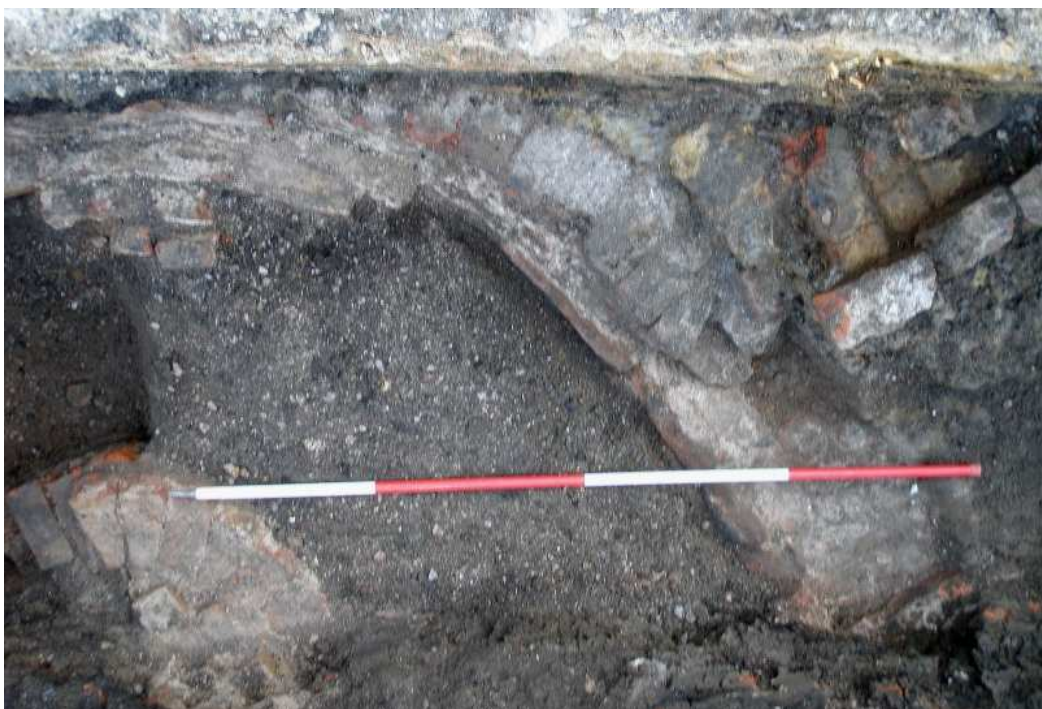
Plate 8: View of the flue 5 in Trench 1, looking east

- 4.2.5 Structure *5* comprised two side walls (*6* and *7*), which survived to a height of four courses, with the remnants of an arched roof (*9*) surviving *in-situ* (Plate 8). The surviving fabric of the arched roof appeared to be keyed into the base of a north-west/south-east-aligned culvert (*8*). This comprised two single-skin brick walls, which survived to a height of two courses, and capped with sandstone.

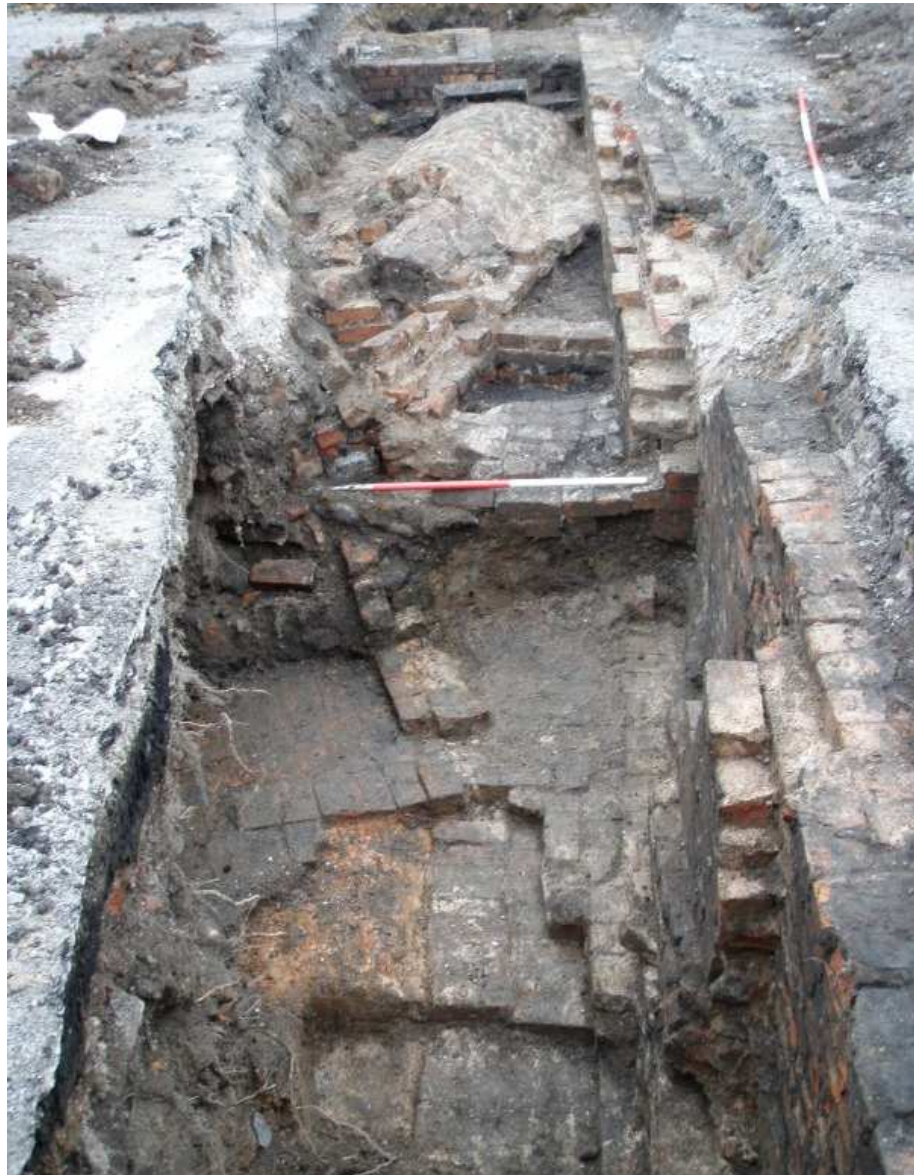
Plate 9: View of Trench 2, looking south-east

- 4.3.1 Trench 2 was aligned north-west/south-east across the north-western part of the site. It measured 12 x 2.3m, and was excavated to a maximum depth of 1.7m (Plate 9). The remains exposed in the trench comprised the eastern external wall (**24/25**) of the mill, and two well-preserved flues (**26** and **27**); these structures were examined further during the detailed excavation work carried out subsequently (Fig 4).

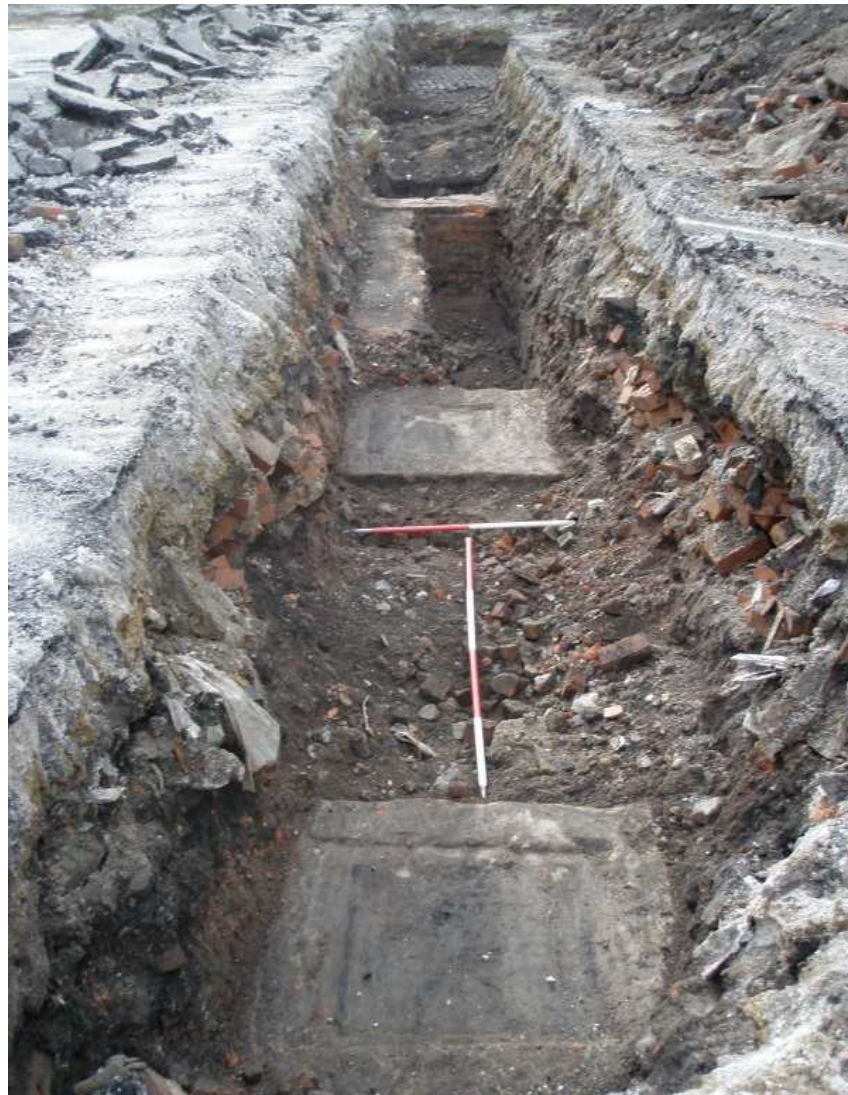
*Plate 10: View of Trench 3, looking west*

- 4.4.2 Historic mapping shows the mill comprised two principal ranges aligned north-west/south-east (Fig 2), which by the late nineteenth century had been incorporated into a larger building (Fig 3). The buried remains exposed in the trench represented the development of the original mill and the subsequent grain store. In particular, substantial foundation structures associated with the eastern range were identified (Fig 7). A surface situated between the two original ranges was represented by a spread of cobbles (*17*) that was exposed in the south-western part of the trench (Fig 8), with another later cobbled surface (*138*; *Section 4.4.6 below*) laid during the use of the site as a grain store.

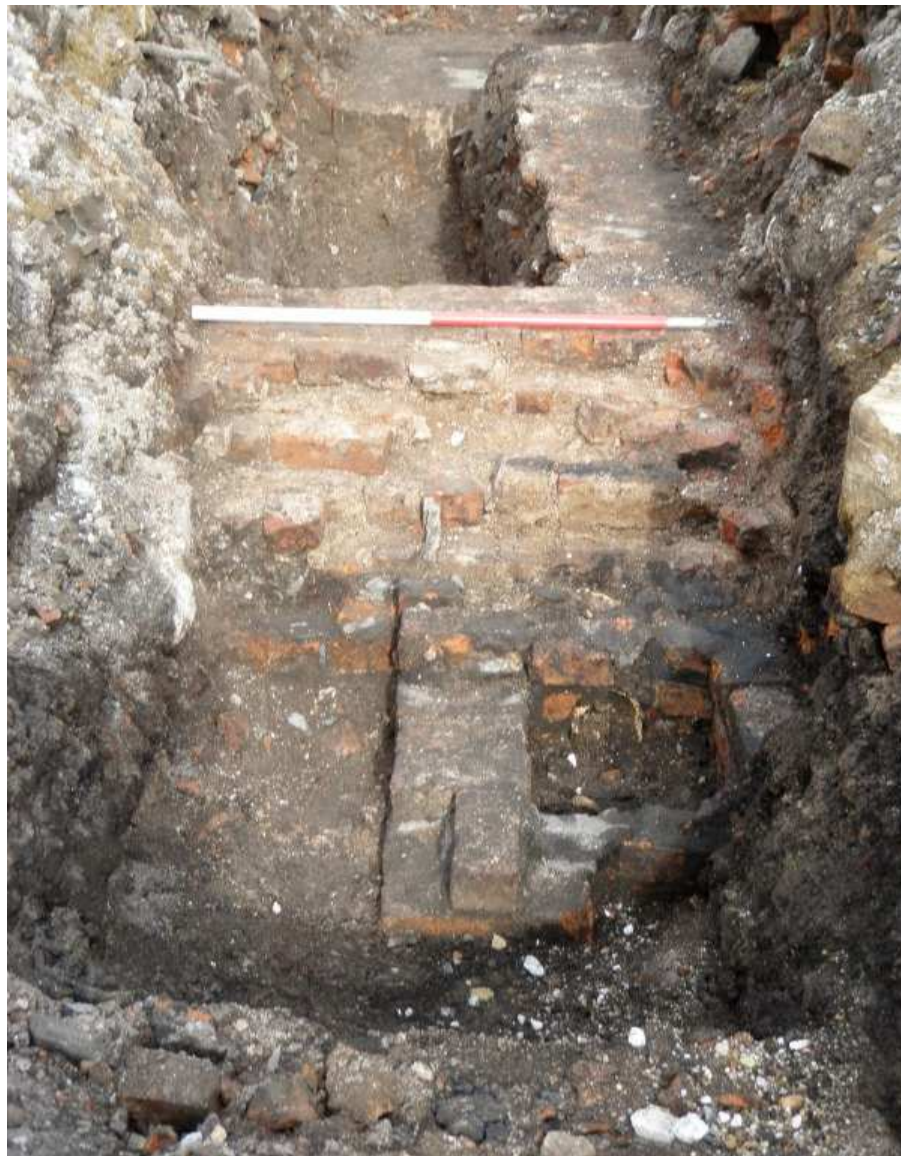
*Plate 11: Remains of drain **I6** and the western wall (**I2**) of the mill*

- 4.4.3 The physical remains of the early nineteenth-century eastern range of the mill complex was provided by a 0.7m wide brick wall (**I2**), which was aligned north-west/south-east across the central part of the trench (Plate 11). The top of the wall was exposed at a depth of 1.1m beneath the modern ground surface, and it survived to a height of ten courses, laid onto the natural clay geology. Other remains of the original mill included a 0.50m wide wall (**I3**), representing an internal partition. Wall **I2** was butted along its western side by a square-shaped brick chamber (**I6**; Plate 11) which is likely to have formed a cavity for an upright drain against the wall.

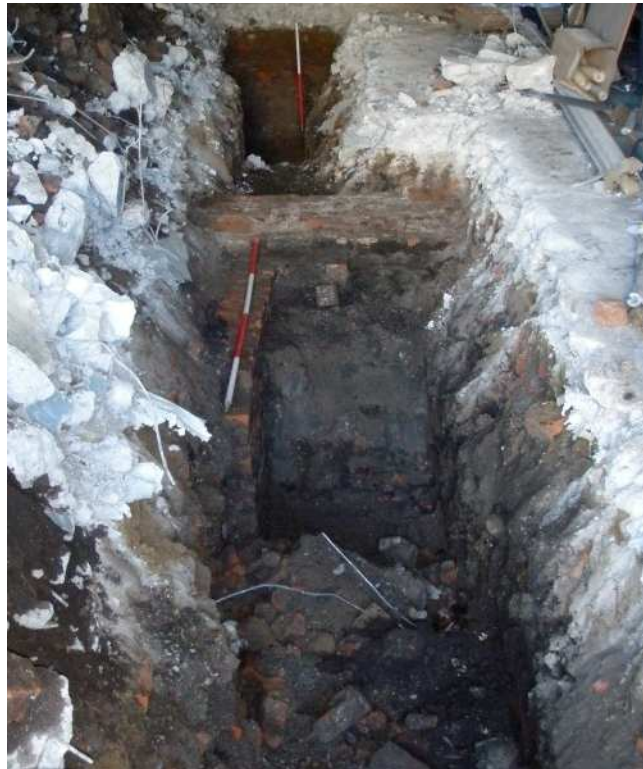
Plate 12: View of Trench 4, looking south-east

- 4.5.1 Trench 4 was aligned north-west/south-east within the eastern bay of the modern building, and was targeted on the footprint of an engine house shown on the Ordnance Survey map of 1849 (Fig 2). It was intended to measure 20m long but because of its limited space its excavated dimensions were limited to 13.3 x 1.45m (Plate 12). It was excavated to a maximum depth of 2m in the northern part of the trench to determine the depth of a natural clay horizon. The modern surface comprised a 60mm thick layer of reinforced concrete, which sealed up to 0.5m thick deposits of hardcore levelling and sand, which in turn overlaid walls that were likely to have been associated with the engine house. These were identified in the central (**20**) and south-eastern (**19**) parts of the trench (Fig 5).

- 4.5.2 Wall **19** was aligned east/west, measured 2m wide, and was exposed to a depth of eight courses. It comprised hand-made bricks, each measuring 230 x 110 x 70mm and set in a lime-based mortar in a random bond.
- 4.5.3 Wall **20** was situated 5.1m to the north-west, and was aligned parallel to wall **19** (Fig 5). Wall **20** was not as wide, measuring only 0.8m across, but similarly comprised hand-made bricks bonded in a lime-based mortar. In addition, the interior, south-east-facing elevation of the wall was lined with a single skin of refractory bricks. Wall **20** was strengthened along its north-west-facing elevation by a buttress (**22**), which measured 1.0 x 0.6m and was exposed to a depth of

- 6.3.3 Excavation of Trench 4 in the eastern part of the study area revealed two walls (**19** and **20**) that almost certainly represented the external walls for the detached engine house, which was perhaps erected in the 1830s. Other structural remains exposed in this trench (buttress **21** and wall **22**), and during the watching brief (surface **142**) carried out subsequently pertained to a later development of the engine house. However, no other physical remains for the steam engine located in this part of the site were identified. Similarly, no structural remains of the foundations for the associated boilers were encountered.

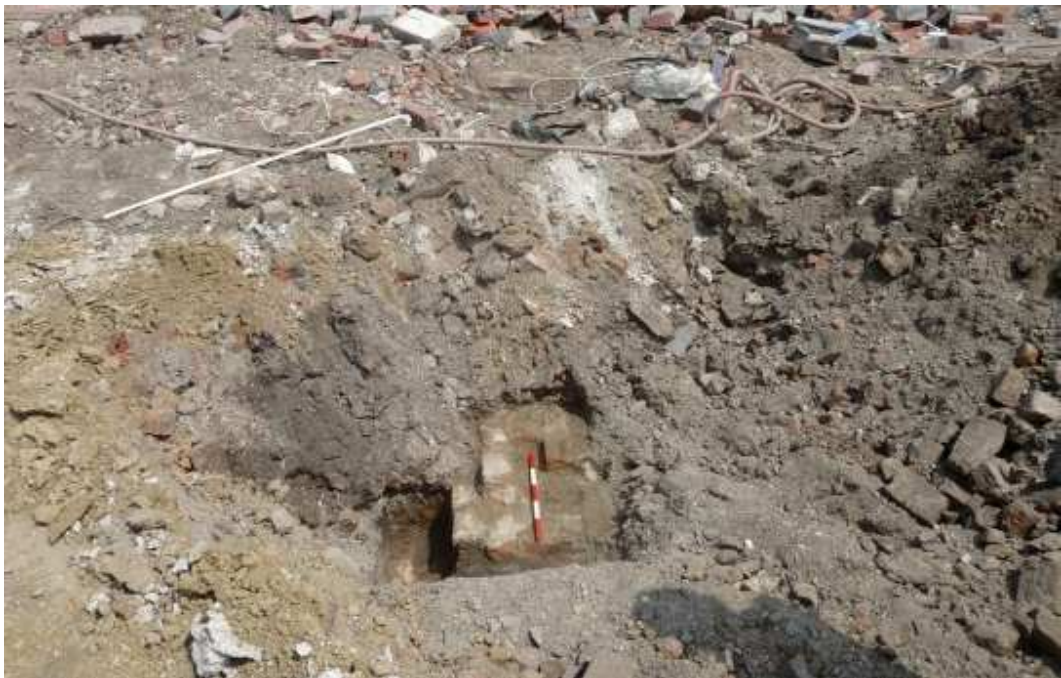
*Plate 13: A continuation of wall **20** during the watching brief*

4.5.5 **Watching brief:** a watching brief was maintained during the removal of the modern concrete floor as part of the demolition works, and a small test pit was excavated manually to establish the presence or absence of further remains of the engine house. Up to 1m thick deposit of hardcore and clay levelling was removed to reveal the remains of a north-east/south-west aligned wall that measured 0.47m wide, and comprised hand-made bricks bonded with a lime-based mortar. The position and alignment of this wall suggested that it was a continuation of wall **20** (Fig 5). The wall was abutted by an evenly laid brick surface (**142**), which was also constructed from hand-made bricks. It is possible that this surface represented a former floor within the engine house.

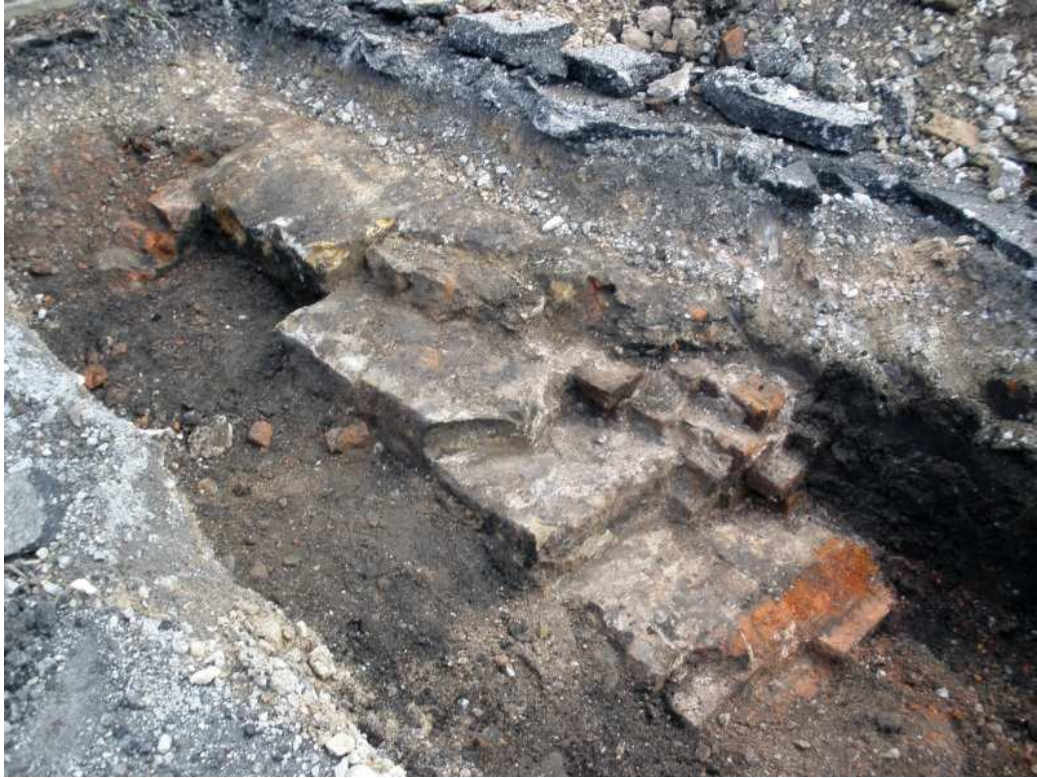
*Plate 14: View of sandstone blocks 48 at the north-eastern end of Trench 7*

was not fully exposed, although at least two strings (0.25m) were revealed and its width seemingly extended beyond the edge of the excavated trench (Fig 6). The position of this wall corresponded with a small projection against the boiler house shown on the Ordnance Survey map of 1849.

- 6.3.4 A single trench (Trench 7) was excavated across the footprint of a second engine and boiler house, which is depicted on the Ordnance Survey map of 1849. A row of large sandstone blocks exposed in this trench are likely to have represented the remains of foundation bases for a steam engine installed in this engine house. In addition, walls **125** and **126** and in Trench 7 probably represented the projection shown on the north-western part of the boiler house on the Ordnance Survey map of 1849. However, this part of the study area will not be subject to any earth-moving works as part of the proposed development, and therefore further archaeological investigation was not merited.

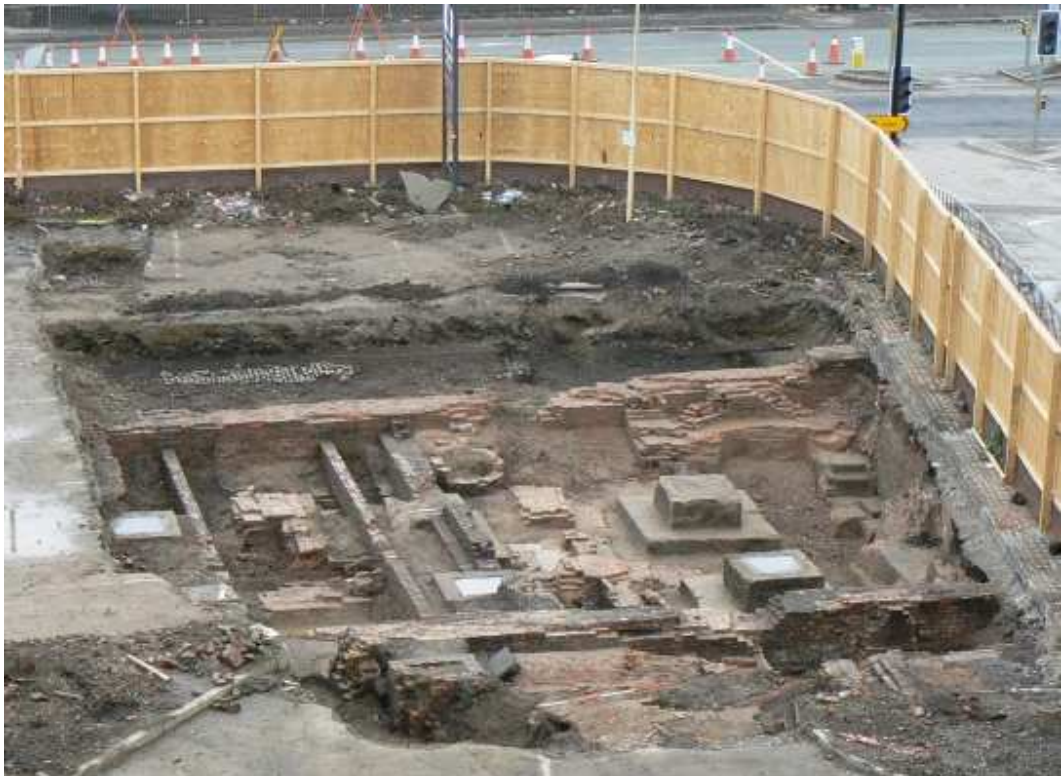
*Plate 15: General view of the excavation area, looking west*

5.1.1 Following the completion of the initial evaluation trenching, and consultation with the Greater Manchester County Archaeologist, it was recommended that the buried remains exposed in Trenches 2 and 3, in the northern part of the site, merited further detailed excavation. The targeted area measured 25 x 16m, and was defined by the footprint of the proposed new building. Excavation of this area exposed structural remains that represented three broad phases in the development of the site:

- *Phase 1, 1804-1870s*: this represent the period of the initial development of the cotton mill by James Kennedy & Co, and its occupation subsequently by John Blair;
- *Phase 2, 1870s-1920s*: the conversion of the cotton mill to a grain store under ownership Midland Railway by 1876, the engine house at the southern end of the mill was demolished by 1888, as shown on the Ordnance Survey map produced in 1893.
- *Phase 3, post-1920s*: the final phase of the site's development, involving its transition from a grain store to a warehouse.

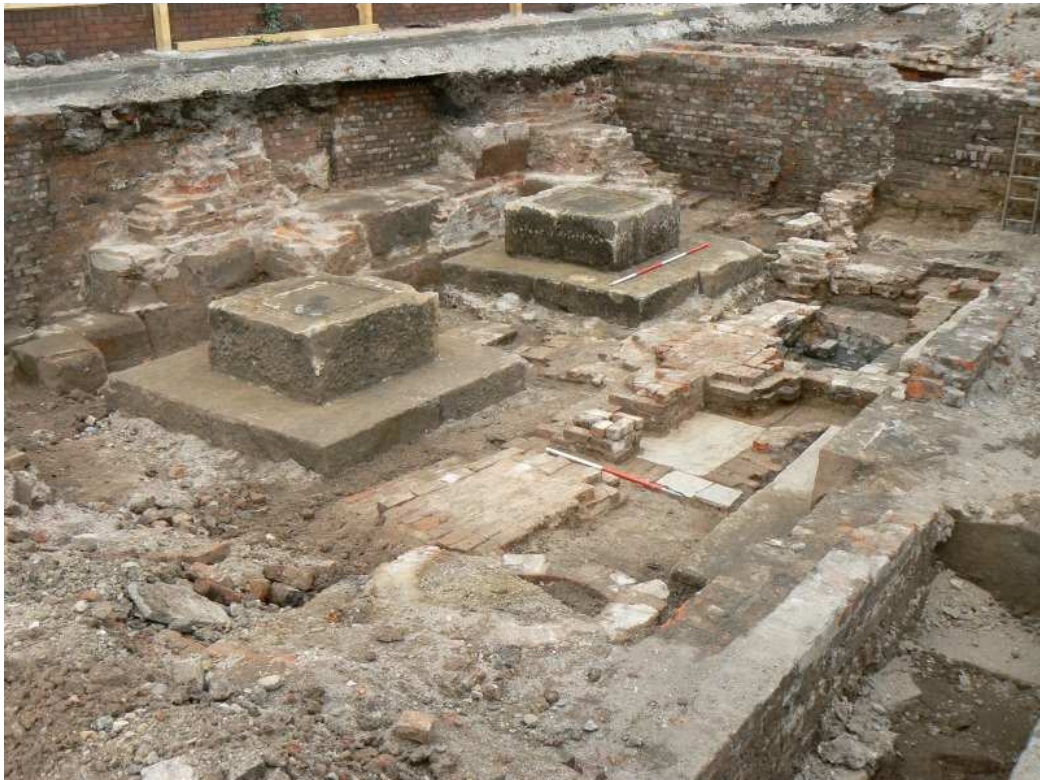
Plate 16: View of the remains in the north-western part of the mill

5.2.2 **External walls:** three contiguous walls (**24/25**, **109** and **139**) pertaining to the north-eastern range of the cotton mill were exposed. Each wall was constructed primarily from partially-reduced hand-made bricks, although some sections of walling incorporated machine-pressed Accrington-type bricks, representing late nineteenth- or early twentieth-century repairs or modification. The original fabric was bonded with lime-based mortar, with the later bricks being set in a dark grey ash-rich mortar (Plate 16).

5.2.3 An 11m long section of the eastern wall of this range (**24/25**) was exposed in Trench 2 (*Section 4.3.2 above*), where it survived to a height of 21 courses (1.85m) above a brick surface (**102**) along its western face. The northern wall (**109**) of the range was partially exposed at the limit of excavation, with its upper surface lying at a depth of less than 0.10m below the modern ground surface (Plate 16). The south-east-facing elevation of wall **109** was exposed for a length of 13m, and was recorded to a depth of 1.87m. It was keyed into wall **24/25**, and the south-western wall (**139**) of the mill. Wall **139** was exposed for a distance of 14m, measured 1.14m wide, and was exposed to a depth of 10 courses (0.85m). The wall was strengthened by a buttress (**144**) measuring 1.1m long by 0.35m

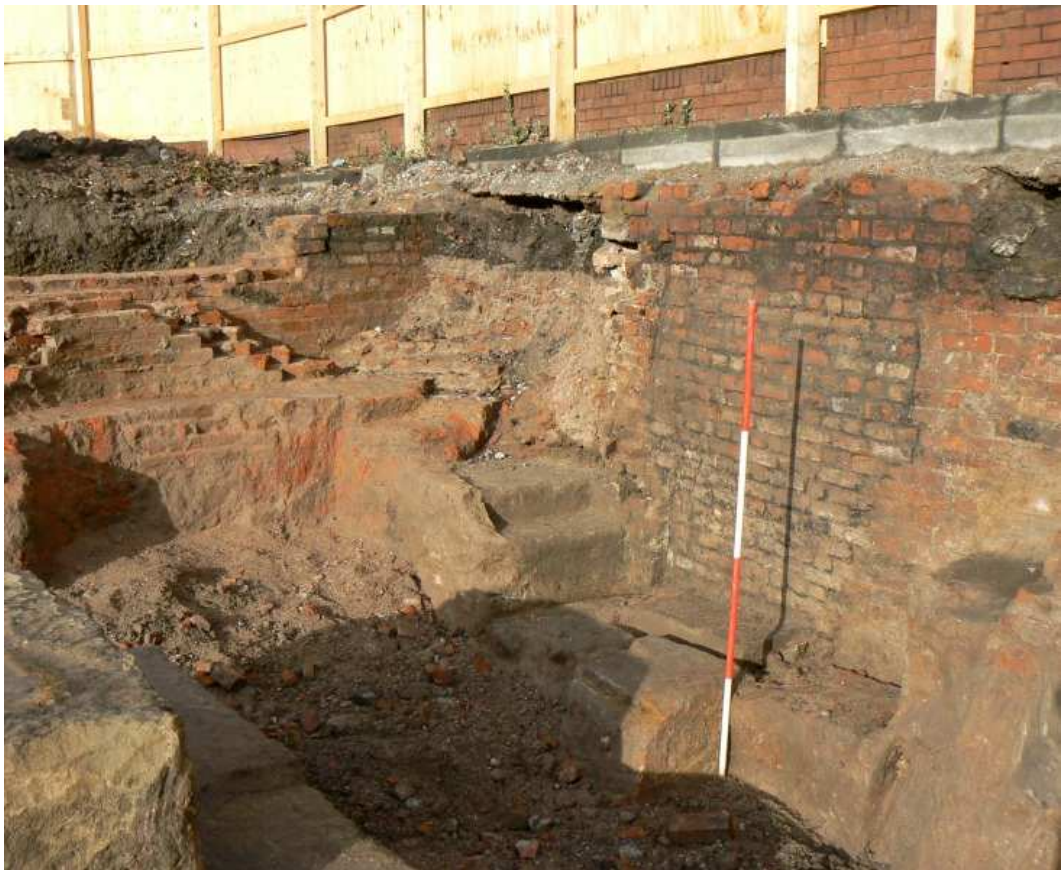
Plate 17: View of the stair foundation (**119**) constructed against the mills south-western (**139**) and northern (**109**) walls, looking north-west

- 5.2.4 **Stair tower foundation:** access into the cotton mill was afforded via the south-western part of wall **109**, adjacent to wall **139**, where the foundations of a stair tower (**119**) were exposed (Fig 7). The remains of the stair tower comprised a semi-circular structure measuring 3.6m across, constructed entirely of brick, and surviving to a height of ten courses (0.65m) above a broad brick base (**121**) that had a depth of 0.66m (Plate 17). The stairs were partially constructed on a row of sandstone blocks (**106**) which butted the southern face of wall **109**, contiguous with another row of steps (**107**) that provided access to the basement. The steps were retained on their north-western side by a curving brick wall, which extended from the northern side of **119**, and continued beyond the limit of the excavated area.

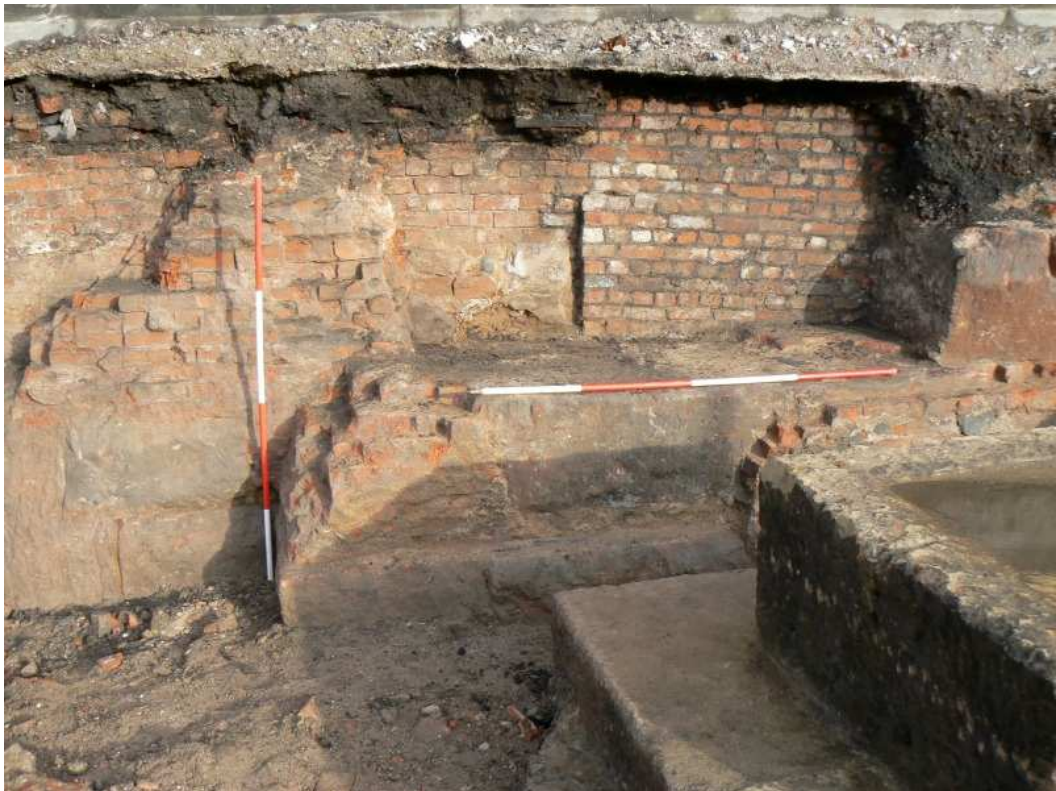
Plate 18: View of part of a possible engine foundation against wall **109**, looking north

- 5.2.5 **Machine foundation:** a row of sandstone blocks (**101**, **104** and **105**), extending for a total distance of 7m, was located at the northern end of the building, abutting wall **109** (Fig 7). These blocks may have collectively provided a foundation for a large item of machinery, perhaps an engine, within the northern part of the mill (Plate 18); numerous friction scars incised into wall **109** provided further indication for machinery having been housed in this area, although none of the stone blocks incorporated iron machine ties.

- 5.2.6 The earliest block (**101**) measured 0.8m long and 0.54m wide, and retained chisel marks on its southern and western asides. Block **101** was overlaid by a split-level brick foundation (**103**), measuring 1.8m wide and 1.45m deep, which had been burnt along its southern face. The longest element of the sandstone foundation (**105**) measured 5.5m long and 1.93m high, and comprised two courses of ashlar, each measuring 1.1m and 0.63m deep; a thin layer of slates was noted between the two courses of stone. Block **104** formed the north-eastern extent of the row. Its southern face retained a 0.20 x long by 0.04m wide groove, which may have represented the position of an axle.

- 6.3.1 The documentary evidence suggests that a steam engine was installed in the mill during the 1820s, with additional models ordered in the 1830s and 1840s. Substantial remains abutting the northern wall (**109**) of the mill are likely to have represented the foundation base for large machinery. These remains included an arrangement of stone ashlar (**101**, **104**, **105** and **106**) and split-level brick foundations (**102**, **103**, and **108**) forming an L-shape in the north-eastern corner of the mill. The configuration of these structural remains was consistent with the foundation bed for a steam engine. It was commonplace for early nineteenth-century cotton mills to have a steam engine situated within the main spinning block, and usually at one end of the building (Williams with Farnie 1992), and the excavated remains in James Kennedy's Mill are consistent with this configuration.

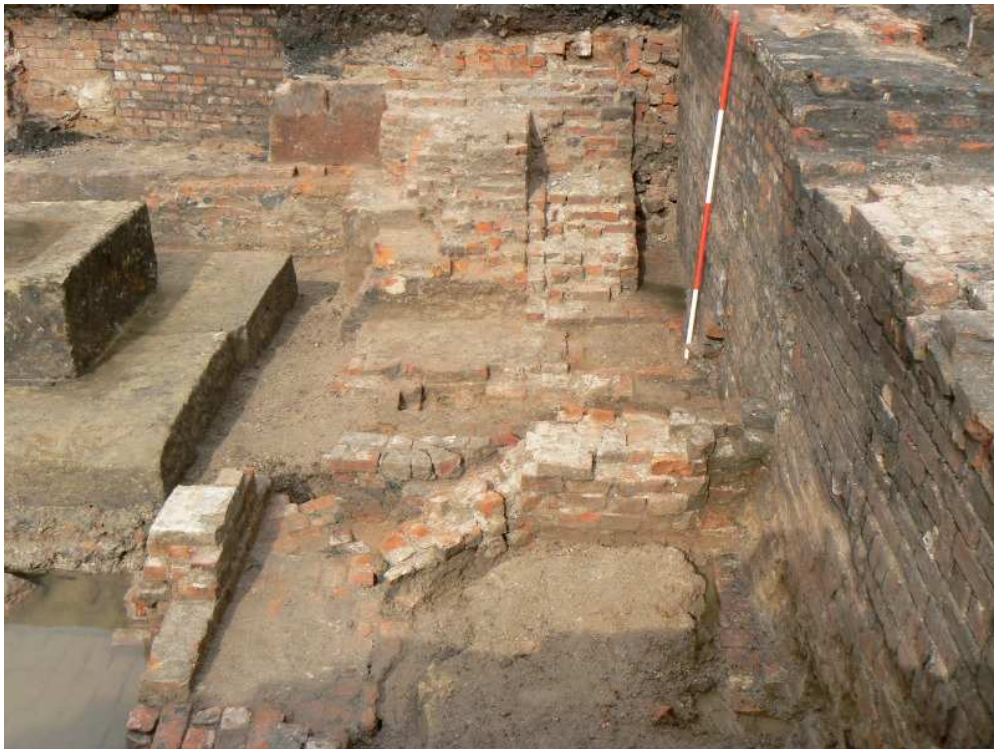
Plate 19: Foundation 103 against wall 109, and remains to the south-west of wall 24/25

- 5.2.8 Further evidence of a floor was represented by a cruciform-shaped surface (**84**) observed across the central part of the site (Plate 19). The entire surface had been truncated by two rows of sandstone blocks, representing a later phase of the building. The surviving part measured 4.4 x 4.3m, and comprised a combination of brick (**83**) and sandstone, and incorporated a concave-shaped pit

measuring 1.2 x 0.9m and 0.45m deep, which may have housed a small flywheel. A narrow-diameter metal pipe protruded above the pit floor, which perhaps suggests that it may have housed a gas engine. This was bounded by a small rectangular-shaped sunken chamber (87), measuring 2 x 1.1m, and bordered by split-level walls on its northern and eastern sides (89 and 97). The eastern wall of the chamber (97) was abutted by another brick surface, representing the base of a former channel that extended north/south. This had been blocked by a short east/west-aligned wall (99), which abutted the eastern side of wall 97. A possible continuation of the surface (92) was observed along the northern side of wall 99, although it was slightly higher than floor surface 91. Surface 92 was aligned broadly north/south toward the southern part of surface 108. These chambers and floor surface collectively represented small flues and channels which may have been associated with a boiler situated to the north of the building.

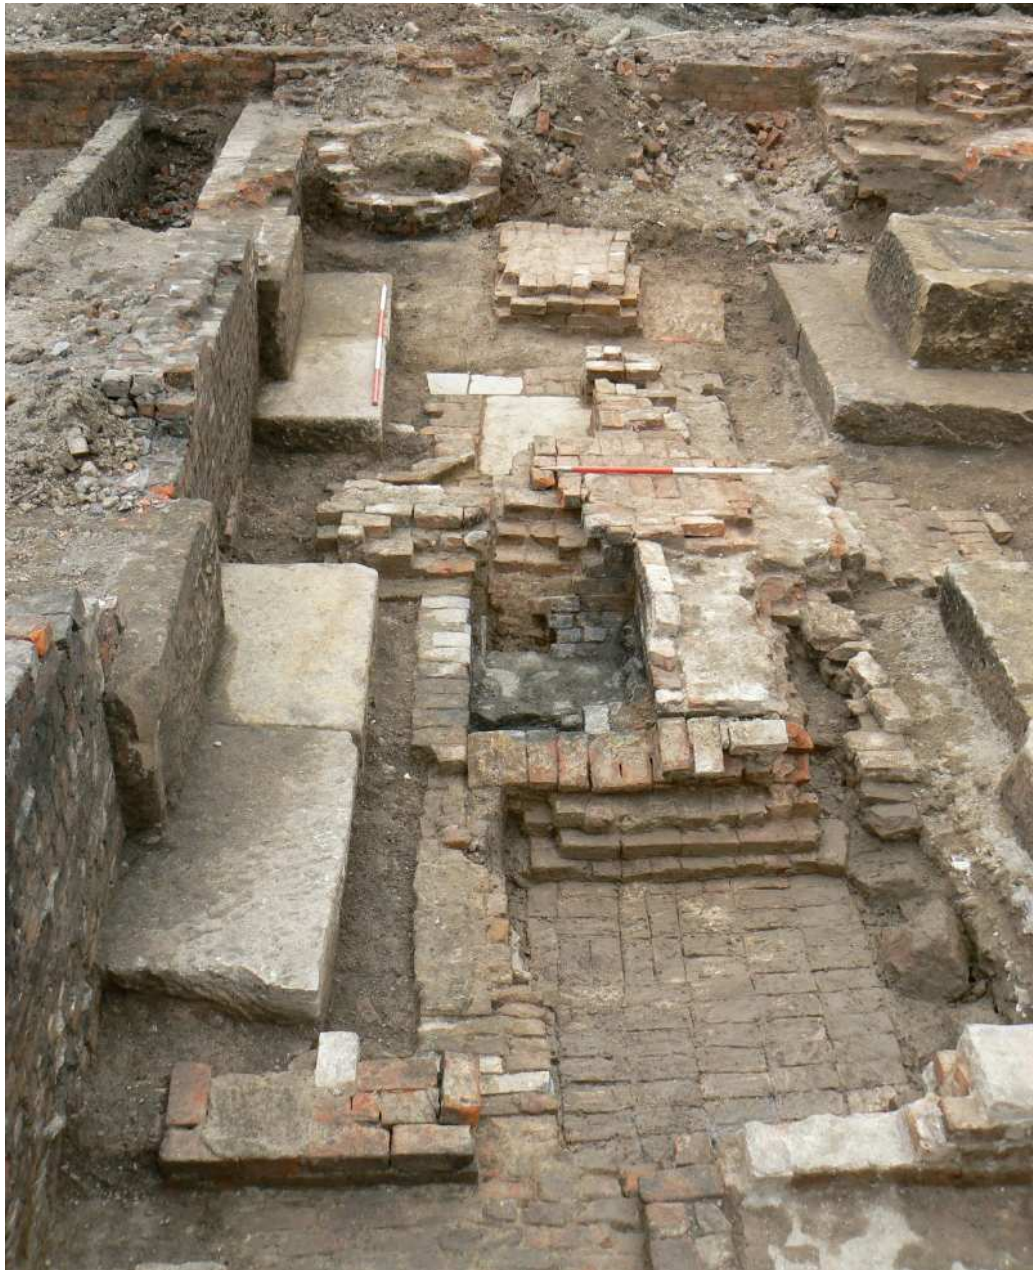
*Plate 20: View of the remains within the central part of the excavation looking south-west*

- 5.2.9 **Water management:** a well (81) was located close to the eastern side of wall 139 (Plate 20). It measured 1.4m in diameter, with an internal diameter of 0.9m. It was constructed from hand-made bricks bonded with lime-based mortar, and was exposed to a depth of five courses, although a full depth of the structure was not ascertained. The well was abutted along its south-western side by the stub of a north-west/south-east-aligned retaining wall (82), which measured 1.2m long.

- 5.2.10 A north-west/south-east-aligned brick and stone culvert (56) formed by two-course high brick walls (60 and 62) and sealed with a stone capping (61), was observed passing beneath walls 45 and 46 in the direction of the well. Further elements of a water-management system included a drain that passed beneath an arch (72) within wall 46. The drain passed along the external side of a brick foundation (74).

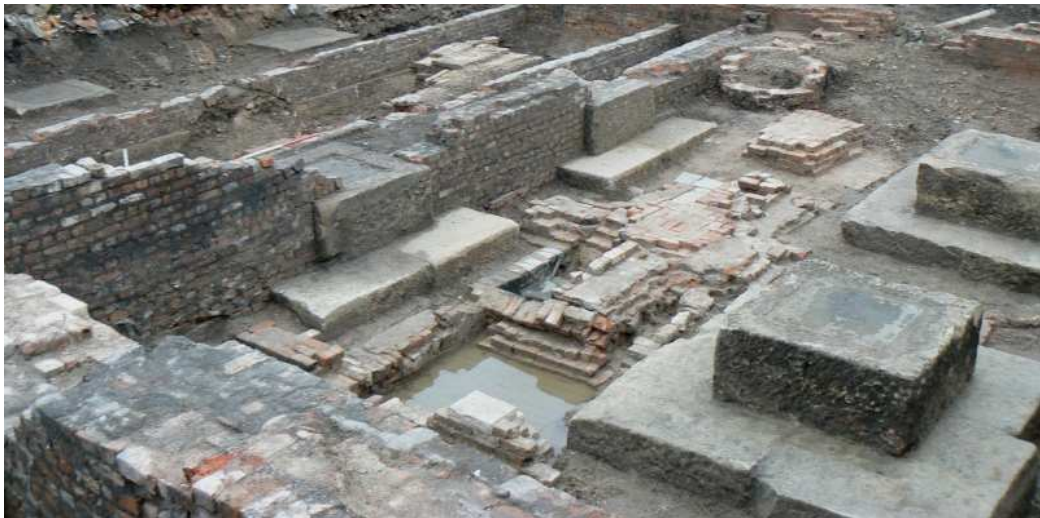
*Plate 21: The large sandstone blocks aligned through the building, looking south*

- 5.3.1 The excavated remains ascribed to this phase included two rows of sandstone blocks (**15, 80, 53, 54, 85, 86**), and railway tracks (**130-134, 135** and **137**).
- 5.3.2 Two rows of six stone blocks (**15, 80, 53, 54, 85, 86**; Plate 21), aligned north-west/south-east, were exposed in the central part of the excavated area. The blocks were set at regular intervals of 4m. Each comprised a single, square ashlar block measuring 1m<sup>2</sup> and 1m deep, with a recessed shallow niche across the upper surface (Plate 21). Each ashlar block was laid above a wider stone foundation, comprising an arrangement of four blocks forming a surface area measuring 3m<sup>2</sup>. All of the foundations were contained within concrete-filled construction trenches, indicating that their construction dated to the late nineteenth or early twentieth century.

- 6.4.1 This period represents the continued expansion and remodelling of the mill building for use as a grain store owned by Midland Railway in the 1870s. Evidence of this transition is represented by the row of six large stone block foundations (**15**, **80**, **53**, **54**, **85**, and **86**) which partially truncated the internal foundations of the original mill. Further evidence of the site's use by the railway company was provided by the sections of railway tracks (**130-134**, **135** and **137**) located along the western side of wall **139**.

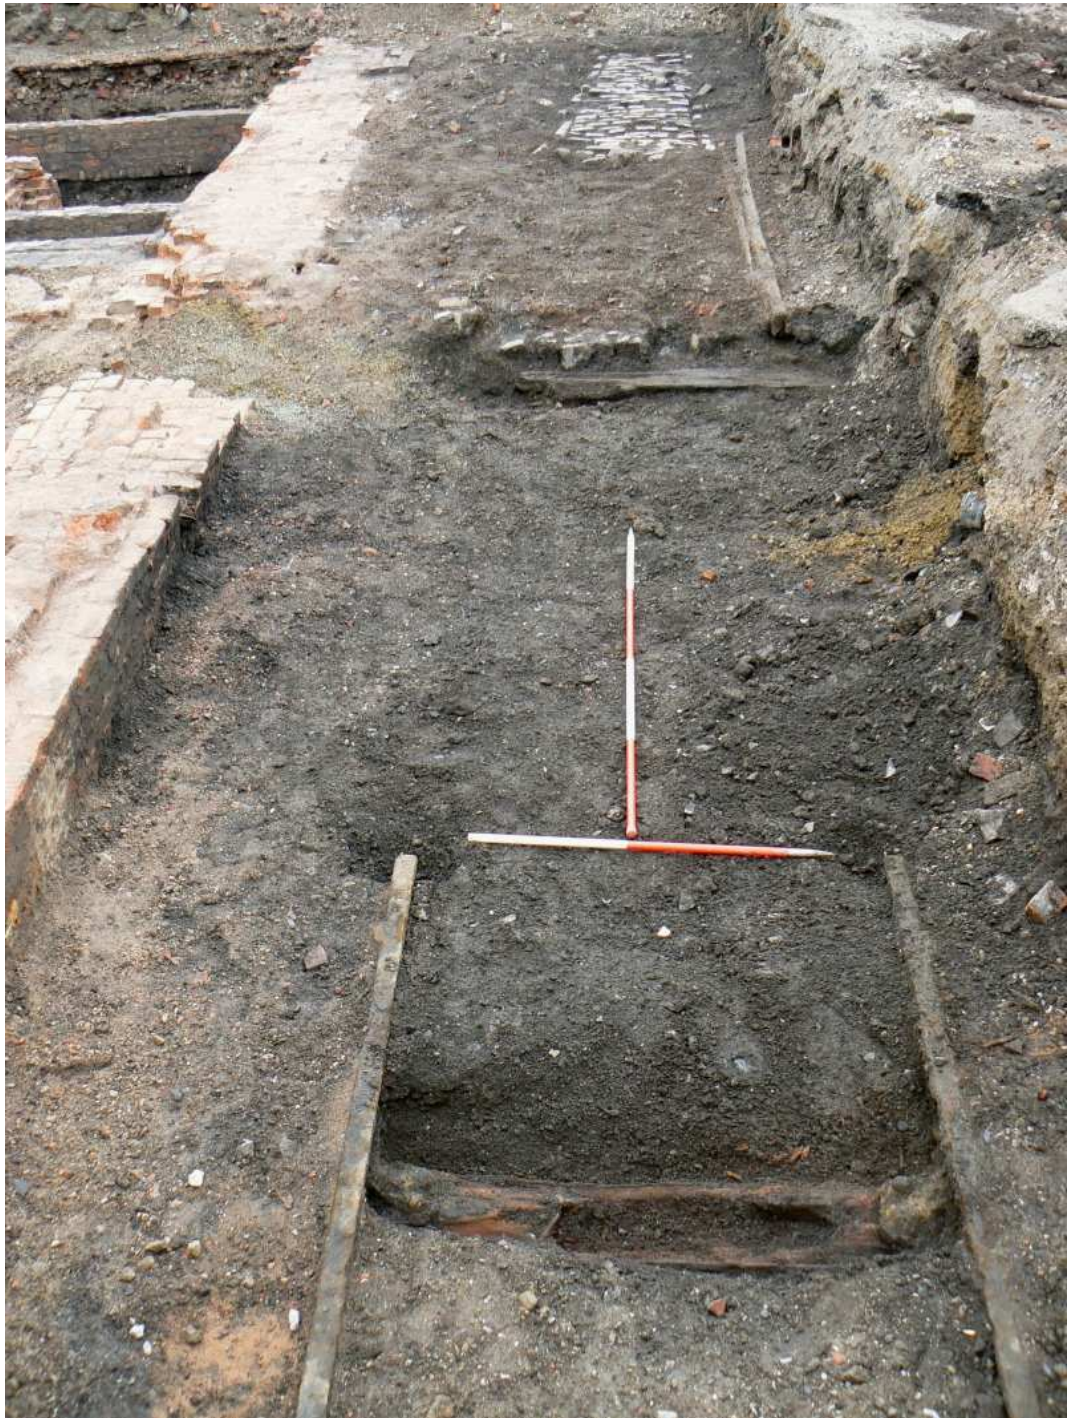
*Plate 22: View of the railway track along the western side of wall 139, looking south-east*

- 5.3.3 The remains of short sections of railway lines (**130-134, 135** and **137**; Plate 22), aligned north-west/south-east and set into compact black ash ballast (**50**), were exposed along the western edge of the excavated area. The longest section (**130** and **131**) measured 2.6m long with a line gauge of 1.8m. Part of a sleeper (**132**) survived beneath the rails housed within a cradle (**133**). Remains of another sleeper (**135**) and rails (**137**) were located 4m to the south-east, although these had been disturbed by a modern drain (**51**). These lines are shown clearly on the Ordnance Survey map of 1893.

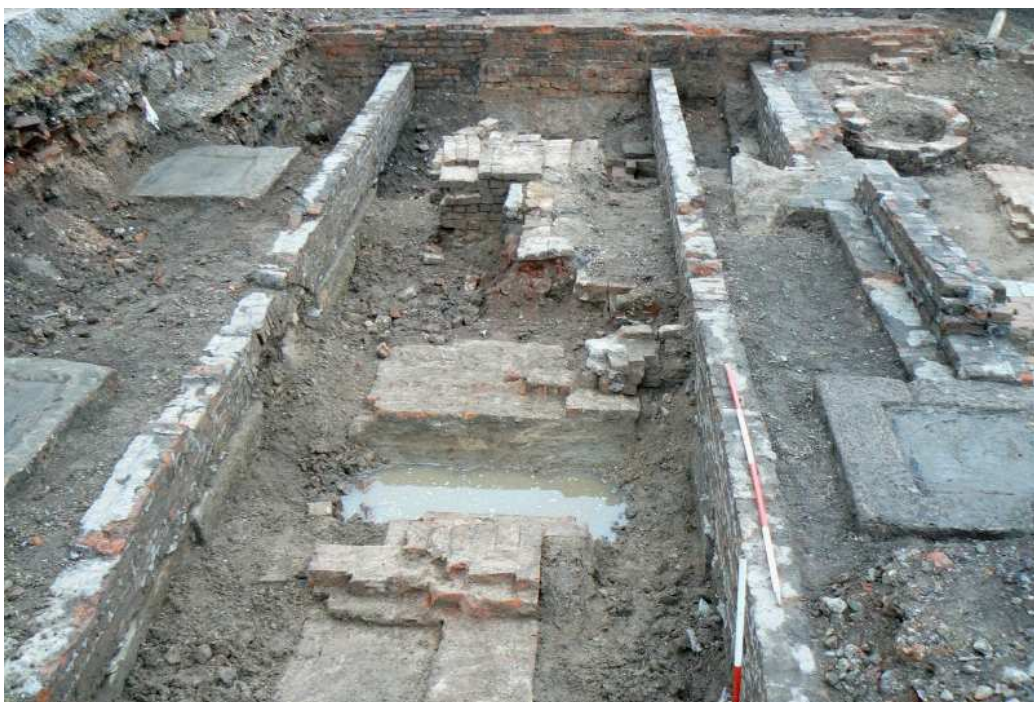
Plate 23: View of internal walls **45**, **46** and **47**, looking south-west

- 5.4.4 Wall **47** was also identical in fabric to walls **45** and **46**, and was exposed to a depth of five courses at the south-western end, where it was laid above rubble, cinder and ash, with parts of the wall built over blocks **15** and **80** (Fig 7). The upper surviving courses of walls **46** and **47** were abutted by a concrete floor (**57**), which was 50mm thick and was exposed over an area of 5 x 2m. The surface was overlaid by a partition wall (**59**) composed of machine-pressed bricks, which measured 2m long and 0.52m high, and which abutted the eastern face of wall **24/25**. It is possible that walls **46** and **47** provided a foundation for floorboards, and that wall **45** formed the north boundary of the room.

- 6.5.1 Several indicators of internal modifications to the building during the twentieth century were identified, including three partition walls (**45**, **46** and **47**) constructed from re-used hand-made and machine-pressed bricks, which were located within the southern part of the excavation site. These butted the sandstone block foundations and extended across the width of the former spinning block, forming two narrow rooms. These were overlaid by a concrete surface **14** (Trench 3) and **57**, representing a working floor. Floor **57** was in turn partitioned with a brick partition wall (**59**) composed of machine-pressed bricks.
