# **Kennedy's Mill, Pollard Street, Ancoats**

**Manchester**

## **Archaeological Investigation**

November 2010

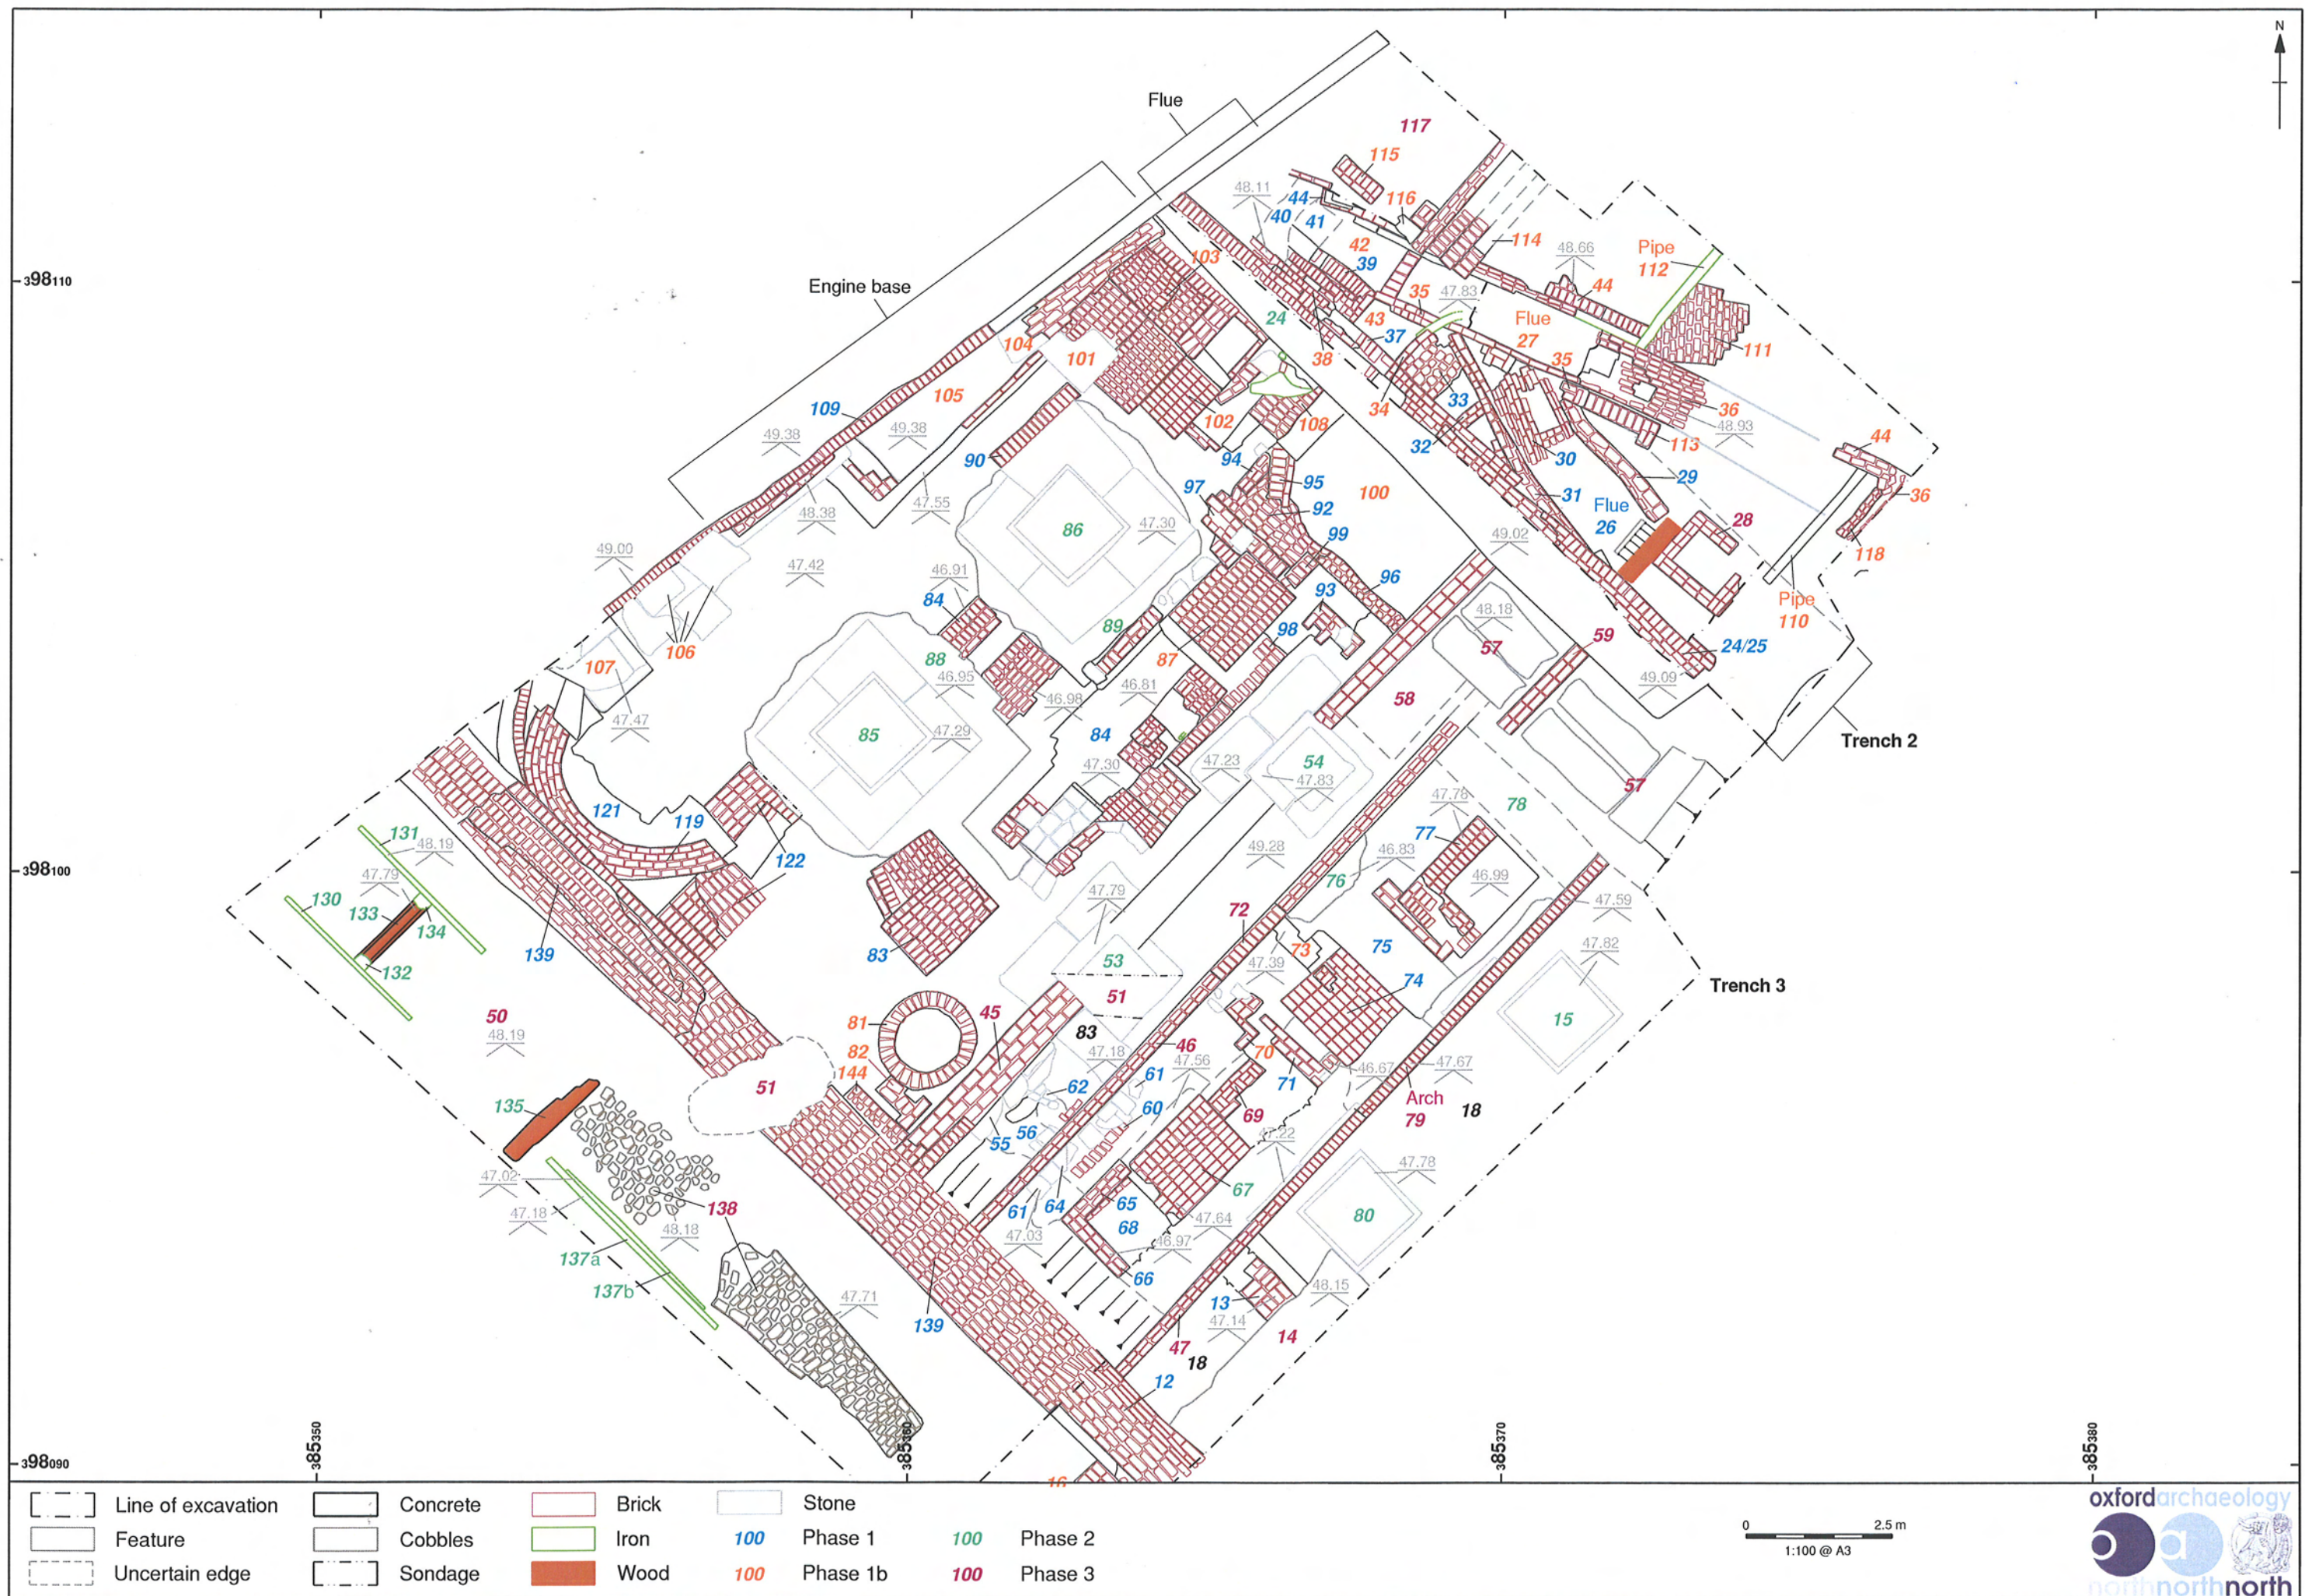
Figure 7: Phased plan of the excavation site (east) and Trench 2

- 4.3.2 A substantial, north-west/south-east-aligned wall (**24**) was exposed along the southern edge of the trench (Fig 7). Wall **24** was five bricks wide, and survived to a height of 12 courses. The position of the wall corresponded closely with the north-eastern external wall of the early nineteenth-century mill, as shown on historical mapping (Fig 2). The south-eastern end of the exposed wall was of a slightly different build, although seemingly of a broadly contemporary date. This section (**25**) also formed the south-western side of flue **26** (Fig 7). The fabric of all elements of the wall comprised hand-made bricks bonded with a mixture of lime and ash-rich mortar, suggesting some re-pointing, perhaps carried out during the late nineteenth century.
