QUARRY WAREHOUSE, DALLAM TOWER ESTATE, SANDSIDE,

CUMBRIA

Archaeological Building Investigation

Oxford Archaeology North

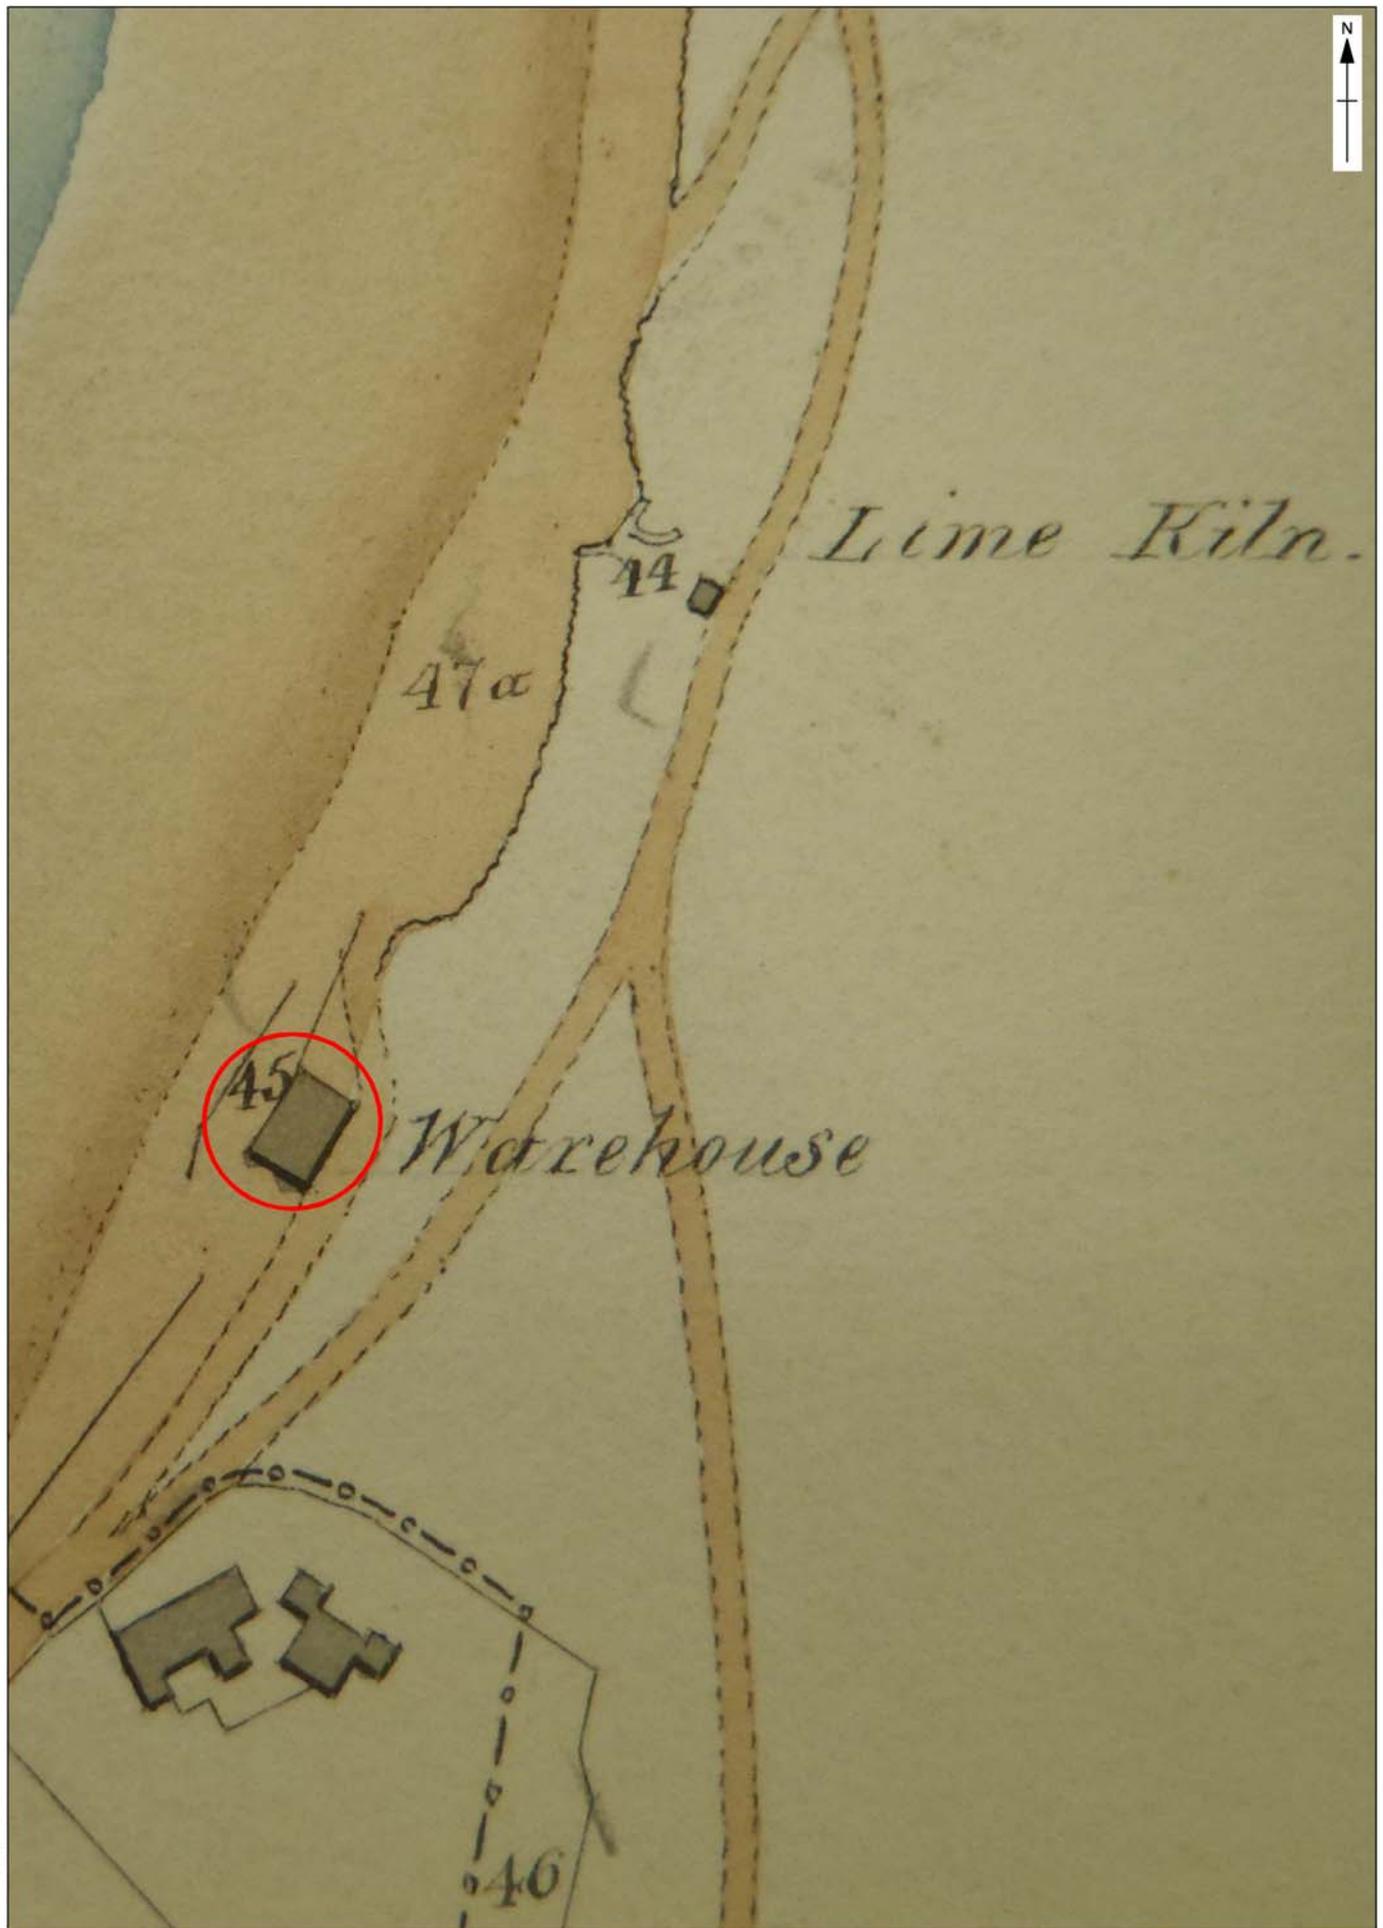
Figure 2: Extract from the Haverbrake Tithe Map, 1839

3.3.1 *Haverbrack Tithe Map 1839*: the tithe map is the earliest available cartographic evidence illustrating the warehouse (Fig 2), and it is shown as a rectangular building marked as warehouse, just adjacent to the shoreline of the River Kent, with the high tide line also marked. The tithe apportionment states that the building is a warehouse and wharf owned by George Wilson Esq, of Dallam Tower. John Jackson and others, who also occupied three local cottages, the limekiln and associated shed, and part of a nearby orchard, occupy it. Together with the evidence from the 1836 lease (*Section 3.2.3*), the

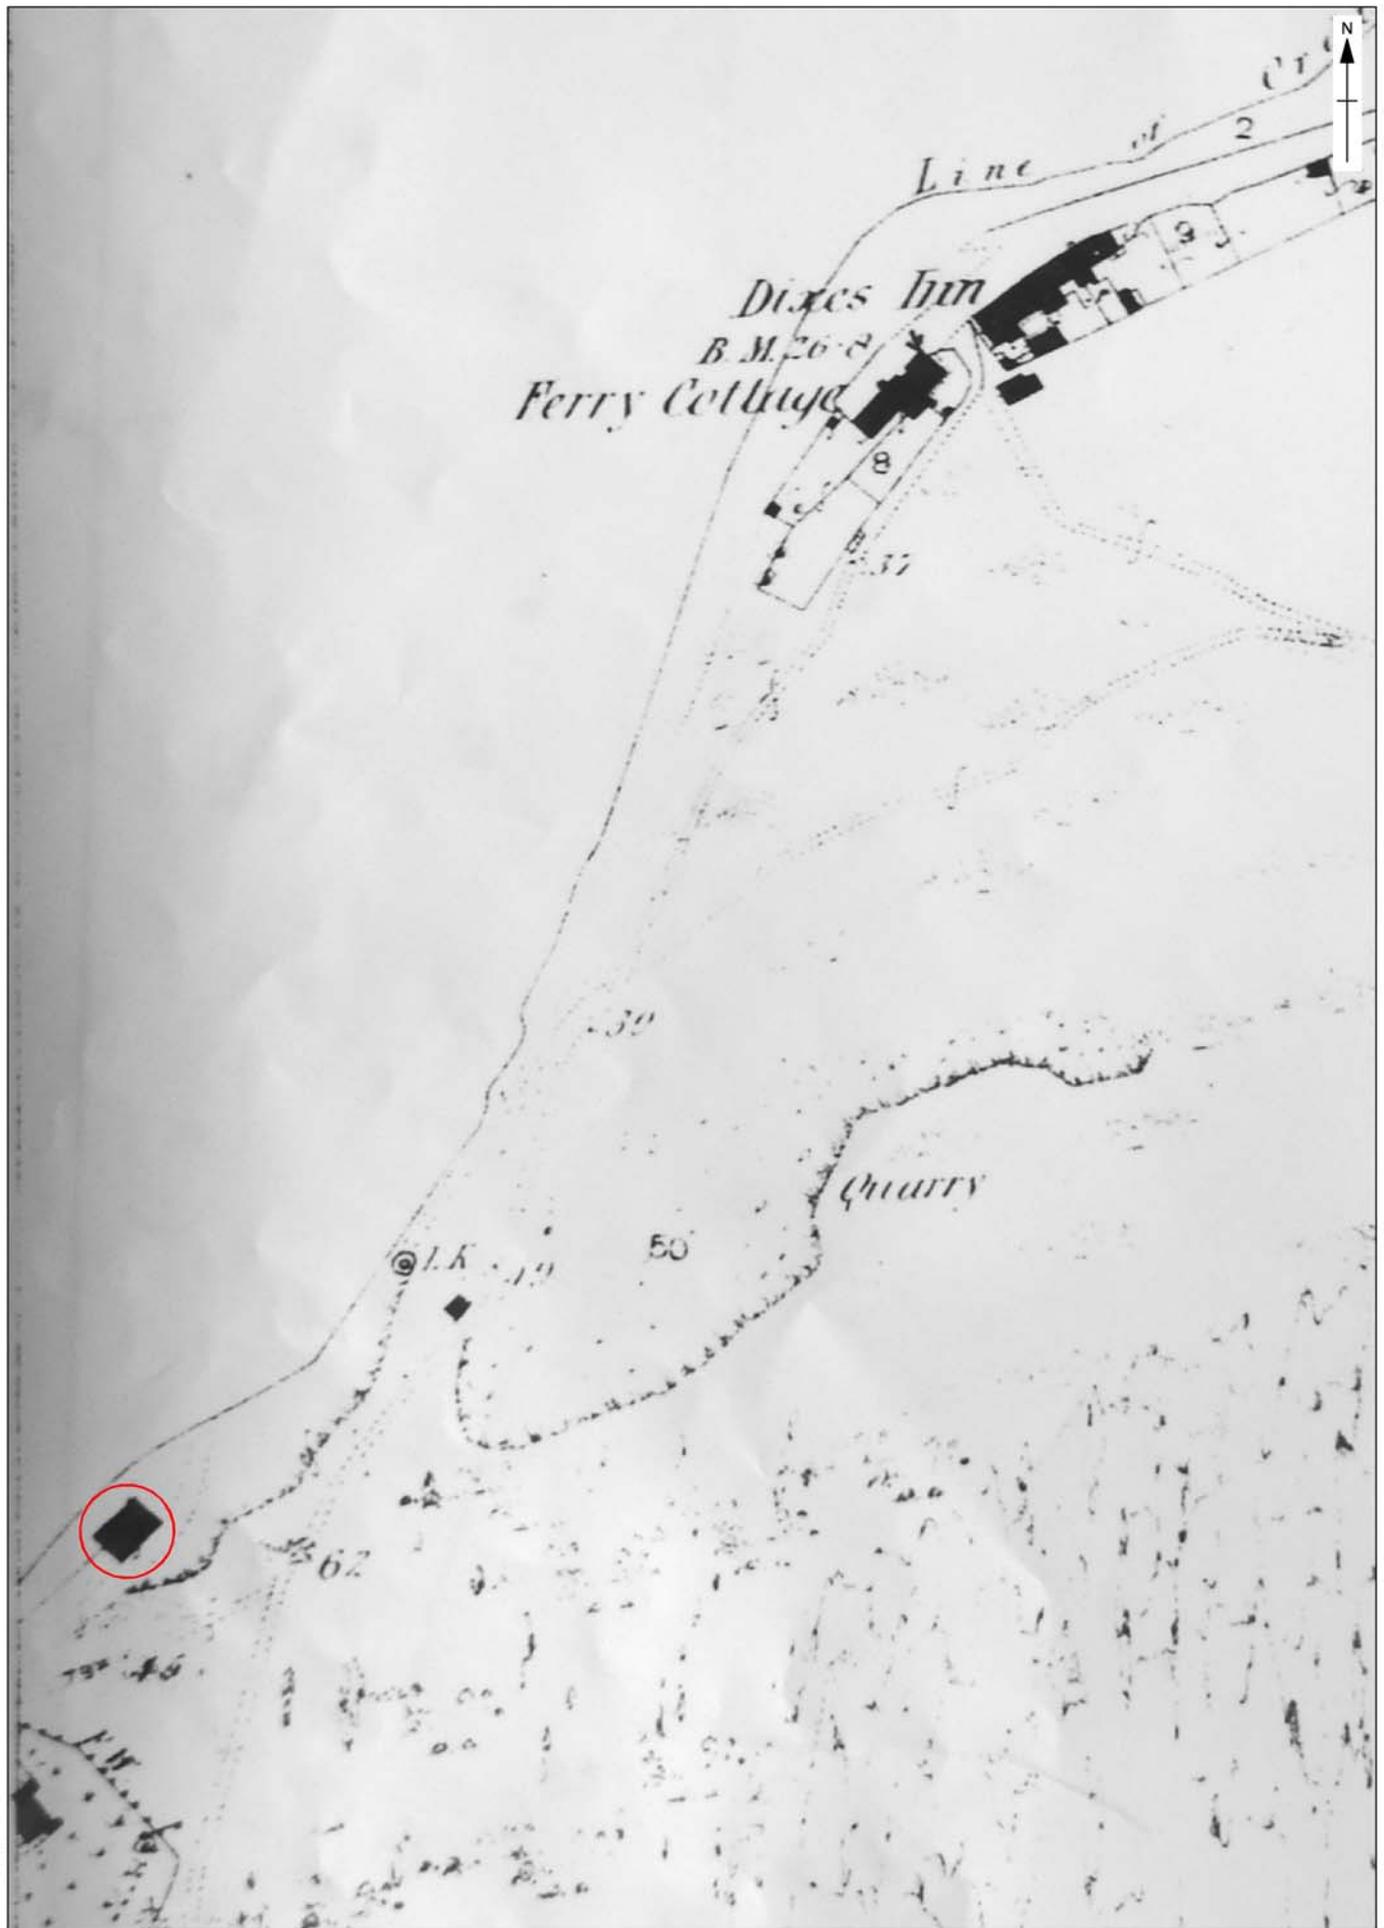
Figure 3: Extract from the Ordnance Survey First Edition 6" to 1 mile Map, 1859

- 3.3.2 **Ordnance Survey, First Edition, 25" to 1 mile, 1859:** this shows little change, and provides less detail than the 1839 Tithe map (Fig 3). It is interesting to note the presence of 'Ferry Cottage' to the north-east of the warehouse, which provides further evidence for the use of the river as a transport route.

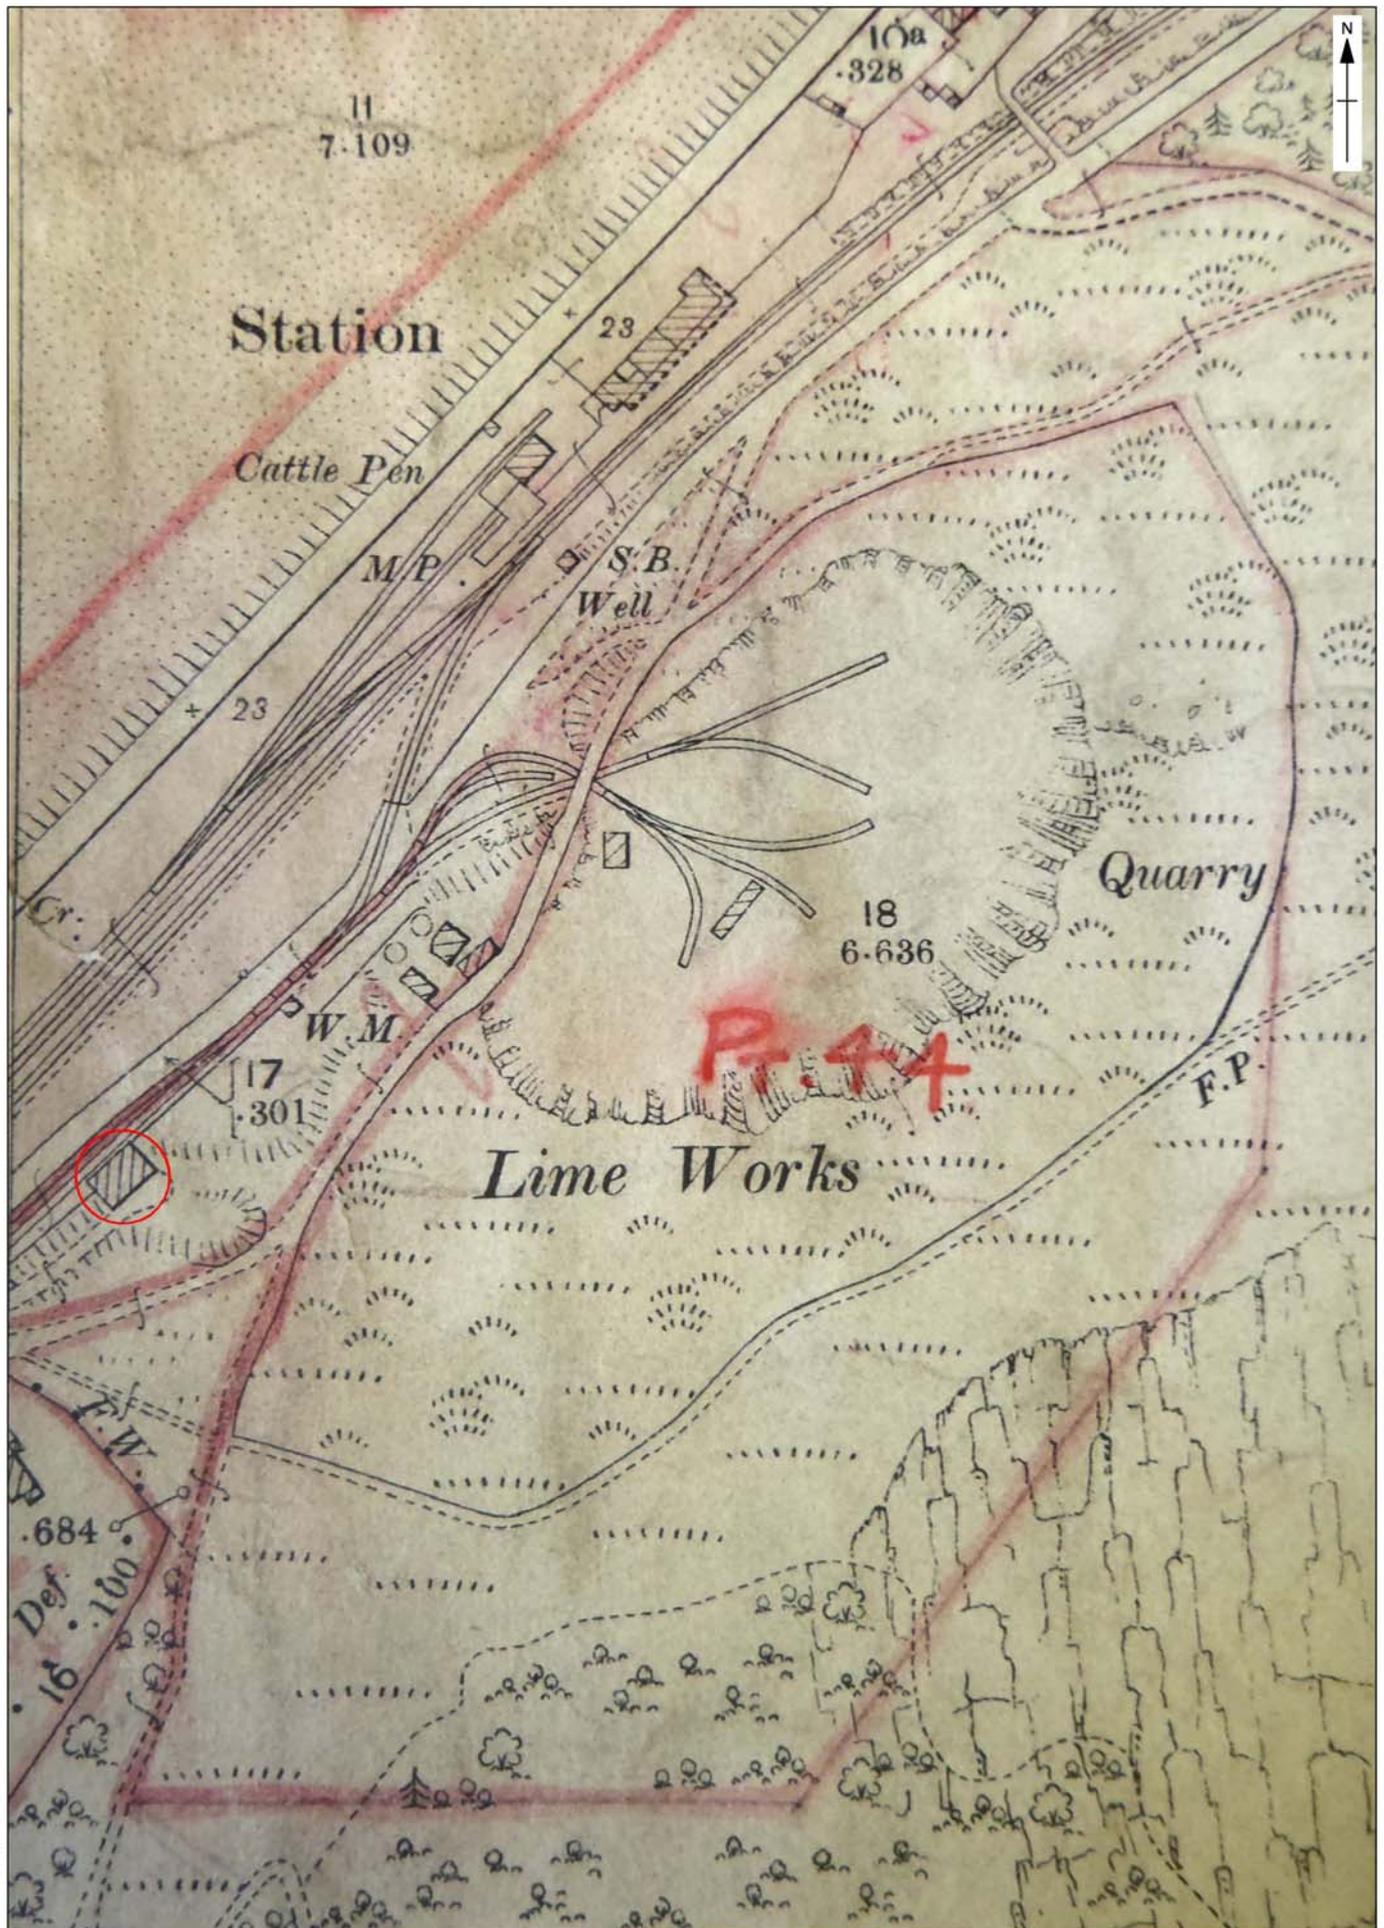
Figure 4: Extract from the Ordnance Survey Second Edition 25" to 1 mile Map, 1898

- 3.3.3 **Ordnance Survey, Second Edition, 25" to 1 mile, 1898:** the landscape has changed quite considerably by 1898. A programme of land reclamation has facilitated the construction of a railway line and possibly station to the west of the warehouse (Fig 4). The Arnside to Hincaster line of the Furness Railway was opened in 1876 (<http://cumbrianrailwayassociation.org.uk>). A branch line of this appears to service the warehouse, or at least passes directly in front of the building en-route to Sandside quarry. The limekiln to the east now has two working kilns.

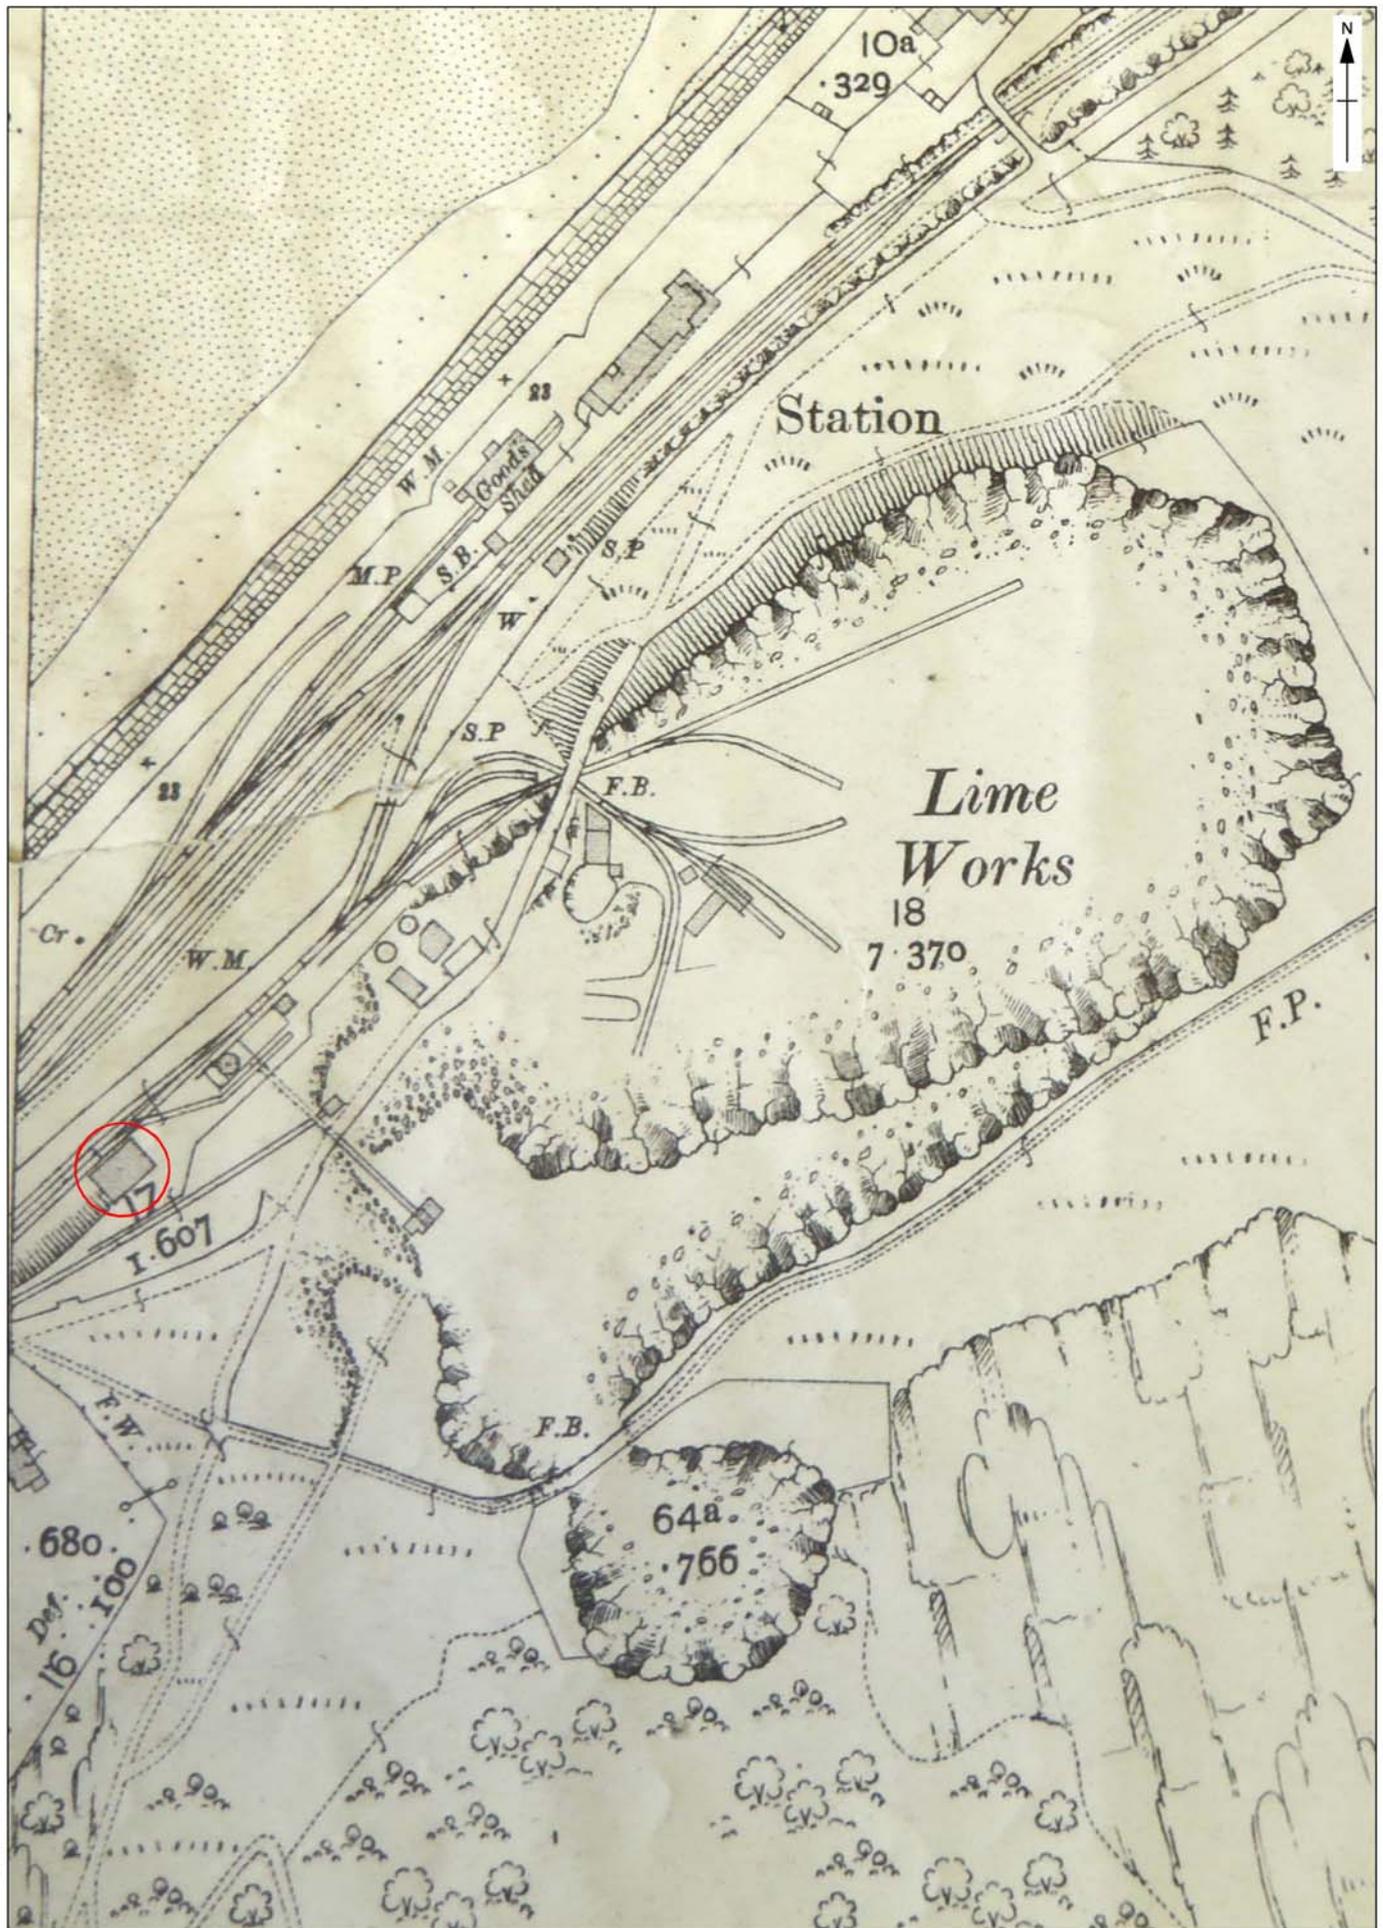
Figure 5: Extract from the Ordnance Survey Third Edition 25" to 1 mile Map, 1914

- 3.3.4 **Ordnance Survey, Third Edition, 25" to 1 mile, 1914:** the warehouse retains its original shape, but several small buildings appear to the north-east, presumably relating to the processing and extraction of lime. A goods shed has also been constructed and the adjacent building is labelled as station.

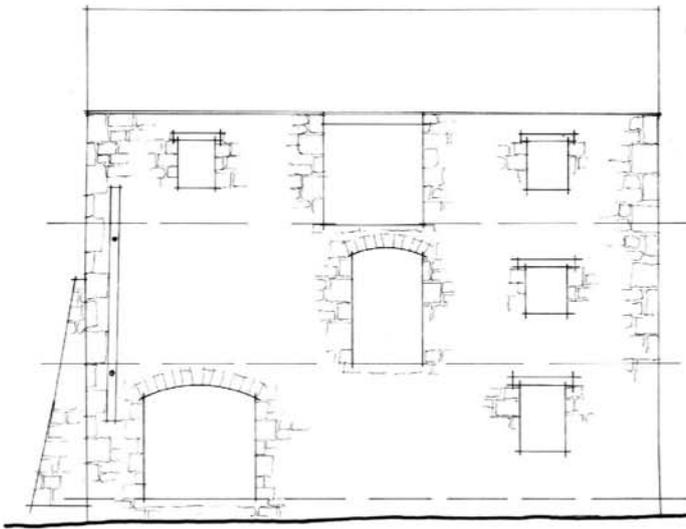
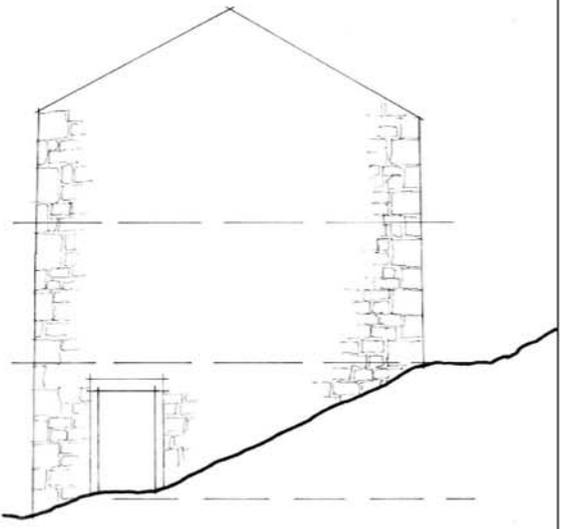
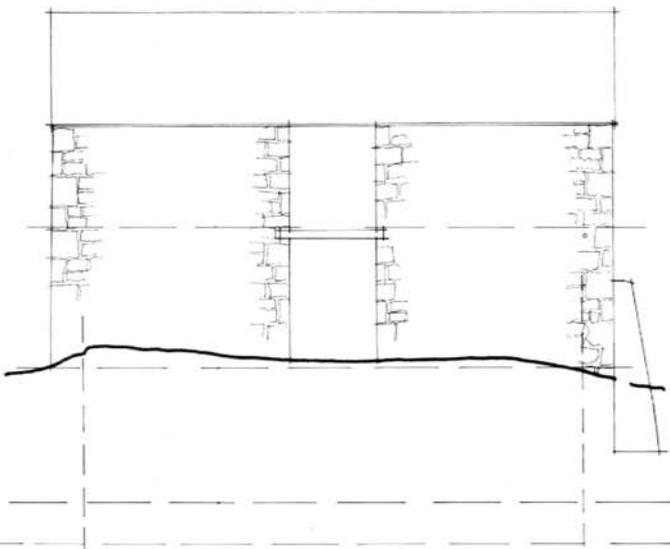
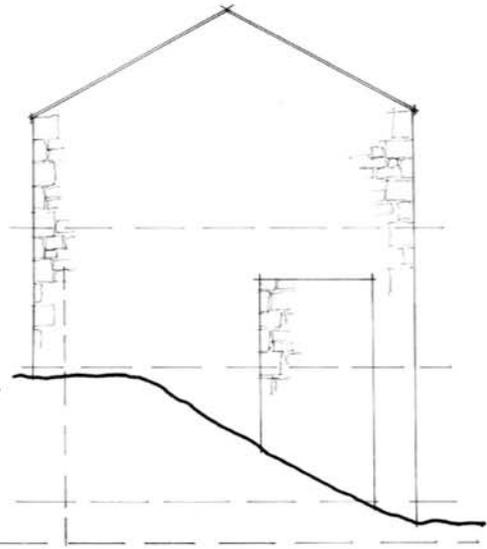
Figure 6: Architect's Elevations of the former Quarry Warehouse

4.2.1 The warehouse is built into the hillside, consequently, it has three storeys to the front elevation and two storeys to the rear (Fig 6; Plate 1). It is located to the west of Sandside quarry, and is adjacent to Sandside double limekiln (Plate 2), and a disused railway line. A high limestone wall skirts the back of the building, and the front faces into the River Kent.

4.3.1 ***Principal Elevation (north-west):*** the front elevation (Fig 6) of the warehouse faces immediately on to Quarry Lane (Plate 4). At ground floor level at the left hand side of the building is a goods doorway under a limestone-constructed segmental arch. The sill is constructed from refractory brick and is not original. To the right of the elevation is a window with brick voussoirs. The window appears to be set within a blocked doorway, also beneath a large stone segmental arch, and mirroring that to the left. To the first floor is a centrally placed loading doorway with the same arch as those seen below but with a deep limestone sill. To the right of this is a window heavily covered in vegetation. The second floor has the central loading doorway as the floor below, but this has been adapted to house a window, with the lintel lying in the eaves. A further window is located each side of this former doorway. A large timber has been utilised as a vertical wall tie-plate on the far left of the elevation.

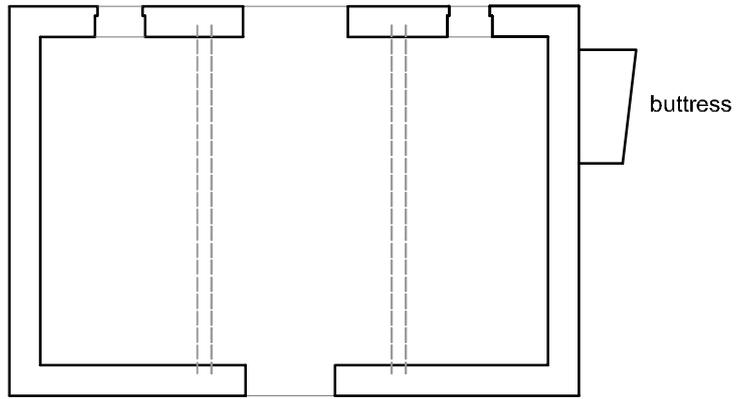
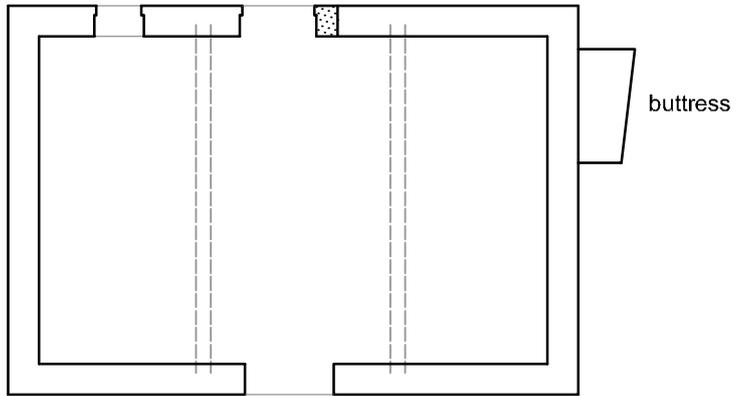
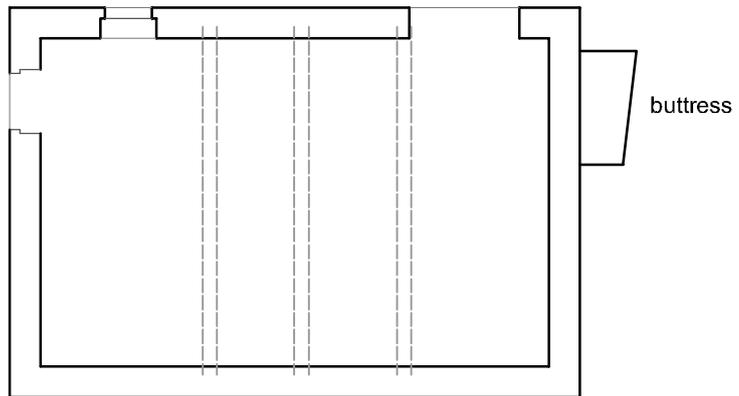
Figure 7: Floor plans of the former Quarry Warehouse

- 4.4.2 ***Ground floor plan:*** access to the ground floor would have been via both the single door in the south-west gable, and the large arched doorway to the front. The ground floor comprised at least two separate rooms. Currently, access is only possible from the gable door, which leads into a stable comprising two stalls, a hayrack, and a manger attached to the rear wall (Plate 9). Beyond this is a further room accessed more easily through the arched doorway on the front elevation. The function of this room is unclear as it was full of collapsed material from the floors above, and access was not possible, but the arched doorway certainly suggests access for a cart or small wagon.

- 4.4.3 ***First Floor plan:*** the first floor comprised one large open storage area, with a centrally-placed loading door to both the front and rear elevations, presumably to move goods in and out onto carts below.

- 4.4.4 ***Second floor plan:*** the second floor comprises one main room similar to the first floor, but with a timber partition in the front left-hand corner, which presumably functioned as an office. The loading door on the front elevation has been altered to function as a window, and a large workbench is located directly in front of it. A tall cupboard sits between the 'office' and the workbench (Plate 10).

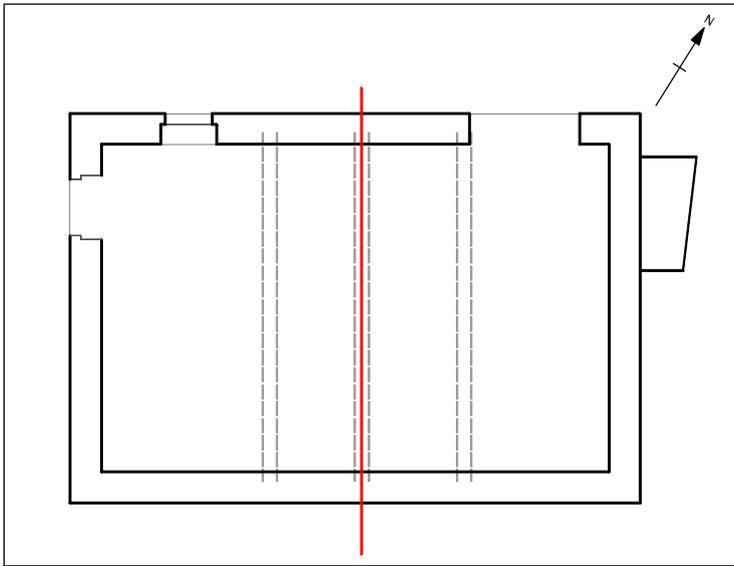
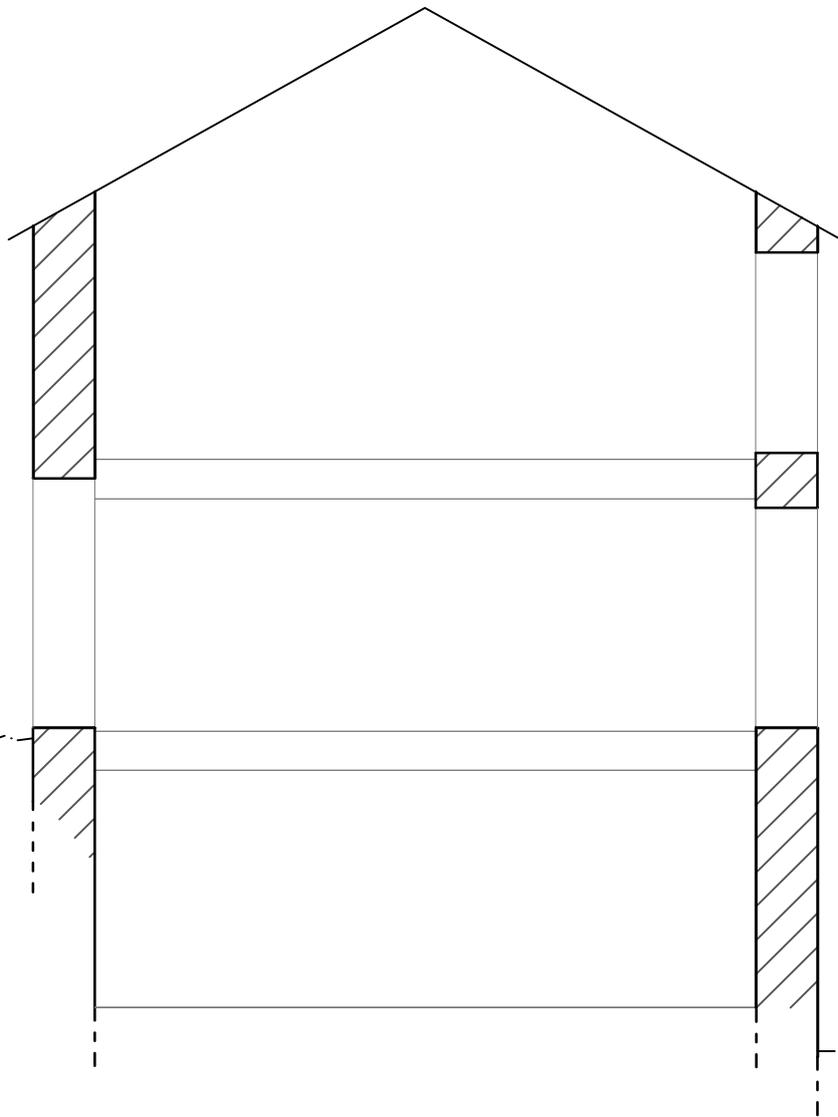
Figure 8: Cross-section through the former Quarry Warehouse

- 4.4.1 Although the building investigation was intended to be an external survey only, the scaffold allowed a slightly more detailed internal survey than was previously intended. Although access to the interior was not possible, it was however, possible to view most of the internal arrangements of the building safely from a distance (Fig 8).

- 4.4.5 The roof is supported by two through-purlin tie-beam trusses. There are three lapped and truncated purlins to the original pitch of the roof. The trusses are supported within the external wall construction. The timbers for the replacement roof pitch are all modern.

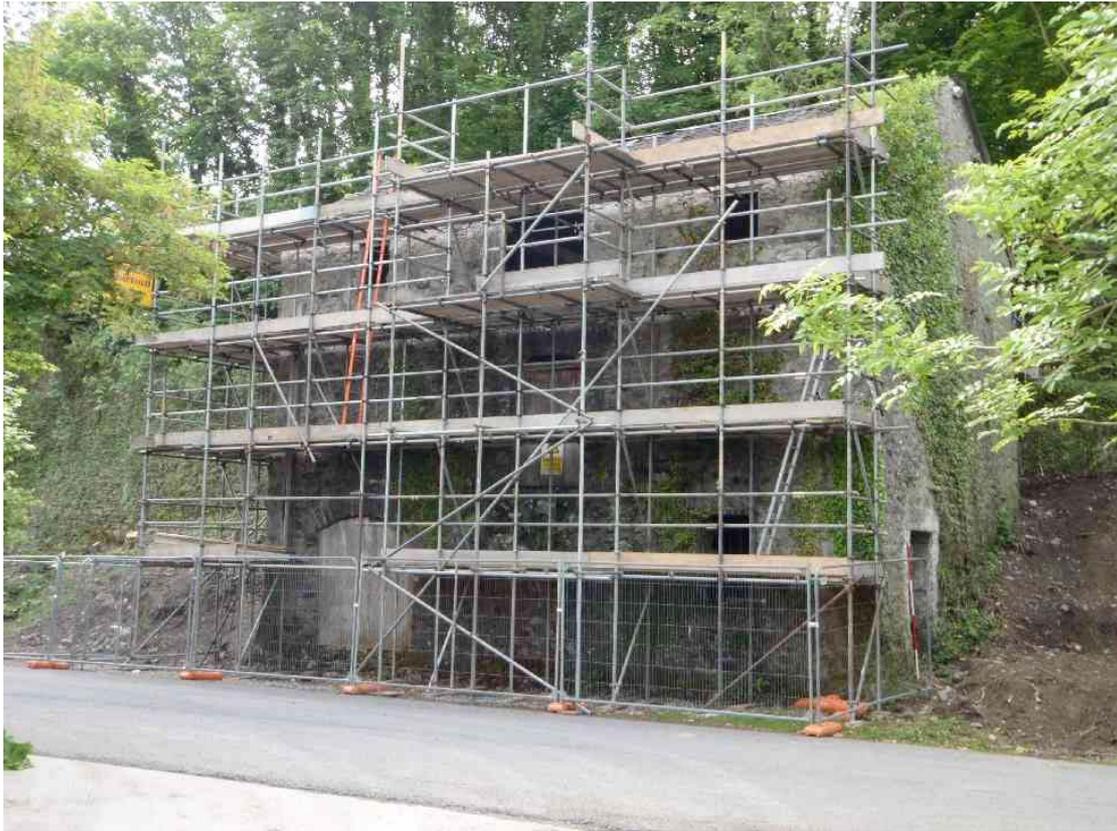
Plate 3: Scaffolding surrounded the warehouse on three sides at the time of the building investigation

4.1.1 The subject of the building investigation is a warehouse belonging to the Dallam Tower Estate, and this is located just to the south-west of Milnthorpe, near the village of Sandside. At the point that the building investigation was undertaken, the warehouse was surrounded on three sides by scaffolding, which extended from the floor to the eaves (Plate 3). The only elevation left exposed was heavily obscured by vegetation. The building is currently in a state of disrepair with no internal access possible.

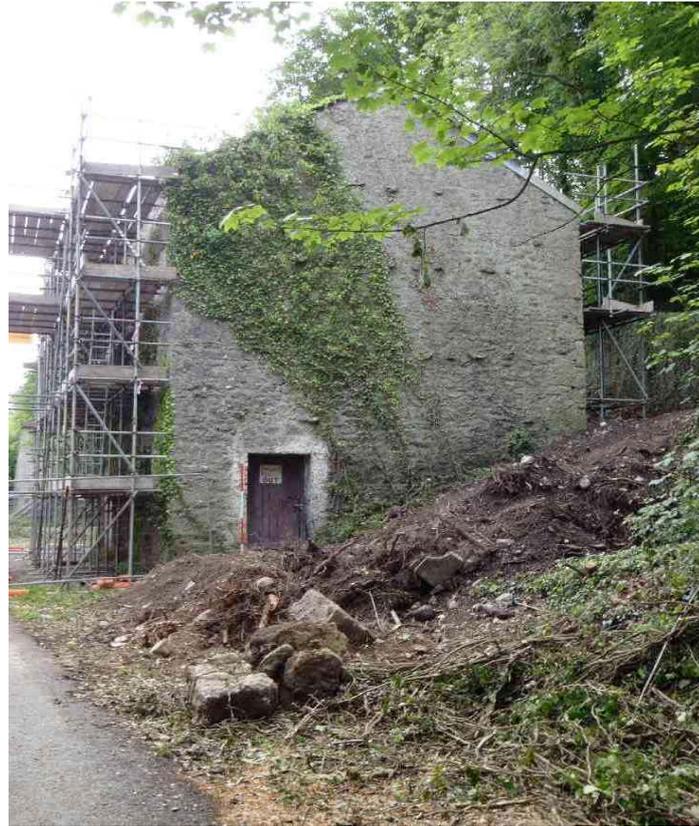
Plate 5: The south-west gable of the warehouse

- 4.3.3 ***Gable end of warehouse (south-west):*** this elevation (Fig 7) has a single door under a large stone lintel to the bottom left corner (Plate 5). It is possibly a later addition to the building, as the area surrounding the door has been heavily re-pointed, and the door jambs are constructed from refractory brick. Although this elevation is quite heavily covered in vegetation, three rows of through stones are evident between the first floor and the eaves (Plate 6). The purlins of the replacement rear pitch of the roof can be observed under the right side of the eaves.
- 4.3.4 ***Rear elevation (south-east):*** the rear elevation (Fig 7) of the building is two storeys in height, with a wide centrally-placed goods doorway on each floor (Plate 8).

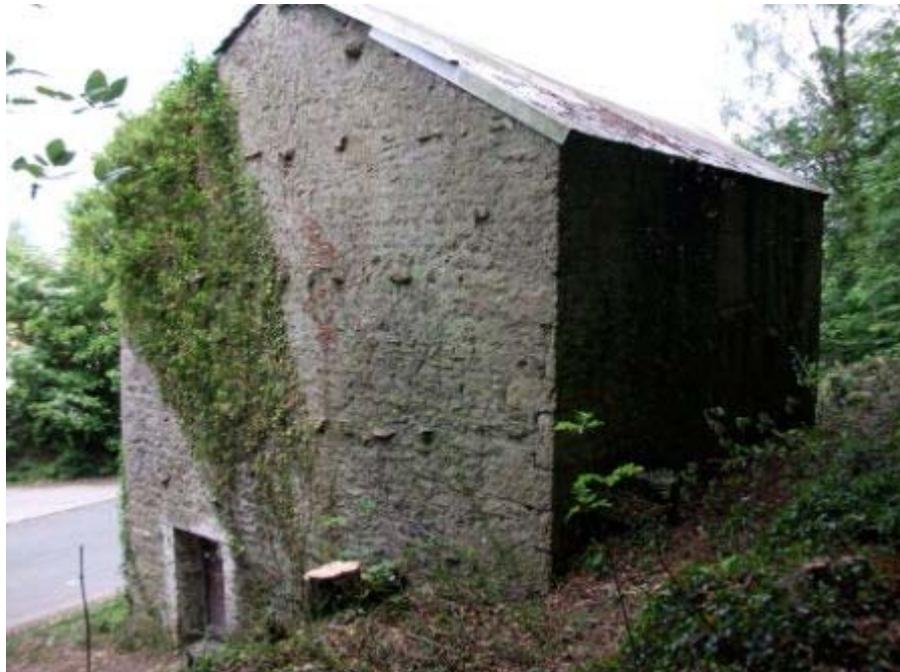
Plate 6: Detail of the through-stones in the south-west elevation
(Reproduced with kind permission of the Dallam Tower Estate)

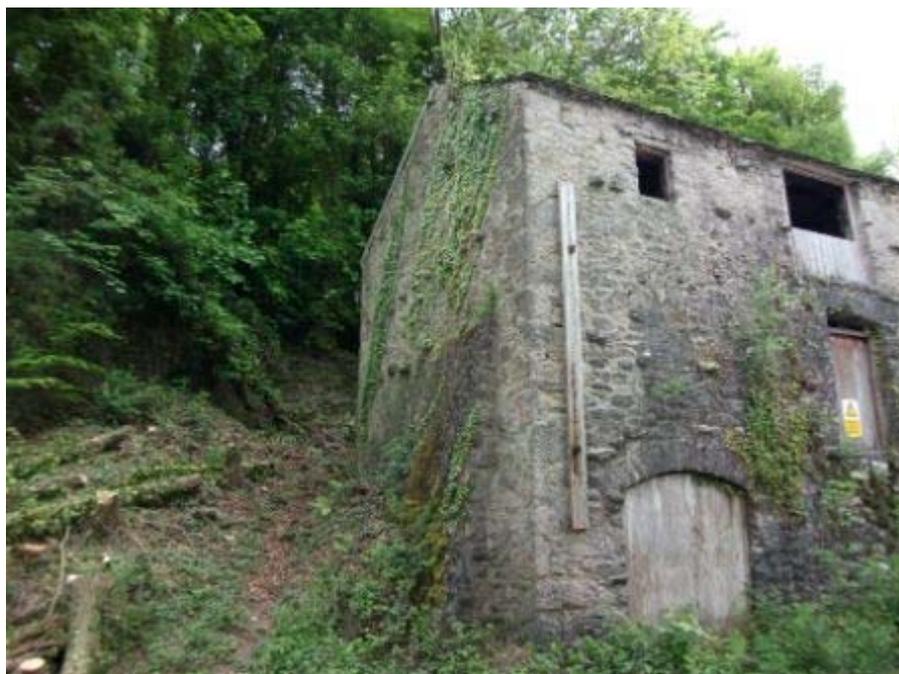
Plate 7: The north-east gable of the building
(Reproduced with kind permission of the Dallam Tower Estate)

4.3.2 ***Gable end of warehouse (north-east):*** there is a single buttress to the bottom right hand corner of this elevation, extending to the first floor (Fig 7; Plate 7).

This almost certainly adds additional support to the wall, which may have been weakened by the goods doorway in the front elevation, and by its split-level construction. Three stringcourses of through-stones are present in the gable.

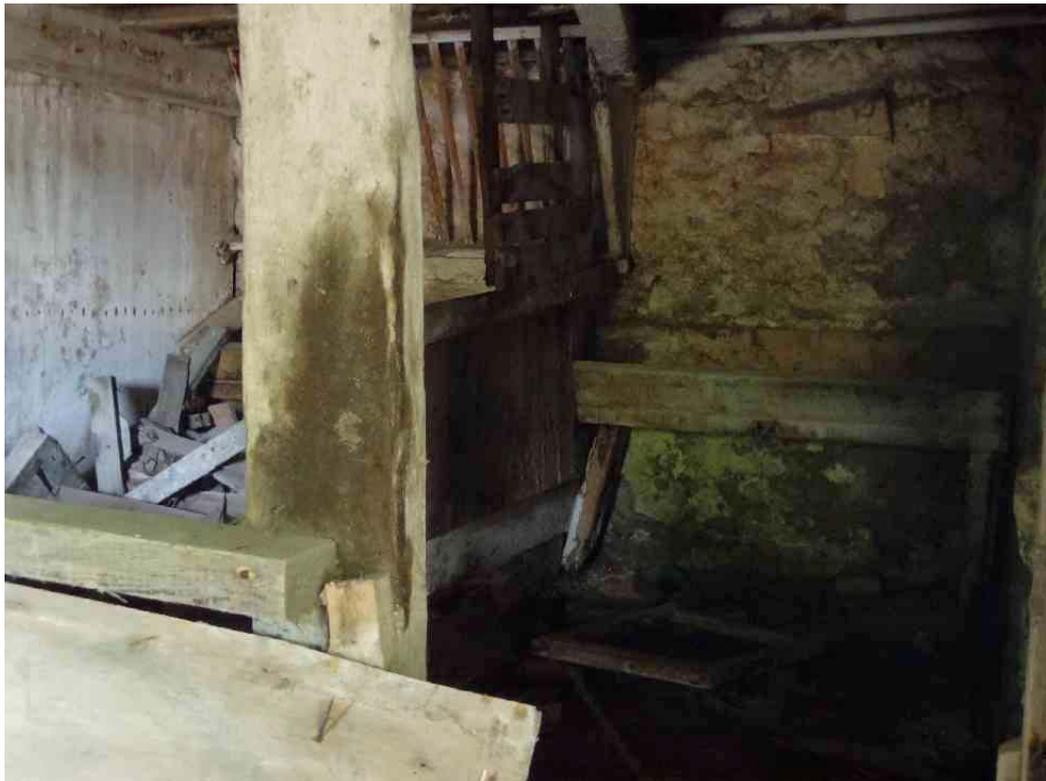
Plate 9: Detail of stables with manger on ground floor

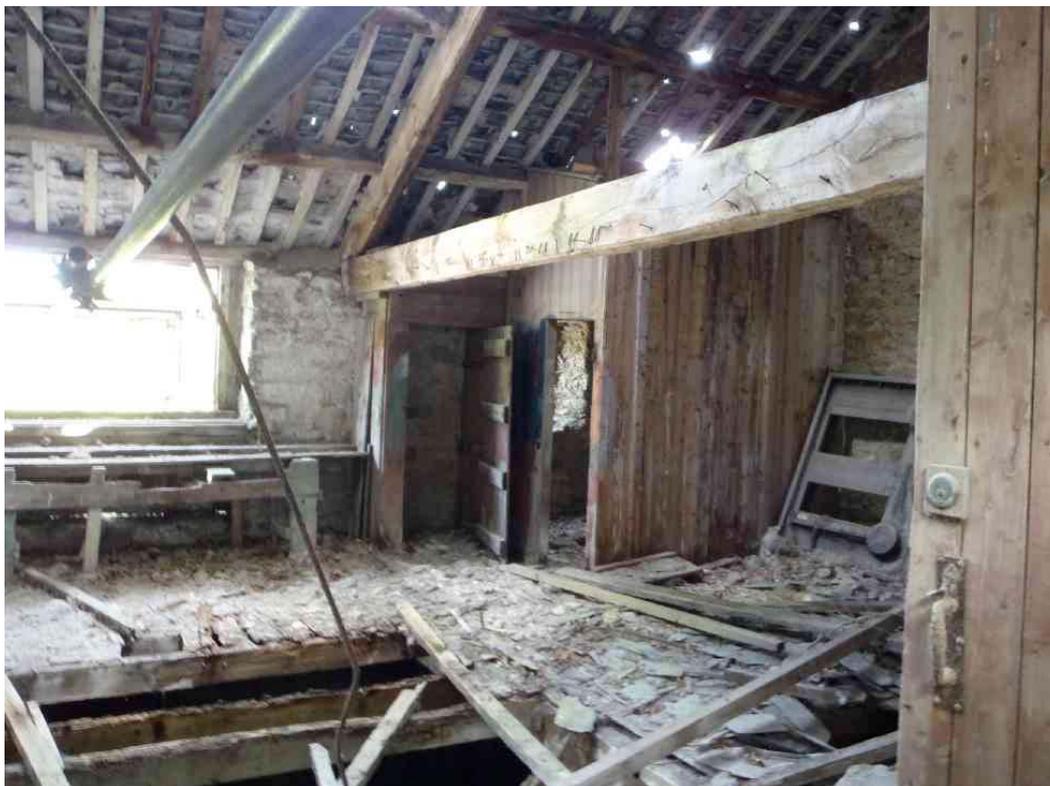
Plate 10: Office partition on second floor, with cupboard and workbench under window
