Guide Service Reservoir. Blackburn, Lancashire,

Archaeological Watching Brief and Evaluation Report

Oxford Archaeology North

May 2008

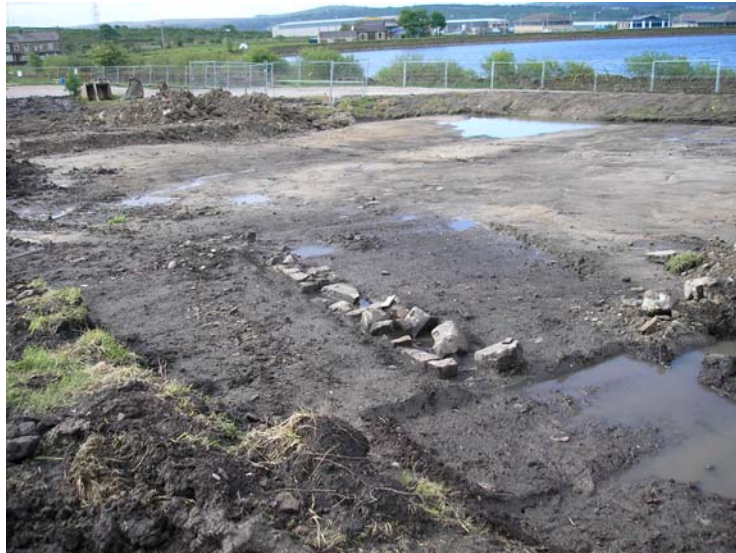
Plate 1: Wall *16* at the southern end of Trench 1, looking south

5.2.3 Four wall foundations appeared to have been cut into the natural subsoil, **102**. Walls **16**, **100** and **101** were aligned north-west/south-east and **103** was aligned north/south. Wall foundation **16** measured 0.50m wide by 0.40m high, and was observed in the centre of the eastern end of the trench for a distance of 5.60m (Plate 1; Fig 3). The extant structure comprised two courses of faced stone blocks, placed two abreast. These were laid directly onto the natural clay, **102**. The masonry varied from 540mm by 240mm (within the lower course) to 290mm by 210mm (within the upper course). The core of the wall was packed with hardcore. The wall appeared to return to the north for a distance of 3m. The return section (**120**) was not as substantial as the main section (**16**), and it comprised disturbed small stones similar to the type of material used as hardcore within the main body of wall **16**. This suggests that masonry from structure **120** may have been re-used elsewhere. Wall **101** extended into Trench 2, and was observed as a 2m long section aligned

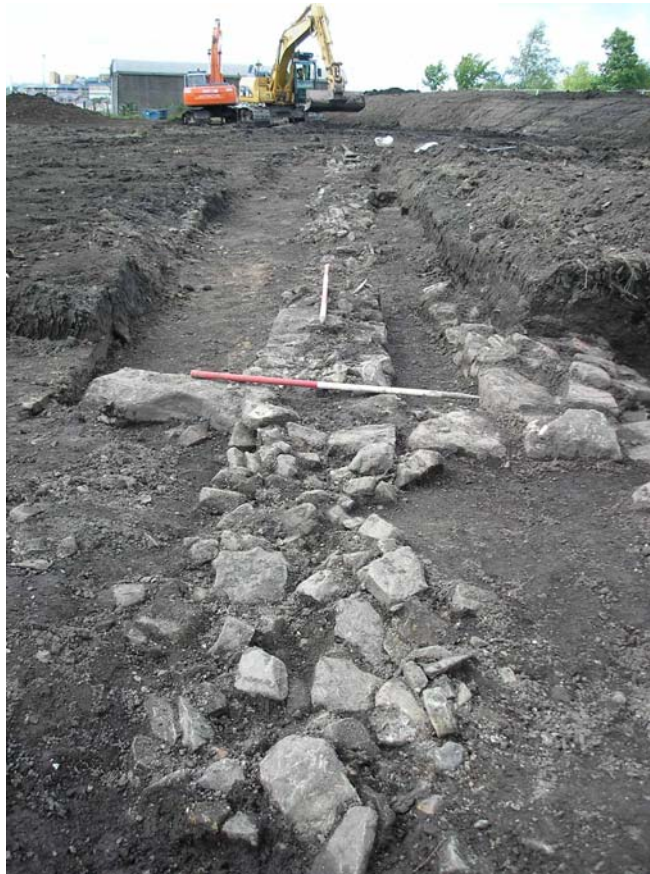
Plate 2: Remains of walls *100*, *101* and *103*, located at the junction of Trenches 1 and 2, looking north-west

east/west, butting against (and thus later than) wall **103**. Wall structure **100** was aligned east/west along the length of the trench for a distance of 10.60m, and it appeared to truncate part of wall footing structure **103** (Plate 2), although no obvious cut or trench was apparent. The footing comprised poorly-dressed faces and a rubble core, and it was observed extending west beyond the extent of the trench across the field toward the extant Sudell Nook cottages. This wall probably represents a perimeter or boundary wall (see comments in *Section 7.2.1* below).

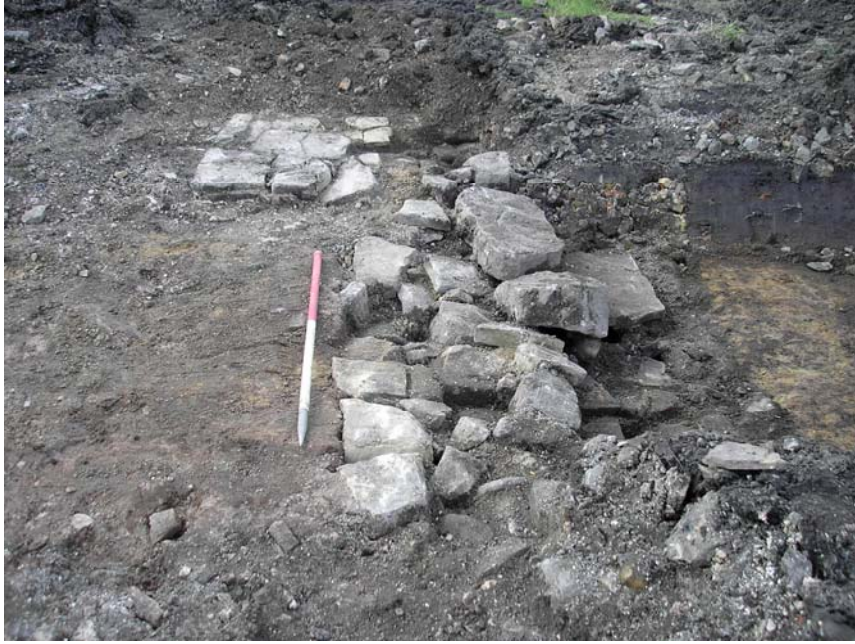
Plate 3: Wall *105* and culvert *104* in Trench 2, looking north-west

- 5.3.2 A stone wall (**105**) measuring 0.50m in width, was observed occupying a north-west/south-east alignment at the northern end of the trench (Plate 3). At its north-western end, the wall was seen to return to the south-west for a distance of 1.10m, at which point it appeared to terminate. The structural fabric comprised stone blocks of varying dimensions surviving to a height of three courses or 0.35m. Traces of lime-based mortar were recorded within loose stone rubble core of the wall, which perhaps suggests that it was partially dismantled and the stone re-used. The wall probably represented part of the north-east exterior wall of the farmhouse.

- 5.3.3 The north-eastern face of wall **105** was adjacent to a north-west/south-east aligned stone culvert (**104**) measuring 0.50m wide. The culvert physically butted against the wall foundation (**105**) (Plates 3 and 7), although they appear to have been contemporary features or at least part of the same construction episode.

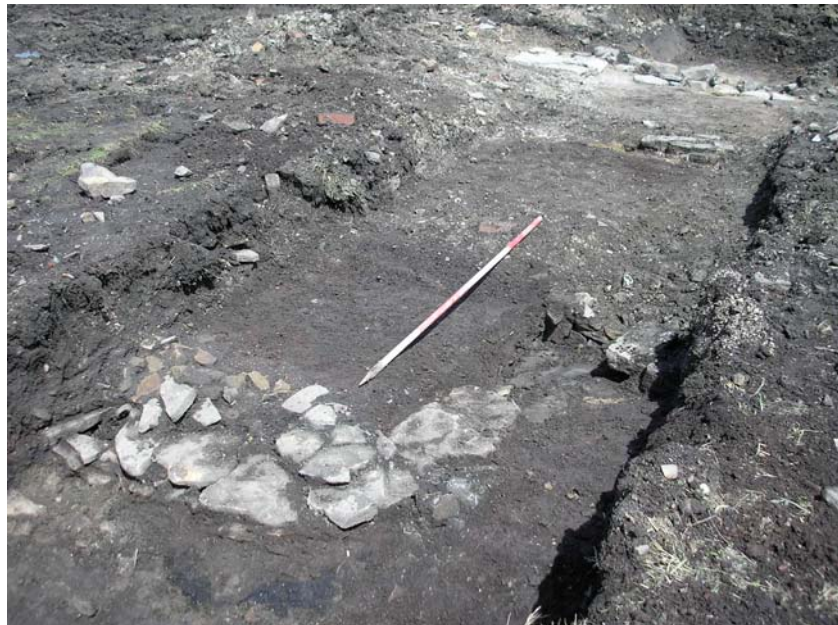
Plate 4: Culvert *106* in Trench 2, looking north

- 5.3.5 A stone drain, **106**, was observed cutting the subsoil, **123**, in the centre of the trench, performing a right-angled turn before extending to the south-east beyond the limit of the trench (Fig 3; Plate 4). This comprised three courses of small roughly-hewn unbonded masonry walls, capped with large flat stones. The dog-leg suggests that the foundation cut for the drain had had to accommodate an extant structure during its construction.

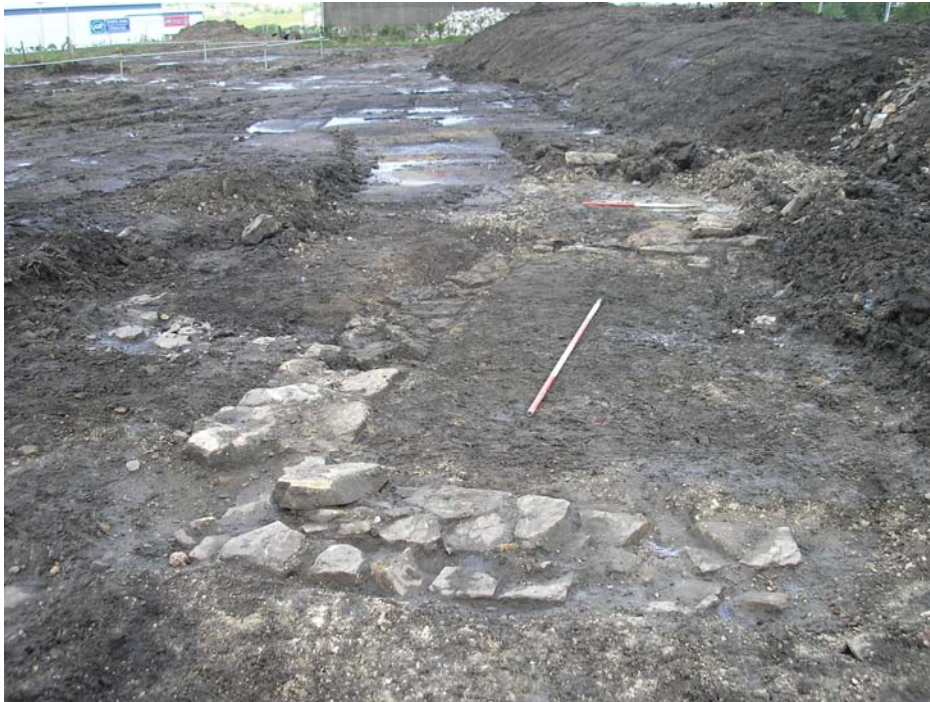
Plate 5: Building *110* in Trench 3, looking north

- 5.4.2 Structure **110** survived as a footprint aligned approximately north-east/south-west, recording the layout of a building measuring 6.8m long by at least 2m wide (Fig 3; Plate 5). The building comprised a west wall footing (**124**) with returns from the eastern side at both ends. The northernmost of these returns butted an north-west/south-east aligned stone wall (**125**), which was located against the northern edge of the building. Wall **125** extended north from wall **124** for a distance of approximately 2m, with fabric comprising roughly-hewn fine-grit sandstone displaying no apparent bonding. The stone survived to a height of two courses (and measured two stone blocks wide, with each block measuring between 430mm x 260mm x 60mm, to 300mm x 80mm x 80mm. A single 0.04m thick sandstone flag (**116**) butted against structure **125**, possibly representing levelling for or a remnant of the original floor surface. Amorphous large spreads of mortar observed along the inside edge of the walls comprising building **110** may also represent rudimentary levelling for a floor surface.

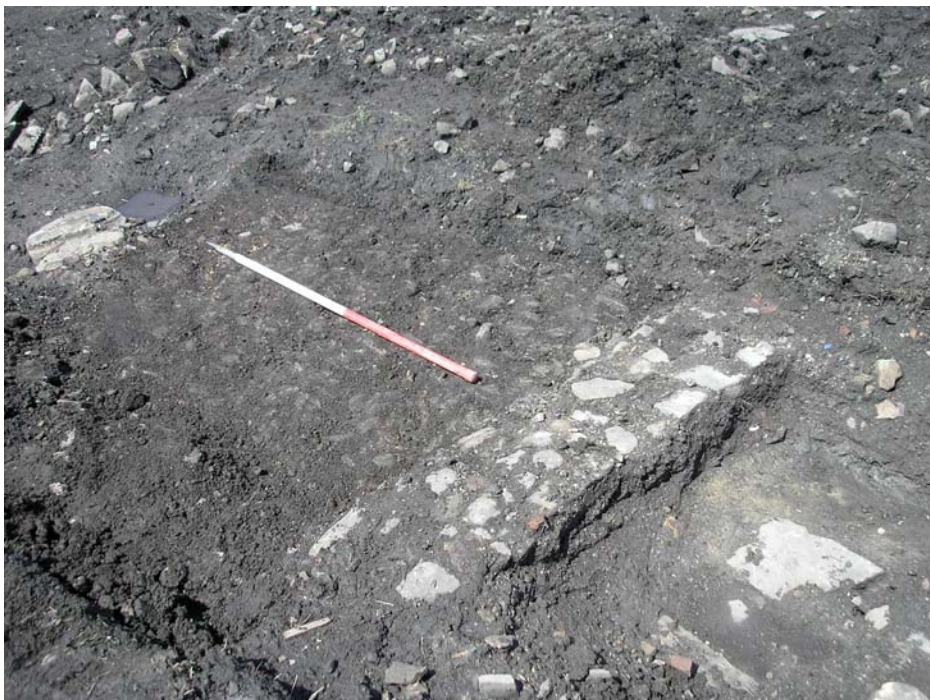
Plate 6: Cobbled surfaces *113* and *114* in Trench 3, looking south-west

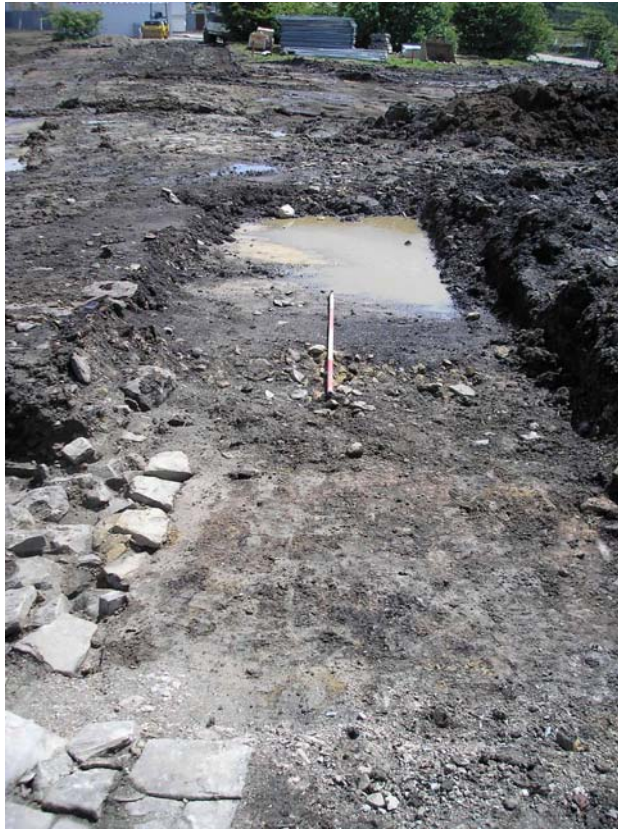
Plate 7: Wall *105* in Trench 4, looking south-east

- 5.5.2 Wall **105** was seen to continue into Trench 4 for a distance of 0.50m along its previous alignment (Plate 7). Wall **105** seems to have terminated or returned to the north-east beyond the confines of the trench.
