FERRY TERMINAL, PIERHEAD

**Liverpool,
Merseyside**

Archaeological Evaluation Report

OAN Job No: L9908
Report No: 2007-8/786
NGR: SJ 3381 9018

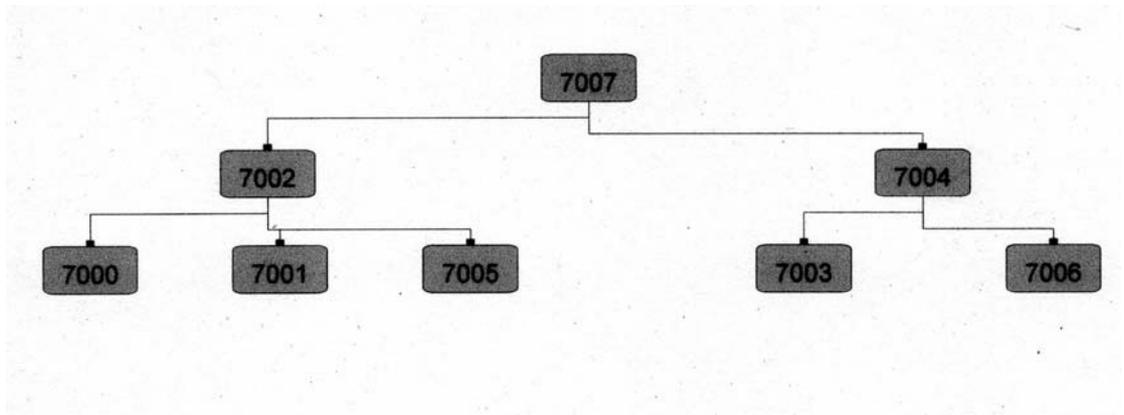
Harris matrix showing stratigraphy

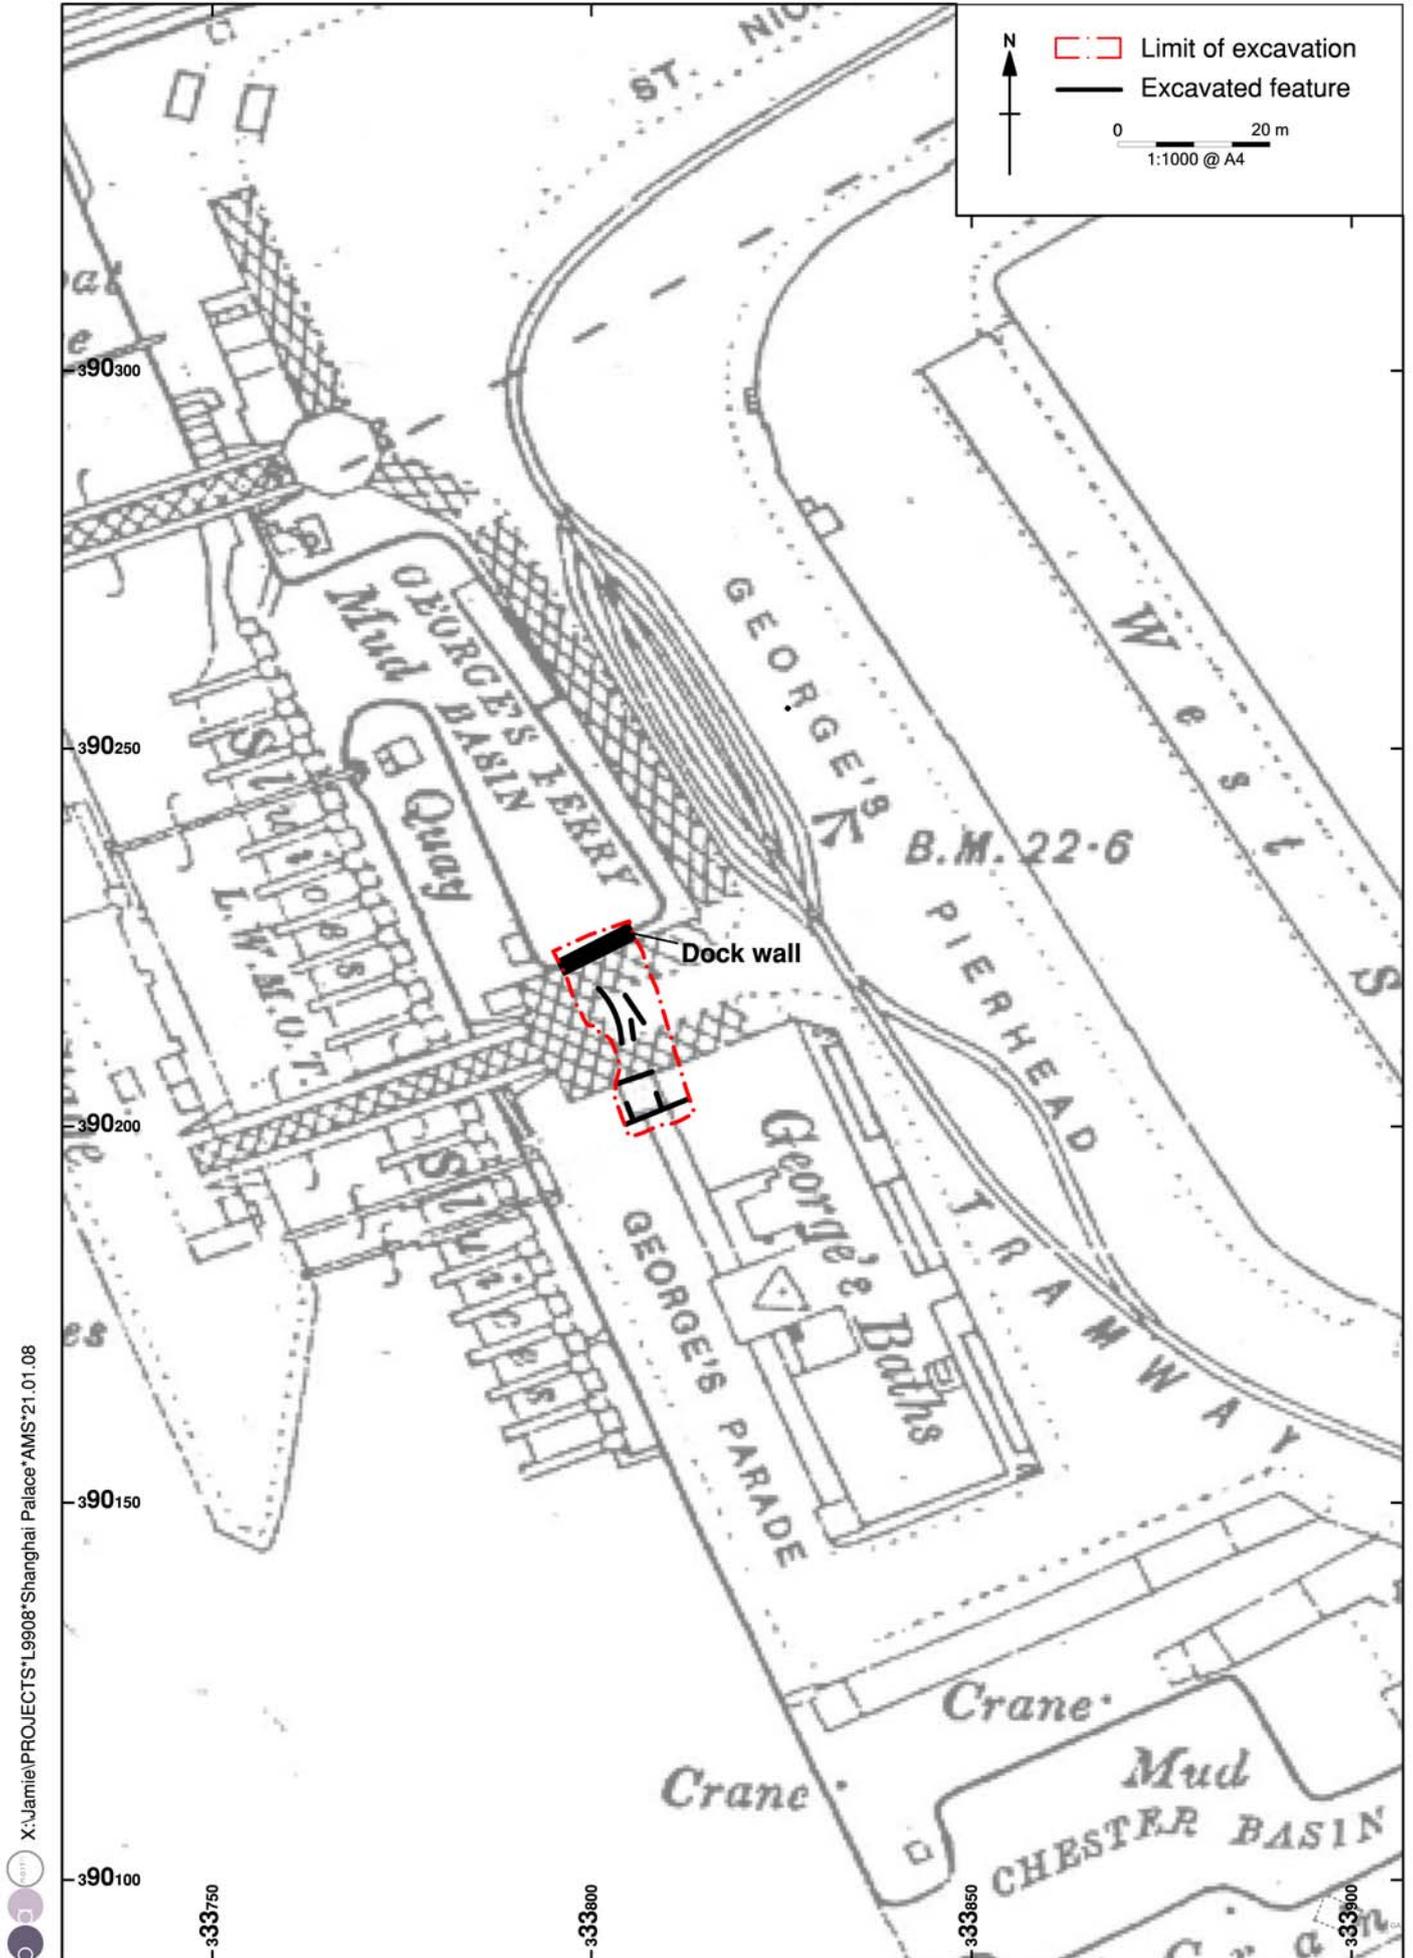
Figure 5: Excavation features overlain on the 1:2500 Ordnance Survey map, 1893

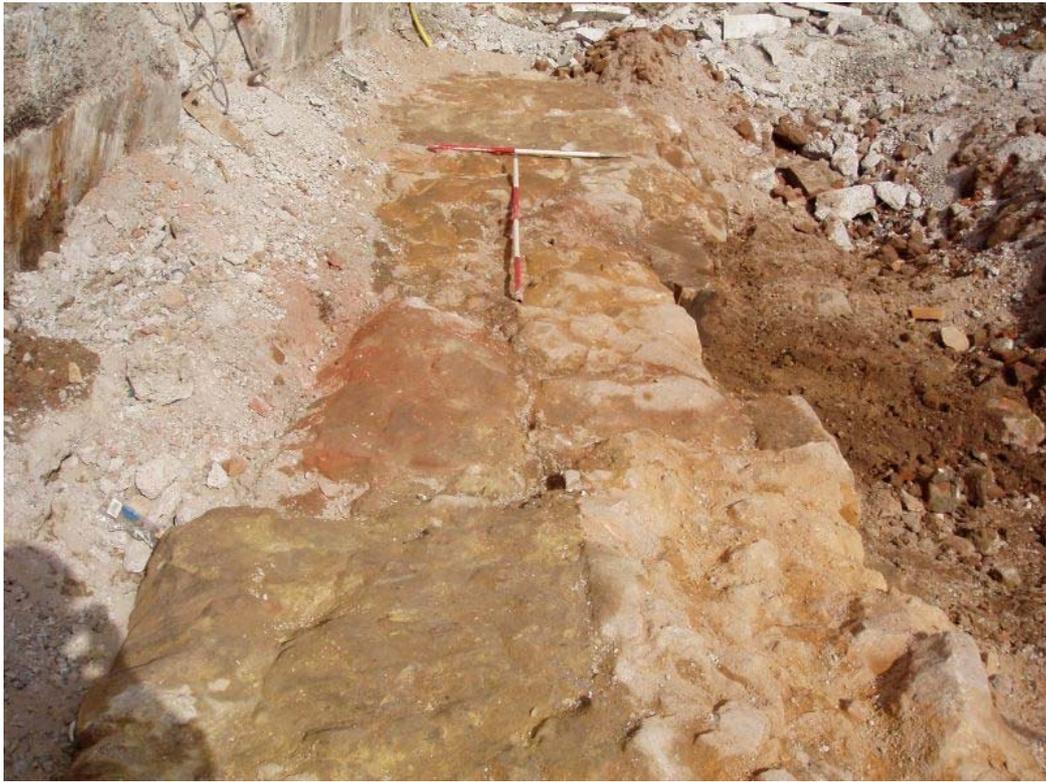
4.2.3 The George's Ferry Basin wall **7000** measured 8m long, 2.20m wide and was excavated to a depth of 0.50m. It was constructed of pink and yellow sandstone blocks measuring 1.20m long and 0.9m wide (with some variation probably derived from a local quarry (possibly St James Cemetery Quarry behind the Anglican Cathedral). The stones were tightly keyed into place with some evidence of a mortar bond, which comprised a mid-grey, lime mortar with pebble inclusions. The top of the sandstone blocks had a rough, damaged appearance, the original surface having been removed when the modern concrete surface was constructed. The northern elevation of the wall remained unexcavated beneath concrete, being just beyond the limits of excavation. The southern elevation of the wall (Plate 5) revealed some linear chisel marks, but a large proportion of the wall was degraded and showed little detail.

Plate 3: Southern wall of George's Ferry Basin (7000), looking east

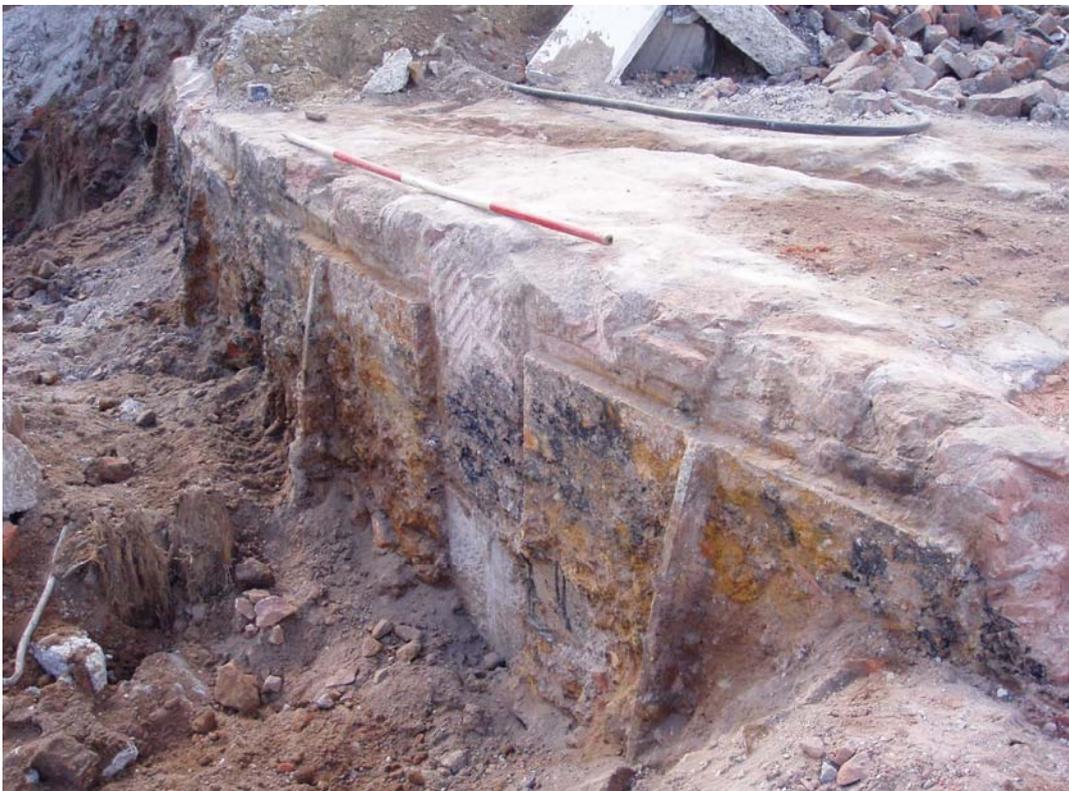
- 4.2.9 The sandstone blocks were the main component of the footing's construction and their full extent was not revealed, as the footing extended westwards towards the River Mersey and beyond the limit of excavation. The eastern elevation revealed some linear chisel marks and also what were probably marks from a rotary saw. There was some damage at the southern and northern extents of the elevation where the sandstone was truncated. The size and shape of the sandstone blocks was difficult to establish due to the concretion and the iron plates obscuring the masonry. Two upright timbers were placed immediately to the east of the pier footing, but their function is unknown.

6.3.3 The sandstone and iron foundations of the landing stage structures were in good condition, and survived to a height just below the modern concrete layers (c0.6m below the present surface). The iron elements were in particularly good condition.

Plate 4: Iron supports for the pier footing (7001), looking south

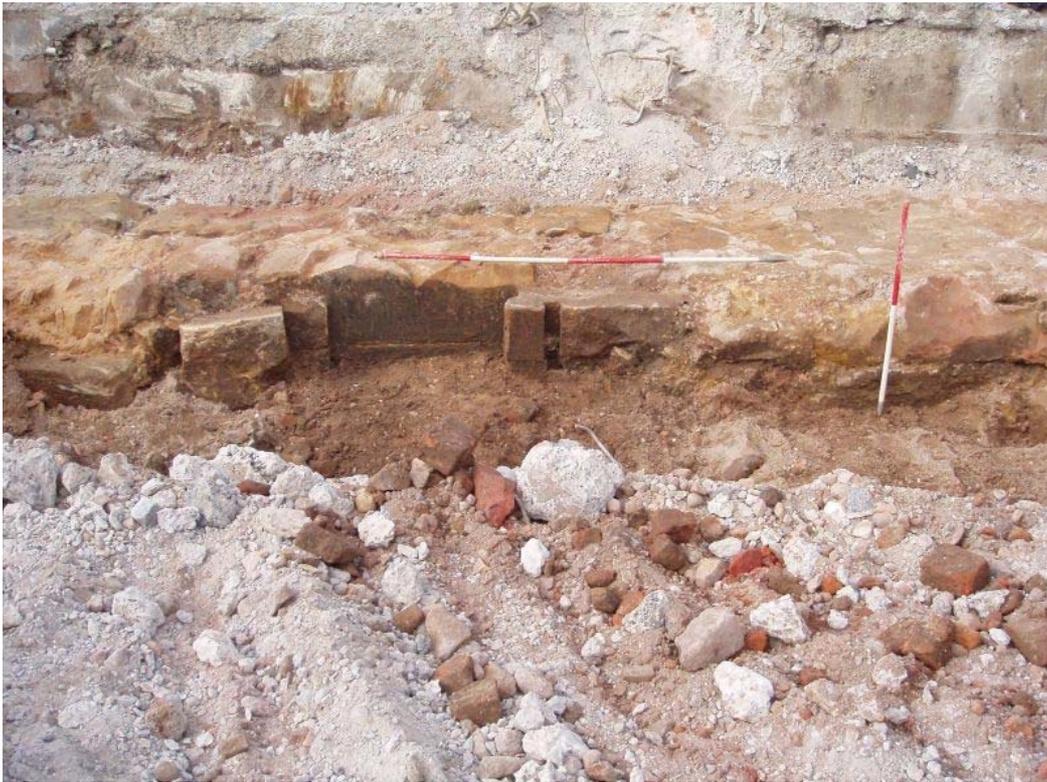
6.3.1 The evaluation aimed to determine the extent, condition, nature, character, quality and date of any archaeological remains present. The remains of George's Ferry Basin, built around 1770, were revealed to be in a reasonable state of preservation, although concrete had been set directly on to the top of the sandstone wall top, which means that the uppermost surface does not survive once the concrete has been removed. The wall was found at a depth of approximately 0.65-0.75m below the present ground surface and will survive to a greater depth than was investigated by the present evaluation. It was formed mostly of large pink sandstone blocks, although yellow sandstone was also found to have been used in the construction. The face of the wall, as far as was seen on the northern side, showed it to be vertical, while on the southern side there was tentative evidence of structural elements, such as a possible niche.

Plate 5: Elevation view of wall **7000**, the rear face of George's Ferry Basin south wall, looking north

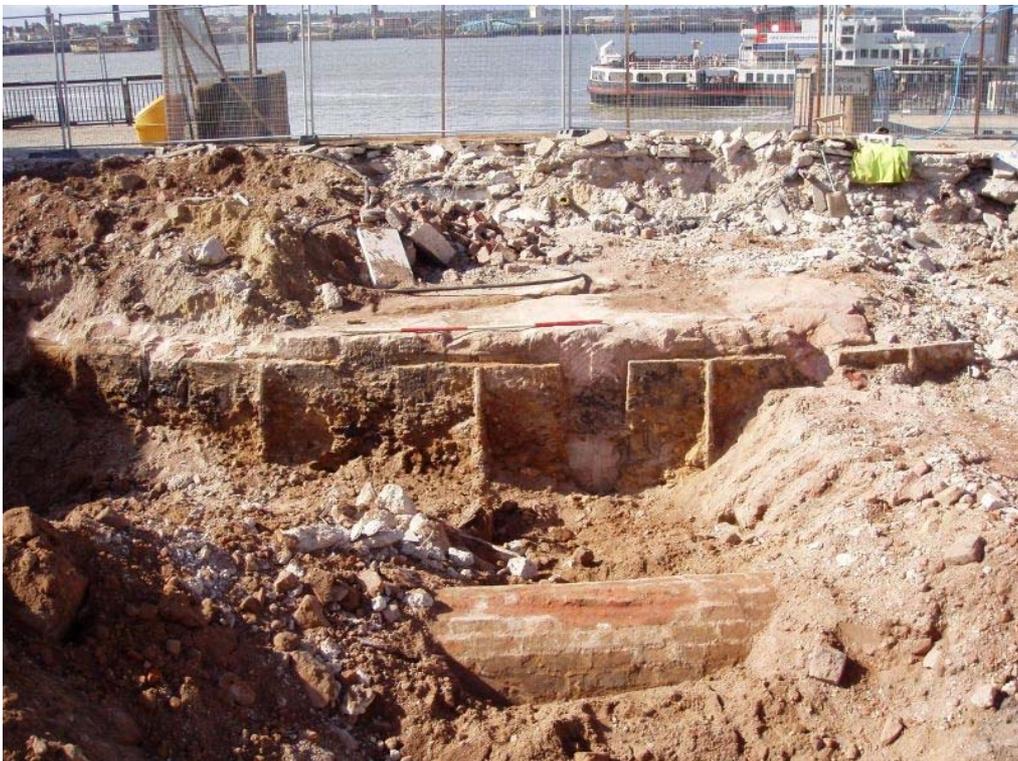
Plate 6: A view of landing stage foundation **7001** and culvert **7005**, looking west

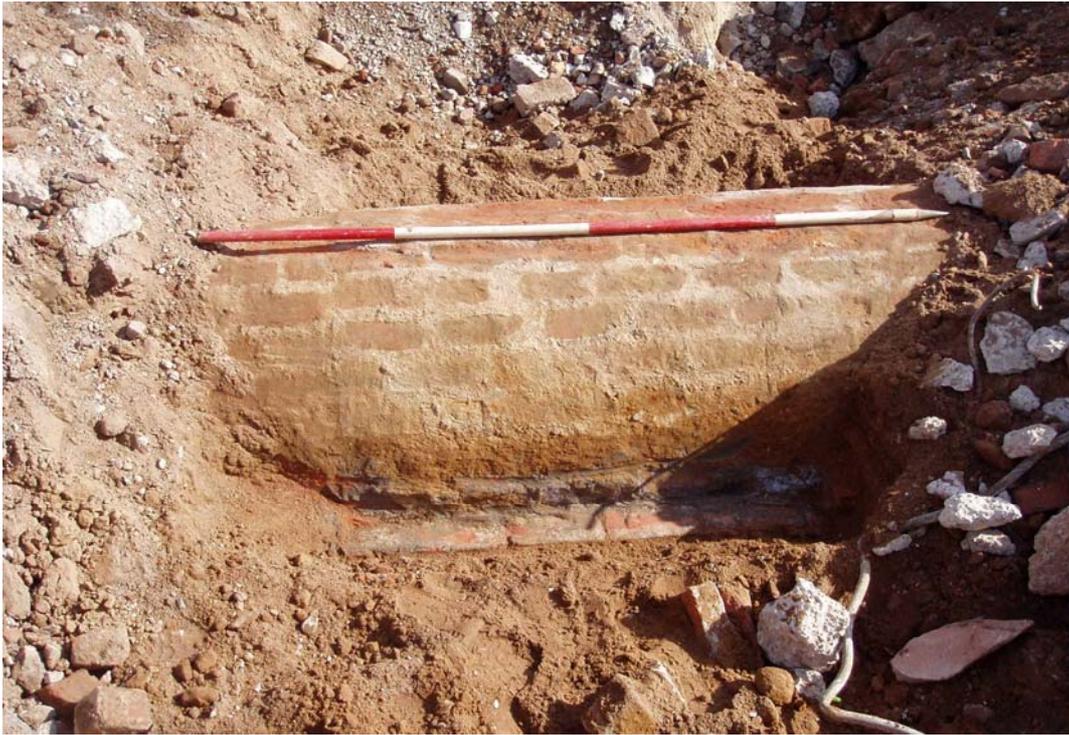
Plate 7: Brick culvert *7005*, looking east

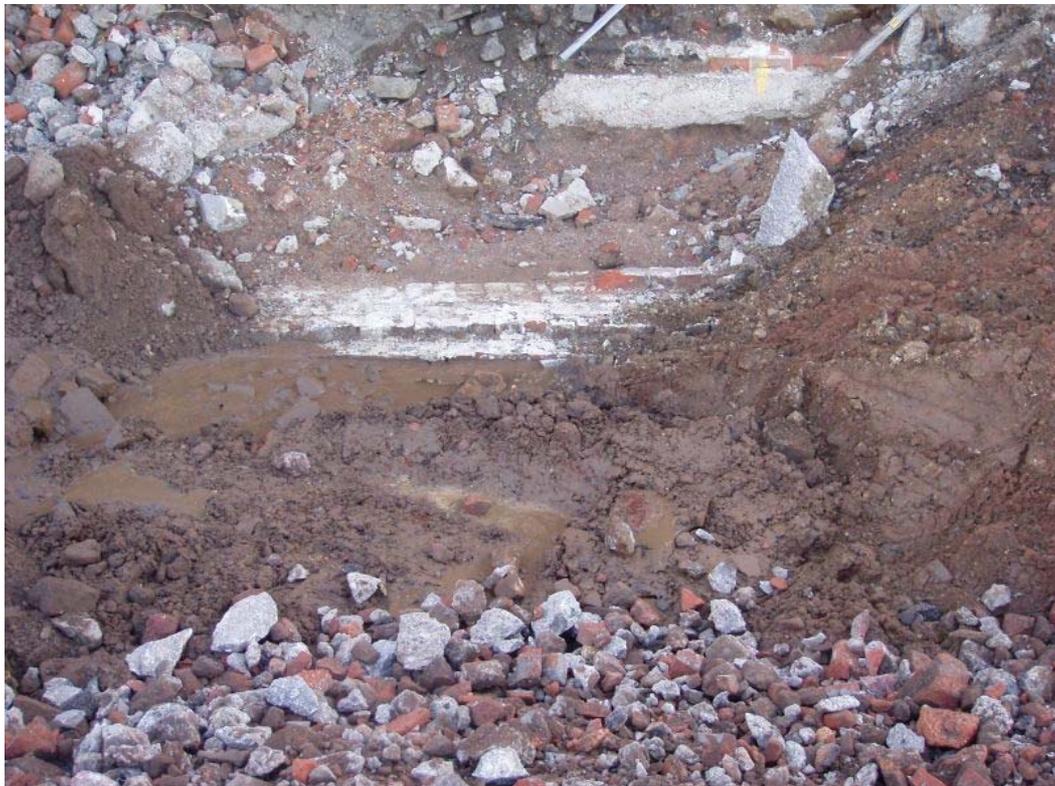
6.3.2 The bulk of the remains of George's Baths (built in 1828) lie mostly beneath the Shanghai Palace building, but brick wall **7003** revealed in the southern part of the trench, and aligned east north east/west south west, had brickwork of the right period and was probably related to the northern extent of the baths; its brickwork was generally in good condition where it was uncovered.

Plate 8: Plan view of wall *7003*, the northern wall of George's Baths, looking south
