# Jubilee Colliery, Shaw, Oldham

## Community-led Archaeological Investigation

**Oxford Archaeology North**

November 2014

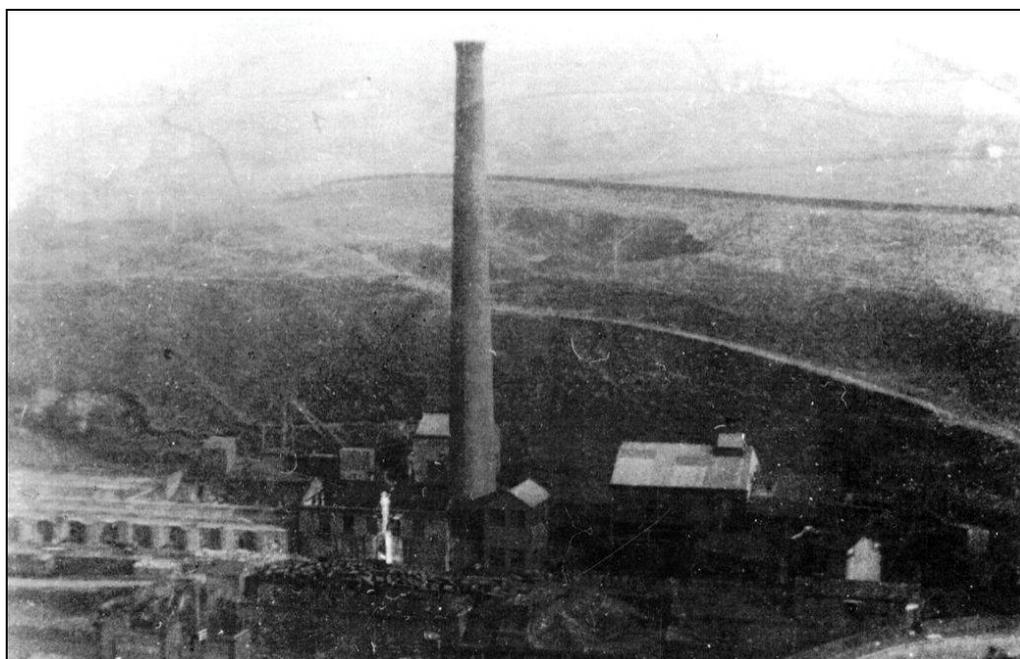
*Plate 1: Jubilee Colliery in the 1930s, shortly after it had closed, showing the pit bank around the downcast shaft, including the winding engine house (to the rear), chimney and boiler house (missing its roof), coke ovens (far left), and railway sidings in the foreground*

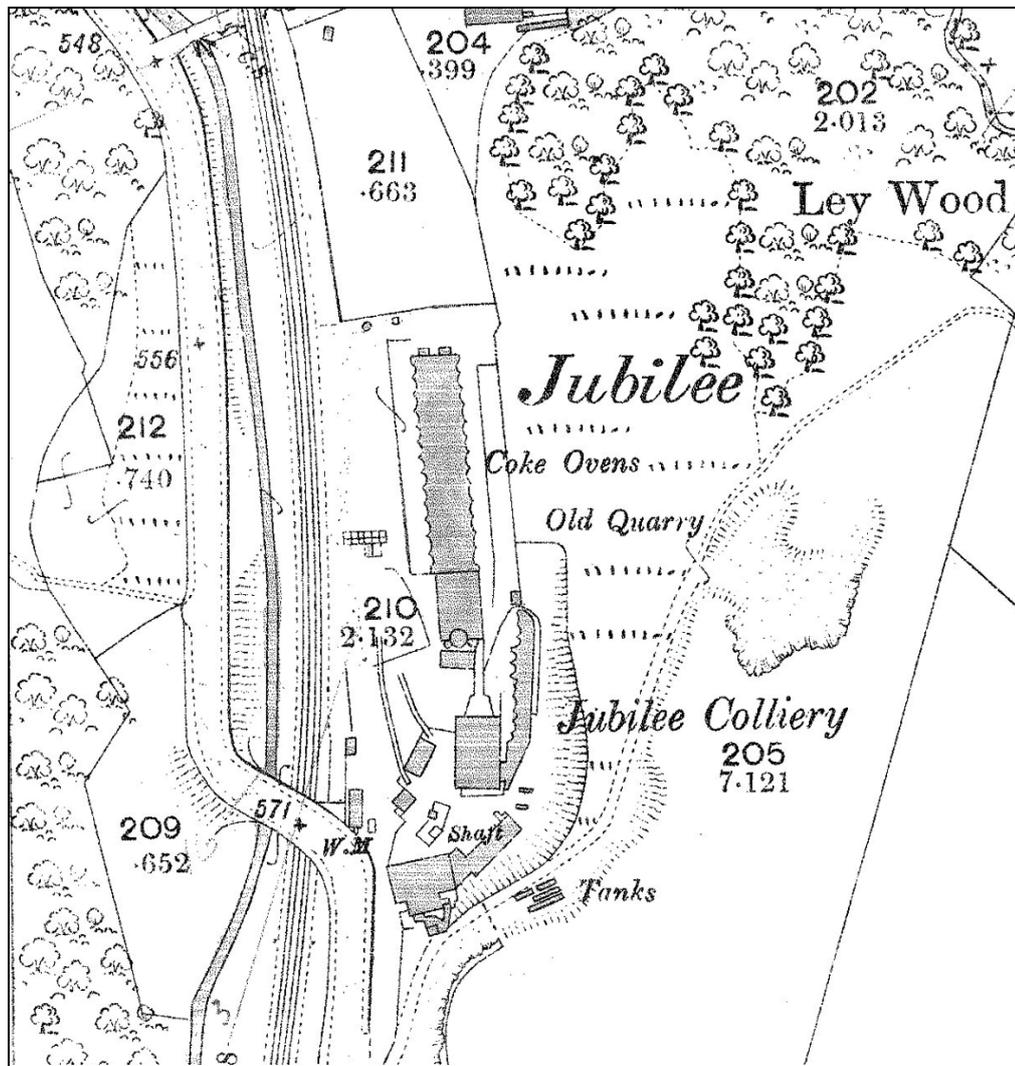
Plate 4: Extract from the Ordnance Survey map of 1893

- 3.3.5 The layout of the whole colliery site during this period is captured on the Ordnance Survey map published in 1893 (Plate 4). This shows the bank of 26 coke ovens arranged back-to-back occupying the northern part of the site, with the large boiler house and chimney immediately to the south. Another bank of coke ovens is shown along the eastern boundary of the complex, although this appears to have been a single row of ovens, suggesting that they may have been of a slightly earlier date. The railway is shown passing the colliery immediately to the west, although no direct link to the railway is evident.

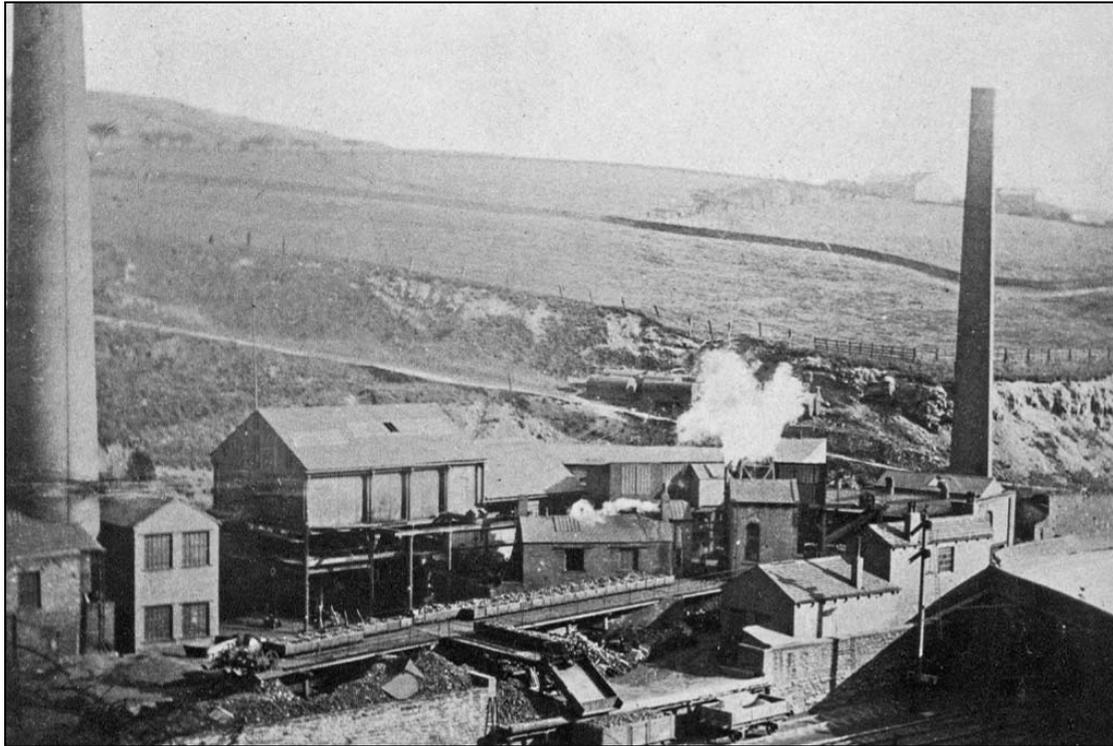
*Plate 5: The pit bank in c 1900, showing some development of the site since the photograph of c 1893. The crushing and washing plant appears to have been renewed and enlarged, and a new range housing offices and the lamp room had been built in front of the winding engine house*

- 3.3.6 A fatal accident at the colliery was reported in 1898. John Longstaffe of Buckley Square in Milnrow, age 18, was going down an incline in the pit with a tub laden with coal. Having failed to put the 'scotches' in the wheels of the tub, it pushed him down the incline for about 20 yards when it overturned and killed him (*Manchester Times*, 21 October 1898). By this date, the colliery employed 153 men underground and 14 surface workers. Several evocative photographs of the colliery were taken during this period, which again focus on the pit bank, and provide some evidence for improvements that were carried out to the site during the late 1890s (Plates 5 and 6).

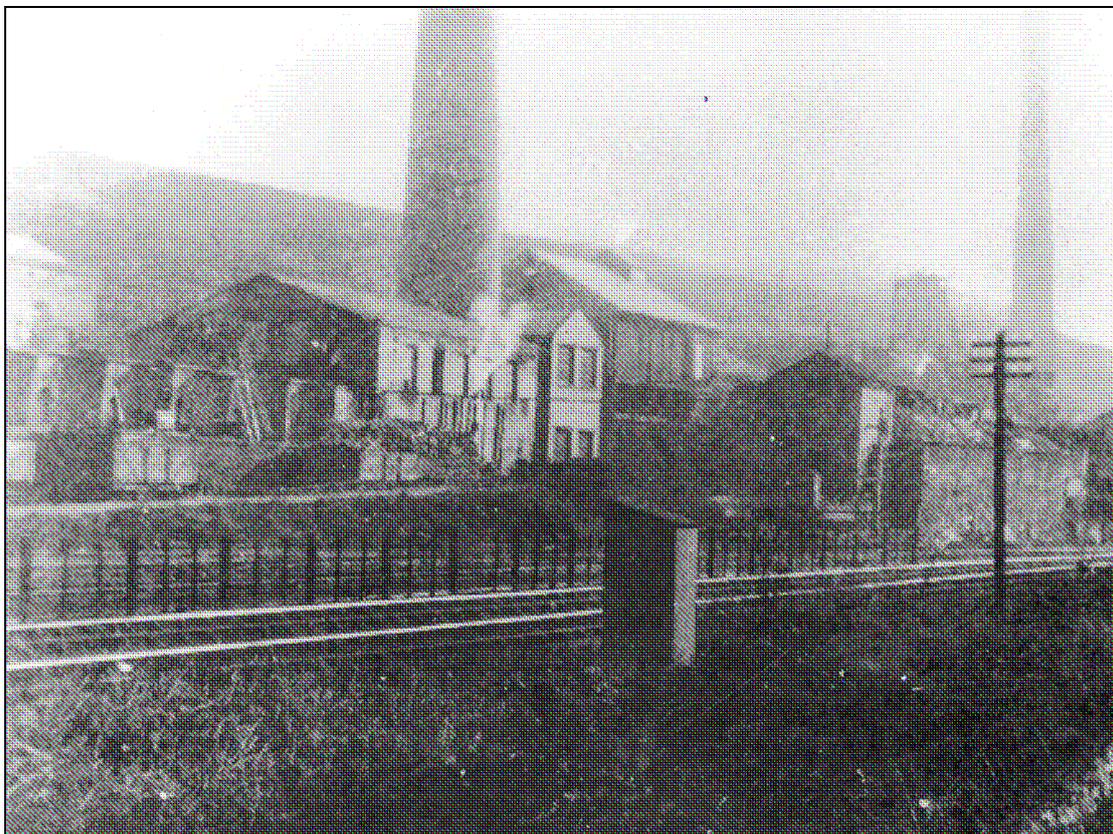
*Plate 6: A view of the boiler house and railway sidings in c 1900. Part of the bank of coke ovens is also visible*

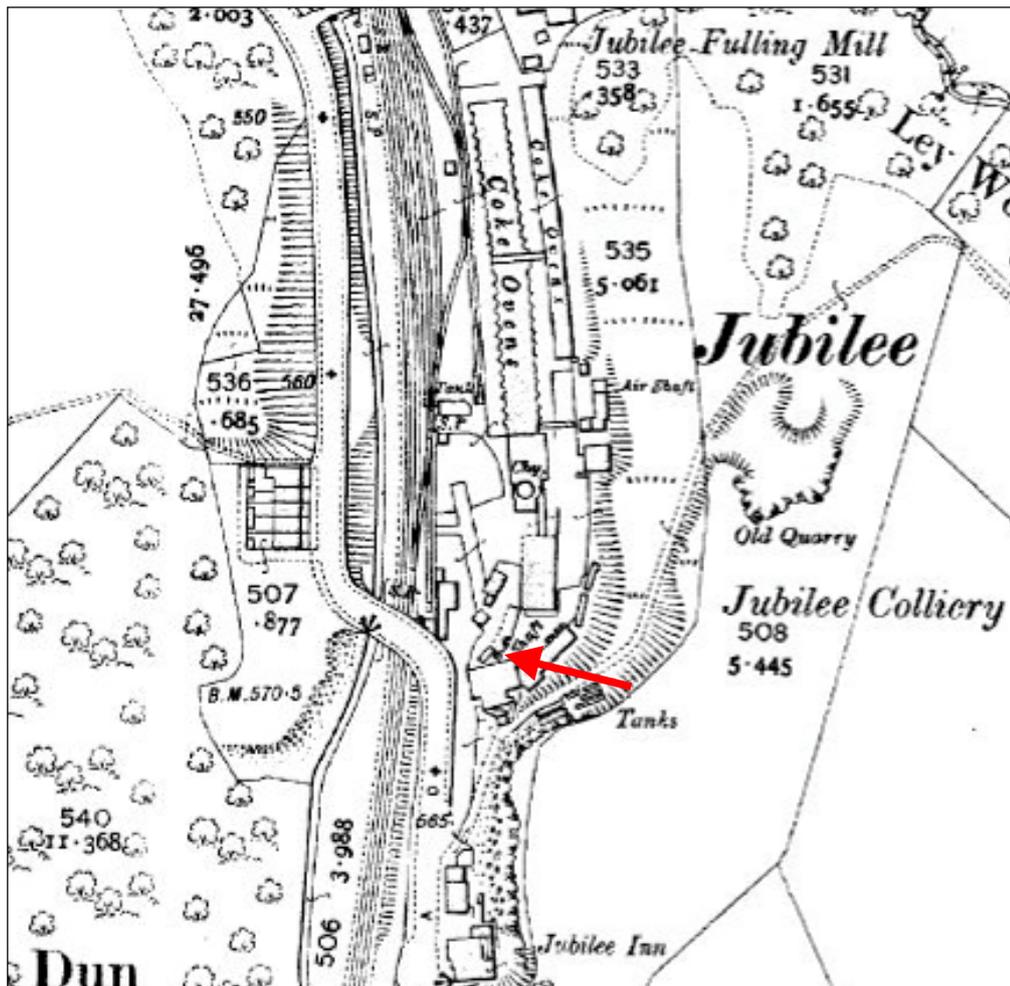
Plate 7: The Ordnance Survey map of 1909, with arrow marking the downcast shaft

- 3.1.7 A notable addition to the colliery marked on the 1909 map is the upcast, or air shaft, which is shown to the east of the coke ovens. This will have been intended primarily to improve ventilation in the underground workings, which will have been assisted by a steam-driven fan. The engine that powered the ventilation fan was housed in the L-shaped building immediately to the south of the shaft. It has been suggested that the coke ovens were charged by means of a gravity-fed tramway running from the upcast shaft to the tops of the ovens (Nadin 2006, 128).

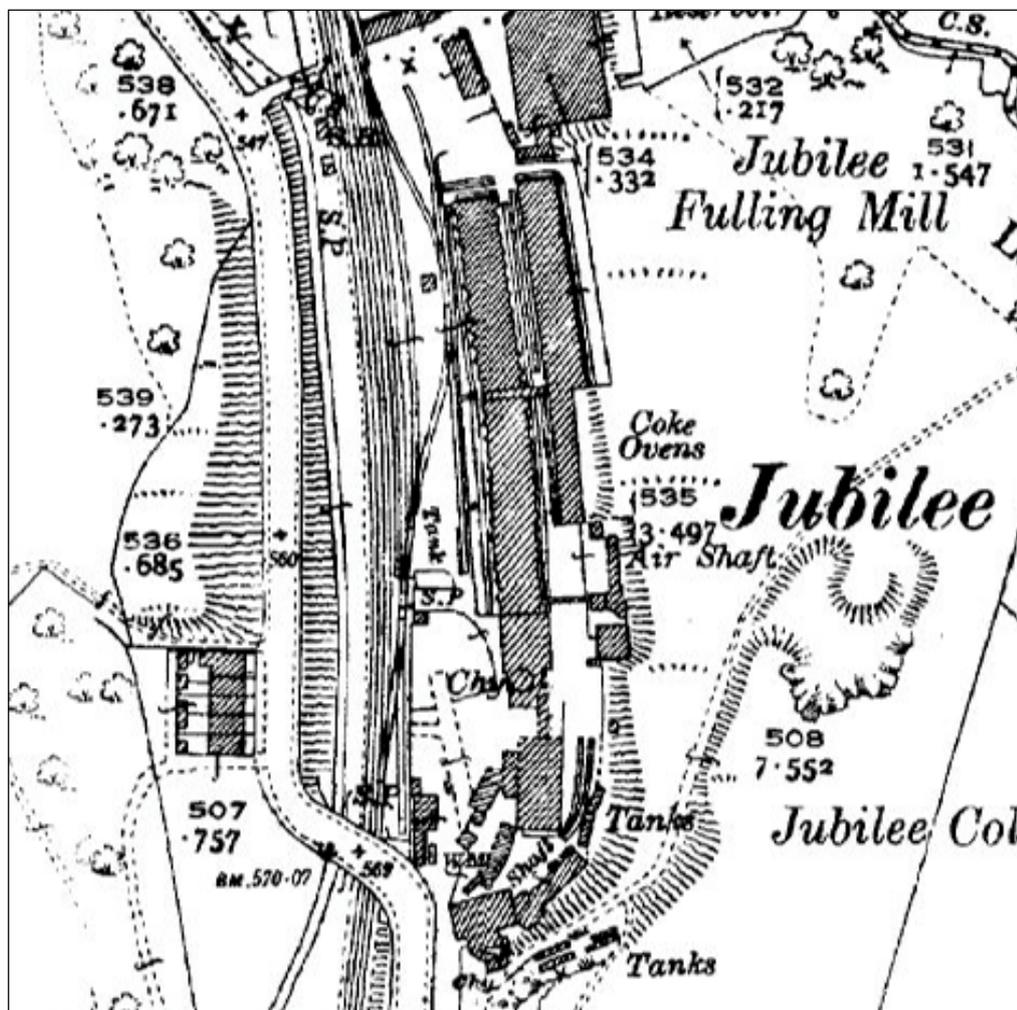
Plate 8: Extract from the Ordnance Survey map of 1930

- 3.1.10 The layout of Jubilee Colliery at its greatest extent is captured on the Ordnance Survey map of 1930, which shows further expansion of the site since 1909 (Plate 8). In particular, the single row of coke ovens in the north-eastern part of the site appears to have been expanded creating, at least in part, back-to-back ovens.

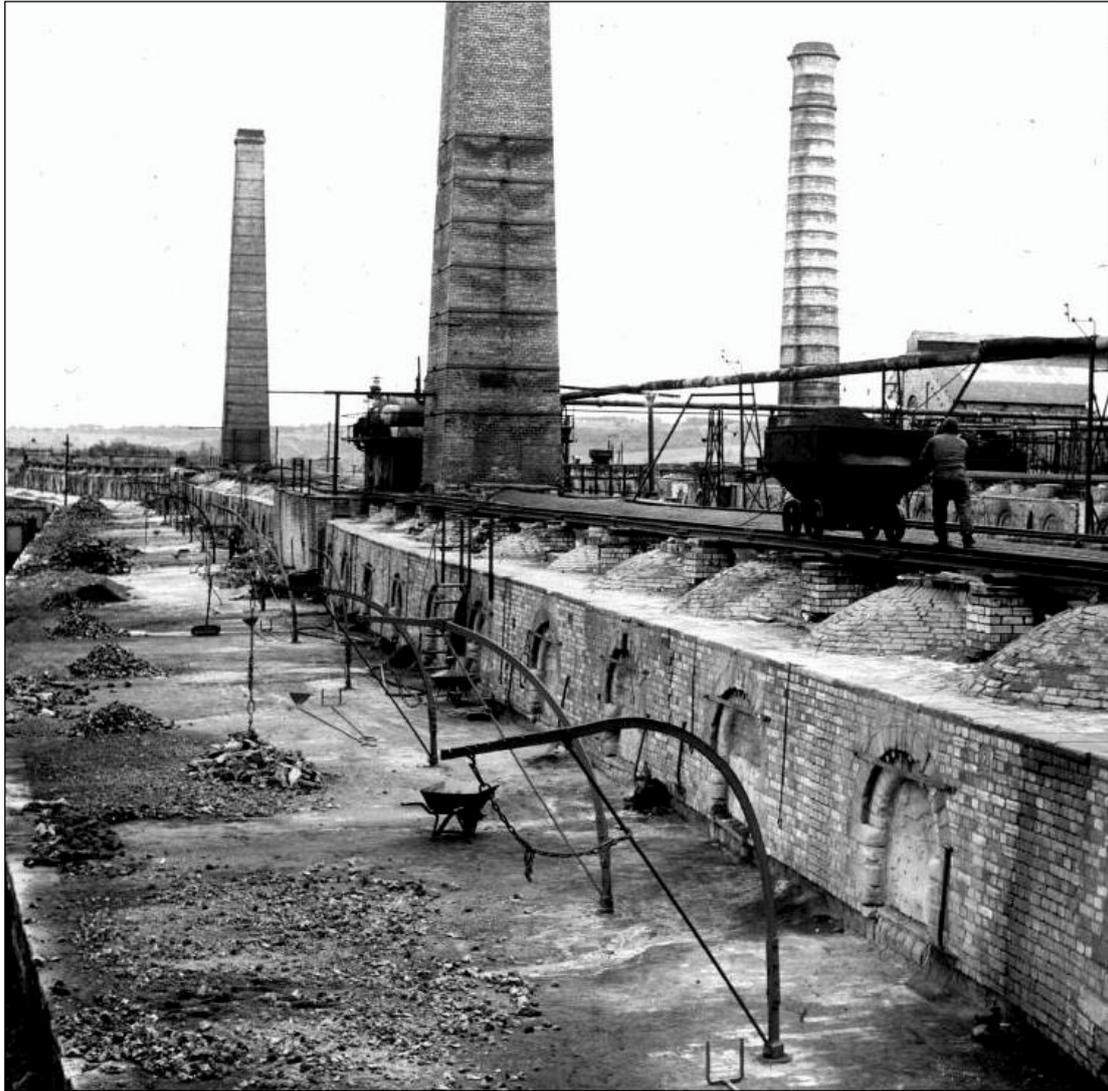
Plate 9: A bank of beehive coke ovens

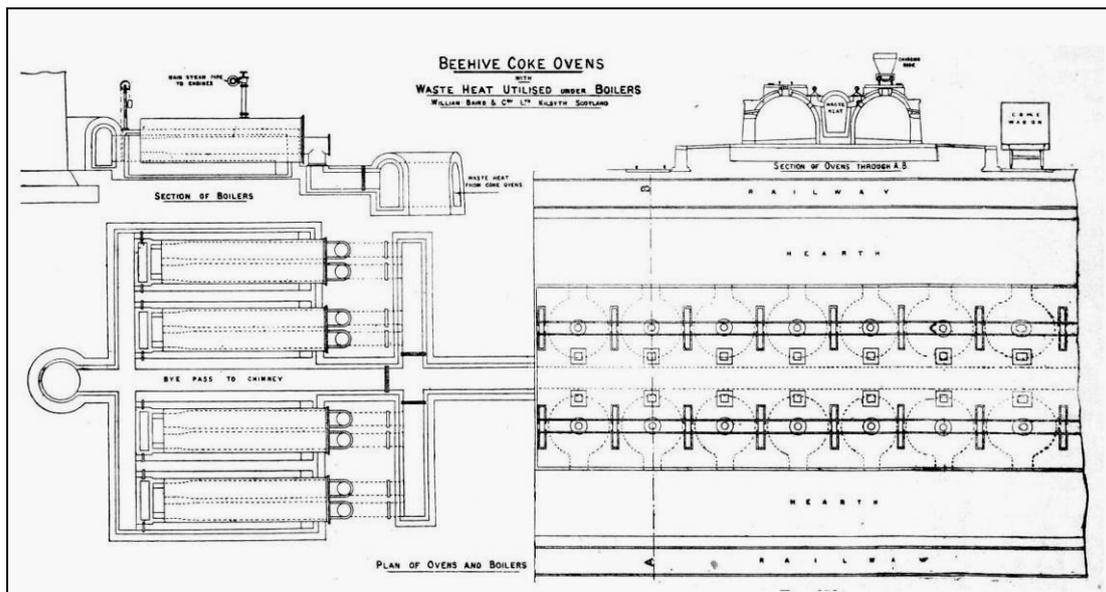
Plate 10: Plan and section of beehive ovens and associated boiler house

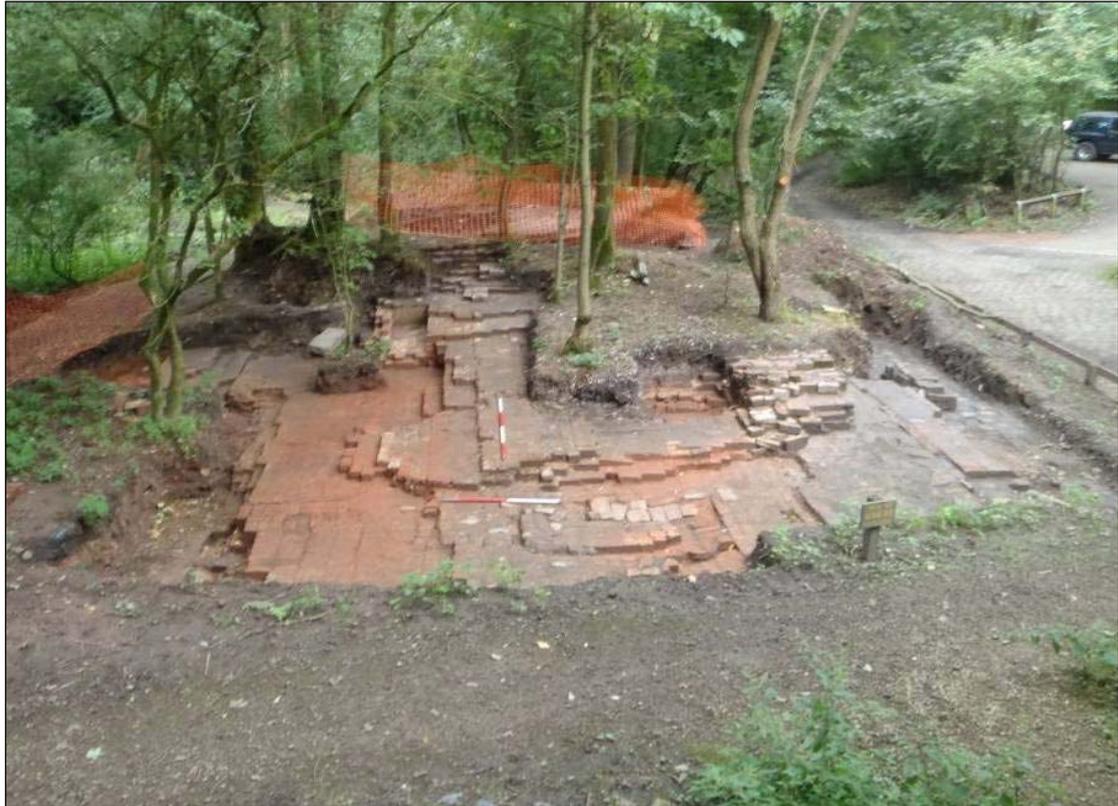
*Plate 11: View across the excavated boiler house, looking south towards the chimney*

4.2.2 An irregularly-shaped trench, with maximum dimensions of approximately 10 x 10m was placed on the southern side of an entrance path into the site, and was bounded by a southern return of the path on its eastern side, and by the extant cobbled track to the west (Fig 2-5). At its southern end, the trench was linked to a 7 x 7.5m excavation area around the chimney (*Section 4.3*). Excavation revealed well-preserved *in-situ* remains of the boiler house immediately below the present ground surface (Plate 11). The extant fabric comprised several floors surfaces, all composed of hand-made, mould-thrown bricks (Plate 12), many of which were stained red by exposure to heat. The central part of the trench was typically raised two to three courses higher than the surrounding floor, and represents the 3' (0.91m) wide base of a flue, which ran from the coke ovens to the north into the chimney immediately to the south (Plate 13). The outer part of this structure also appeared to have formed the edges of the raised beds carrying the cylindrical boilers. A similar 3' raised brick boiler bed survived to a higher level at its southern exposed end, in the north-western corner of the trench (Fig 6). This comprised six courses of horizontal and edge-set red bricks and refractory bricks at its maximum, but was marked only by the different alignment of the bricks at extant floor level, to which it had been reduced at its southern end. The area between these two raised beds was stained red, and comprised up to two courses of brickwork, mainly of refractory type, forming the floor beneath the boiler.

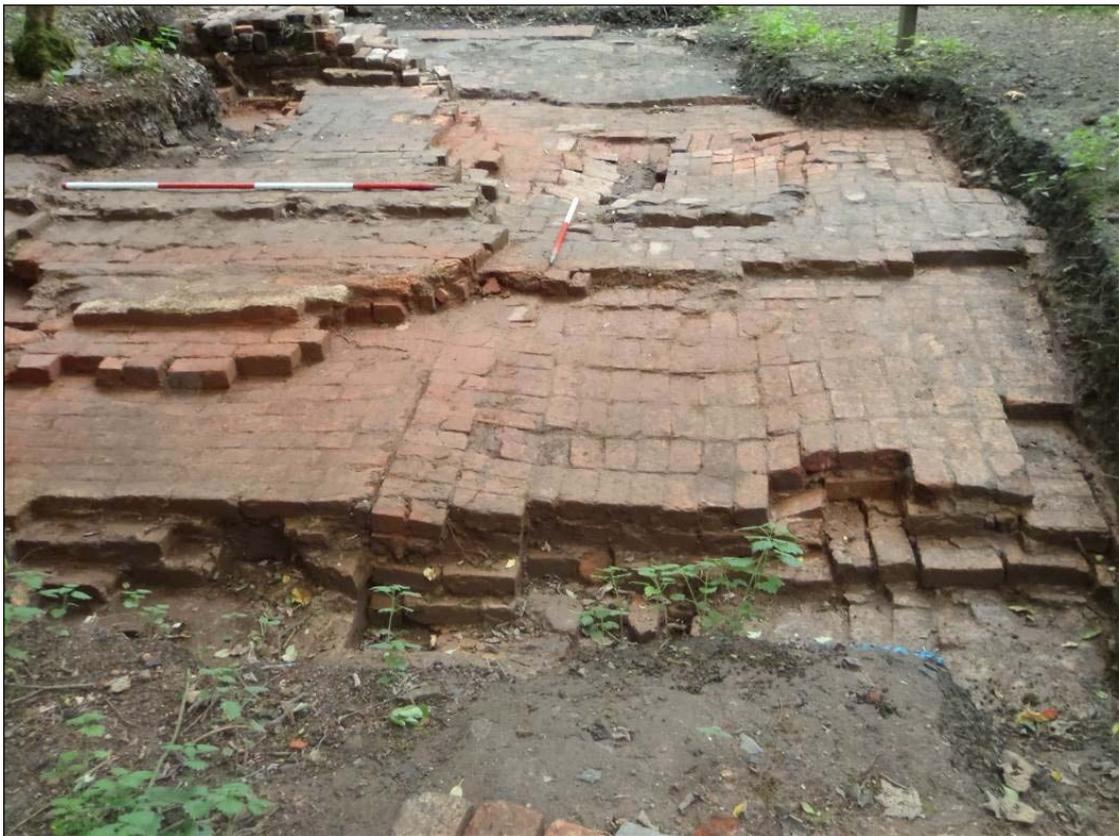
*Plate 12: The foundations for the boilers, showing part of the base of the flue*

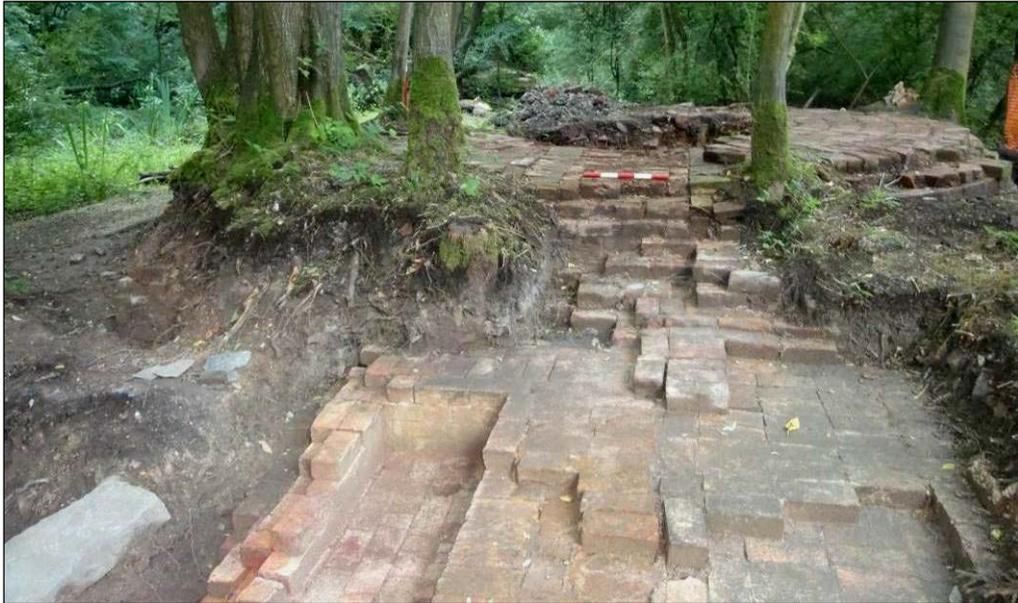
*Plate 13: Base of flue from coke ovens extending beyond boiler house into chimney*

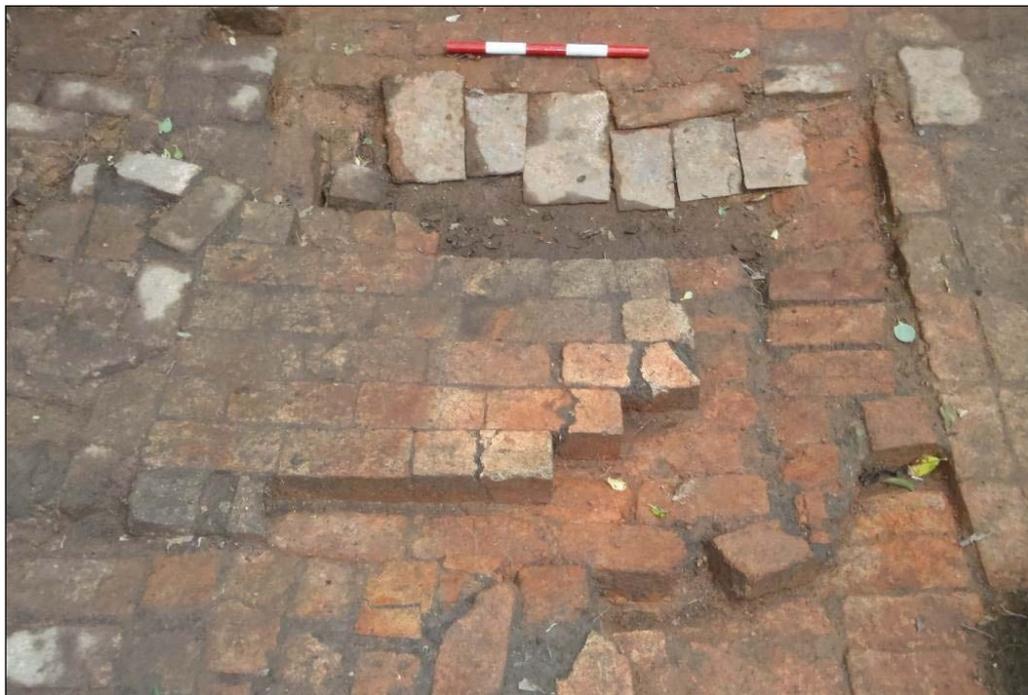
*Plate 14: An area of sagging brickwork, with sloping slates to the south*

- 4.2.3 The area lying between 1.5 and 1.8m from the northern edge of the exposed floor had a noticeable sag and appeared to have had several episodes of repair, including a row of sloping slates at its southern end (Plate 14). Much of the extant flooring to the north comprising only fragments of brick, bonded in a black sooty mortar, typical of the turn of the twentieth century, rather than the more regularly coursed brickwork to the south. It is possible that the floor had sunk into a void, possibly representing blow-down holes for earlier small Cornish boilers, which appear to have been replaced with longer Lancashire boilers in the late nineteenth century.

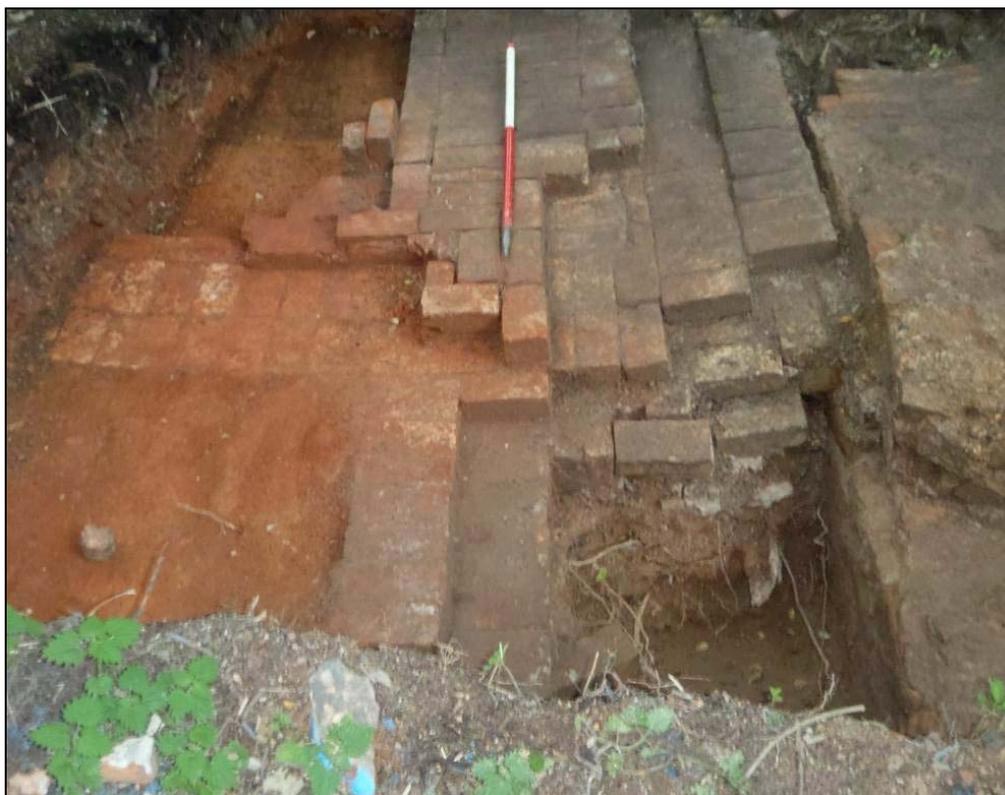
Plate 15: The floor of the boiler house to the east of the central flue, showing part of the earlier stone-built wall

- 4.2.4 To the east of the central flue, the floor was similar to that to the west, and was again heavily stained by heat (Plate 15). In the northern part of the trench, its eastern side was truncated, showing the floor to be of four-courses depth, with it surviving to its full width of 8' (2.44m) only at its southern exposed end. Here it comprised only two courses of brick fragments, bonded in a grey cementitious mortar, and overlying a sandstone rubble wall, only exposed on its outer edge, to a depth of 0.35m (Plate 15). This probably represented the original eastern wall of the original mid-nineteenth century boiler house, but this could not be investigated further without damaging the extant remains of the later phases.

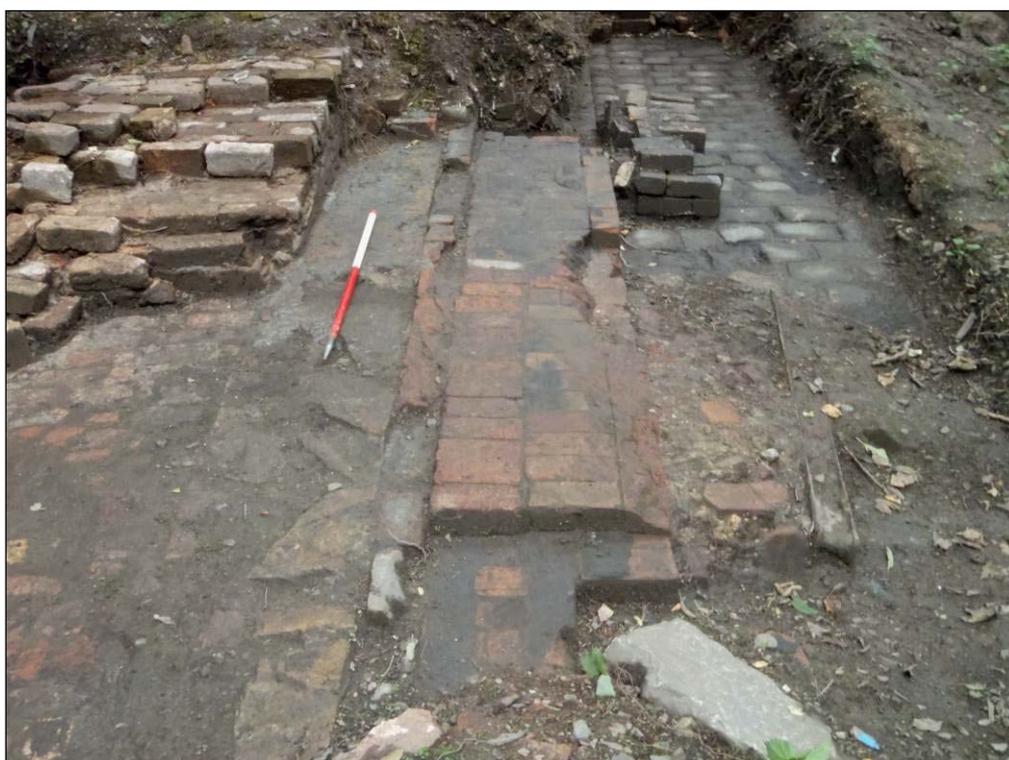
*Plate 16: The stone-built western wall of the boiler house*

- 4.2.6 Another stone wall of 0.45m thickness was observed in the western part of the trench (Fig 6). It was of fragmentary sandstone construction, faced on both sides and with a rubble core, and formed the western external wall of the boiler house (Plate 16). It was abutted on its western side by a 4.5m length of 0.75m wide floor, of brick construction, comprising two rows of machine-made brick set between rows of edge-set brick (Plate 16). This was bonded in a black sooty mortar, and overlay a brick levelling course of similar width. Remains of a cast-iron rail, set within an indurated rubble deposit immediately to the west raises the possibility that the narrow short floor formed a threshold for a sliding door, probably inserted in the late nineteenth or early twentieth century.

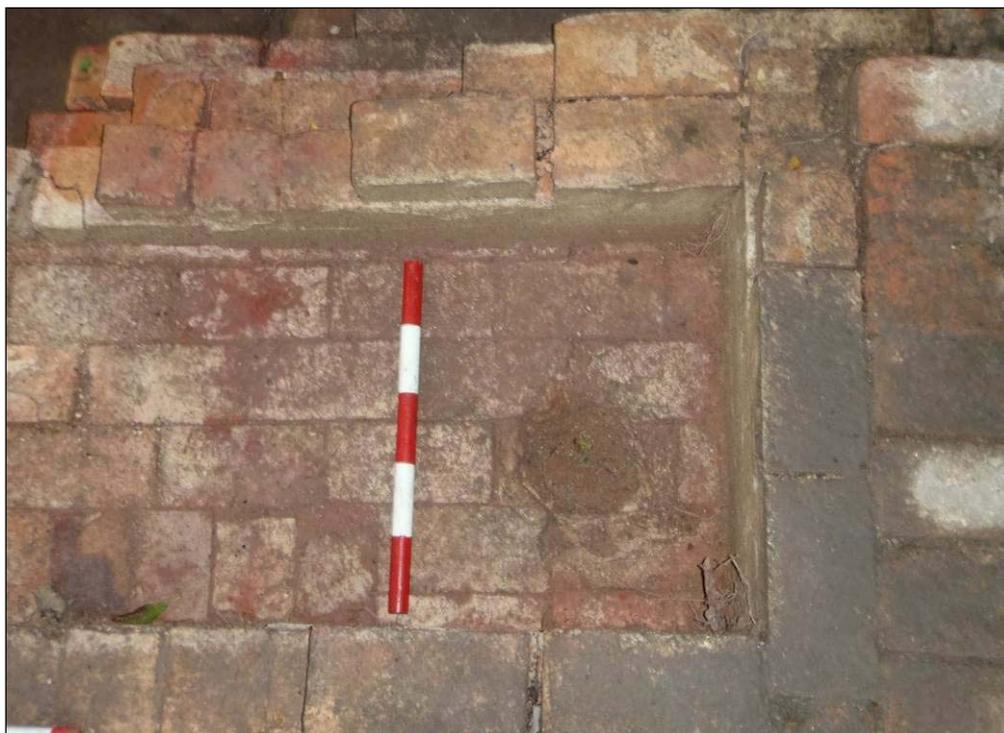
Plate 17: Narrow flue set towards the rear of the boiler bed

- 4.2.7 Within the central boiler bed, at its southern end, the well-preserved remains of an internal wall survived to a height of up to four courses. It was of refractory-brick construction, with the floor of similar brick surviving to two additional courses above that surrounding, and with a full-brick thickness wall forming its eastern side (Plate 17). It formed a narrow flue that was 0.51m wide within the boiler bed, and had a central circular aperture within its base of 0.20m diameter. This had presumably housed the base of a butterfly valve at the rear of the boiler. Although longitudinal walls within boiler beds were a feature of Lancashire-type boilers, these were generally of only single-skin thickness, and the excavated example was placed too close to the western side of the boiler bed to split the flow of exhaust gases efficiently. It is therefore probable that this represented part of the flues to the rear of the boiler, and that to the east was built following the extension of the boiler house in the late nineteenth century.

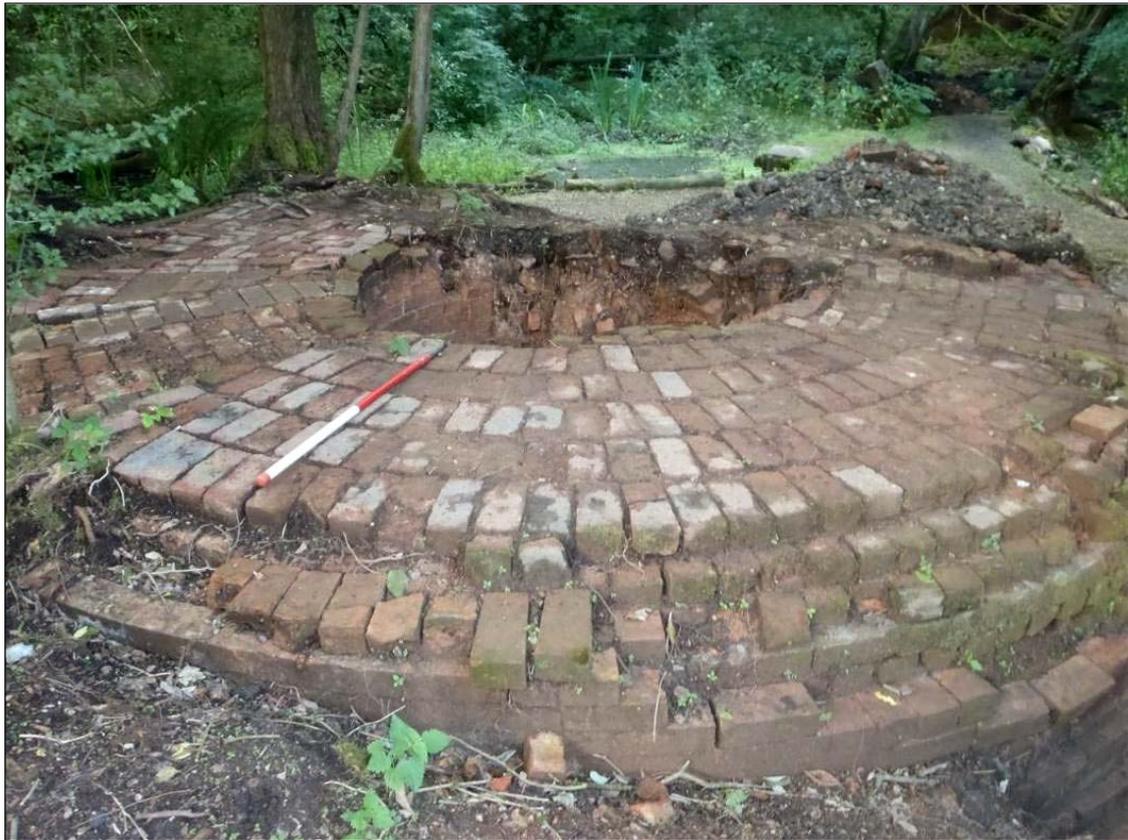
*Plate 18: General view across the excavated remains of the chimney*

- 4.3.2 The main structural element of the chimney that survived comprised six radial courses of hand-made bricks (Plate 18), forming a wall of 5'5" (1.68m) thickness around a central 7' (2.13m) diameter circular chamber (Plate 19). Externally, the six courses of the chimney wall were set on a raking plinth, observed to a depth of eight courses (Plate 20), but almost certainly extending to a much greater depth.

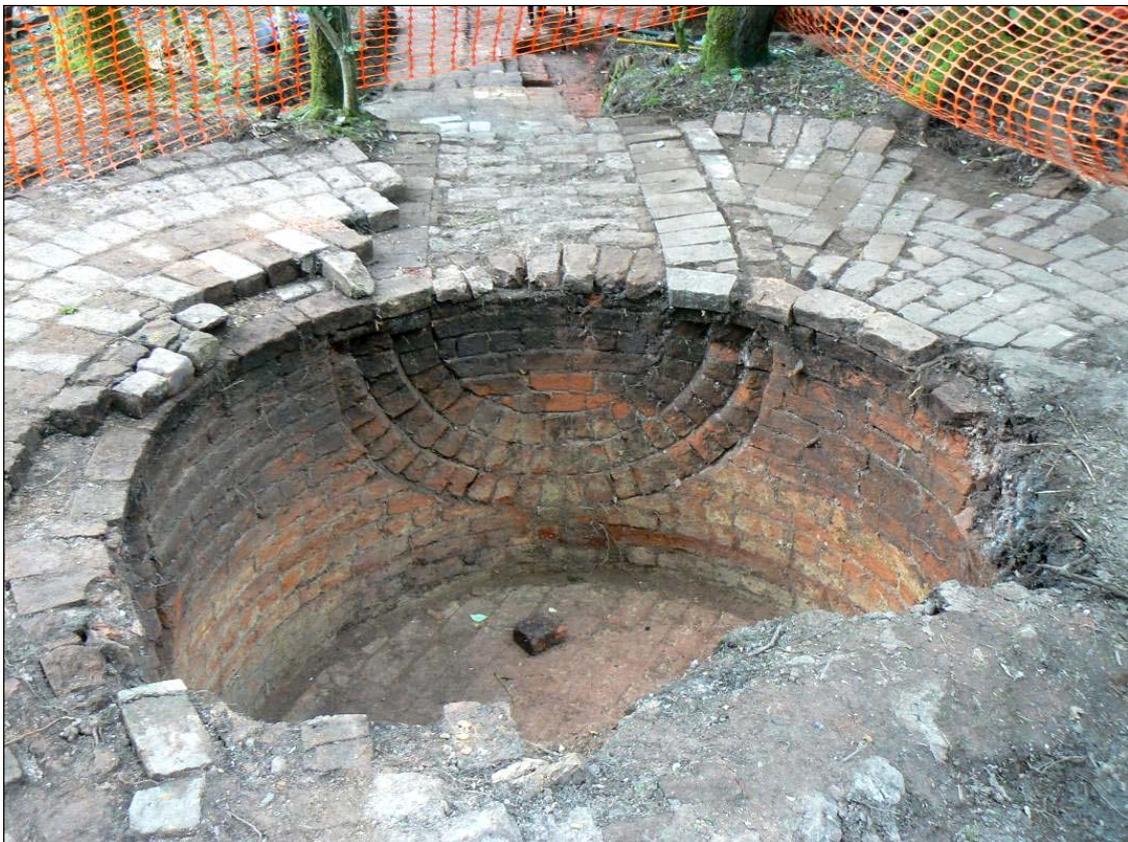
*Plate 19: The central chamber of the chimney*

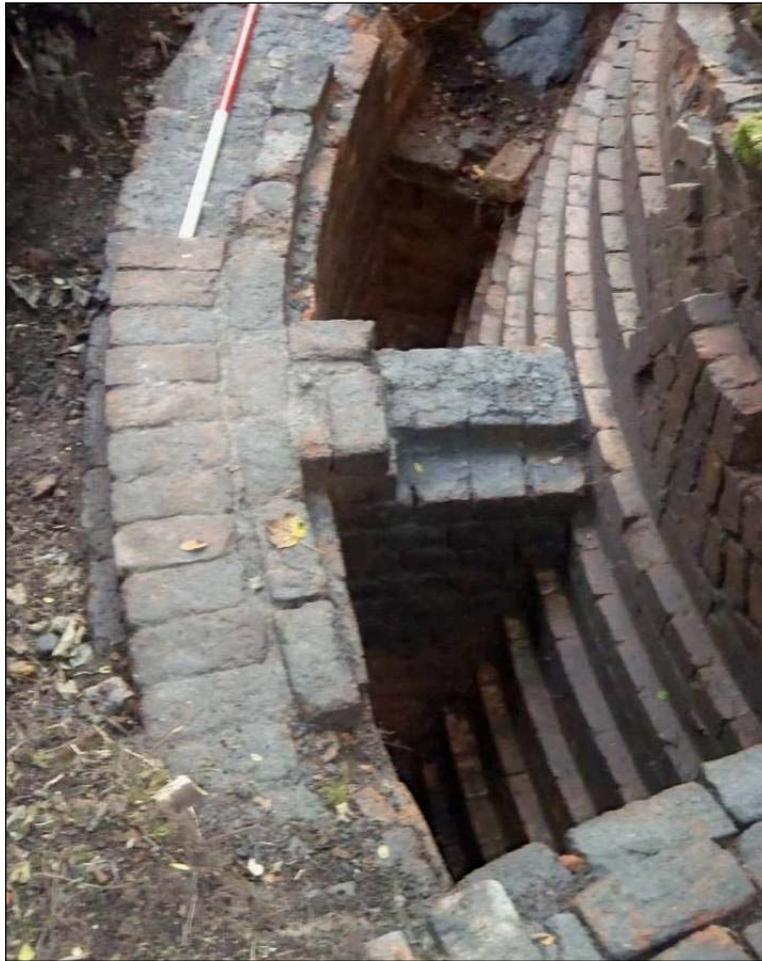
*Plate 20: The raking plinth foundation of the chimney*

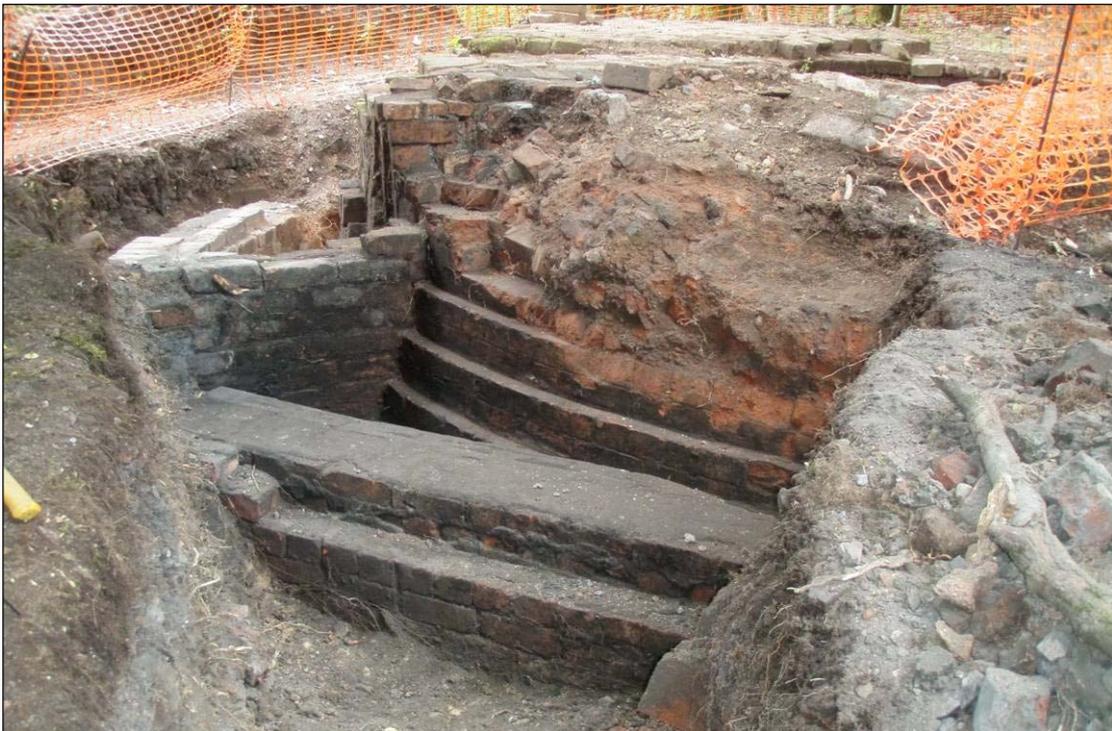
*Plate 21: Strengthening wall added to the chimney*

- 4.3.3 The foundation of the chimney had been strengthened at some point, with a 1½-2-brick thickness wall added on its outer face, with raking buttresses to the tiered base of the chimney (Plate 21). The use of black sooty mortar to bond these walls suggests it was undertaken during the expansion of the colliery in the late nineteenth century. On the southern side of the chimney, the outer wall did not follow the radial outline of the chimney, but was aligned with the structure to the south, which was also probably erected at this time.

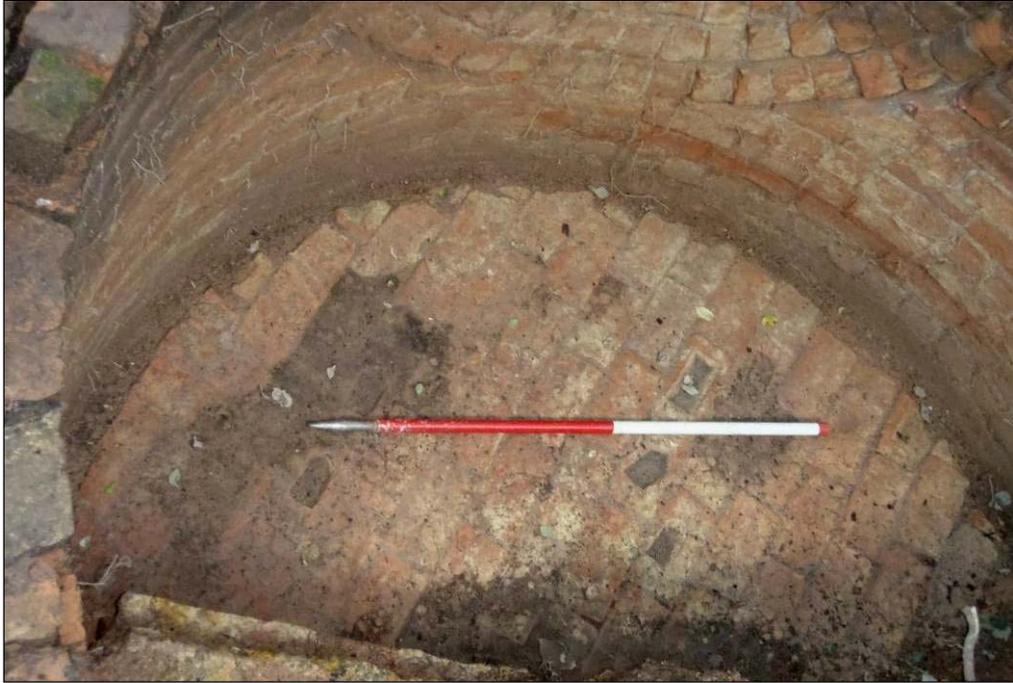
Plate 22: The exposed floor of the chimney

- 4.3.4 Part of the floor of the chimney was revealed during the excavation, generally comprising hand-made refractory bricks (Plate 22), although with several froged examples presumably representing repairs to the original fabric. A pair of cast-iron bars laid horizontally within the rubble infill of the chimney (Plate 23), almost certainly represent lintels to access hatches or flues, rather than remnants of control valves or fan apparatus set within the chimney base.

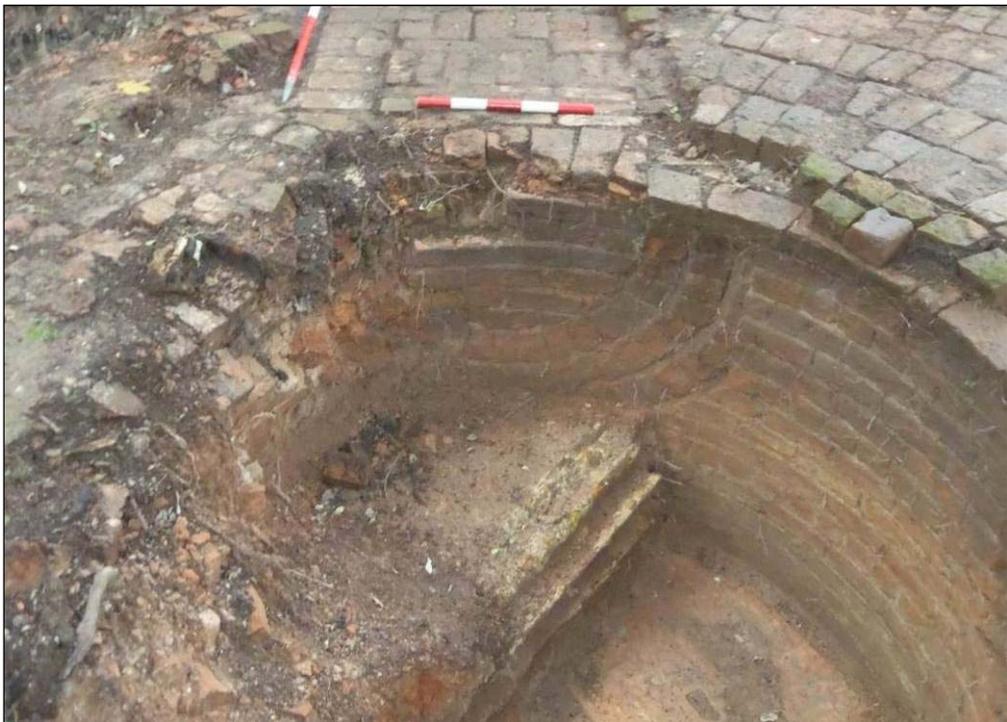
Plate 23: Cast-iron bars exposed at the base of the chimney

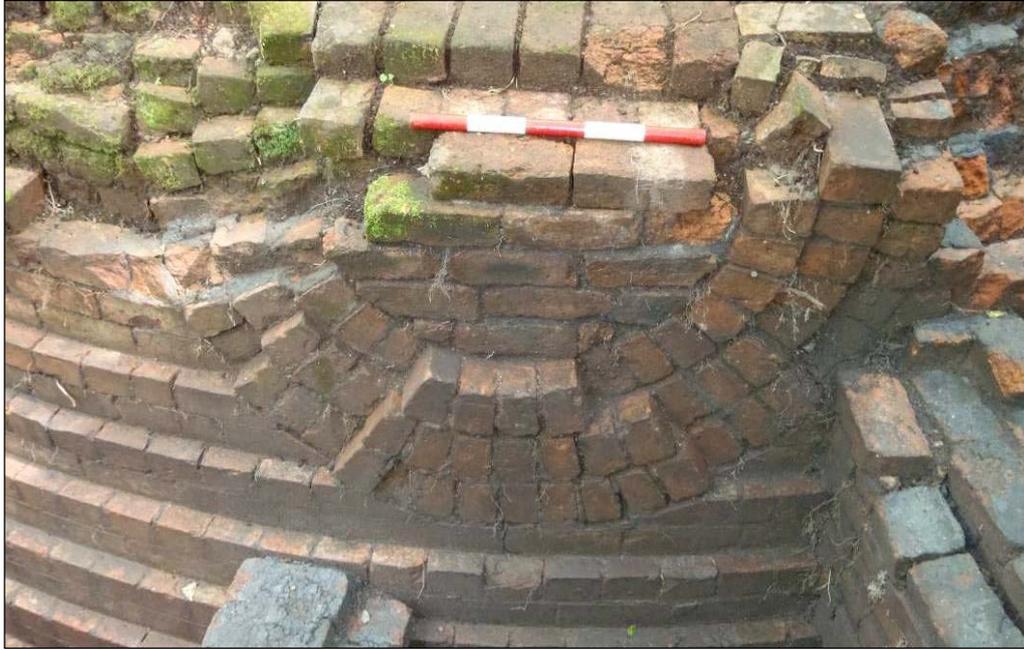
*Plate 24: Relieving arch associated with a flue on the south-western side of the chimney*

- 4.3.5 Within the walls of the chimney, two relieving arches, comprising three courses of brick, were placed below two brick flue bases (Plates 24 and 25). These were 2'6" (0.76m) wide internally, and with full-brick thickness side-walls, and appeared to survive to original floor level. One was placed at the northern point of the chimney, adjacent to the boiler house, and served flues from the boilers and the coke ovens further to the north, whilst the second flue was placed in the south-western quadrant, and probably served the blacksmith's workshop, which lay in that direction. Excavation on the external side of the chimney revealed that the relieving arch associated with the south-western flue was of full-wall thickness (Plate 24).

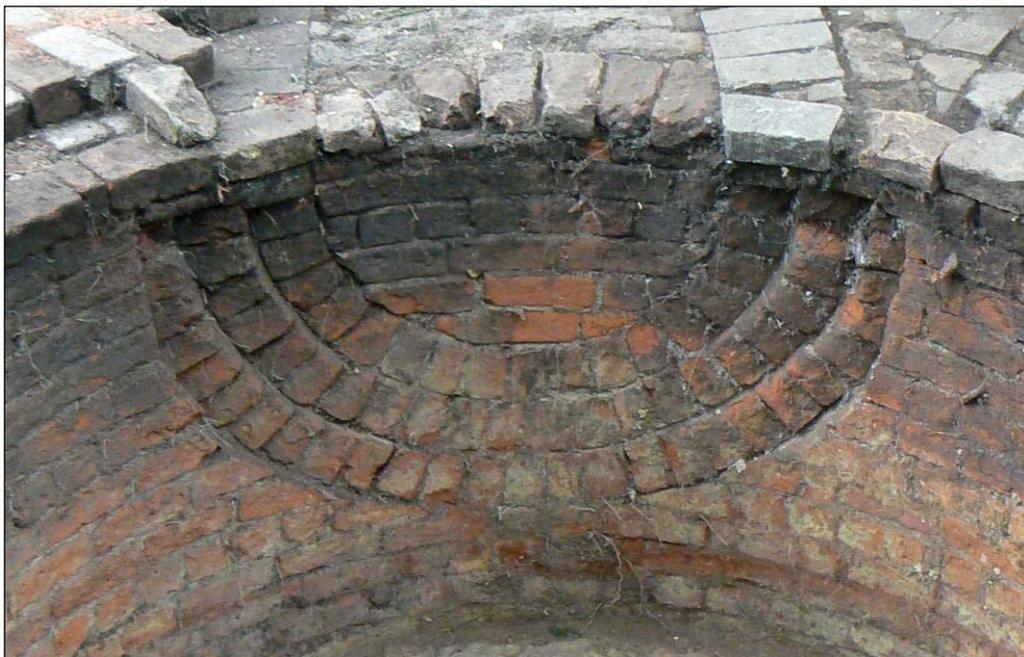
*Plate 25: Relieving arch in the northern side of the chimney*

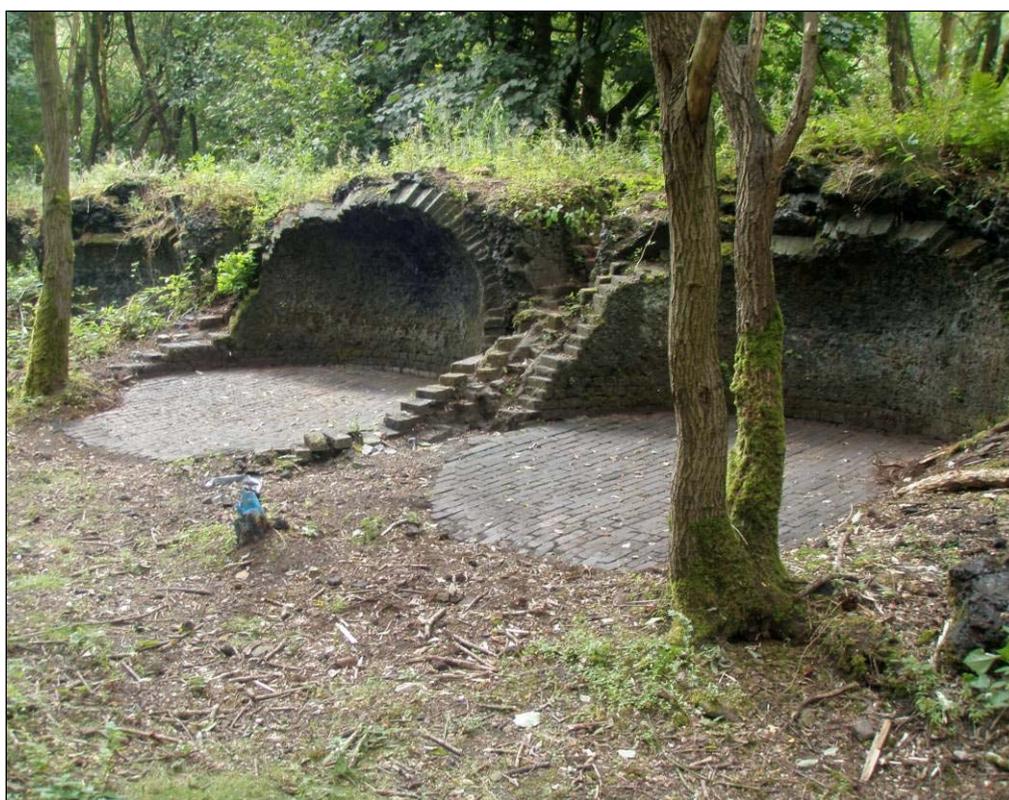
*Plate 26: General view of part of the coke oven battery, looking west*
