# Jubilee Colliery, Shaw, Oldham

## Community-led Archaeological Investigation

**Oxford Archaeology North**

November 2014

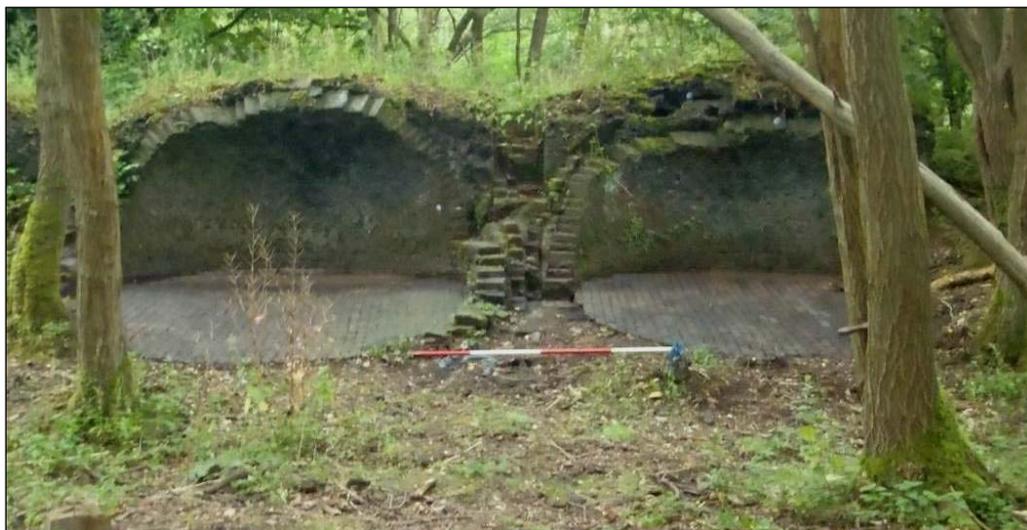
*Plate 27: View of two of the surviving coke ovens in the main double bank*

4.4.4 All of the excavated ovens in the main double bank were constructed with full-brick thickness external walls, with a vaulted roof, and with rubble infill between each oven, and a central high-level flue placed between the two rows of the battery. The heat generated by the coking process, combined with the chemicals released, led to the significant vitrification of the upstanding remains (Plate 27). The edge-set, hand-made brick floors did not have similar accumulations of vitreous deposits, however, as they were regularly exposed and scraped during the removal of the coke following firing. Several of the floors survive in near-perfect condition (Plates 27 and 28), whilst bricks within several of the others display the effects of heating, particularly in the form of cracking and erosion. (Plates 29 and 30). Root damage has further impacted on the survival of the single-brick thickness floors (Plate 30).

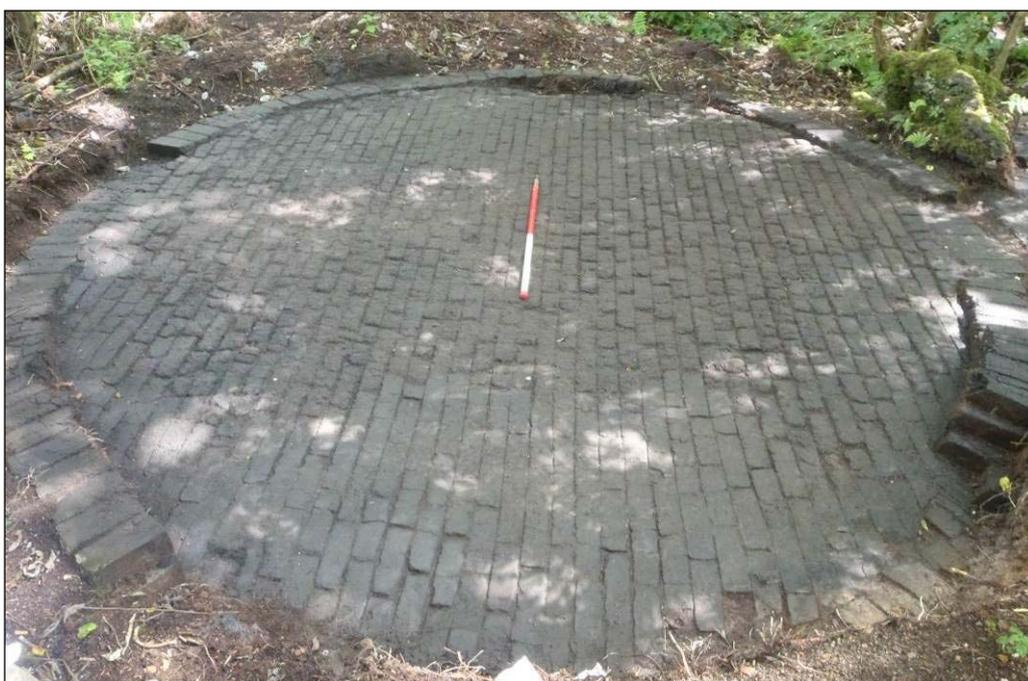
*Plate 28: The excavated floor of one of the ovens in the main double bank*

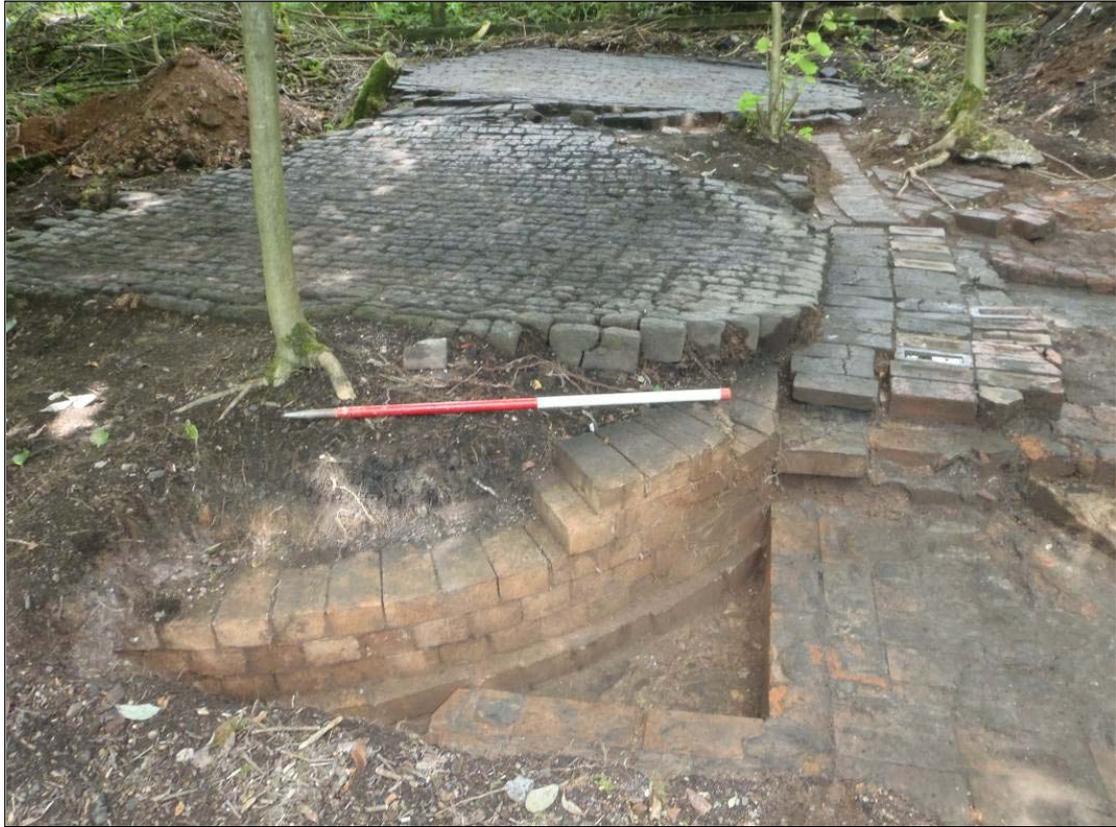
*Plate 29: The remains of one of the coke ovens added to the main double bank between 1893 and 1909*

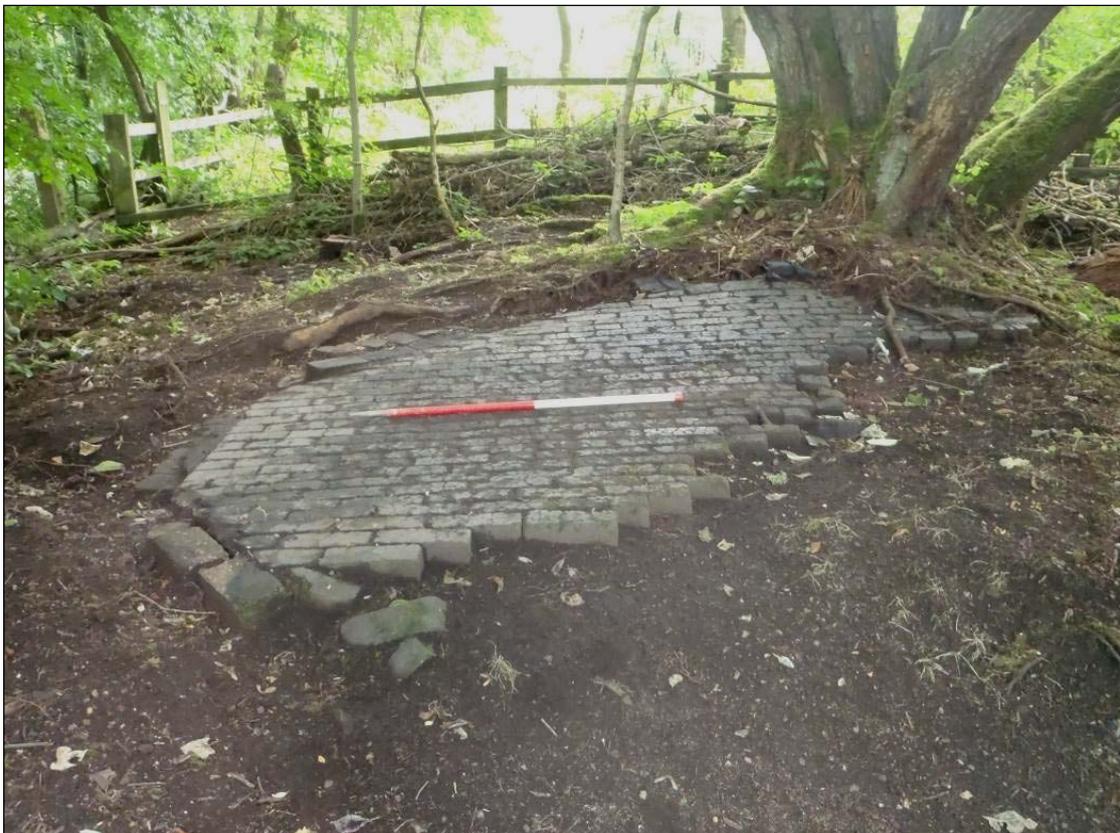
*Plate 30: The fragmentary remains of one of the coke ovens added to the site 1893 and 1909*

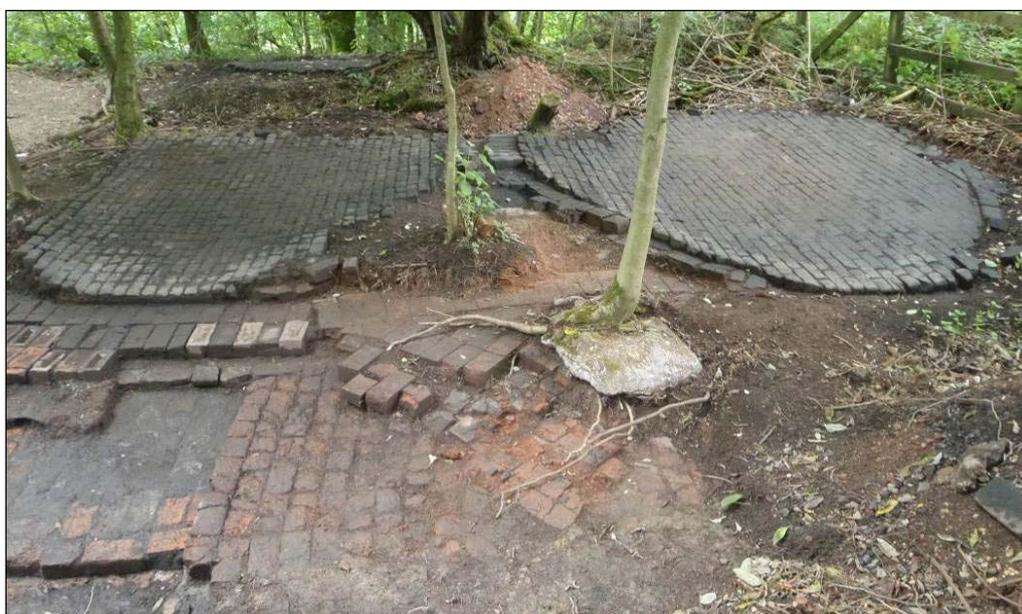
*Plate 31: Two coke ovens in the northern extension to the double battery*

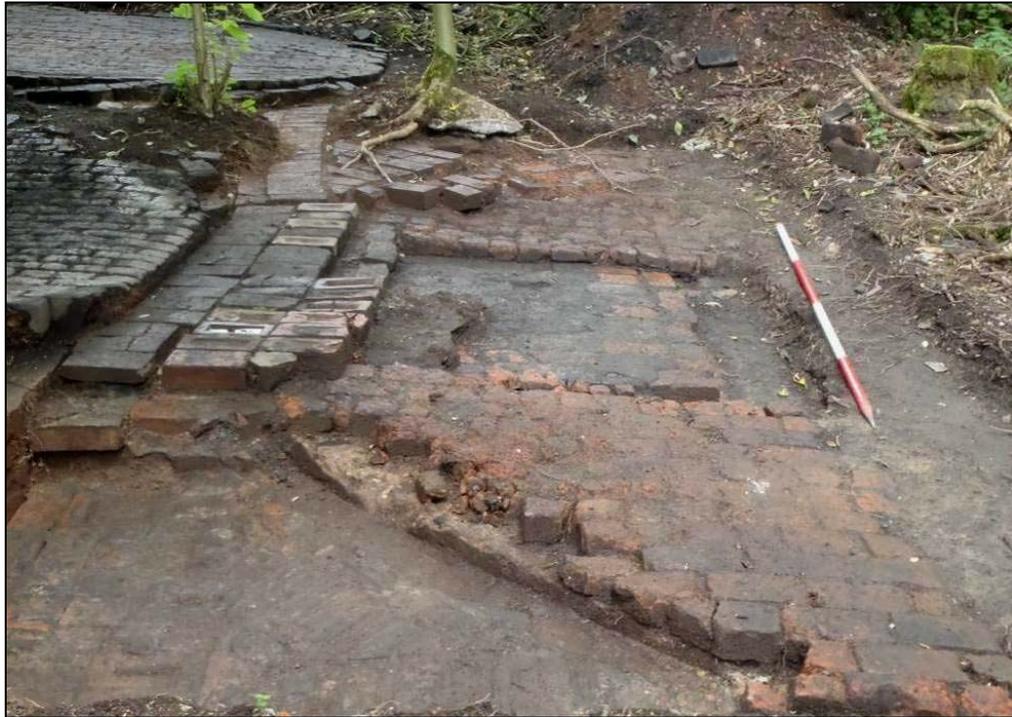
*Plate 32: The foundations for a coke oven placed adjacent to those added to the double bank between 1893 and 1909. However, whilst appearing to incorporate the exterior circular wall, Ordnance Survey mapping suggests that an oven was not actually built in this location*

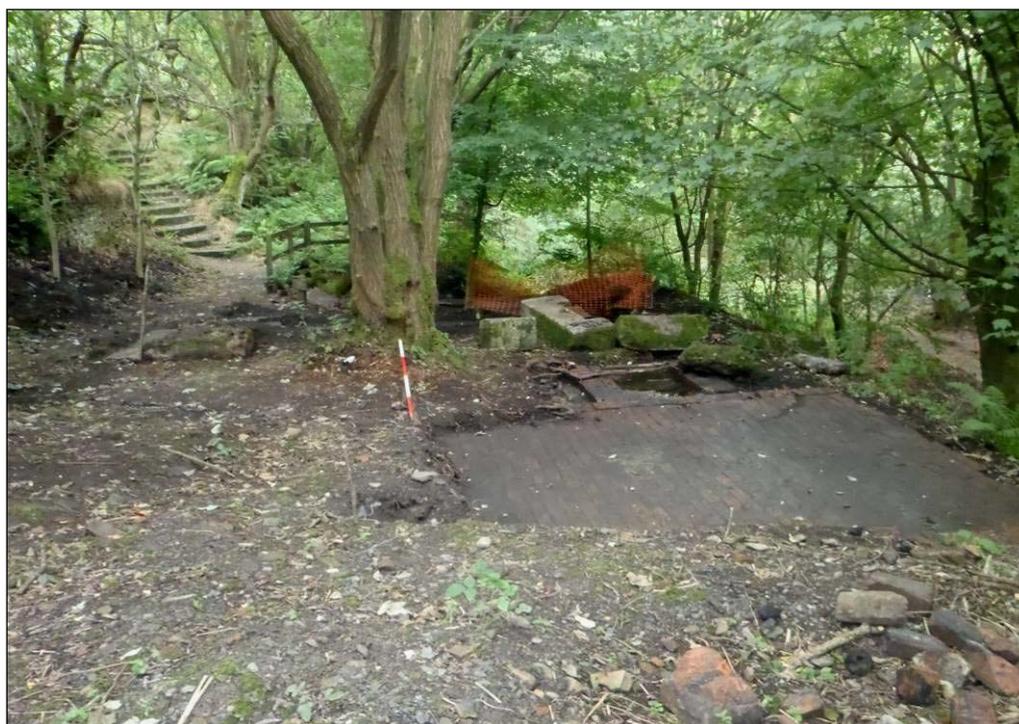
*Plate 33: General view of the trench to the south of the upcast shaft*

4.5.1 The upcast shaft took advantage of the local topography, and was placed on higher ground to the east of the complex, above a high retaining wall. It allowed for the ventilation of the underground workings, and air would have been 'pulled' up the shaft with the aid of a large fan, placed in a fan house directly to the south. Two very small trenches excavated in the previous public-led excavation in 2012 revealed well-preserved remains of these twentieth-century structures (ARS 2013). A trench of approximately 12 x 7.5m was placed in the area of the fan house, adjacent to an exposed machine base. The trench was split around a mature tree (Plate 33).

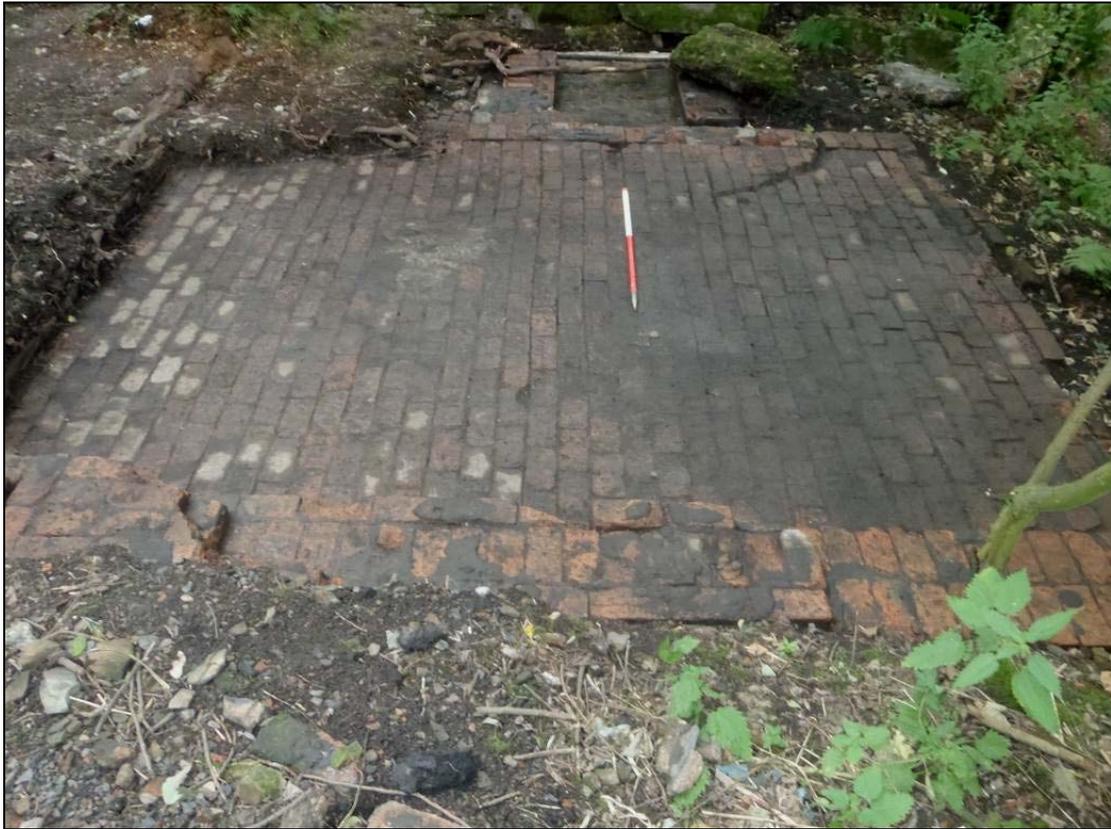
*Plate 34: The brick floor in the ventilation fan house*

- 4.5.2 Excavation of the northern part of the trench revealed a uniform surface of hand-made red brick, of exactly 10' (3.05m) width, and comprising north/south-aligned rows of stretchers (Plate 34). An arced scar along its southern edge, also observed in the earlier trench (ARS 2013), appeared to have been gouged by a door bolt, strongly suggesting the position of a doorway at the western end of the south wall.

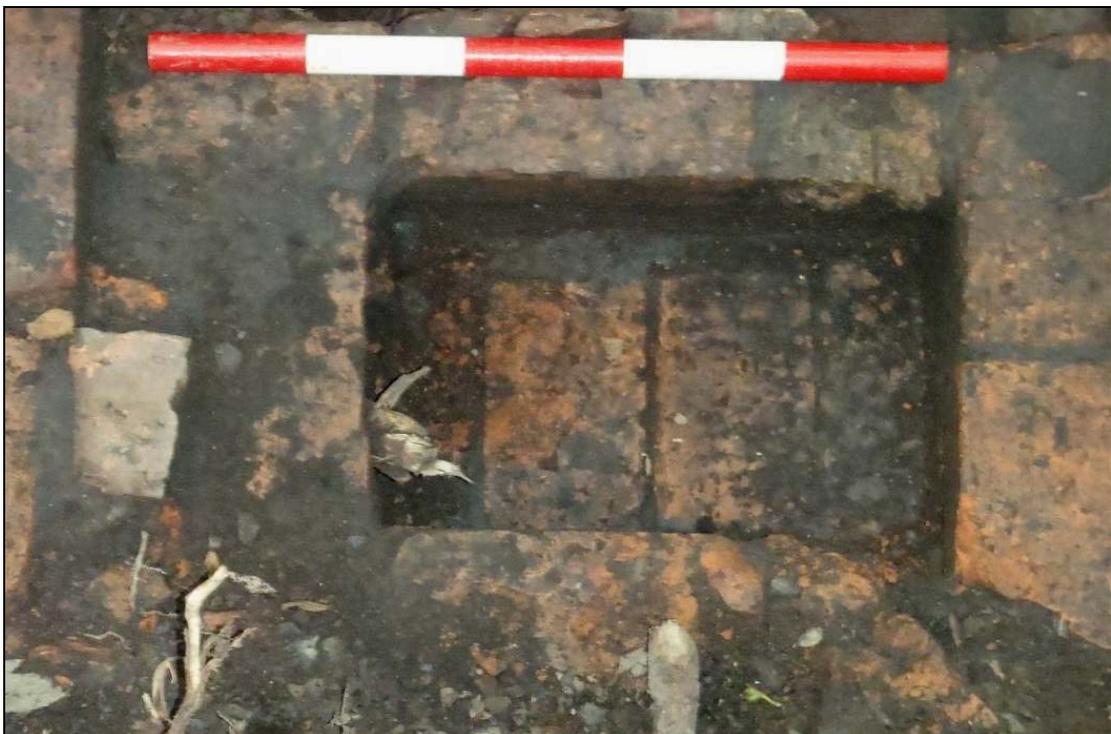
*Plate 35: Setting for a vertical post on the wall of the fan house*

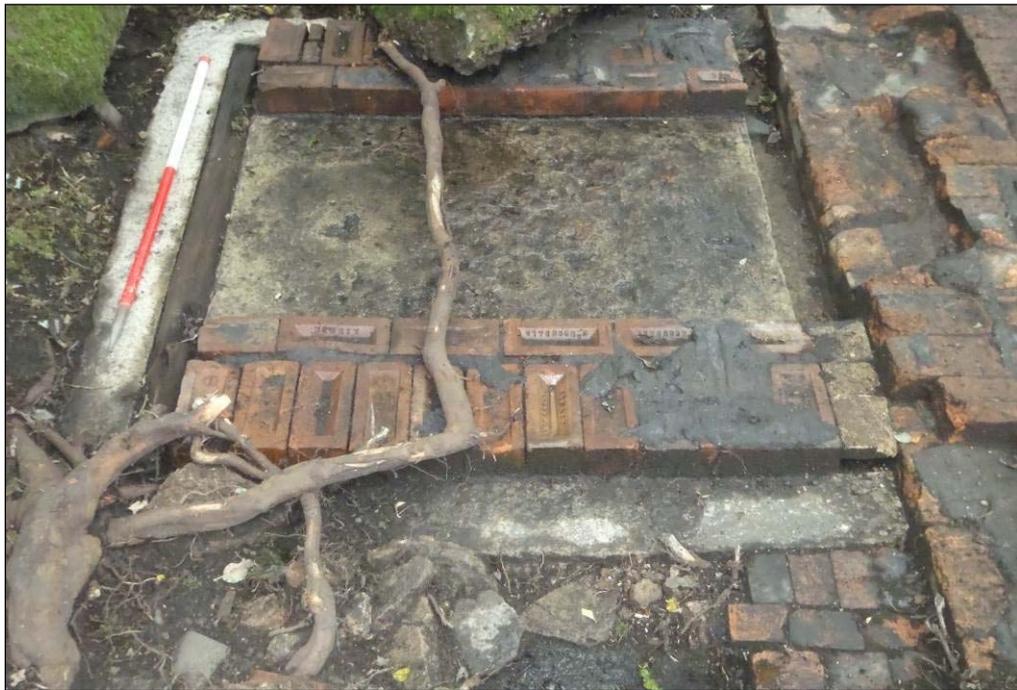
*Plate 36: Small chamber within the fan house, probably representing the housing for an electric motor*

- 4.5.4 The doorway in the south wall afforded access into a small chamber of approximately 5' (1.53m) square (Plate 36). This had a concrete base below machine-made brick side walls of 1½-brick thickness bonded in black sooty mortar and with a channel along the southern edge of the brick walls, presumably housing an aperture frame forming the south wall. Many of the bricks were froged, and had a stamp from the local New Hey Brickworks (Plate 37). The feature is certainly of a late date, and probably housed a small electrical motor or ducting associated with the upcast fan.

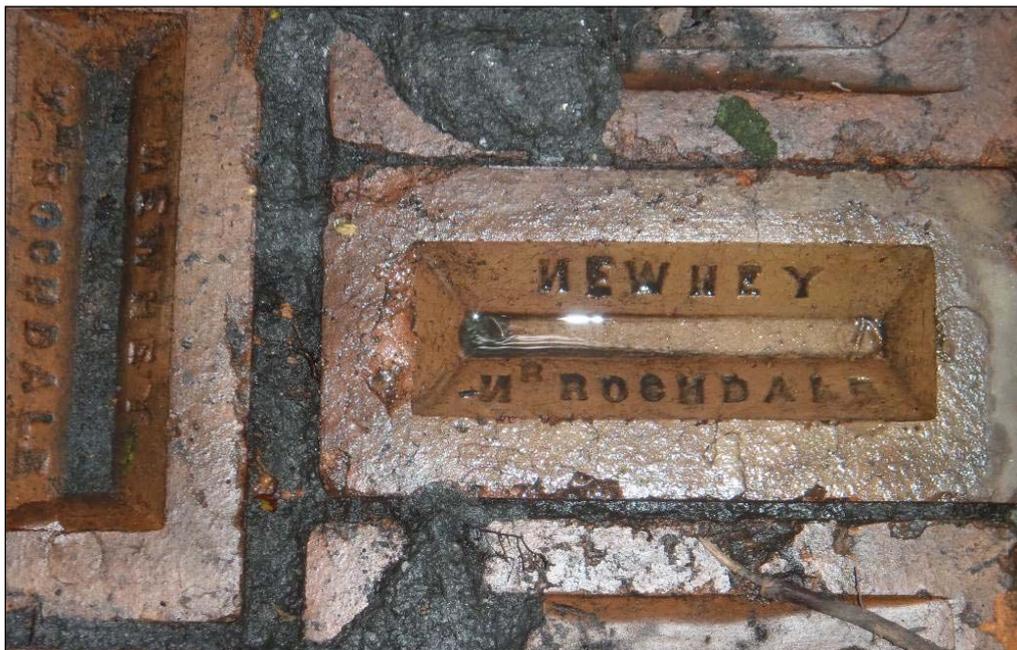
*Plate 37: New Hey bricks in the fabric of the chamber wall*

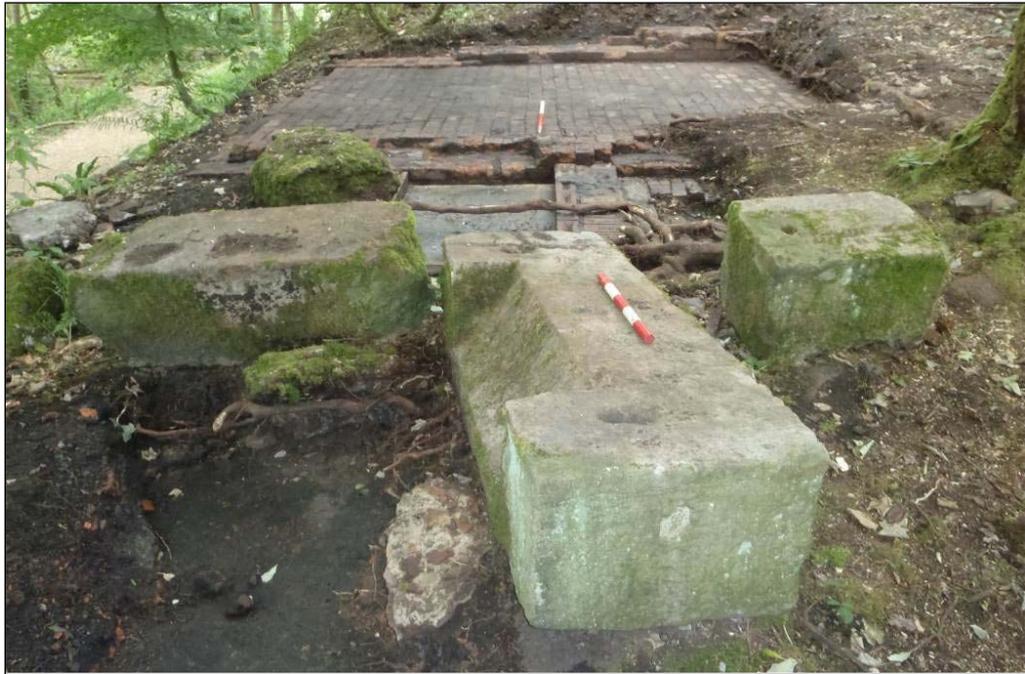
*Plate 38: Dressed sandstone blocks in area to the south of the fan house*

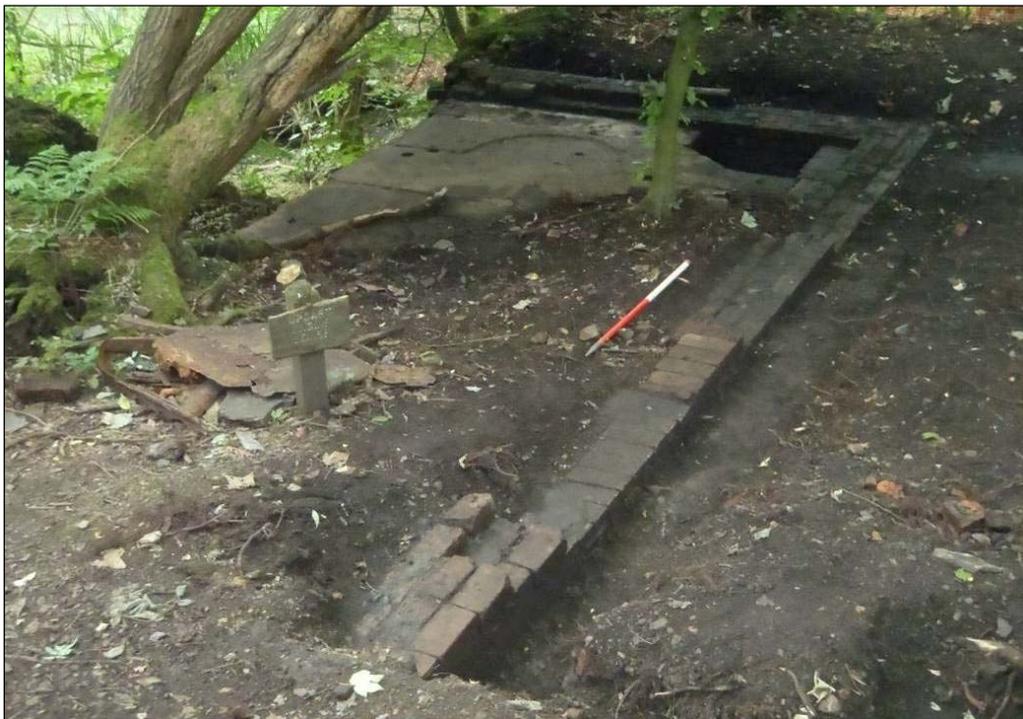
*Plate 39: Remains of the square-shaped structure shown on historic mapping*

4.5.5 The southern part of the trench examined square-shaped structure that was situated a short distance to the south of the fan house, as shown on the Ordnance Survey map of 1909 (Fig 4). Dressed sandstone blocks with through-bolt holes were littered around the surface in this area (Plate 38), although all appear to have been repositioned. Removal of the shallow topsoil revealed an L-shaped wall of 1½-brick thickness bonded in black sooty mortar (Plate 39), forming the western and northern walls of the structure depicted on the historic maps (Figs 4 and 5).

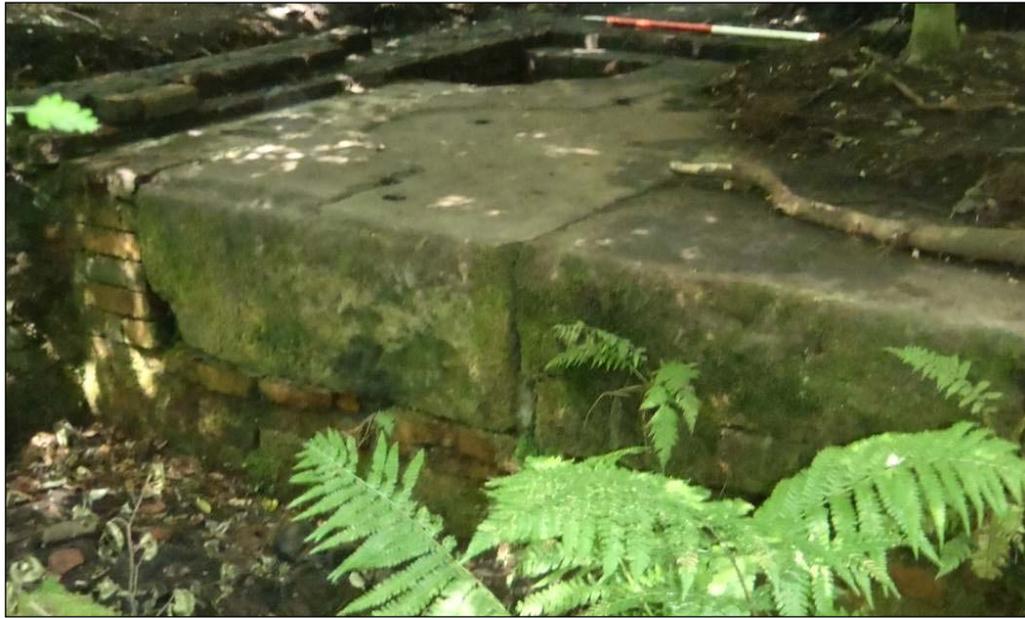
*Plate 40: Large stone blocks forming the base for a small steam engine*

- 4.5.6 The structure housed a large machine base at its western end, comprising a single course of dressed sandstone blocks (Plate 40) with a rebated surface housing what appeared to have been a small engine. The western block had a semi-circular end to this shallow rebate (Plate 41), typical of a small horizontal steam engines, suggesting that the structure housed an engine inserted after 1893 to power the ventilation fan for the upcast shaft. A pit filled with loose rubble, which formed the southern limit of the excavated area, almost certainly represented a flywheel pit for the engine. It was of brick construction, and continued below the sandstone engine bed.

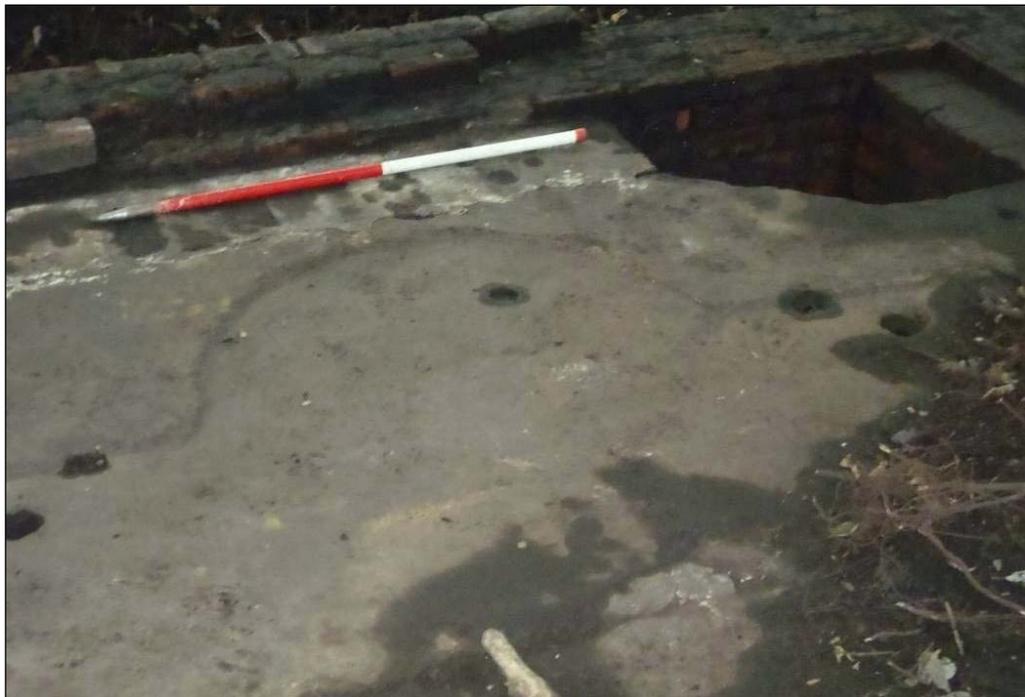
*Plate 41: Shallow rebate cut into the surface of the stone engine bed*

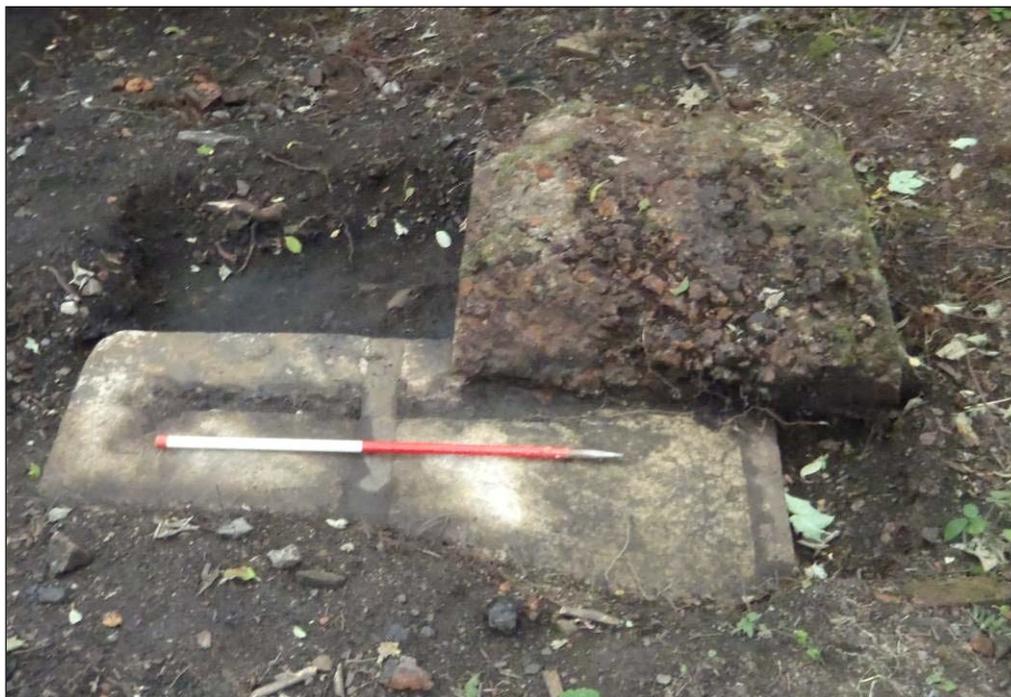
Plate 42: Small part of the concrete surface to the north of the engine house

- 4.5.7 At the eastern end of the trench, beyond the northern wall of the engine house, was a concrete floor with metal strengthening bars set in its surface. This was partially overlain by a degraded concrete base, which had a large proportion of brick fragments within its matrix, typical of concrete from the earliest years of the twentieth century (Plate 42). Its intended purpose is unclear, but it appeared broadly contemporary with the engine house, and seemed to have formed a base for something placed between the engine house and fan flue.

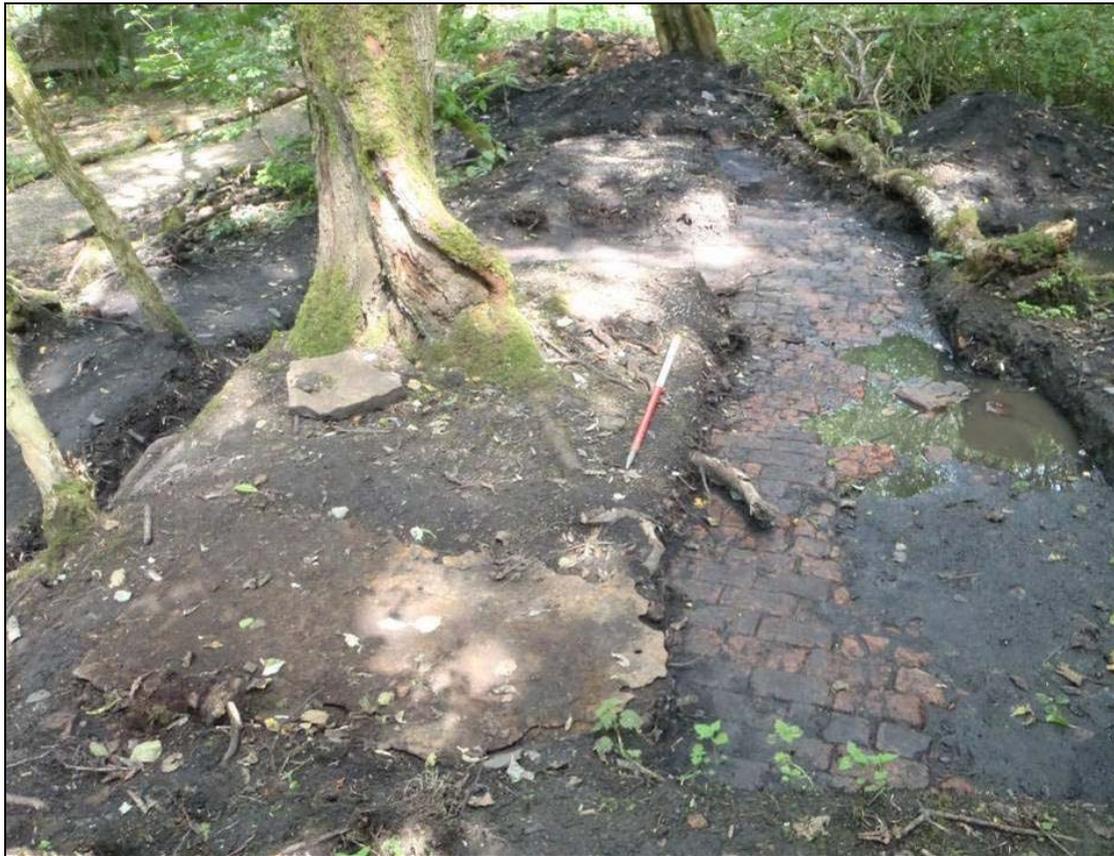
*Plate 43: General view of the excavated remains of the crushing and washing plant*

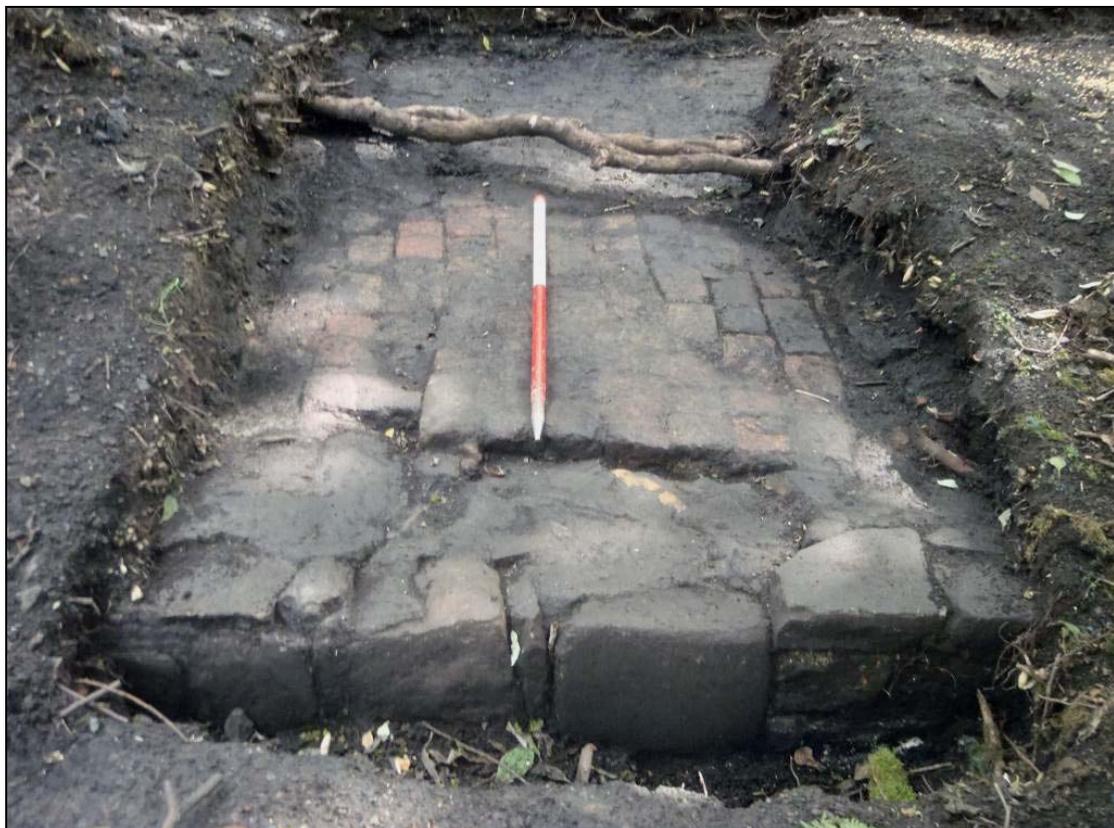
*Plate 44: The excavated remains of the eastern wall of the washing and crushing plant*

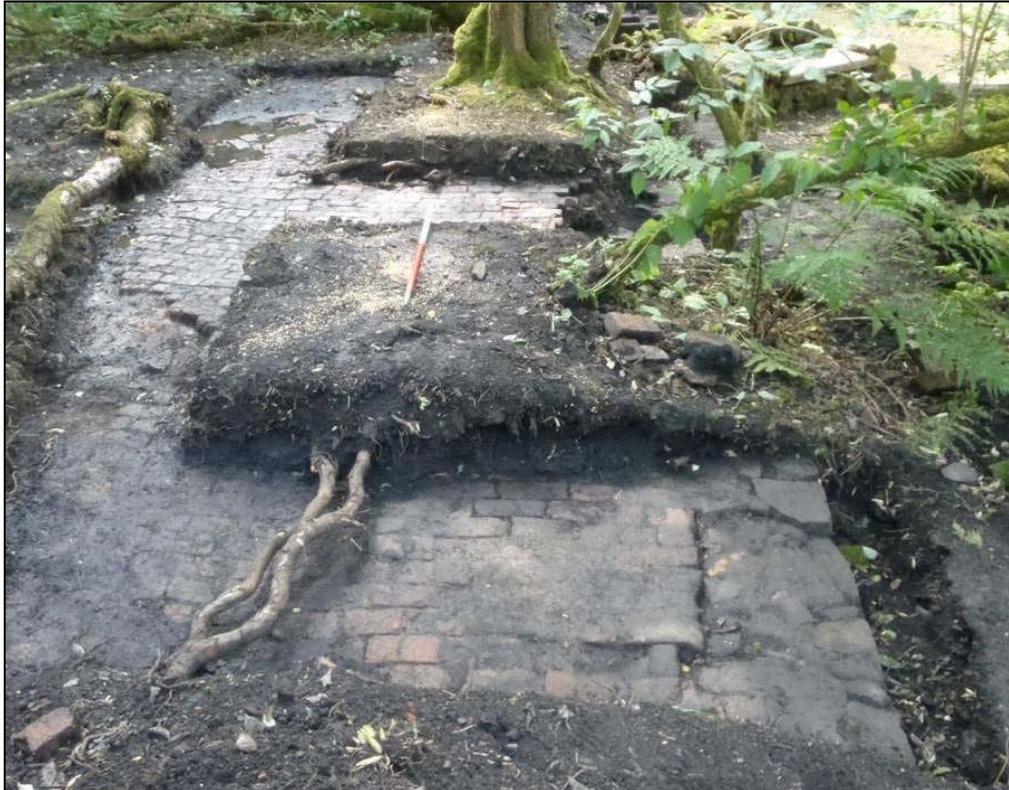
*Plate 45: The excavated remains of the eastern wall of the washing and crushing plant*

- 4.6.3 The entirety of the excavated trench to the east contained an irregular floor of broken brick fragments. This was relatively uneven, and generally dipped slightly to the east where it became waterlogged (Plate 45). The surface appears to have formed a yard between the washing/crushing plant, and the high retaining wall to the east, apparently forming access to the original coke ovens that are shown in this area against the retaining wall to the east on the Ordnance Survey map of 1893 (Fig 3). An attempt to extend the trench towards the location of these original ovens did reveal a continuation of the brick surface, but became flooded too quickly to facilitate practical excavation within the remit of a volunteer-based excavation.

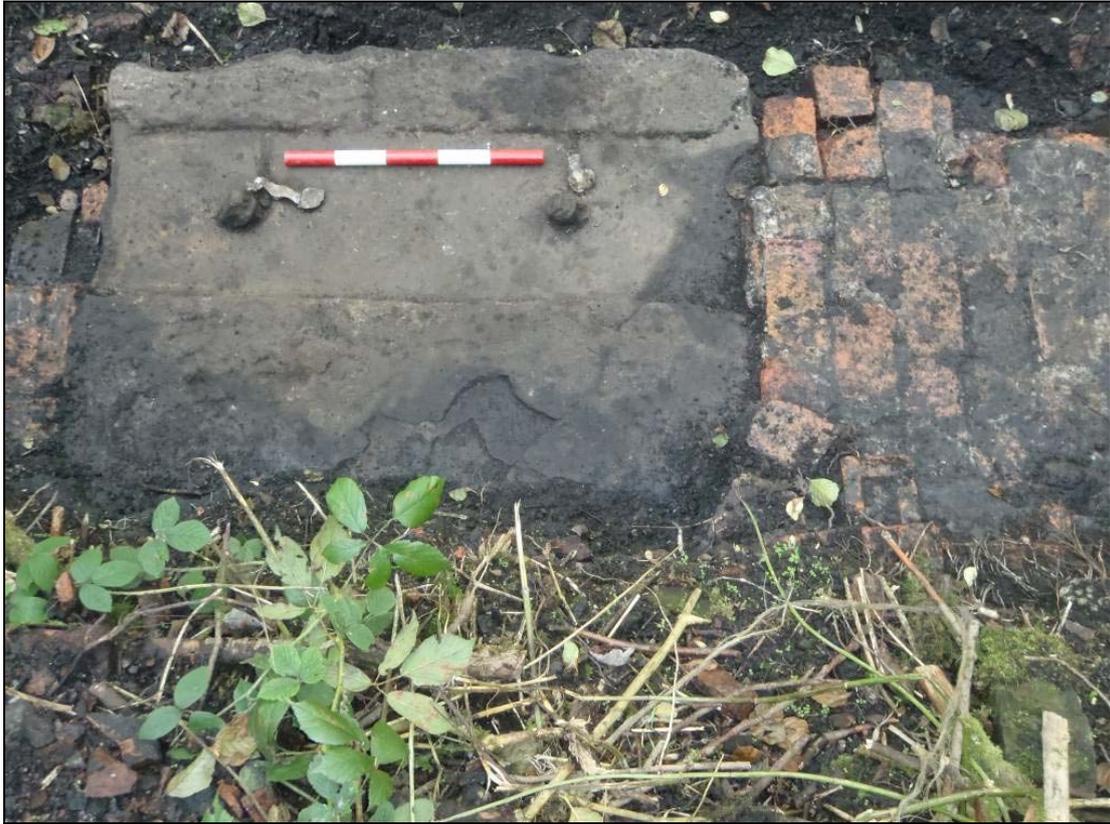
*Plate 46: Sandstone machine base with holding-down bolts*

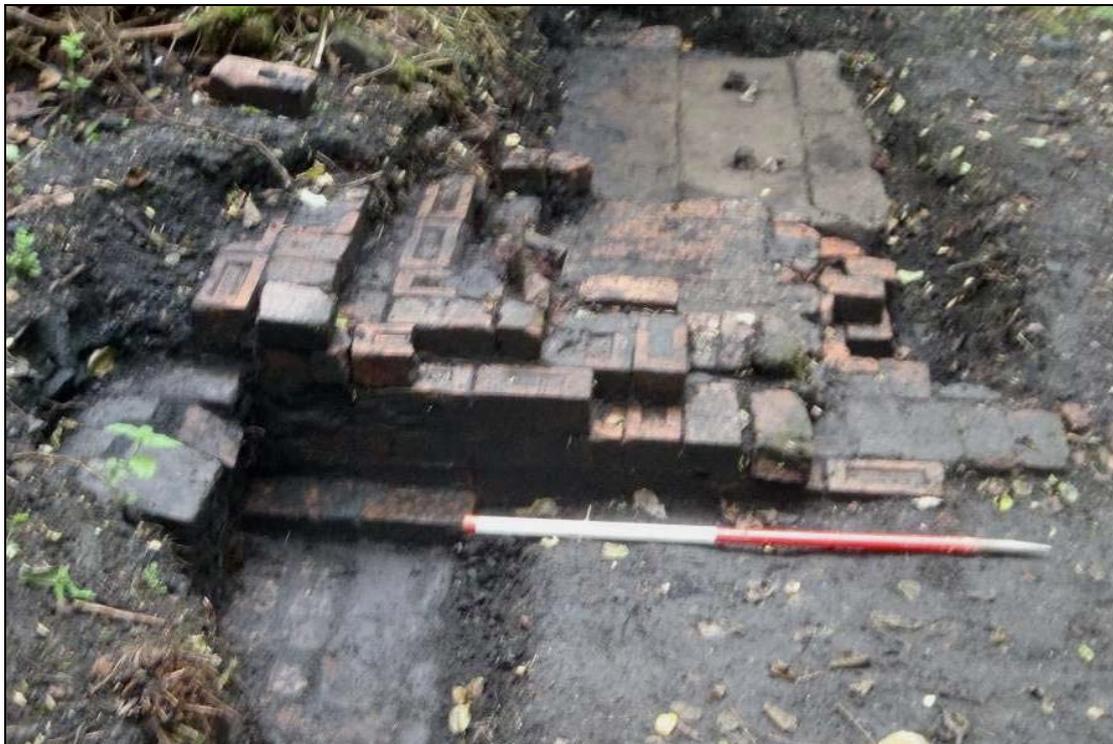
*Plate 47: Twentieth-century brick-built structure exposed in the northern part of the trench*

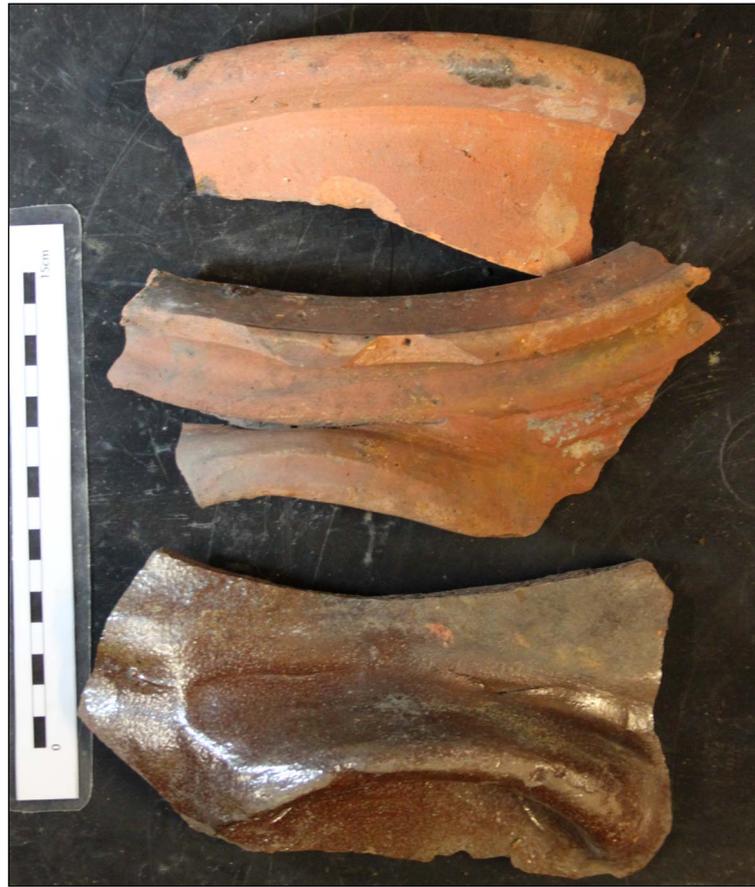
Plate 48: Fragments of large red earthenware storage jars

- 4.7.2 **Pottery and other ceramic objects:** amongst the fragments of pottery were several sherds of large red earthenware storage jars. In broad terms, the earthenwares all had a reddish-pink, medium to coarse fabric with medium to large gritty inclusions. The identifiable forms included fragments of large bowls or pancheons and tall, cylindrical storage jars with lug handles close to the rim, typical of the forms produced in a number of centres within the south Lancashire coalfields from the eighteenth century onwards (Plate 48). For a while these potteries flourished and multiplied, their market increasing as the population rose during the eighteenth century. In response, there was corresponding rise in the number of relatively small-scale country potteries, many appearing in the later eighteenth and early nineteenth centuries (Brears 1971, 56-8). The examples from Jubilee Colliery, however, are all likely to date from the nineteenth or early twentieth century, and may have been dumped on the site following the closure of the colliery in the 1930s.

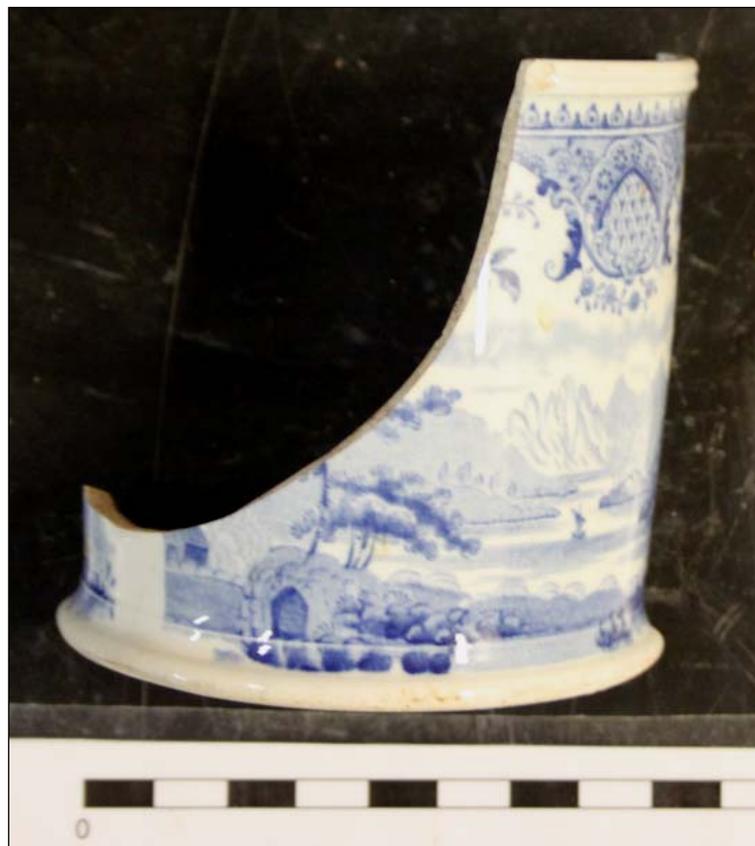
Plate 49: Fragment of under-glaze transfer printed ware mug dating to c 1810

- 4.7.3 A limited range of plain and under-glaze transfer-printed refined white earthenwares, all dating to the late nineteenth and twentieth centuries, were also recovered from unstratified deposits, and may similarly have been dumped on the site following the closure of the colliery. These included a large sherd of a mug depicting a view across Loch Katrine, which can be dated to c 1810 (Plate 49).

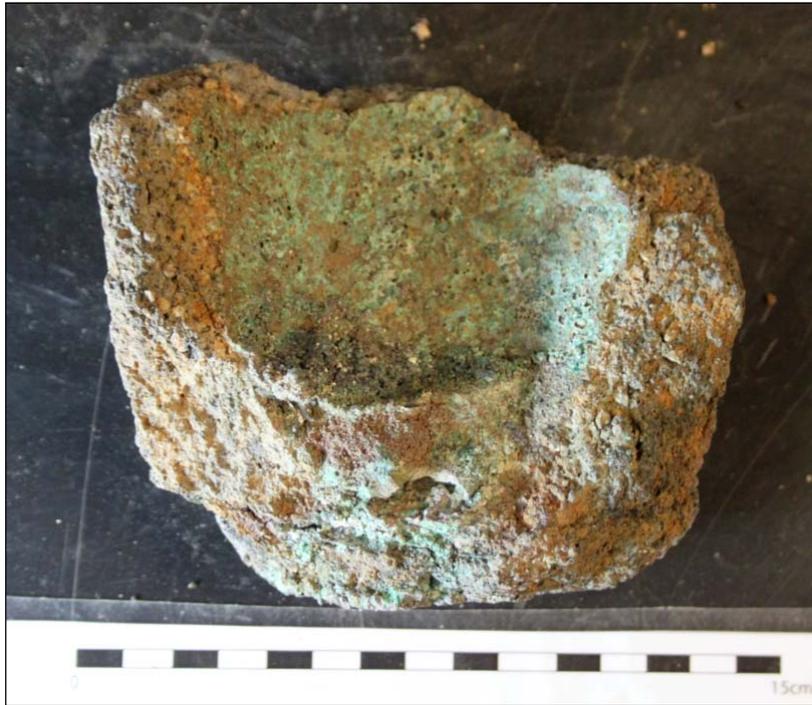
*Plate 50: Fragment of a crucible with traces of a molten alloy residues*

- 4.7.4 Amongst the other ceramic objects was a large fragment of a crucible, which had clearly been used for the processing of metal alloys (Plate 50). The coarse fabric of the crucible comprised refractory material, which was stained with the residues of melting a metal alloy, possible bronze. The crucible may have been used in the blacksmith's shop in the colliery.

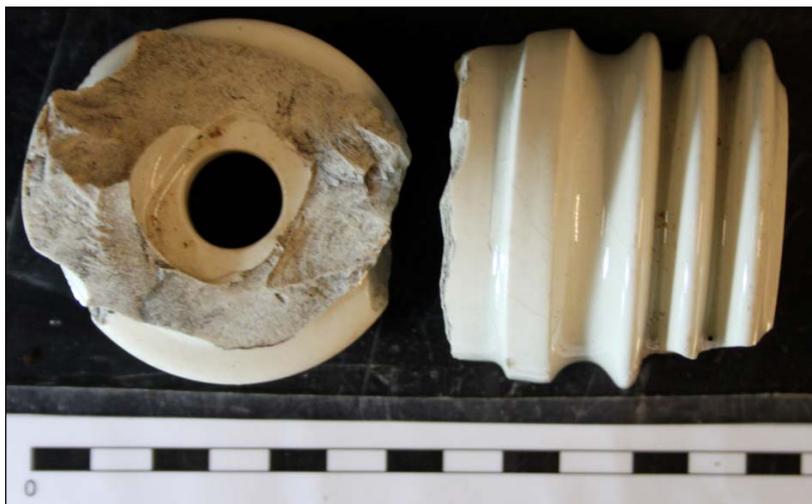
*Plate 51: Ceramic electricity insulators*

- 4.7.5 The finds assemblage also contained two fragments of ceramic isolators (Plate 51). These almost certainly date to the twentieth century, and were probably associated with the generation of electricity on the site.

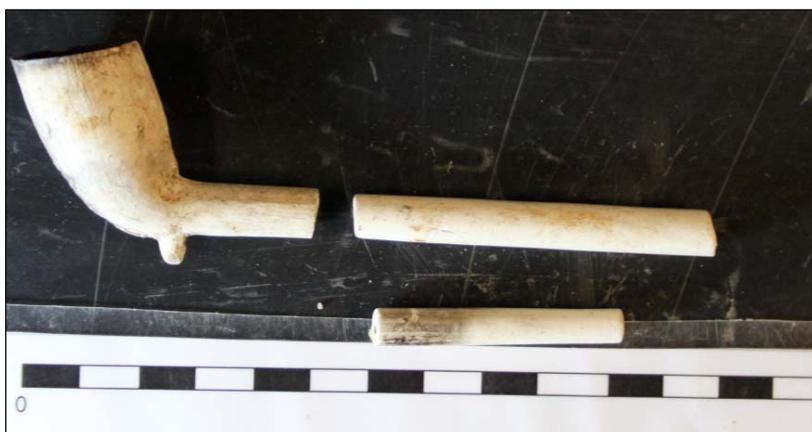
*Plate 52: Clay tobacco pipe fragments*

- 4.7.6 **Clay tobacco pipes:** three fragments of clay tobacco pipes were recovered from the excavation (Plate 52). This small group comprised two stem fragments and a complete pipe bowl. This was undecorated, providing no indication of the manufacturer, and is thus difficult to date accurately, although the form of the pipe suggests that it may have been made in the eighteenth century. The stem fragments have no distinguishing features, and cannot be dated with any degree of accuracy.

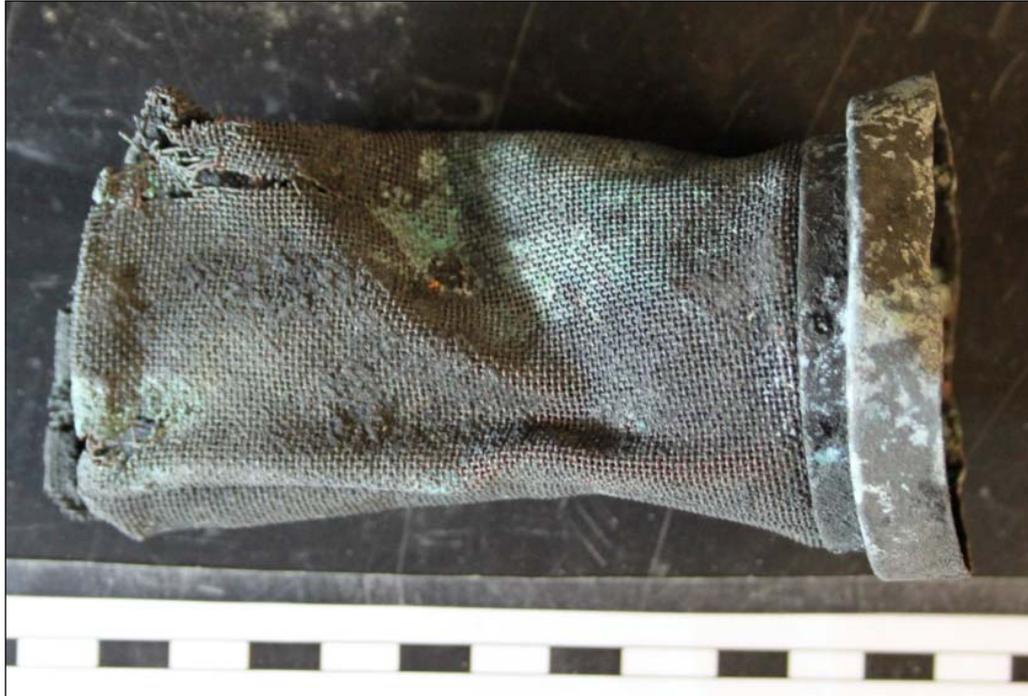
*Plate 53: Outer gauze of a miner's safety lamp*
