# Jubilee Colliery, Shaw, Oldham

## Community-led Archaeological Investigation

**Oxford Archaeology North**

November 2014

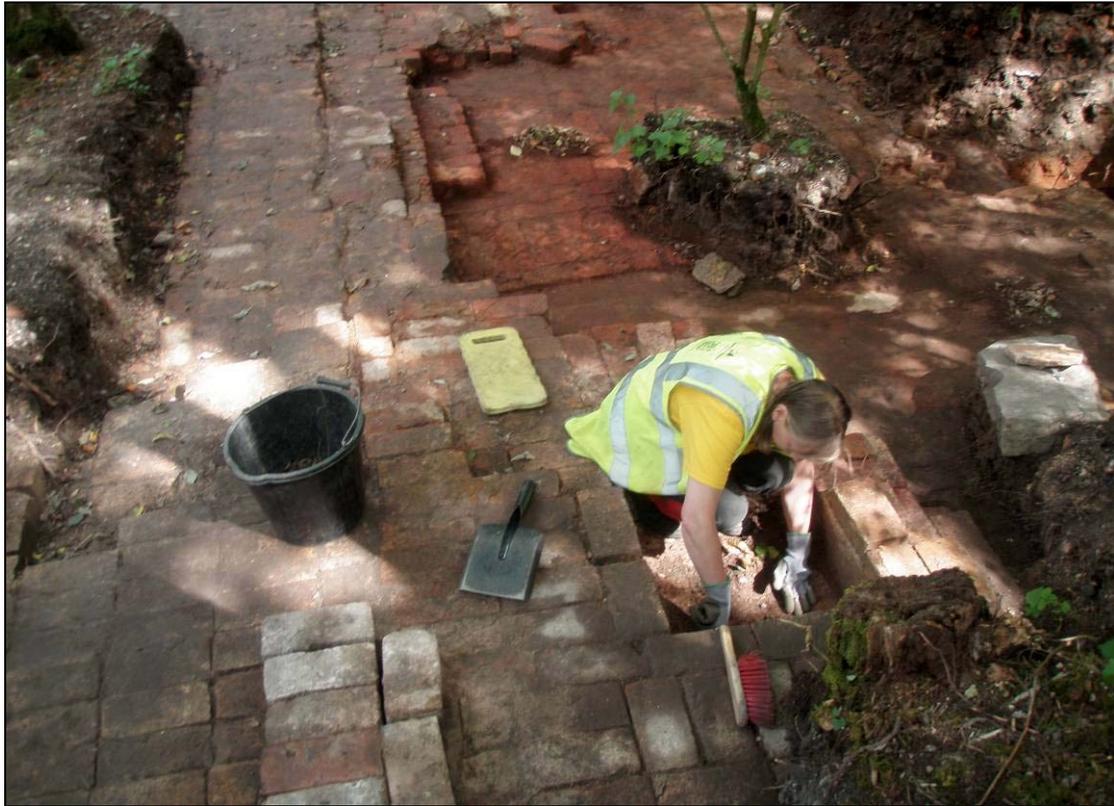
*Plate 55: Excavating the rear part of one of the boiler bays*

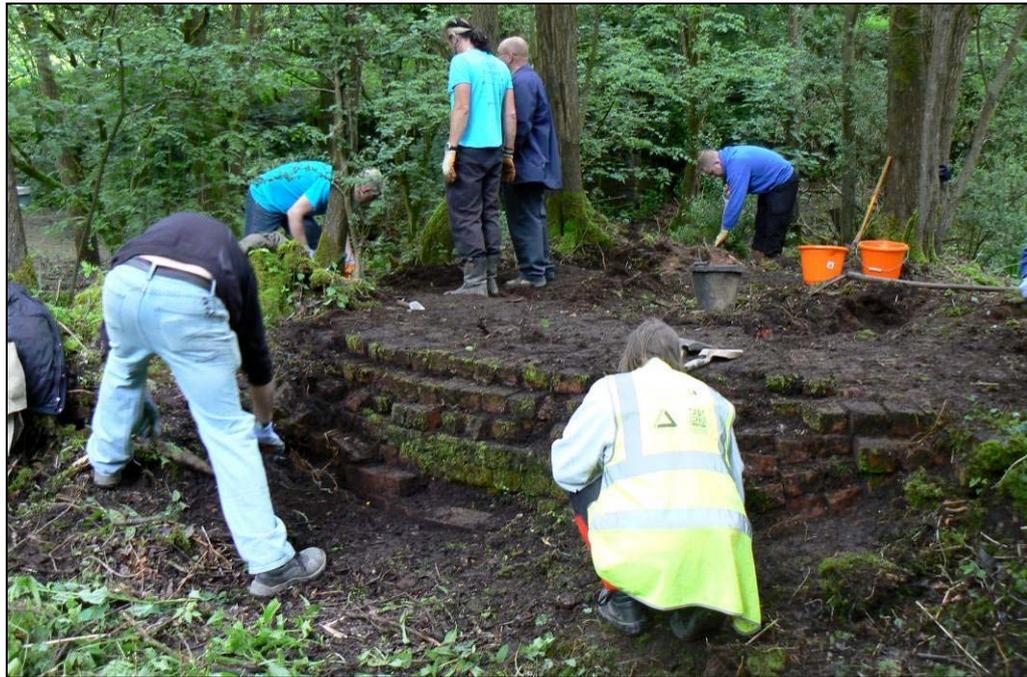
*Plate 57: An early stage in the excavation of the chimney*

- 5.3.1 Excavation of the chimney revealed details of its design and construction, and provided a striking visual reminder of a formerly significant local landmark. The chimney appears typical of the second half of the nineteenth century, being a tapering brick cylindrical structure on a deep raking plinth. Few chimneys of such size have been excavated in the region, and thus the excavation at Jubilee Colliery provided a useful opportunity to study the construction of these important features of the industrial landscape.

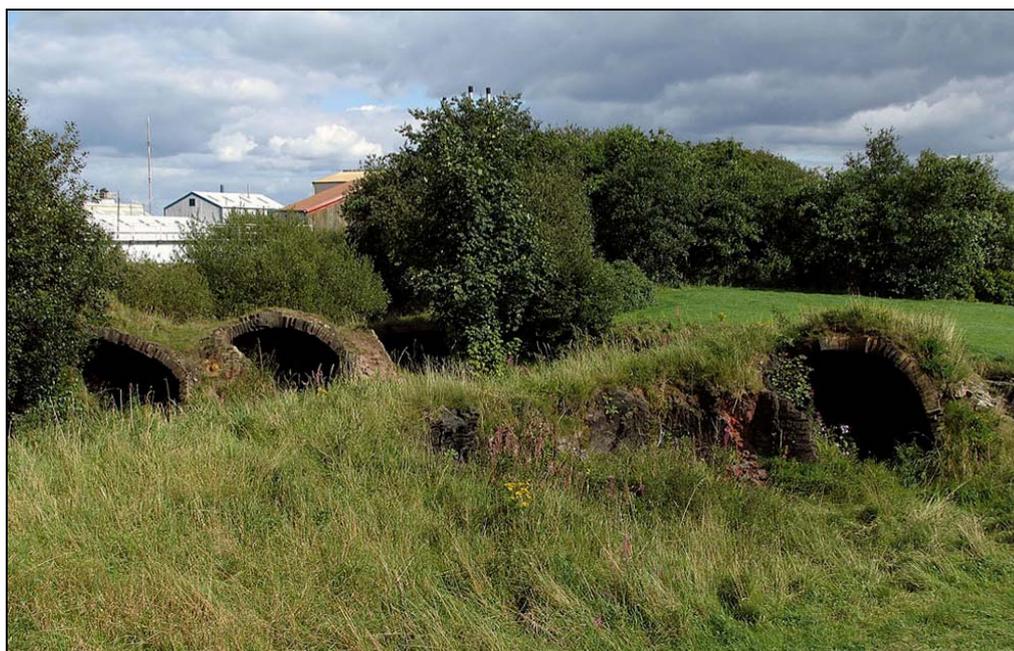
*Plate 58: The remains of the beehive coke ovens at Aspden Colliery near Oswaldtwistle are comparable in size, form and date to those at Jubilee, but are afforded legal protection as a Scheduled Monument*

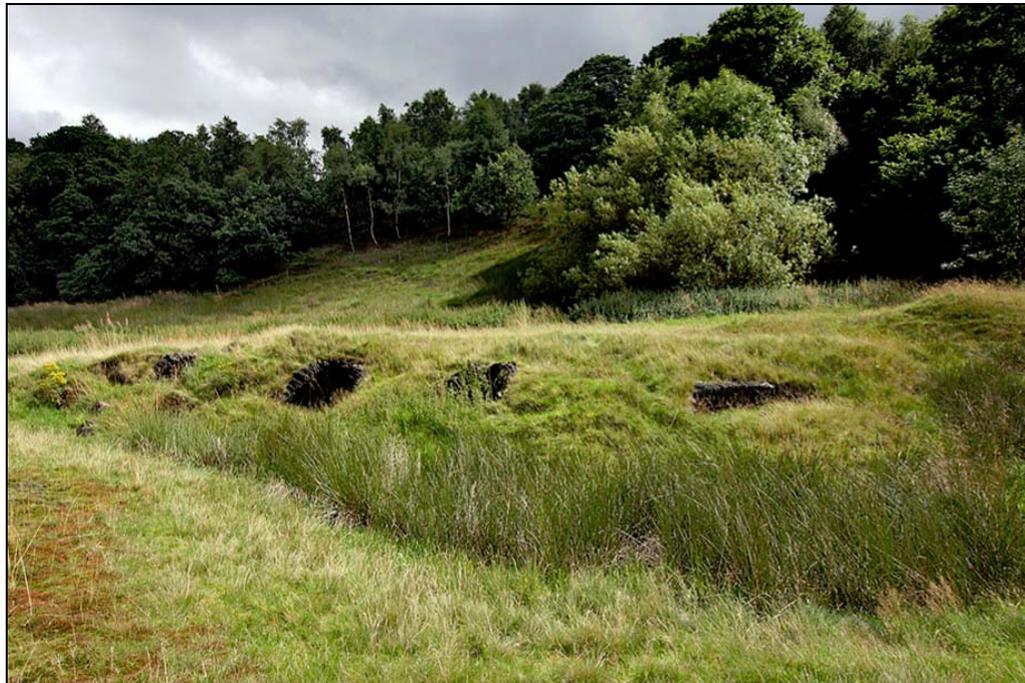
Plate 59: The remains of the beehive coke ovens at Schofield Hall Colliery, Littleborough

- 5.4.4 There are also the remains of four beehive coke ovens surviving at the site of Schofield Hall Colliery, near Littleborough (Plate 59). These ovens were in existence prior to 1851, and had probably fallen into disuse by 1870. Again, these examples are likely to be earlier than the double bank at Jubilee Colliery. As is the case at Jubilee and elsewhere, the stone facings of the ovens have been robbed out, leaving the brick-built elements to the rear exposed.

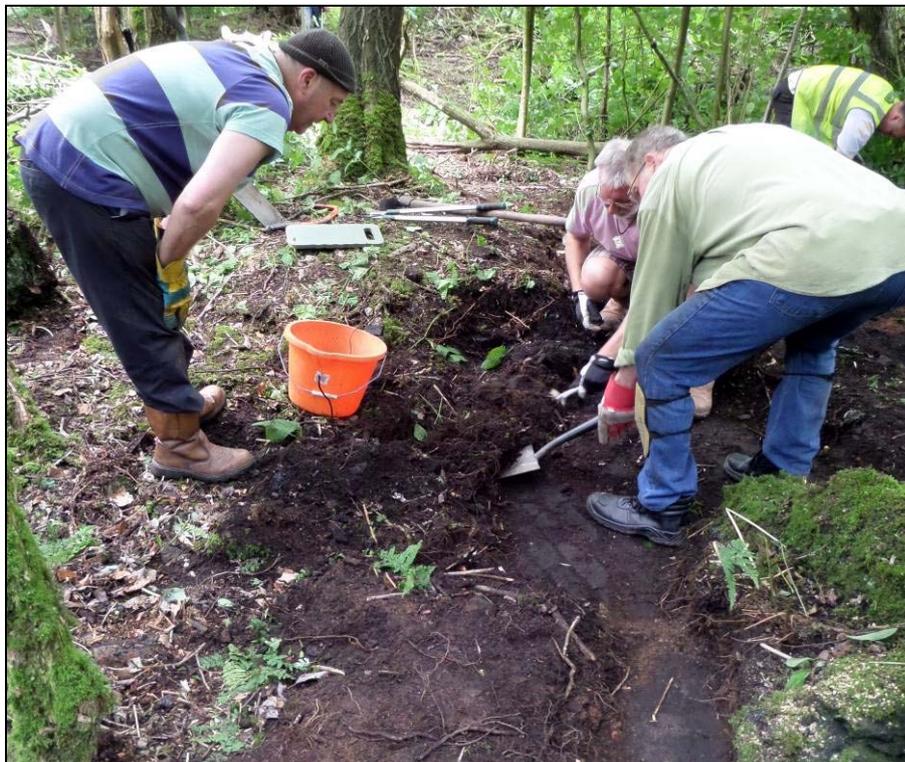
*Plate 61: Revealing the remains of the ovens built between 1909 and 1930*
