# **Cinderford Northern Quarter, Spine Road, Gloucestershire**

## **Archaeological Evaluation Report**

**Oxford Archaeology North**

June 2014

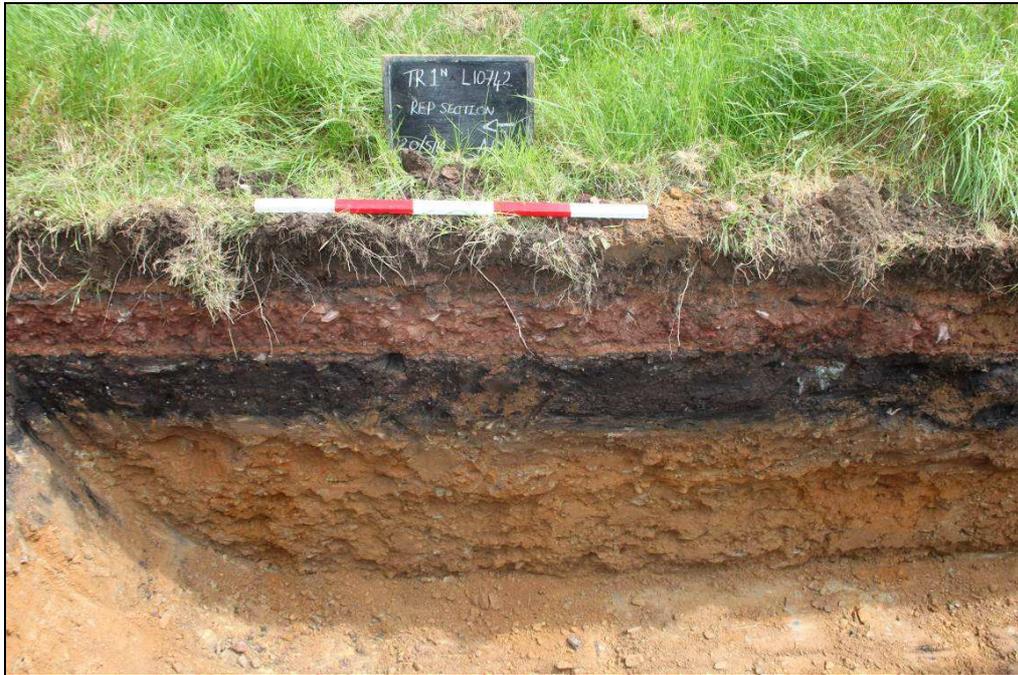
3.2.2 The natural subsoils were encountered at a depth of between 1.4 and 1.5m below the modern ground surface, and comprised orangey-brown broken angular bedrock brash, presumably a form of local sandstone, with lenses of gravels.

3.2.3 The natural geology was overlain by a thicker deposit of up to 0.70m of sub-angular gravels, within a loose orangey clay matrix, probably representing a colluvial natural deposit (Plate 1). This was sealed by a 0.30m thickness of dark brown / black silty clay, which contained brick fragments and residues of industrial waste, primarily fine fragments of compacted boiler clinker, or similar furnace waste. It was sealed by a 0.26m thick layer of relatively modern hardcore (Type II) rubble, used as a levelling layer below a thin layer of scrub vegetation, comprising rough turf.

3.2.4 No features of archaeological significance were cut into any of these deposits, which were also devoid of artefacts.

*Plate 1: West-facing section of Trench 1*

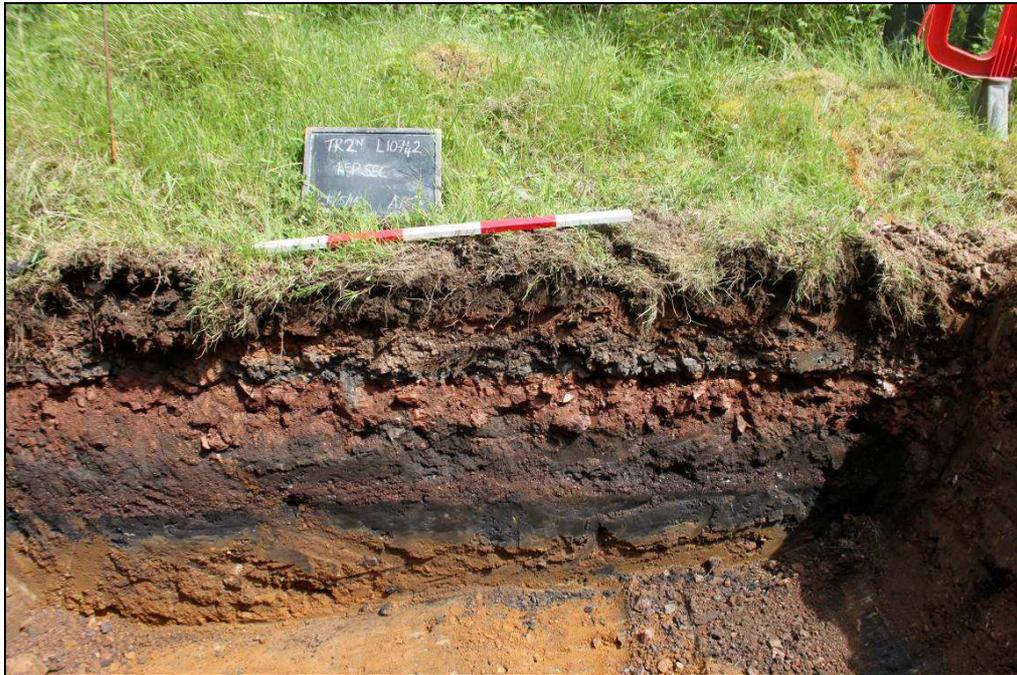
- 3.3.2 The natural geology was exposed at a depth of 1.35m below ground level, and comprised a reddish-orange silty sand, presumably forming a significant colluvial lens above plastic clays.

- 3.3.3 The natural geology was sealed by a thick deposit of up to 0.60m of compacted dark brown / black dumped material. This was similar to that within Trench 1, and contained large fragments of broken brick, and other industrial residues. Its depth and highly compacted nature suggest that it was used to form made ground to provide a levelled area. It was overlain by a further deposit of apparently dumped material, comprising a similar thickness of broken sandstone fragments and angular gravels within a loose sandy clay matrix. This appears to represent a re-deposition of natural stratigraphy, sealing the earlier made ground, and probably forming a level bed for the extant trackway to the immediate west.

Plate 2: West-facing representative section of Trench 2

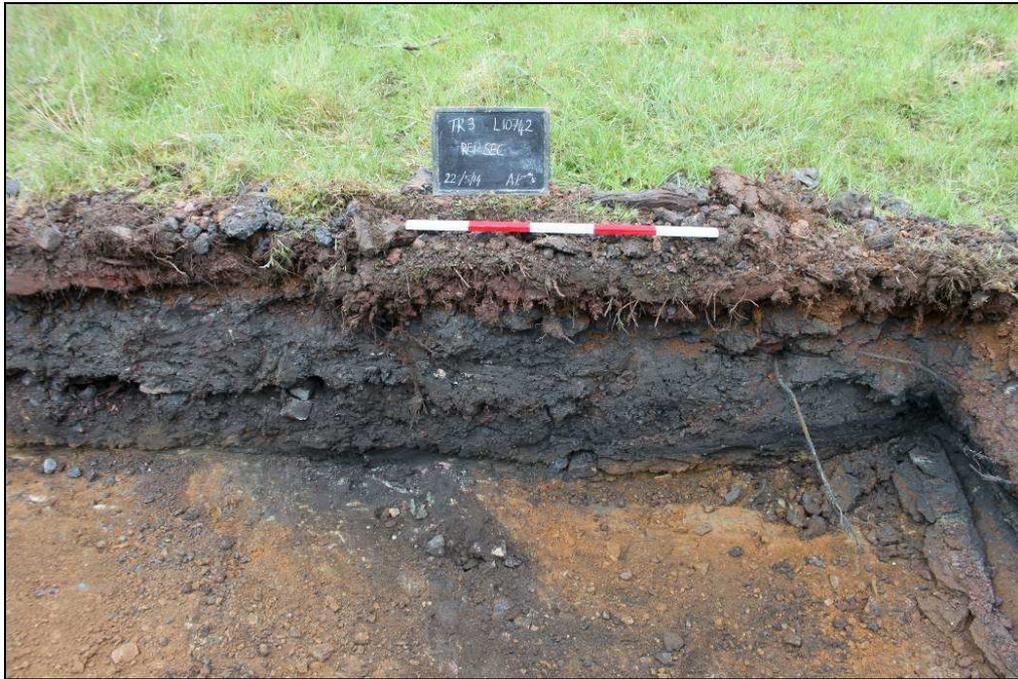
- 3.4.2 Natural gravels and fractured sandstone brash were encountered within an orangey-brown sand/ clay matrix at a depth of only 0.90m below the modern ground surface, with a sondage excavated at the northern end of the trench establishing that the deposit was at least 0.6m thick.

- 3.4.3 A single feature was cut into these natural deposits, situated 1.9m from the southern end of the trench (Fig 3). It comprised a sub-circular feature (**301**), of approximately 0.90m diameter, which continued beneath the eastern section of the trench (Fig 3). A section was placed across the feature, and was excavated to a depth of 0.4m, at which point its base had not been determined, but further investigation would have been beyond permissible depth of the trench. The pit had steep sides and was filled with greyish-brown sandy silt (**302**).

- 3.4.4 Feature **301** seemingly represented a small pit, which was sealed with a thin lens of black silty clay that appeared to represent an industrial residue, below a further lens of similar, but greyer deposit. These were sealed with a 0.12m deposit of red sandy clay with angular sandstone fragments, again below a slightly thicker layer of similar material, but of a greyer hue. Both represent re-deposited natural soils, used to raise the ground surface, and were sealed with a thin (0.1m) deposit of fine orange gravels, which formed the upper levelling layer beneath the topsoil.

*Plate 3: West-facing representative section of Trench 3, showing feature 301*

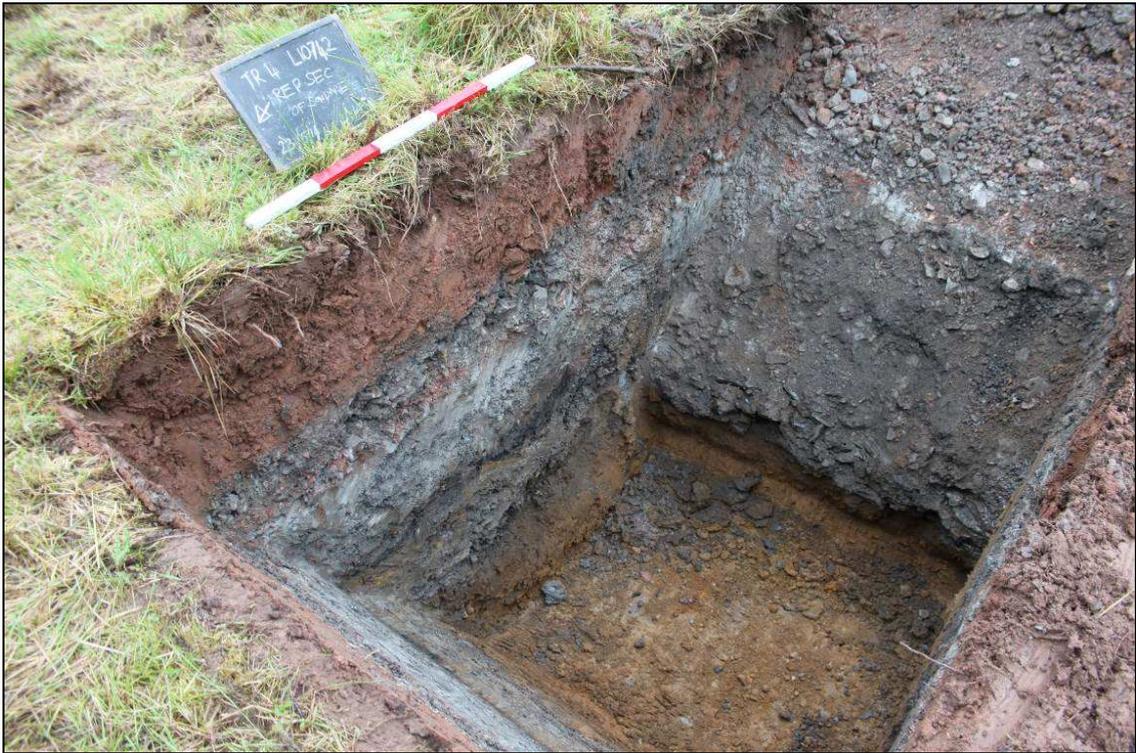
- 3.5.2 Natural orangey gravel and sands were encountered within a sondage at the northern end of the trench (Plate 4), at a depth of 1.9m, below a modern make-up layer, containing fragments of twentieth-century plastics. This was sealed in the central 4.4m of the trench with a concrete slab (Plate 5), which appears to have represented a building platform, or possibly hard-standing yard surface, and appeared to be of mid-/late twentieth-century date, continuing beyond the limit of excavation to both the east and west. It was placed only 0.5m below ground level, and was sealed by a modern dumped material with asphalt fragments and red chippings mixed within a matrix of reddish-brown silty subsoil.

*Plate 4: South-west-facing representative section of Trench 4*

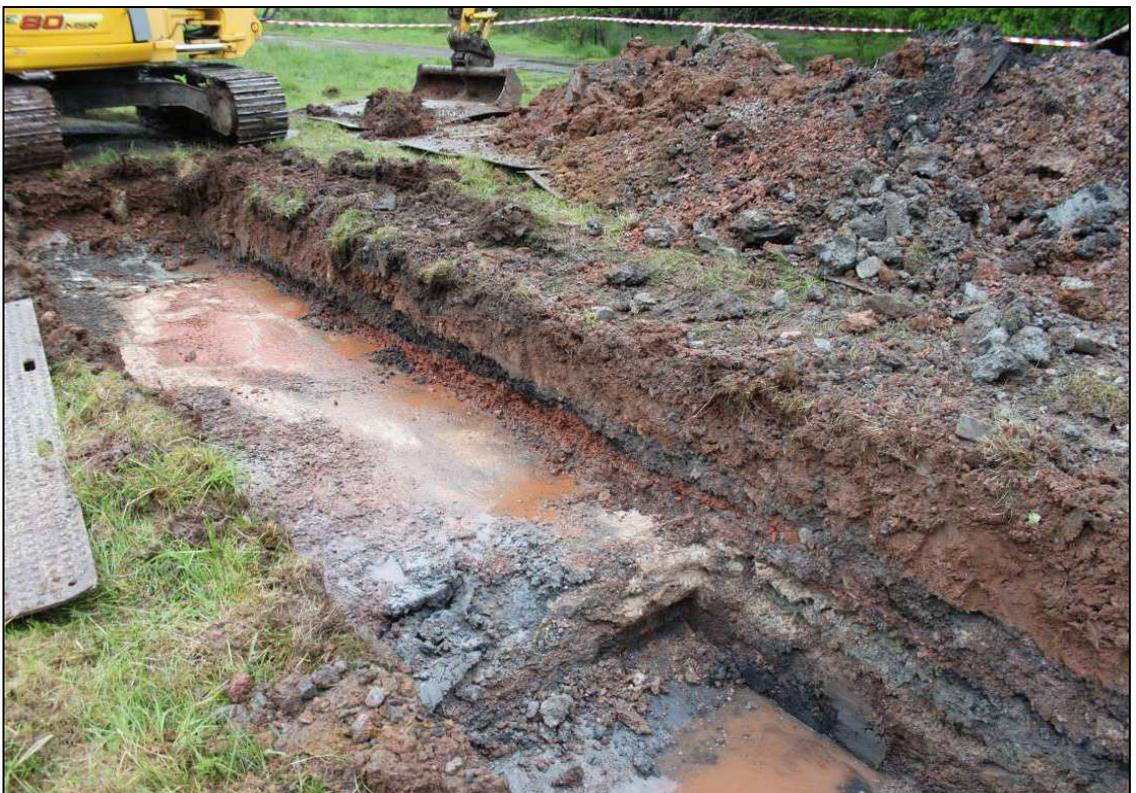
*Plate 5: Concrete platform in Trench 4, facing south-west*

- 4.1.2 The concrete platform within Trench 4 appeared to be of a late date, and is likely to represent the final phase of coal-mining activity in the study area, but elsewhere ground level appears to have been made-up, rather than reduced. Modern topsoils and mixed re-deposited subsoils typically overlay dark, blackish deposits, characteristic of nineteenth-century industrial sites, and generally encountered as make-up layers, generally established immediately below floors, yards or open ground. It would therefore appear that the ground level associated with earlier coal-mining activity survives intact below more recent deposits, and that features relating to early coal mining may survive elsewhere within the site. Indeed, the feature identified within Trench 3 perhaps derived from this earlier phase of activity, but given its position within the trench, and its depth below present ground level, detailed investigation to establish its precise nature was not possible, and it remains uncertain whether it represented a pit or the terminus of a linear feature.

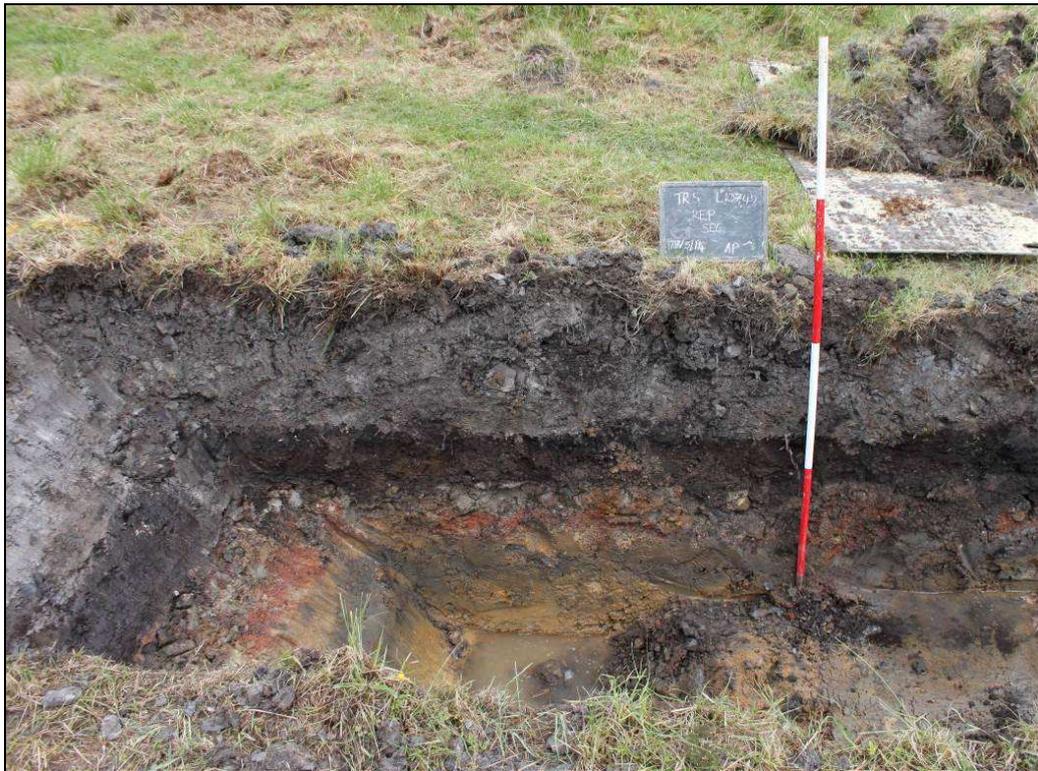
- 3.6.2 Plastic natural clay subsoils were established at a depth of only 0.74m below the modern ground surface, and was sealed in the western 3.2m of the trench by a 0.12m thickness of angular sandstone brash, which appeared to represent a colluvial wash, and was encountered at a similar position on the hill slope within Trench 6 to the north. This, and the natural clay to the east, was sealed with a 0.22m thickness of dark brown/black deposit of industrial backfill, which was relatively loose, as it contained a high percentage of clinker, as well as ceramic and glass fragments and what appeared to be automotive parts, suggesting that it was of mid-/late twentieth-century date.

- 3.6.3 The backfilled material was sealed below a 0.4m thickness of pale grey shaley clay, which had the appearance of having originally been a relatively deep natural deposit, possibly relating to the open-cast extraction to the south, prior to having been used as a backfill material containing twentieth century detritus, below a thin, 0.12m layer of turf.

Plate 6: North-facing representative section of Trench 5

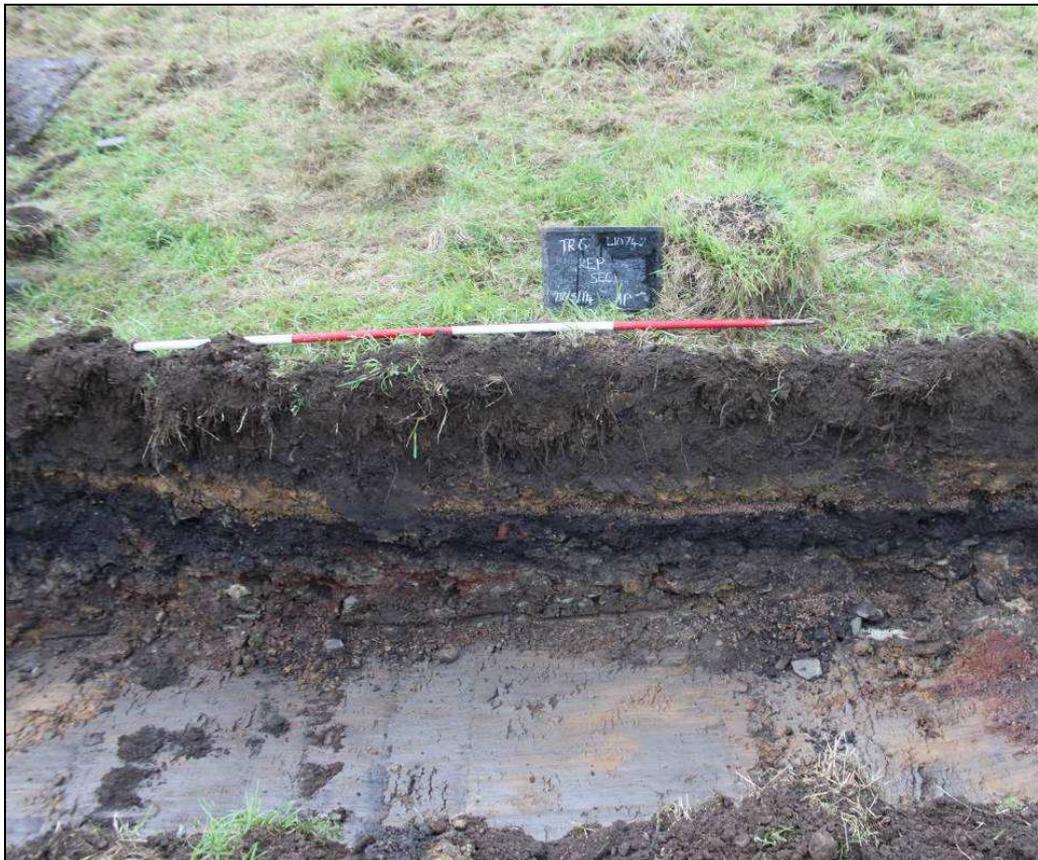
- 3.7.1 Trench 6 was placed on a slightly raised level area to the north of Trench 5, and was excavated on a perpendicular alignment for a length of 10m (Fig 2). It was excavated to a maximum depth of 0.97m below the modern ground surface, where natural yellowish plastic clays were established, similar to those in Trench 5.
- 3.7.2 The natural geological deposits were sealed with a 50mm lens of reddish silty sand, below a 0.12m compacted layer of angular sandstone brash, similar to that within the western end of Trench 5 (Plate 7). This was overlain by 0.25m of black industrial material, which unlike that in Trench 5, was highly compacted, but of similar material. It was sealed with a thin, 0.15m thickness of re-deposited yellow plastic clay, with frequent small grits within its matrix, below a 0.25m depth of mid-brown silty clay subsoil and 0.15m of turf and black topsoil.

Plate 7: West-facing representative section of Trench 6

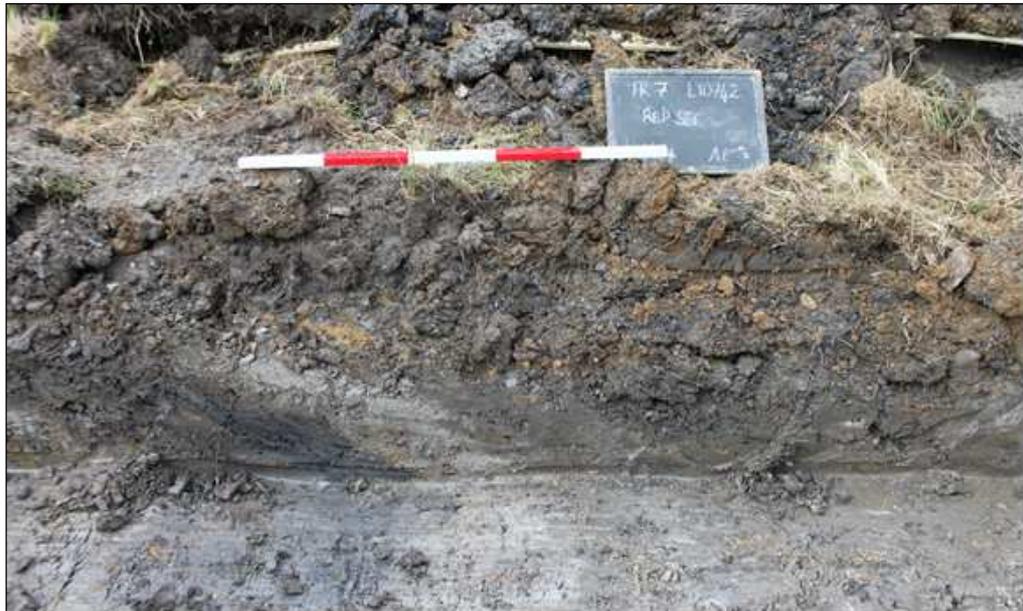
3.8.1 Trench 7 was placed in the north-eastern part of the main trenching area, perpendicular to the main road which forms the boundary of the site (Fig 2). It was excavated for a length of 10m, and to a maximum depth of 1.2m, within a sondage cut into the natural yellowish clay at the southern end of the trench. This was established at a depth of only 0.7m below the modern ground surface (Plate 8), and was sealed by a mixed deposit of dark blackish-grey mixed clay, with frequent angular stone inclusions and some brick fragments, below 0.1m of turf and topsoil.

Plate 8: East-facing representative section of Trench 7

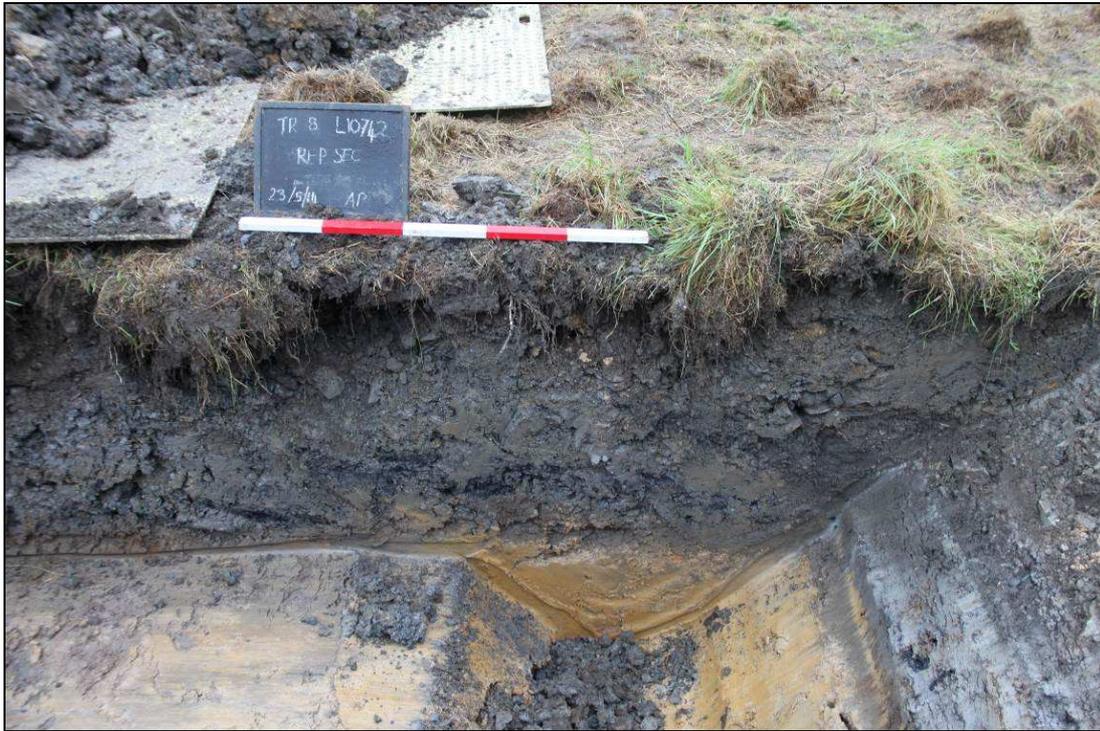
3.9.1 Trench 8 was placed to the west of Trench 7, in a hollow to the south-east of the apparent pit-head. Natural yellowish plastic clay subsoils were established at a depth of 1.2m, above a deep deposit of mixed dark blue-grey clay overburden, representing a dumped backfill material below the topsoil and turf (Plate 9).

Plate 9: West-facing representative section of Trench 8

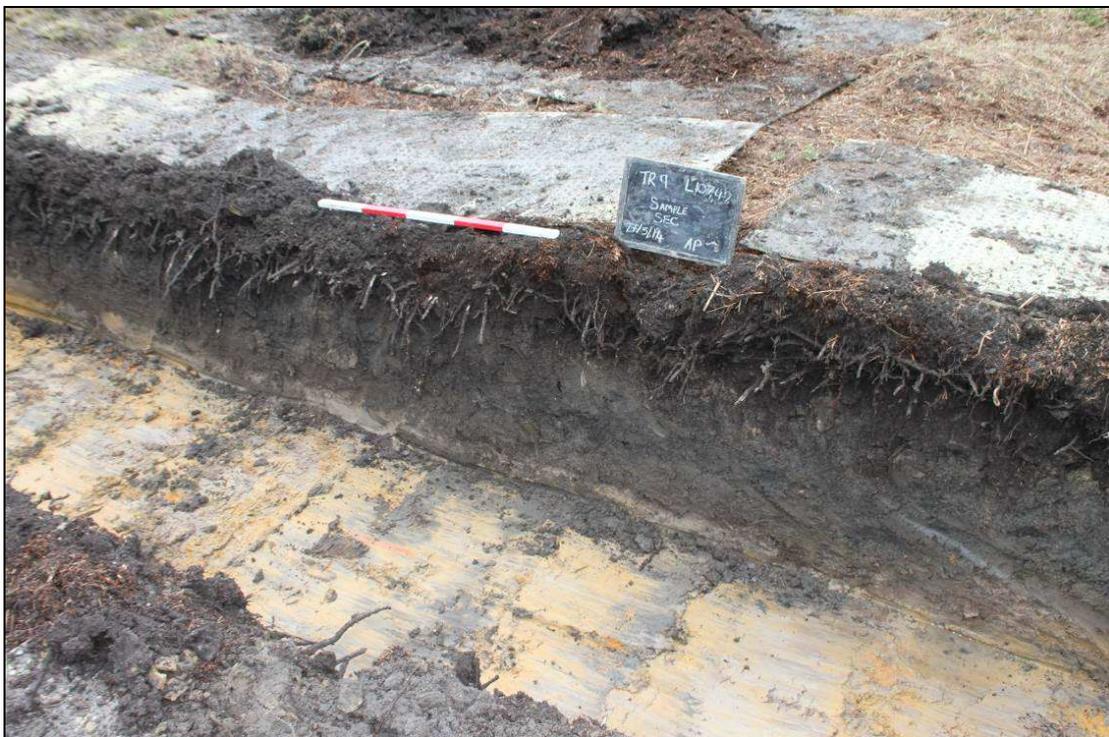
3.10.1 Trench 9 was placed to the north of Trench 8, and to the north-east of a capped mine shaft. Excavation of the 10m trench revealed mottled orange/yellow plastic clay at a depth of 0.90m. This was sealed with a 0.6m thickness of dark grey silty colluvium, which was less mixed than deposits elsewhere, suggesting that this part of the site had been less disturbed by recent mining activities. It was sealed with a 0.3m thickness of loose silt topsoil, creating a thicker deposit than observed in the other excavated trenches (Plate 10).

Plate 10: South-west-facing representative section of Trench 9

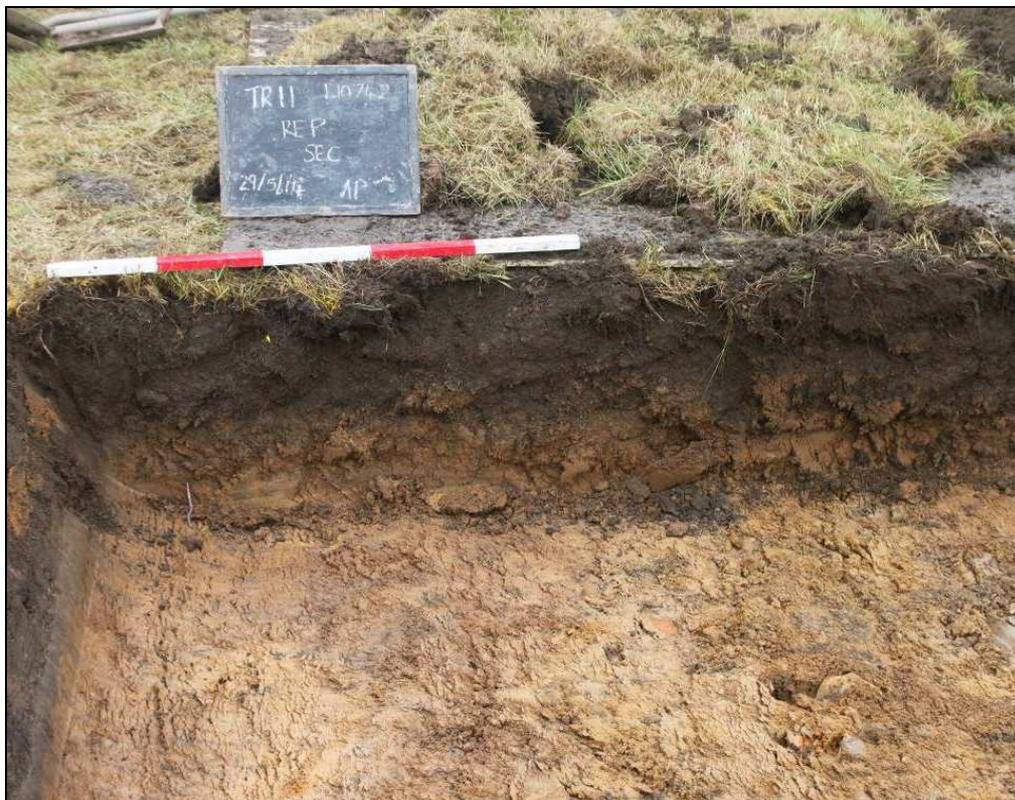
3.12.1 Trench 11 comprised the first of two trenches targeted on a chemical works to the south of the main trenching area (Fig 2). It was placed on an approximately east/west alignment, and was excavated for a length of 10m, and to a maximum depth of 0.5m, where orangey-brown natural sandy clay subsoils were exposed (Plate 11). These were overlain by up to 0.35m of clean mid-brown subsoils, below a well-established 0.15m thickness of turf and topsoil.

Plate 11: North-facing representative section of Trench 11

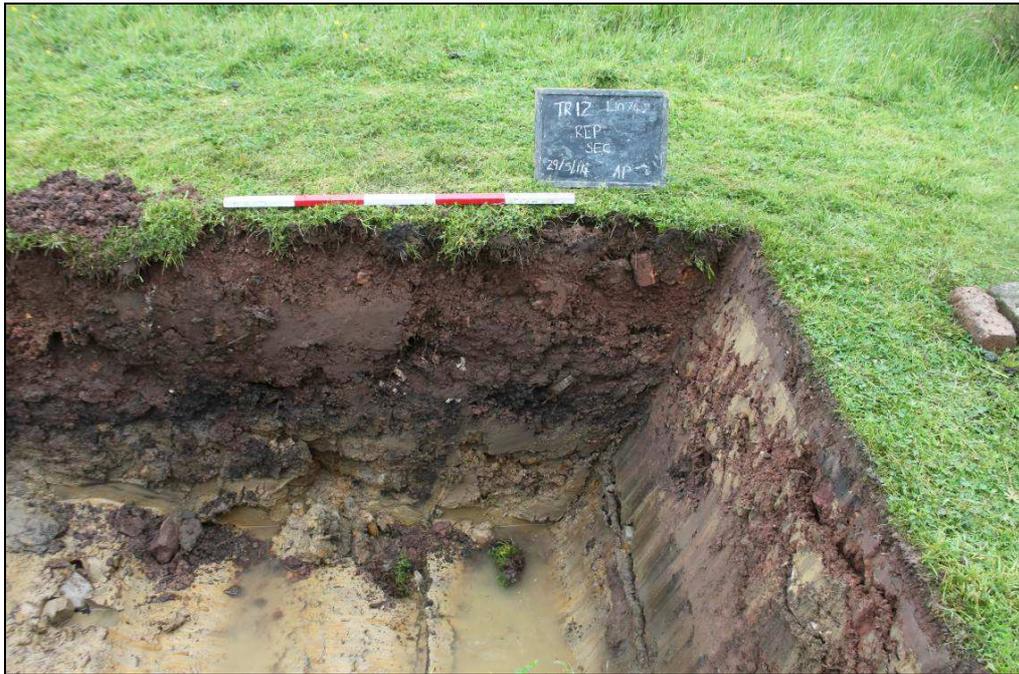
3.13.2 The natural clay was sealed with a 0.16m thickness of greyish-brown silty clay, which contained frequent plant roots, representing an earlier soil horizon (Plate 12). The colour of the deposit leached through grey and pale brown into that of the natural clays below. The layer was sealed with a 0.2m thickness of reddish-brown silty clay subsoil which contained a large percentage of grits and frequent fragments of twentieth-century debris, including machine-made bricks and plastics, below 0.1m of loamy clay topsoil and turf.

Plate 12: South-facing representative section of Trench 12

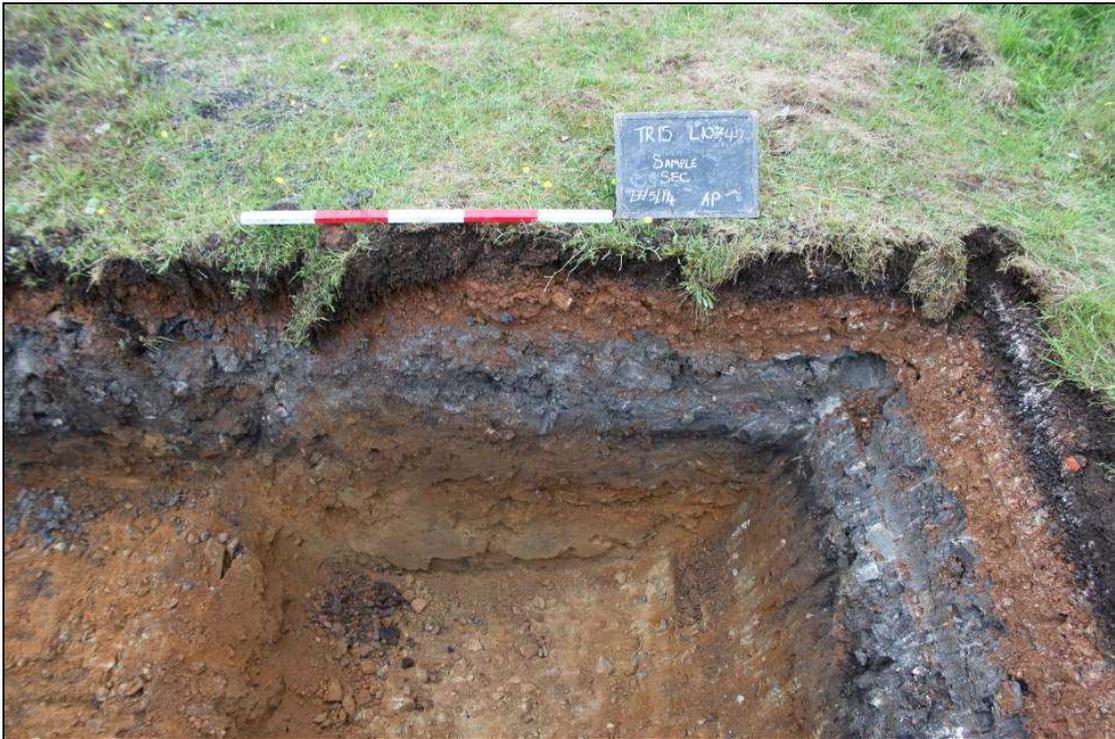
3.15.1 Trench 15 was placed between Trenches 2 and 3, on an east/west alignment, and to the east of a track that formed the western boundary of the main trenching area (Fig 2). It measured 10m long, and was excavated to a maximum depth of 1.5m at its eastern end to prove the nature of the natural orangey sandy gravels established at a depth of 0.90m throughout the trench. These were sealed with a 0.15m deposit of dark brown/black silty clay, with brick fragments, representing an industrial levelling layer, below a 0.35m deposit of re-deposited plastic blue-grey plastic clay. This was sealed with a further recent levelling layer of 0.2m of compacted rubble hardcore beneath 0.2m of mixed topsoil and turf.

Plate 13: South-facing representative section of Trench 15

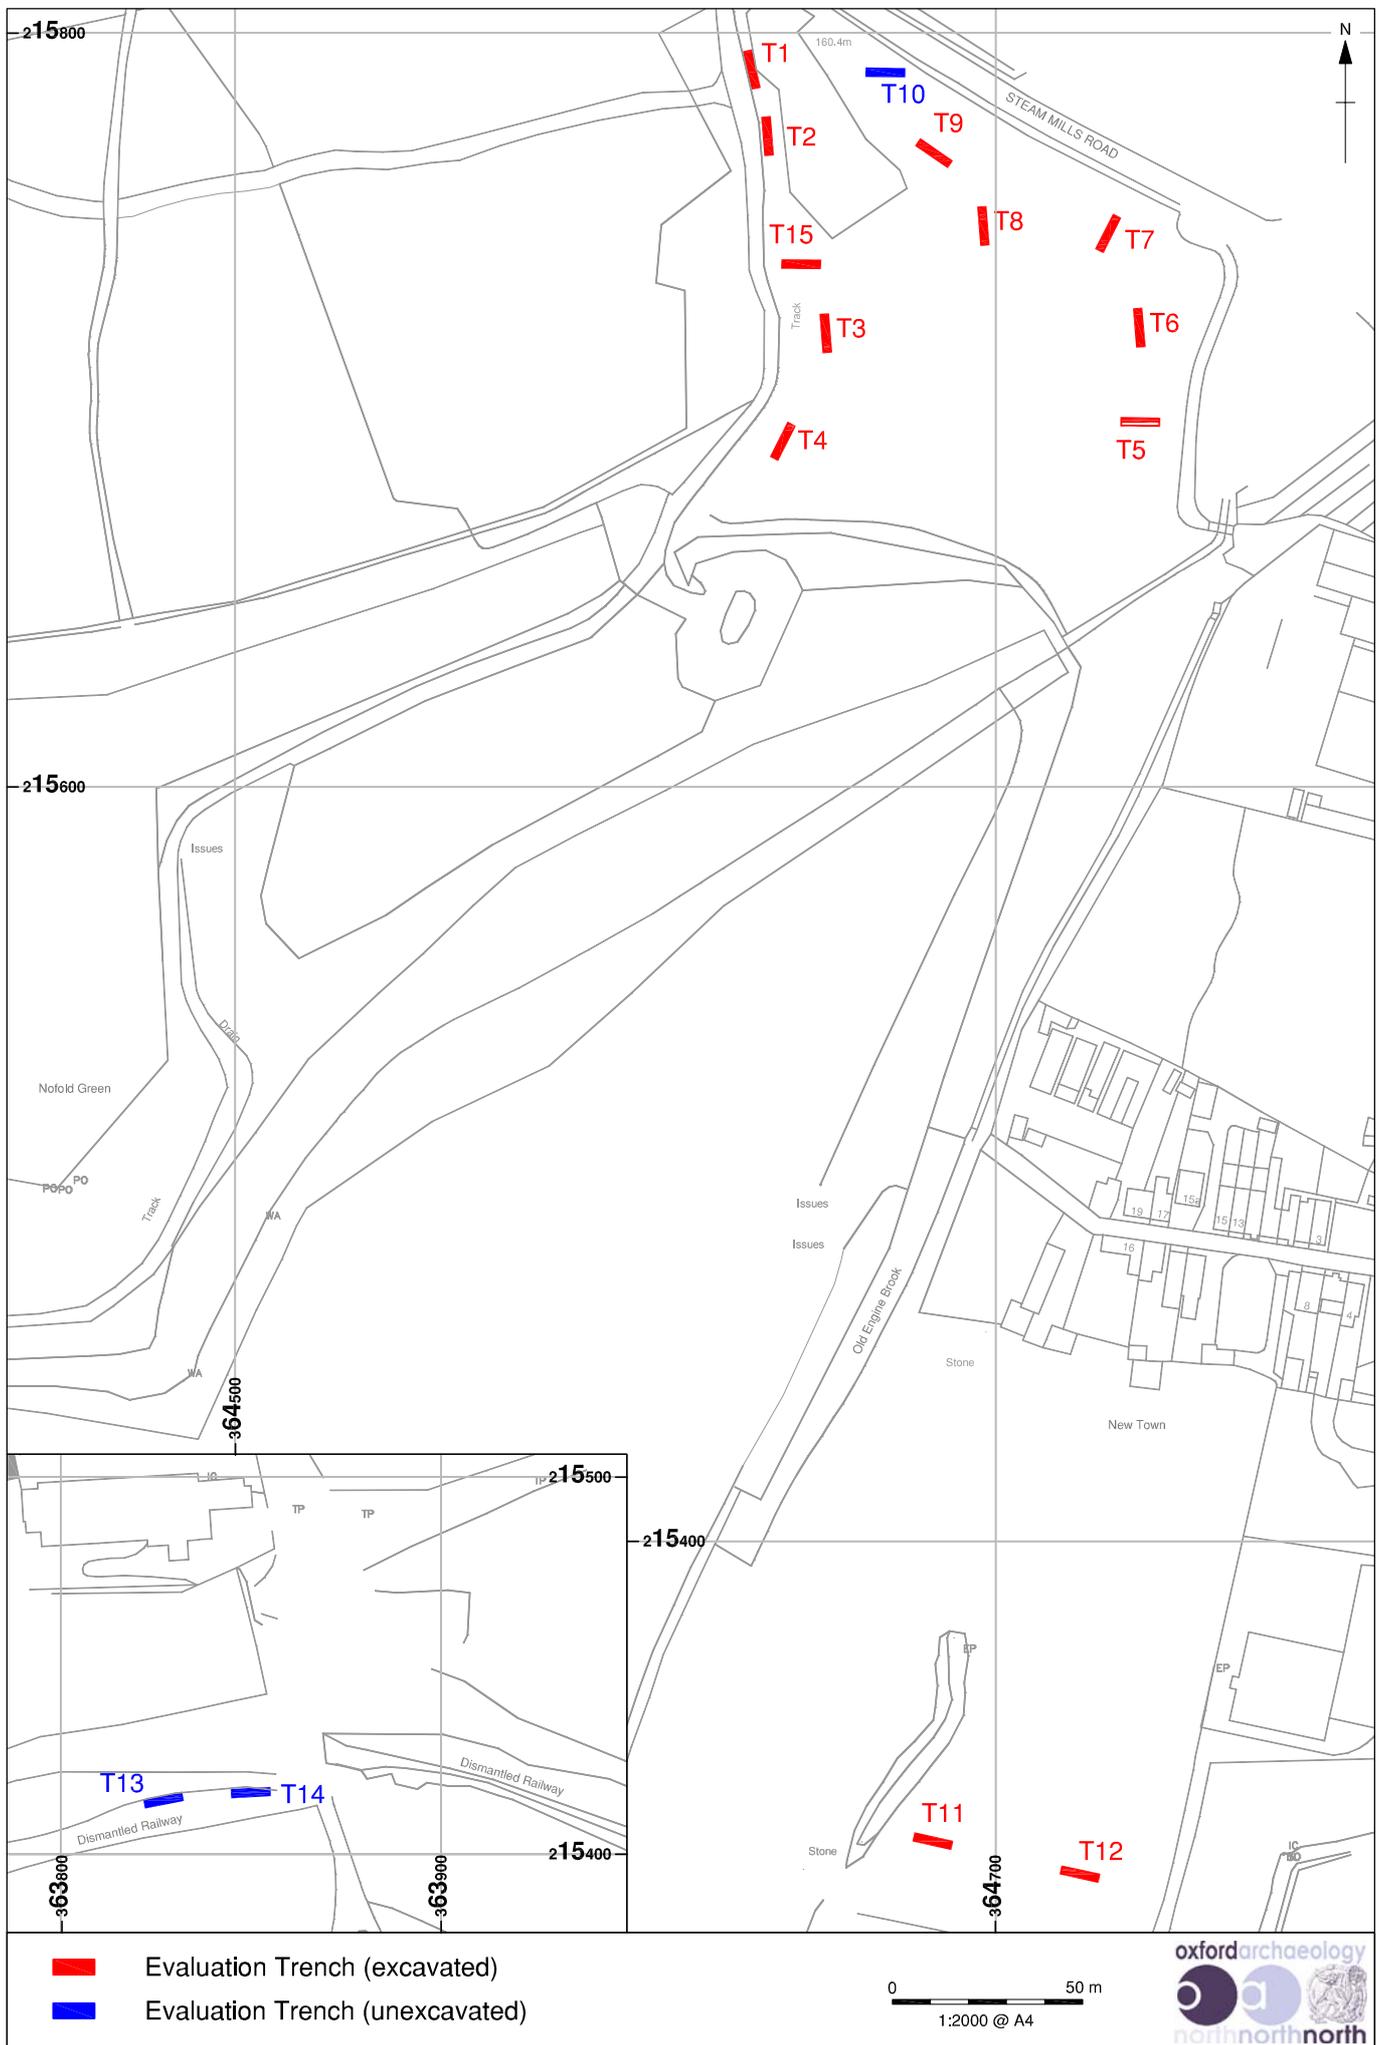
3.1.1 Of the proposed 14 trenches, 12 were excavated during the course of the investigations, consistent with a 2% sample of the viable development area (Fig 2). Plans to excavate trenches 13 and 14 had to be abandoned due to issues of land access and ecological concerns, whilst Trench 15 was excavated in preference to Trench 10, which had been located within an area deemed ecologically sensitive. Each trench was excavated to a length of 10m, and varied from 1.6-1.8m wide. A summary of the results for each trench is presented below

Figure 2: Evaluation trench location plan

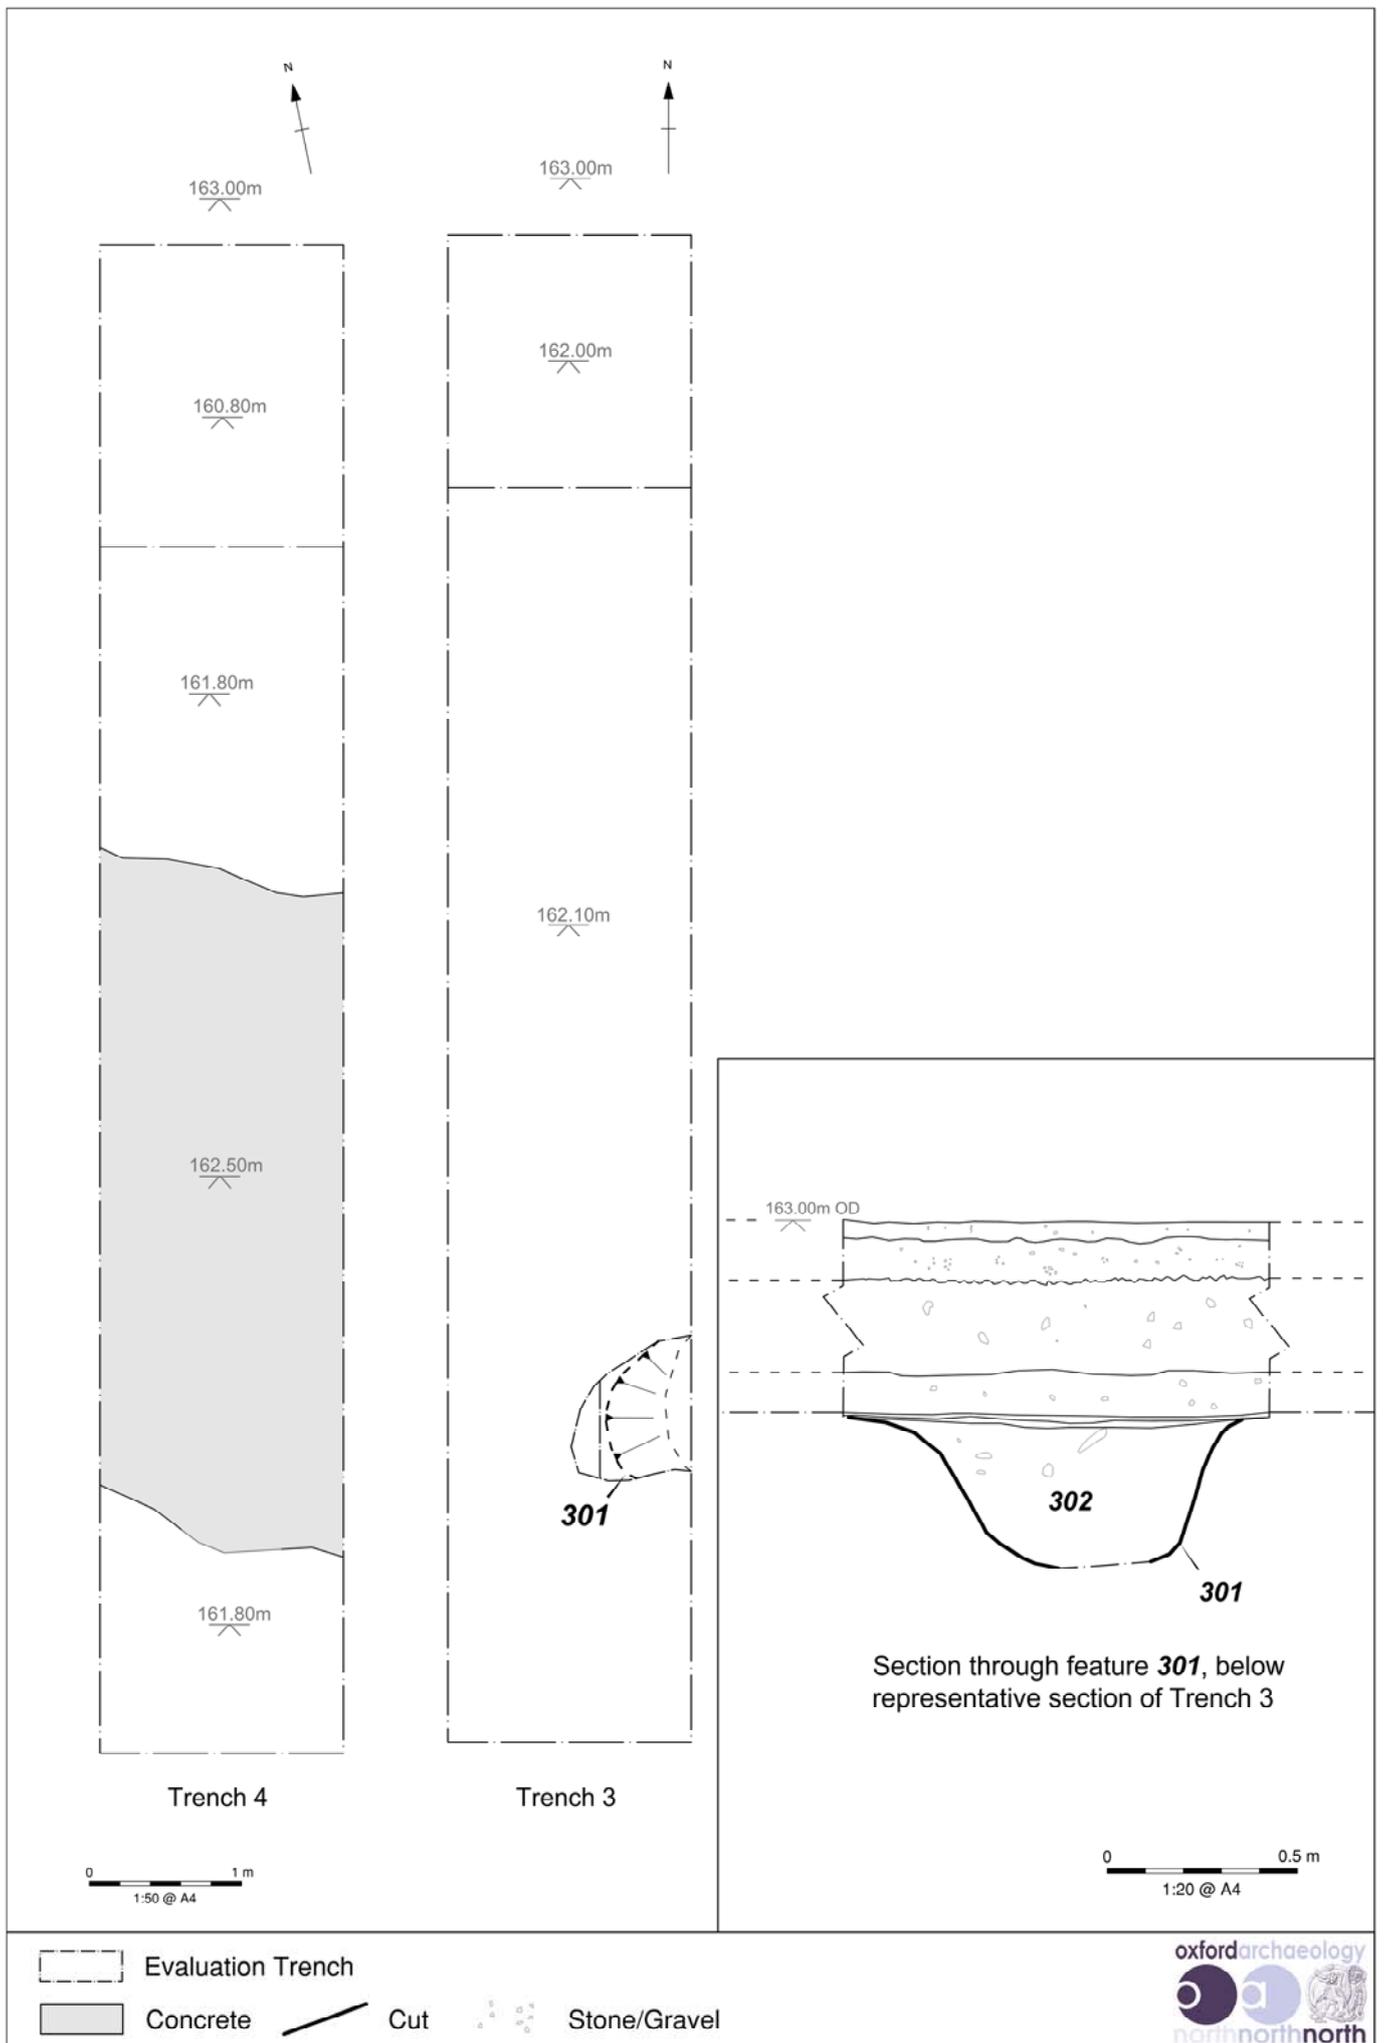
Figure 3: Plans of Trenches 3 and 4, with section through Trench 3
