Hartdale House, Mill Lane, Cheadle, Cheshire

Archaeological Investigation

Oxford Archaeology North

June 2009

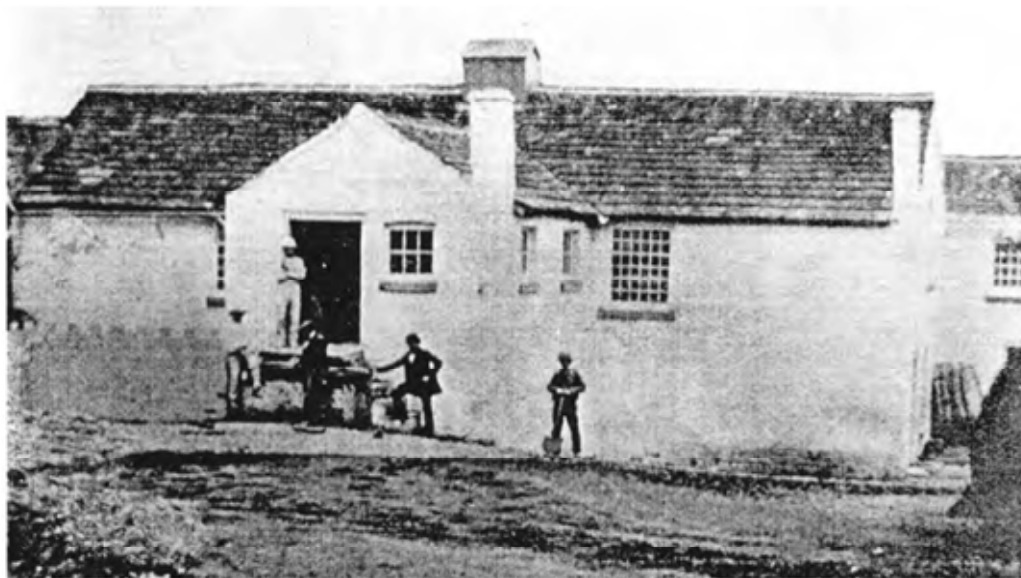
Plate 2: The south-facing elevation of Cheadle Lower Mill in c 1864 (SLS 22345)

- 3.1.18 The principal building is depicted on a photograph taken in c 1864 (SLS 22345), which also shows the mill yard at the end of Mill Lane (Plate 2). The photograph confirms that the mill was a two-storey structure, whilst its layout and component materials is consistent with an eighteenth- or nineteenth-century structure. A small part of another building is visible to the right of the mill, and it seems possible that this is Hartdale House.

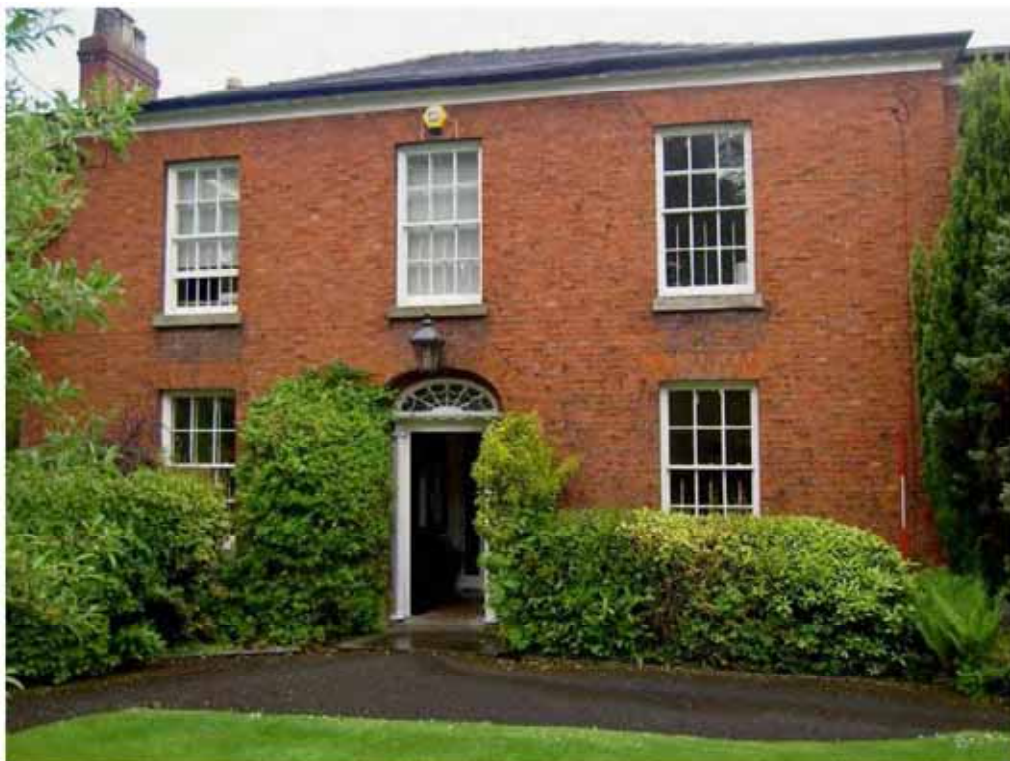
Plate 3: Front (south) external elevation of the main house, showing the polite symmetrical building style and decorative doorway

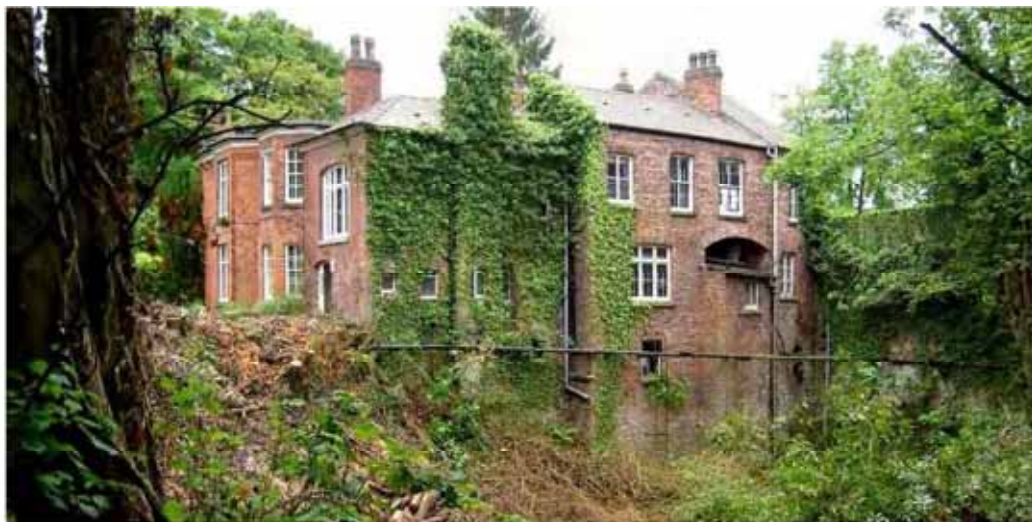
- 4.2.1 **North elevation:** this is a large and complex elevation, with several phases of addition and alteration evident (Plate 4). The elevation extends to a considerable height because of the steep slope down to the former course of the Micker Brook, with the ground on this side of the building dropping down from the east, exposing the elevation to basement level (Fig 7). The west end of the elevation is at a slight angle to the west elevation for some 2m before turning south. At this point there is a large flying arch over a recess with the top 0.5m or so open, above which the wall has evidently been raised in height. The rationale for the flying arch remains uncertain, although it seemingly represents an original feature, and the blocking wall in the associated recess is a later addition. The wall within the recess has been roofed with slate, below which is a window with a sandstone sill with a two-light timber frame.

Plate 4: General view of the north-facing external elevation

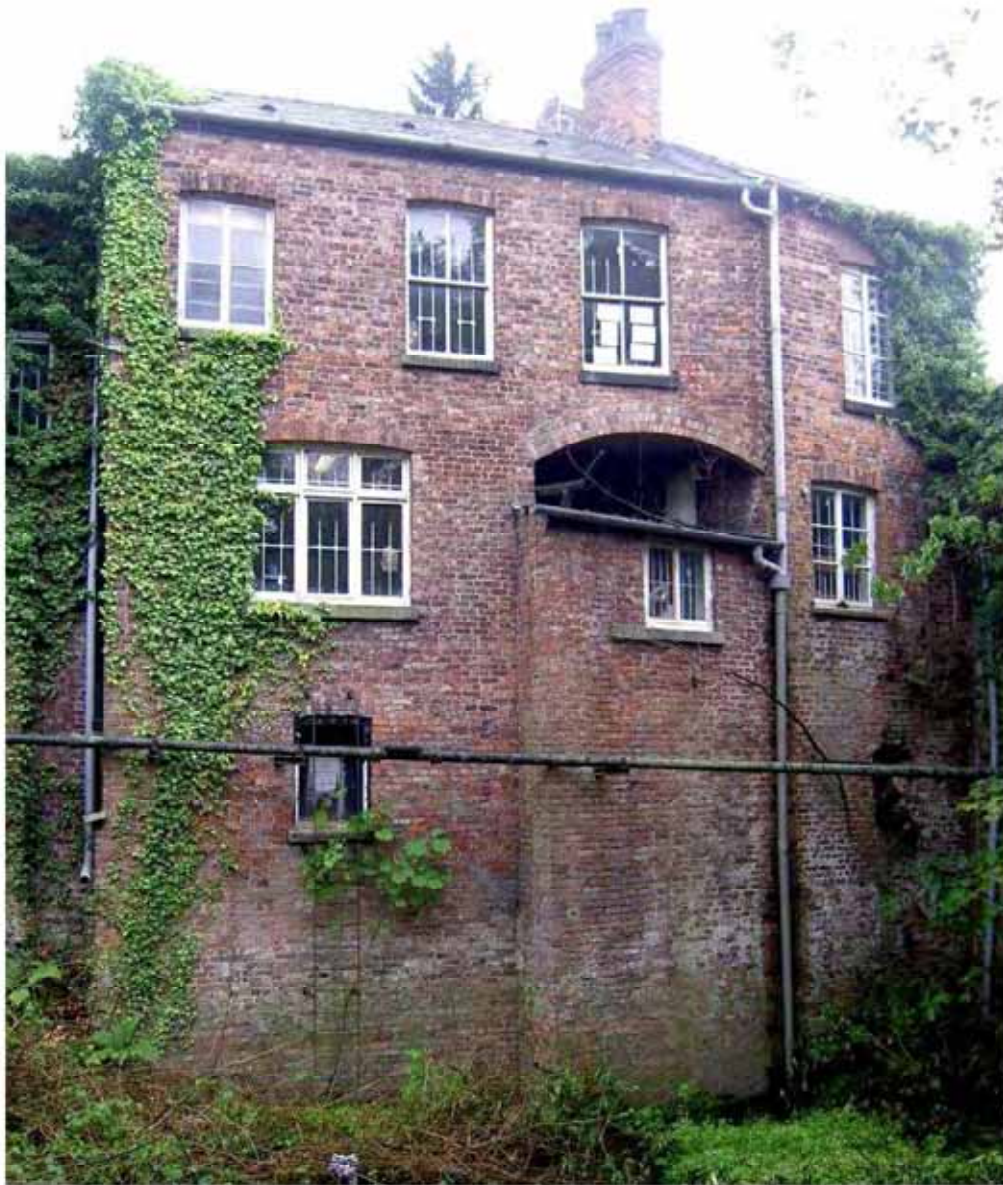
Plate 5: West end of north-facing external elevation

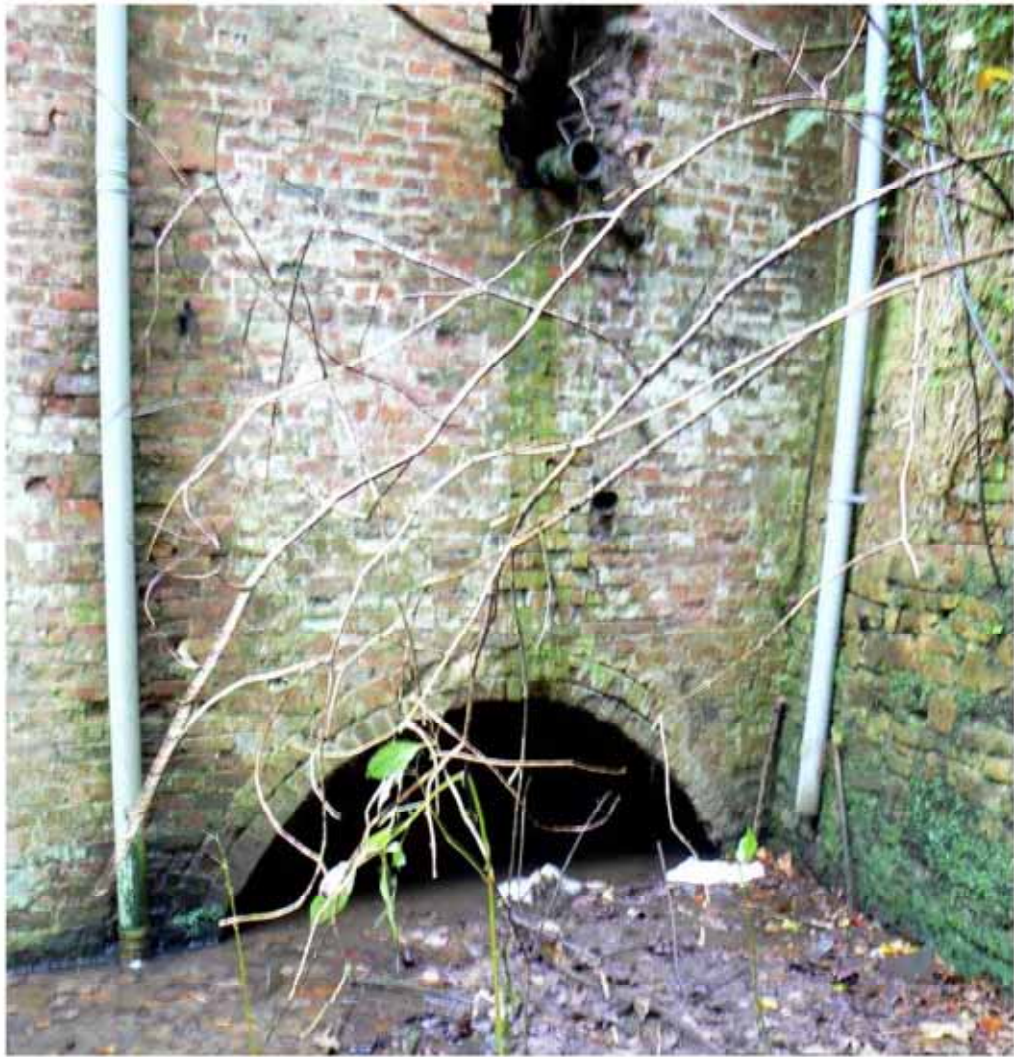
- 4.2.4 At the foot of the west end of the elevation is a brick-arched aperture, forming a north/south-aligned tunnel beneath Hartdale House (Plate 6). The position of the aperture corresponds with the southern bank of the former river course, as shown on historical mapping (eg Fig 4). The aperture is approximately 2m wide at its northern end, although it is of a reduced size a little way in (Plate 7); the full depth of the aperture is obscured by stagnant water and river silt.

- 4.2.5 The aperture almost certainly represents an element of the water-management system of the former mill. The mechanics of this system are presently poorly understood, not least because the exact position of the mill's waterwheel remains uncertain, although it would seem likely that the aperture was part of a by-wash system, providing a conduit for excess water entering the head-race to the waterwheel chamber.

Plate 6: Brick-arched aperture at foot of north-facing elevation

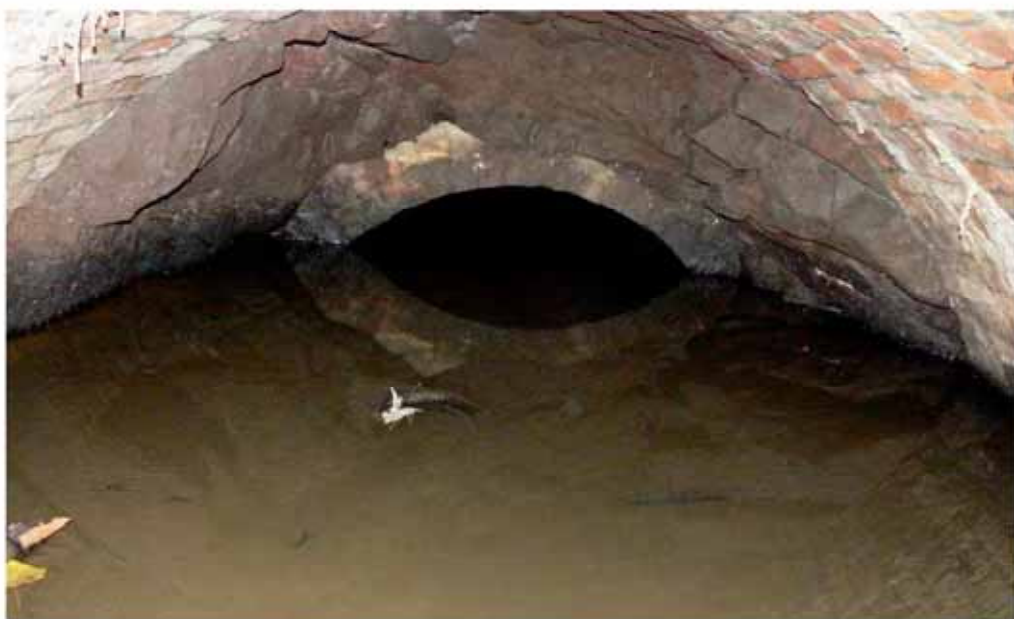
Plate 7: View inside the brick-arched aperture

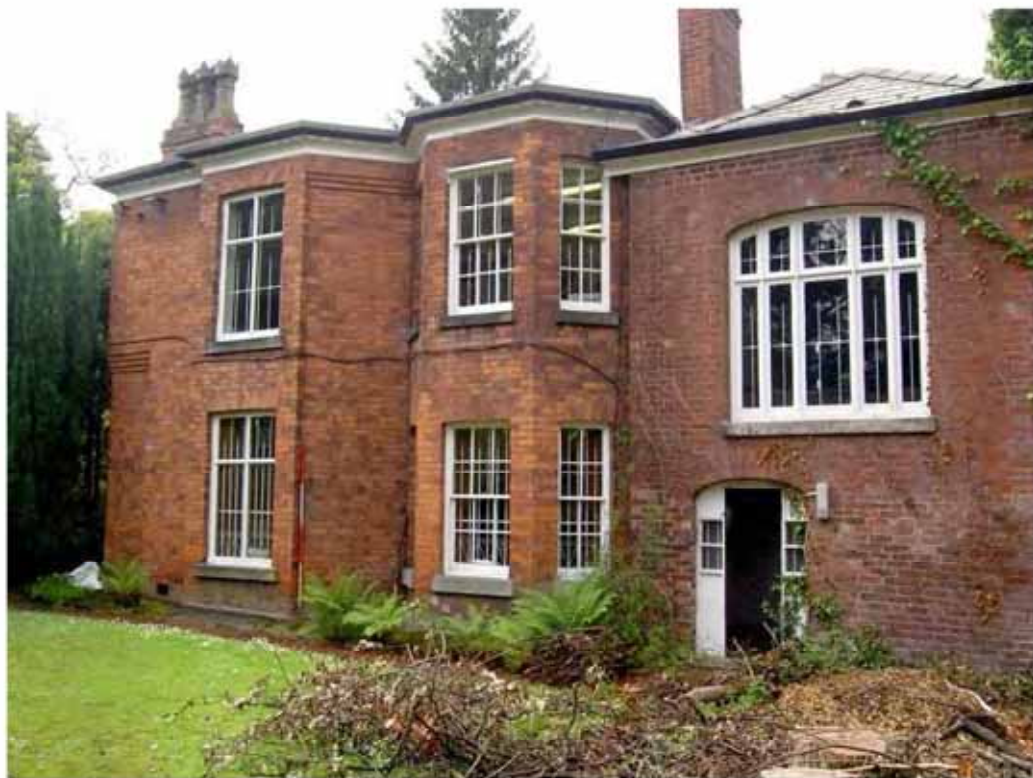
- 4.2.6 **East elevation:** the south side of the east-facing elevation is constructed of bright orange, mould-thrown brick in Flemish bond with a corbelled section midway up (Plate 8). There are two projecting asymmetrical bays. The south bay is three-sided with a large central four-light timber window frame with sandstone sill and flat arch of brick voussoirs, the first floor window is of similar dimension and construction (Fig 8). The north bay has a window in each elevation; a 12-light timber sash window in the central elevation, and eight-light sash framed widows in the side elevations. The first floor windows are of similar design and construction. The ground floor sills are concrete while those of the first floor windows are sandstone.

Plate 8: East-facing external elevation, showing the bay windows and raised height of the north-east end

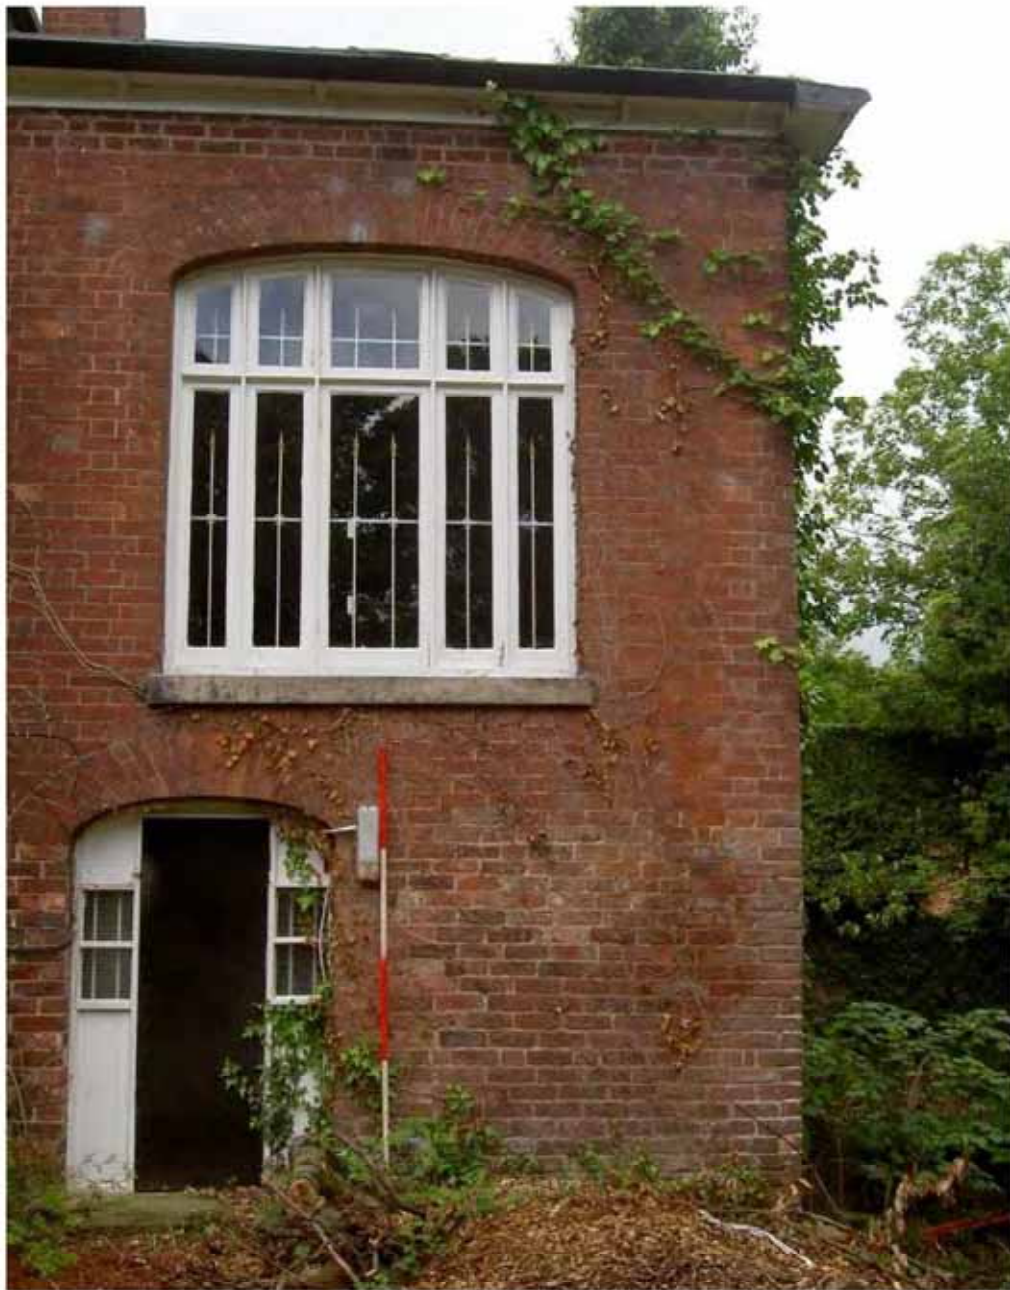
- 4.2.7 The north side of the elevation is constructed of a dark red brick, typically 0.23m long by 0.11m wide and 0.07m thick, and laid in a slightly random bond largely comprising stretchers, with a rough face and wide bonding. There is a wide doorway with a four-point arch of brick voussoirs. The door is centrally placed and panelled either side, each side inset with a small two-light window. Above the door and situated centrally is a very large window, also with a four-point brick arch and sandstone sill. The window has a ten-light timber casement frame. The upper part of this wall, above a height of about 1.8-1.9m, has been raised; it is also constructed from a dark red brick, but of much better quality with narrower joints and typically 0.23m long by 0.11m wide and 0.08m thick and laid in Flemish bond (Plate 9). This raised section incorporates both the large window on the first floor and the arch of the lower doorway. The top of the wall has also been repaired in a more modern brick, attached to which is a barge board with projecting brackets.

Plate 9: North end of the east-facing external elevation, showing the raised height

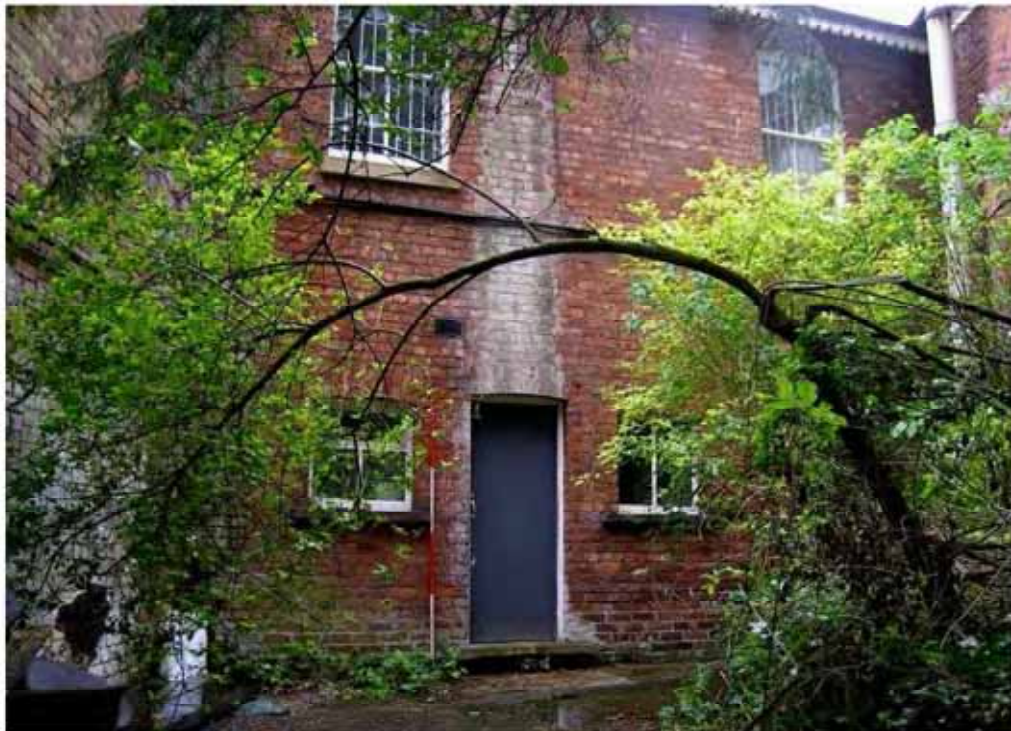
- 4.2.8 **South elevation:** the elevation comprises mould-thrown brick in neat Flemish bond on a sandstone plinth, and the roof is hipped. The bricks are a brick-orange colour, and typically 0.23m long by 0.11m wide and 0.07m thick. There is a central doorway with a window either side, and three windows on the first floor in line with the ground floor window and doorway (Plate 3). The doorway has fluted Ionic columns supporting a denticulate entablature, and a rounded arch with ornate fanlight (Fig 9). The windows are uniform and appear to have concrete sills and the lintels are fronted with brick voussoirs. The timber sash windows have 12 lights. The west end returns to the north to form the west side of the main house (Plate 10). The ground floor window has a timber eight-light sash frame, and there is a blind window above, below which there are three or four courses of earlier brickwork.

Plate 10: West wing of front (south) external elevation showing the later extension

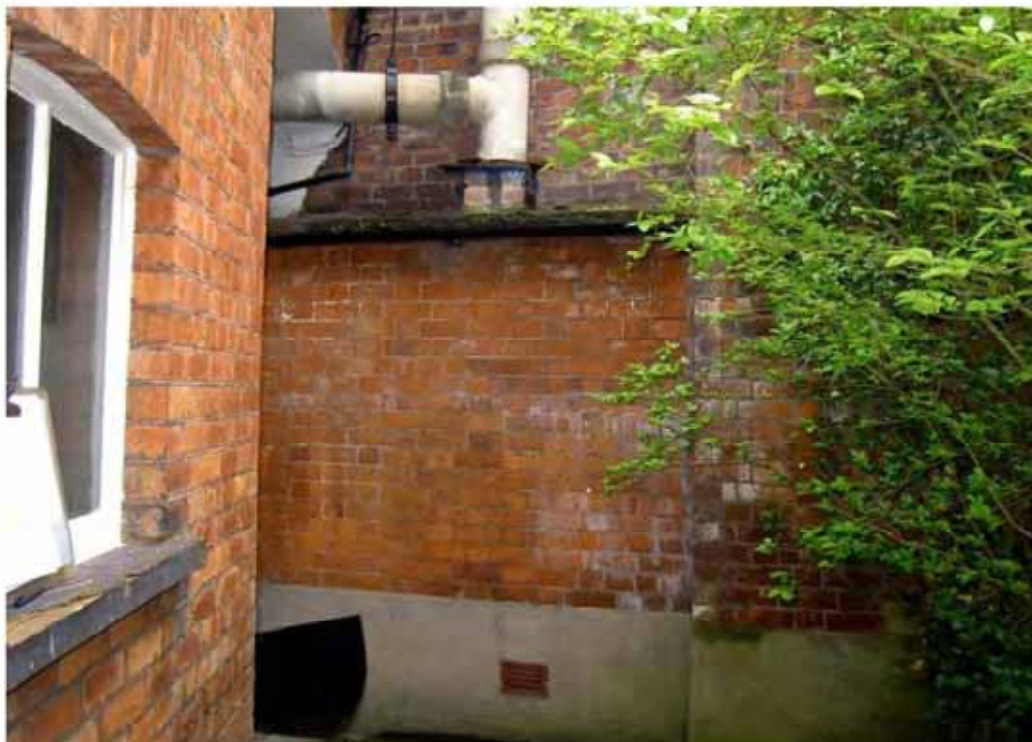
- 4.2.9 The large chimney on the north side of the windows is constructed from slightly darker bricks to the main building, but seems to be contemporary. On the north side of the chimney there is a low wall some 2m in height capped with stone flags, which runs across a former opening of some type, the brick-arched top of which is visible although it is blocked (Plate 11).

Plate 11: Junction of the main house (Phase 3) and earlier walling (Phase 2). The blocked arched aperture in the north return of the south-facing elevation is just visible below the pipe

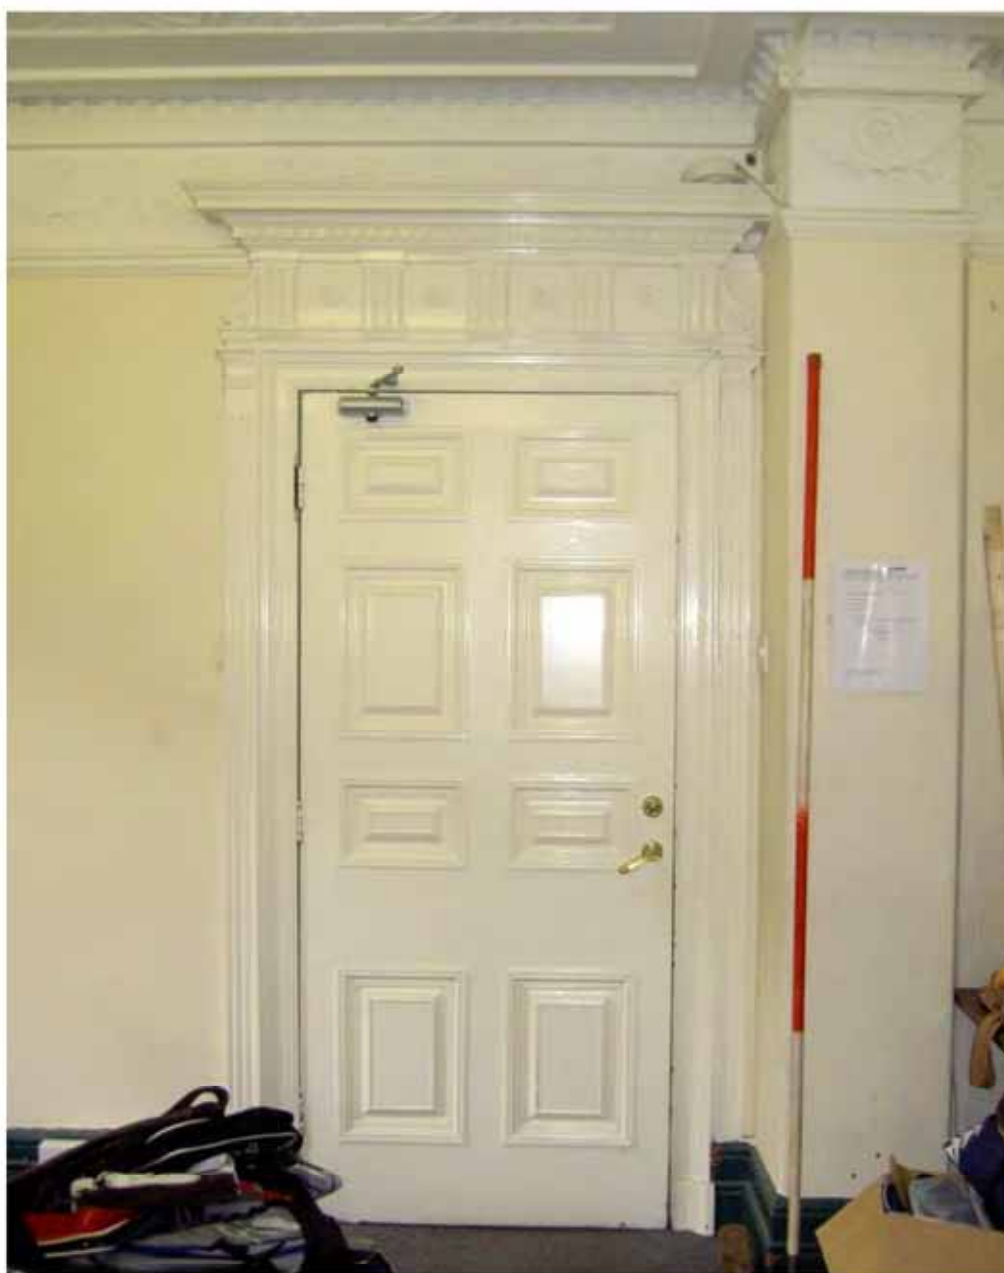
Plate 12: Decorative doorway in west elevation of Room G1

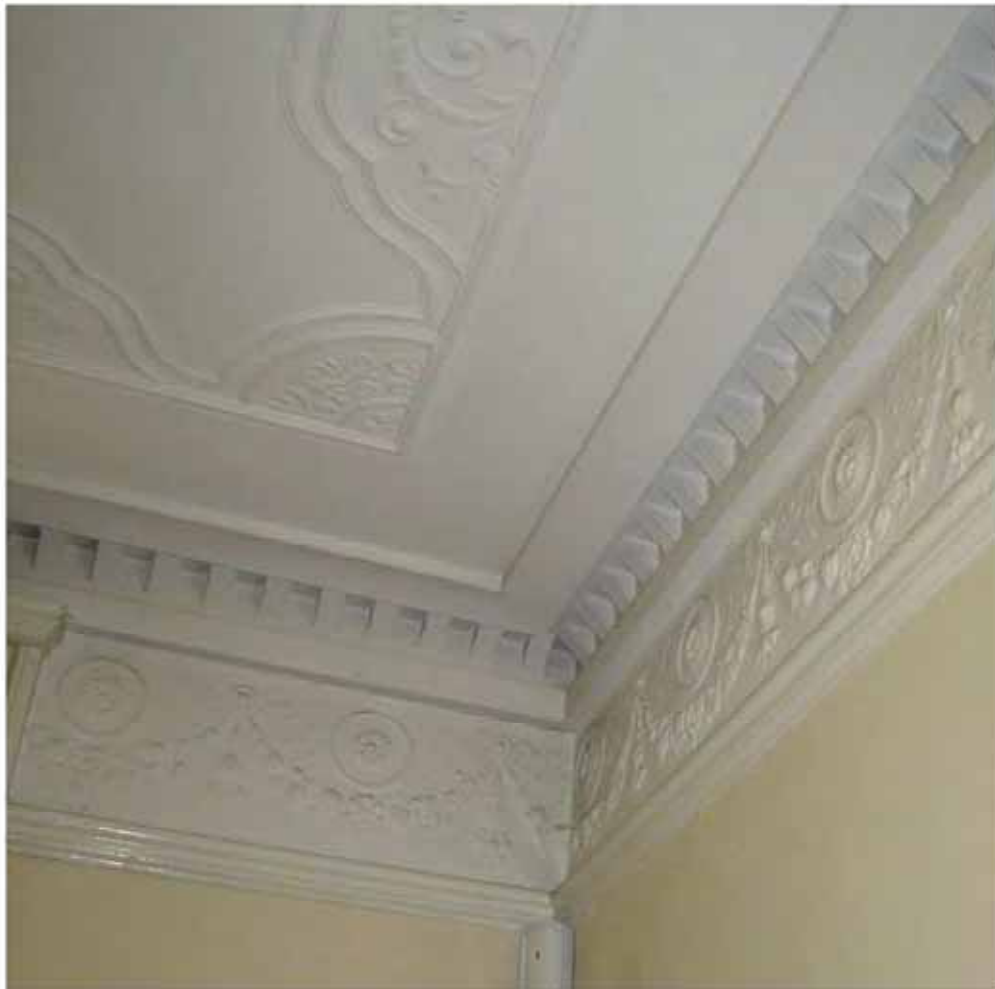
Plate 13: Detail of cornice in Room G1

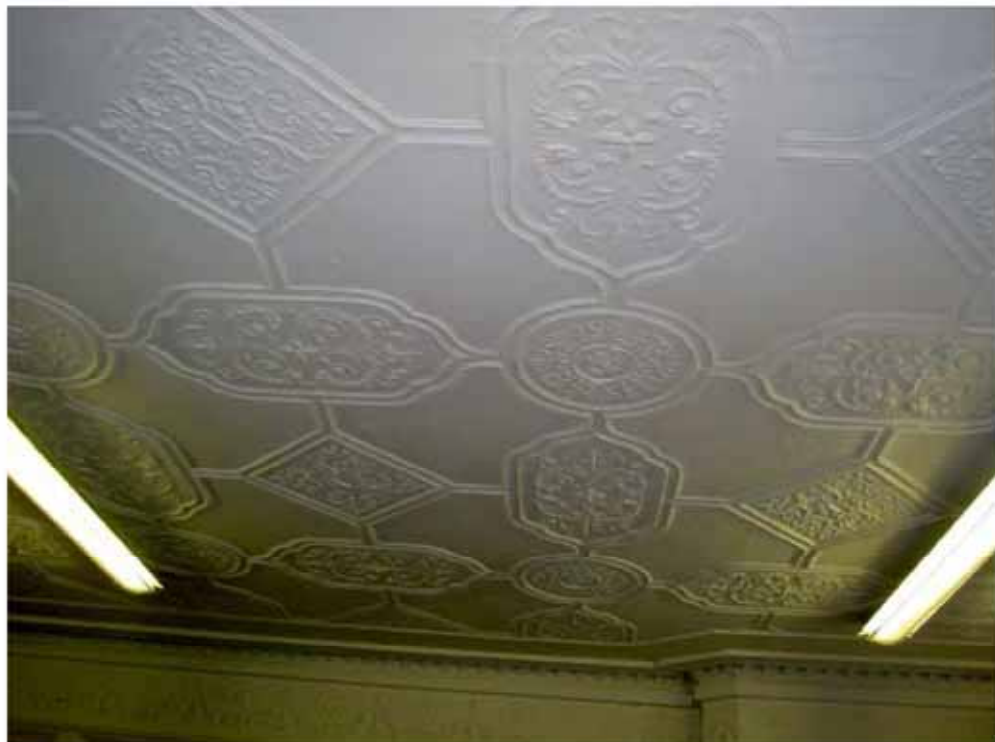
- 4.4.1 **Room G1:** this forms a large reception room with elaborate decoration. The south elevation has a tall window with a 12-light sliding sash casement (apparently a modern replica) with a moulded surround and entablature and modern shutters. The west elevation has an elaborately decorated doorway with fluted pilasters and an entablature on scrolled brackets decorated with denticulate decoration, roundels, and triglyphs (Plate 12). The door is heavily moulded with eight raised and fielded panels. The east elevation has two more windows, one of which is a three-part canted bay, the largest with 12-light sliding sash casements (modern replicas) and the smaller ones with eight-lights. The decorative scheme continues into a wide cornice also with applied plaster decoration, including floral swags, roundels, denticular brackets, and moulded rails, with circular fittings for former gas lights regularly spaced along the wall (Plate 13). The ceiling is decorated with interlinked applied plaster panels with floral motifs and Lancashire(?) roses (Plate 14).

Plate 14: Detail of ceiling in Room G1

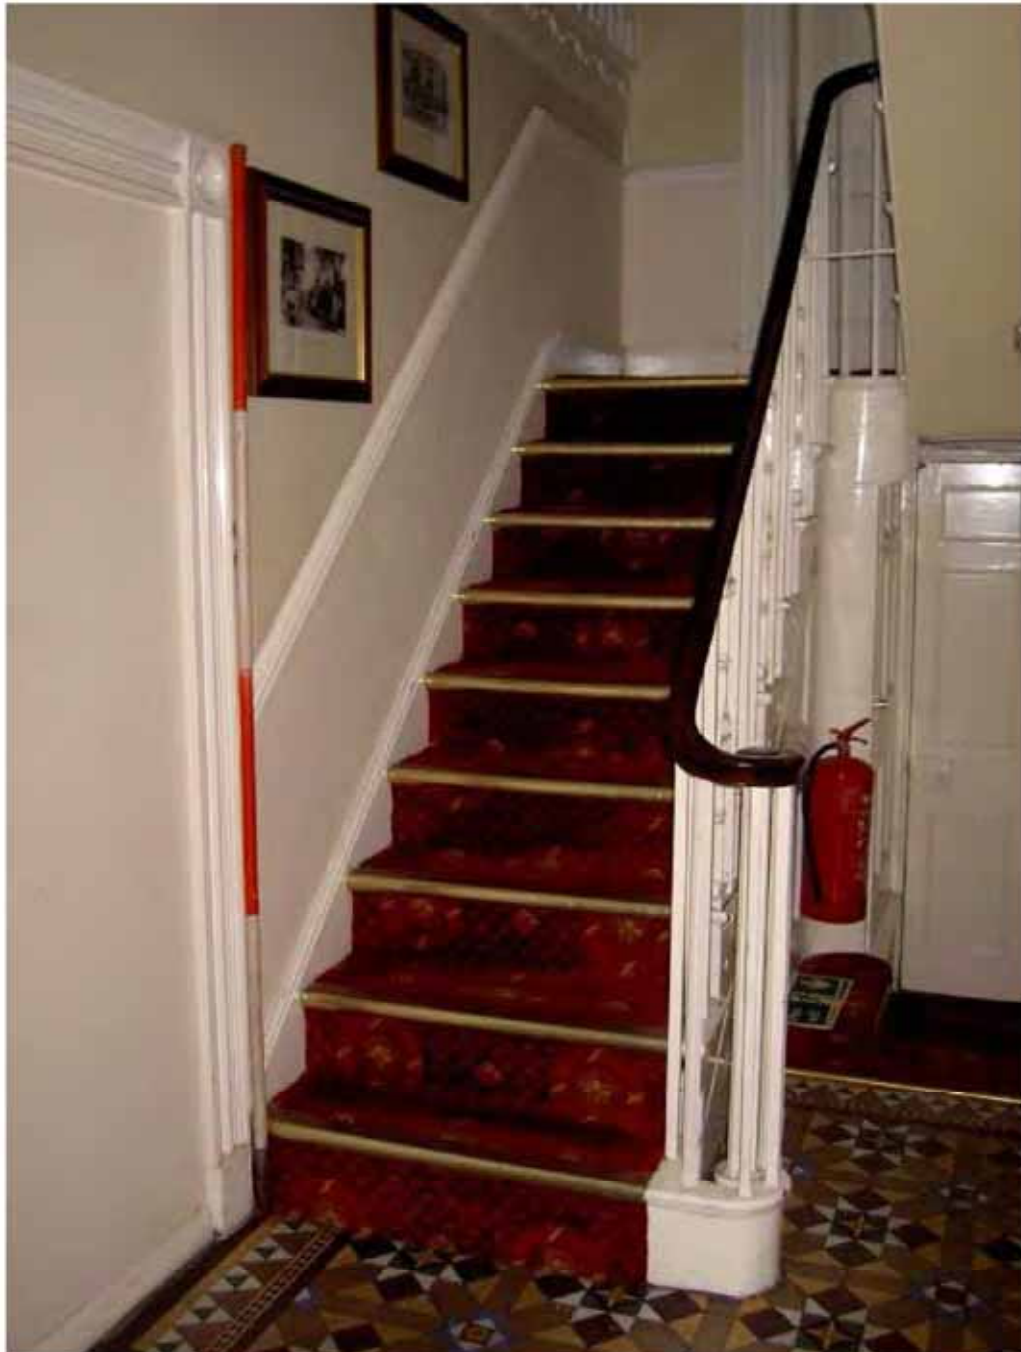
- 4.4.2 **Room G2:** the ceiling is plaster, with a roll-moulded cornice. The staircase is situated at the north end of the corridor on the west side (Plate 15). The stairs handrail is turned and scrolled supported by plain stick balusters, except every third one which is decorated with a flower motif, below which is a moulded tread end. The staircase is enclosed with the space below the stairs being panelled with moulded surrounds.

Plate 15: Staircase in Room G2

- 6.3.2 **Room G2:** this too has several features of interest, specifically the turned staircase, which is a good example of a late Georgian type and is in good condition, and the doorways to the east and west, which are of a similar date and retain good quality moulded surrounds and the cornice. The tiled floor is perhaps more likely to be a little later in date, but is still in good condition and a piece of the historic fabric worth retaining. The main doorway to the south has a number of important decorative features, particularly externally, such as the fan light and columns, and these should all be retained.

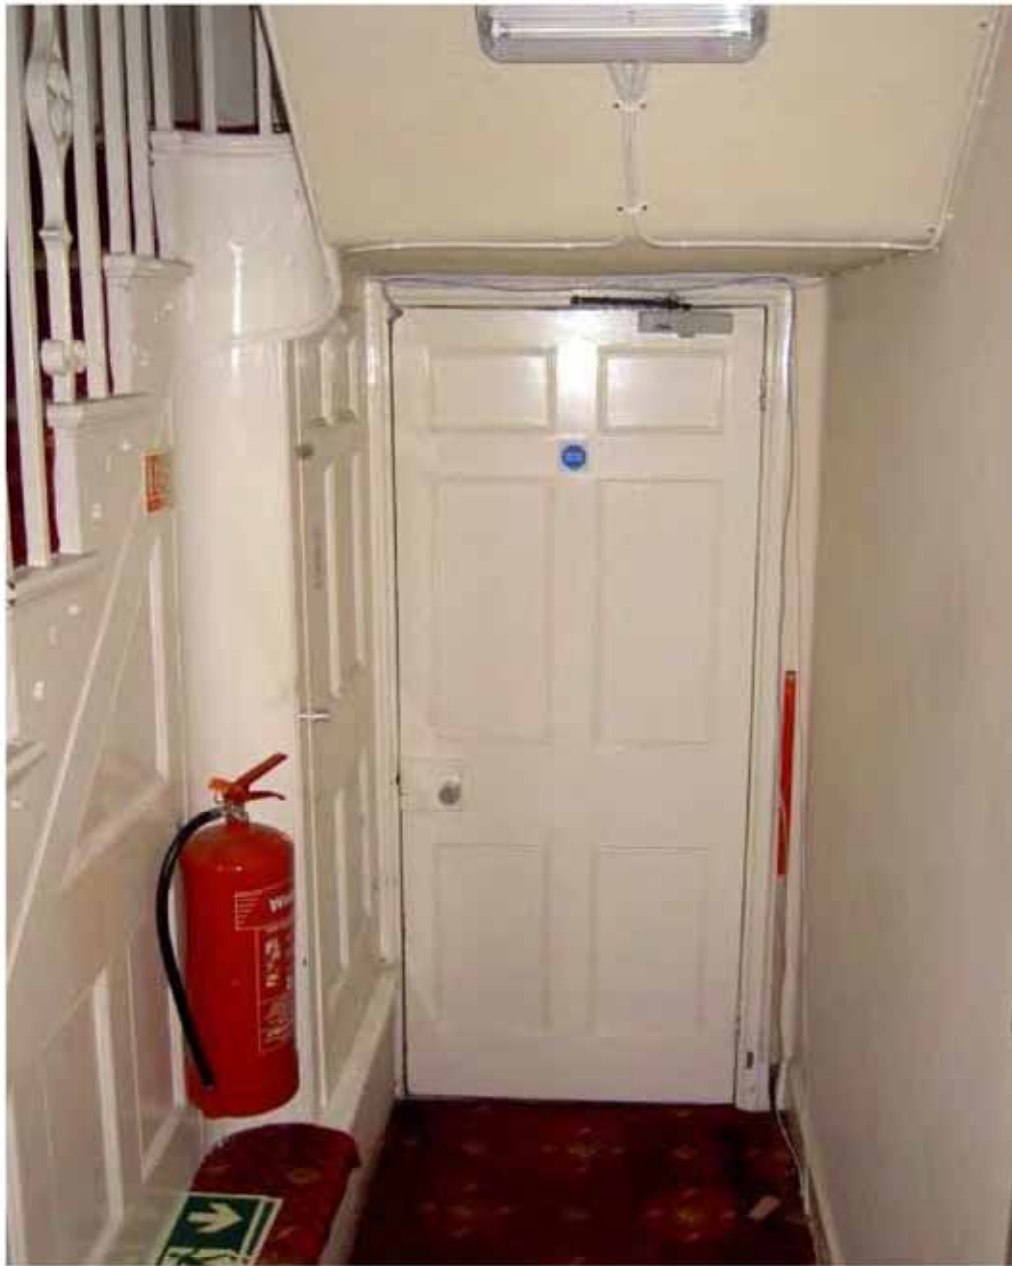
- 4.4.3 There is a raised six-panel three-quarter door giving access to the under-stair space. Below the return of the staircase in the north elevation is the doorway to Room G6. This door is six-panelled and moulded, probably original (Plate 16).

Plate 16: Doorway at north end of Room G2

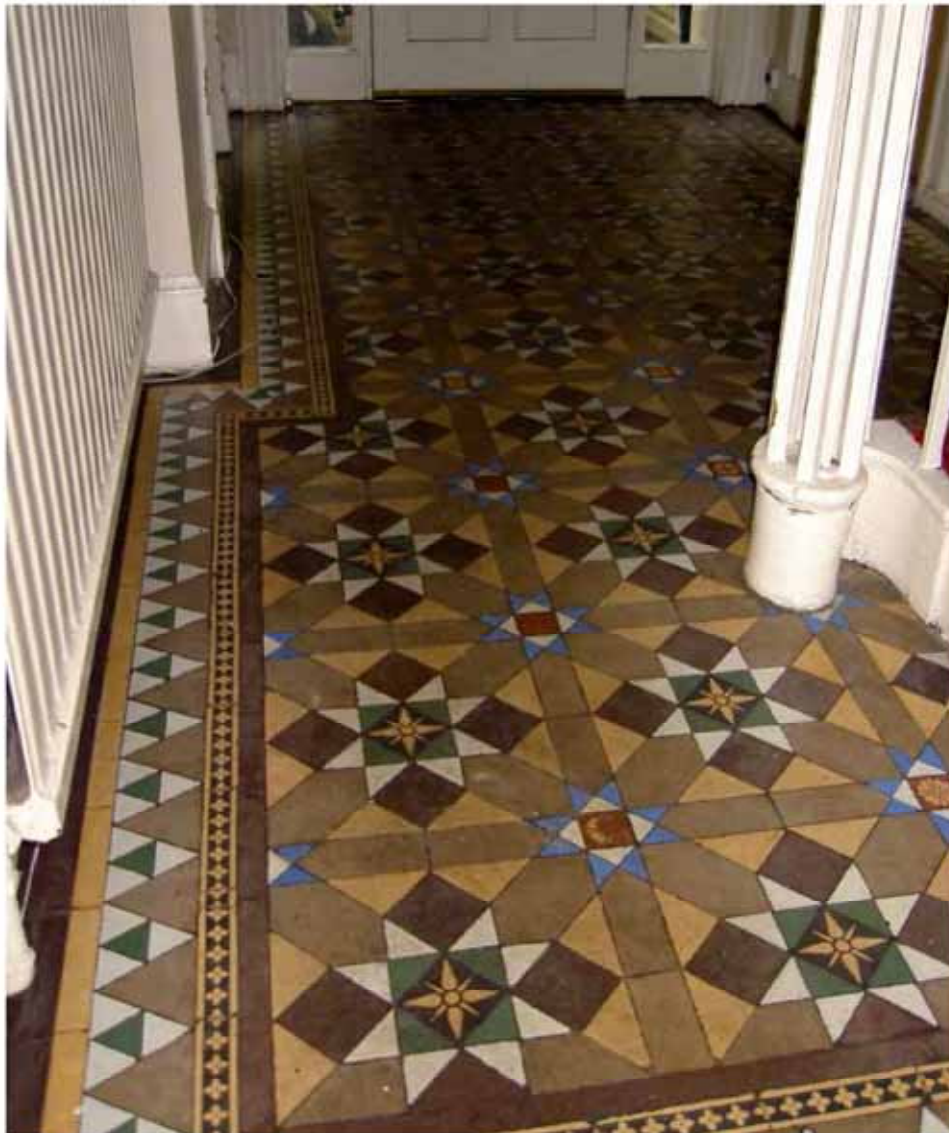
- 4.4.4 On the east elevation is the doorway to Room **G1** to the north of which the wall steps out to create a pillar. The eight-panel door, with moulded surrounds, is also probably original. The door surround is heavily moulded with roundels. The middle of the west elevation has a doorway to Room **G3**. This door is set into what was a larger opening some 1.7m wide, which has been partially blocked. This opening has a moulded surround with roundels of a similar design to the door surround in the east elevation. The doorway in the south elevation is the main entrance, the door being of a six-panel design, the middle panels being glazed. The floor of Room **G2** is laid with decorative tiles (Plate 17).

Plate 17: Tiled floor in G2

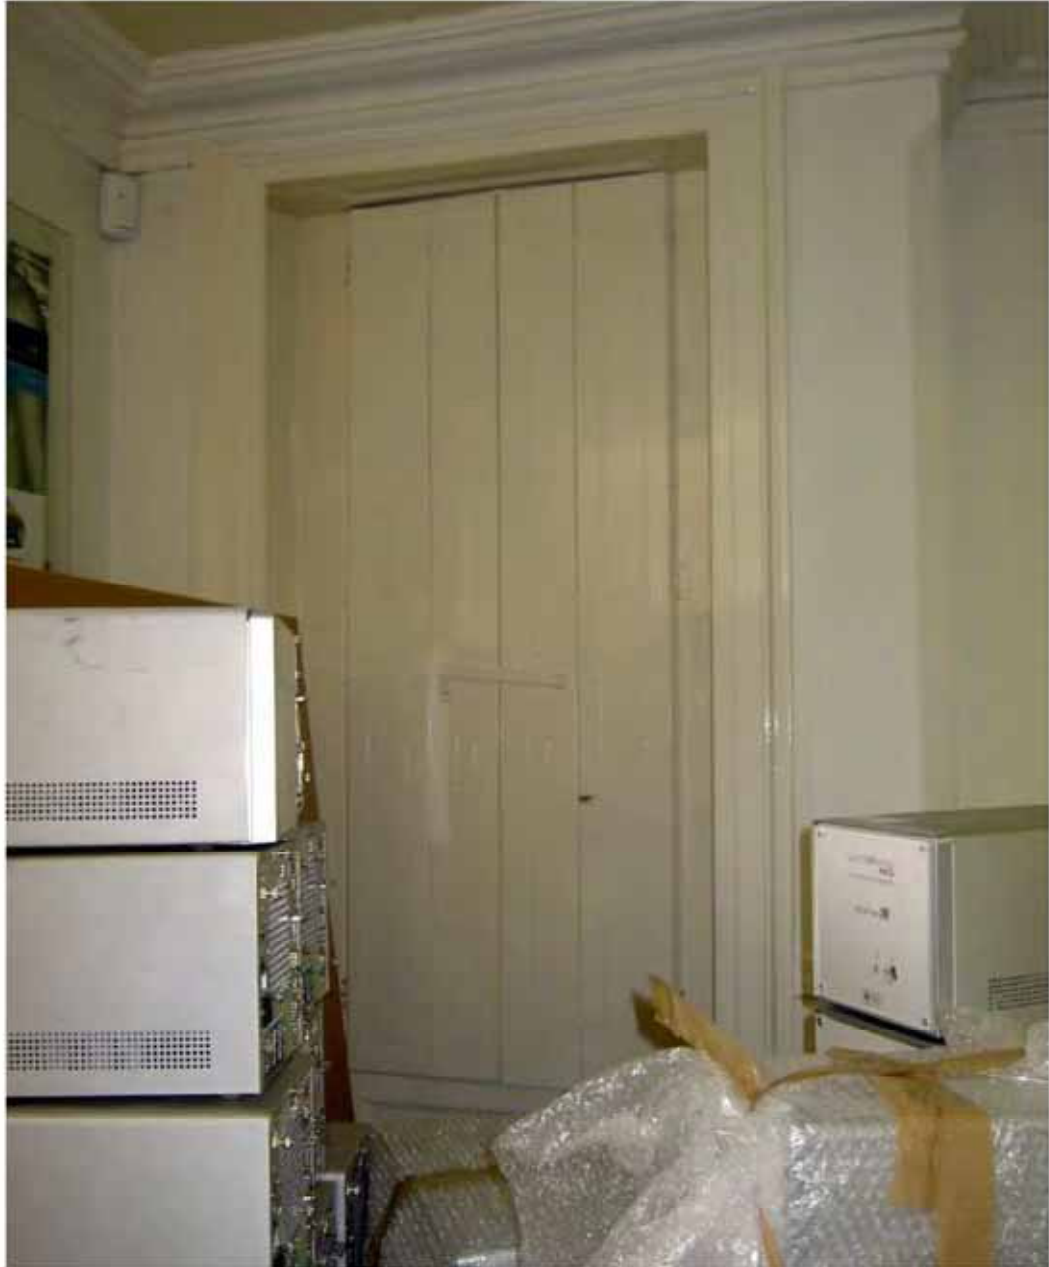
Plate 18: Original shuttering remaining the south-west corner of Room G3

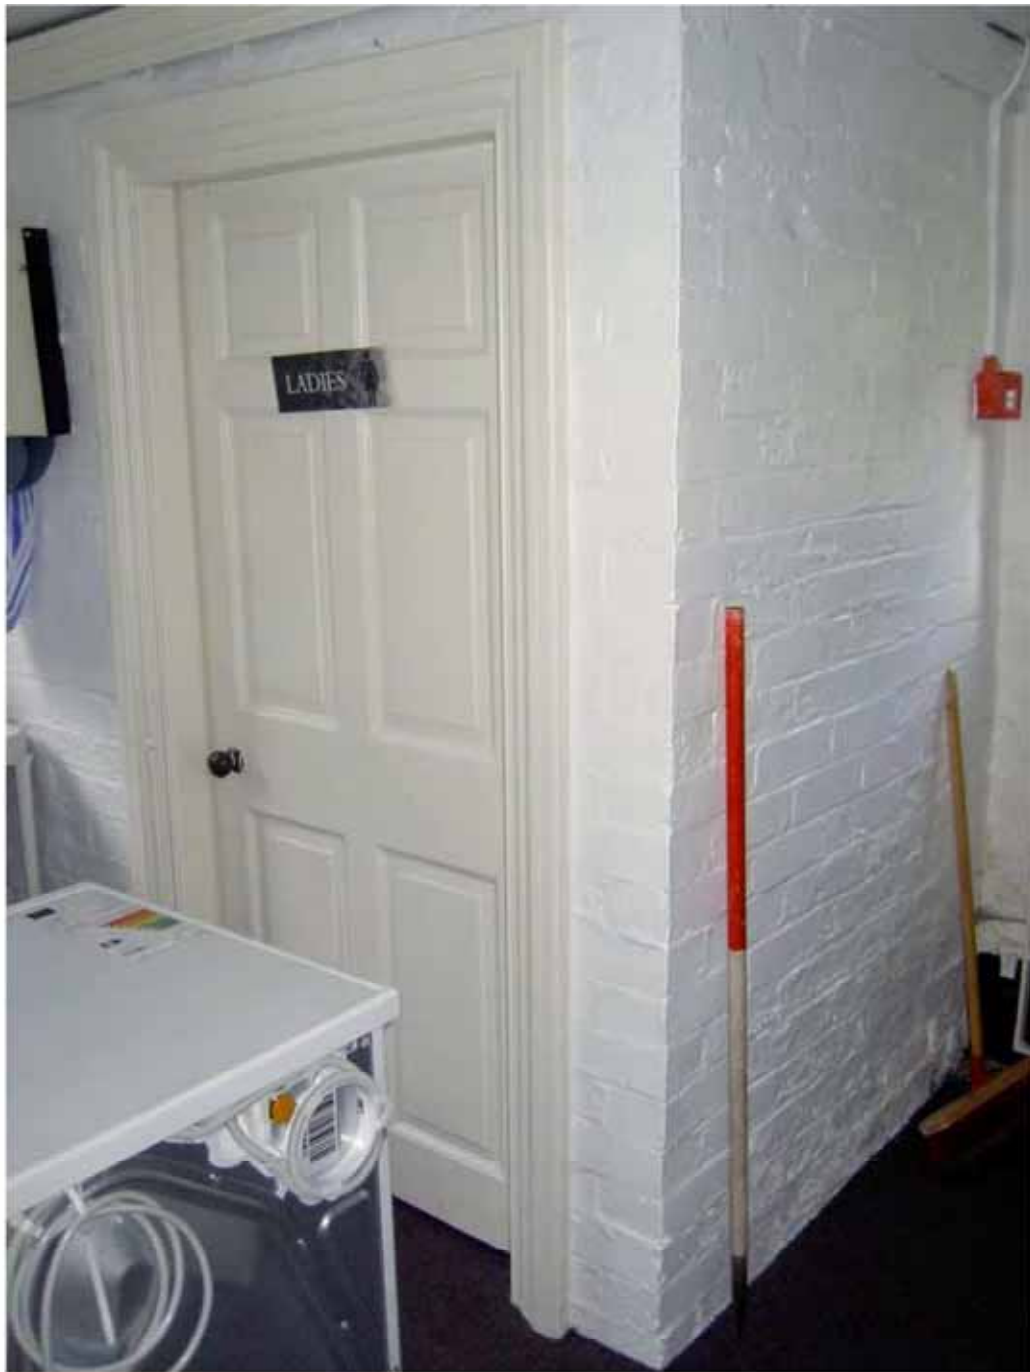
Plate 19: Thick internal walls in the north-east corner of Room G5

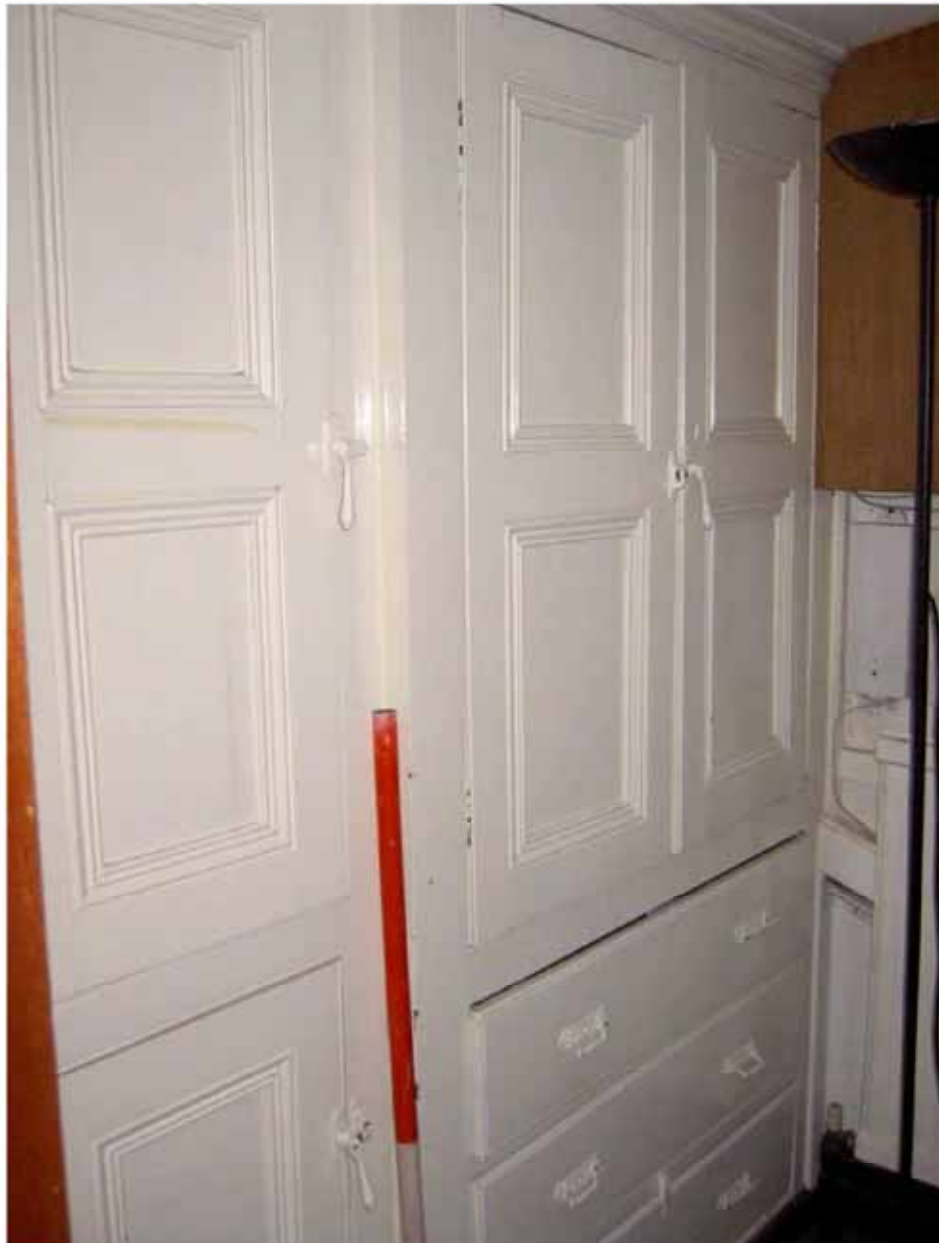
Plate 20: Early cupboards in the west elevation of Room G6
