Hartdale House, Mill Lane, Cheadle, Cheshire

Archaeological Investigation

Oxford Archaeology North

June 2009

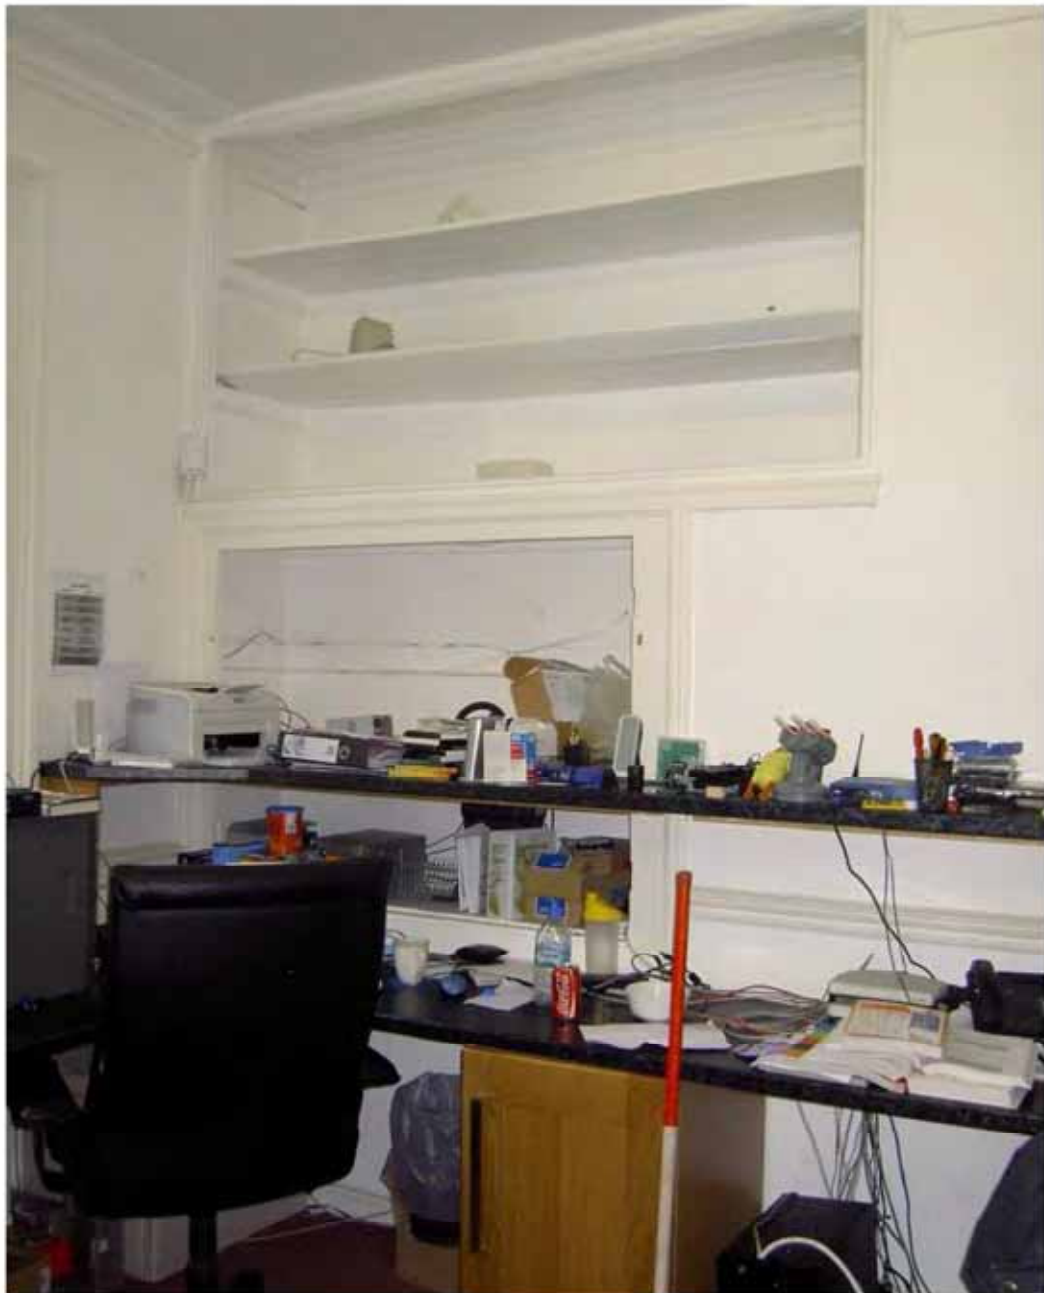
Plate 21: Built-in cupboards in the east elevation of Room G7

- 6.3.6 **Room G7:** again, there are the remains of early built-in cupboards in the east elevation, but these are not in particularly good condition. The cornice present in this room should be retained, but the partition to the south could be removed.

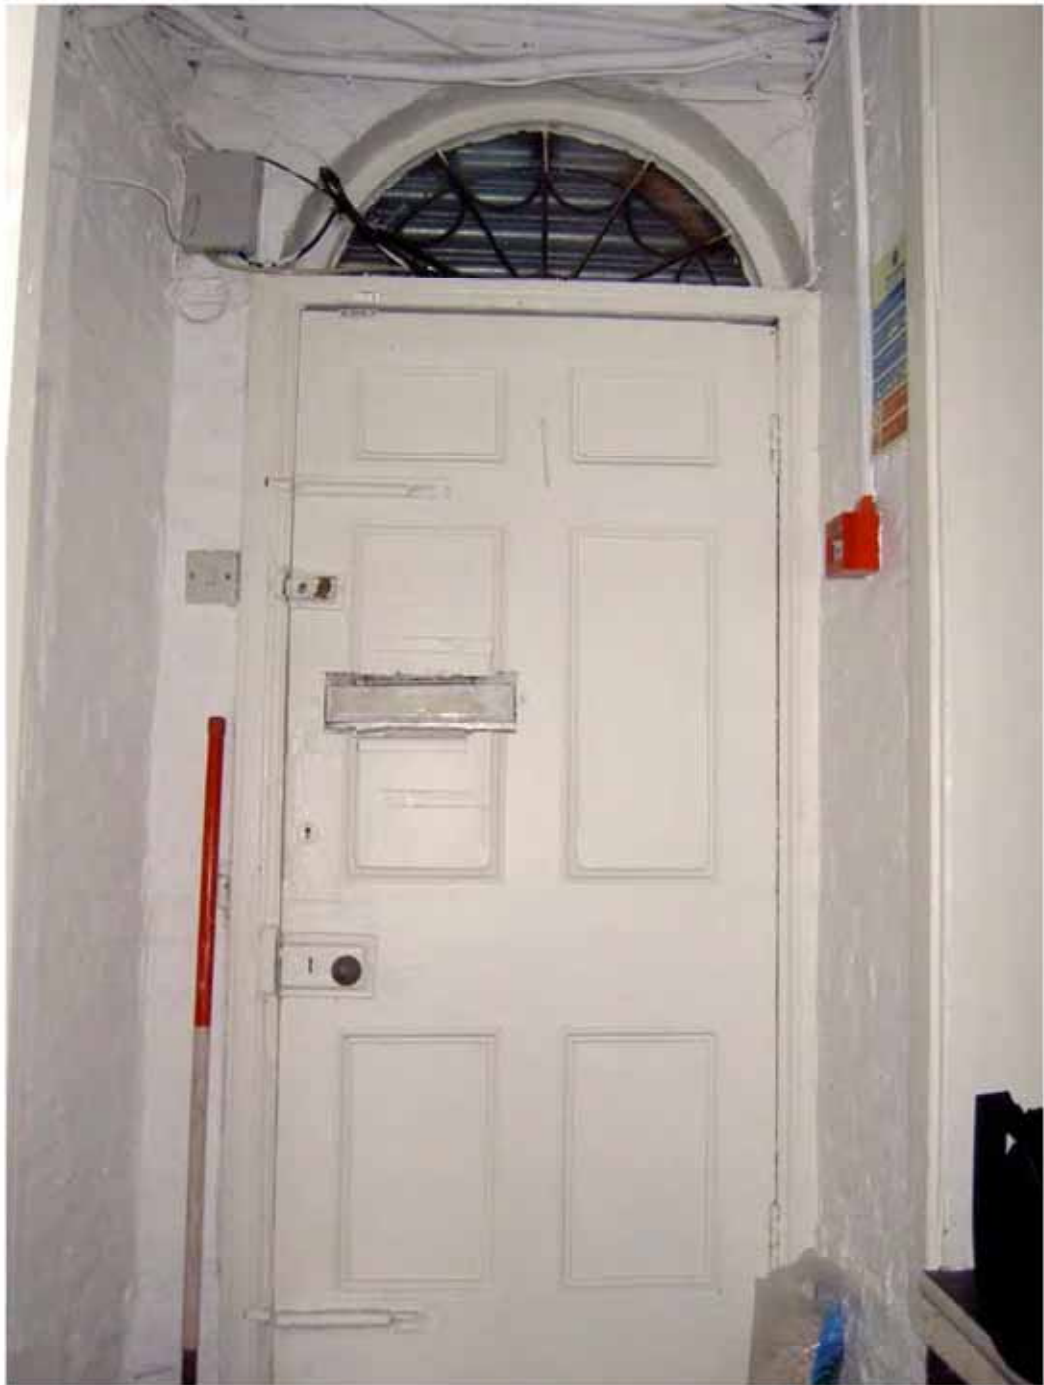
Plate 22: Decorative doorway with fanlight in the south side of the vestibule to the south of Room G8

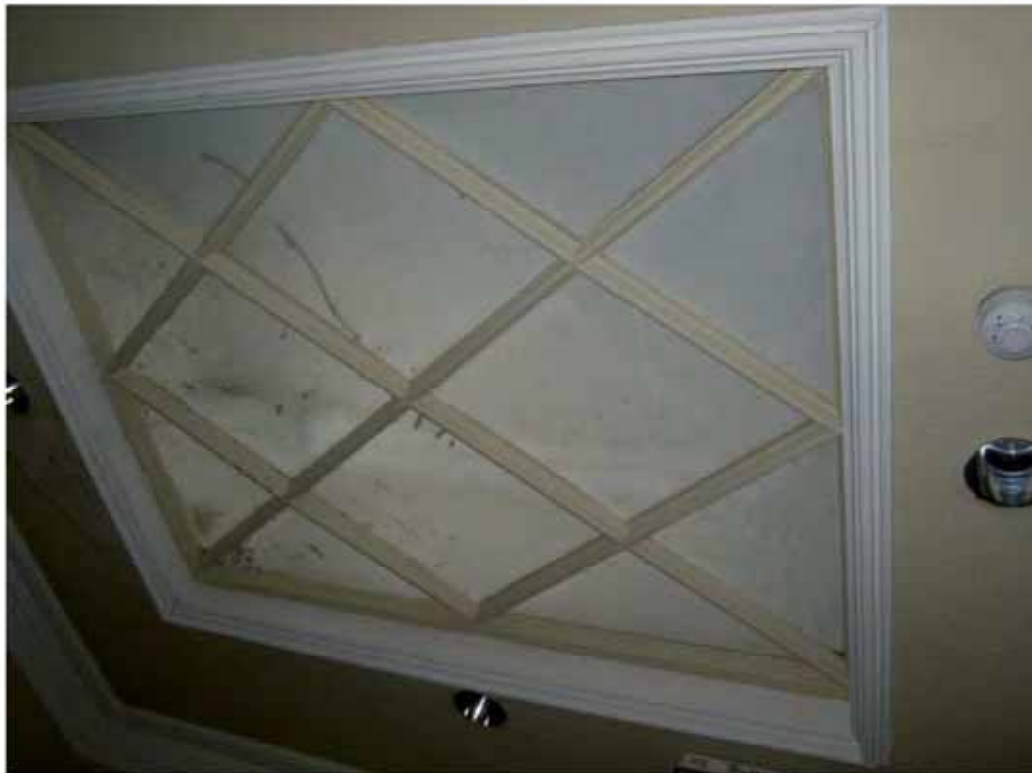
- 4.5.2 **Room F2:** this forms the upper part of the corridor and staircase. The stairs are as per the ground floor, and have a large skylight comprising several rhomboid panels with a moulded surround (Plate 23). The ceiling is also decorated with a moulded cornice. There are doorways in every elevation, most with original ogee moulded surrounds and modern doors. One to the north, on the landing midway up the stairs, is an original six-panel door with more heavily moulded surround (Plate 24), and there is another on the west side of the north elevation, also with what is probably an original surround and six-panel door. At the north end of the room there is a tall cupboard built into the return of the wall with original panelled and moulded doors. There is also a small vestibule forming a toilet at the far north end, which has an entirely modern finish except for a moulded cornice that respects the size of the room. There is a modern wall at the north end forming a cubicle and a small four-light hinged casement window in the north wall.

Plate 23: Skylight in Room F2

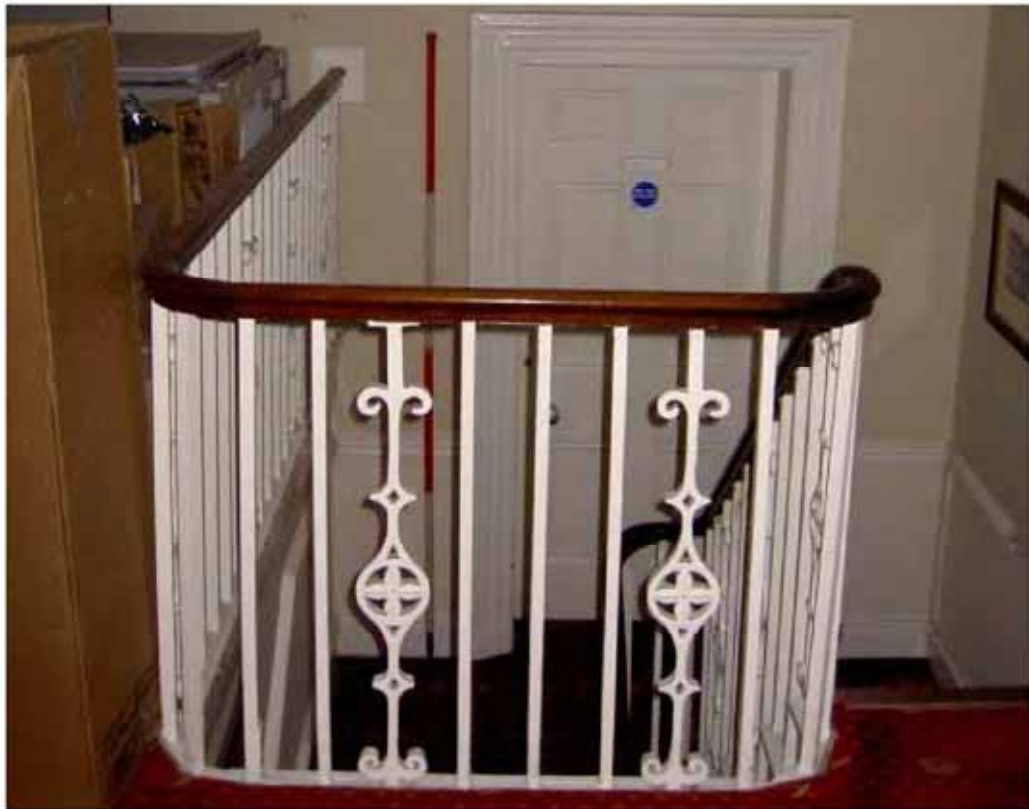
Plate 24: Staircase in Room F2

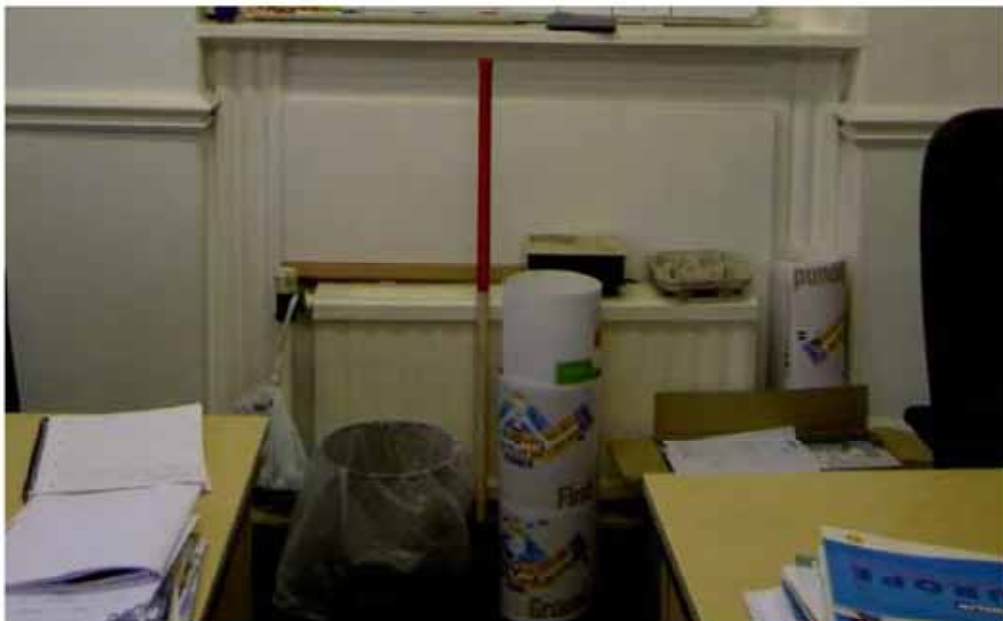
- 4.5.3 **Room F3:** this room has a plaster ceiling with roll-moulded cornice, moulded dado and skirting. There is a beam orientated north/south in the south-east corner. The two 12-light sash windows in the south elevation have splayed plain timber-panelled jambs with moulded surrounds. The west elevation has a recess with fireplace, the recess having moulded jambs and plain moulding (Plate 25). The doorway is in the north-east corner, and has the original surround but a modern door.

Plate 25: Fireplace in west elevation of Room F3

- 6.4.3 **Room F3:** this contains an original fireplace in good condition on the west side, original windows to the south, and a moulded cornice, all of which should be retained.

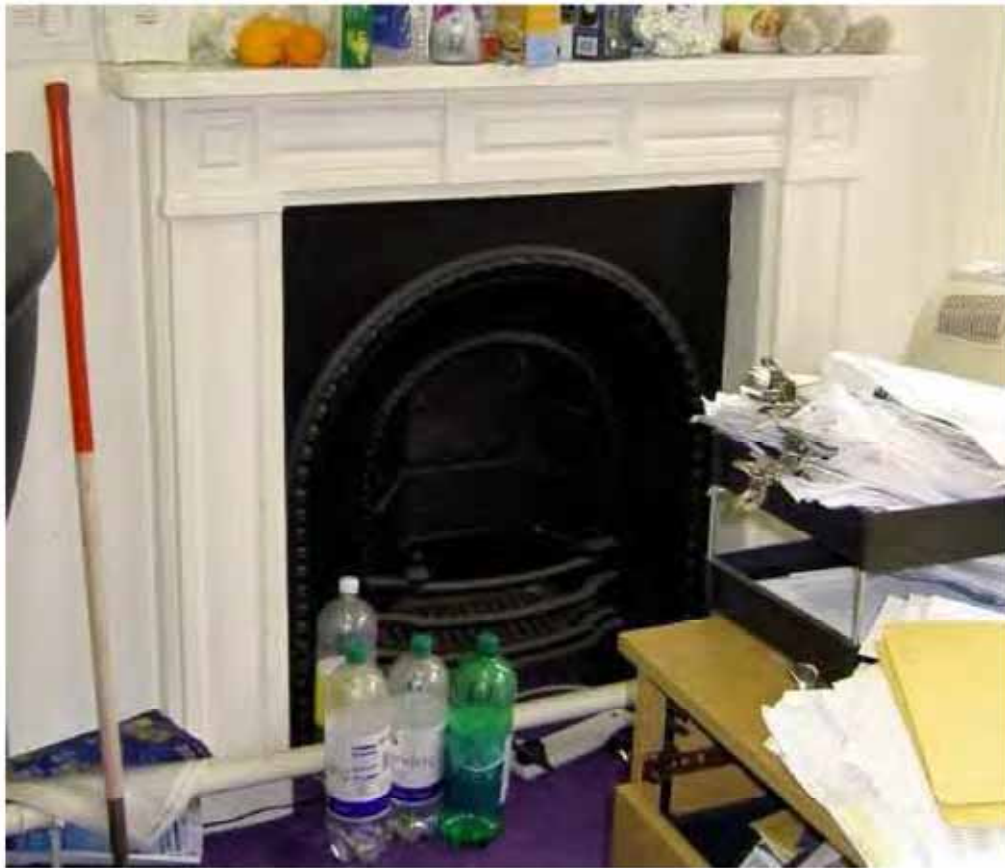
- 4.5.4 **Room F4:** the ceiling is plain with no cornice, and the skirting board is moulded. The door is in the west elevation and has a moulded surround. The east elevation contains a bay window which has moulded sash windows on all three sides. The windows are fitted with half-height iron railings. There is a fireplace situated at the east end of the north elevation with a stone surround and an iron insert and grate (Plate 26). The surround is decorated with raised geometric roundels and columns.

Plate 26: Fireplace in the north elevation of Room F4

- 6.4.4 **Room F4:** this has an original fireplace, also in good condition, in the north-east corner, which should also be retained.
- 6.4.5 **Room F5:** this has an original cornice that should be retained.

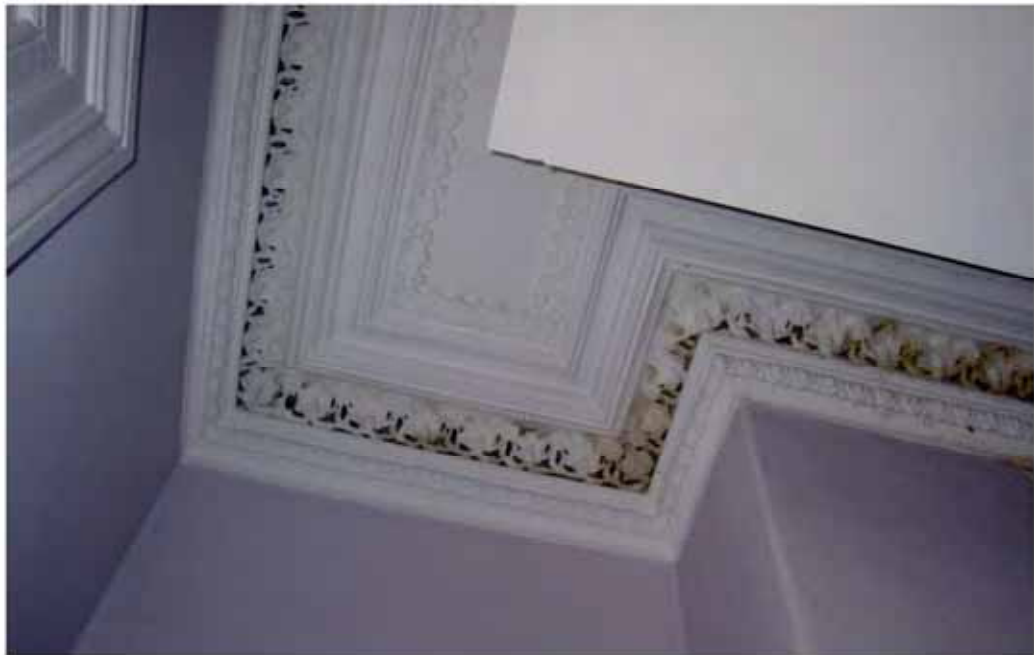
- 4.5.6 **Room F6:** this is a large room with an elaborate ceiling, although it has been heavily modernised. There is an original plaster cornice decorated with egg and dart and floral motifs and mouldings (Plate 27). A modern suspended ceiling has been added in the central part of the ceiling beyond this cornice. There is a boxed radiator against the north elevation and one below the east window and boxing (presumably for pipes) at floor level on the south wall. There is a narrow three-light window at west end of the north elevation, the top light of which has a round arch. In the east elevation there is a large 10-light window, also with an arched top and both windows have moulded surrounds. There is modern board cladding the west elevation and a large chimneybreast at the east end of the south elevation. At the west end of the south elevation there is a doorway to the landing (Room F2), which has its original moulded surround and six-panel door.

Plate 27: Decorative cornice in Room F6

- 6.4.6 **Room F6:** this has a very elaborate cornice, which should be repaired and retained. The large window to the east is a significant architectural feature, although the casements within it are probably not original. Ideally, the modern suspended ceiling, wall coverings, and boxing for pipes should be removed.

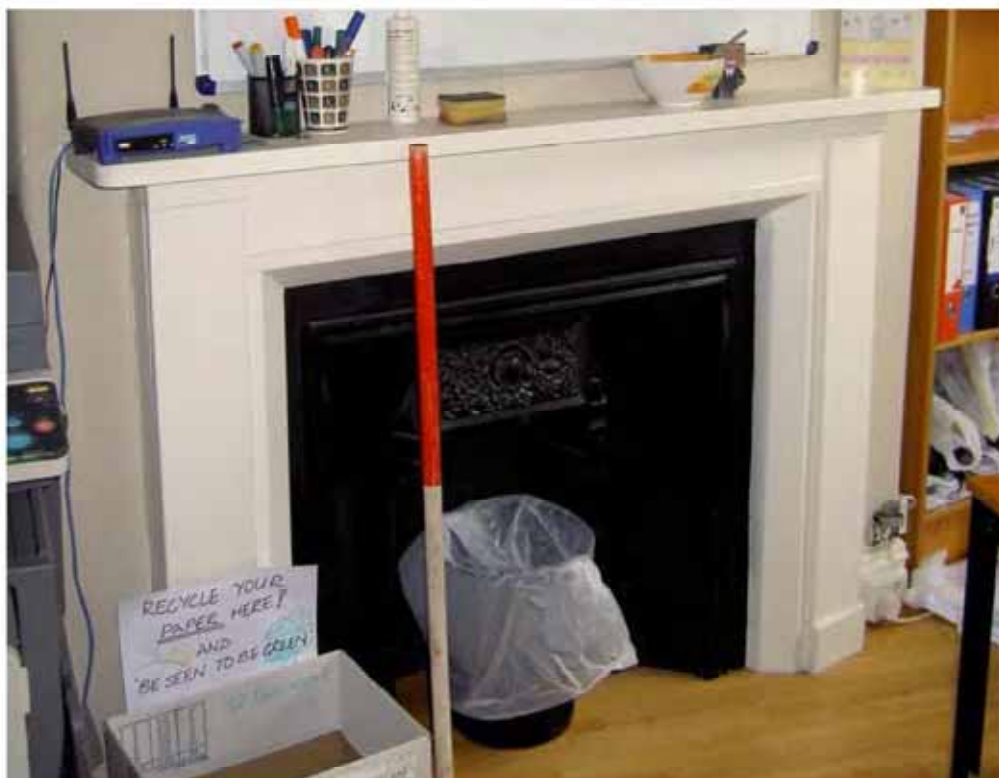
Plate 28: Fireplace in the west elevation of Room F7

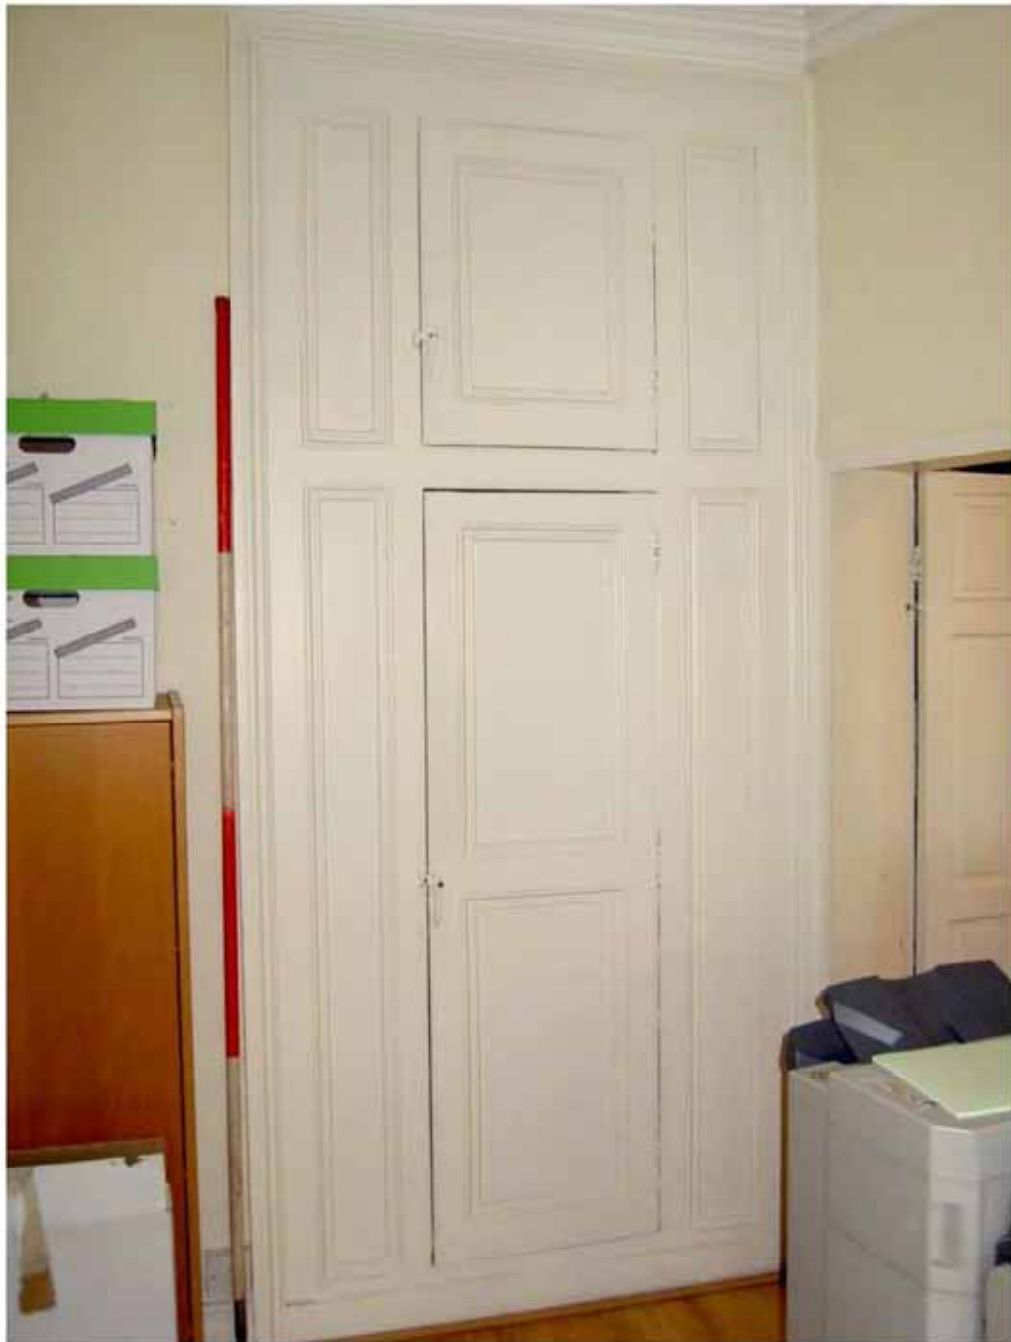
Plate 29: Built-in cupboard at the south-west corner of Room F7

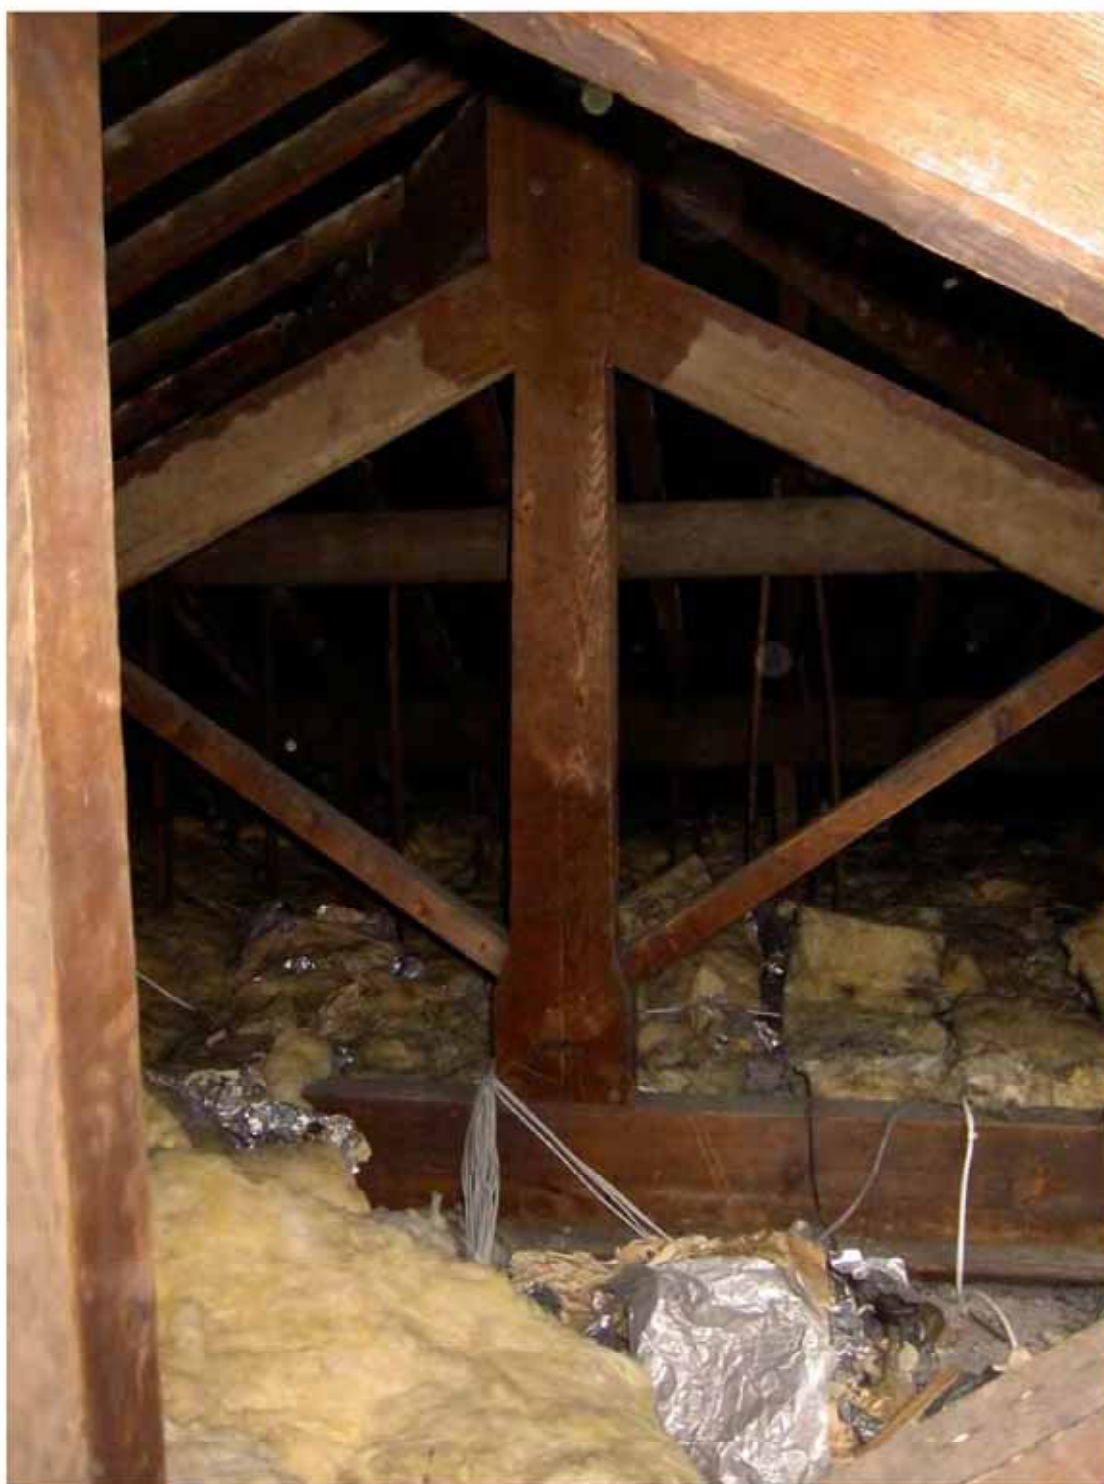
Plate 31: King-post truss in the roof space above Rooms F1-F5

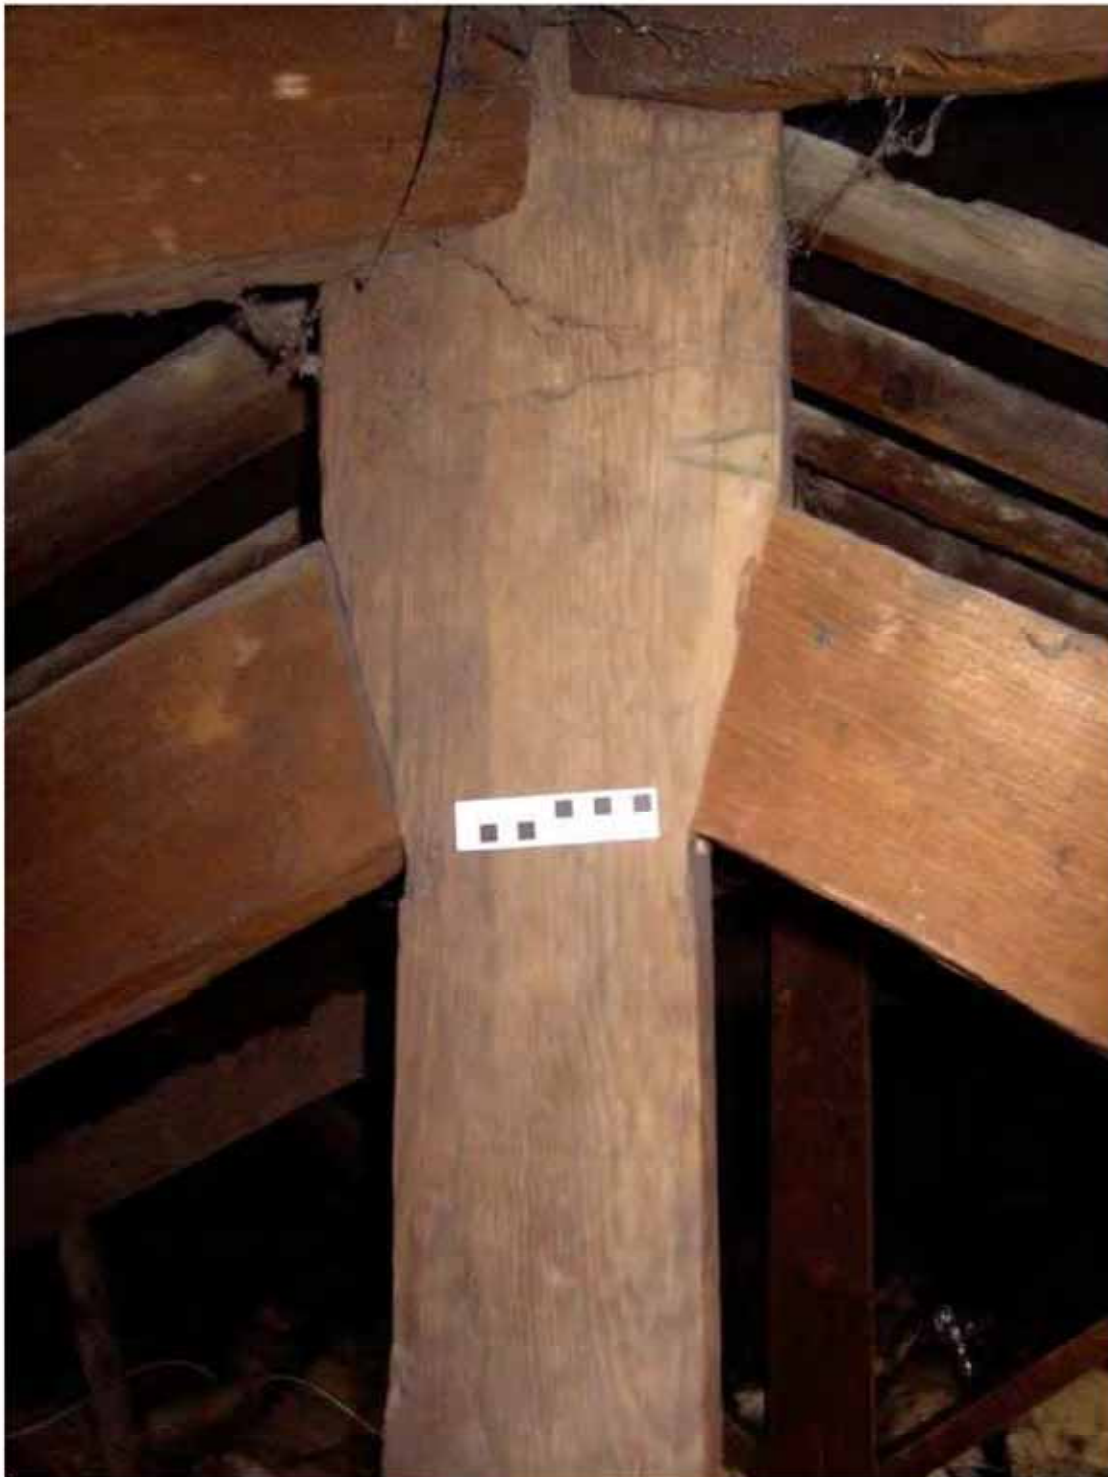
- 4.6.1 **Roof space over Room F7 and F8:** this is very plain, with no trusses just beams and rafters. The timbers are of all hand-sawn red pine, one purling per pitch.
- 4.6.2 **Roof space over Room F6:** this roof space reveals a basic construction of one purling per pitch with a truss at the east end and simple tie beam, utilising similar timber to that mentioned above.
- 4.6.3 **Roof space over Rooms F1-F5:** this roof is more complex, with two king posts slope-joggled for angled braces with carpenter's marks, in form of Roman numerals 'I' and 'II'. The king post is secured to the tie beam by a bolt from beneath. The timbers are also red pine and hand sawn and there are two purlins per pitch (Plate 31). There are Baltic timber marks on the east face on the eastern truss in the form of inscribed curvilinear lines (Plate 32).

Plate 32: Baltic timber marks on one of the king post trusses

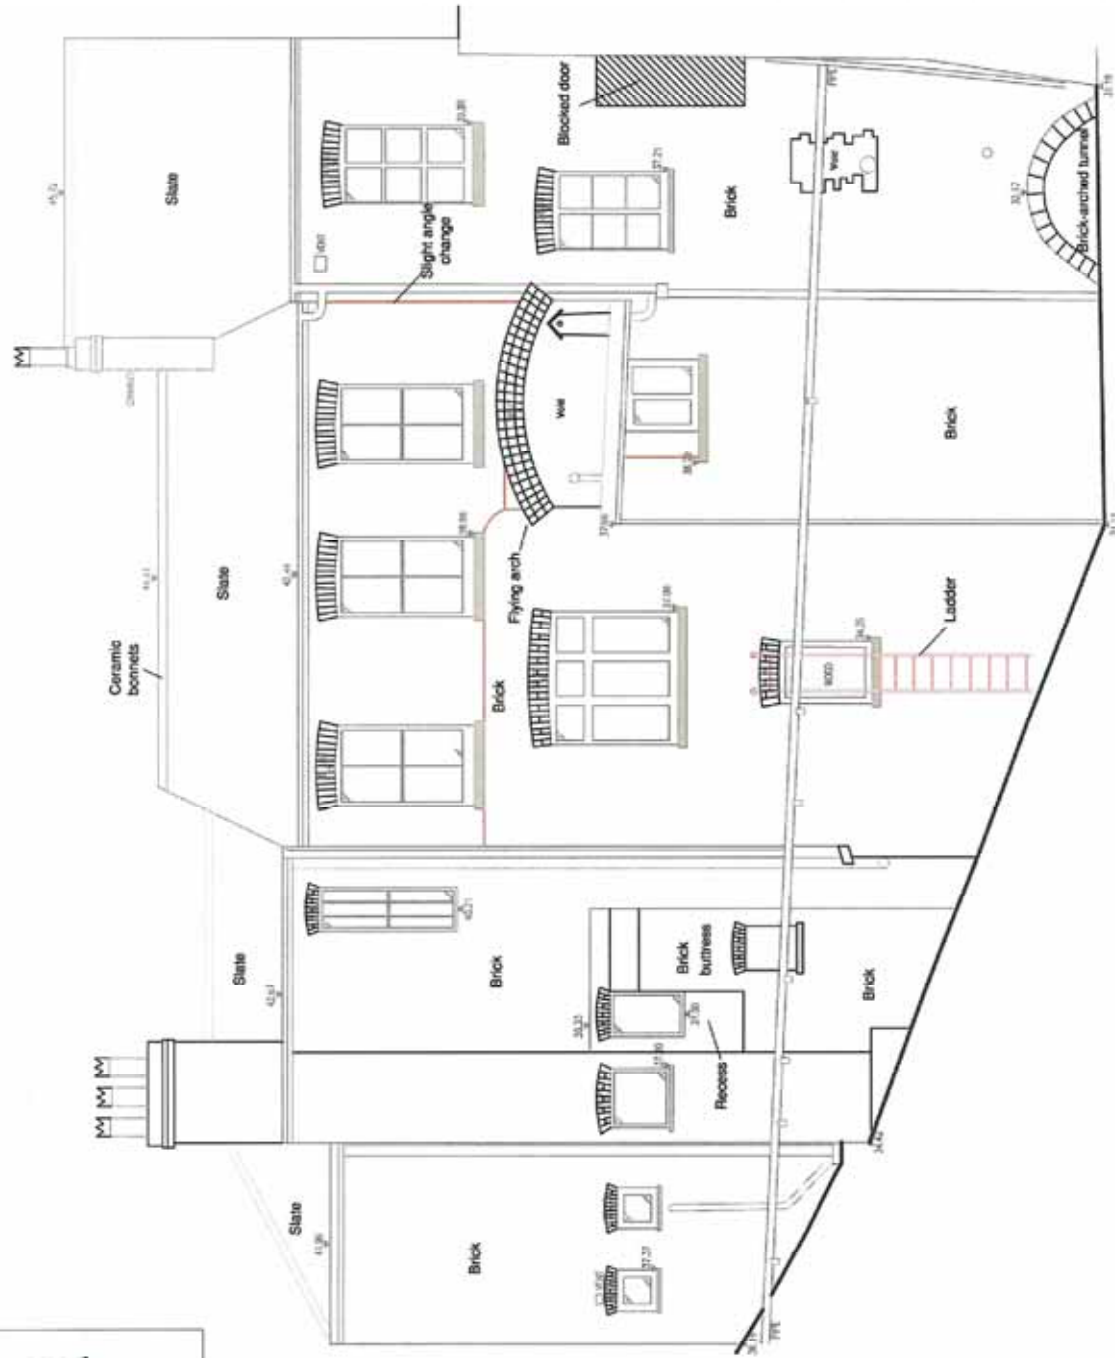
Figure 7: Hartdale House, north-facing elevation (Elevation A), based on a measured survey carried out by Malcolm Hughes Land Surveyors

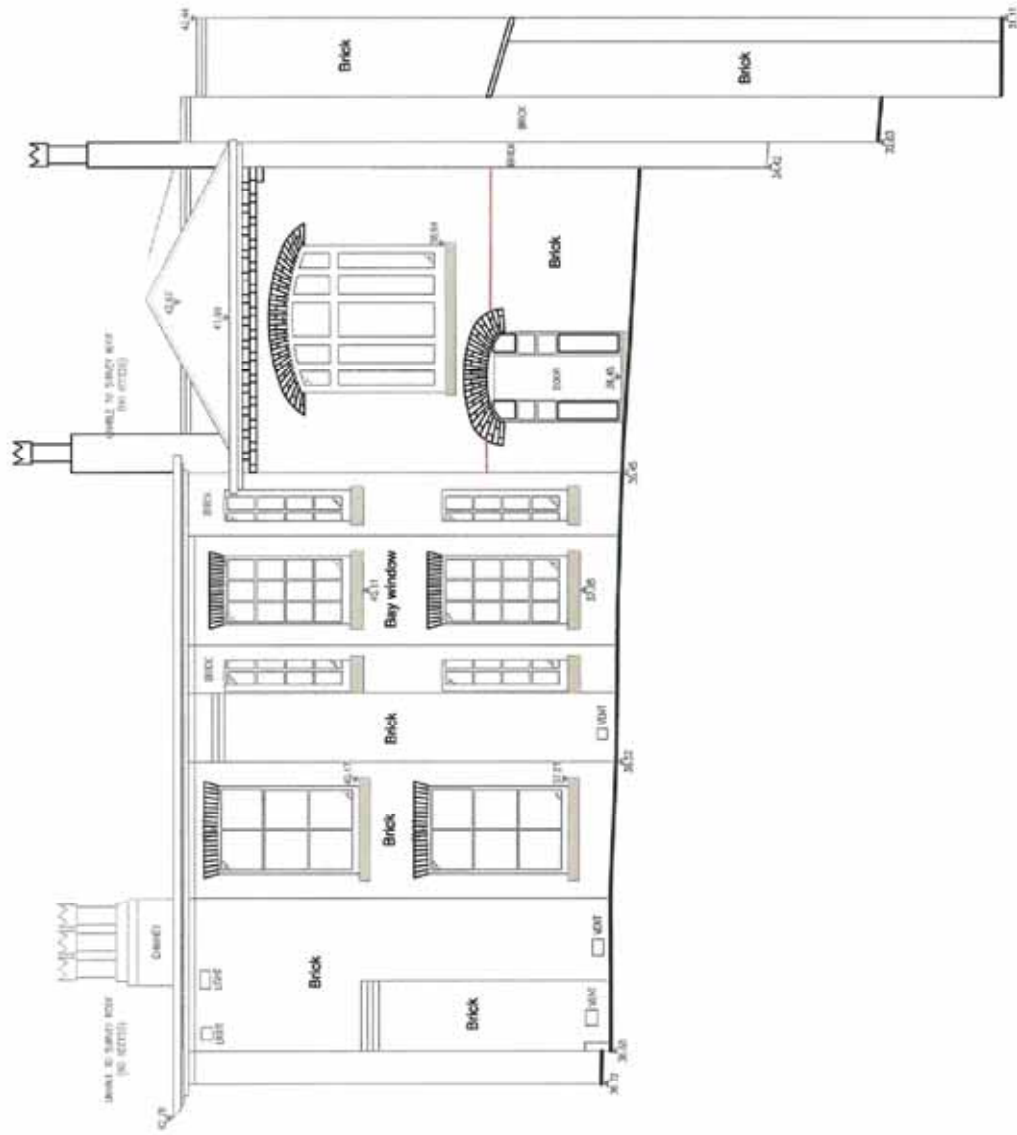
Figure 8: Hartdale House, east-facing elevation (Elevation B), based on measured survey carried out by Malcolm Hughes Land Surveyors

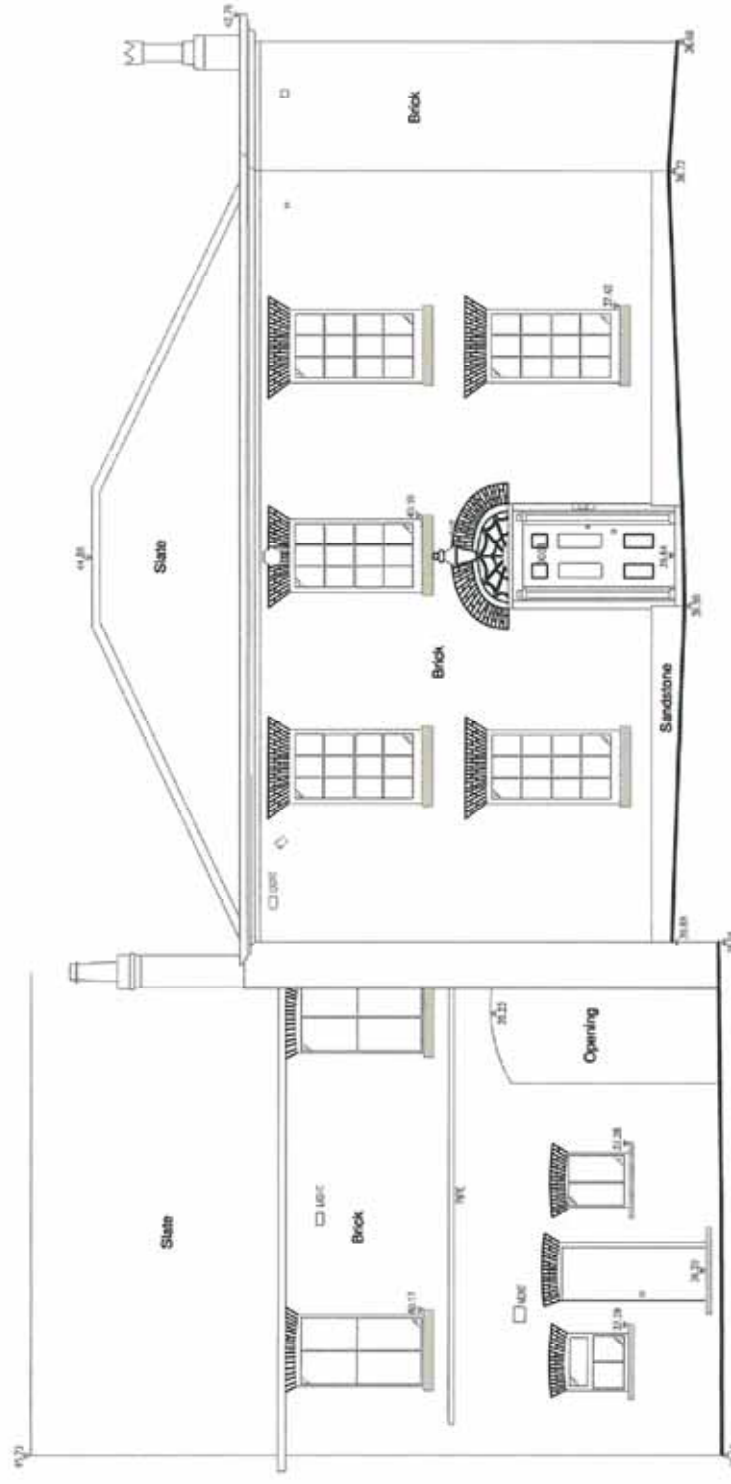
Figure 9: Hartdale House, south-facing elevation (Elevation C), based on a measured survey carried out by Malcolm Hughes Land Surveyors

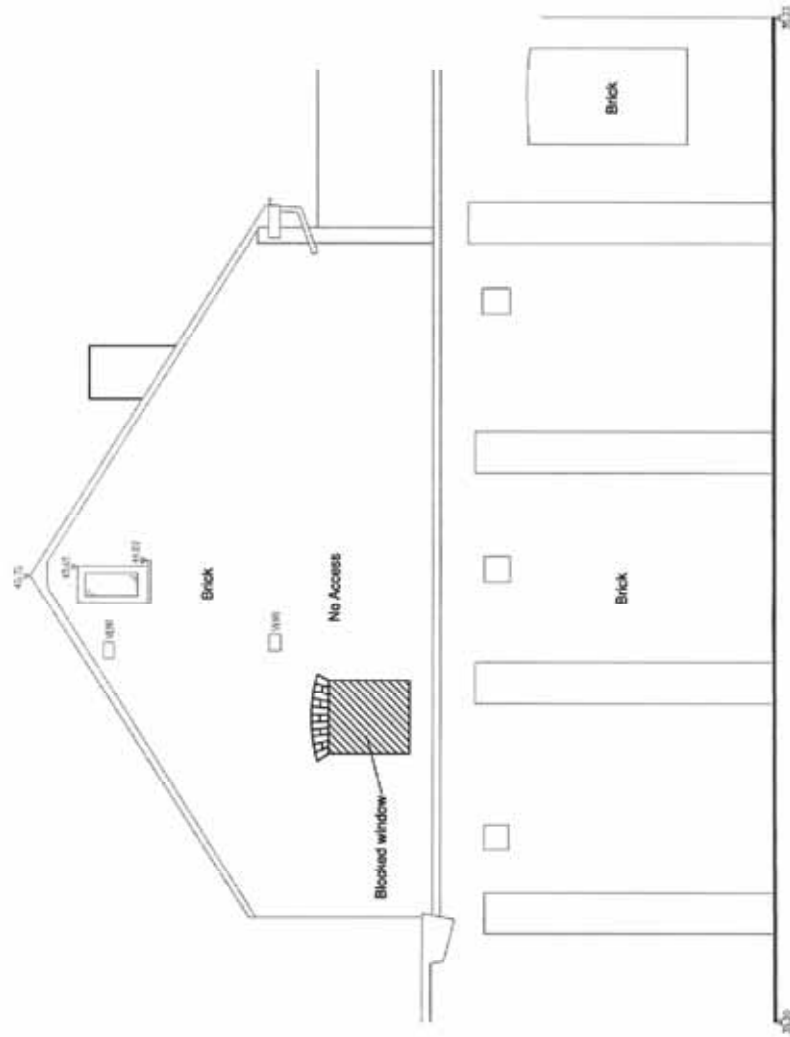
Figure 10: Harddale House, west-facing elevation (Elevation D), based on a measured survey carried out by Malcolm Hughes Land Surveyors

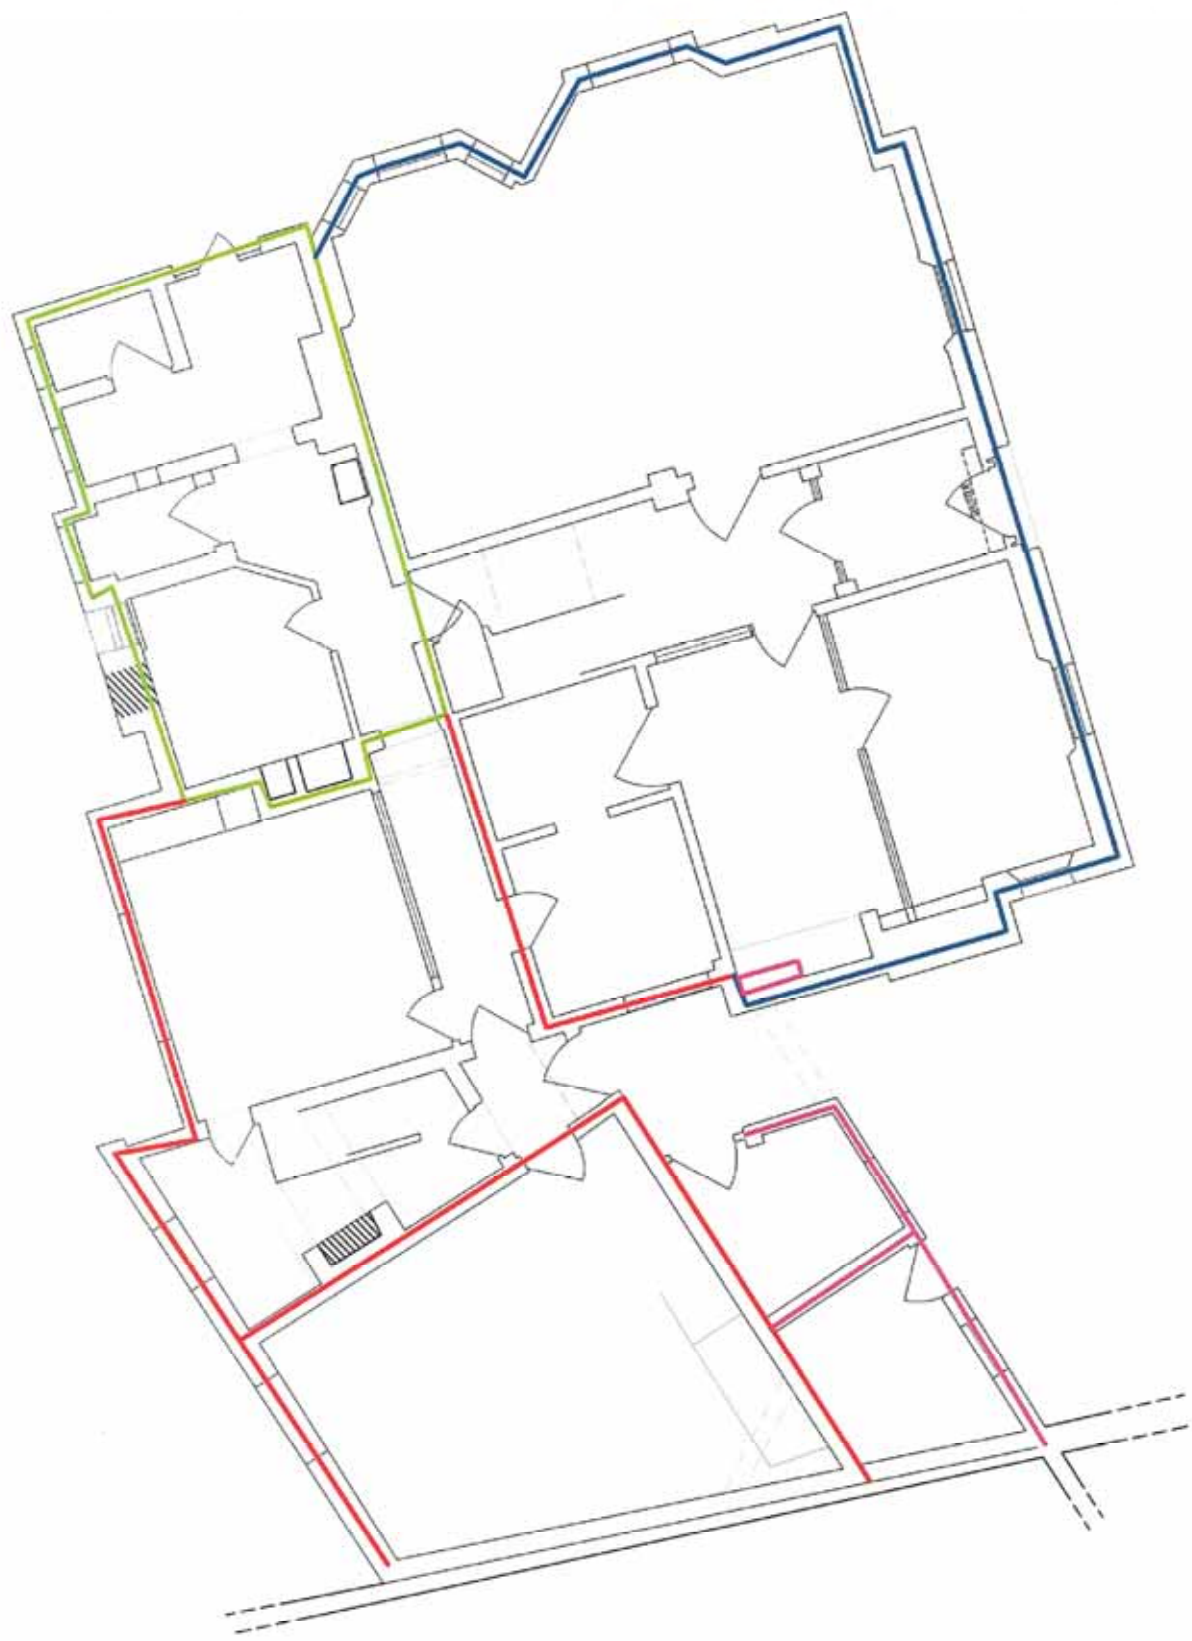
Figure 14: Handale House, phased development, based on a measured survey carried out by Malcolm Hughes Land Surveyors
