STOKER'S GARAGE, KIRKLAND, KENDAL CUMBRIA

Archaeological Desk- Based Assessment, Evaluation and Photographic Recording

Oxford Archaeology North

Issue No: 2007-8/621
OA North Job No: L9756
NGR: SD 5160 9203
Planning Ref: SL/06/0197

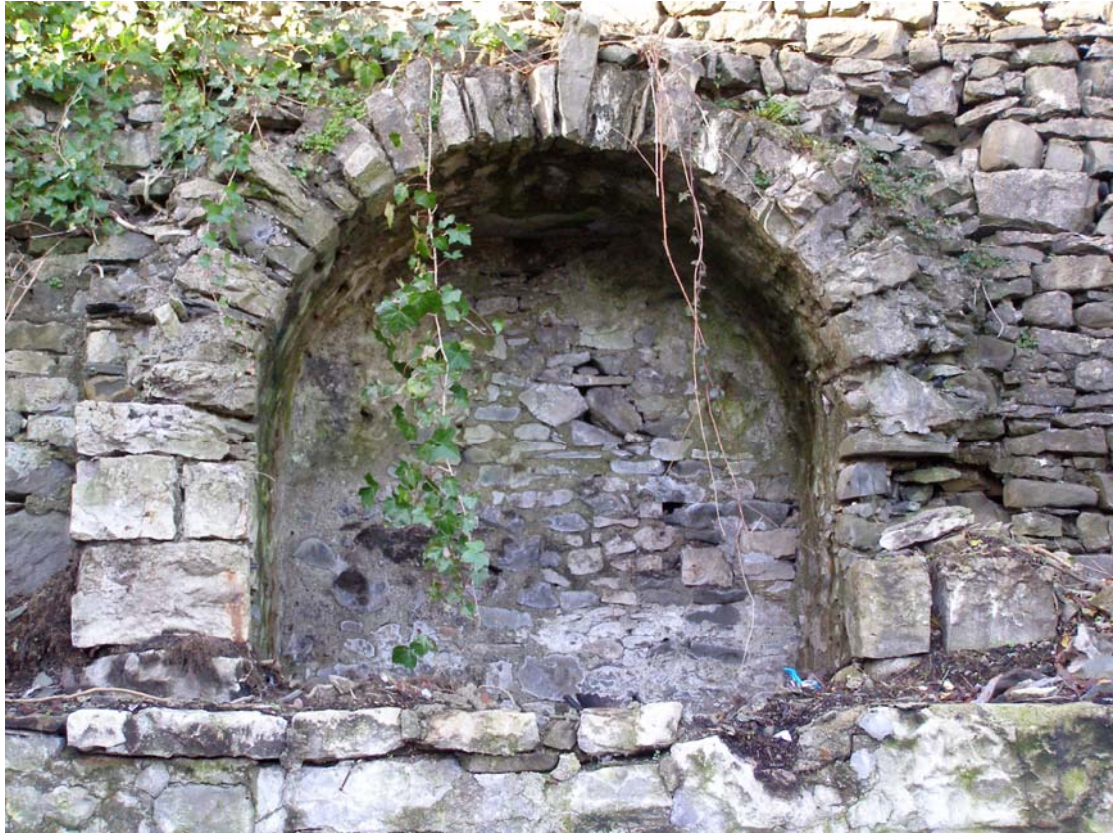
Plate 15: Detail of southern arch, east-facing elevation

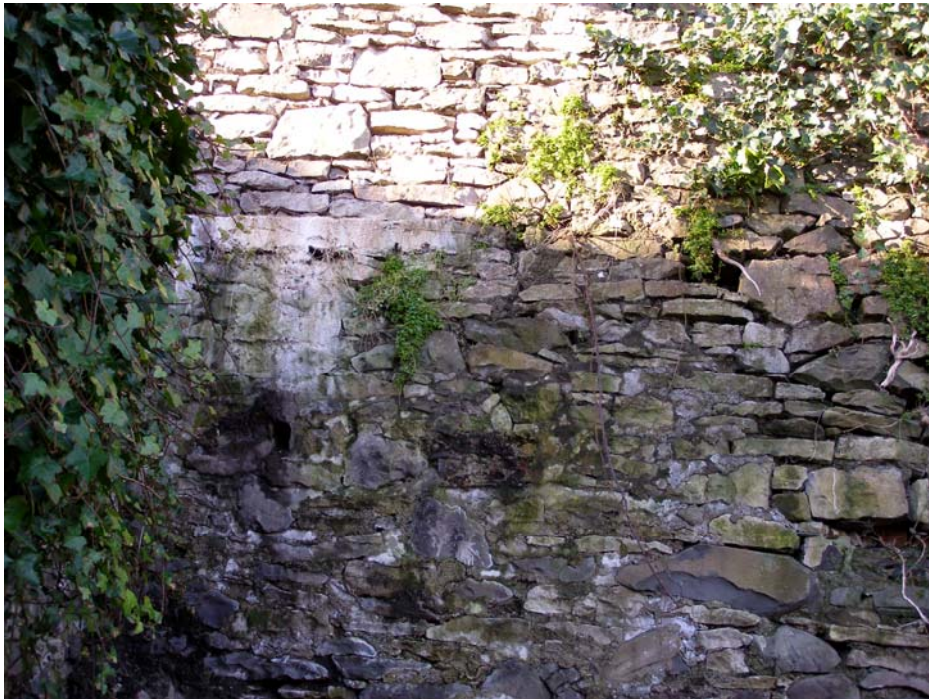
Plate 16: East-facing elevation of boundary wall, southern end showing the join between the earlier and modern wall

Plate 16: East-facing elevation of boundary wall, southern end showing the join between the earlier and modern wall.
